Proposed Taronga Wildlife Hospital, Sydney
Nutrition Centre
Heritage Impact Assessment

FINAL REPORT
November 2021

for the Taronga Conservation Society Australia

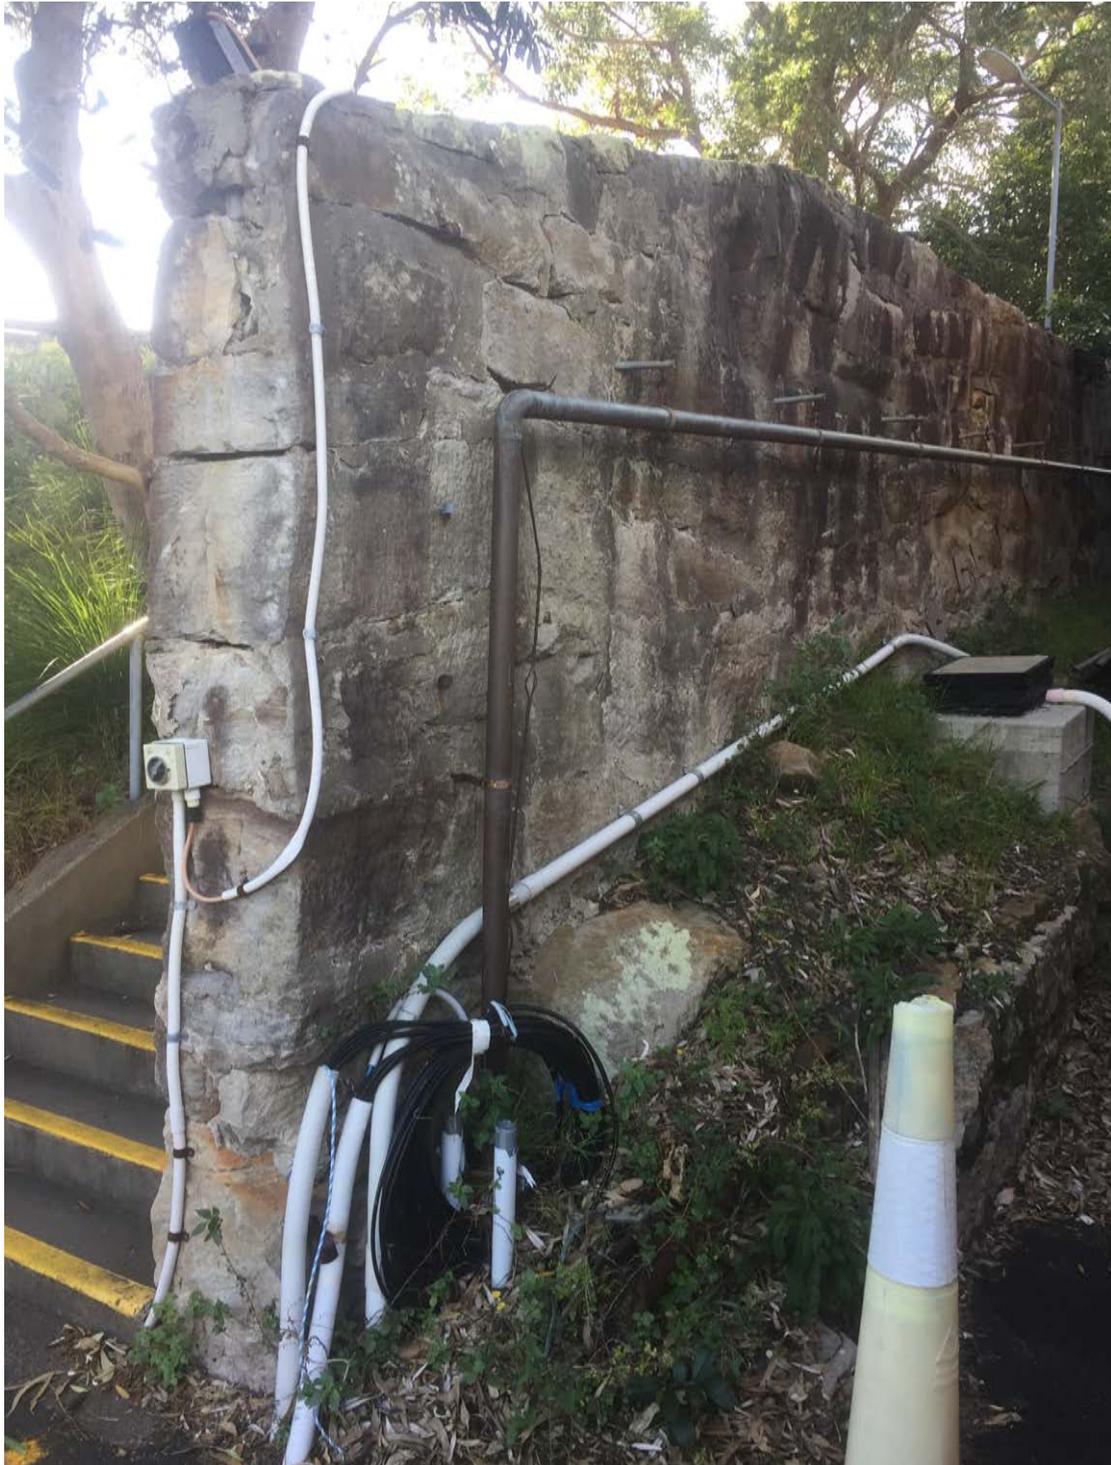
Figure 48 The section of the northern boundary wall within the study site showing its construction over the sandstone bedrock and with a plethora of fixtures and services connected to it. A flight of concrete steps and a landing have been built against it on the northern side. Along with all of the zoo boundary stone walls, this section has been the subject of a recent structural engineering investigation by Sumeer Gohil of Shreeji Consultant (Consulting Engineers). The 2017 report (draft) indicated that this section (referenced to engineering photograph 3474) is in good condition though recommended that the various redundant fixings and biological growth (including a fig tree seedling) should be removed within several years as part of its routine cyclical maintenance (not undertaken to date). The report also recommended the wall be stabilised using a tie-rod and that all non-redundant fixings be replaced with non-ferrous fixings. None of these recommendations appear to have been undertaken to date.

Both 2017 and more recent structural assessments of the remnant boundary wall section have involved recommendations for the conservation of the structure and there is an opportunity to undertake any necessary conservation actions for the remnant wall through the current building program.

This recommendation further reinforces the need to address the conservation of the remnant stone wall section by removing later accretions to both sides and undertaking the various maintenance works advised previously by the consultant structural engineer.

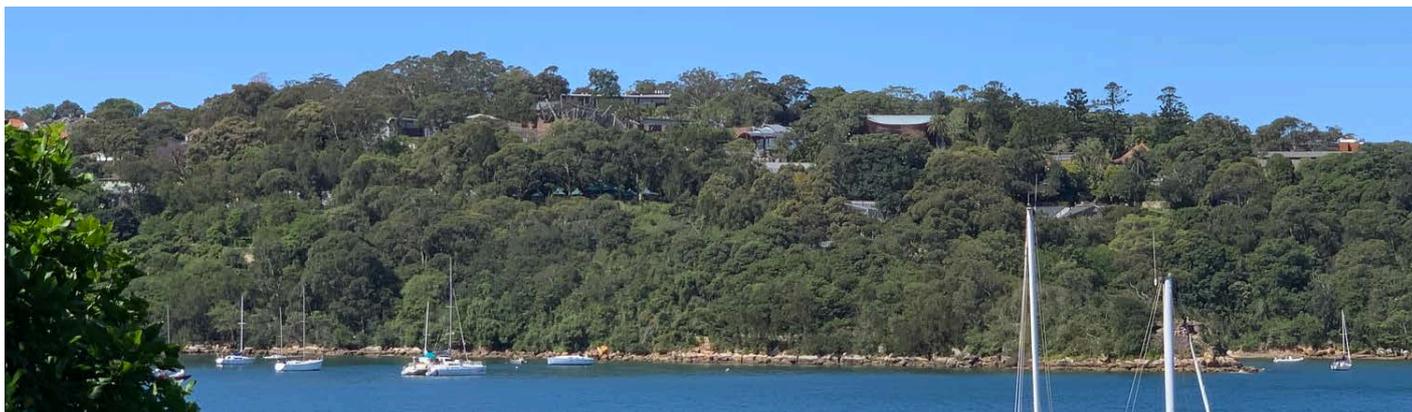
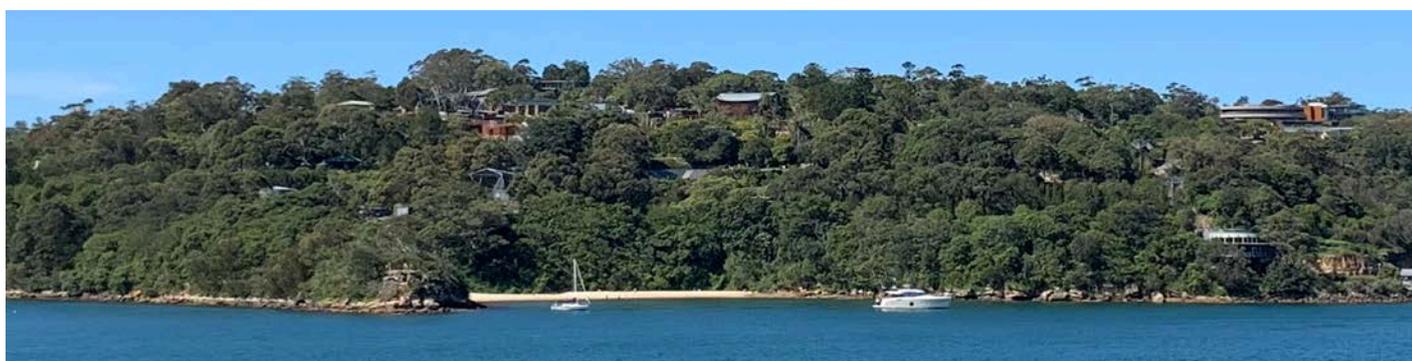
Figure 51 ABOVE Part of the zoo campus from Cremorne Reserve. **Figure 52** BELOW View from Robertson Point, Cremorne Reserve with an increasing prevalence of buildings within the erstwhile forested landscape setting of the zoo campus. All of these views illustrate the importance of existing mature site vegetation as part of the setting of the zoo and the specific study site as well as the need to reinforce this vegetation wherever possible. (Images for Figures 53 to 55 courtesy of Dr Anna Britton)

From numerous locations along the eastern Cremorne Point reserve it is possible to see parts of the study site beyond the tall poles and mesh of the Chimpanzee Park and Serpentina roofline (Figures 50 to 52). The line of Maiden's Gums is clearly visible along the skyline in these views indicating that these plantings are now a prominent and important feature of the zoo landscape and contribute to the zoo's cultural setting. The other site element contributing to the zoo's cultural setting is the remnant 1920s zoo perimeter wall section. Both the remnant wall section and most of the line of gums are proposed for retention (pending further safety risk assessment).
