REPORT TO
ERILYAN PTY LTD

ON
DETAILED (STAGE 2) SITE INVESTIGATION

FOR
**PROPOSED NORTHSIDE WEST CLINIC STAGE 2
DEVELOPMENT**

AT
23-27 LYTTON STREET, WENTWORTHVILLE, NSW

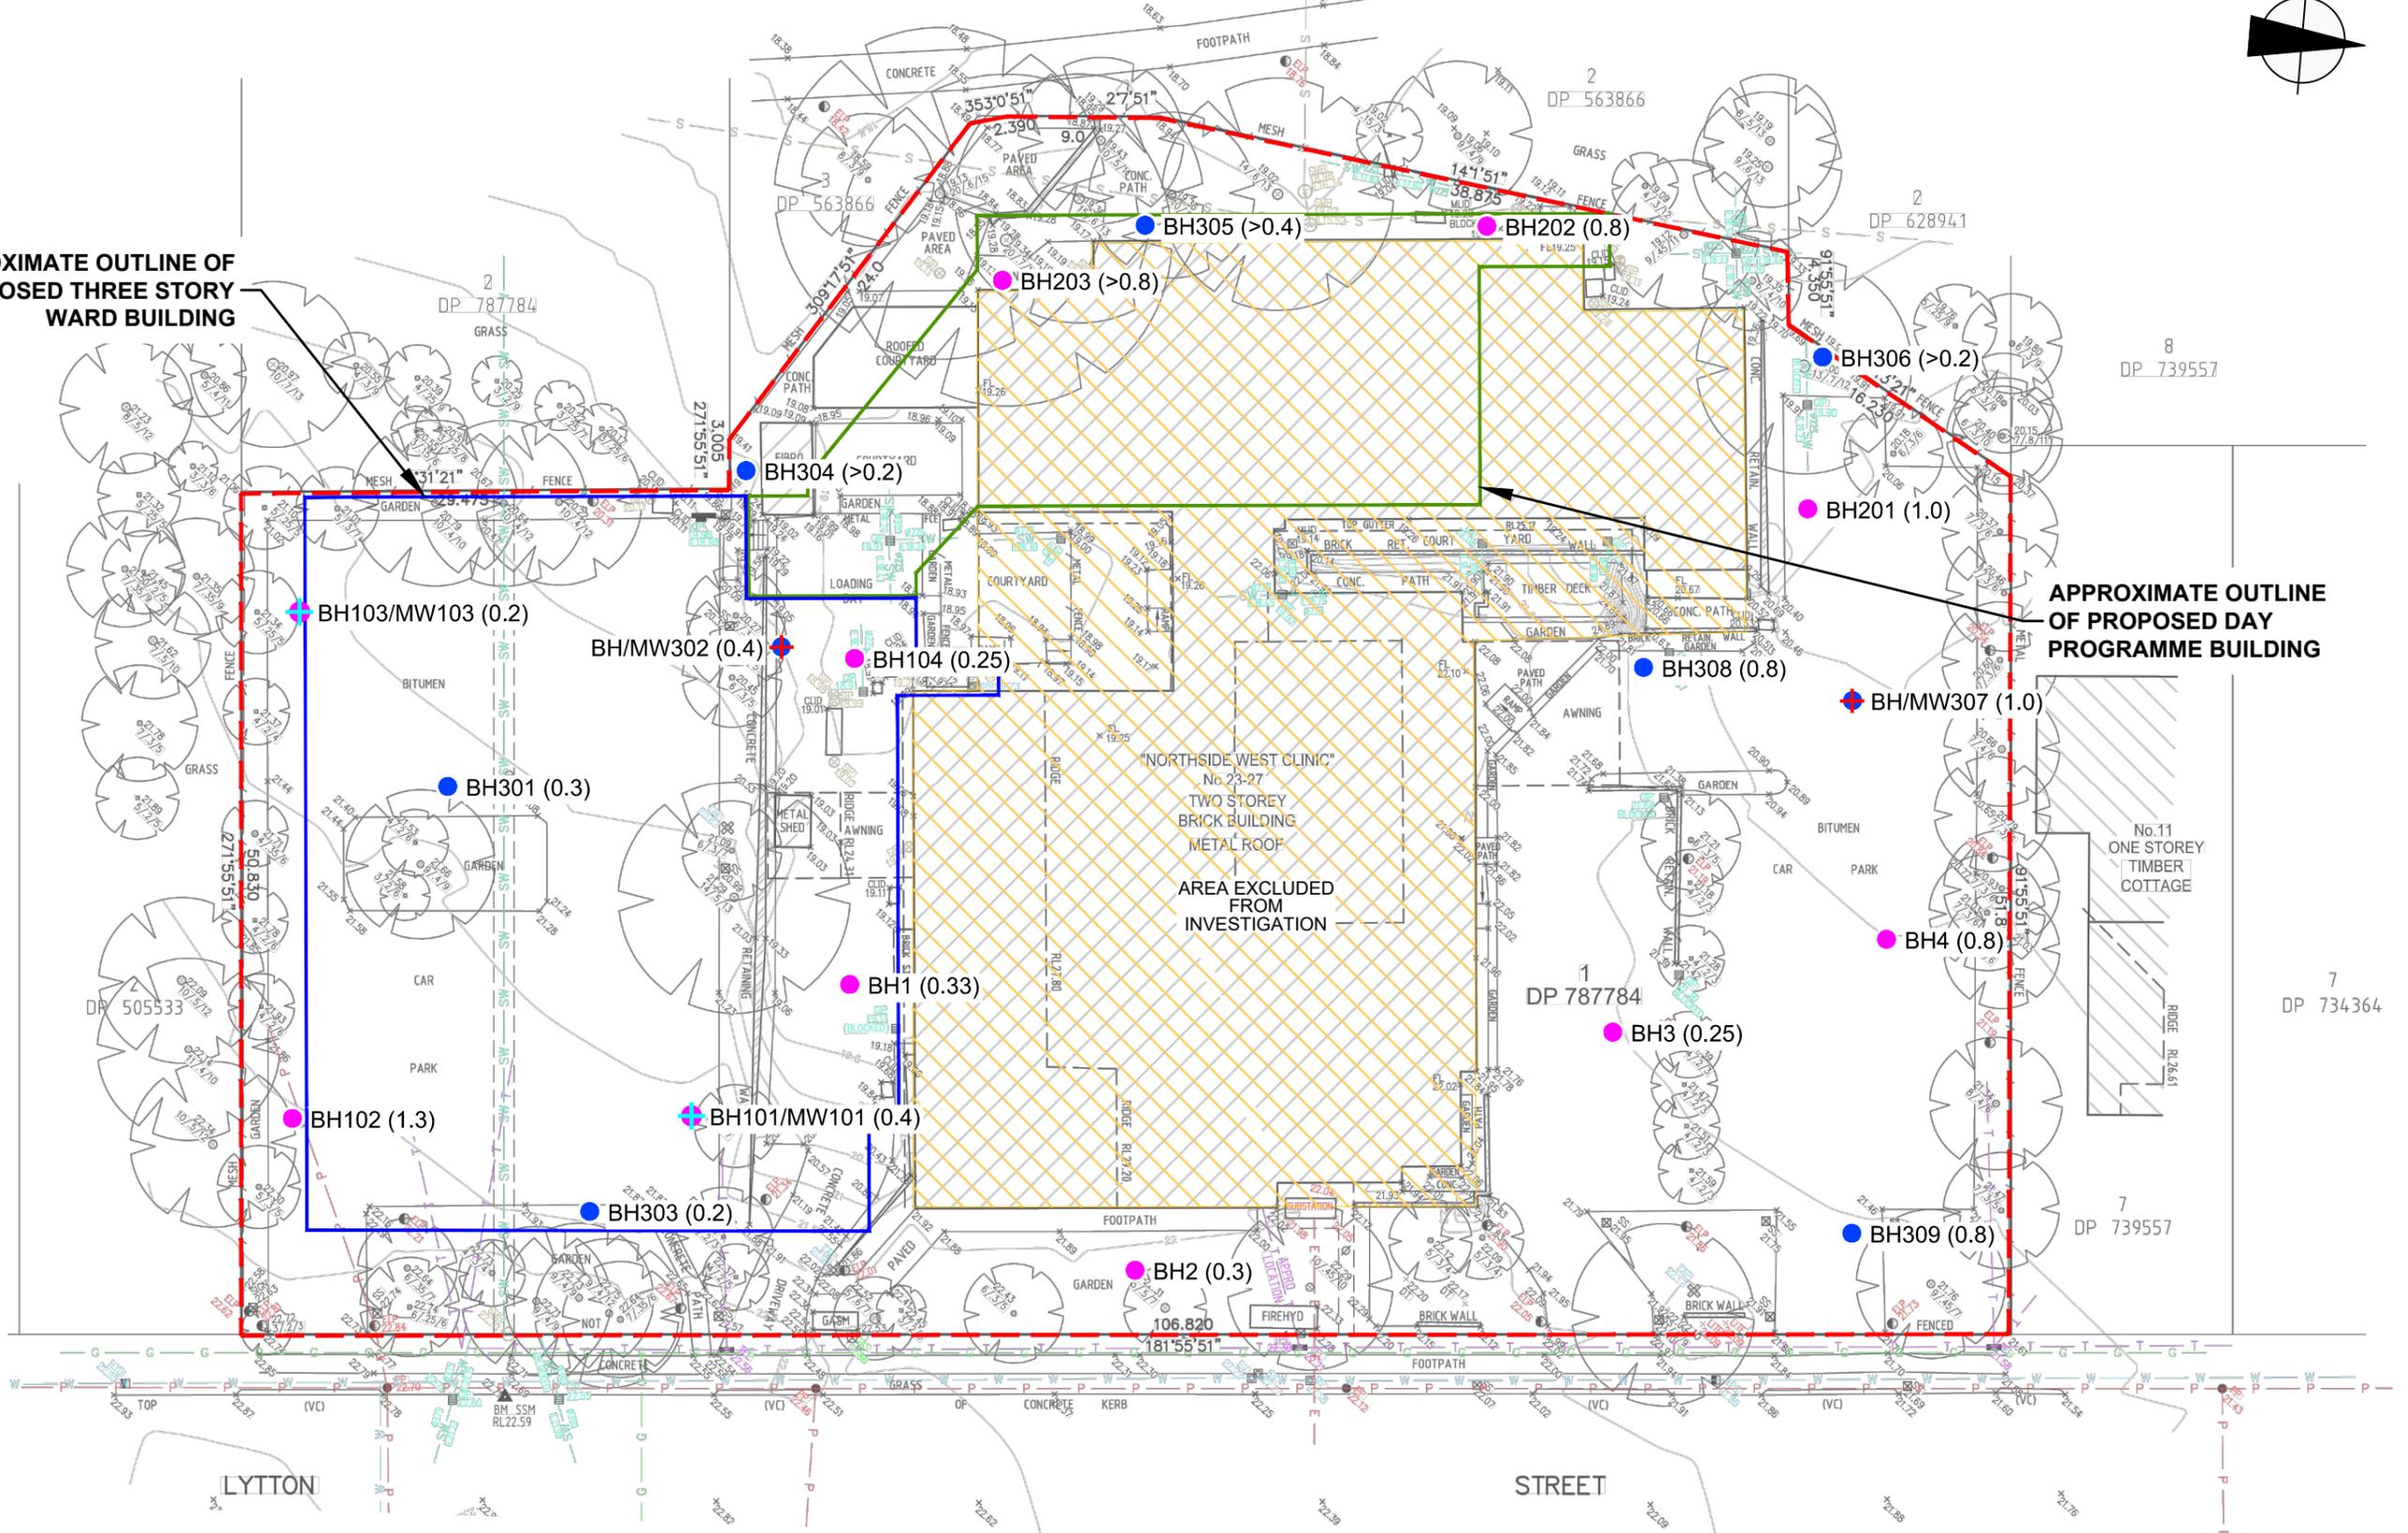
Title: SAMPLE LOCATION PLAN	
Location: 23-27 LYTTON STREET, WENTWORTHVILLE, NSW	
Project No: E27318PH	Figure No: 2
JKEnvironments

- APPROXIMATE SITE BOUNDARY
- BH(Fill Depth) PREVIOUS BOREHOLE LOCATION, NUMBER AND DEPTH OF FILL (m)
- BH/MW(Fill Depth) PREVIOUS BOREHOLE AND GROUNDWATER MONITORING WELL LOCATION, NUMBER AND DEPTH OF FILL (m)
- BH(Fill Depth) DSI BOREHOLE LOCATION, NUMBER AND DEPTH OF FILL (m)
- BH/MW(Fill Depth) DSI BOREHOLE AND GROUNDWATER MONITORING WELL LOCATION, NUMBER AND DEPTH OF FILL (m)

Erilyan ('the client') commissioned JK Environments (JKE) to undertake a Detailed (Stage 2) Site Investigation (DSI) for the proposed Northside West Clinic Stage 2 development at 23-27 Lytton Street, Wentworthville, NSW ('the site'). The purpose of the investigation is to meet the recommendations contained in the Preliminary Site Investigation (PSI) report (ref: E27318PHrpt). The DSI will focus on sampling in the development areas outside the main building footprint, where access is reasonable. The site location is shown on Figure 1 and the investigation was confined to the site boundaries as shown on Figure 2.

Erilyan ('the client') commissioned JK Environments (JKE) to undertake a Detailed (Stage 2) Site Investigation (DSI) for the proposed Northside West Clinic Stage 2 development at 23-27 Lytton Street, Wentworthville, NSW ('the site'). The purpose of the investigation is to meet the recommendations contained in the Preliminary Site Investigation (PSI) report (ref: E27318PHrpt)¹. The DSI will focus on sampling in the development areas outside the main building footprint, where access is reasonable. The site location is shown on Figure 1 and the investigation was confined to the site boundaries as shown on Figure 2.

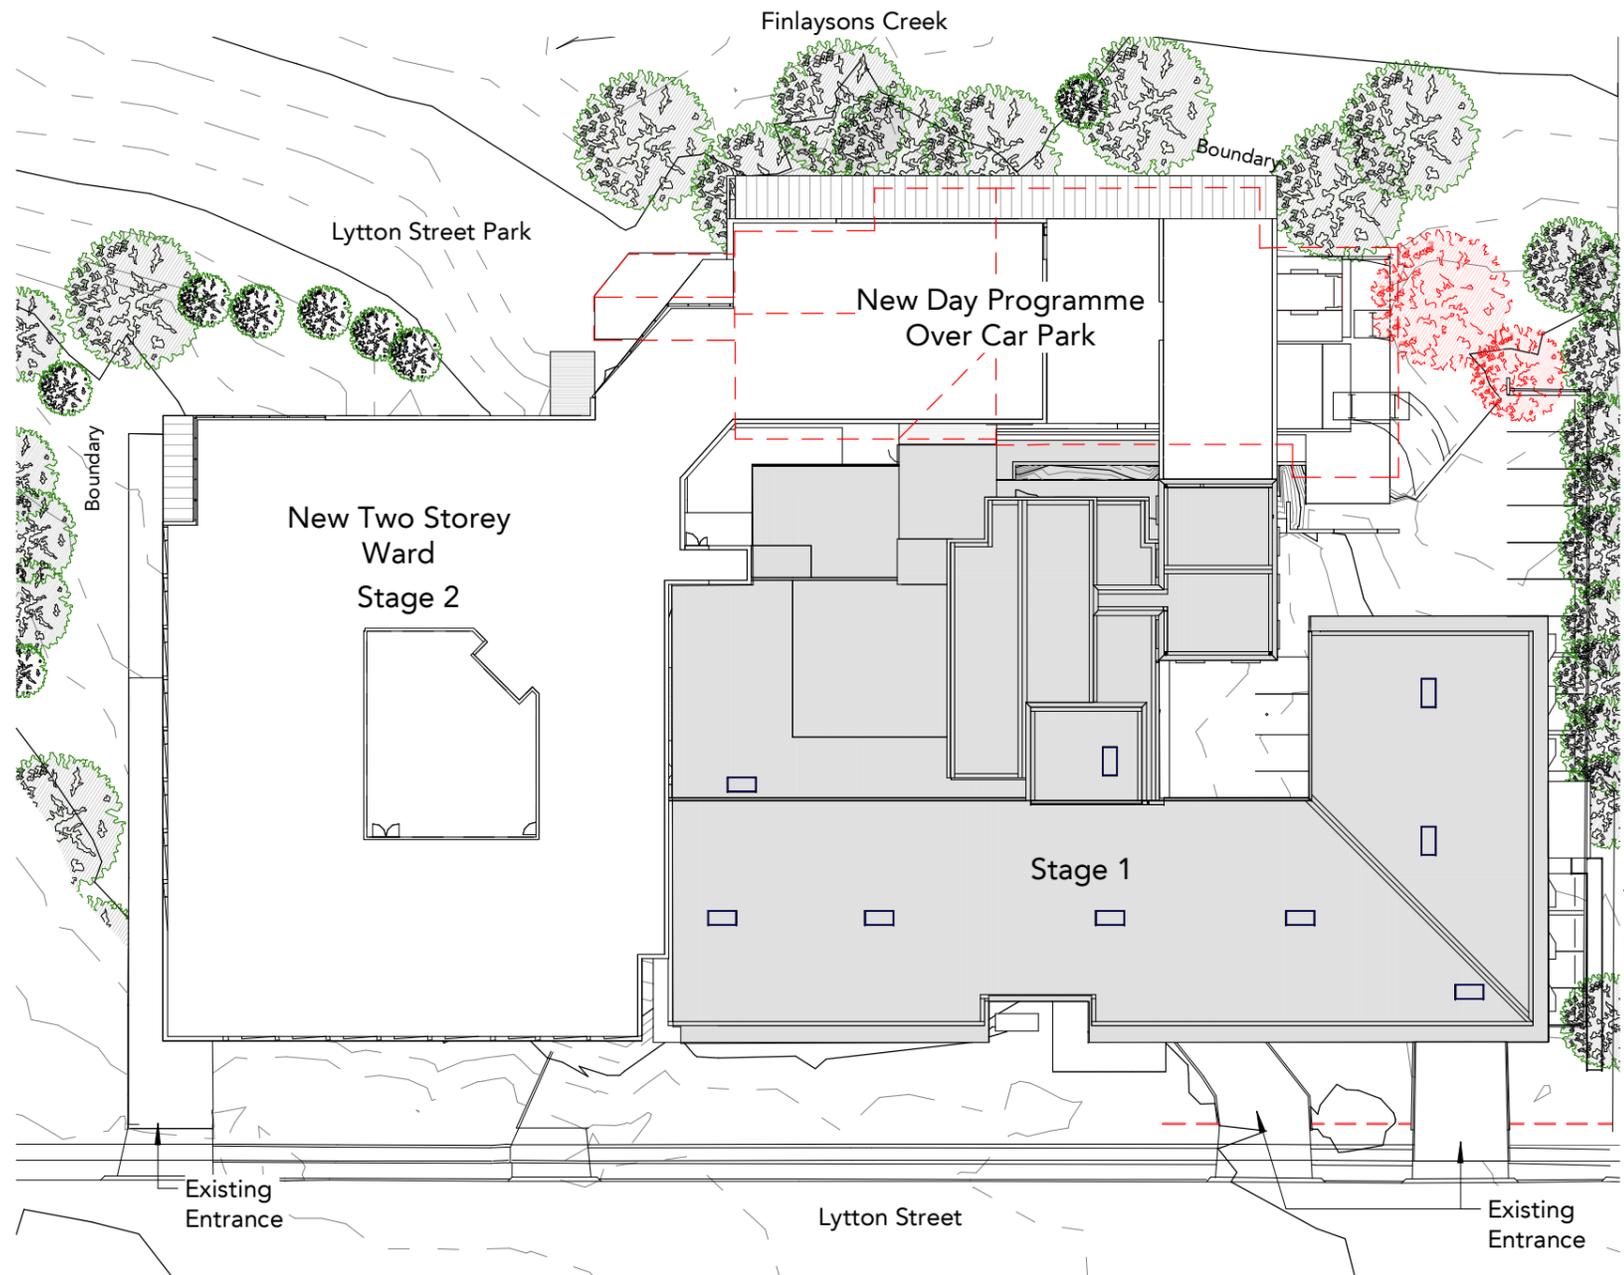
Title: Site Plan			
Project #: 903	Scale: 1 : 500 @A3	Drw: IK	Ckd: ZA
Drawing #: SK0010	Rev: P5

1 SK Site Plan
Scale: 1 : 500

The proposed undercroft car park on the western side of the site will be approximately at the existing ground level and we will only require minimal or no excavation or filling. Extensive landscaping is not proposed as part of this development, however, it is noted that existing garden beds and trees are to be retained. Please refer to the development plans attached in the appendices.
