REPORT TO
ERILYAN PTY LTD

ON
PRELIMINARY SALINITY ASSESSMENT

FOR
**PROPOSED NORTHSIDE WEST CLINIC STAGE 2
DEVELOPMENT**

AT
23-27 LYTTON STREET, WENTWORTHVILLE, NSW

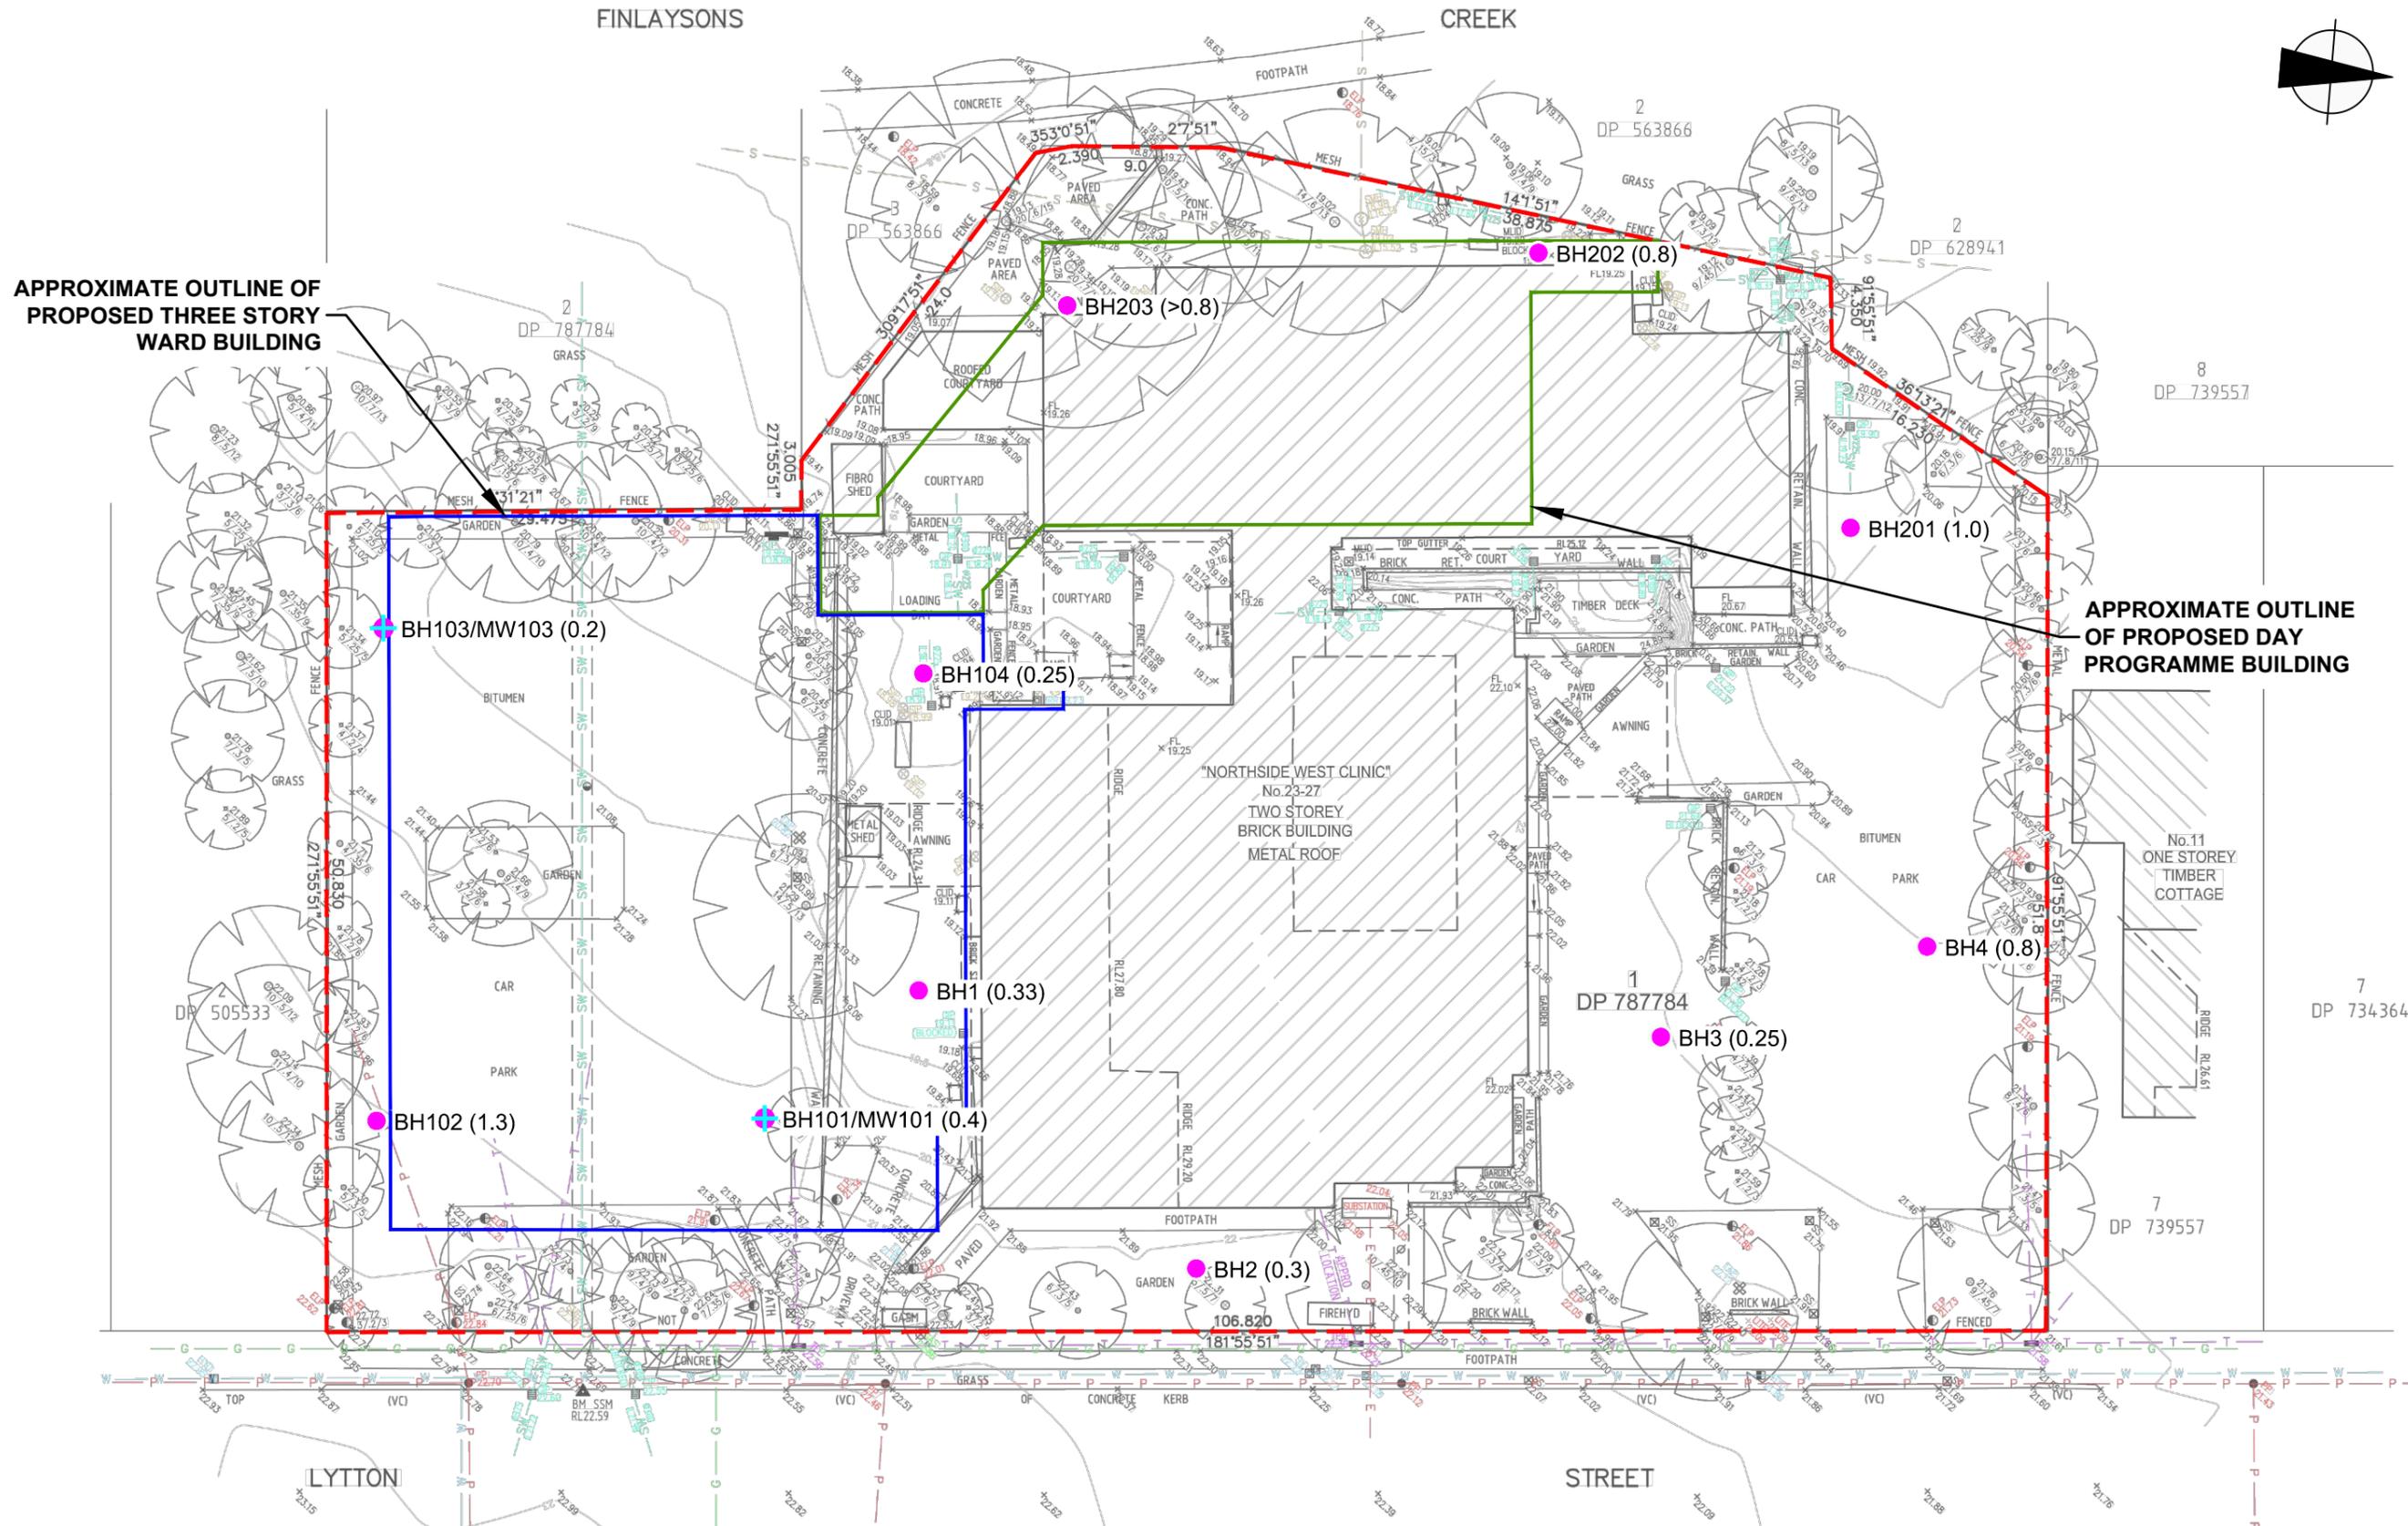
APPROXIMATE OUTLINE OF PROPOSED THREE STORY WARD BUILDING

APPROXIMATE OUTLINE OF PROPOSED DAY PROGRAMME BUILDING

The investigation included soil sampling from three locations (BH201 to BH203) in accessible areas of the west section of the site as shown on Figure 2. This density is equivalent to approximately three sampling points per hectare (the area of the site is approximately 0.66 hectares) and meets the requirements for an 'initial site investigation' recommended in the DLWC 2002 document for 'moderately intensive construction', however we note that sampling locations were not evenly distributed across the site. The density was considered adequate to identify large areas of salinity impacted soils at the site.

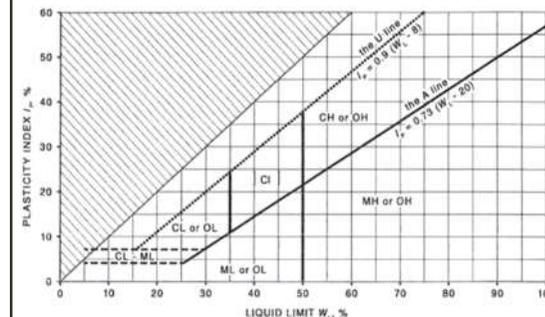
Modified Casagrande Chart for Classifying Silts and Clays according to their Behaviour
