REPORT TO
ERILYAN PTY LTD

ON
REMEDIATION ACTION PLAN

FOR
**PROPOSED NORTHSIDE WEST CLINIC STAGE 2
DEVELOPMENT**

AT
23-27 LYTTON STREET, WENTWORTHVILLE, NSW

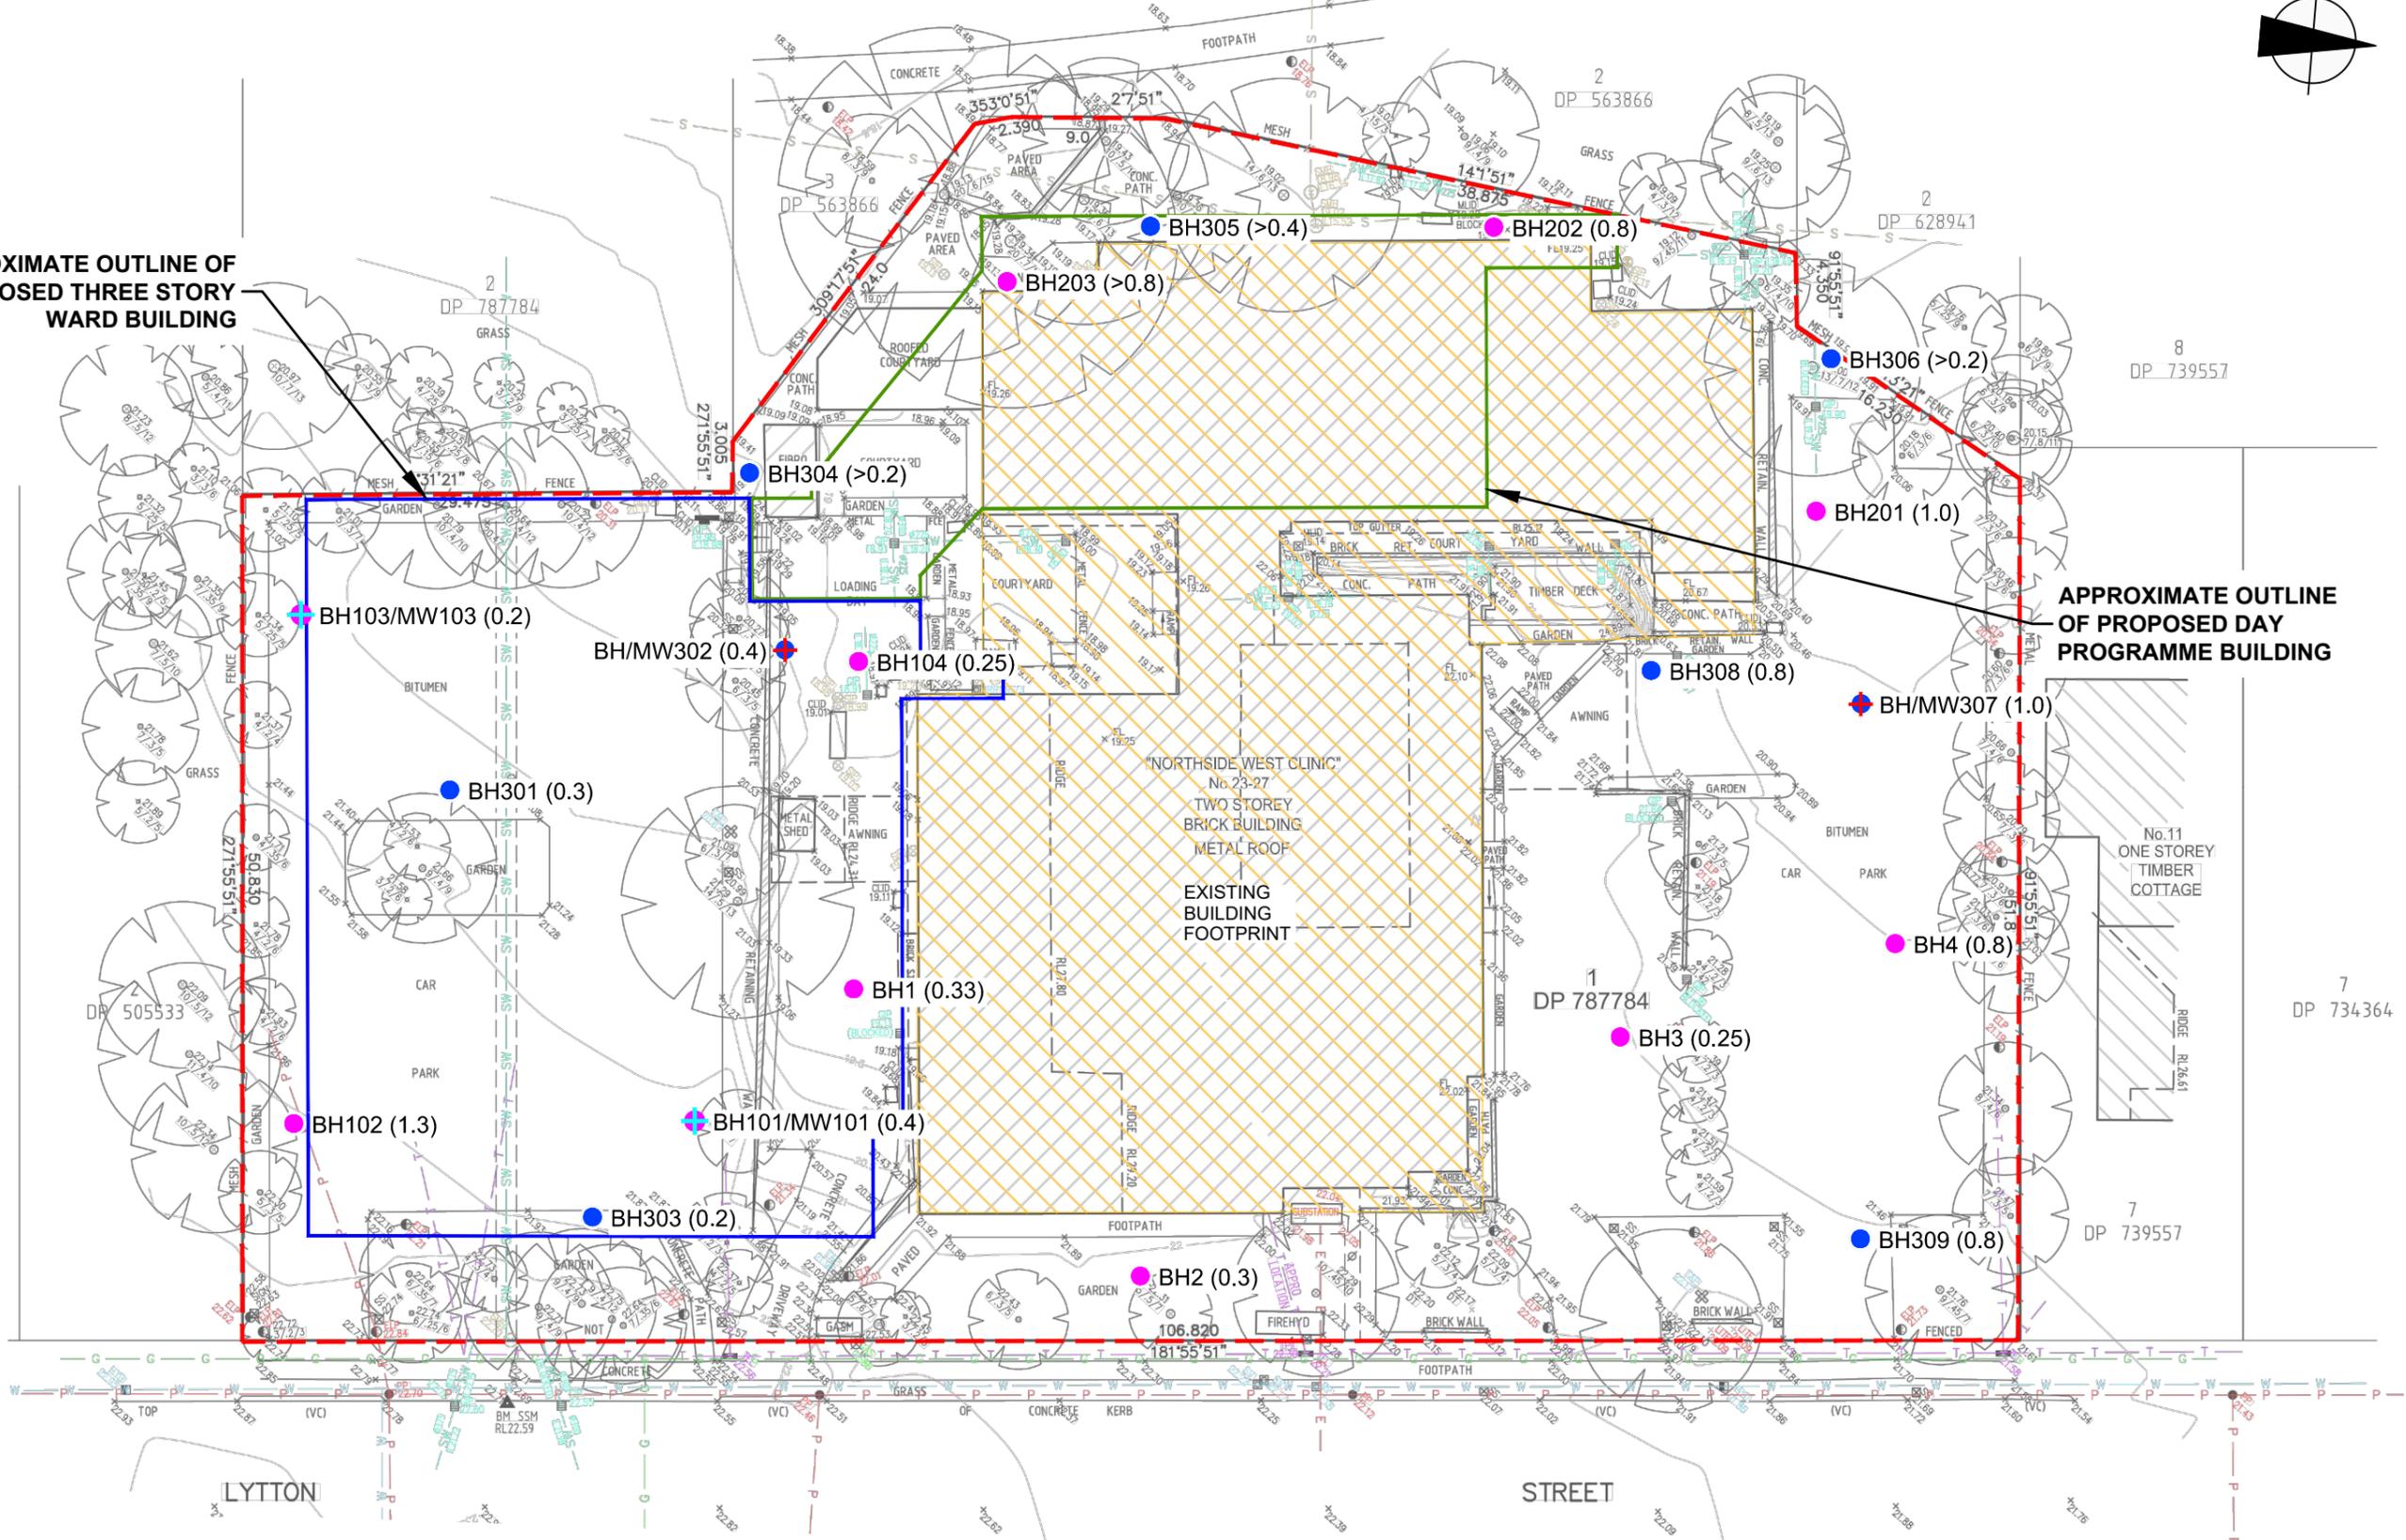
Title: SAMPLE LOCATION PLAN	
Location: 23-27 LYTTON STREET, WENTWORTHVILLE, NSW	
Project No: E27318PH	Figure No: 2
JKEnvironments

- APPROXIMATE SITE BOUNDARY
- BH(Fill Depth) PREVIOUS BOREHOLE LOCATION, NUMBER AND DEPTH OF FILL (m)
- BH/MW(Fill Depth) PREVIOUS BOREHOLE AND GROUNDWATER MONITORING WELL LOCATION, NUMBER AND DEPTH OF FILL (m)
- BH(Fill Depth) DSI BOREHOLE LOCATION, NUMBER AND DEPTH OF FILL (m)
- BH/MW(Fill Depth) DSI BOREHOLE AND GROUNDWATER MONITORING WELL LOCATION, NUMBER AND DEPTH OF FILL (m)

Erilyan ('the client') commissioned JK Environments (JKE) to prepare a Remediation Action Plan (RAP) for the proposed Northside West Clinic Stage 2 development at 23-27 Lytton Street, Wentworthville, NSW ('the site'). The site location is shown on Figure 1 and the RAP applies to the land within the site boundaries as shown on Figures 2 and 3 in Appendix A.

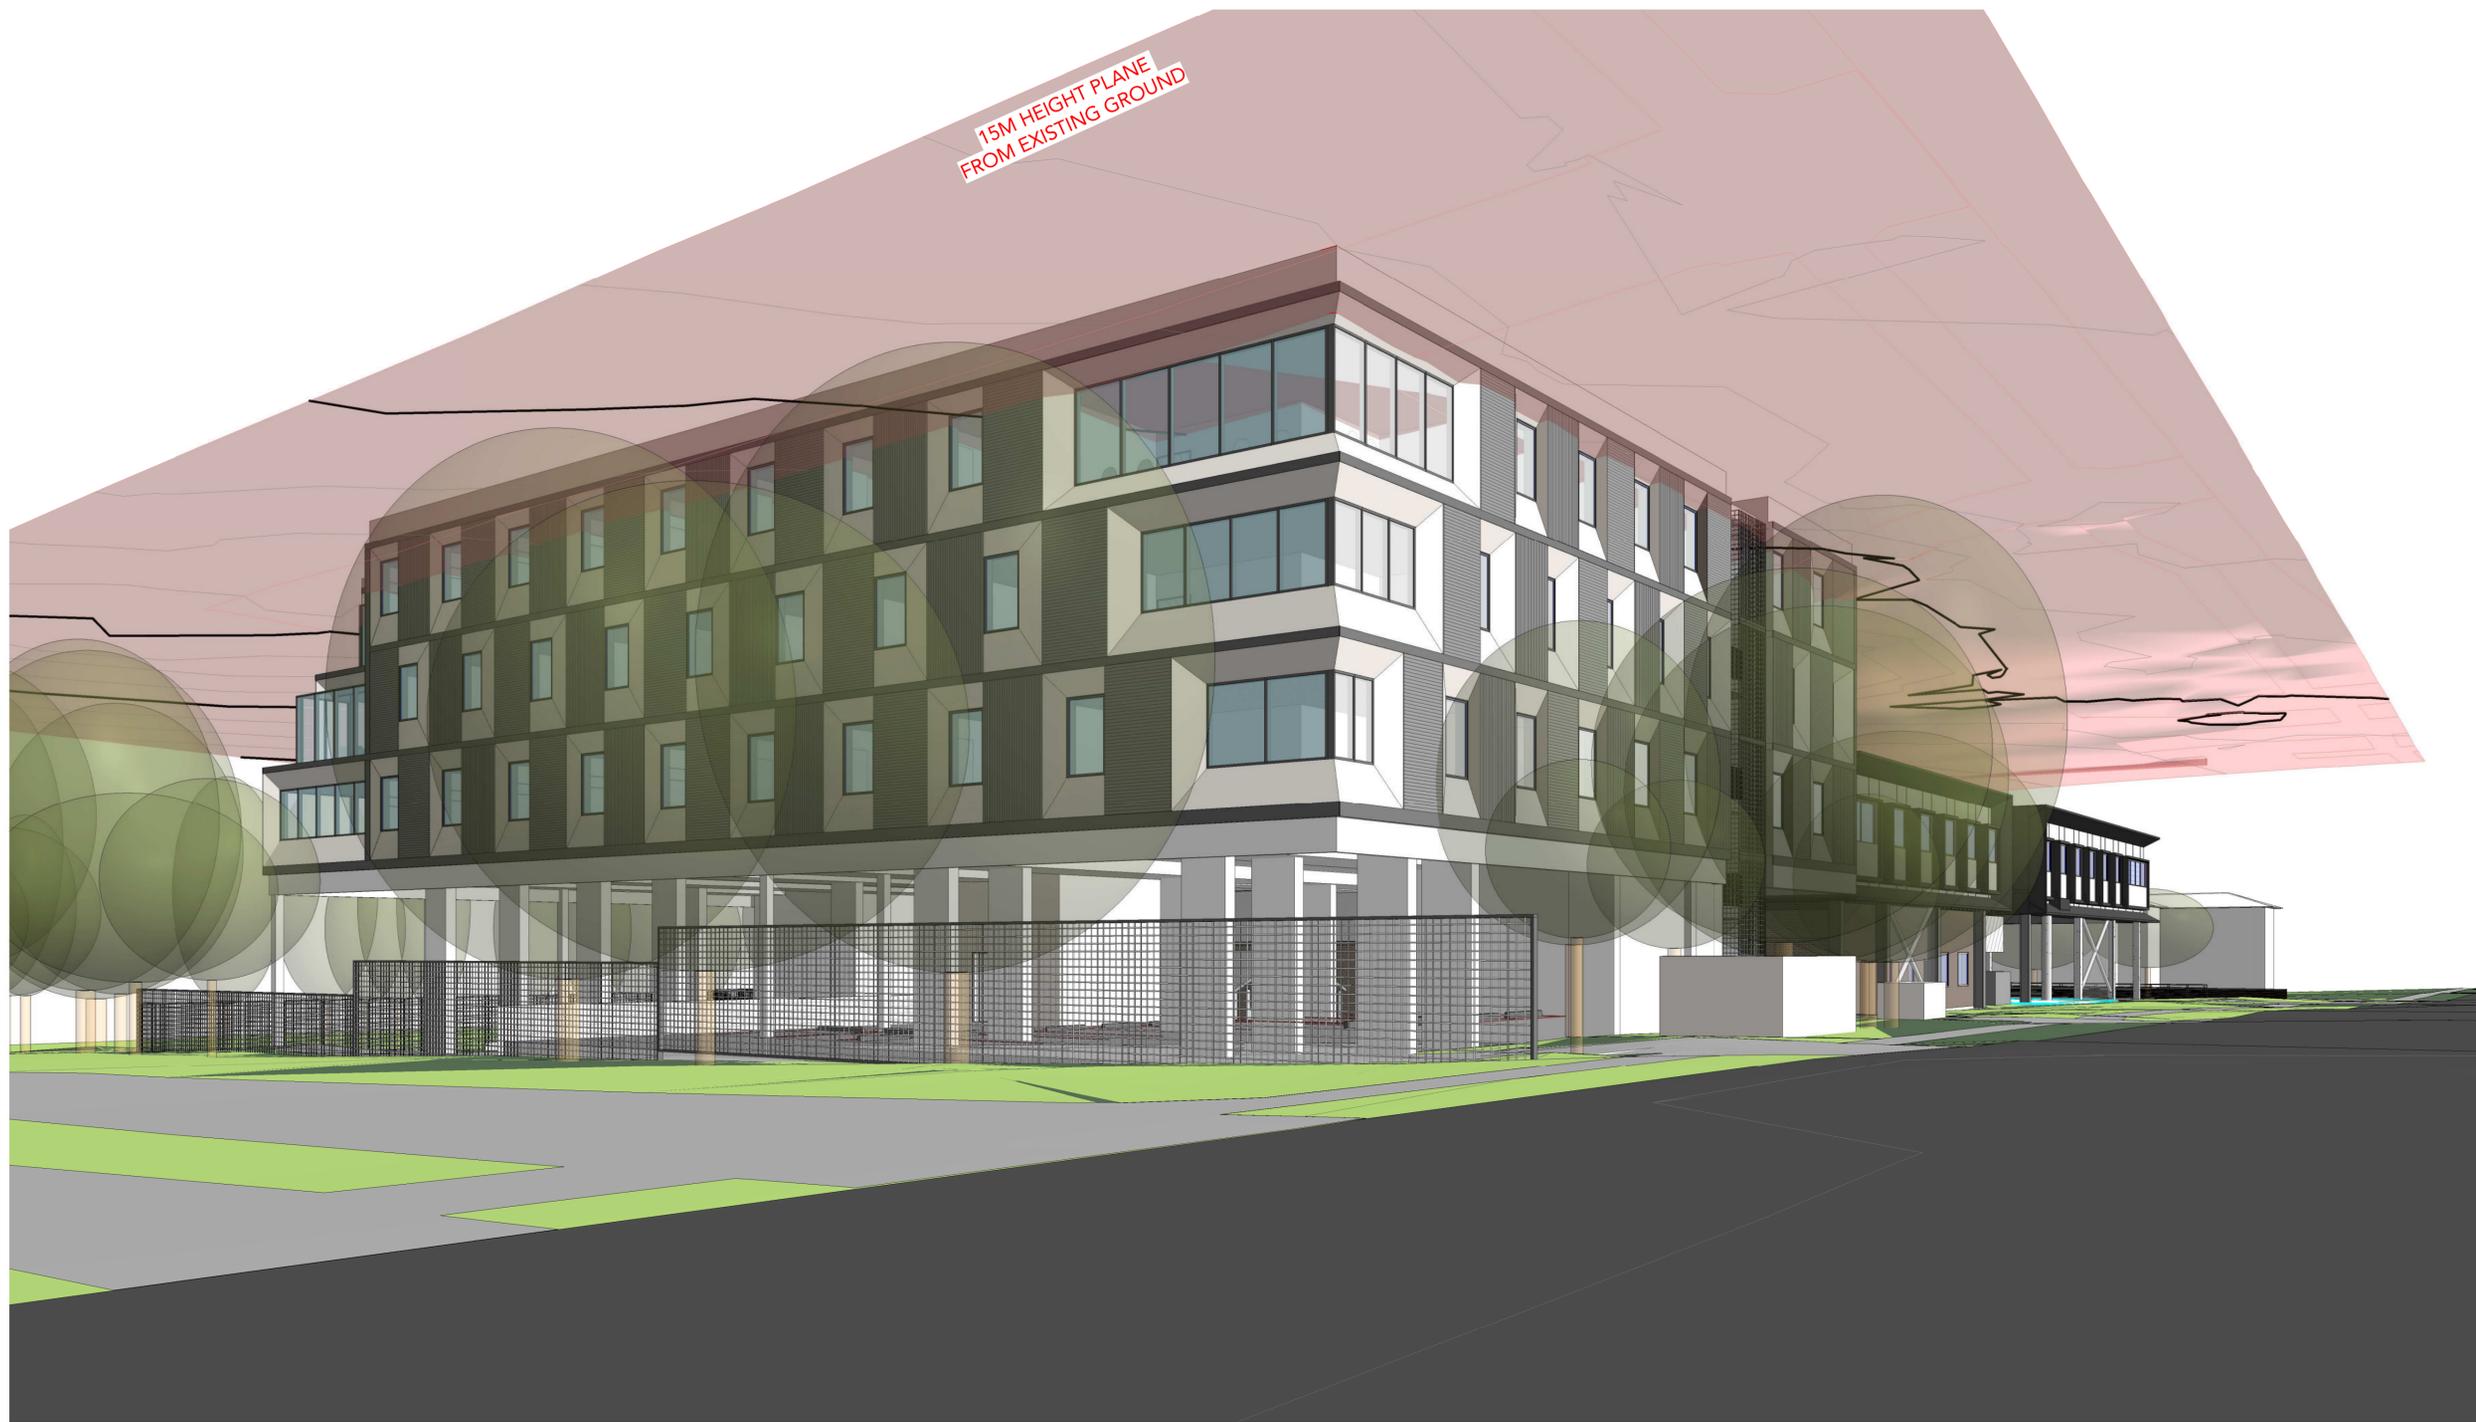
1 LEP Height - Lytton Street - South Street View
Scale:

15M HEIGHT PLANE
FROM EXISTING GROUND
