Pells Sullivan Meynink
Environmental Site Assessment

14 Distribution Drive,
Orchard Hills, NSW

20 April 2021

60586/136769 (Rev 0)
JBS&G Australia Pty Ltd

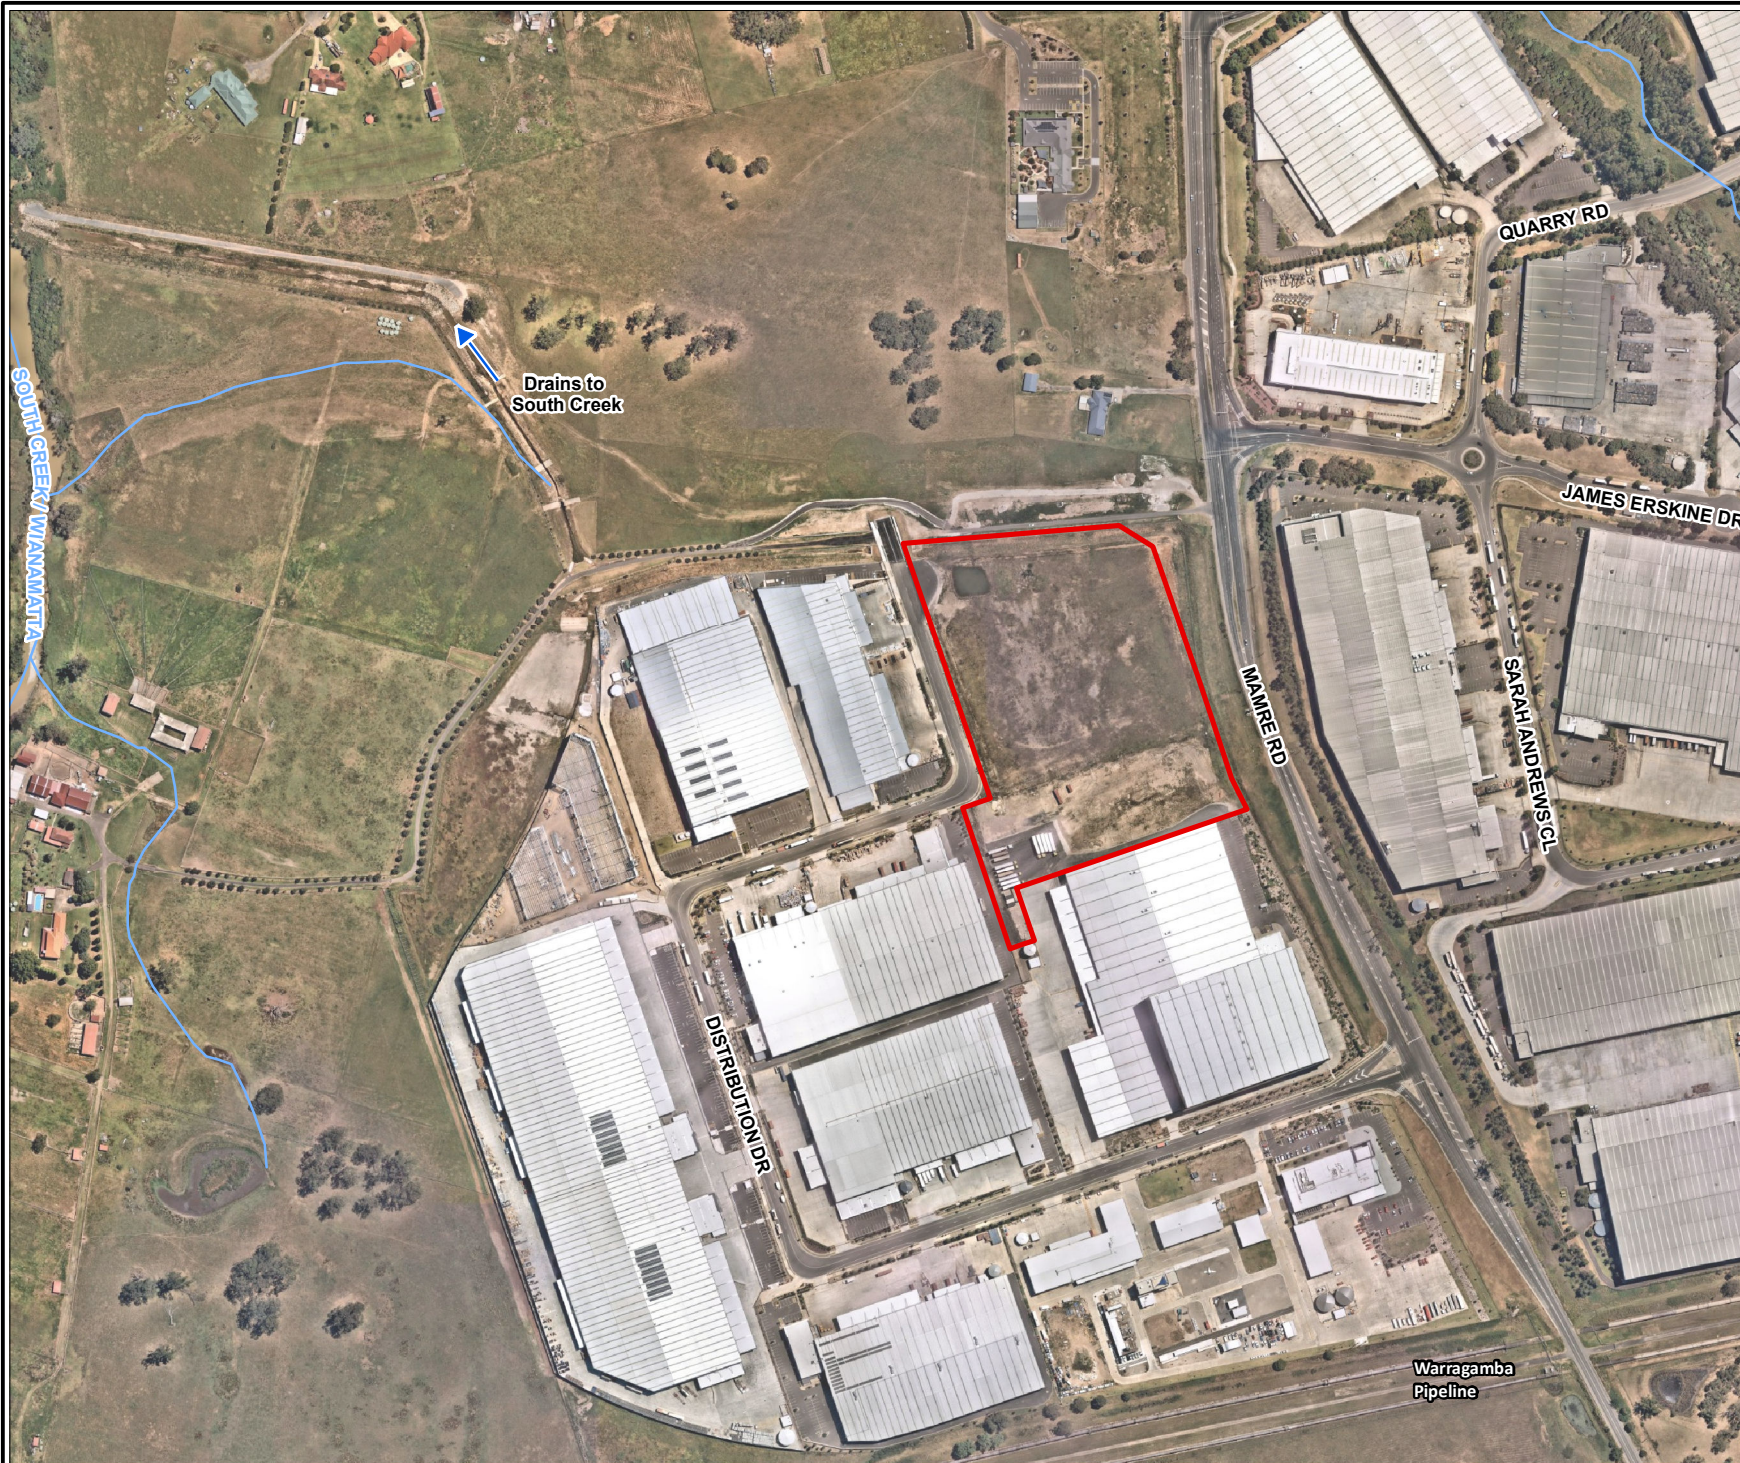
FIGURE 2

SITE LAYOUT

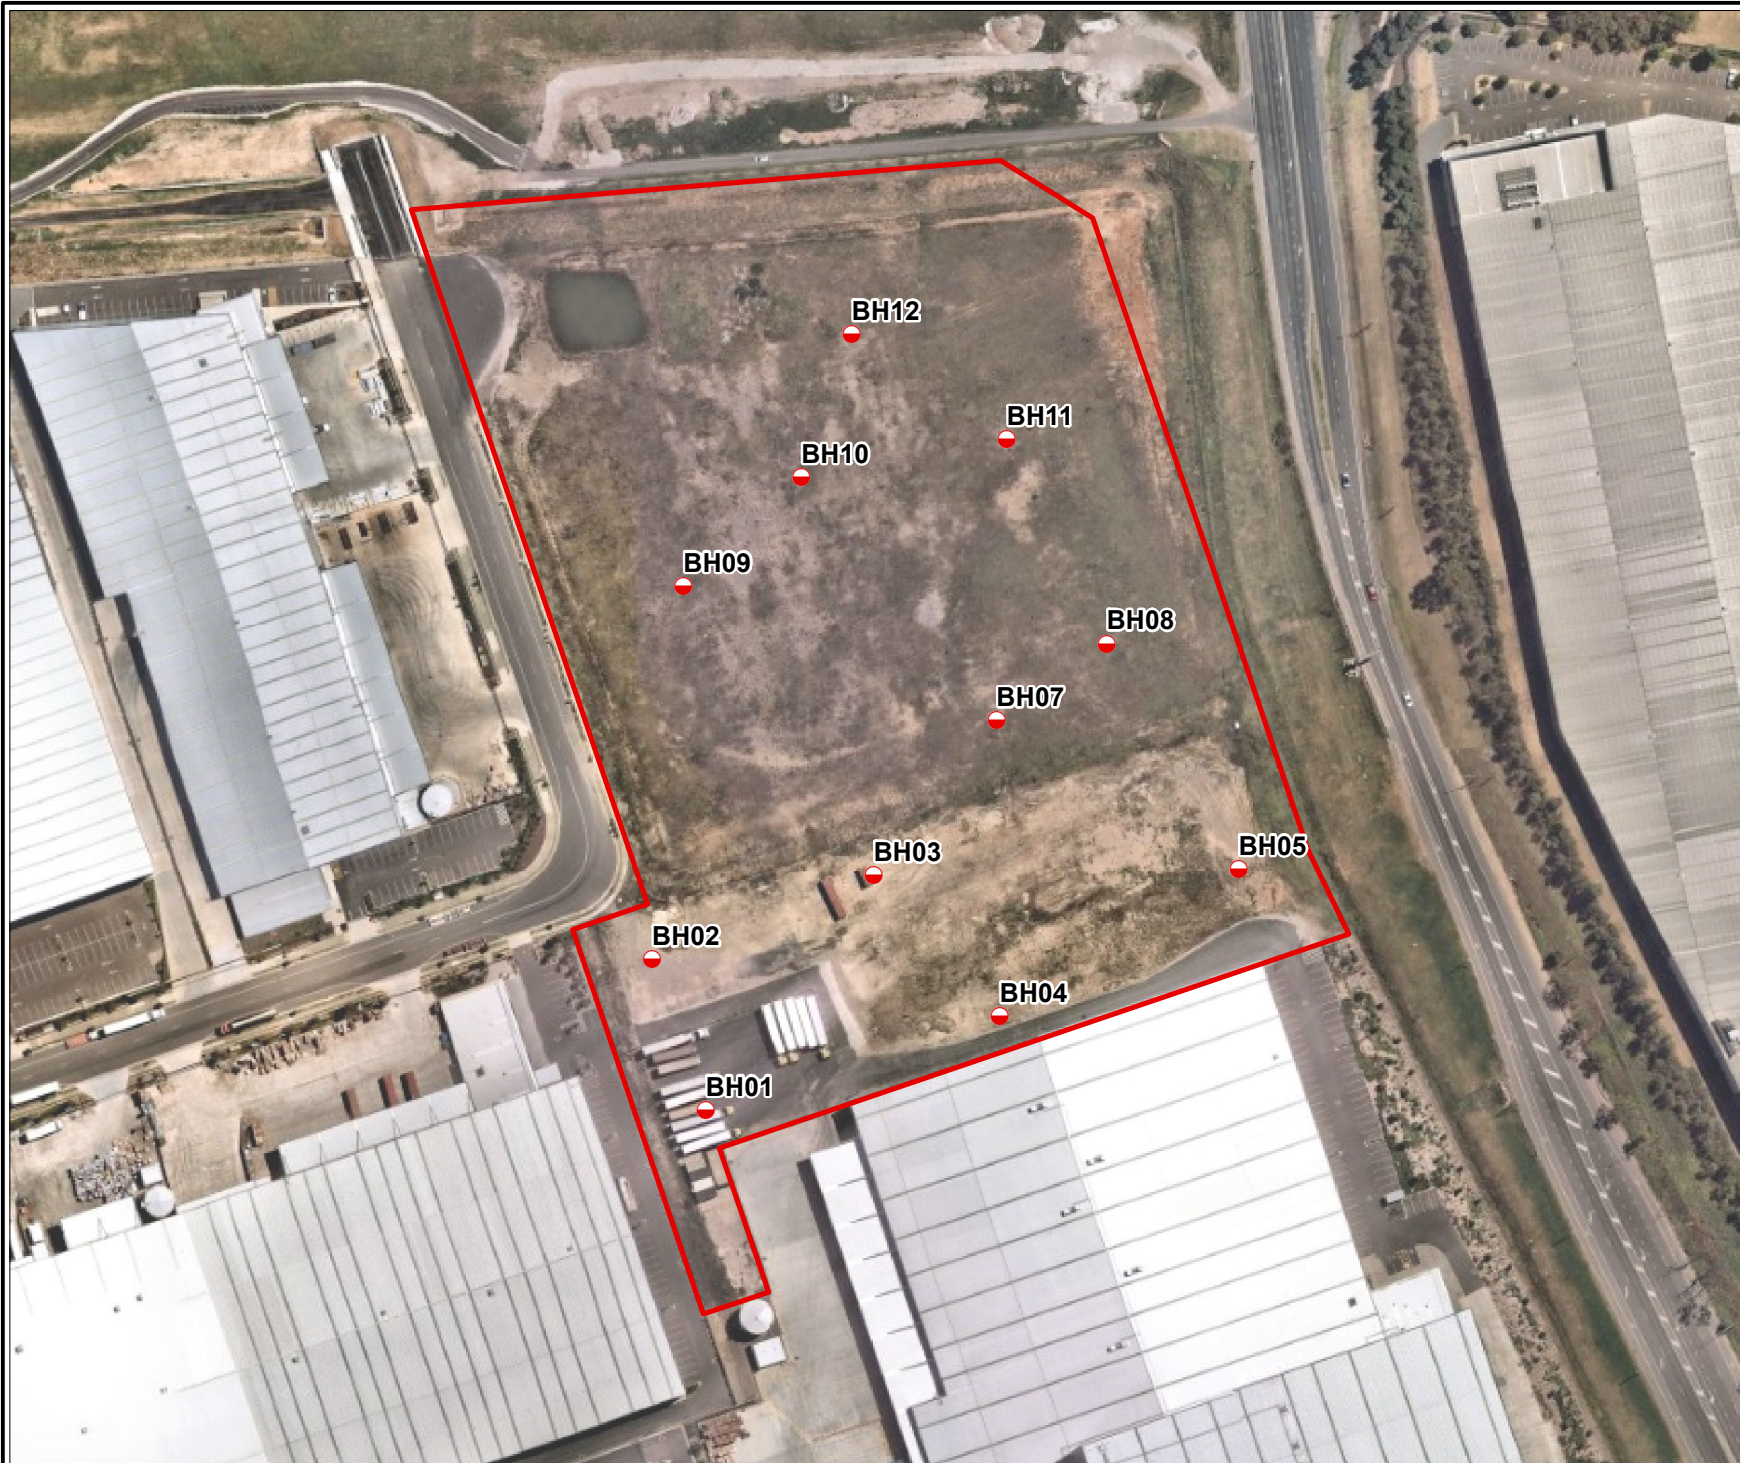
- Legend:**
- Approximate Site Boundary
 - Sample Locations

Selected soil samples were collected by auger (150 mm diameter) advanced using a drill rig. Within boreholes, soil samples were generally collected at depths from the surface (0-0.1 m) and then at 0.5-1.0 m intervals to a maximum depth of 11.5 m below ground surface (m bgs) or 0.5 m into natural materials, whichever was shallower. During the collection of soil samples, a minimum of 10L of material was inspected from each distinct fill/soil layer and features such as seepage, discolouration, staining, odours and other indicators of contamination were noted on the borehole logs (**Appendix B**).
