# Geotechnical Investigation Report

Elizabeth Enterprise Precinct (EEP) Stage 1  
and 2 (1669 - 1723 Elizabeth Drive, Badgerys  
Creek)

PSM3530-018R Rev 4      4 March 2025

Mirvac Industrial Developments

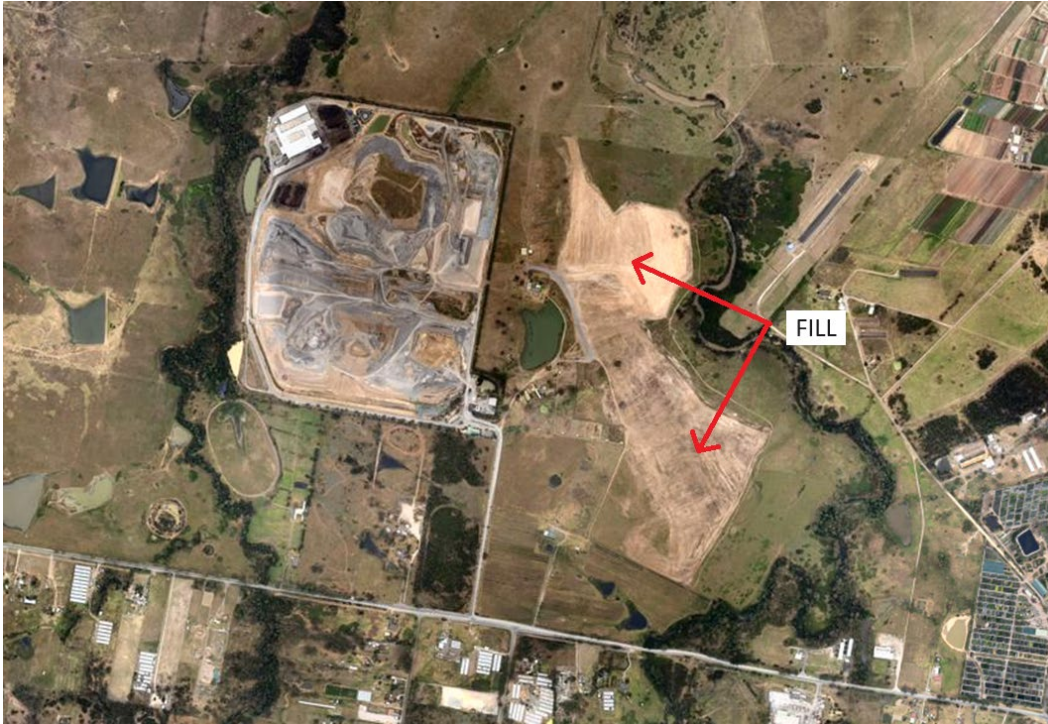
**Inset 1: NearMap aerial image of placed fill on 11 February 2011**

In particular, we note that between year 2009 and 2011 fill was placed on Site. According to STS report (Ref. 17210/8439B Report No. 11/0905 LWI/pi/ja), SMEC Testing Services undertook the Level 1 testing for the fill placement and the following was also reported in the STS report:

- The ground was stripped of topsoil and unsuitable material prior to placement of fill
- The fill material was assessed to be compacted to a minimum density ratio of 98% of standard maximum dry density with moisture content in the range of +/- 2% of the optimum moisture content.

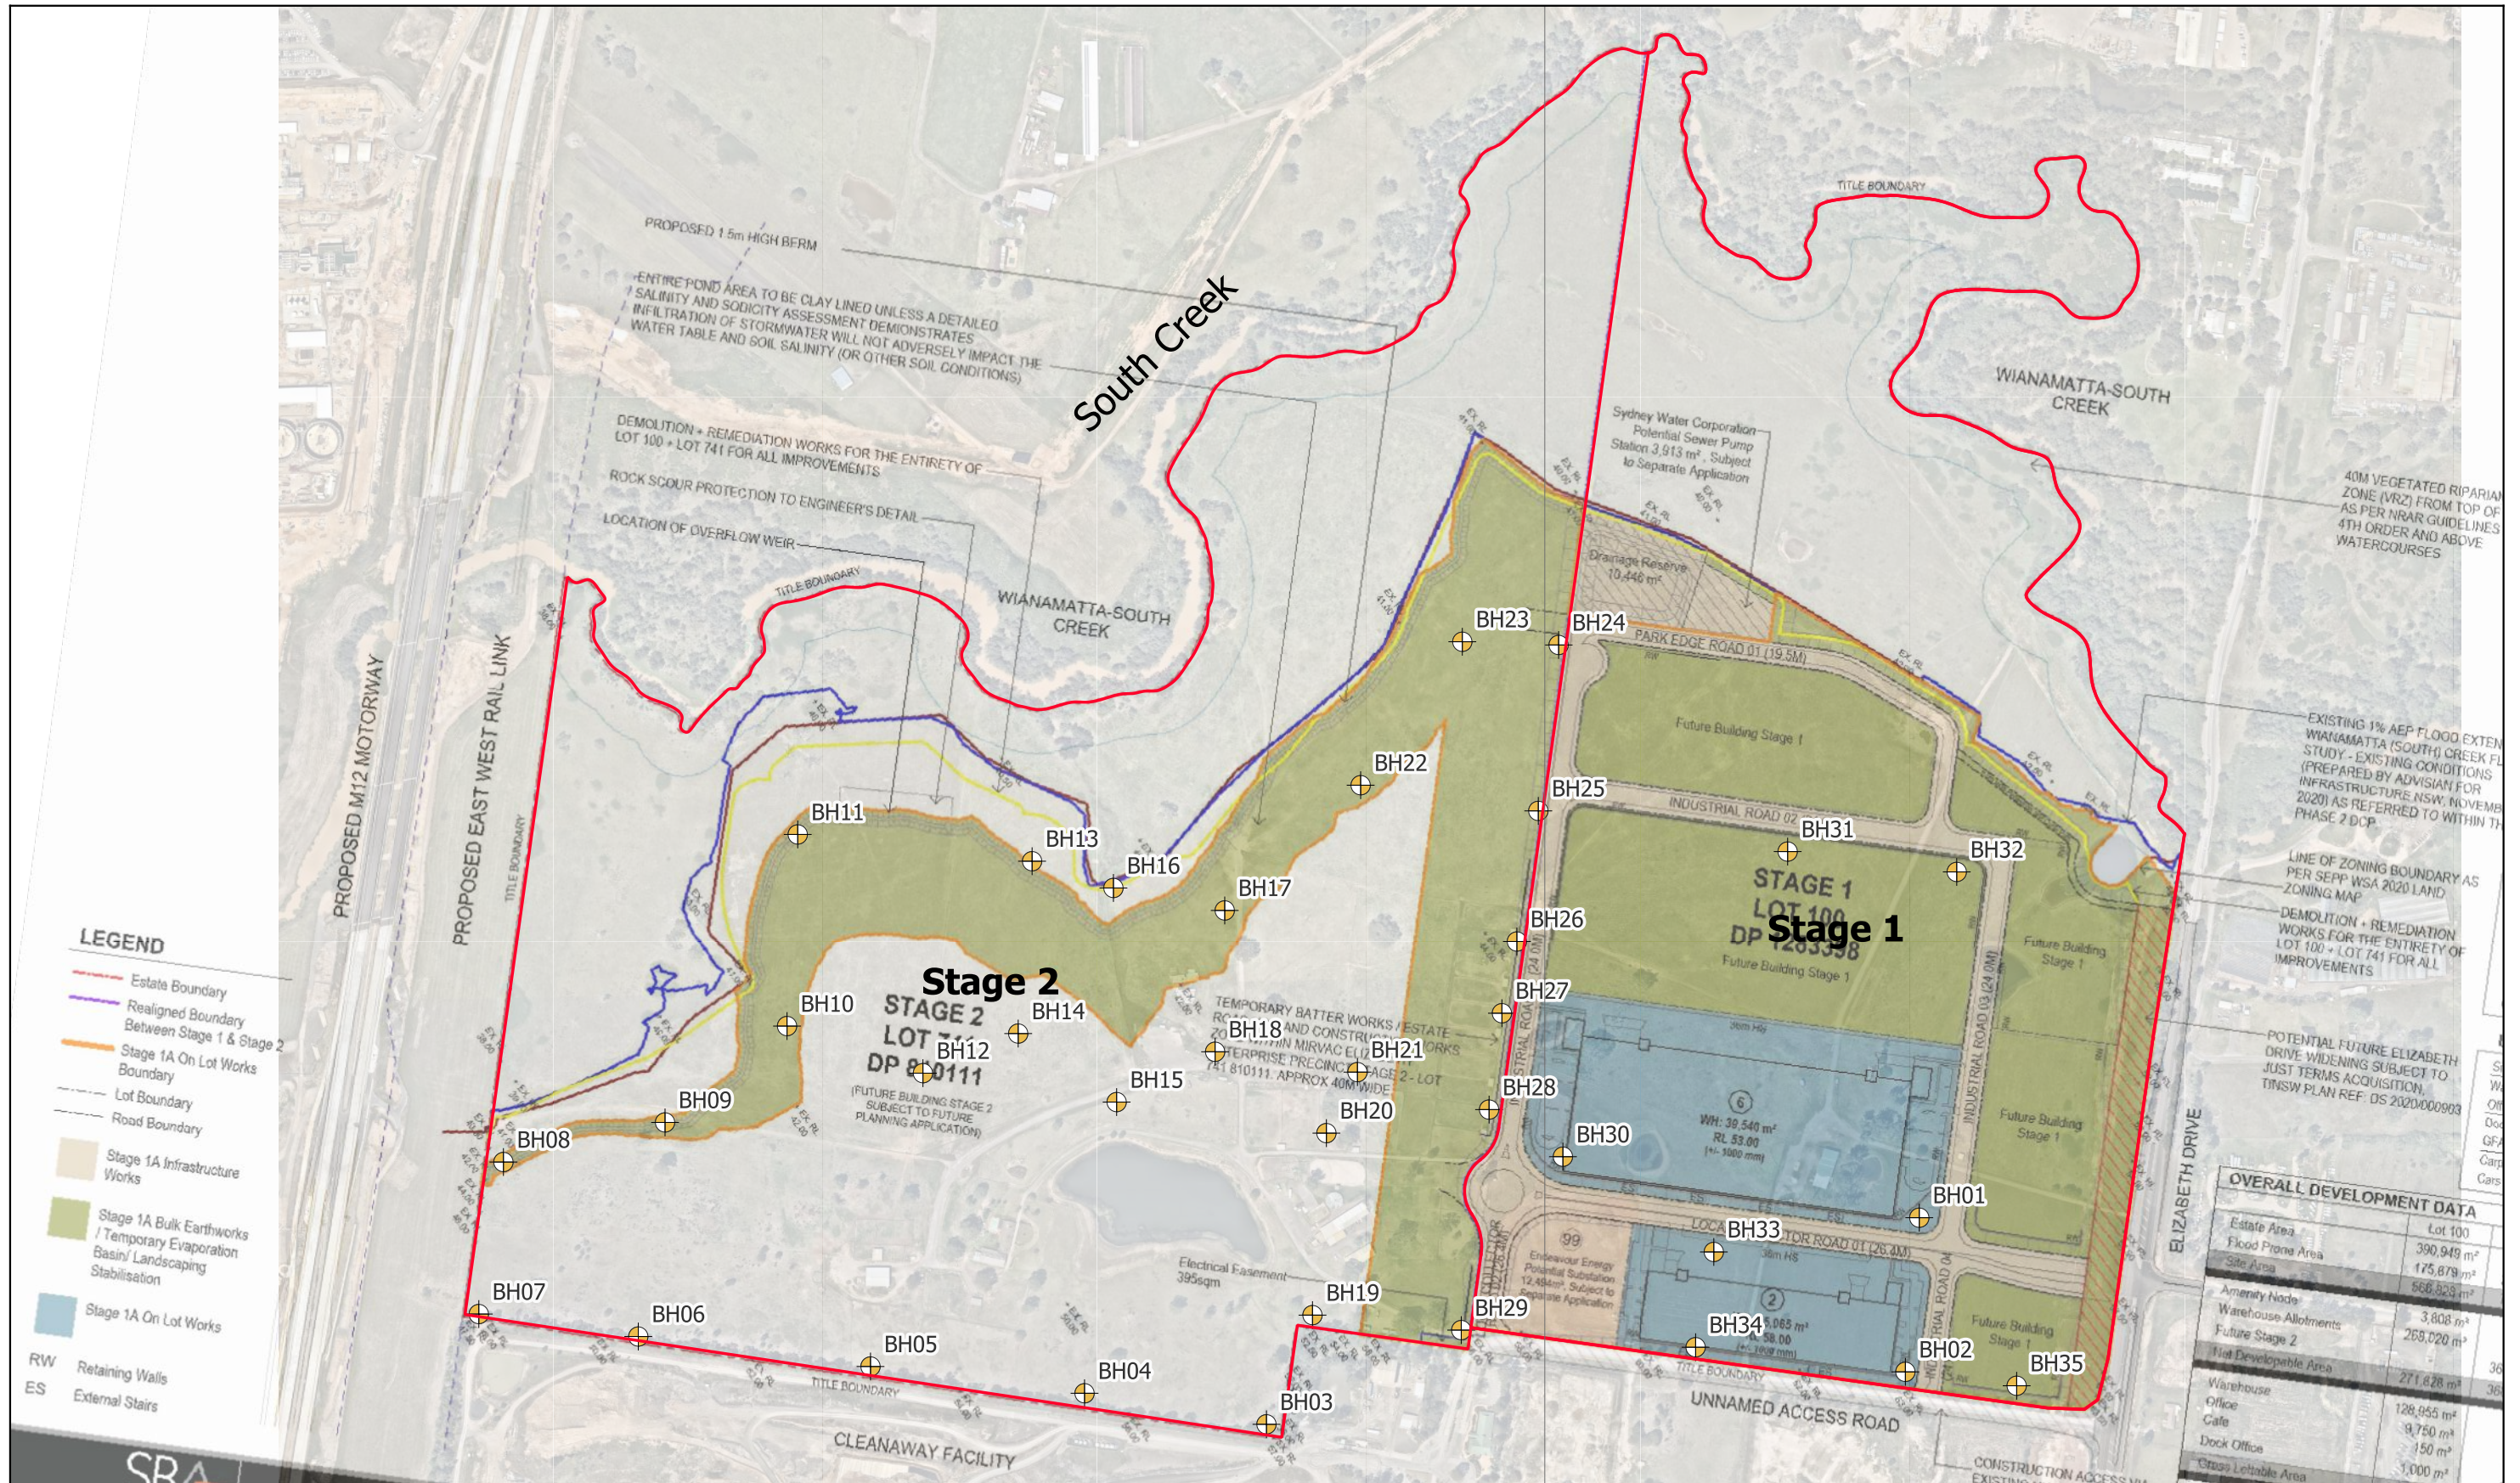
Figure 1

- Approximate site boundary
- Approximate BH Locations

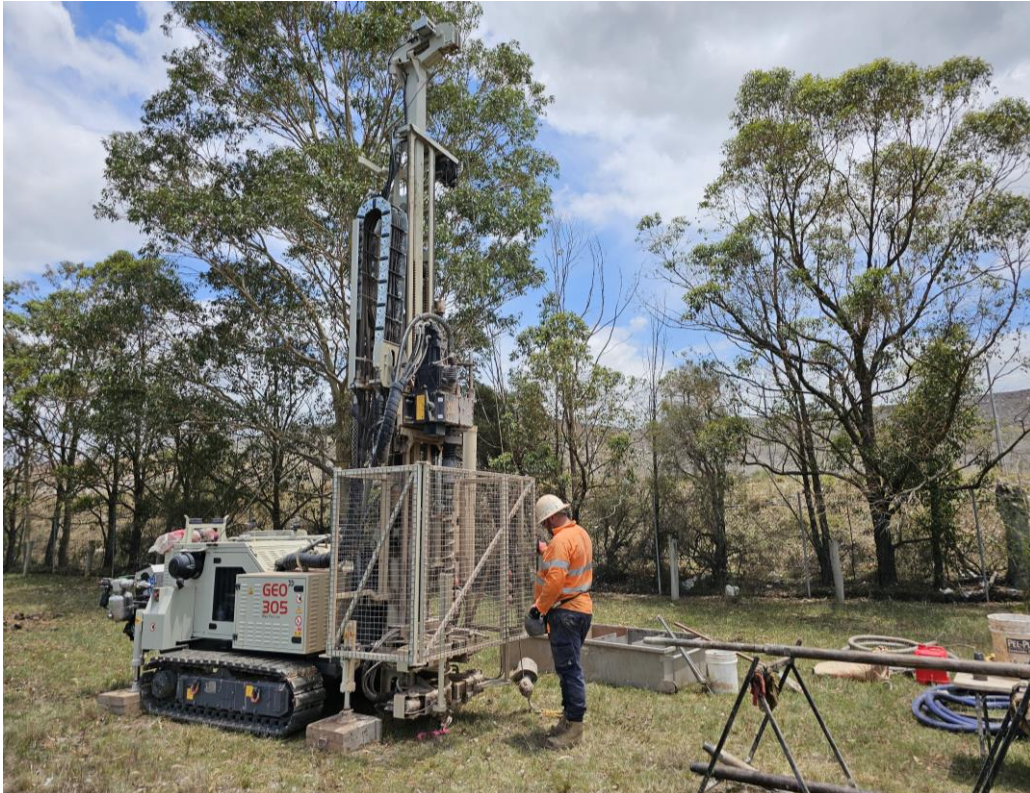
Photo 9 - Typical Drill Rig Set Up

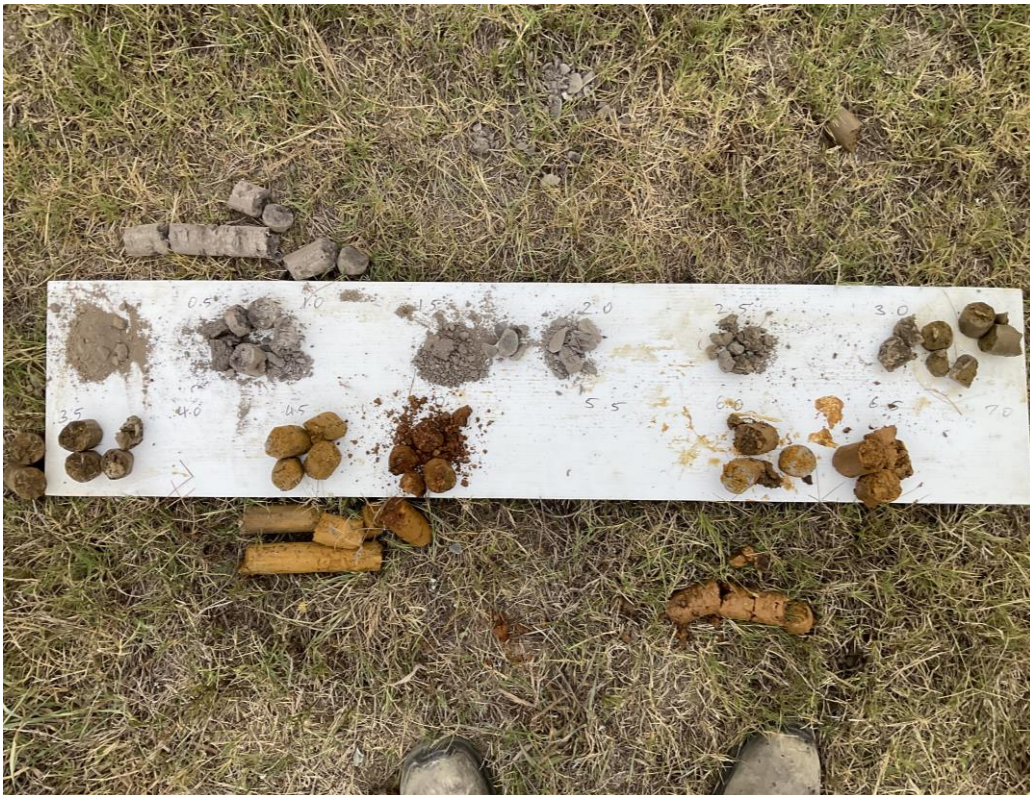
Photo 10 - Typical Soil Profile Encountered

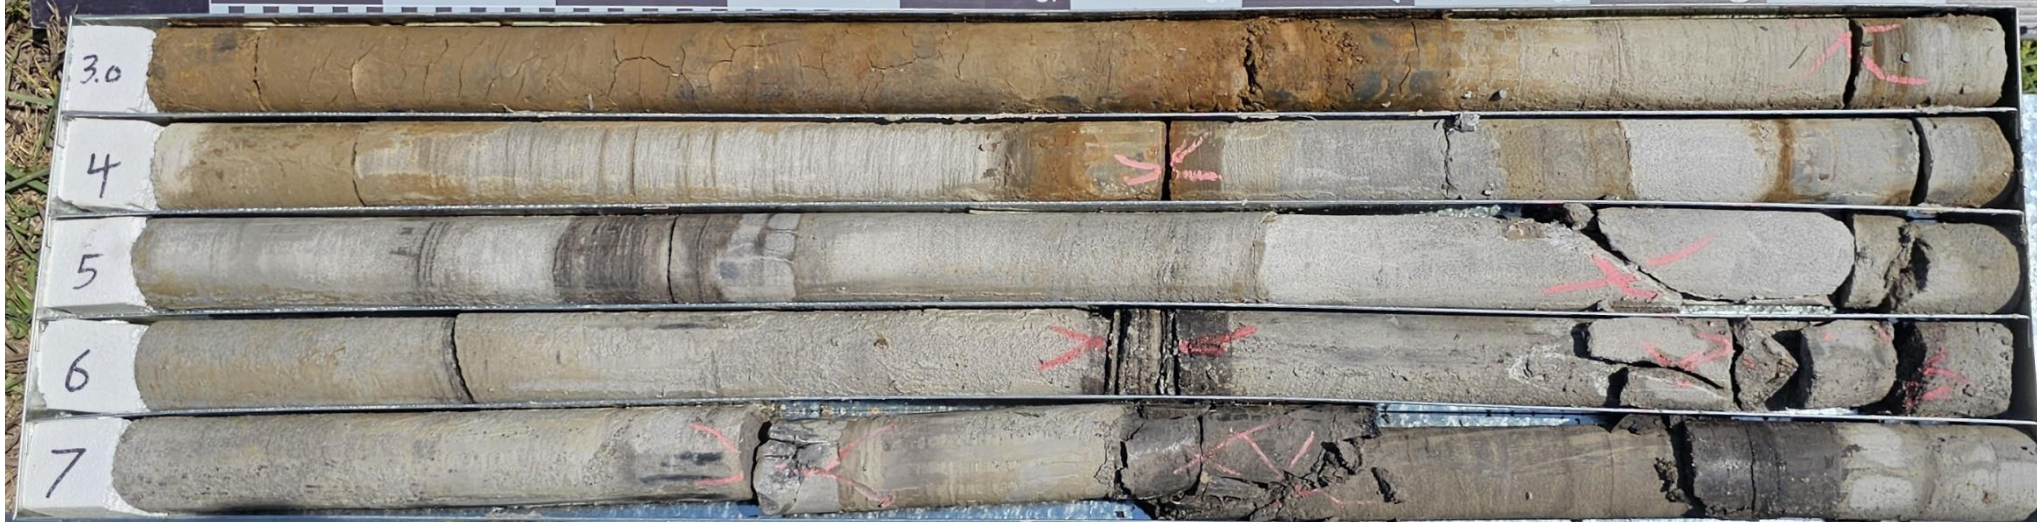
BOREHOLE ID: BH01

DEPTH: 3.0-8.0

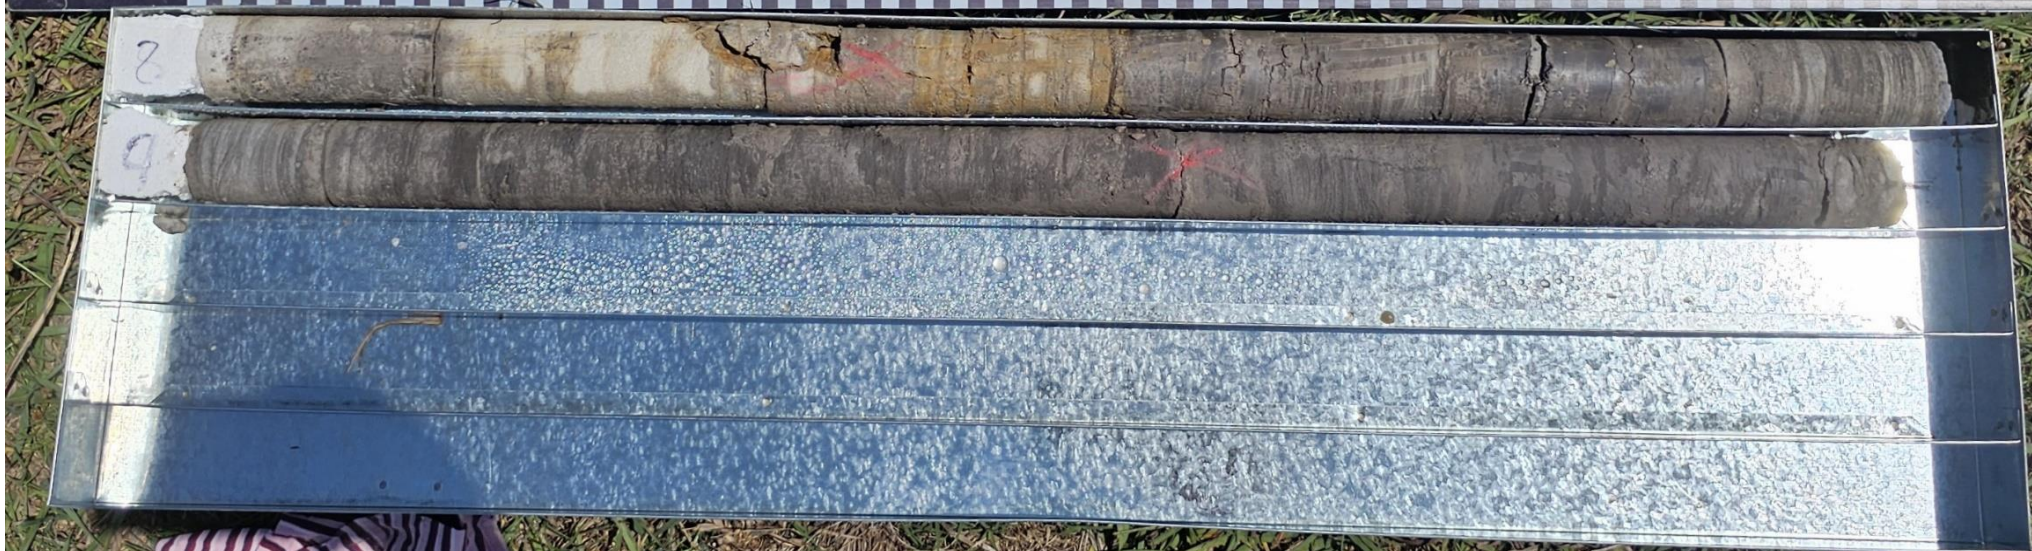
BOREHOLE ID: BH01

DEPTH: 8.0 - 10.0

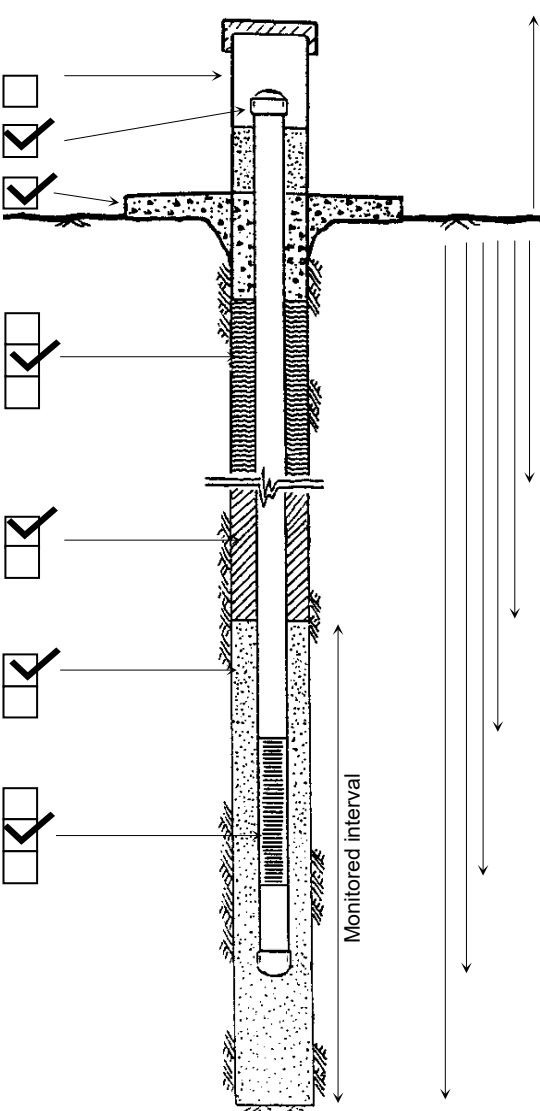
Height of stickup (m)	<u>0.5</u>
PVC cap	<input checked="" type="checkbox"/>		Diameter of PVC (mm)	<u>50</u>
Concrete collar	<input checked="" type="checkbox"/>			
Back fill type: Cement bentonite Soil None	<input checked="" type="checkbox"/>		Depth to top of seal	<u>2</u>
Seal: Bentonite pellets Other	<input checked="" type="checkbox"/>		Depth to top of gravel pack	<u>2.5</u>
Gravel type: 2-5mm gravel Other	<input checked="" type="checkbox"/>		Depth to top of screen	<u>2.7</u>
Perforation type: Drill holes Hack saw cuts 40um machine slots	<input checked="" type="checkbox"/>		Depth to base of screen	<u>5.7</u>
			Depth to base of piezo	<u>8.7</u>
			Depth to base of gravel	<u>8.7</u>

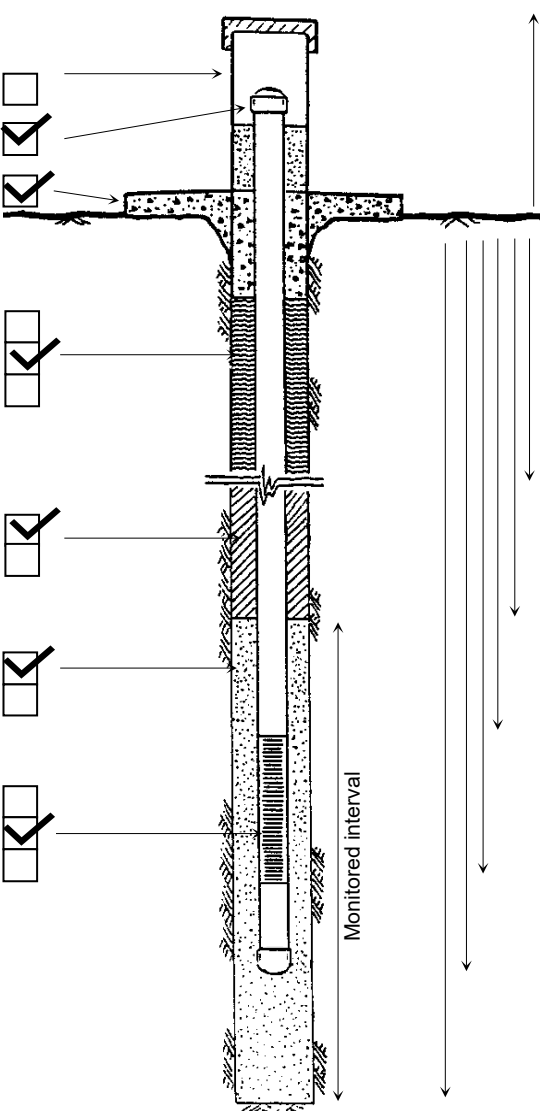
Height of stickup (m)	<u>0.4</u>
PVC cap	<input checked="" type="checkbox"/>		Diameter of PVC (mm)	<u>50</u>
Concrete collar	<input checked="" type="checkbox"/>			
Back fill type: Cement bentonite Soil None	<input checked="" type="checkbox"/>		Depth to top of seal	<u>1</u>
Seal: Bentonite pellets Other	<input checked="" type="checkbox"/>		Depth to top of gravel pack	<u>1.5</u>
Gravel type: 2-5mm gravel Other	<input checked="" type="checkbox"/>		Depth to top of screen	<u>1.7</u>
Perforation type: Drill holes Hack saw cuts 40um machine slots	<input checked="" type="checkbox"/>		Depth to base of screen	<u>4.7</u>
			Depth to base of piezo	<u>10.7</u>
			Depth to base of gravel	<u>10.7</u>
