Report on
Geotechnical Investigation

Wilkinson House Redevelopment
167 Forbes Street, Darlinghurst

Project 86514.03
November 2021

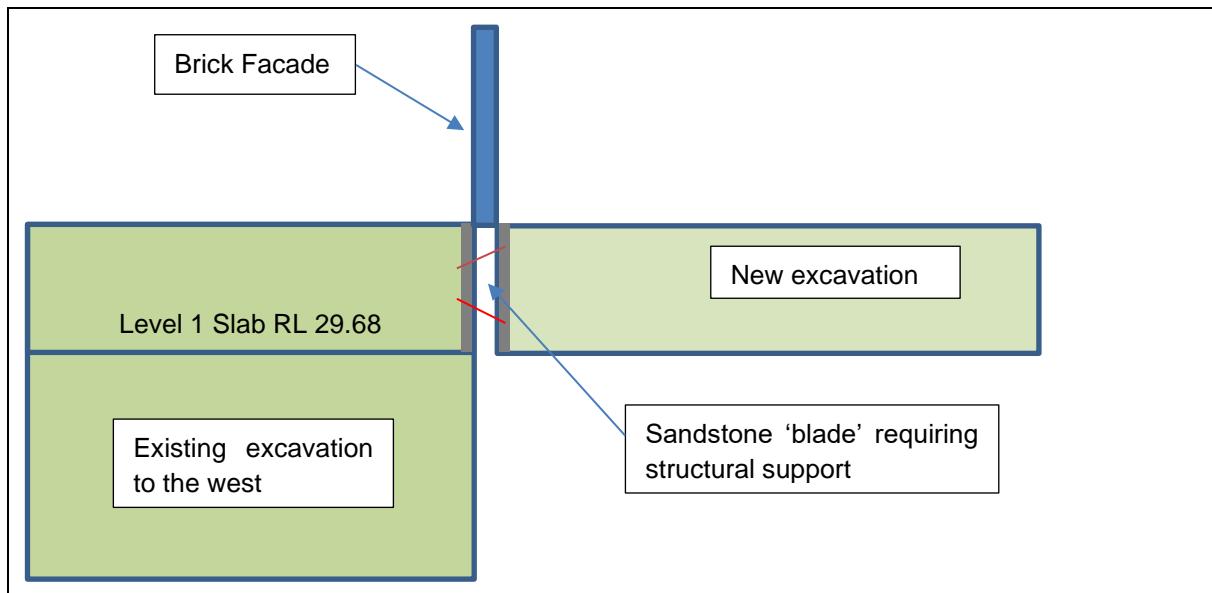
Figure 1 –Potential Sandstone ‘Blade’ Along Western Boundary

Excavation along the western brick façade is complicated by the existing unsupported cuts in the sandstone of the adjacent basement to the west. Excavation for the proposed lower ground floor will leave a slender 'blade' of sandstone to support the existing brick façade within a portion of this elevation. It is possible that there may be natural defects within the bedrock which could cause shear failure of this blade of sandstone and it will also require structural support to prevent buckling failure.

The risk of failure increases with the slenderness (height to width ratio) of the sandstone left in place. It is recommended that height to width ratio of no greater than 1:1 be left unsupported in the short term.

A suitable support system would include reinforced concrete walls installed on either side of the 'blade' of sandstone, dowelled or bolted together (through the sandstone). The outside wall will likely need to be installed prior to excavation internally. A sketch of the suggested system is provided in Figure 1 below and would need to be designed by a structural engineer.

Based on the levels of the sandstone bedrock shown in Drawing 2 it appears that the northern portion of the brick façade is founded either below or less than 0.5 m above the proposed BEL of 29.5 m. The southern 7-8 m however of this wall appears to be founded between 1 m to 2 m above the proposed BEL and this portion will require structural support.

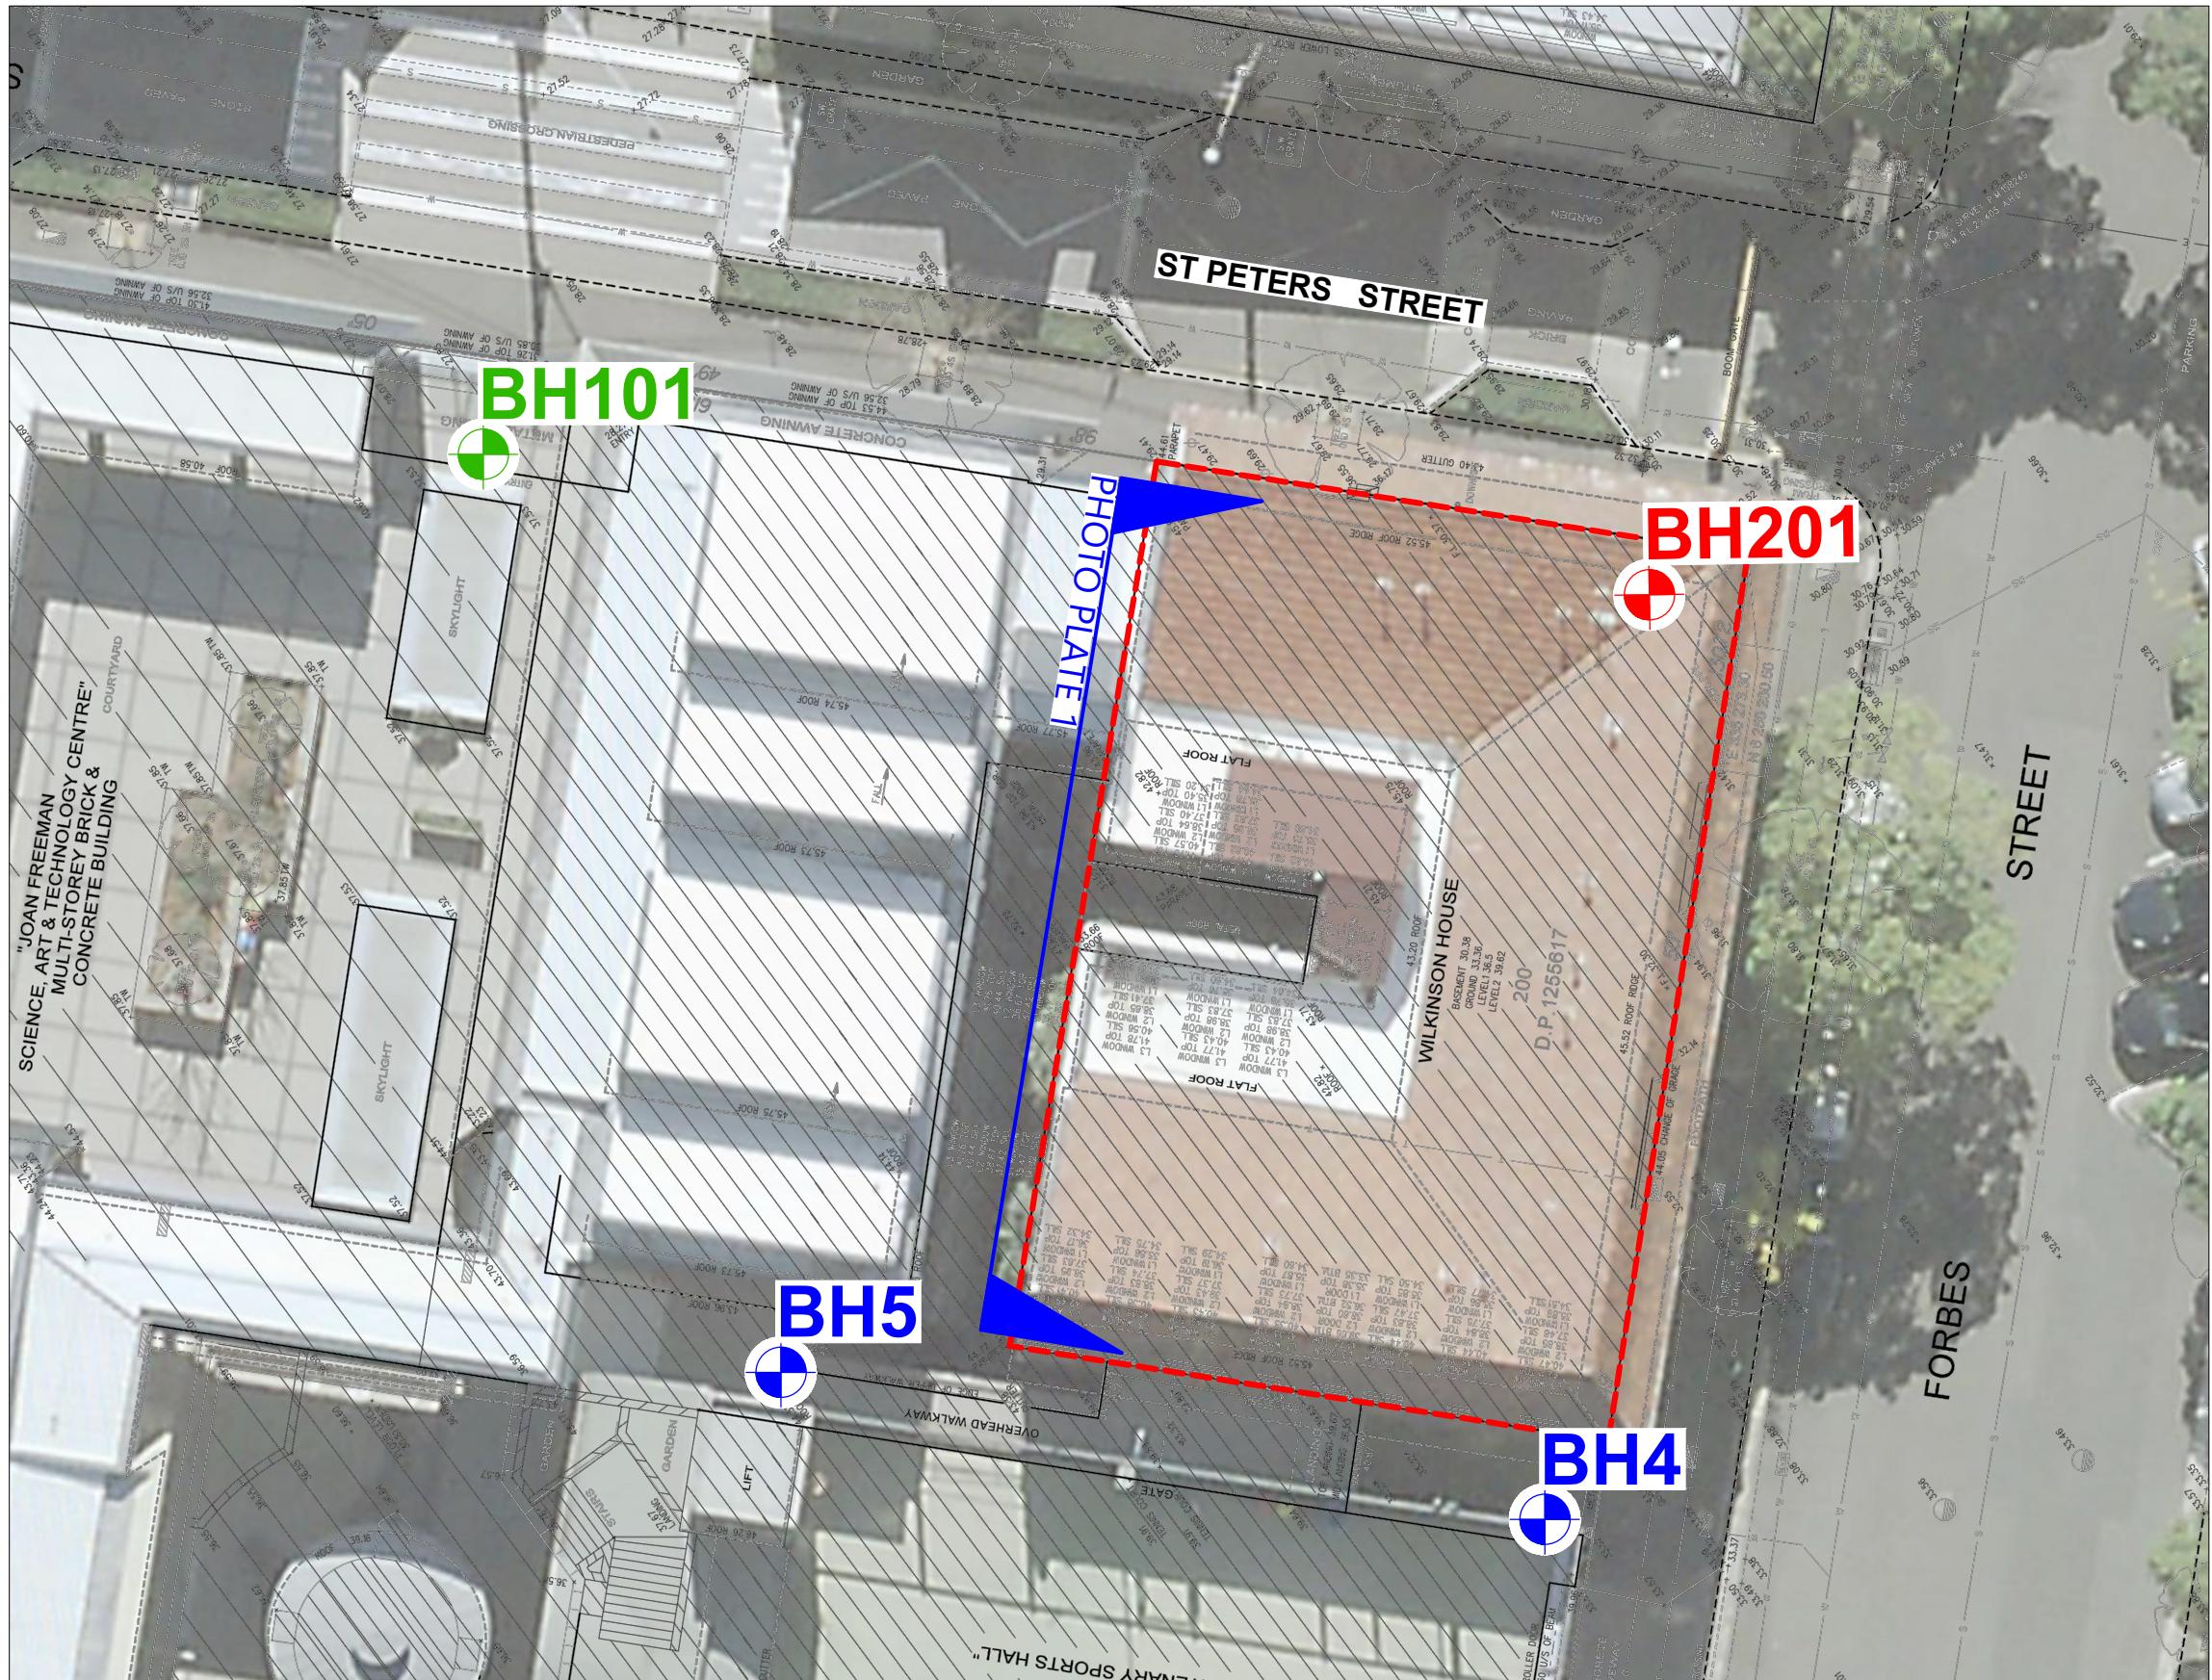
PROJECT No: 86514.03
DRAWING No: 1
REVISION: 0

The field work for the current investigation included the drilling of one rock-cored borehole (BH201) to a depth of about 4.5 m using hand operated equipment. Diatube coring techniques were used to obtain continuous core samples of the bedrock. Following completion of drilling the borehole was spoon tested to identify the presence and thickness of the defects within the bedrock to a depth of about 2 m. The location of the borehole is shown on Drawing 1 in Appendix B.

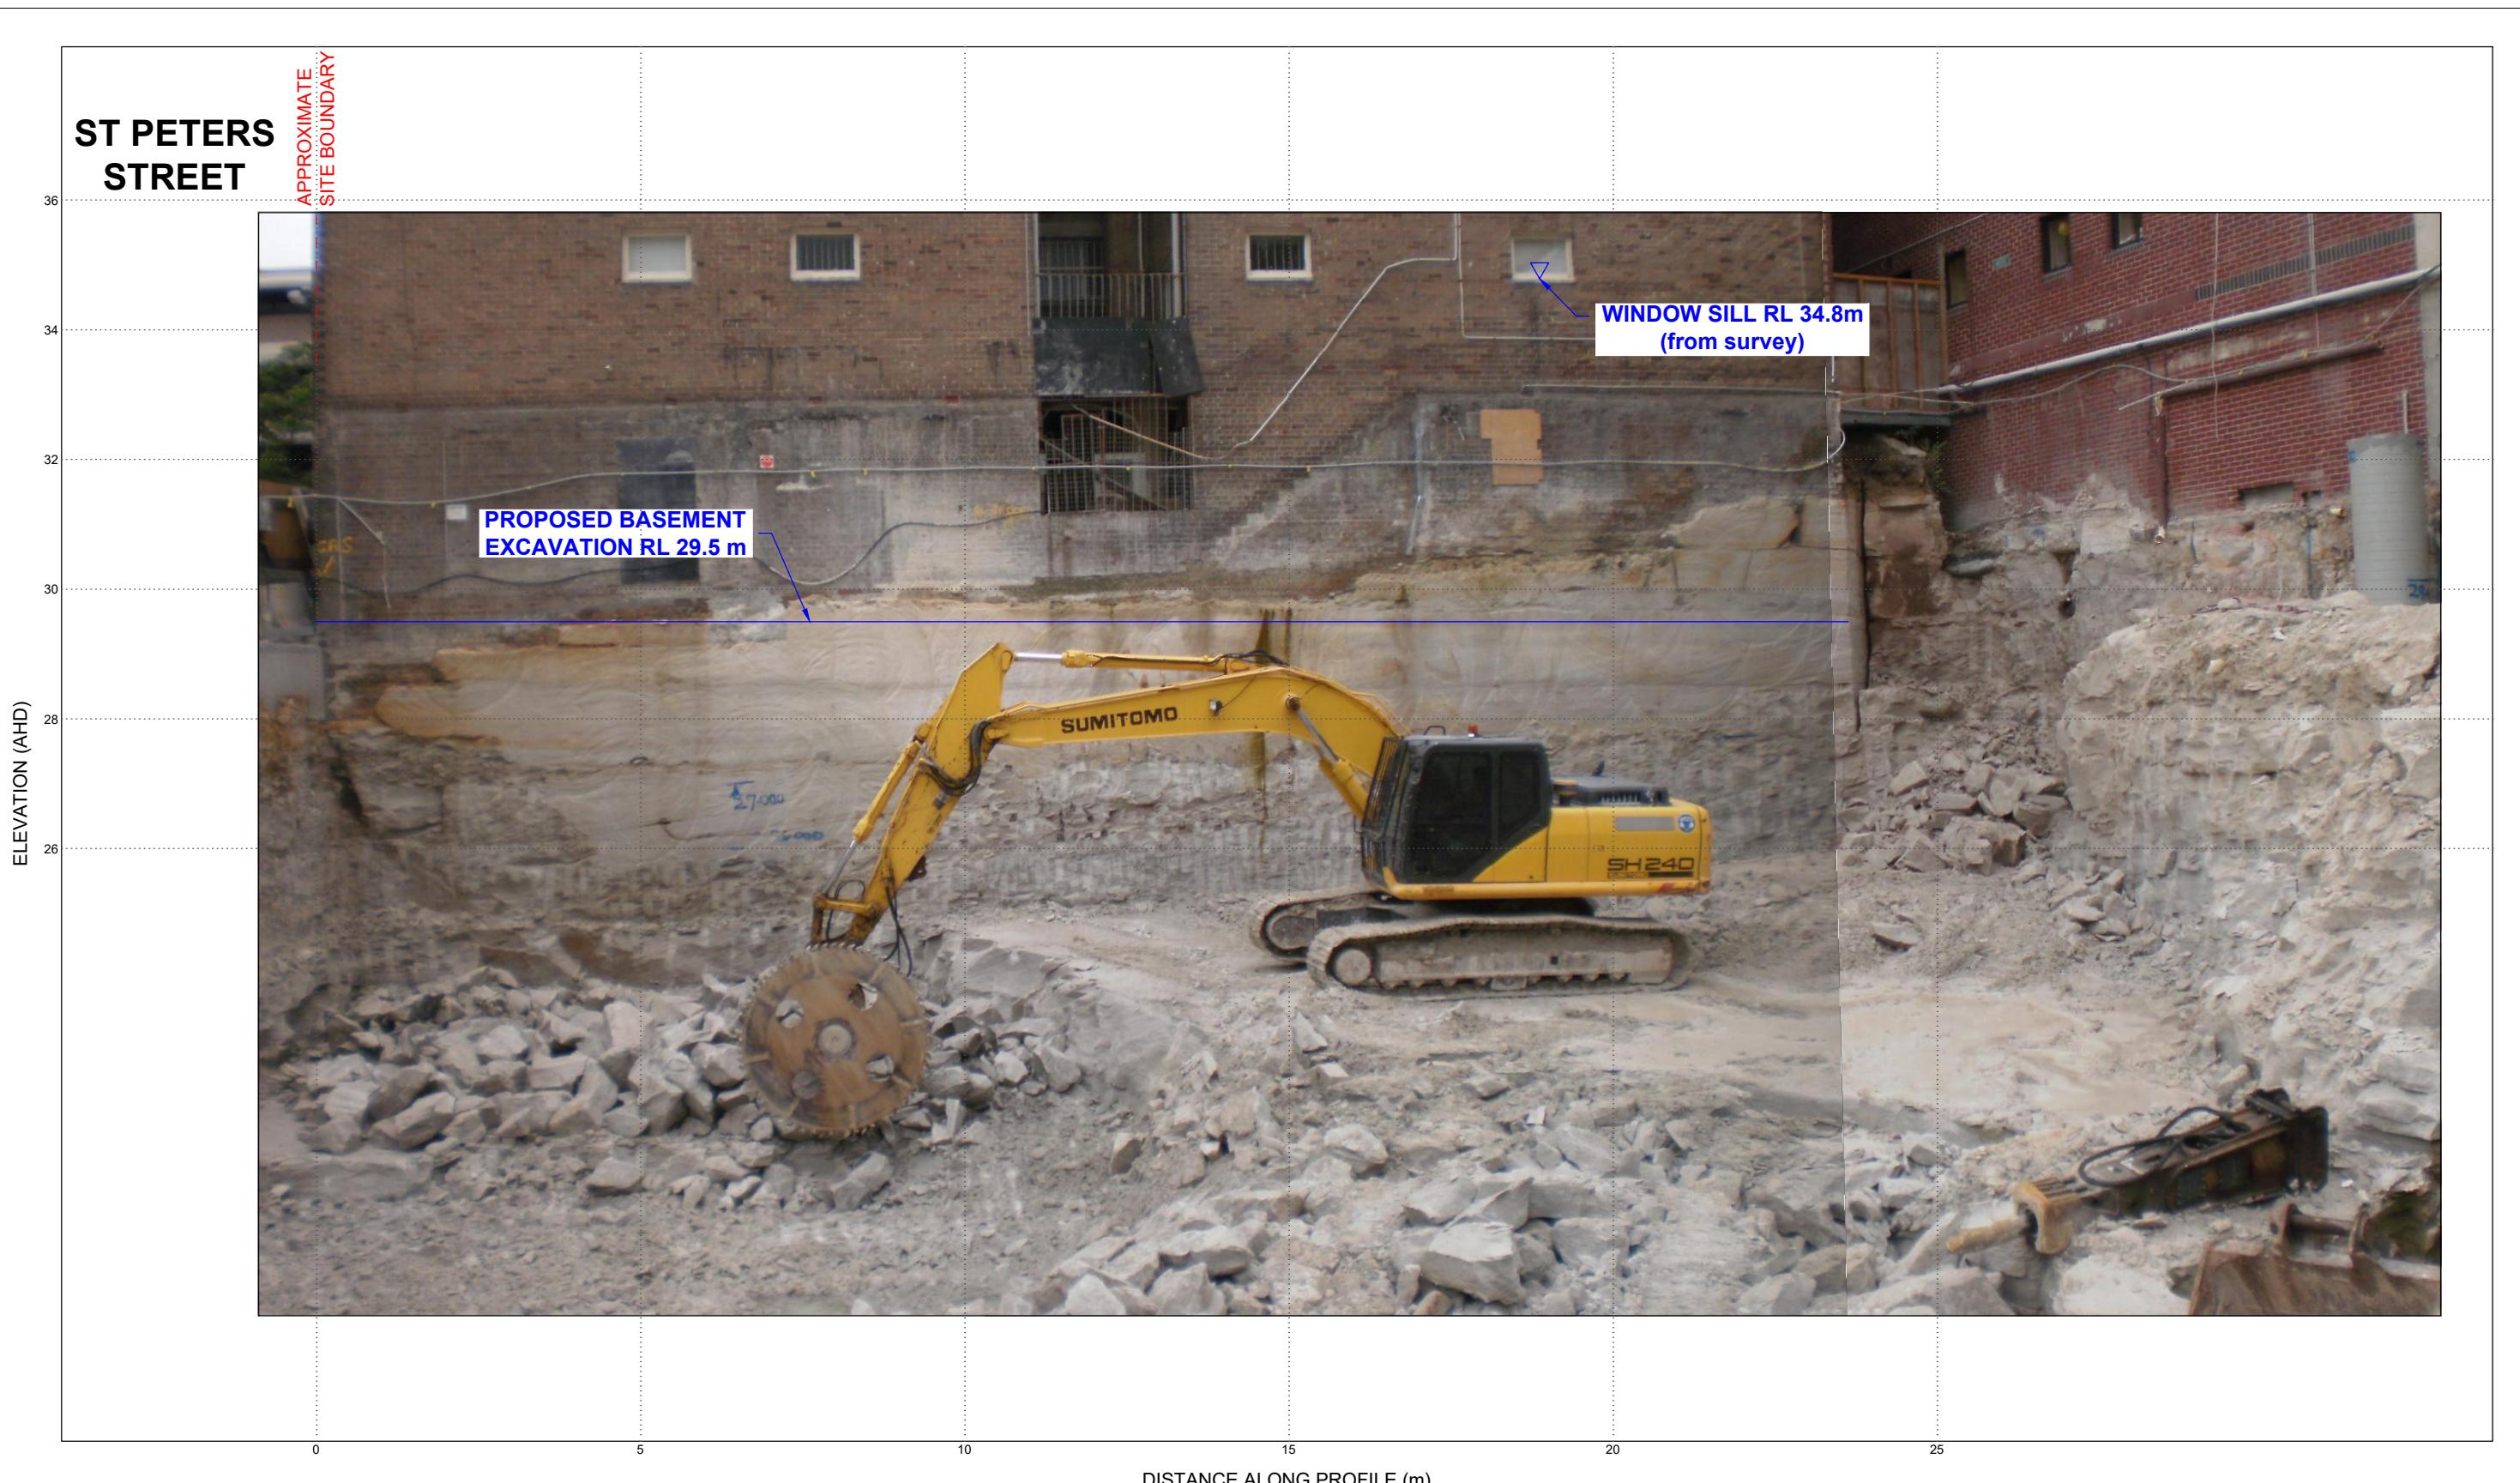
been included in this report. Site photographs of the western boundary wall from within the adjacent basement excavation, taken on 28 January 2011 have been included on Drawing 2 in Appendix B.

- 1: Base image from rock face inspection by Douglas Partners Pty Ltd (Dated 28.01.2011)
- 2: Image approximately to scale only, with reference rockface survey marks and window sill RL from Survey Plan by Rygate & Company Pty Ltd, Reference No. 79584 (Dated 12.04.2021)

It is recommended that a series of test pits be completed adjacent to the base of the brick façade along the perimeter of the proposed excavation when excavation commences to confirm whether underpinning is required. Site photographs of the adjoining basement excavation on 28 January 2011 (included on Drawing 2 in Appendix B) confirms that the western wall of the brick façade is founded on medium to high strength sandstone bedrock.

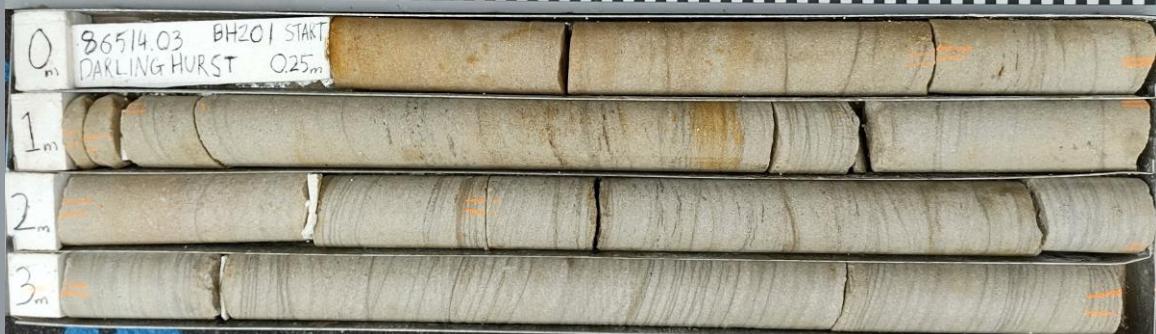
Core Box No.: 1 of 2

Depth: 0.25m - 4.0

0.25m - 4.00m

BORE: BH201

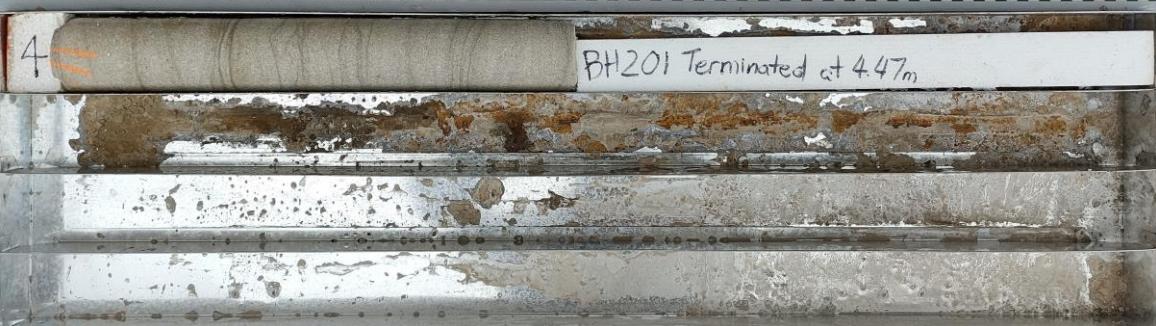
Core Box No.: 2 of 2

Depth: 4.0m - 4.47m

4.00 - 4.47m

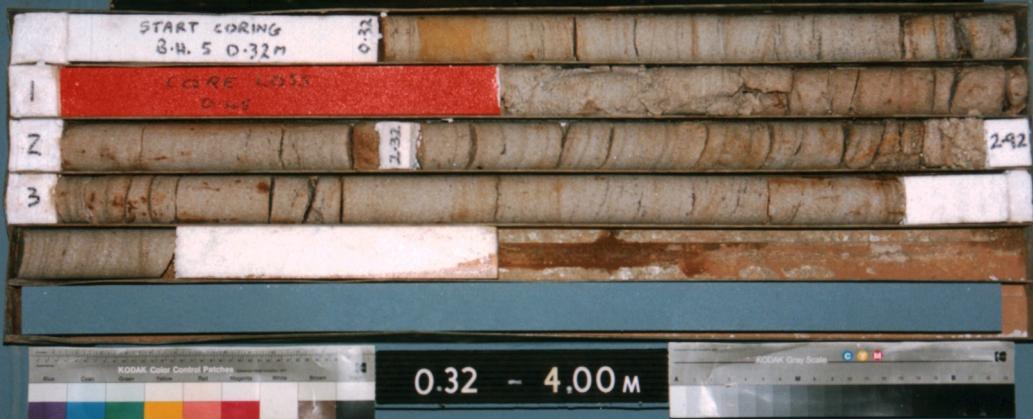
D J DOUGLAS & PARTNERS PTY LTD
PROPOSED SPORTS HALLS - DARLINGHURST
BORE 5 JOB NO 20080 JUNE 1994
