SCEGGS Darlinghurst

Existing stage road safety audit

Report No TRF-PROJ-0034-01 ES RSA SCEGGS REV 3

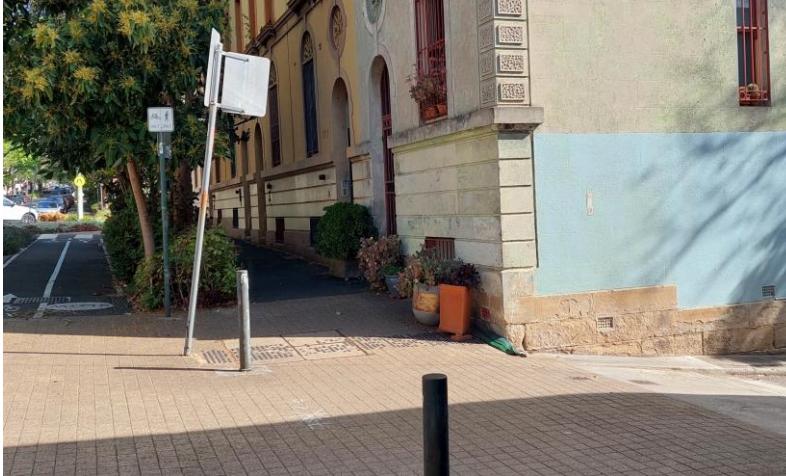
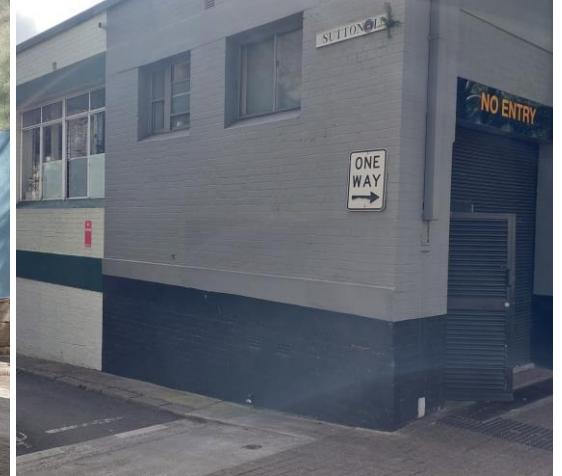
| Ref | Location | Road safety audit finding | Priority |
|---|--|---|---|
| 1 | Sutton Lane at its southern connection with Bourke Street. | <p>The southern connection of Sutton Lane enters Bourke Street within the school zoned section. This side road is a one-way eastbound only road. However, there are several missing signs which are considered critical. These include:</p> <ul style="list-style-type: none">▪ There is no ONE WAY sign indicating the one way <i>eastbound only</i> restriction in this side road, that is visible to southbound traffic on Bourke Street (see left-hand image). The audit team notes that there is a sign for northbound traffic (see right-hand image). As a matter of consistency, there should also be a similar sign for the southbound direction on Bourke Street.▪ There are no access restriction signs for traffic on Bourke Street to prohibit inbound (westbound) movements into Sutton Lane. For example, these could include (i) a pair of NO ENTRY signs facing east with one sign placed either side of Sutton Lane, or (ii) NO RIGHT TURN/ NO LEFT TURN signs for the southbound and northbound travel directions on Bourke Street respectively, or (iii) both sets of signs.▪ An outbound (eastbound) pavement arrow in Sutton Lane would also improve legibility of the one-way <i>eastbound only</i> travel restrictions on this side road. | High |

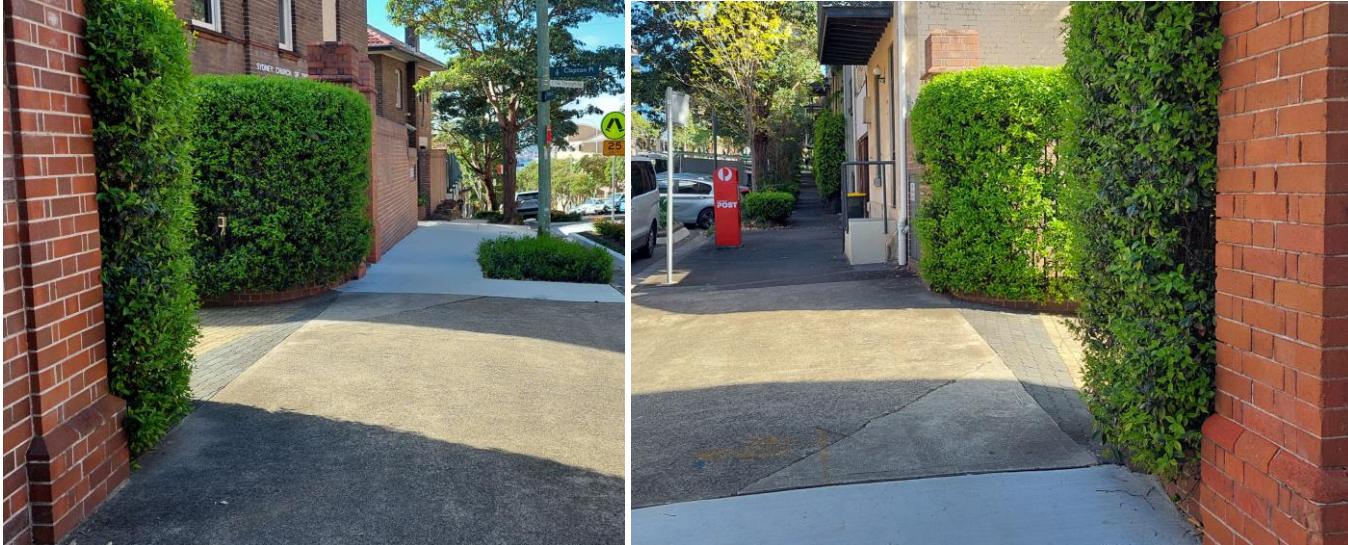
| Ref | Location | Road safety audit finding | Priority |
|---|--|--|---|
| 2 | Vehicular gate to the school from Forbes Street. | <p>There is a vehicular access to the school on the western side of Forbes Street. However, as shown there is limited visibility between any outbound driver from the driveway and pedestrians on the footpath approaching from either direction. The main sight-obstructing features are the hedges and brick walls either side of the driveway. This could present risks of <i>vehicle-pedestrian</i> crashes.</p> <p>Left: Looking north along the western footpath of Forbes Street showing the lack of mutual sight line between a pedestrian facing in this direction, and any egressing driver/ vehicle from this gate. Right: A similar visibility constraint for a southbound pedestrian approaching from the north.</p> | High |

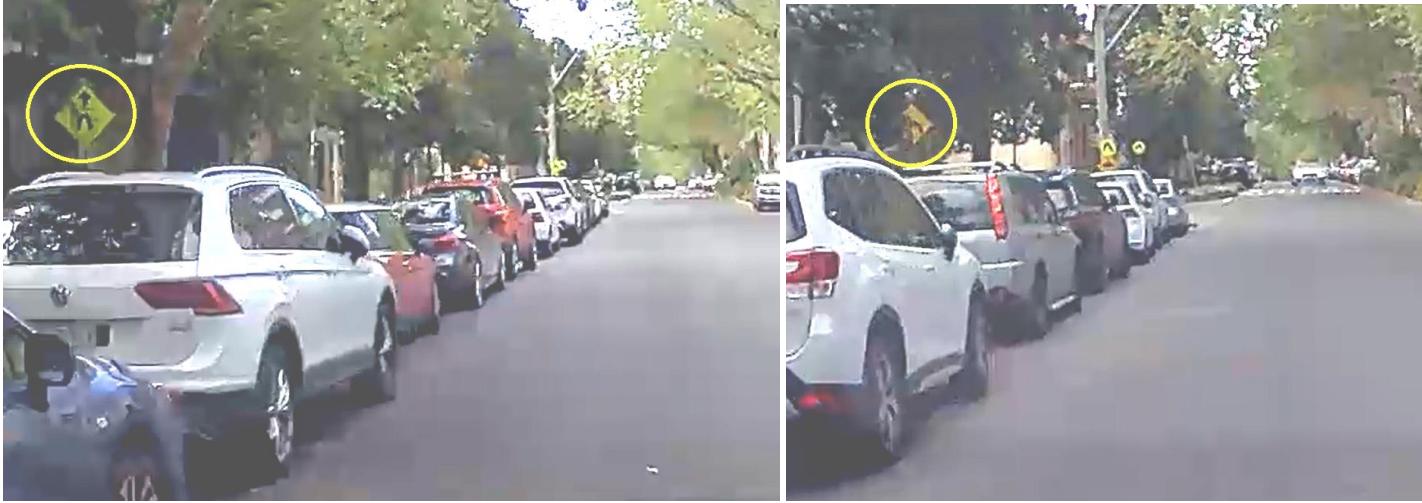
| Ref | Location | Road safety audit finding | Priority |
|---|--|---|---|
| 3 | Northbound direction of Bourke Street between Liverpool Street and Stanley Street. | <p>The PEDESTRIAN CROSSING AHEAD sign (left-hand image) provided for northbound traffic on Bourke Street to the north of Liverpool Street is partially obscured by overhanging tree foliage. This sign may also be blocked by any tall vehicles parked along the western kerbline. This reduces the effectiveness of the sign as an advanced warning device. As such, consideration should be given to providing a zig-zag pavement markings to complement this sign.</p> <p>Further north, there is a sign warning of <i>left-turn on bicycle</i> crashes (see right-hand image). This sign is also partially obscured by overhanging tree foliage. As such, drivers that fail to see/ notice this sign may lack awareness of cyclists crossing over Stanley Street. This could lead to <i>left-turn on bicycle</i> crashes or near miss events.</p> <p>Left: The PEDESTRIAN CROSSING AHEAD sign is partially obscured by overhanging tree foliage. Northbound drivers may lack awareness of the wombat crossing in the road ahead, including its pedestrians. The crossing would be used by many school students as part of their walk-trips to and from the school. Right: The overhanging foliage on the western side of Bourke Street also visually obscures the LEFT TURN ON BICYCLE CRASH warning sign.</p> | Medium |

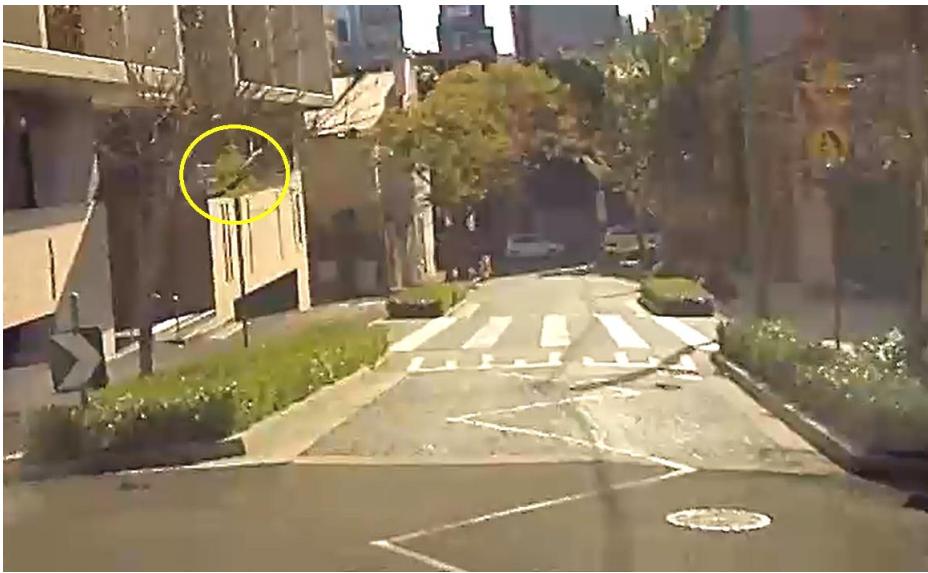
| Ref | Location | Road safety audit finding | Priority |
|---|---|---|---|
| 4 | Wombat crossing on St. Peters Street. | <p>A wombat crossing is in place over St. Peters Street to provide pedestrian access between the two campuses of the school. PEDESTRIAN CROSSING ("WALKING FEET") signs are in place on both sides of the road. There is also a HUMP 25KM/H sign on the right-hand signpost assembly. Both of these signage assemblies are partially obscured by overhanging tree branches. The left-hand (southern) sign is most critically affected as circled in yellow below. If drivers fail to see this sign, they may lack awareness of the crossing and the presence of pedestrians. This risk would be exacerbated when the tree is in full bloom. At the time of the inspections, the tree lacked foliation (presumably part of its seasonal growth cycle).</p> <p>As shown in the image below, the right-hand (northern) signage assembly is also partially obscured.</p> <p><i>Left: Looking westbound along St. Peters Street showing the two partially obscured signage assemblies due to overhanging tree branches.</i></p> | Medium |

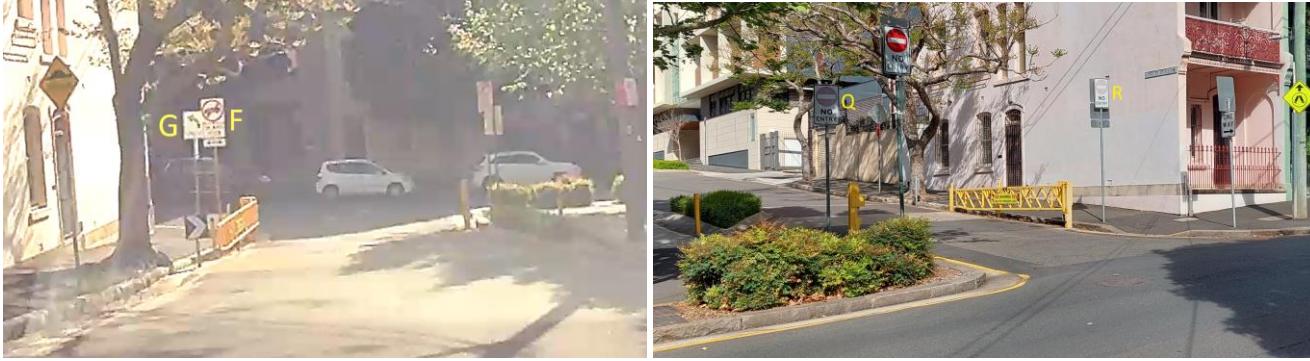
| Ref | Location | Road safety audit finding | Priority |
|---|---|---|---|
| 5 | Western end of St. Peters Street at its interface with Bourke Street. | <p>The audit team noted the following signage issues at the western end of St. Peters Street at its interface with Bourke Street:</p> <ul style="list-style-type: none"> St. Peters Street falls within the signposted school zone since its eastern end is directly accessible from the school zoned section of Forbes Street. The section of Bourke Street that St. Peters Street connects into is not yet part of the Bourke Street school zone (the school zone on Bourke Street commences further to the south of this point). As such, there needs to be an END SCHOOL ZONE – 40 sign provided for outbound (westbound) traffic on St. Peters Street so that drivers are aware that they are leaving the school zone. Although Bourke Street is still within a 40km/h area zone, drivers still need to be aware of when they are in a 40km/h school zone versus a 40km/h common speed zone. This is because there are additional penalty implications for road rule breaches when in school zones versus non-school zones. There is a NO TRUCKS – 3 TONNES AND OVER sign in place for outbound (westbound) traffic on St. Peters Street labelled F in the left-hand image. This contains a two-way arrow base plate. Although the two-way arrow indicates that the overhead load limit rule applies to both directions of Bourke Street, this is potentially misleading. As noted from the other signs in place, all westbound traffic on St. Peters Street are required to turn left into Bourke Street. The most significant sign effecting this rule is the LEFT TURN ONLY sign (labelled G). However, sign G is partially obscured by sign F. Furthermore, the two-way arrow on sign F gives a false impression that outbound traffic (as long as they are under 3 tonnes in GVM) would normally be allowed to turn left or right. In these respects, consideration should be given for removing the NO TRUCKS – 3 TONNES AND OVER sign and its two-way arrow base plate (sign F). There is not expected to be a high volume of offending trucks in the first place since St. Peters Street is gated, and has a local access road character. Furthermore, if there were any offending vehicles at this point, they have no choice but to proceed into Bourke Street since any other alternative movement would also involve a road rule breach (such as u-turning and proceeding the wrong way along St. Peters Street). The load limit restriction should really commence at a more strategic point such as the entry to the section of Forbes Street from its intersection with Liverpool Street. There are three NO ENTRY signs facing west to advise drivers on Bourke Street that they are not permitted to enter St. Peters Street (in the eastbound direction). Two of these signs (labelled Q and R in the right-hand image) are severely faded and lack effectiveness as regulatory signs. <p>Left: Looking westbound along St. Peters Street towards Bourke Street. There is no END SCHOOL ZONE sign, and the “NO TRUCKS” sign (F) blocks visibility to the more critical LEFT TURN ONLY sign (G). Right: Looking eastbound from Bourke Street to St. Peters Street. The NO ENTRY signs labelled Q and R are severely faded. Sign Q may not be necessary since there is another more prominent NO ENTRY sign in front of this.</p> | Medium |

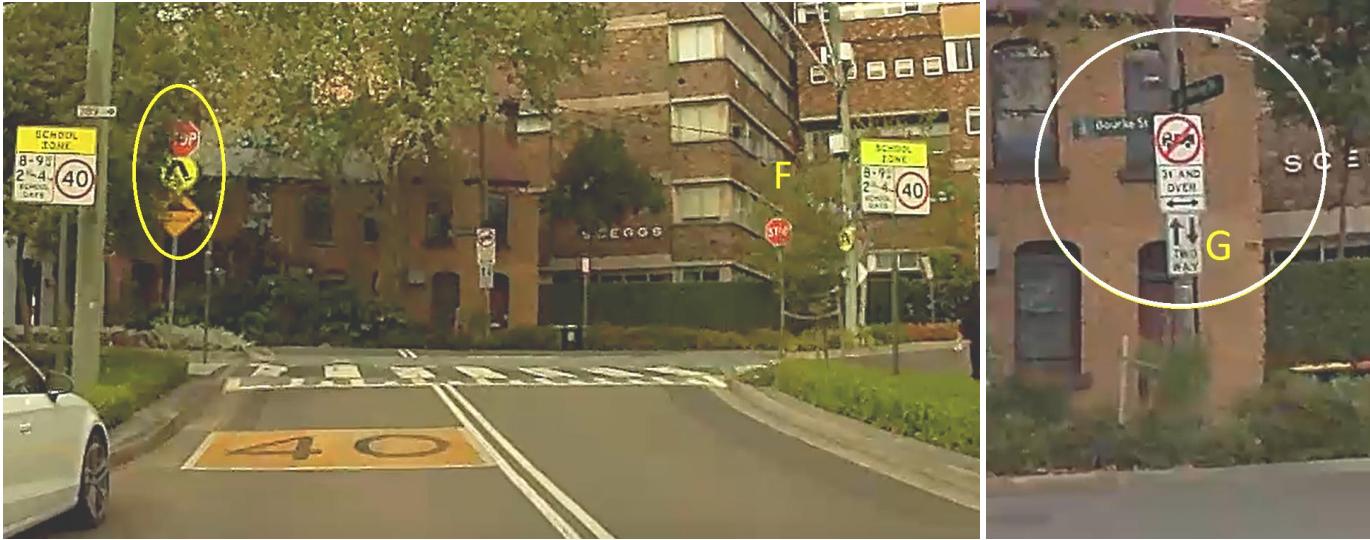
| Ref | Location | Road safety audit finding | Priority |
|---|--|--|---|
| 6 | Eastbound travel direction of Stanley Street in approach to Bourke Street. | <p>For eastbound traffic on Stanley Street, the school zone commences immediately upstream of the Bourke Street intersection. The audit team notes the following signage issues:</p> <ul style="list-style-type: none"> There is a signage assembly consisting of (i) a STOP sign, (ii) a PEDESTRIAN CROSSING "WALKING FEET" sign and (iii) a HUMP 25KM/H sign as circled in yellow in the left-hand image. However, as shown, this signage assembly is partially obscured by overhanging tree foliage. The tree should be pruned to restore visibility. The STOP sign on the three-sign assembly circled in yellow is actually incorrect. Drivers are not required to stop at this point. Rather, they are required to give way to pedestrians on the wombat crossing and cyclists on the two-way cycleway. As such, this STOP sign should be removed. The downstream and right-hand STOP sign at point F is partially obscured by a small tree. This tree should also be pruned to restore visibility to the sign. There is a NO TRUCKS – 3 TONNES AND OVER sign on the eastern side of Bourke Street (see right-hand image) which also contains a two-way arrow base plate and a TWO WAY sign (labelled G). Sign G is unnecessary as there is no condition upstream or downstream of this point that would suggest that any roads are one-way only streets. This sign is also faded and lacks retroreflectivity. It is also unclear whether this sign refers to Stanley Street or Bourke Street. If it refers to Bourke Street, then the arrow directions are very misleading as Bourke Street traffic lanes (from this view point would be left-right aligned, not up-down aligned as the arrows indicate). The audit team also notes that both Bourke Street and Stanley Street are used as part of a bus route and these buses would exceed the 3 tonne load limit. However, it is acknowledged that the load limit is specifically linked to trucks and not other vehicles. <p><i>Left: Looking eastbound along Stanley Street towards Bourke Street where there is a three-sign assembly on the left-hand side which is partially obscured by tree foliage. Right: The TWO WAY sign labelled G is unnecessary.</i></p> | Medium |

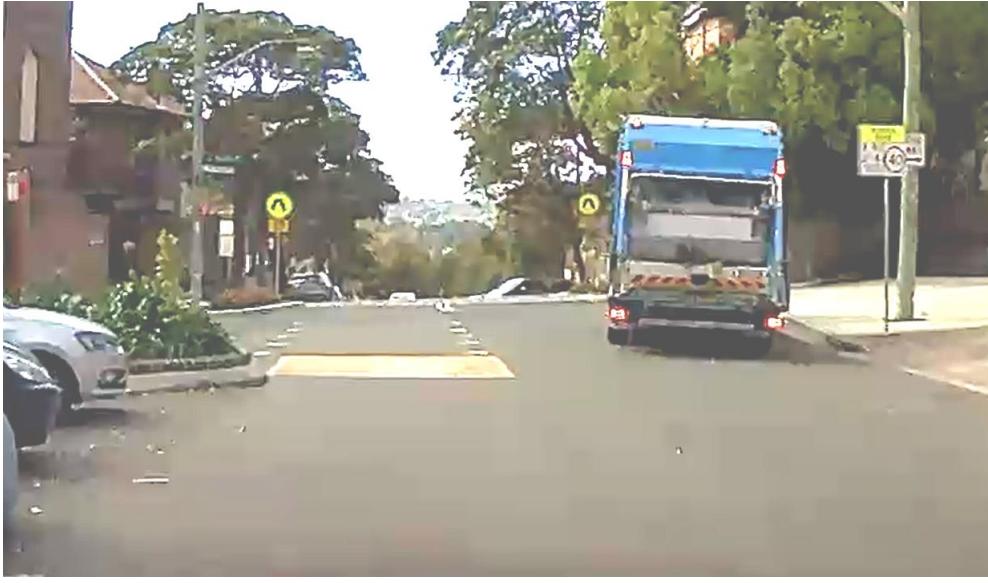
| Ref | Location | Road safety audit finding | Priority |
|---|--|--|---|
| 7 | Northbound direction of Forbes Street at the start of the school zone (just south of Clapton Place). | <p>For northbound traffic on Forbes Street, the school zone commences immediately south of Clapton Place. However, as shown below, there is only one SCHOOL ZONE sign and this is placed on the right-hand (eastern) side of the road. Typically, at changes in speed zones and at commencement of school zones, the speed limit sign (which in this case is the SCHOOL ZONE sign) should be placed on both sides of the road. Consideration should be given to providing an additional SCHOOL ZONE sign on the left-hand (western) side of the road in line with the eastern sign and the 40km/h pavement patch. The audit team acknowledges that upstream of this point, Forbes Street is already part of a 40km/h area zone. However, there are additional road rule and penalty implications when in a 40km/h school zone versus a common 40km/h speed zone. As such, it is critical that drivers understand when they are in a school zone.</p> <p>The 40km/h pavement patch is also faded and should be re-marked.</p> <p>Left: Looking northbound along Forbes Street where there is only one SCHOOL ZONE sign, placed on the right-hand (eastern) side of the road.</p> | Medium |

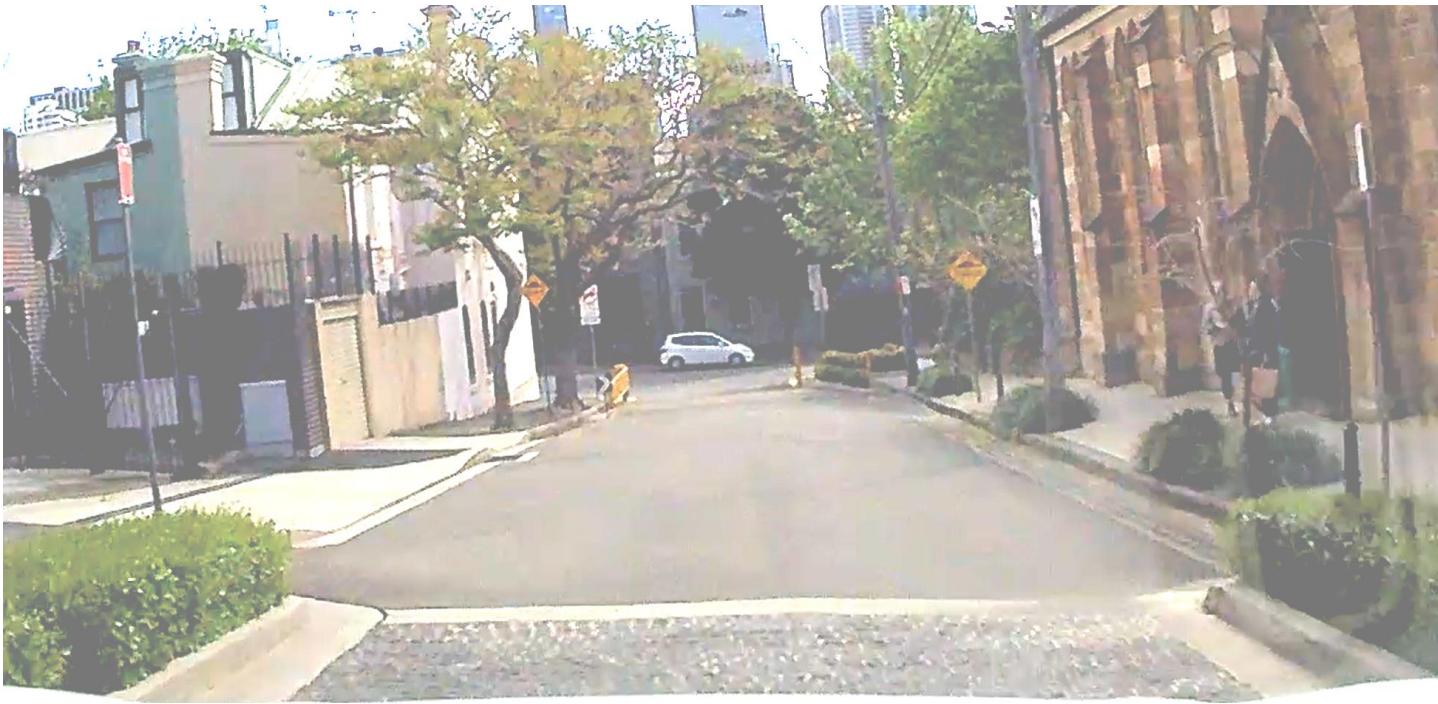
| Ref | Location | Road safety audit finding | Priority |
|---|--|--|---|
| 8 | Kerbline parking restrictions on St Peters Street. | <p>On St Peters Street to the west of the wombat crossing, the northern kerbline is mostly signposted as a <i>no parking</i> zone, which means that drivers can stop (including to drop off and pick up passengers) but they are not allowed to leave the car unattended. The southern kerbline of the road is signposted as a <i>no stopping</i> zone which means that drivers cannot stop or park. This is a missed opportunity as described below.</p> <p>As St Peters Street is a one-way <i>westbound only</i> road, the northern side of the road is effectively the “driver-side” of the road and the southern side of the road is effectively the “front passenger side” of the road. If drivers are only allowed to pull up along the northern kerbline in accordance with the <i>no parking</i> rule, then any passengers boarding into or alighting from the front passenger seat would be required to walk and stand on the roadway with unnecessary exposure to impacts by other traffic. By contrast, if the parking/ stopping restrictions were swapped such that the southern kerbline becomes a <i>no parking</i> zone, then these same drivers would be able to stop along the southern kerbline. This gives direct kerb access to both front and back left-hand doors of the vehicle and there is substantially less need for the pedestrian to walk or stand on the road.</p> <p>Above: Looking westbound along St. Peters Street. There is a missed opportunity since the southern kerbline, as the more favoured door-to-kerb access side is signposted as a <i>no stopping</i> zone. By contrast, the northern kerbline is signposted as a <i>no parking</i> zone and only the rear right door would have direct car-to-kerb access.</p> | Medium |

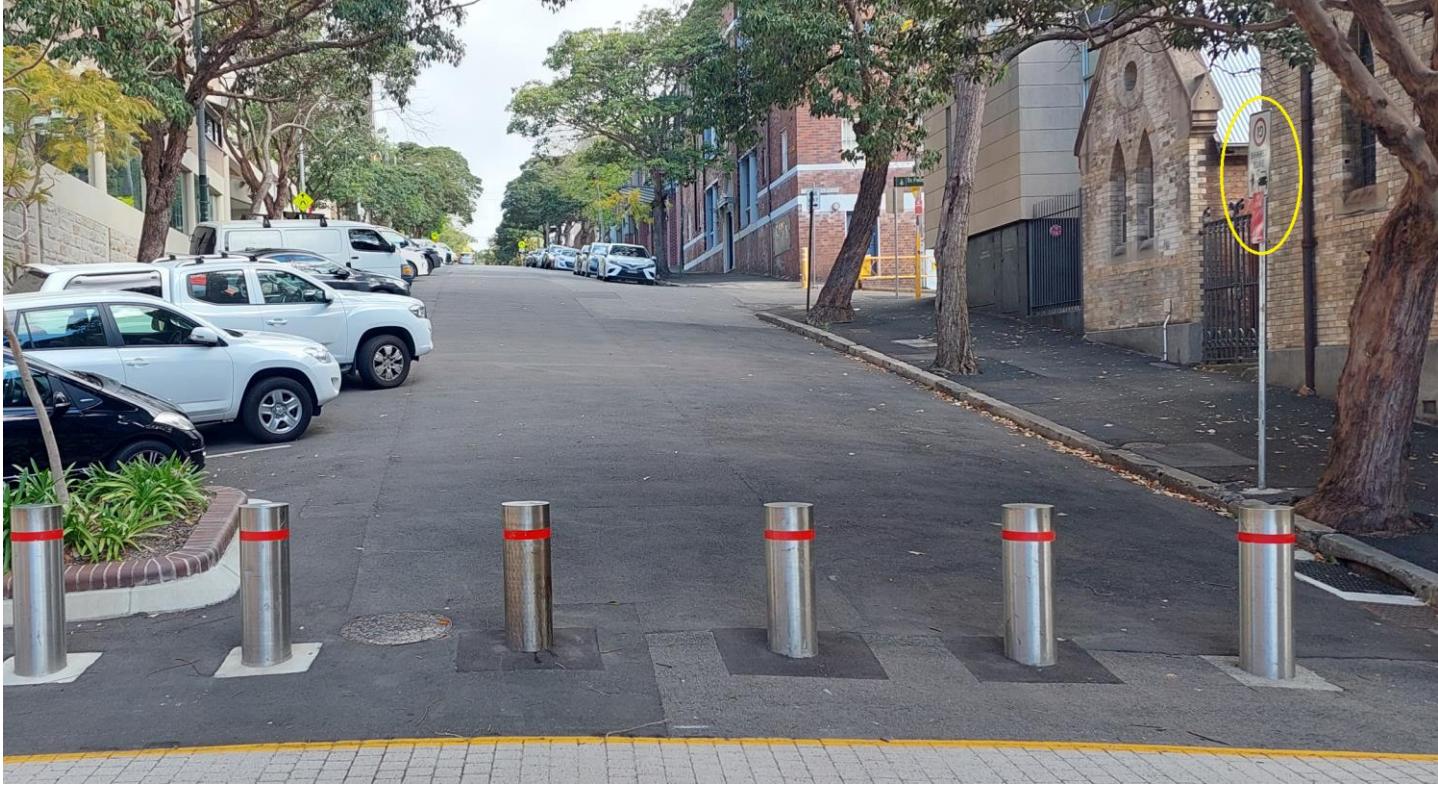
| Ref | Location | Road safety audit finding | Priority |
|---|---|---|---|
| 9 | Northern end of Forbes Street at its cul-de-sac terminal. | <p>The northern end of Forbes Street is a <i>no through road</i> for road vehicles and terminates as a cul-de-sac. <i>Through</i> access to St Peters Lane is still available for pedestrians and cyclists. A 10km/h SHARED ZONE sign is provided as circled in yellow. This is to advise the speed zone and shared space conditions of St. Peters Lane. However, this sign faces east such that it is not immediately clear that it applies to St Peters Lane. The sign should ideally face south towards pedestrians and cyclists that would be moving from Forbes Street into St Peters Lane. The sign should also be placed closer to the interface between these two roads to make it clear where this speed zone and shared space boundary is. Also, a smaller sign should be used to make it clear that it is only intended for pedestrians and cyclists (not drivers of road vehicles).</p> <p>Above: A 10km/h SHARED ZONE sign is provided at the northern end of Forbes Street. However, this faces east and is not immediately clear that it applies to St Peters Lane.</p> | Medium |

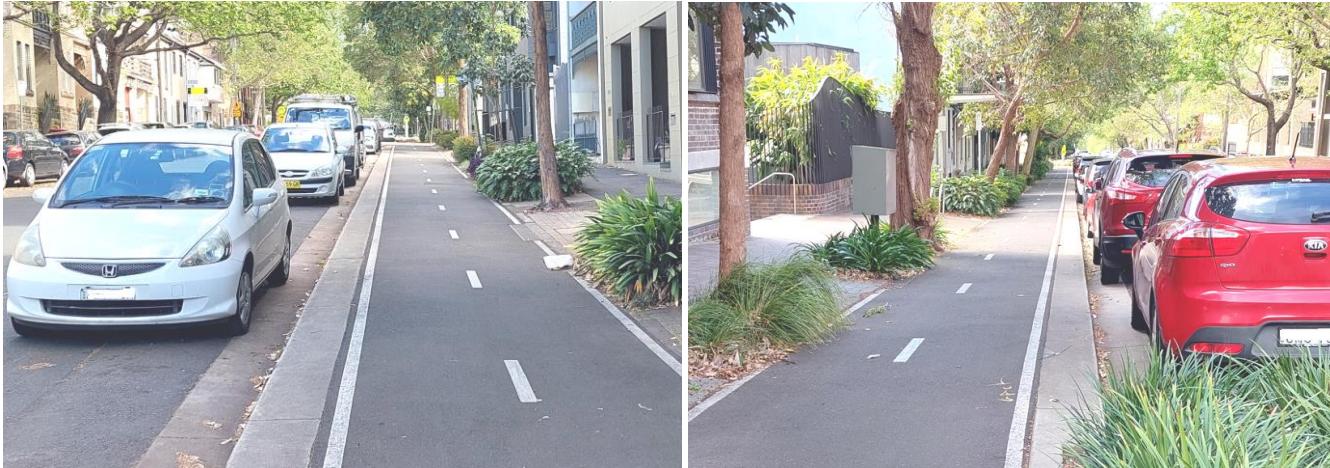
| Ref | Location | Road safety audit finding | Priority |
|---|---|---|---|
| 10a | Cycleway on western side of Bourke Street throughout the length of the school zone. | <p>A two-way cycleway is in place on the western side of Bourke Street. The audit team notes the following spatial clearance issues for cyclists on this facility:</p> <ul style="list-style-type: none"> There is limited door-opening clearance between vehicles parked in the adjacent parallel parking lane and the cycleway. Cyclists may be at risk of being struck by opened car doors. They may also be at risk of impacting any pedestrians accessing these parked cars, particularly those that alight from a vehicle unexpectedly. Alternatively, the cyclist may react by veering away from the parked car/ opened door and tracking too close to other cyclists on the path. There are also signs in place stating that Bourke Street is a bus route and that drivers should park as close to the kerb as possible. This further increases the risk of opened door clashes with cyclists. <p>Continued in items 10b and 10c...</p> <p>Left: There is limited door-opening envelope from the parked cars to the cycleway on the western side of Bourke Street. A view in the southbound direction of the cycleway. Right: Looking north along the cycleway.</p> | Medium |

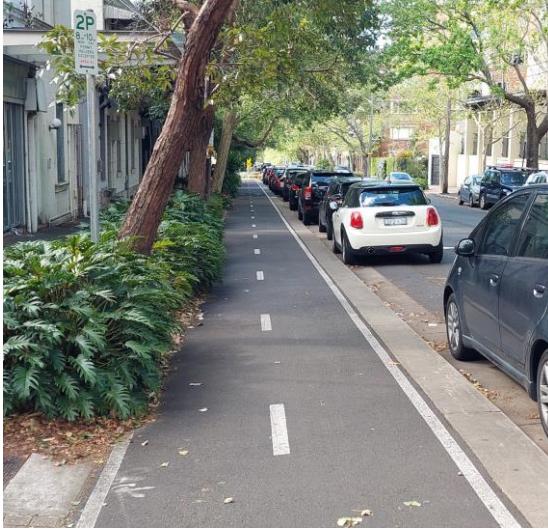
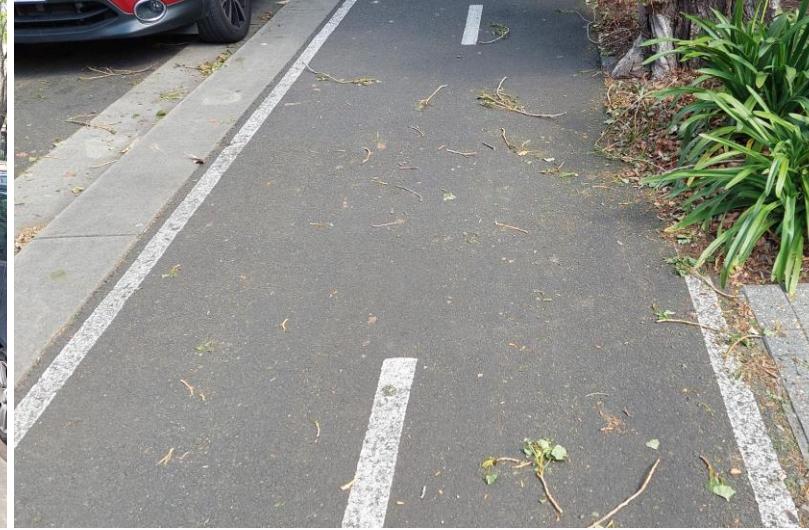
| Ref | Location | Road safety audit finding | Priority |
|---|---|---|---|
| 10b | Cycleway on western side of Bourke Street throughout the length of the school zone. | <p>Continued from item 10a...</p> <ul style="list-style-type: none"> Many of the trees on the western side of the cycleway lean over, or have branches/ foliage that hang over the cycleway. These would pose as obstructions to cyclists on this facility. Alternatively, and as a more likely consequence, many northbound cyclists (the bicycle direction most likely to be affected) would tend to veer to the right and take a more central track/ line along the cycleway. This could impose more <i>head-on</i> crash risk with southbound cyclists. It also shifts both bicycle directions closer to the parked cars and potentially opened doors and alighting passengers. Many of the ground-level shrubbery also encroaches over the edge of the cycleway and could impose a <i>shyline effect</i>, in making cyclists shy/veer away from the edges. Another side effect of the dense tree line is that there was a high degree of leaf and twig litter along the cycleway. Whilst these were light weight and relatively benign to bicycles, they may impose more wheel-snag risk to small-wheeled devices such as scooters. This could lead to toppling/ ejection of the scooter rider. The added risk factor noted during the night-time inspection, is that many parts of this cycleway are poorly lit at night time. Although there are streetlights provided, the tree crowns tend to cast shadows over large portions of the cycleway. <p><i>Left: Looking northbound along the cycleway where there are several large trees that lean over the cycleway. Right: Leaf and twig litter along the cycleway that may pose as a wheel-snag risk for small-wheel devices such as scooters.</i></p> | Medium |

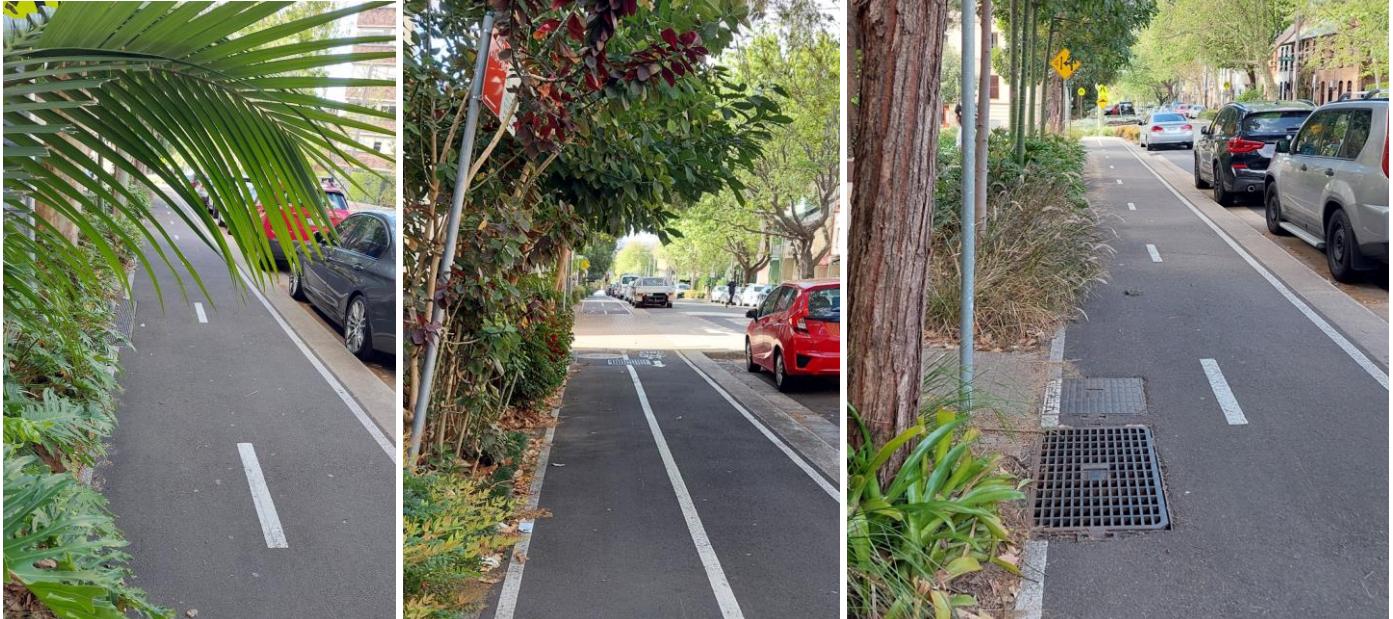
| Ref | Location | Road safety audit finding | Priority |
|---|---|---|---|
| 10c | Cycleway on western side of Bourke Street throughout the length of the school zone. | <p>Continued from items 10a and 10b...</p> <ul style="list-style-type: none"> In addition to posing as lateral width constraints, many of the trees also impose a headroom clearance (vertical) constraint. The fern in the left-hand image and the tree foliage in the middle image reduce the headroom clearance such that cyclists may run into these objects. These may also force cyclists to veer around these trees. Note also the leaning parking sign post in the middle image. Although drainage pits are not considered to be obstructions <i>per se</i>, they have a similar impact since most cyclists do not feel comfortable riding over them. The drainage grate in the right-hand image, whilst being a bicycle-friendly design, would be something that many cyclists would consciously avoid. Cyclists that veer around the pit are more likely to impose <i>head-on</i> crash risks with southbound cyclists. Both bicycle traffic streams are also likely to track closer to the parked cars as a result. <p>Left: Headroom clearance constraint due to the overhanging fern. Middle: Reduced headroom clearance due to the overhanging tree foliage. Right: A drainage pit and grate which may also make cyclists shift towards the parked cars.</p> | Medium |

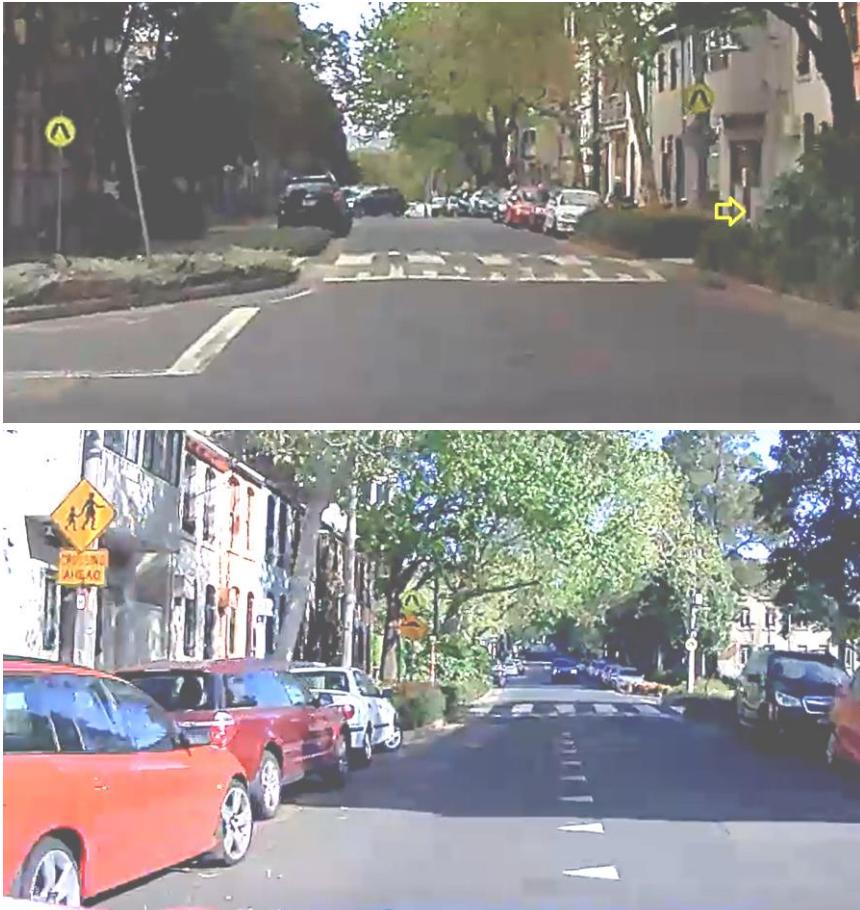
| Ref | Location | Road safety audit finding | | Priority |
|---|--|--|--|---|
| 11a | Wombat crossing over Bourke Street to the north of Stanley Street. | <p>Top: Looking northbound on Bourke Street where the crossing takes the appearance of a wombat crossing, yet it contains flag-holder candy stick poles on the eastern side which are characteristic of childrens crossings. Bottom: Looking southbound towards the same crossing where there is a CHILDREN CROSSING + CROSSING AHEAD signage combination provided. This sign indicates that the facility is a childrens crossing.</p> | <p>A wombat crossing is in place over Bourke Street to the immediate north of Stanley Street. However, drivers may lack awareness of the exact format of this crossing and the prevailing priority rules. The flag-holder candy stick poles on the eastern side of the crossing (southern pole marked by the yellow arrow in the top image) suggest that this crossing operates as a childrens crossing. This is further supported by the CHILDREN CROSSING + CROSSING AHEAD signage combination provided for southbound traffic as shown in the bottom image. On the other hand, there are several features that do not support this as a childrens crossing. These include (i) the lack of STOP lines, (ii) the lack of flag-holder candy stick poles on the western side of the crossing and (iii) the lack of CHILDREN CROSSING + CROSSING AHEAD signage combination for northbound traffic.</p> <p>A decision needs to be made whether this will be a wombat crossing or a childrens crossing, or a combination of both. Signage and pavement marking treatments, as well as flag poles should be provided such that the message is consistent for all road users including northbound and southbound drivers and northbound and southbound cyclists.</p> <p>The audit team notes that there are distinctly different priority rules for wombat crossings (referenced as <i>pedestrian crossings</i> in the NSW Road Rules) and childrens crossing. Most critically, drivers are required to stop when yielding for pedestrians at a childrens crossing. By contrast, they are only required to give way when yielding for pedestrians at wombat (and zebra) crossings.</p> | Low |

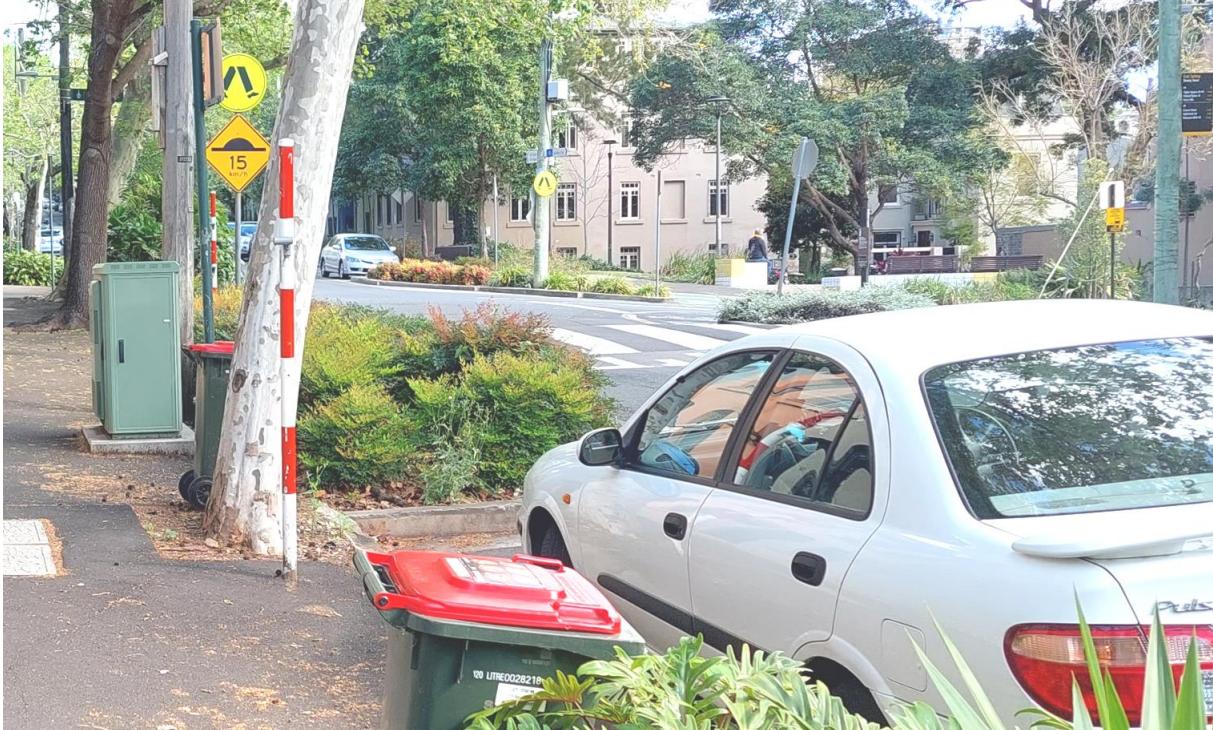
| Ref | Location | Road safety audit finding | Priority |
|---|--|--|---|
| 11b | Wombat crossing over Bourke Street to the north of Stanley Street. | <p>Continued from item 11a...</p> <p>Above: There are flag-holder candy stick poles on the eastern side of Bourke Street (red and white poles). However, there are no corresponding poles on the western side of the road/ crossing. Further to the issues as discussed in item 11a, the pole in the foreground and its accompanying CHILDRENS CROSSING flags (not in place at the time of this photo) would be difficult to see by southbound drivers since it is partially obscured by vehicles parked along the kerbline.</p> | Low |

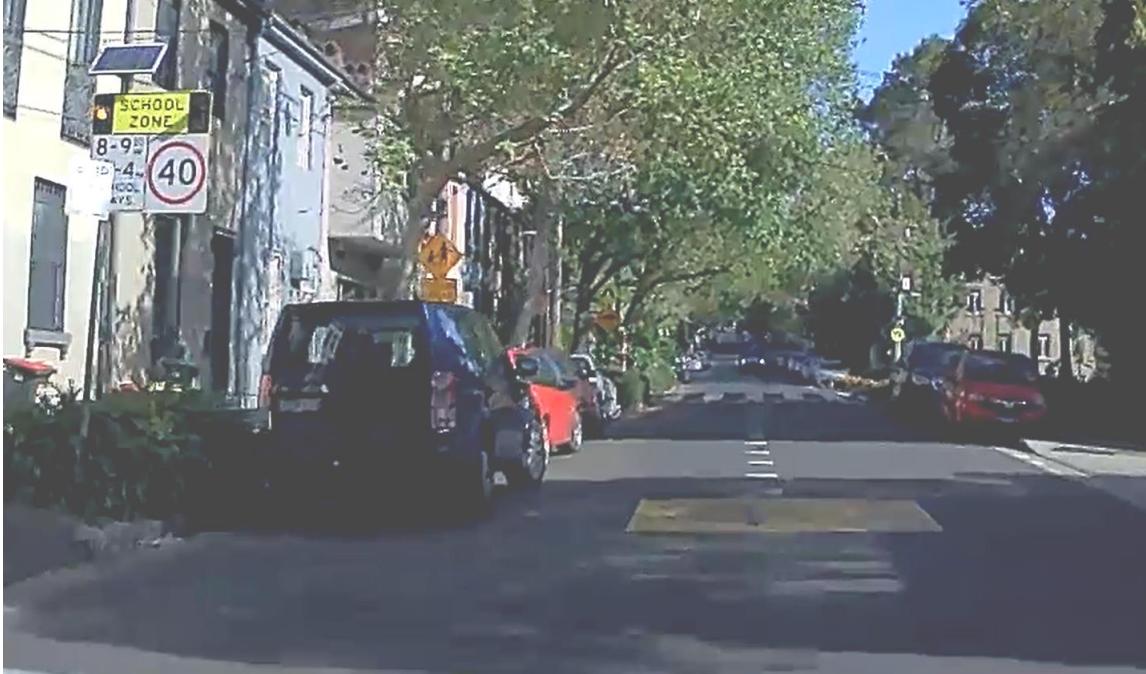
| Ref | Location | Road safety audit finding | Priority |
|---|--|---|---|
| 12 | Southbound direction of Bourke Street at the commencement of the school zone (at the Sutton Lane southern intersection). | <p>A SCHOOL ZONE flashing light assembly is in place to mark the start of the school zone for the southbound direction of Bourke Street. However, the sign is partially obscured by a pair of parking restriction signs. Whilst the impact is limited, and most drivers would still understand and be aware that they are entering a school zone, the partial obstruction could be used as a legal defence against non-complying behaviour. For example, if the driver claims that they were not able to read the supporting information such as the time periods that the school zone is operational, or the SCHOOL DAYS condition.</p> <p>A 40km/h pavement patch is also provided for southbound traffic. However, as shown below, this patch is positioned centrally in the entire roadway rather than in the southbound traffic lane that it applies to. This could give a false impression that the southbound lane is more centrally aligned than it really is. Misguided southbound drivers may track too close to, or even within the northbound traffic lane. This could impose <i>head-on</i> crash risks or simply reduce passing clearance between opposing vehicles. The 40km/h pavement patch is also faded and should be re-marked.</p> | Low |

Above: Looking southbound along Bourke Street at the start of the school zone (near its southern intersection with Sutton Lane).

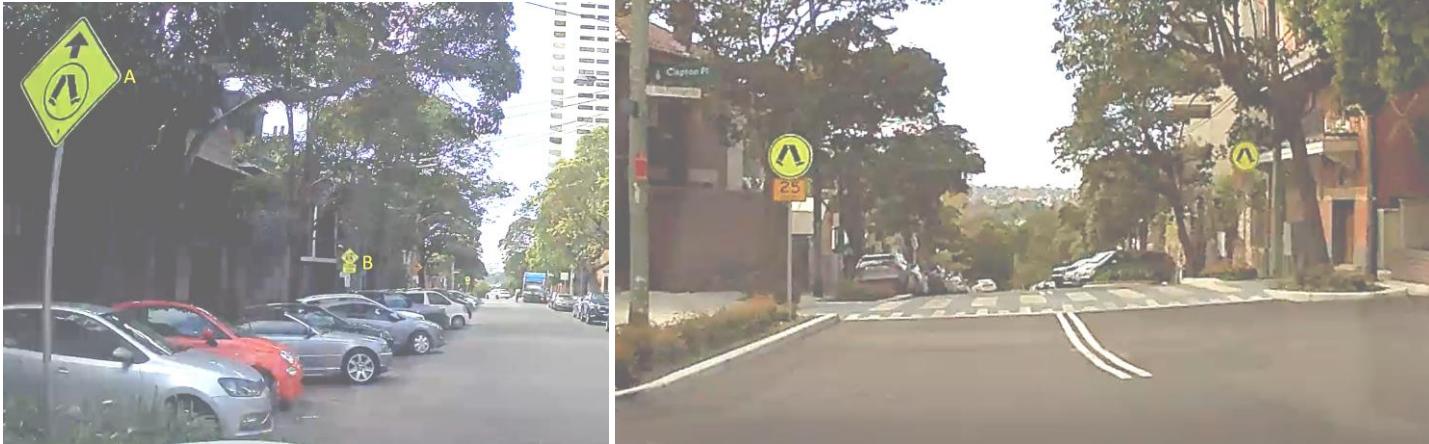
| Ref | Location | Road safety audit finding | Priority |
|---|---|---|---|
| 13 | Wombat crossing over Forbes Street to the north of Clapton Place. | <p>A wombat crossing is in place over Forbes Street to the north of Clapton Place. However, drivers may lack awareness of the exact format of this crossing and the prevailing priority rules. The first sign that northbound drivers encounter is the PEDESTRIAN CROSSING AHEAD sign as labelled "A" in the left-hand image. This indicates that the crossing is either a zebra crossing or wombat crossing and therefore this sign is appropriate. The second sign that the northbound driver encounters is the CHILDRENS CROSSING + CROSSING AHEAD signage combination labelled "B" in the left-hand image. This implies that the crossing would also operate as a childrens crossing. However, the audit team notes the following issues/omissions in these respects:</p> <ul style="list-style-type: none"> ▪ There are no flag-holder candy stick poles (red and white poles) either side of the road to indicate that this is a childrens crossing. These poles would normally be used to support the CHILDRENS CROSSING flags at the times of operation. Also, at the time of the inspections (including the PM school zone period), there were no school crossing supervisors present on this crossing to suggest that this is the control method associated with the childrens crossing. If this is not a childrens crossing, then the CHILDRENS CROSSING + CROSSING AHEAD sign blades at point "B" should be removed and a common PEDESTRIAN (W6-1) sign should be installed instead. ▪ There are also no STOP lines in each direction of Forbes Street prior to the crossing. As such, it would lack legibility as a childrens crossing. This also suggests that the crossing should simply operate as a wombat crossing and not a combined wombat + childrens crossing. ▪ At the crossing itself, a pair of PEDESTRIAN CROSSING ("WALKING FEET") signs is in place as shown in the right-hand image. This is appropriate. However, a 25km/h base plate is provided on the left-hand (western) sign. This should really be accompanied by a HUMP sign as the 25km/h advisory speed applies to the HUMP, not to the crossing <i>per se</i>. <p>The audit team notes that there are distinctly different priority rules for wombat crossings (referenced as <i>pedestrian crossings</i> in the NSW Road Rules) and childrens crossing. Most critically, drivers are required to stop when yielding for pedestrians at a childrens crossing. By contrast, they are only required to give way when yielding for pedestrians at wombat (and zebra) crossings.</p> <p><i>Left: Looking northbound along Forbes Street showing the advanced warning signs in place associated with the wombat crossing.</i> <i>Right: Looking north over the wombat crossing showing all existing signs.</i></p> | Low |

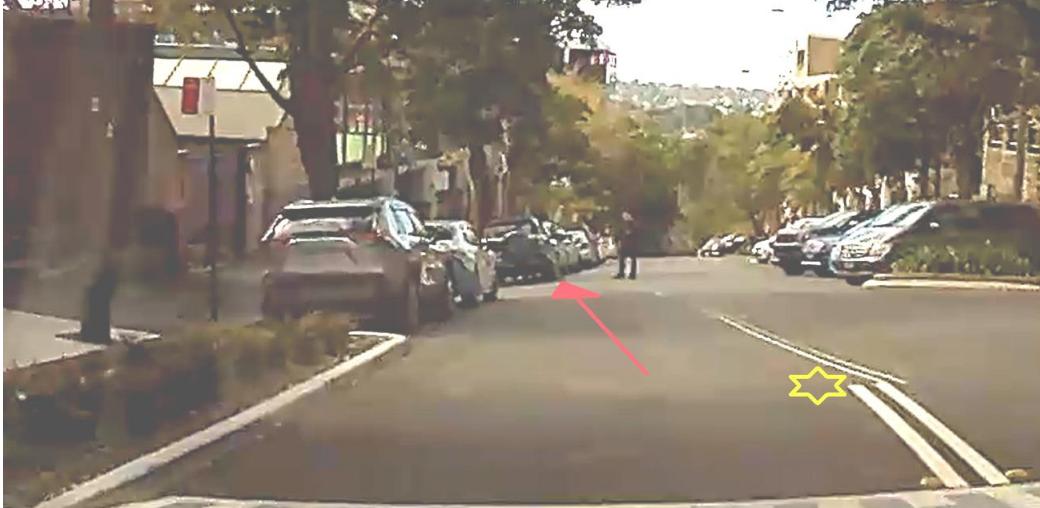
| Ref | Location | Road safety audit finding | Priority |
|---|--|--|---|
| 14 | Forbes Street to the north of the wombat crossing. | <p>A BB double barrier centreline is in place as part of the wombat crossing. However, as shown below, there is a change in the alignment of the traffic lanes to the north of the crossing. This is primarily due to the start of the 60-degree parking on the eastern side of Forbes Street and the need to shift northbound-southbound traffic to the west. The BB centreline has a poor geometric transition as shown below. This includes discontinuity in the centreline itself (marked by yellow star), as well as a sudden change in alignment (see red arrow) with no transition curves included. As a result, northbound traffic would be shifted abruptly to the left (west) and closer to the line of parked cars (in the parallel kerbside parking "lane"). Alternatively, northbound drivers would simply ignore the centreline and drive over it. This appears to be the case with the angled portion of the centreline being faded compared with the upstream one.</p> <p><i>Left: Looking northbound along Forbes Street where there is a poor transition in the BB double barrier centreline.</i></p> | Low |

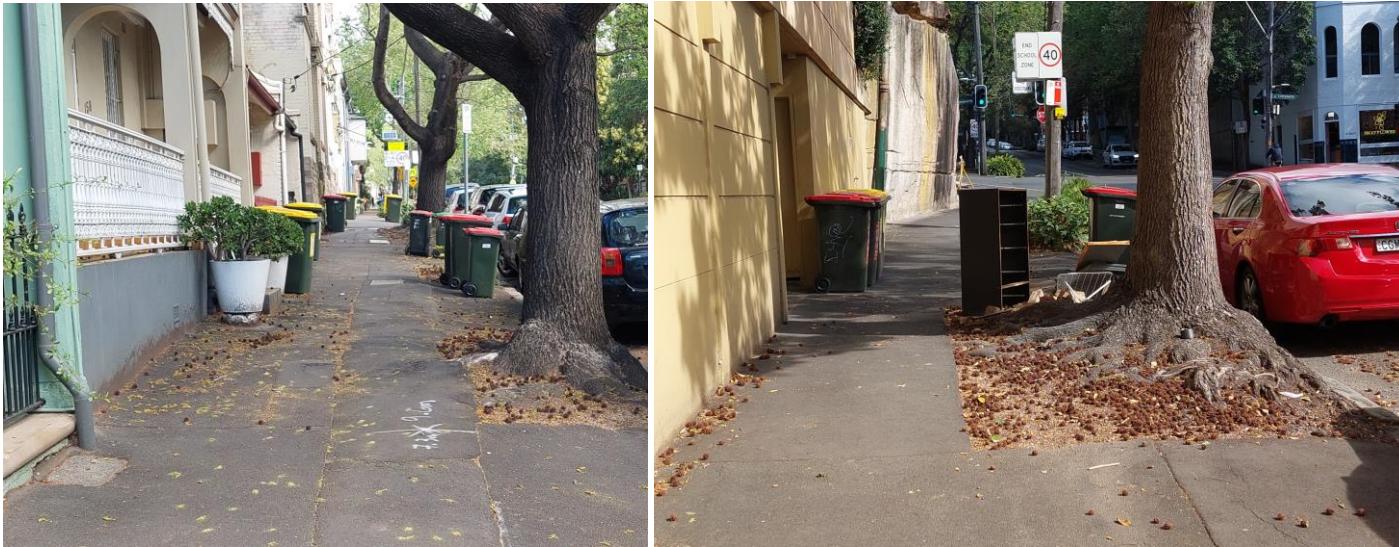
| Ref | Location | Road safety audit finding | Priority |
|---|---|--|---|
| 15 | Eastern footpath of Bourke Street throughout the length of the school zone. | <p>There are many large trees along the eastern side of Bourke Street. These have introduced several access and mobility limitations for pedestrians on the footpath. These include:</p> <ul style="list-style-type: none"> ▪ Many parts of the footpath have been uplifted by root growth. The resulting undulating and cracked footpath has introduced many trip hazards. ▪ There was a high degree of leaf litter and tree material. This may also make the path slippery. <p>Left: Looking south along the eastern footpath of Bourke Street where the footpath has been badly cracked from the adjacent tree root growth. Right: Although there is considerably less pavement cracking, the roots themselves may pose as a trip hazard, especially to pedestrians moving between the footpath and the parked cars. Also, future root growth may lead to uplift and cracking.</p> | Low |
