SCEGGS Darlinghurst

Existing stage road safety audit

Report No TRF-PROJ-0034-01 ES RSA SCEGGS REV 3

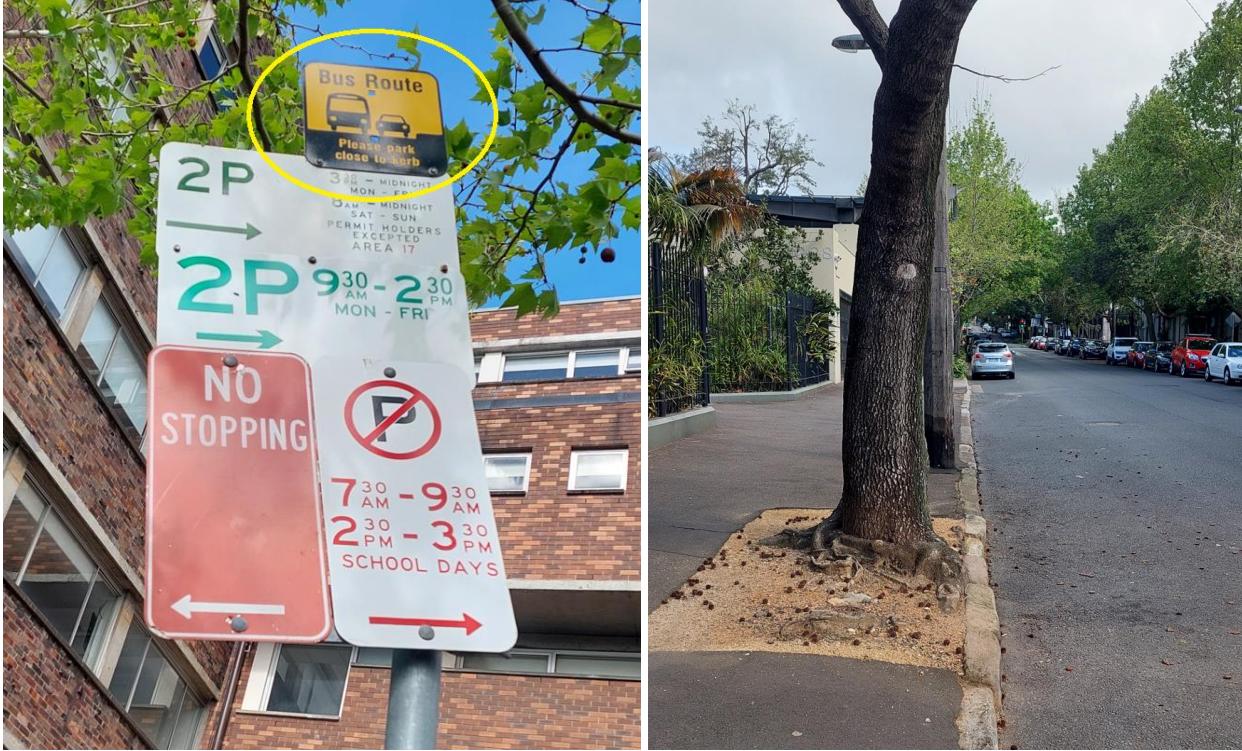
| Ref | Location | Road safety audit finding | Priority |
|---|---|--|---|
| 16 | Eastern side of Bourke Street outside the school gates. | <p>There are signs placed along the eastern side of Bourke Street which advise drivers to park close to the kerbline since Bourke Street is used by buses (see sign circled in yellow in left-hand image). However, if drivers do so, they may be at greater risk of impacting protruding portions of the kerbline. The kerbline is an old sandstone type where many sections jut out into the roadway. The kerbline is not smooth in the same way that a concrete kerb is. Also, as shown in the right-hand image, there are several trees that have limited offset to the roadway and which also lean towards the road. Many drivers could be at risk of impacting the trees if they stop/ park too close to the kerbline. This includes impacts by taller vehicles (mini-buses and vans) and impacts by overhanging vehicle body parts (mirrors, ute-trays) or loads.</p> <p>Left: There are signs along the eastern side of Bourke Street advising drivers to park close to the kerb to leave more residual road width for bus movements. Right: By parking/ stopping close to the kerbline, this could result in more nuisance impacts with the protruding parts of the kerb as well as trees that lean towards the road.</p> | Low |

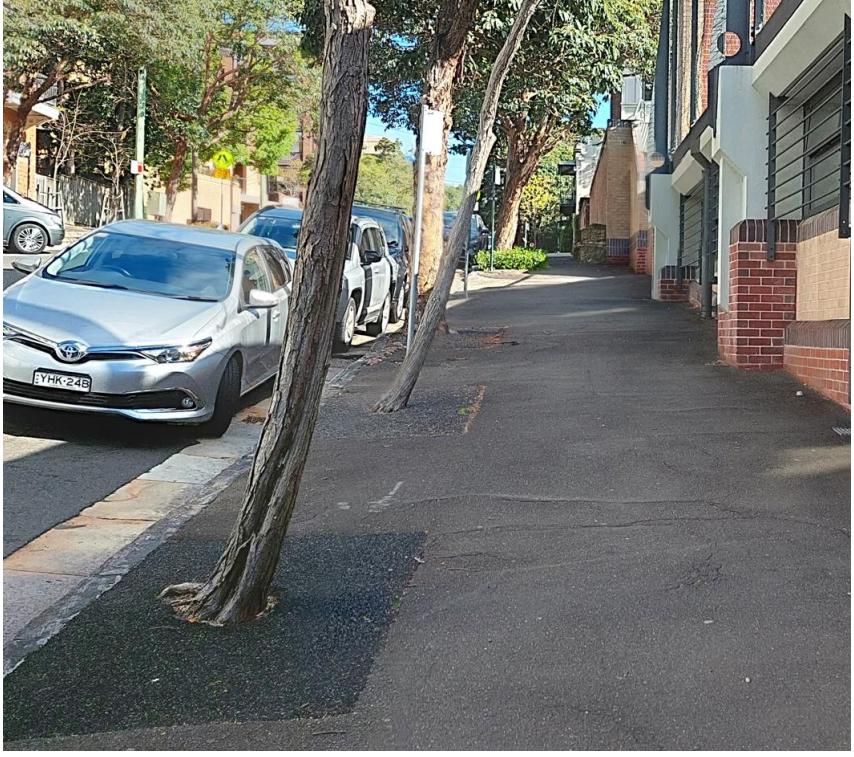
| Ref | Location | Road safety audit finding | Priority |
|---|--|--|---|
| 17 | Western side of Forbes Street along the school frontage. | <p>There are several trees along the western side of Forbes Street which lean across the walk-able area of the footpath. These leaning trunks may pose as head clash hazards for pedestrians or simply obstruct the walk-path. For example, if a vision-impaired pedestrian uses their cane and detects the tree trunk at ground-level, but does not expect the trunk to lean inwards from the point where they make ground-level contact.</p> <p><i>Left: Looking southbound along the western footpath of Forbes Street where there are several leaning trees that obstruct the walk-path for pedestrians.</i></p> | Low |

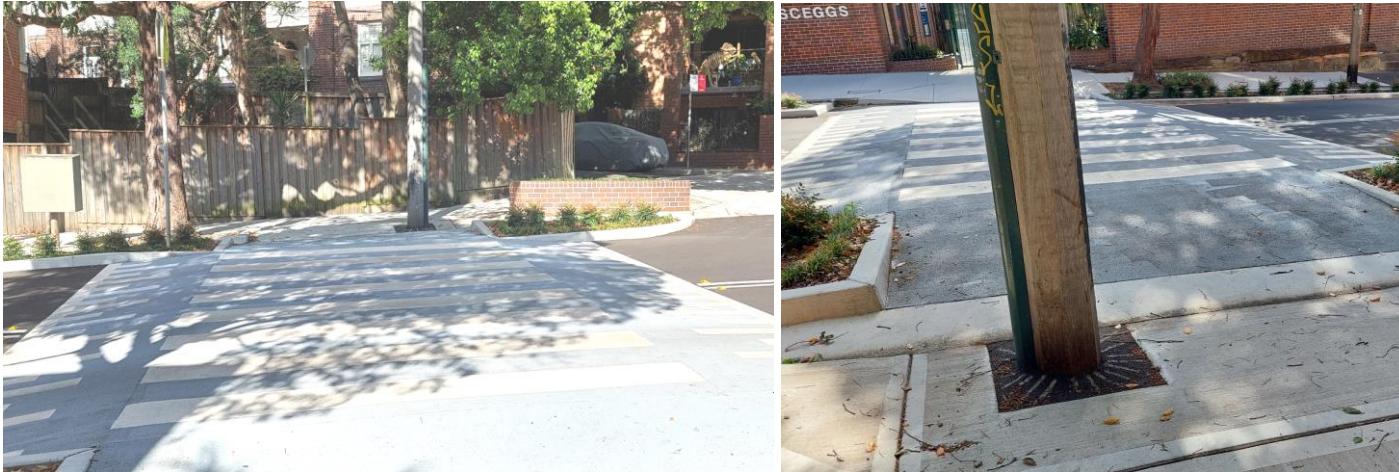
| Ref | Location | Road safety audit finding | Priority |
|---|---|---|---|
| 18 | Eastern side Forbes Street at the wombat crossing. | <p>A wombat crossing is in place on Forbes Street and provides access to the school entrance. However, there is a utility pole on the eastern kerb ramp which partially blocks access to and from the crossing. This may pose as an obstruction to pedestrian movements. The saving grace is that any pedestrians egressing from the crossing would not be trapped on the roadway, but rather in the refuge space created by the kerb blisters. However, any pedestrians with wheeled devices may become stuck at the invert level of the gutter. This includes wheelchair users, walking frames, gophers, and prams.</p> <p><i>Left: Looking east across the wombat crossing showing the utility pole that obstructs the walk-path off the crossing. Right: Looking west across the crossing from the eastern side of the road.</i></p> | Low |
