Preliminary Site Investigation

Woodlawn Advanced Energy Recovery Centre

Veolia Environmental Services (Australia) Pty Ltd

Consultant Document Number: 21455895-003-R-Rev1

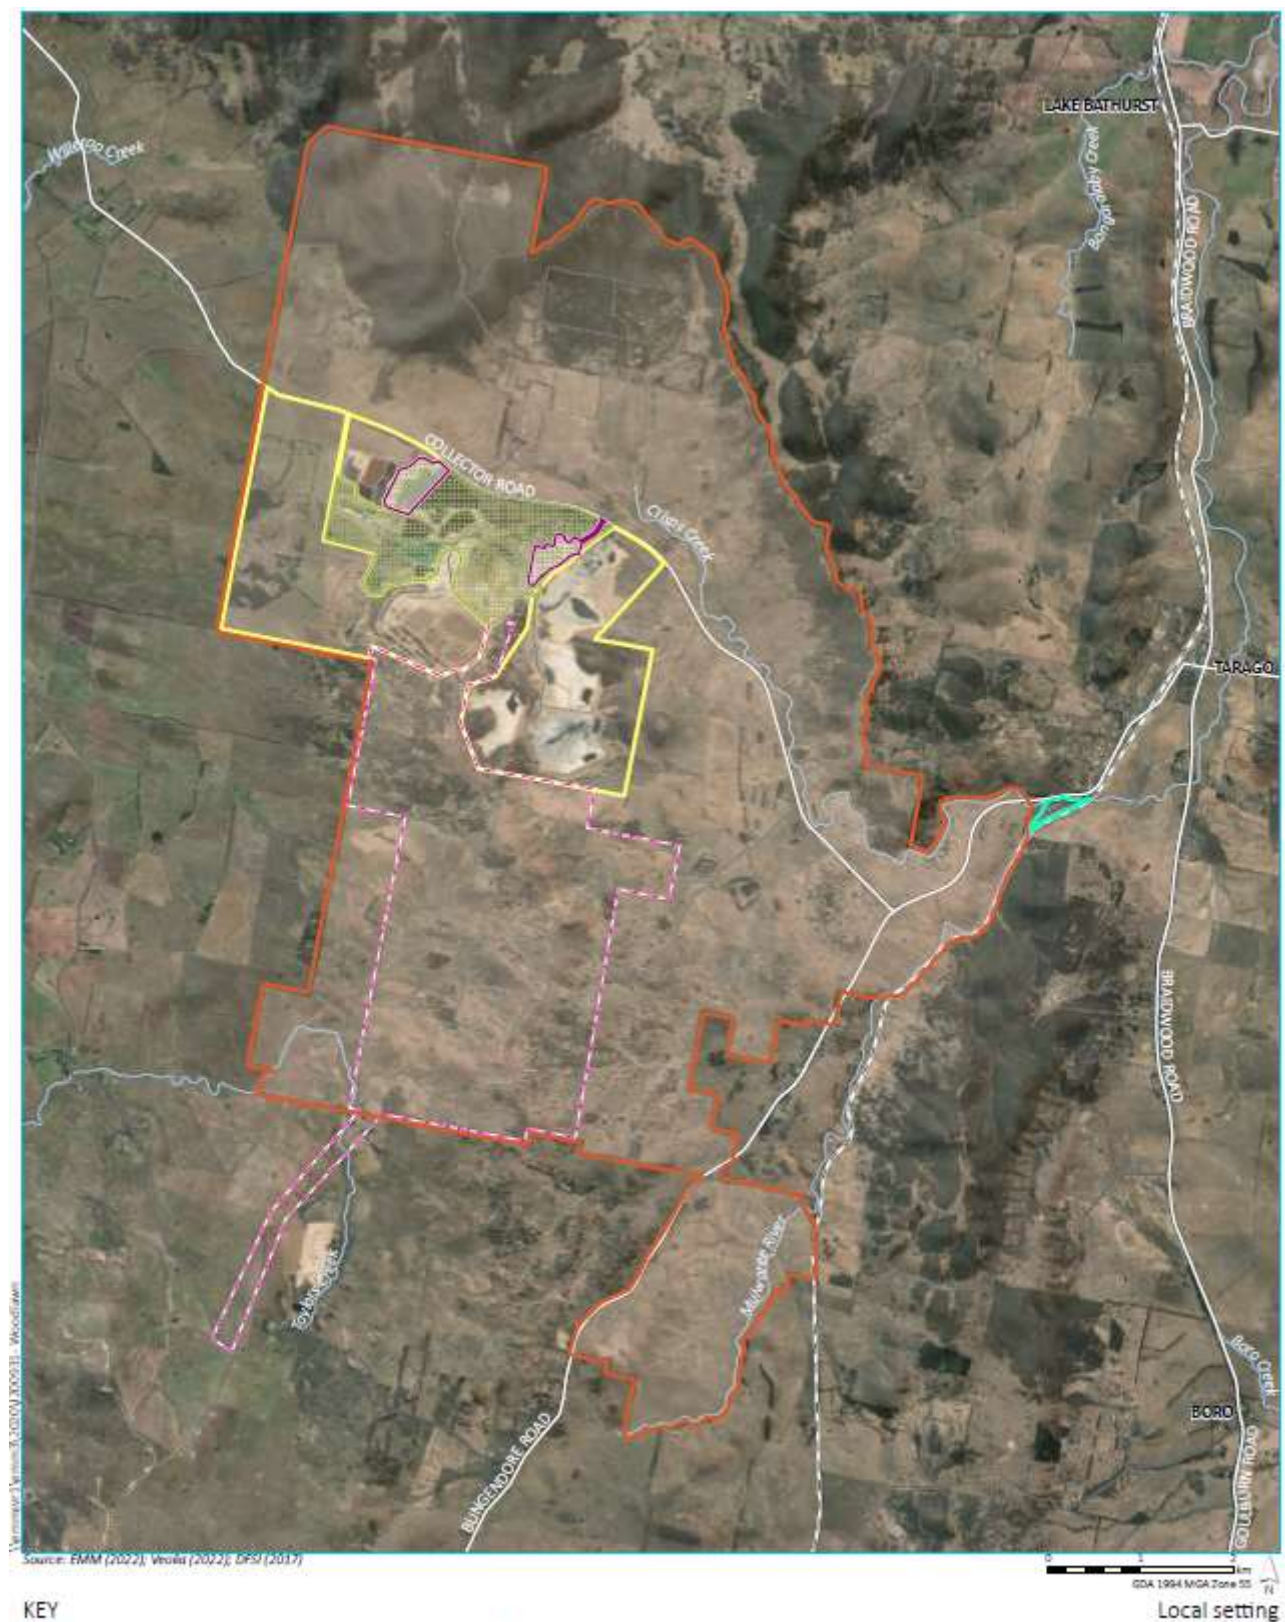
The locations of the investigation areas and proposed ARC development are on Plate 1 (below).

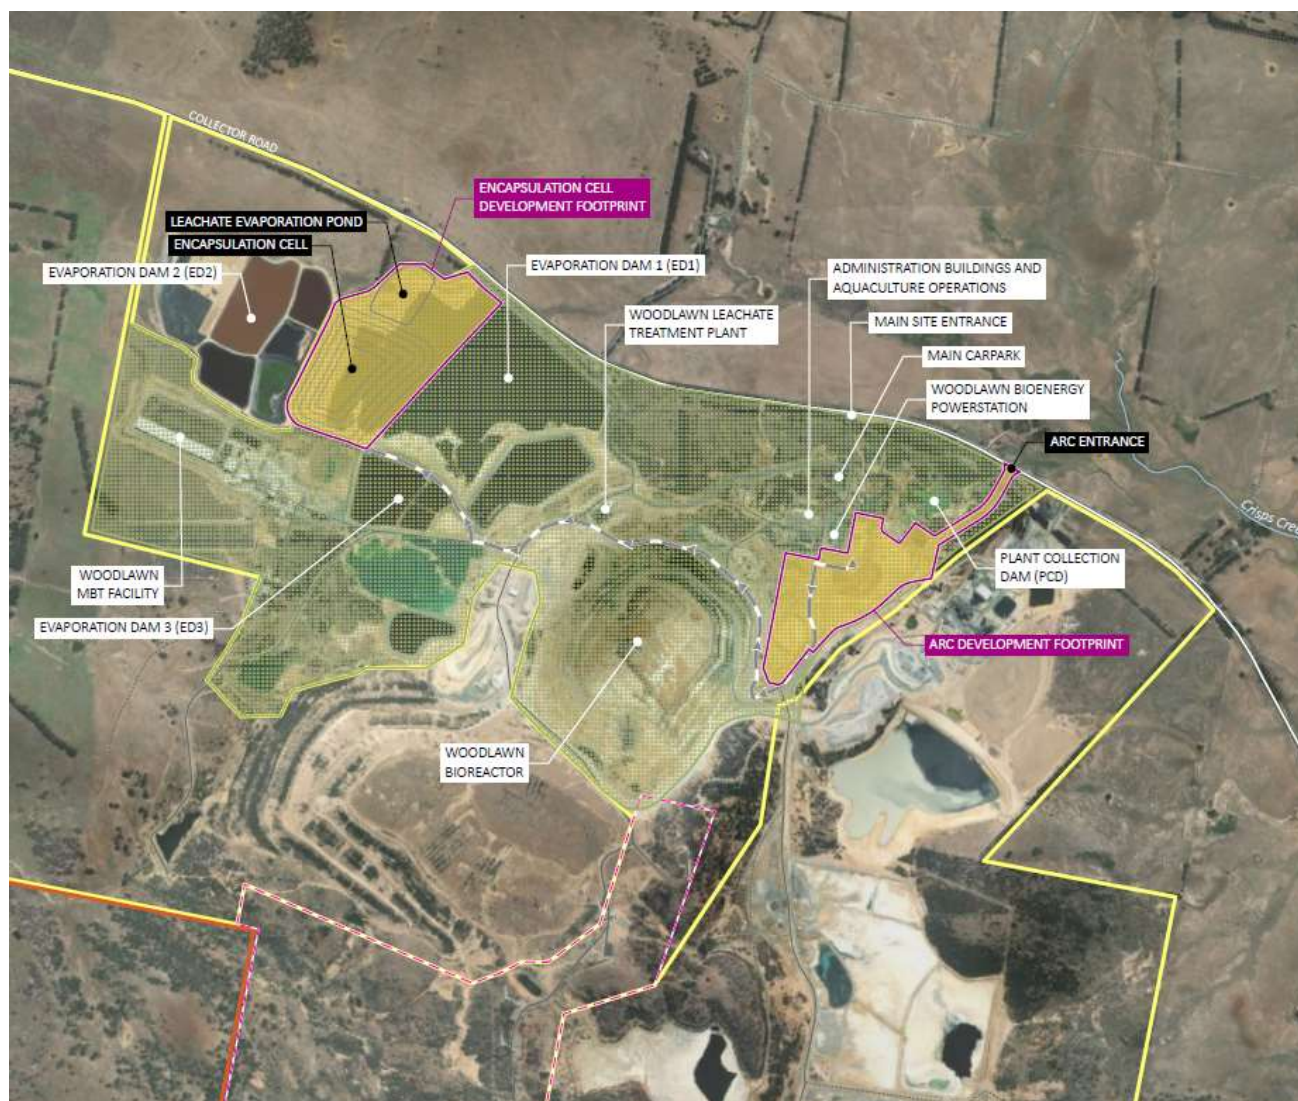
Plate 2: Concept design of proposed ARC development (EMM, 2022)

A plan showing the concept design for the ARC provided by Veolia is presented on Plate 2 below.

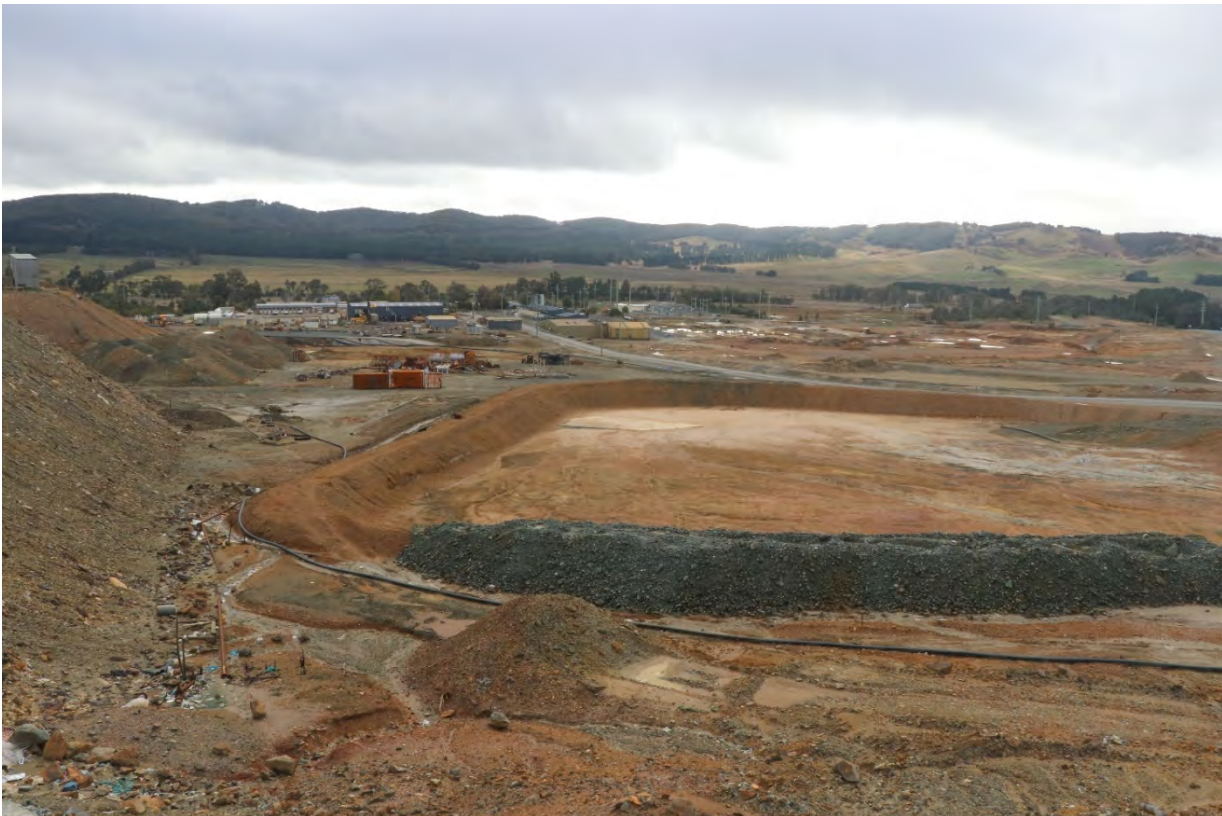
Photo 2: View to the north across the former Mine Plant Area. The former Lead Reverse Dam is visible in the foreground. The main haul road running north south through the site is visible. To the west of the haul road in the background are the site offices and workshop/maintenance area. To the east of the haul road in the background is the Power Station and electrical substation.

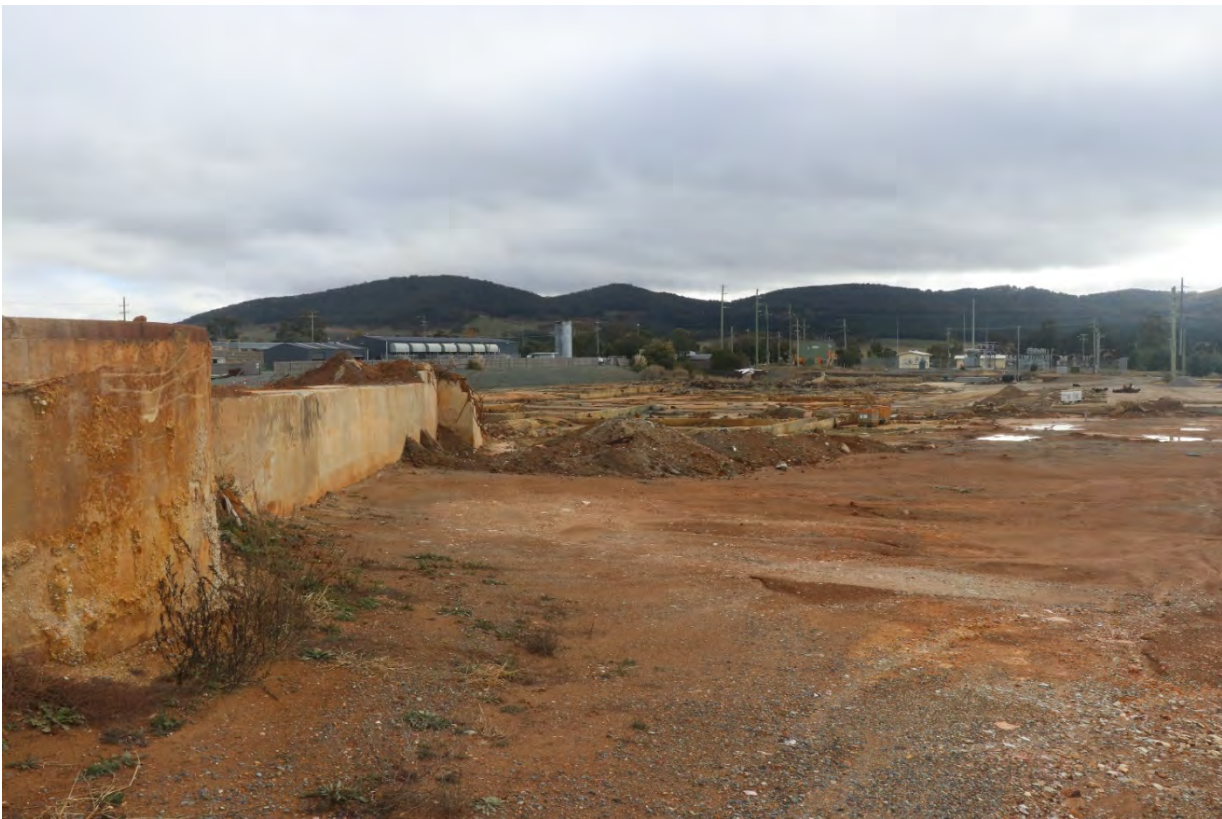
Photo 3: View to the northwest across the former Mine Plant Area. Structures associated with the former Thickeners are visible in the foreground and foundations and remnants of the former Process Building are visible in the midground. The Power Station and the electrical substation are visible in the background.

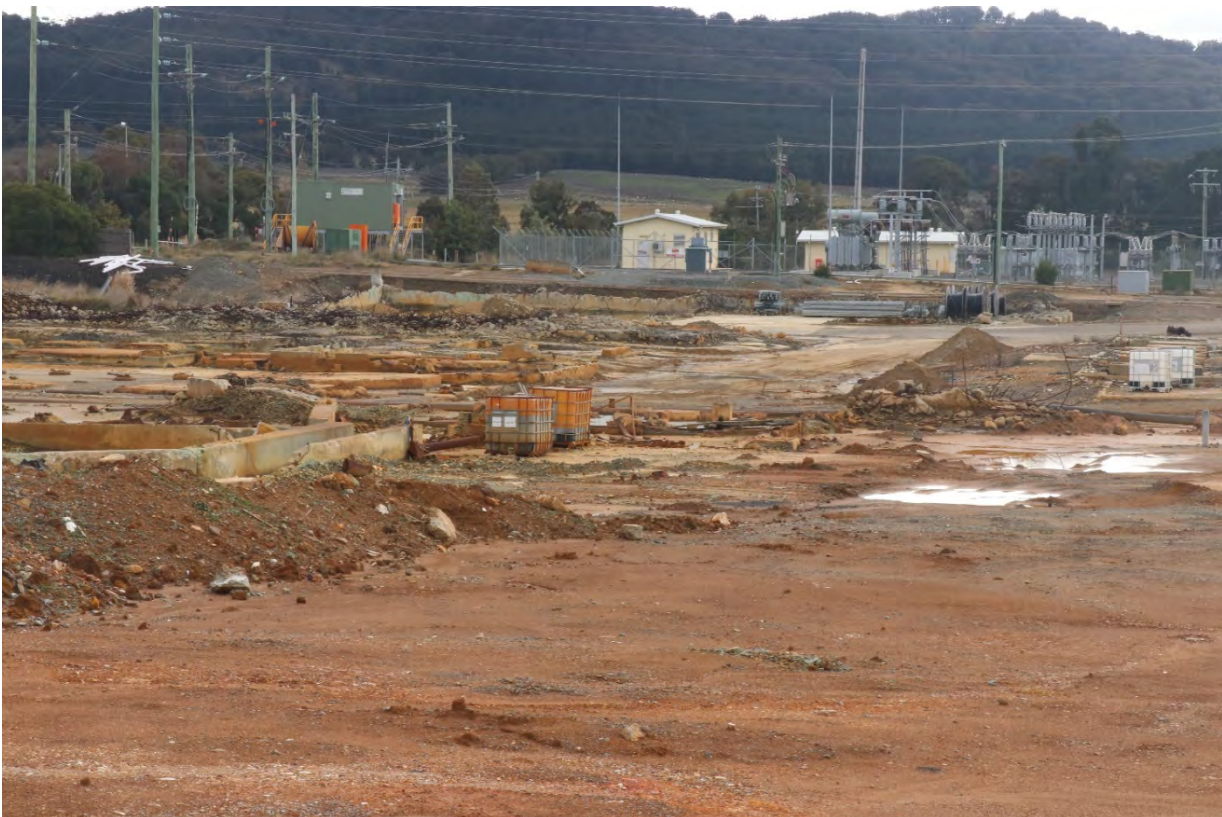
Photo 4: View to the north across the former Mine Plant Area. Foundations and remnants of the former Process Building are visible in the midground and the electrical substation in the background.

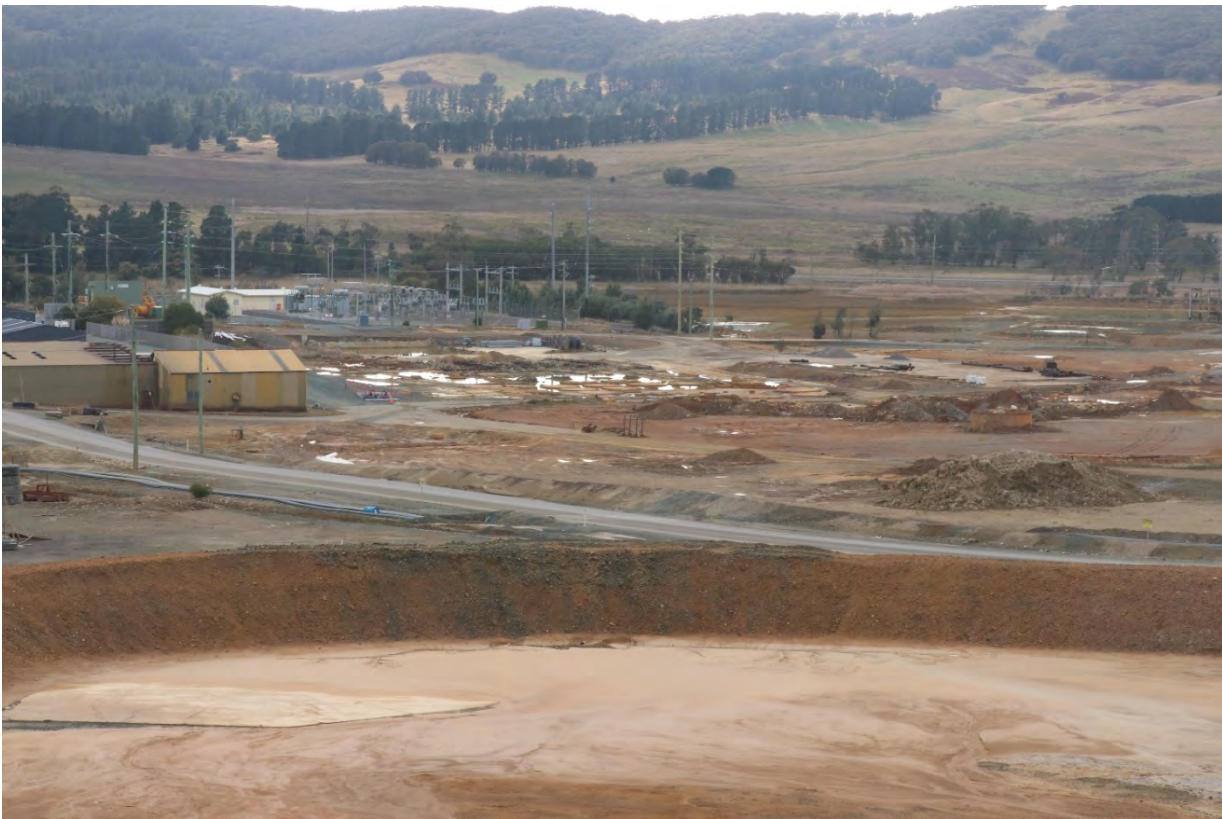
Photo 5: View to the northeast across the former Mine Plant Area and proposed location of the ARC. The former Lead Reverse Dam is visible in the foreground, storage sheds and part of the Power Station in the left midground. The electrical substation, Plant Collection Dam and Collector Road are visible in the background.

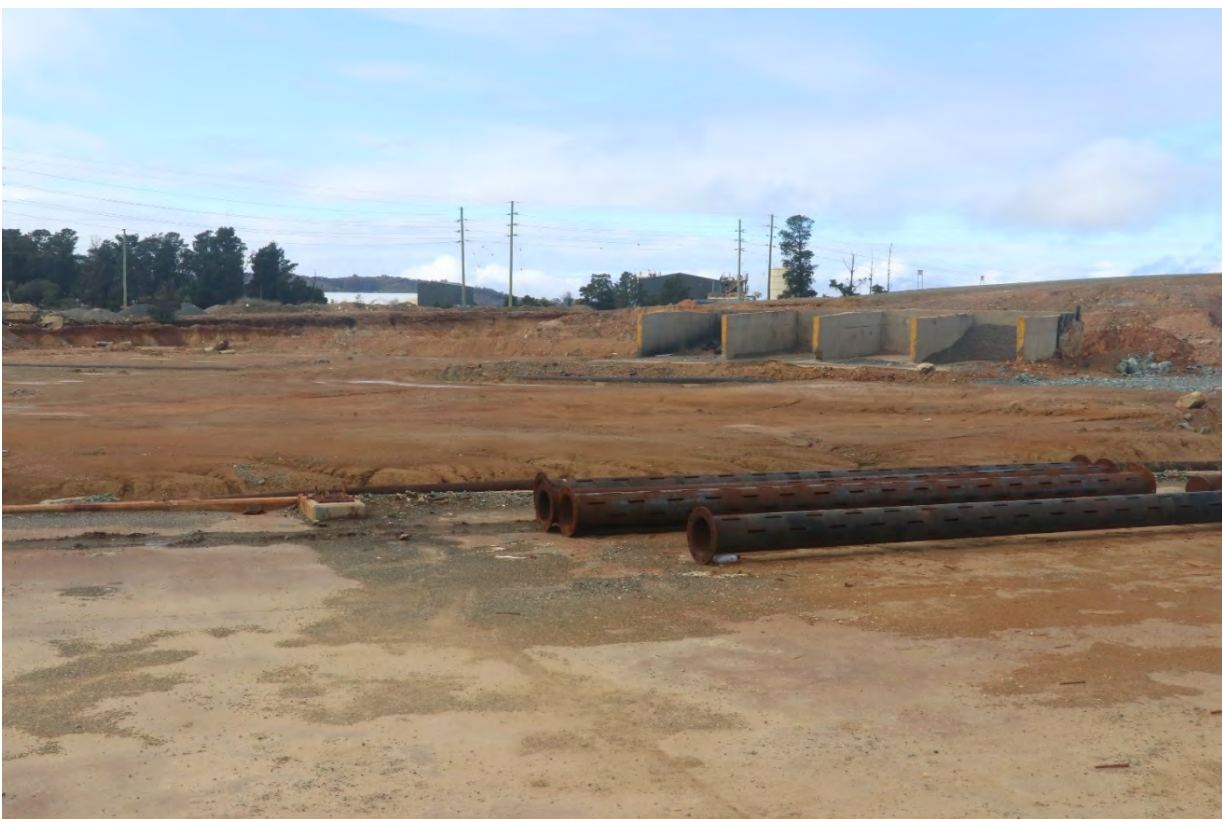
Photo 6: View to the northeast across the former Mine Plant Area showing use as a laydown area, with infrastructure associated with the Heron operations on the adjacent site visible in the background.

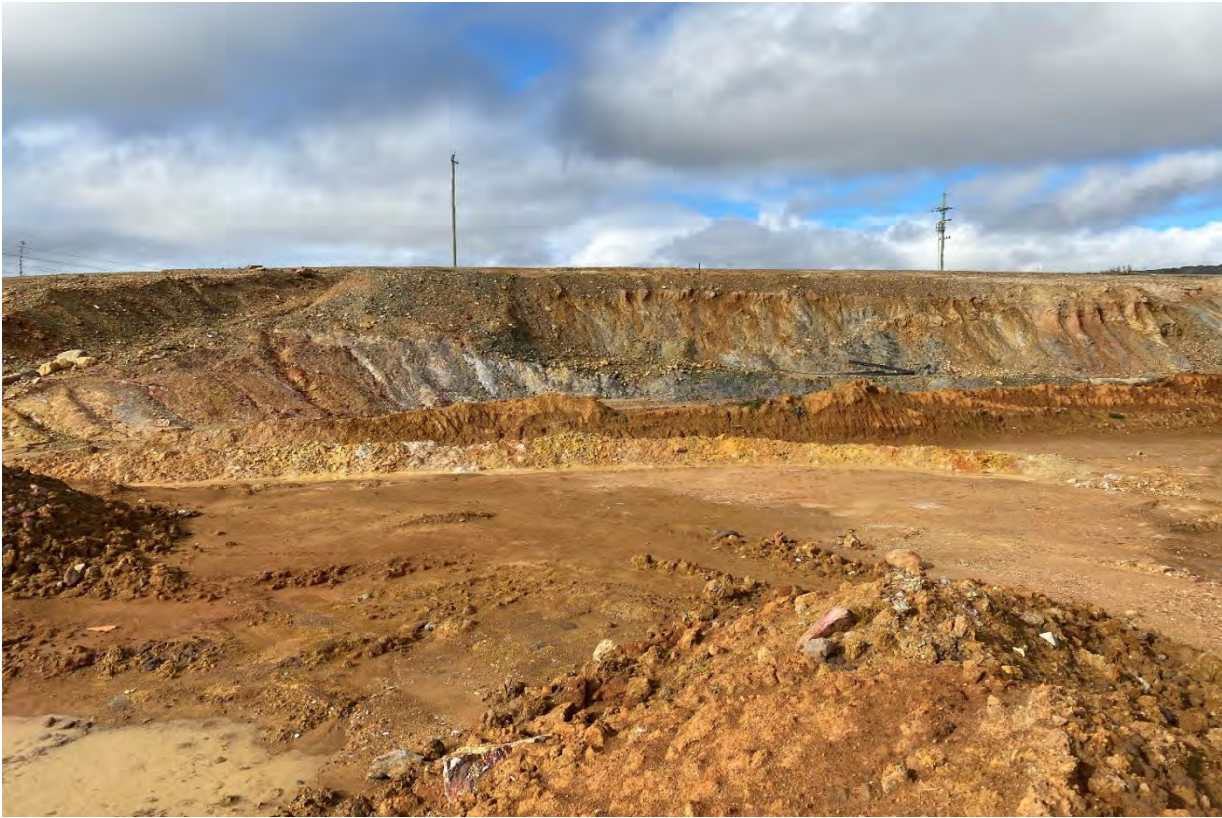
Photo 7: View to the east across part of the location of the proposed ARC. The excavated areas in the mid ground was the former location of the water storage dams. Material has reported to have been excavated from the bank in the background for use as cover on the site.

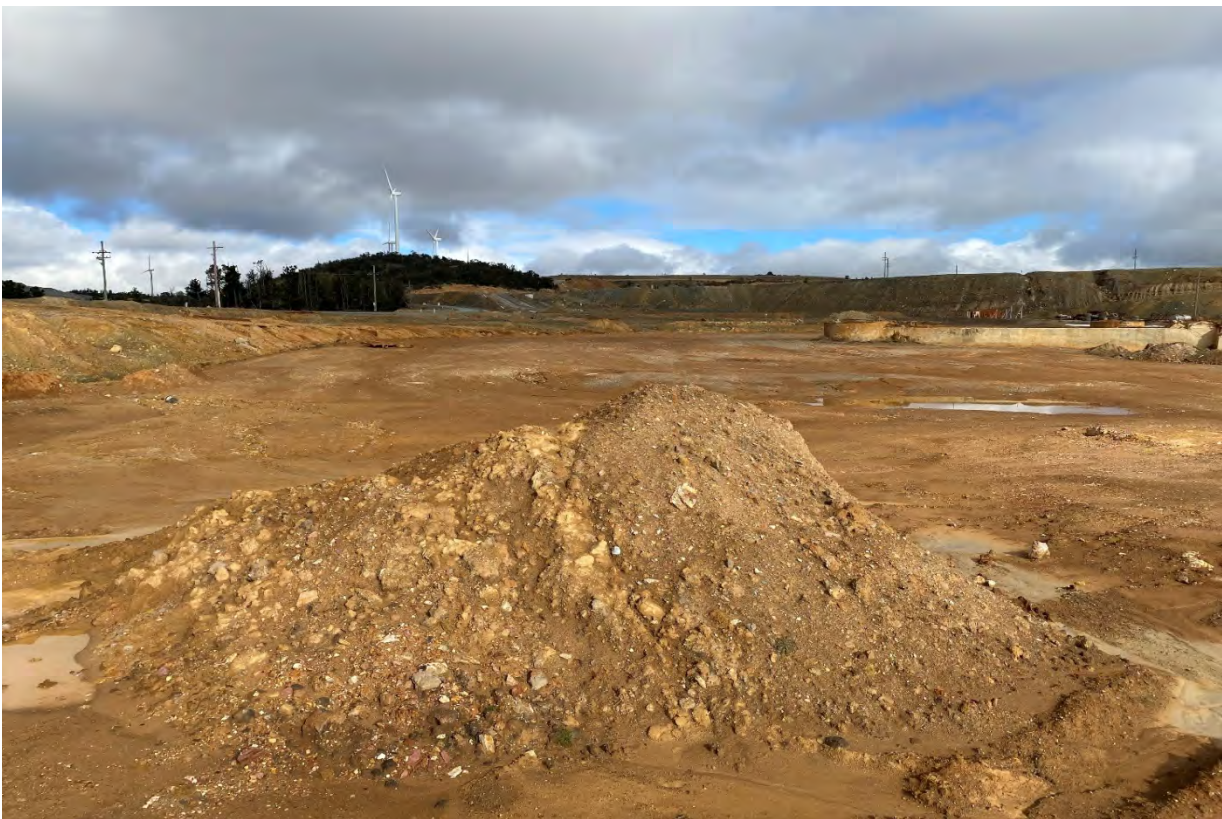
Photo 8: View to the southwest across the location of the proposed ARC. Concrete structures associated with the former Thickeners and the Primary Crusher Pad are visible in the background.

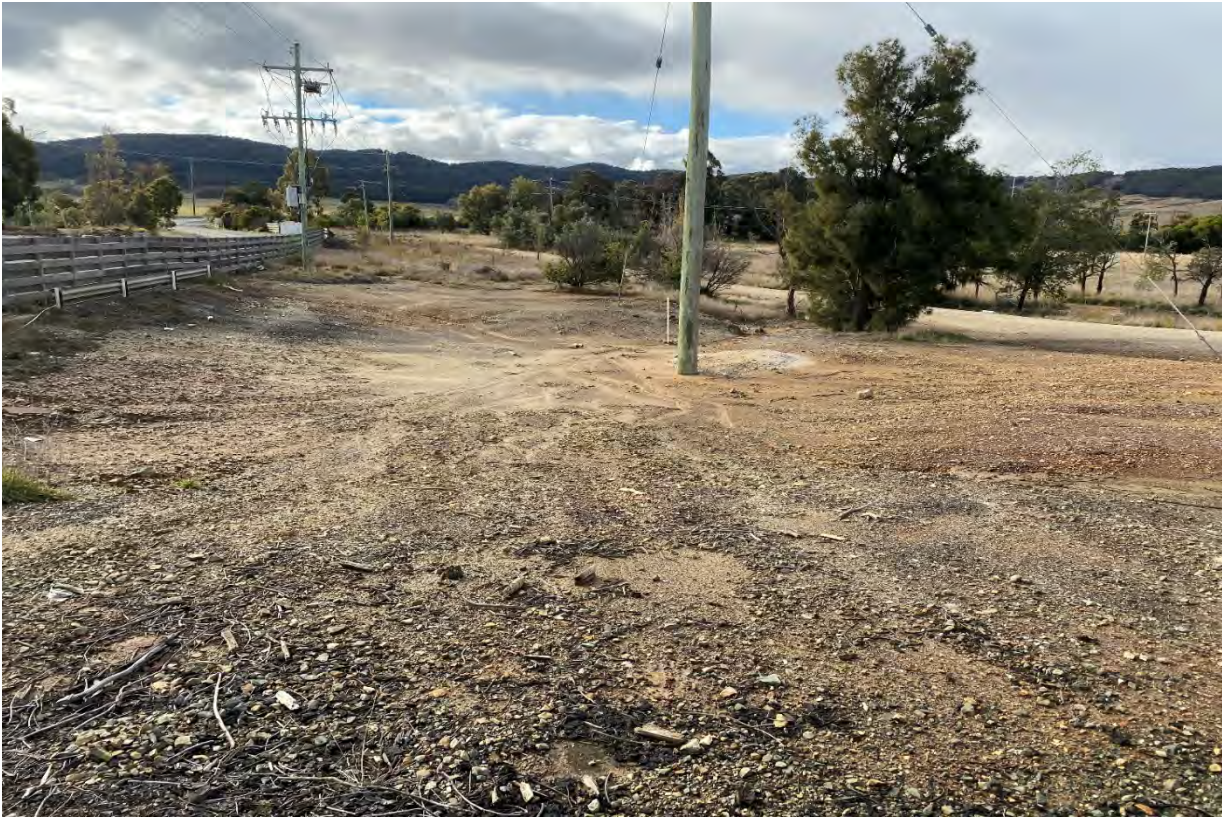
Photo 9: View to the north across the former location of two USTs.

- The USTs observed to the northeast of the gatehouse in the Golder (2007) and (2009a) investigations were not able to be located during the site inspection, and site personnel stated that the USTs had been removed. A copy of the UST removal validation report was subsequently provided (Envirowest, 2012). This report, which also documented the removal of a UST located in the existing maintenance area, is discussed in Section 3.13; and

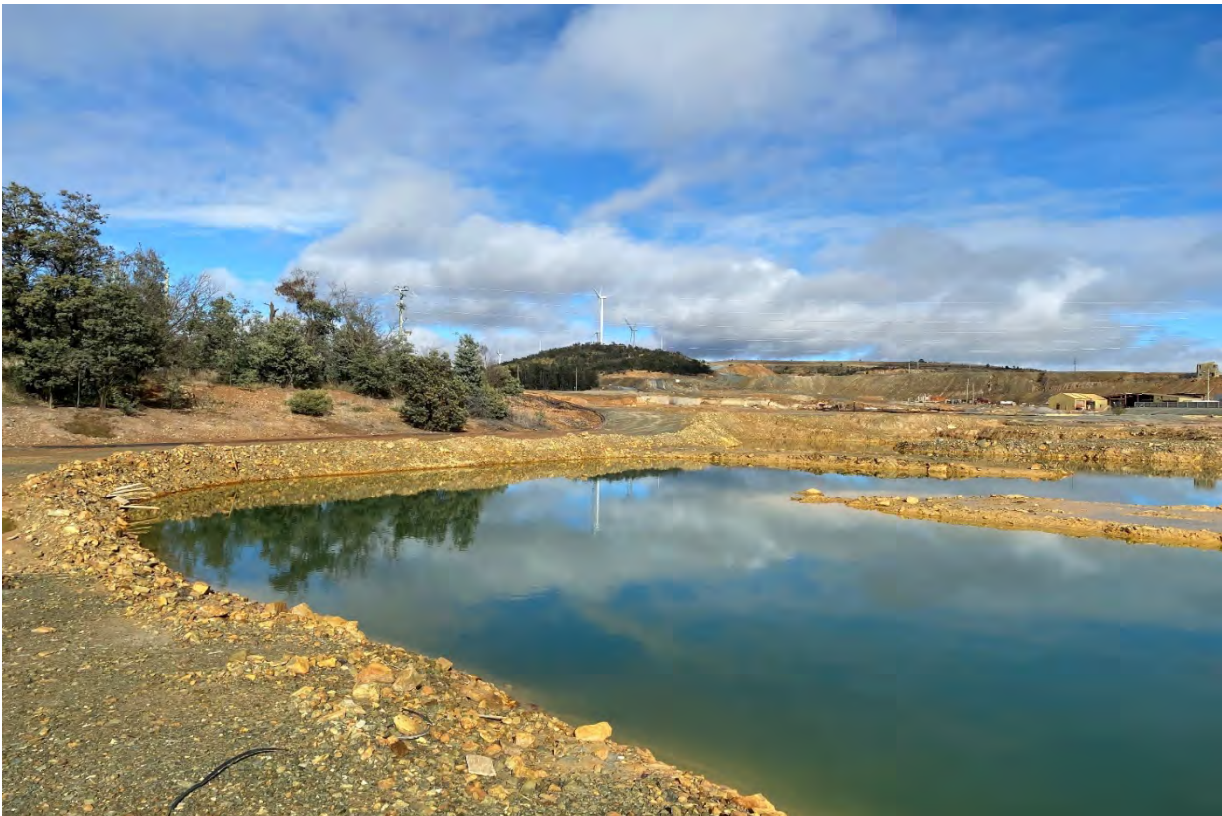
Photo 10: View to south across the Plant Collection Dam.

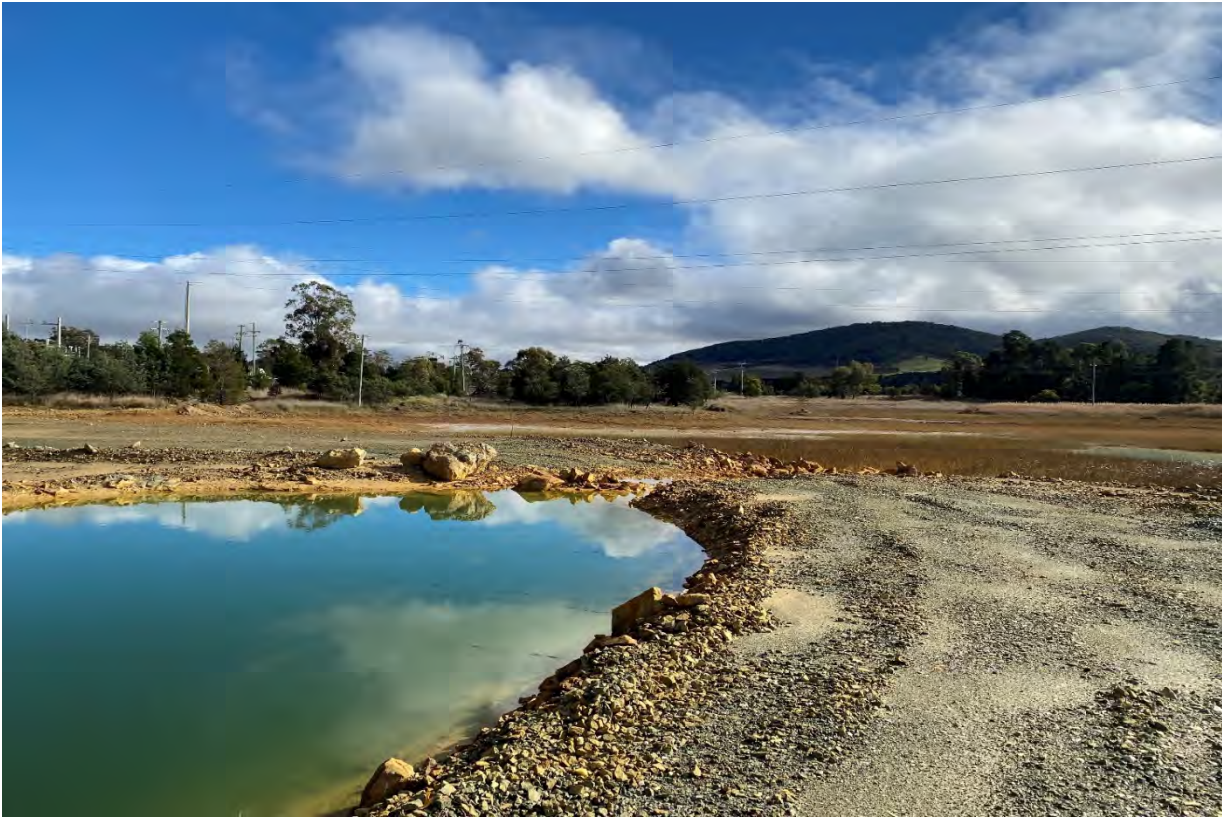
Photo 11: View to the northwest across the Plant Collection Dam. Parts of the low-lying area to the north of the dam were marshy at the date of the inspection.

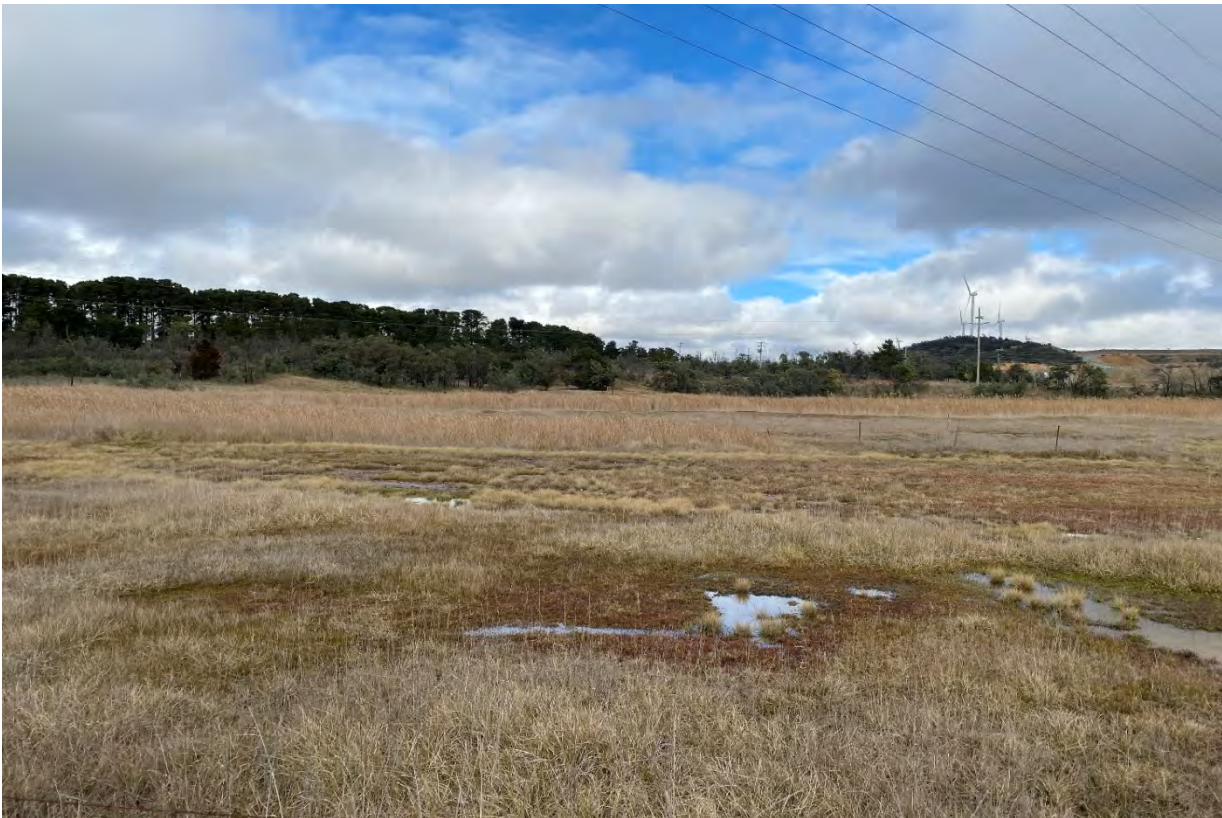
Photo 12: View to the south from the Collector Road boundary of the site. The area in the foreground is located to the north of the Plant Collection Dam.

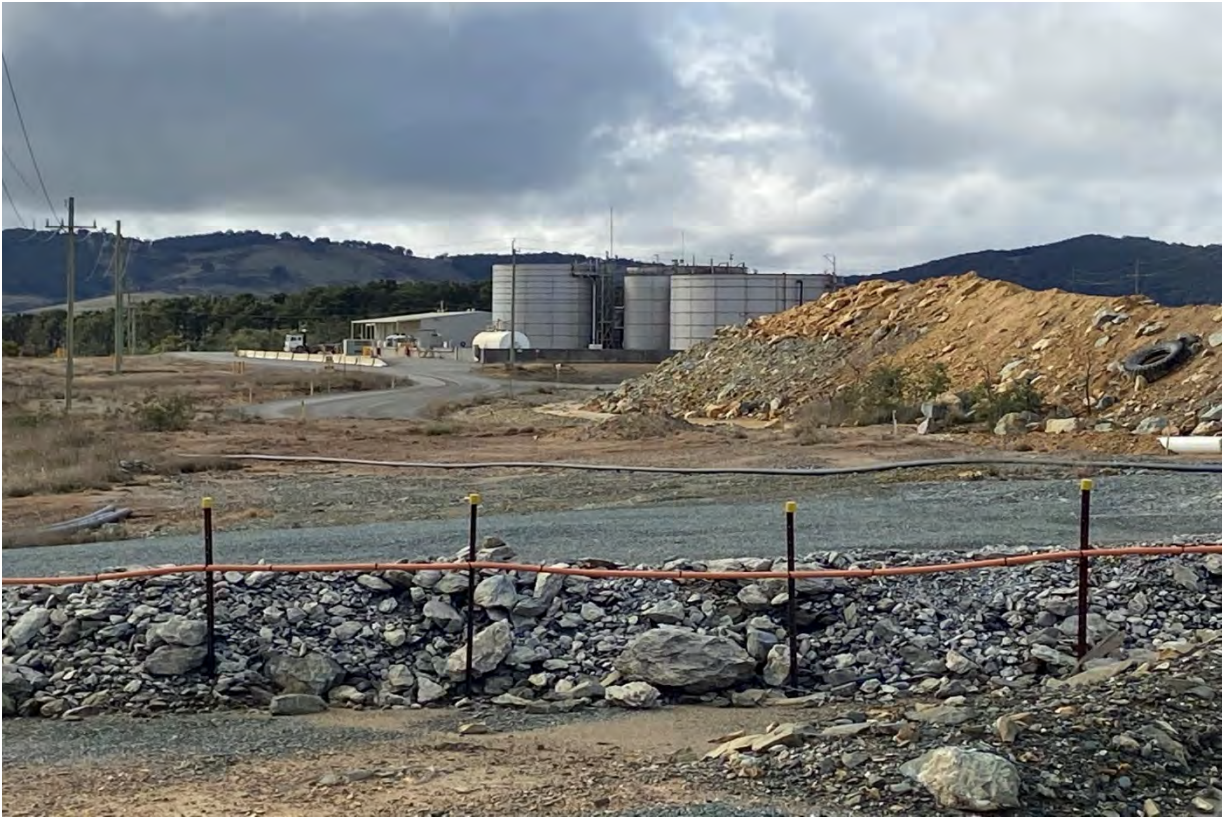
Photo 13: View of the LTP from the MBT haul road.

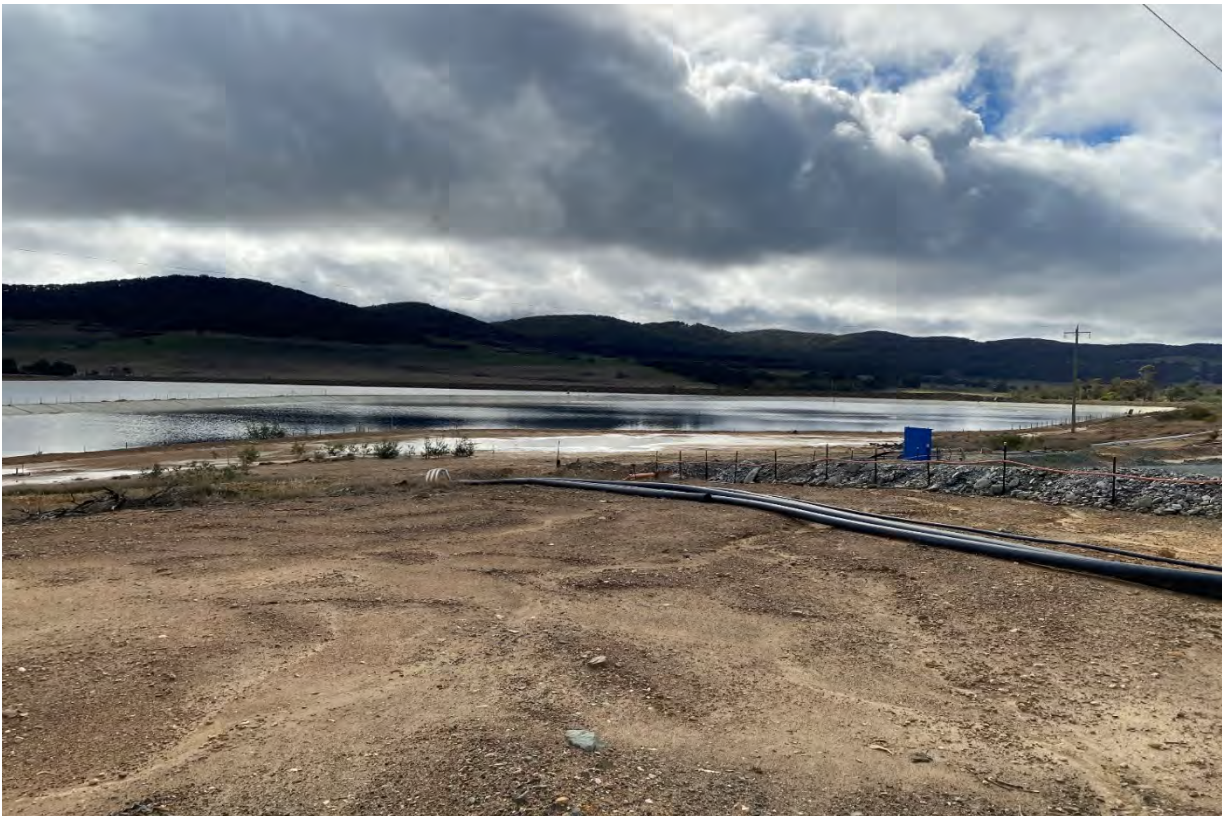
Photo 14: View to the northwest across the lined Evaporation Dam 1 Cofferd Dam, with part of the remainder of Evaporation Dam 1 visible in the background.

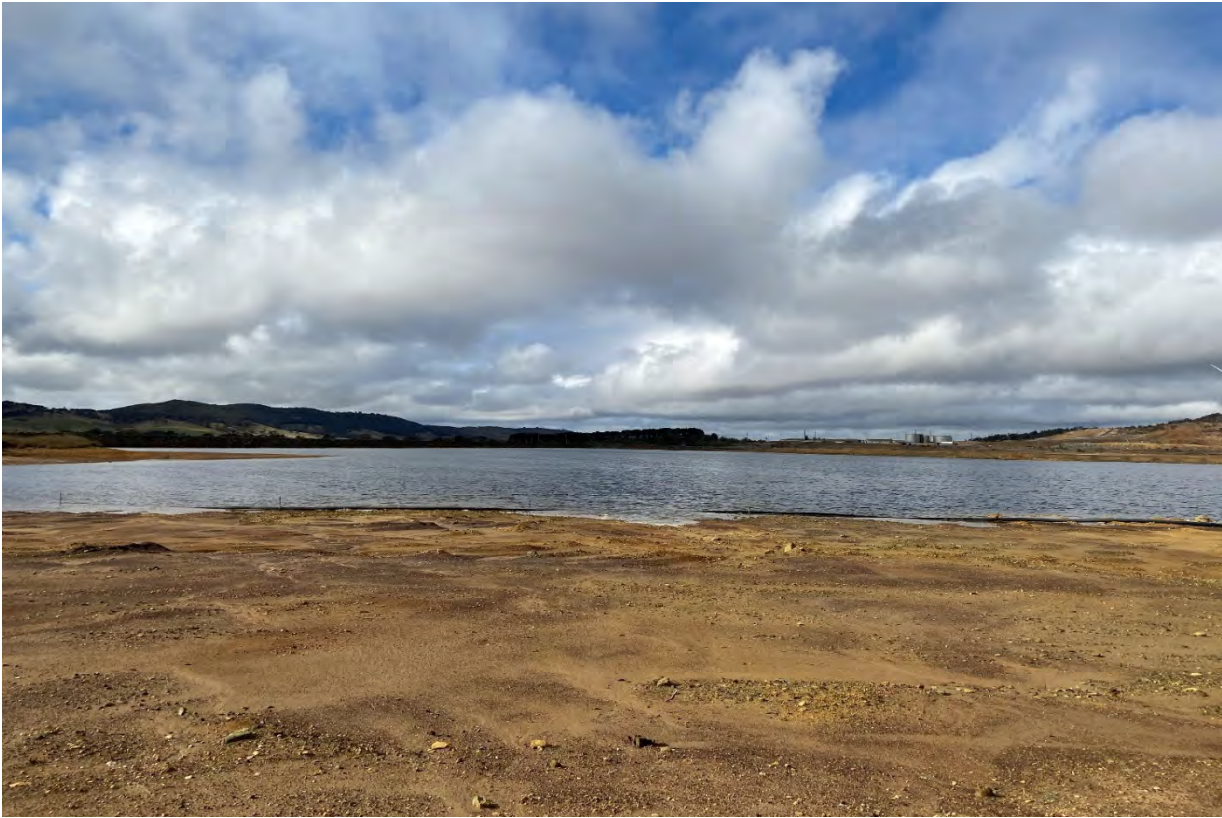
Photo 15: View to the southeast across Evaporation Dam 1. The location of the proposed waste encapsulation cell is in the foreground. The LTP is visible in the right background.

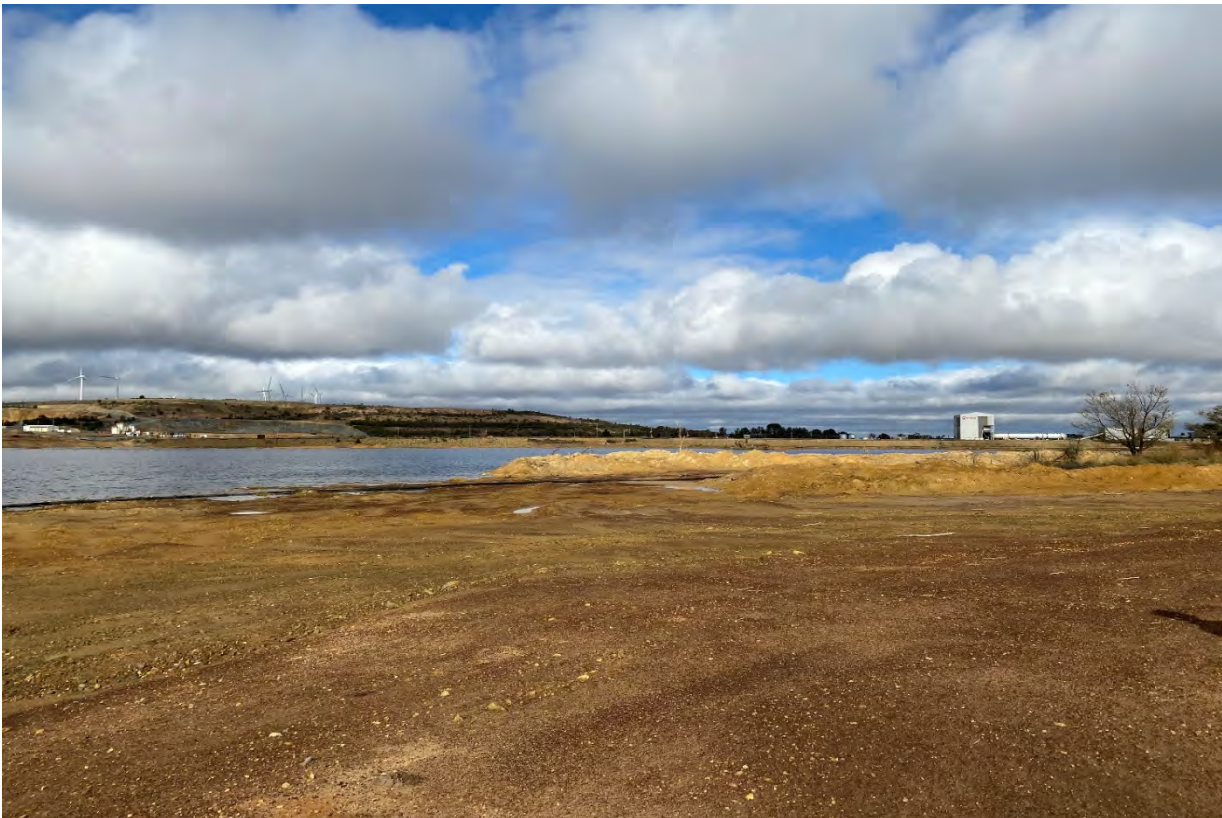
Photo 16: View to the south across the western side of Evaporation Dam 1. The location of the proposed waste encapsulation cell is in the foreground. The MBT facility is visible in the right background.

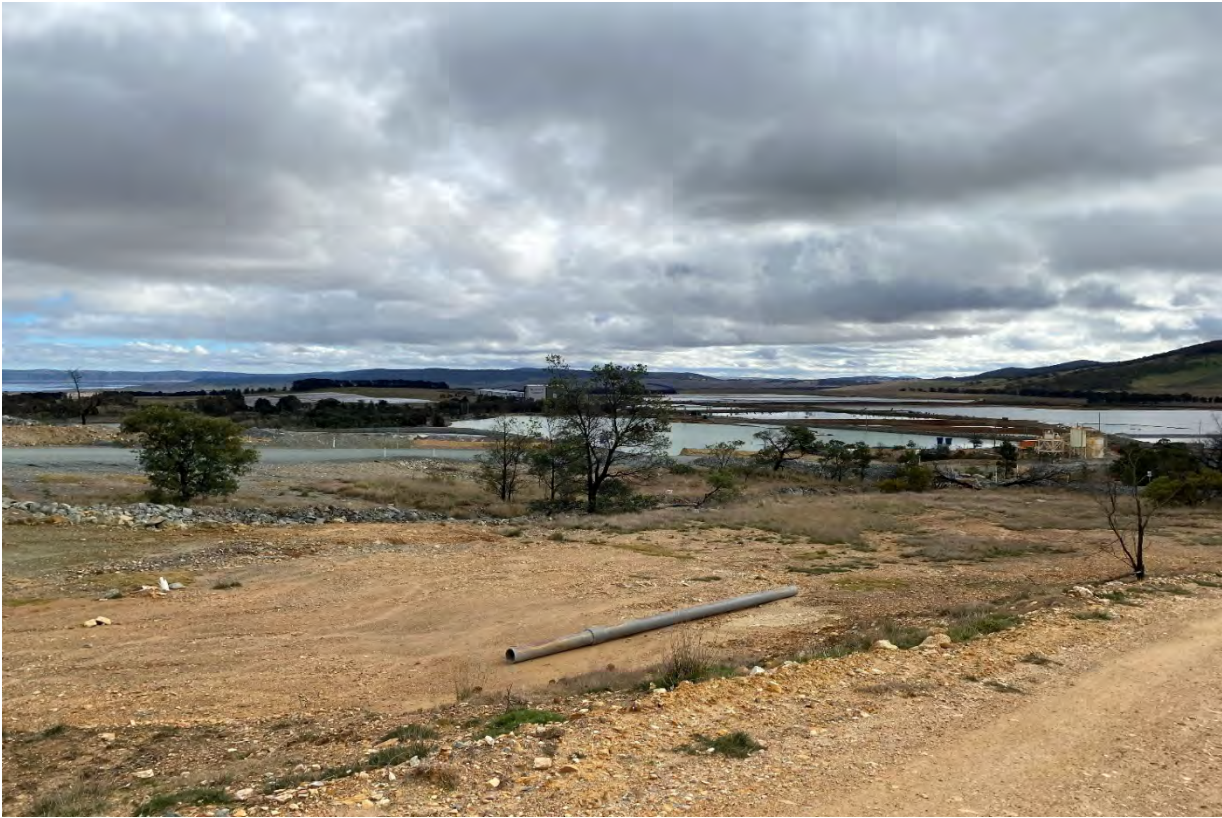
Photo 17: View to the northwest from the Bioreactor. Evaporation Dams 3 and 1 are visible in the right background. The MBT facility and a solar farm are visible on the left background. The structures in the right midground are associated with Heron's underground mining operations.
