Preliminary Site Contamination Assessment

Wee Waa High School
105-107 Mitchell Street
Wee Waa NSW

(Our Reference:35754 ER01)

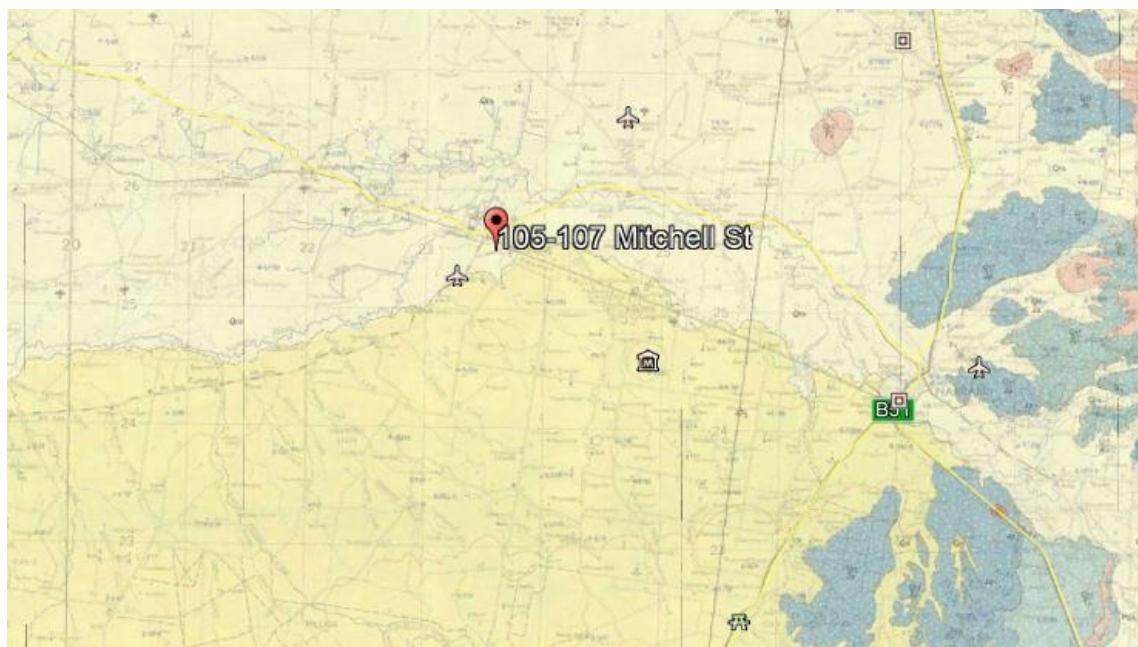
Figure 2.2: Narrabri 1:250000 geology map showing the location of the Subject Site

Geologically, the Subject Site is underlain by unnamed alluvial units consisting of sand, silt and clay. A review of the Narrabri 1:250000 Geology map (refer to Figure 2.2) shows the majority of the basin sequences are covered with Quaternary age alluvial sandy material.

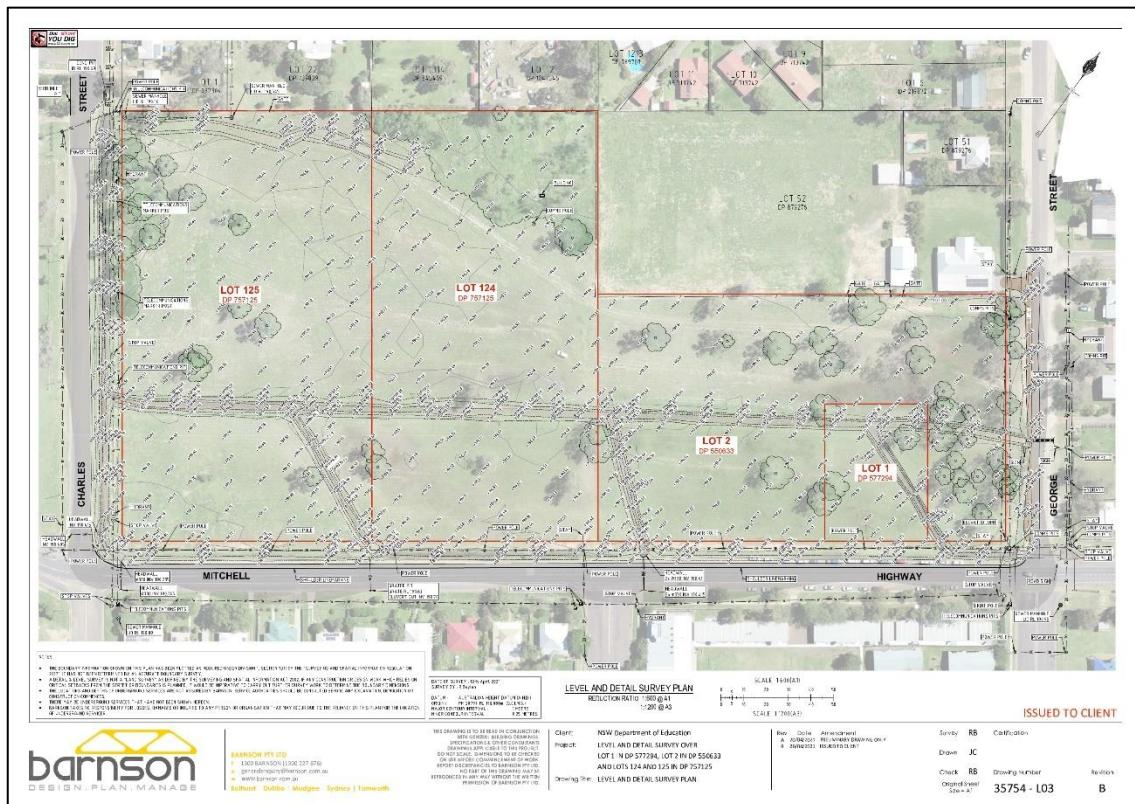
Figure 2.3: Topography of the Subject Site

Figure 2.3 presents topographical information overlain on a map of the Subject Site. The presented data shows that the site is very flat with almost no slope to facilitate surface water runoff. Precipitation runoff at the site and from the surrounding streets will most likely enter the

drainage channels on the site where it will remain until evaporated or infiltrated into the surface soil of the site.

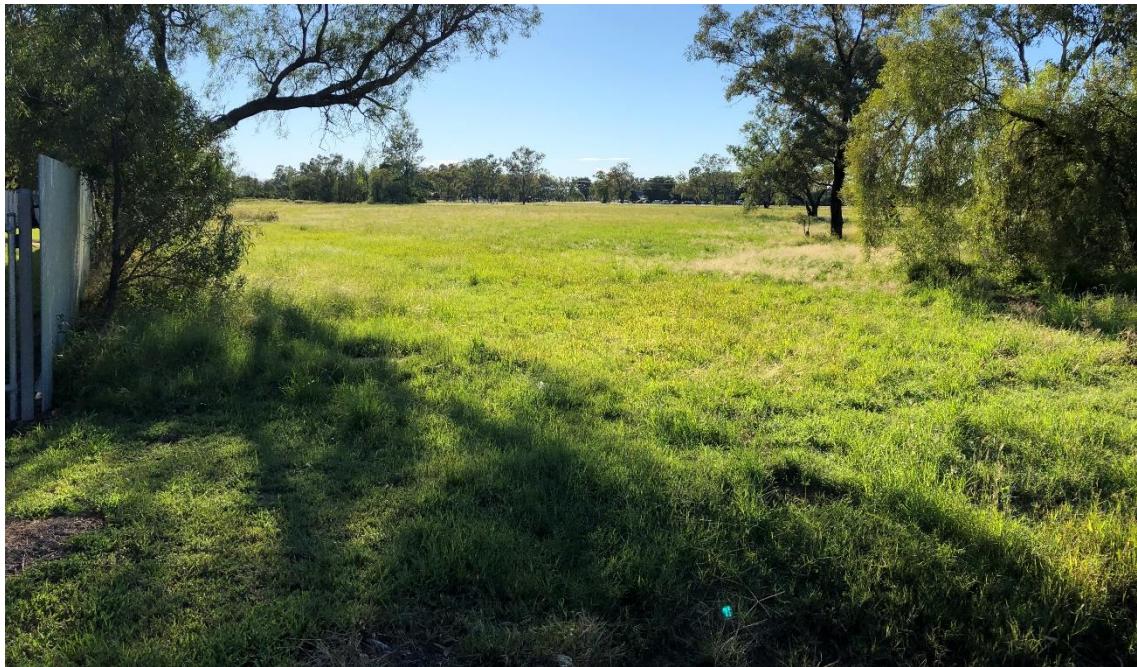
Figure 4.2: Photo A –View across the Subject Site from the north west corner of Lot 125
(see Figure 4.1 for location of photo).

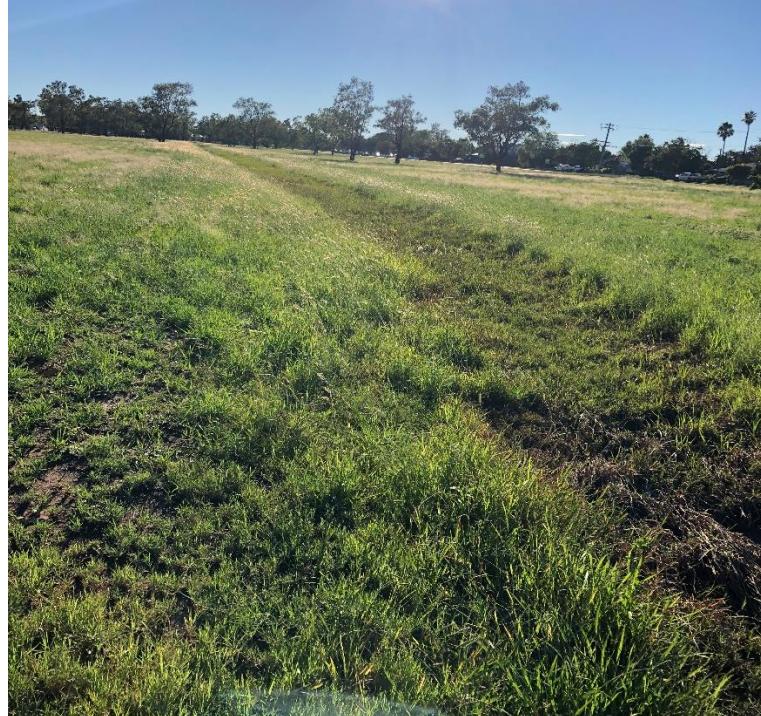
Figure 4.3: Photo B – Shallow drainage channel across the Subject Site (see Figure 4.1 for location of photo).

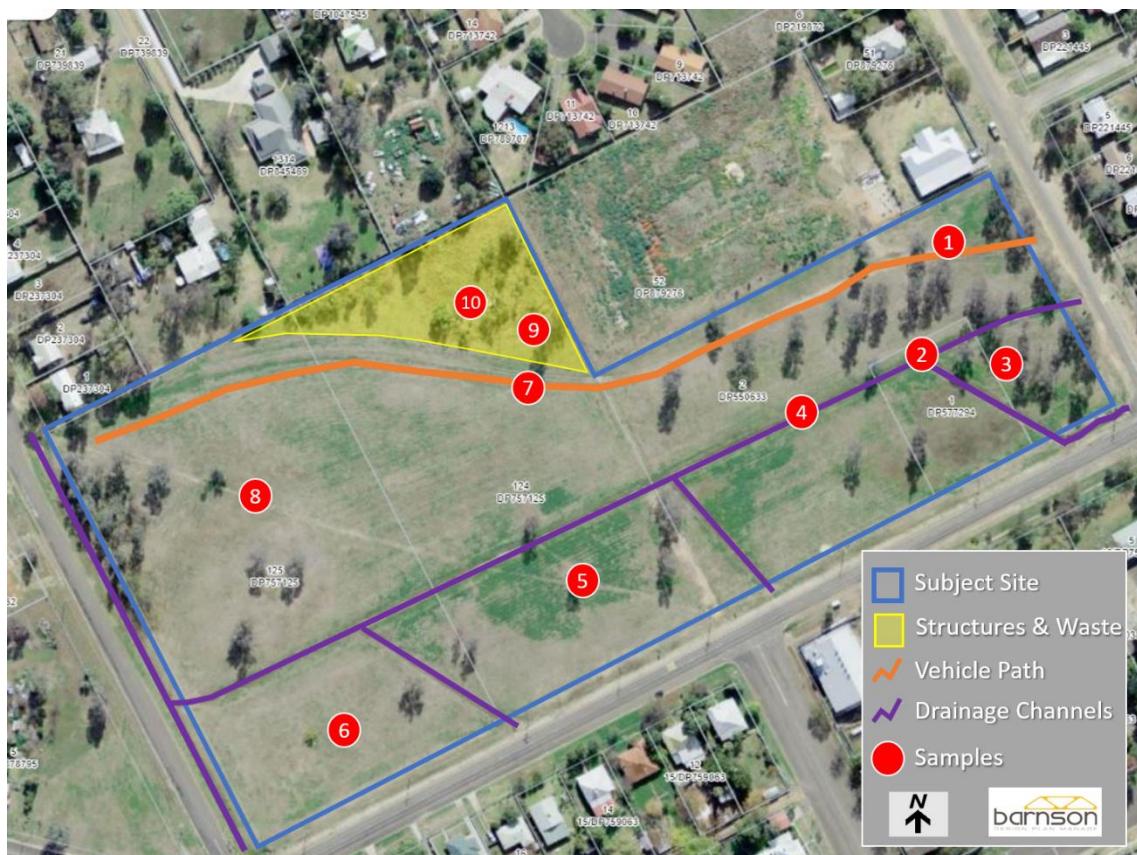
Figure 6.3: Map indicating locations of confirmatory sample collection.

Samples of soil were specifically collected from the drainage ditches as well as the informal vehicle access path, as both these features represent areas where contaminants potentially deposited on site (e.g. pesticides and vehicle associated hydrocarbons) can accumulate. The area where demolition wastes and remnants of structures were observed was also further investigated.

Figure 6.3 presents a map of the Subject Site with the locations of the surface soil samples indicated. Table 6.1 is a summary of the collected samples indicating which samples were included in composites for analysis.
