Detailed Site Investigation

Wee Waa High School
105-107 Mitchell Street
Wee Waa NSW

(Our Reference:35754 ERO2)

Project Name:	Detailed Site Investigation - Wee Waa High School, 105-107 Mitchell Street, Wee Waa, NSW
Client:	NSW Department of Education
Project No.	35754
Report Reference	35754 ER02
Date:	28/09/2021
Revision:	Final

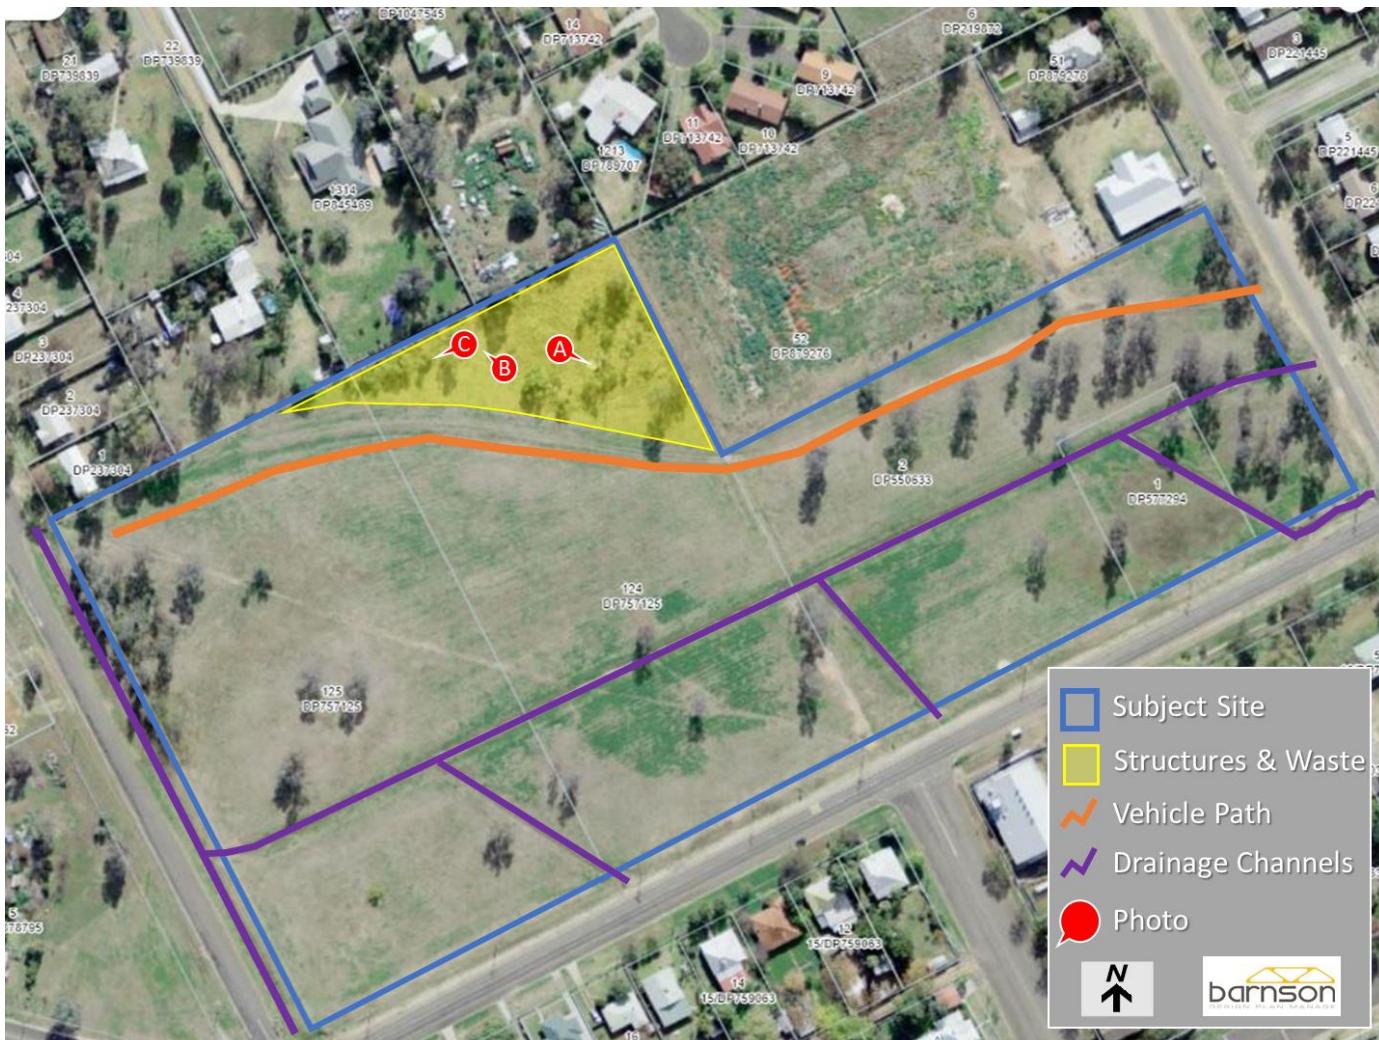
Figure 2.2: General layout of the Subject Site.

Figure 2.2 presents an aerial photograph of the Subject Site with the location and layout of important features of the site indicated. The Subject Site is approximately 6 hectares in size and is vacant land covered with maintained grass and several established trees. The Subject Site fronts onto Mitchell Street to the south-east, George Street to the north-east and Charles Street to the south-west.

The main feature of the site is a series of shallow drainage channels that enter the site from all three (3) street frontages. The site includes fencing on the boundary with the residential properties to the north. Near this boundary, in a corner formed with Lot 124 and an adjoining vacant Lot, remnants of structures as well as piles of discarded building material were observed during the initial site inspection (see Figure 2.3 to Figure 2.5). Figure 2.2 includes markers indicating the vantage point and direction of the photographs.

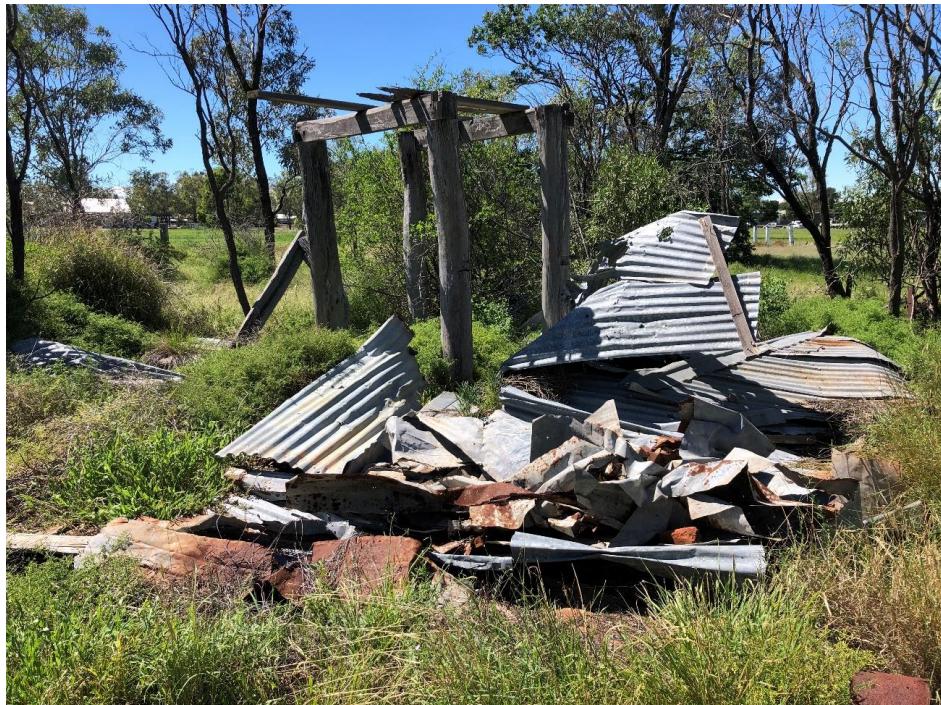
Figure 2.3: Photo A – Remnants of structures and demolition waste present in northern section of Lot 124.

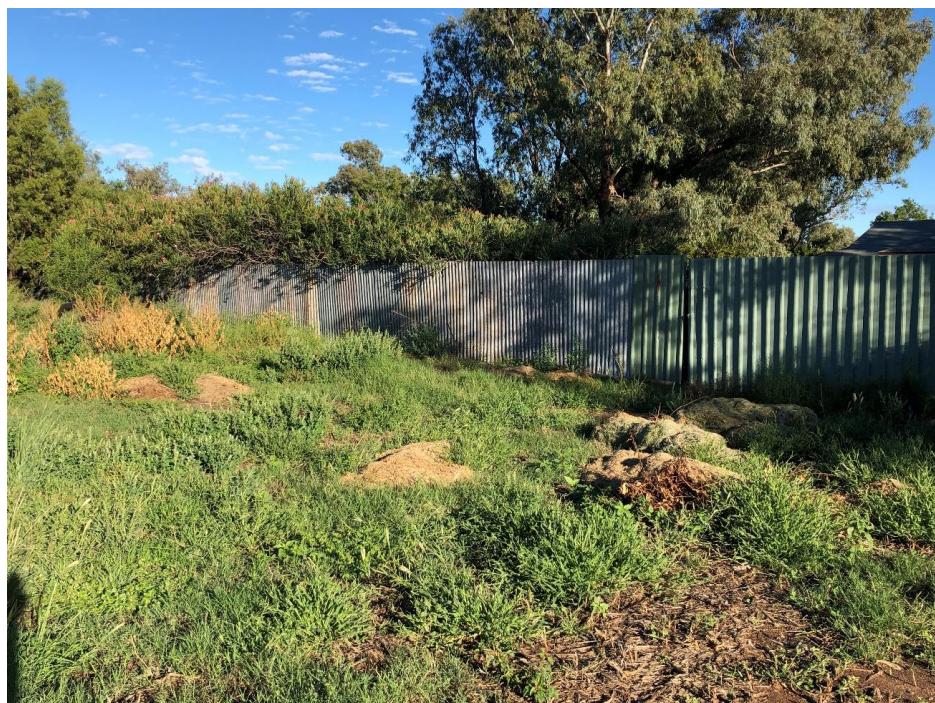
Figure 2.4: Photo B – Grass clippings dumped in the vegetation along northern boundary fence.

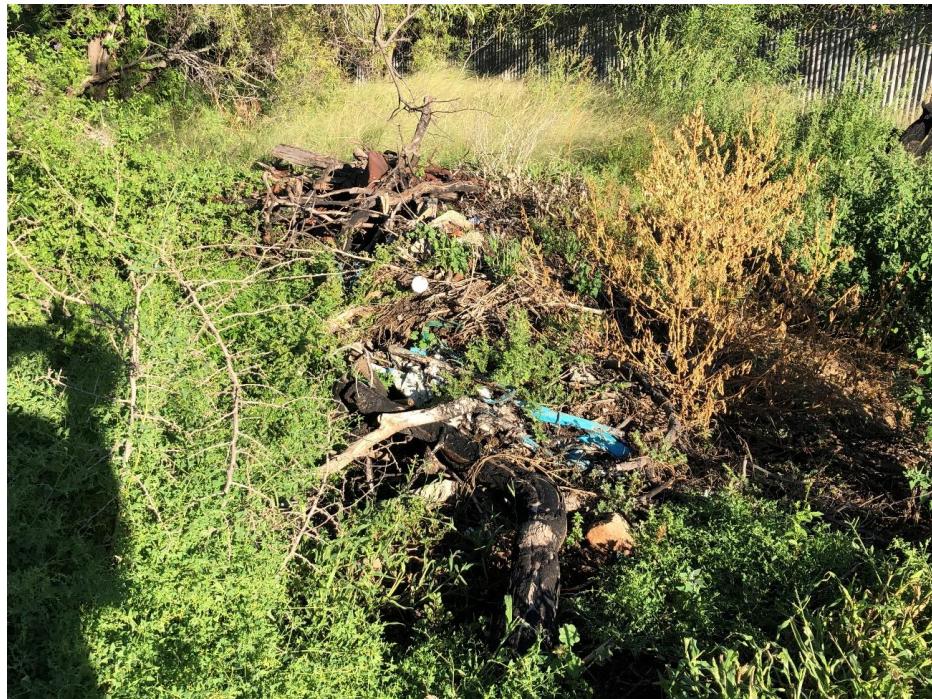
Figure 2.5: Photo C – Discarded garden and general waste in vegetation in northern section of Lot 124.

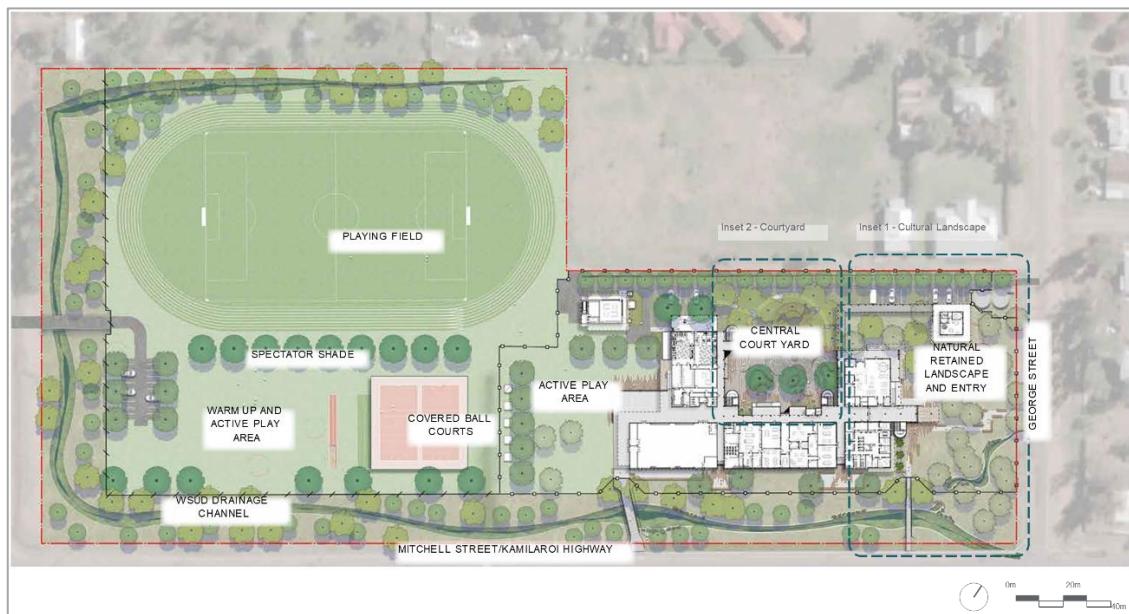
Figure 2.6: Concept landscape and development layout

Figure 2.6 presents a concept design and layout for the proposed school development. A previous concept design (referenced in the preliminary investigation report (Barnson, 2021)) showed the northern section of Lot 124 to be used as large livestock paddocks for agricultural education purposes. The latest concept shows the area used as playing field.

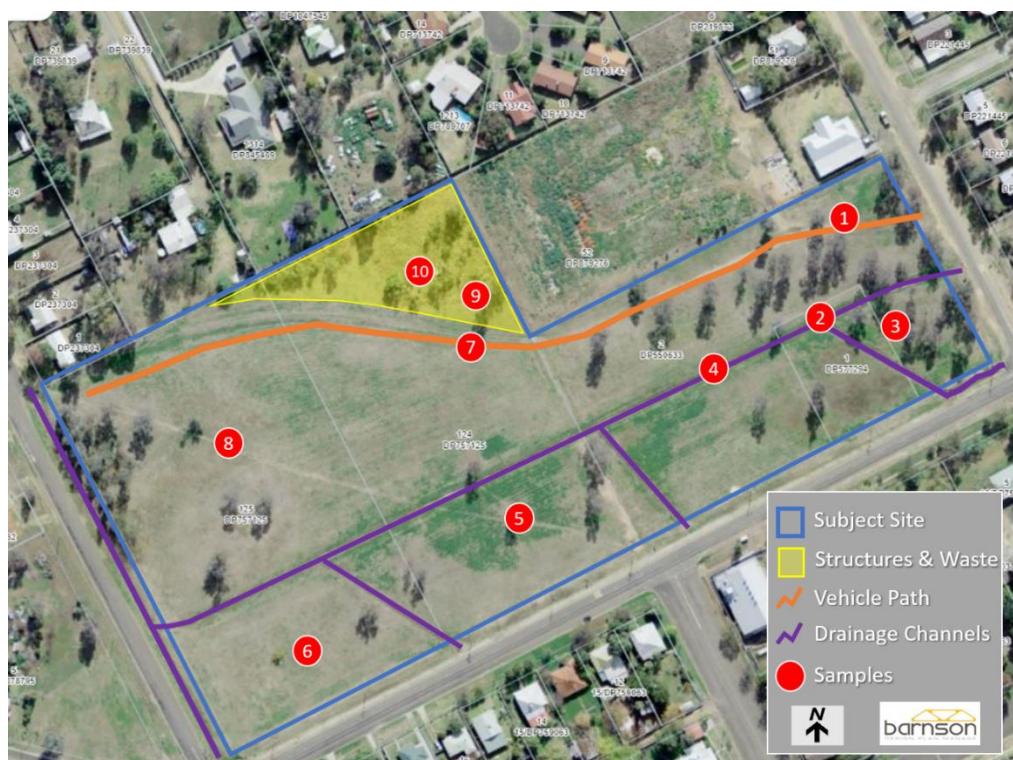
Figure 2.7: Map indicating locations of confirmatory sample collection.

The results from the analysis of the samples indicated that the concentrations of lead ($2,600 \text{ mg.kg}^{-1}$ for sample 9 and $5,400 \text{ mg.kg}^{-1}$ for sample 10) and zinc ($4,300 \text{ mg.kg}^{-1}$ for sample 9 and $3,600 \text{ mg.kg}^{-1}$ for sample 10) in two samples collected in the northern section of Lot 124 (refer Figure 2.7 for location of Lot 124) exceed the Health Investigation Levels (HIL) ($300 \text{ mg.Pb.kg}^{-1}$) and ecological investigation levels (EIL) ($1,100 \text{ mgPb.kg}^{-1}$ and 300 mgZn.kg^{-1}) criteria used for assessment.

Samples of fibre cement fragments observed in the area marked in yellow in Figure 2.7, was retrieved and analysed for asbestos. Both Chrysotile and Amosite asbestos fibres were detected in the fragments of fibre cement. The sample of soil (indicated as number 10 in Figure 2.7), retrieved from the location where the fragments of fibre cement were observed, was also analysed for the presence of asbestos fibres. No asbestos fibres were detected in the soil.

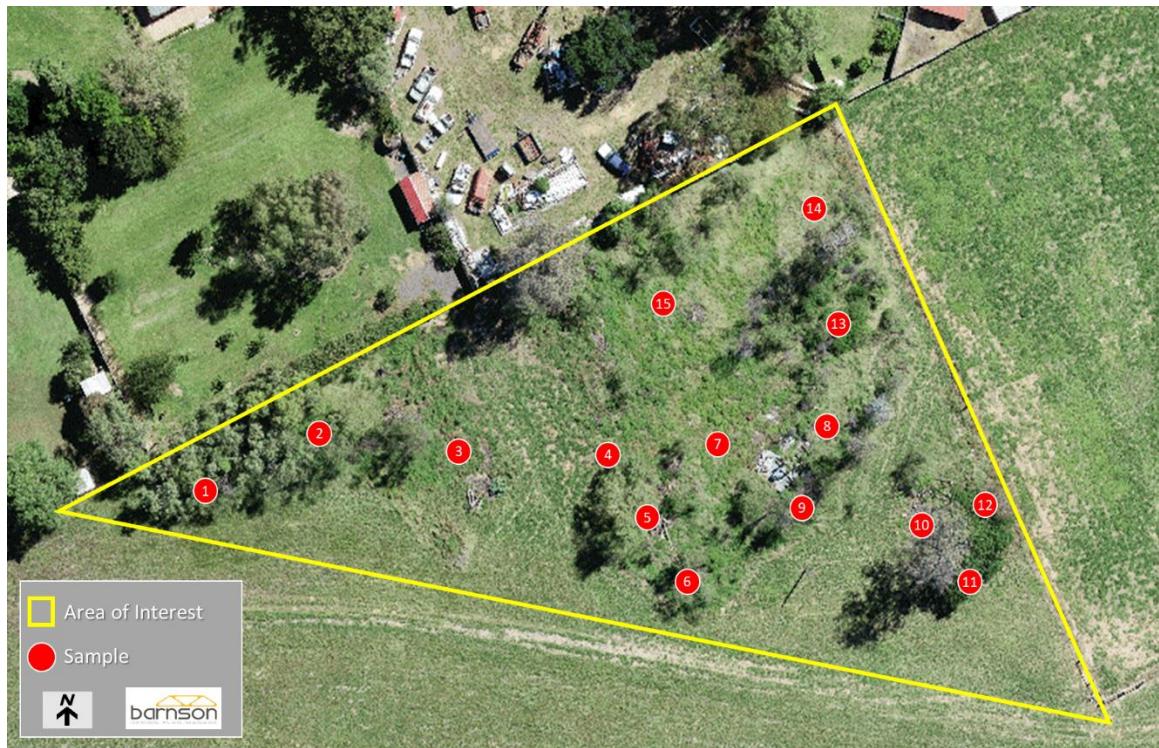
However, with only two data points indicating contamination, the question remained whether the contamination is localised or also occurs in other locations in the area of interest. A further inspection of this area of interest was undertaken on 17 June 2021. A further 15 confirmatory surface soil samples were collected and grouped based on the location of waste and discarded building materials observed at the site. The purpose of the additional confirmatory sampling is not to be used for statistical evaluation of the site contamination and was thus collected using a Judgemental sampling approach, as described in the NSW EPA Sampling Design Guidelines for contaminated sites (NSW EPA, 1995). The samples were grouped into five (5) sample groups consisting of three (3) samples each. The three samples constituting each group were combined to form five composite samples representative of each group. Table 2.2 present a summary of the samples combined into composites for analysis, while Figure 2.8 show the approximate location of the 15 additional samples collected.

Figure 2.8: Area of Interest contaminant delineation

The results show that elevated heavy metal concentrations (lead and zinc) as well as fractions of petroleum hydrocarbons were detected in composite samples WW-01, 02 and 03. Concentrations of heavy metals were also found to be elevated in the WW-05 composite, compared to the levels detected in the WW-04 sample.

The results demonstrate that elevated levels of heavy metals and hydrocarbons are detectable at various locations across the area of interest and although large variation is to be expected, the contamination is largely localised in areas where demolition wastes were observed. The entire area of interest was defined as the Investigation Area.

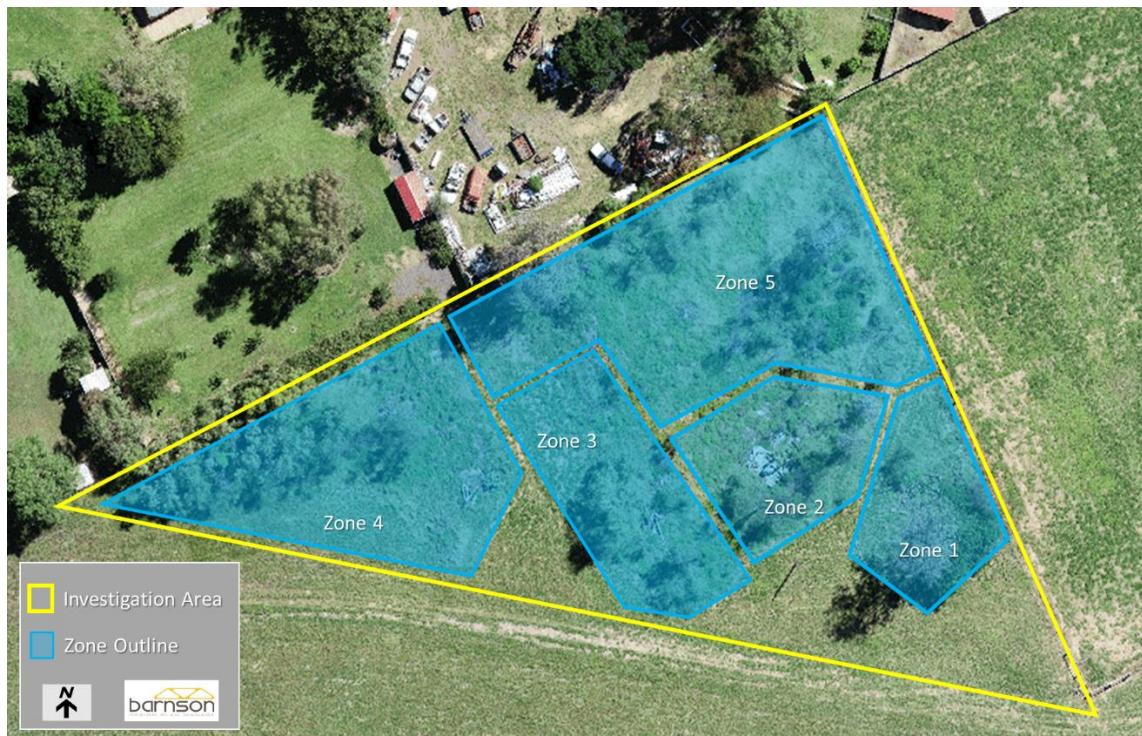
Based on the results presented in Table 2.3 and the observations of where wastes are located, the Investigation Area was further subdivided in five (5) investigation Zones. Figure 2.9 show the approximate extent of the identified Zones. Zones 1, 2 and 3 included demolition wastes while Zone 4 include mainly disposed garden refuse and general waste.

Figure 2.9: Investigation Area and identified investigation Zones.

No wastes or disposed garden refuse was observed in Zone 5. Fragments of fibre cement, previously confirmed to contain both chrysotile and amosite asbestos were observed in Zone 2 and Zone 3. Vegetation made it difficult to inspect other areas for the presence of fibre cement.

Following the 17 June 2021 site inspection it was recommended that the Investigation Area be cleared of waste and that the vegetation be mowed and cleared as far as possible to allow for further detailed investigation of the site.

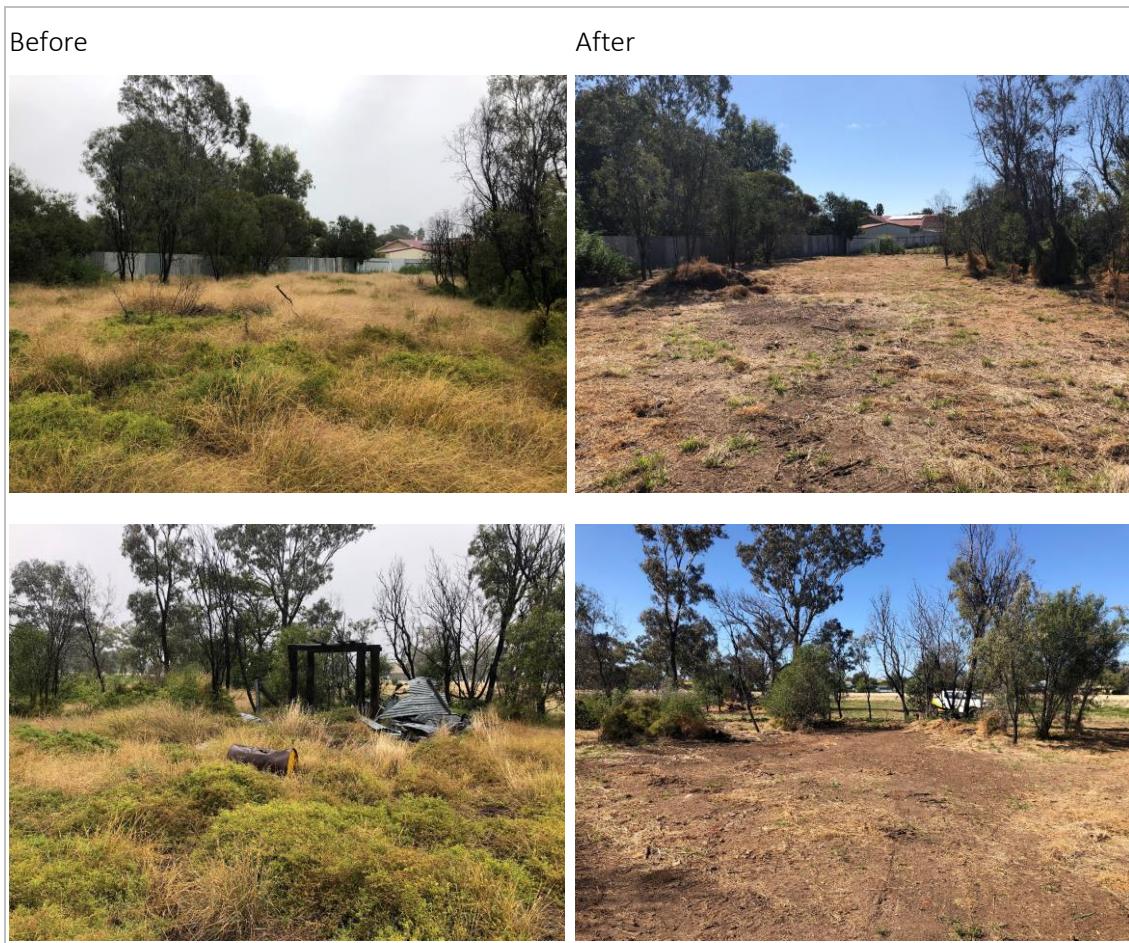
(grass clippings). The investigation area was cleared of most of the demolition waste and mowed before the inspection was undertaken in August. Figure 4.1 shows pictures of the Investigation Area at the time of the June inspection and after the clearing in August.

Figure 4.1: Investigation area before and after waste removal and vegetation clearing.

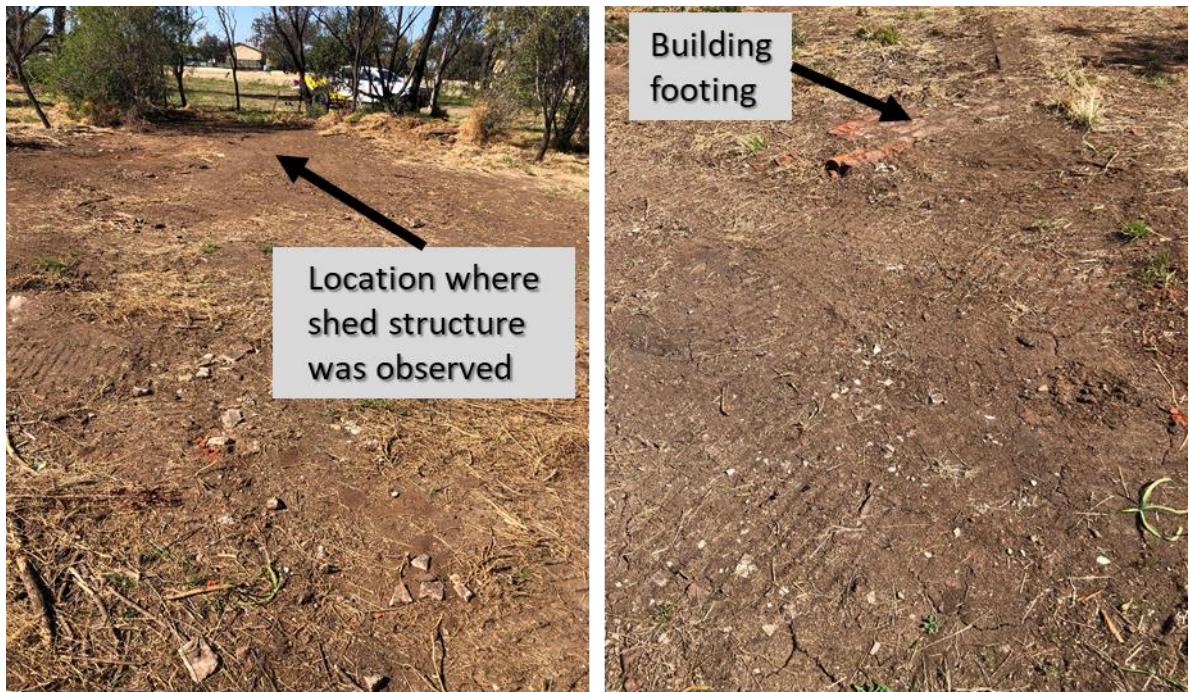
The fragments of asbestos containing material observed at the subject site most likely originate from sheets of fibre cement used in the construction of gables, eaves or wall panels, that were discarded at the investigation area and were broken and dispersed over the area.

- During inspection of the cleared areas several fragments of fibre cement were again observed (see Figure 4.2). The observed fragments were localised to two of the zones identified in Section 2.3.3 (see Figure 4.3) specifically the area in Zone 2 where a shed structure and demolition rubble was previously observed, and Zone 3 in the vicinity of masonry building footings revealed by the clearing of the vegetation in this area.
- The total quantity of fibre cement fragments observed at the Investigation Area is likely less than 10 square meter in size.

Figure 4.2: Fragments of fibre cement observed at the Investigation Area.

- Development of the Investigation Area as part of a playing field is subject to the removal of fibre cement fragments from the surface of the site.
- It is recommended that a Remediation Action Plan (RAP) be developed to inform the removal of the fibre cement fragments from the surface of the site and provide recommendations for the appropriate application of fill as barrier over the contaminated soil.

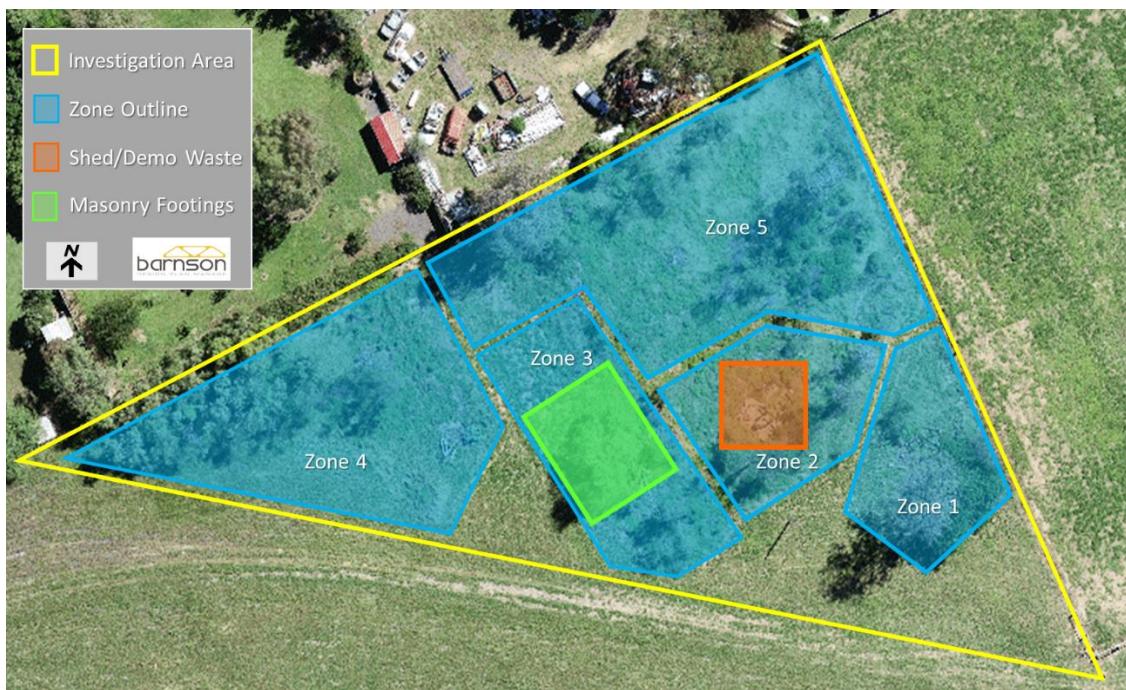
Figure 4.3: Location of fibre cement fragments.

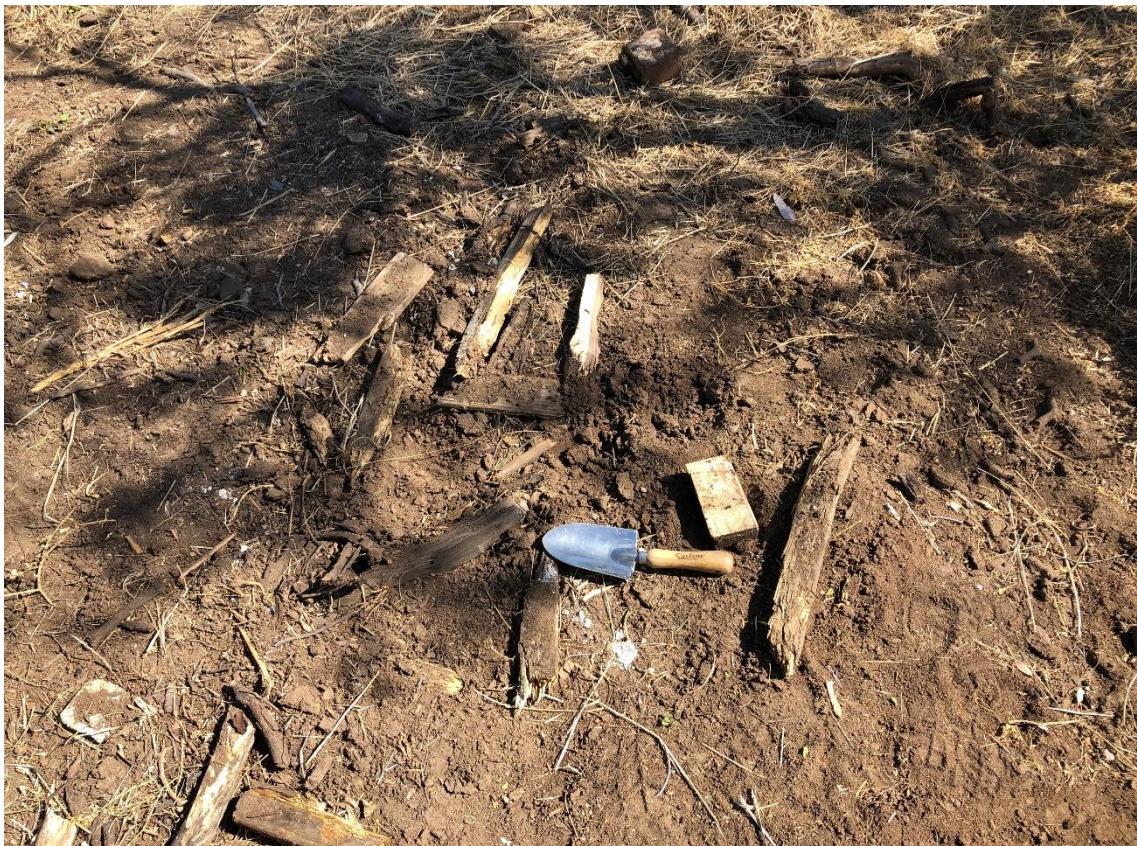
- In the area marked as Zone 1, pieces of painted wood were observed in the area to the west of the tree (see Figure 4.3 and Figure 4.4). A piece of wood similar to the pieces observed here, was previously collected from the same area, during the initial site investigation, and analysed for lead. The results indicated a low concentration of lead (300 ppm Pb) in the paint.

Figure 4.4: **Pieces of painted wood observed in Zone 1.**

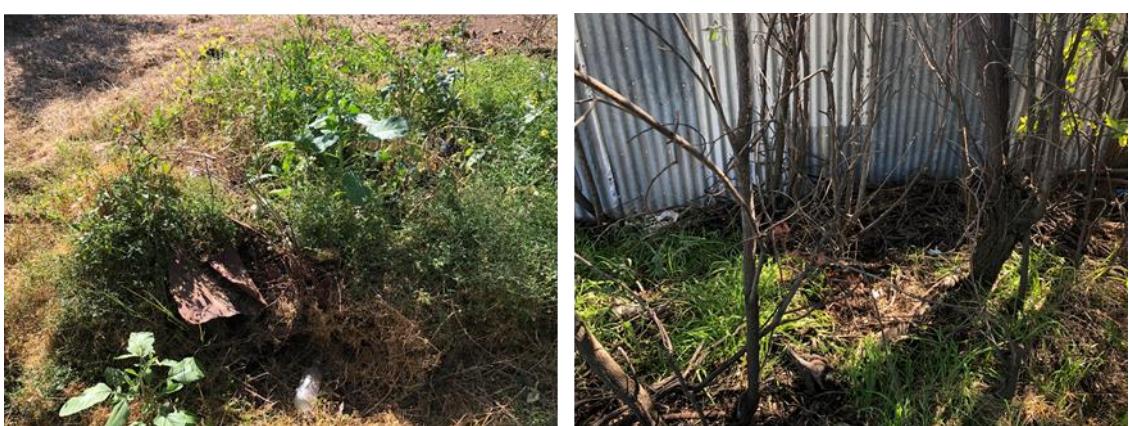
- Discarded waste was still observed among the trees in Zone 4 (see Figure 4.5).

Figure 4.5: **Uncleared waste observed in Zone 4**

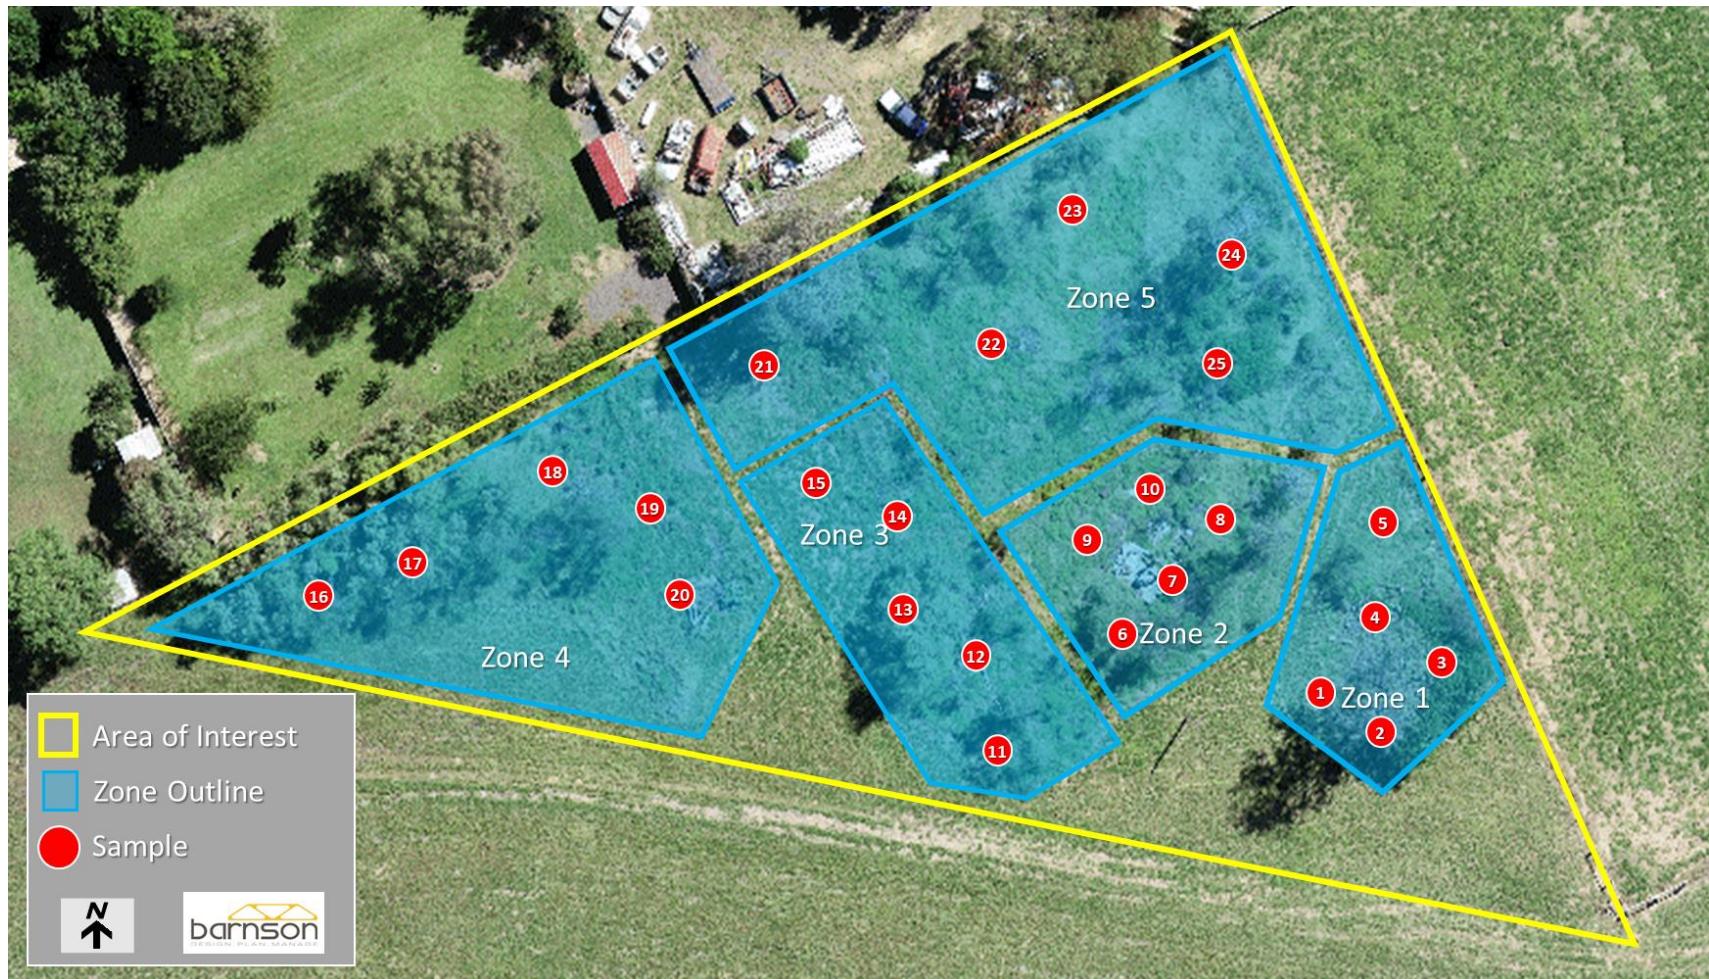
A standard procedure for surface soil sample collection was followed throughout and field records were kept for each sample collected noting sample location, site observations, sample identification, sample depth and a description of the soil. Sampling locations were mapped at the time of sampling.

Figure 4.6: Map indicating soil sample locations at the Investigation Area.

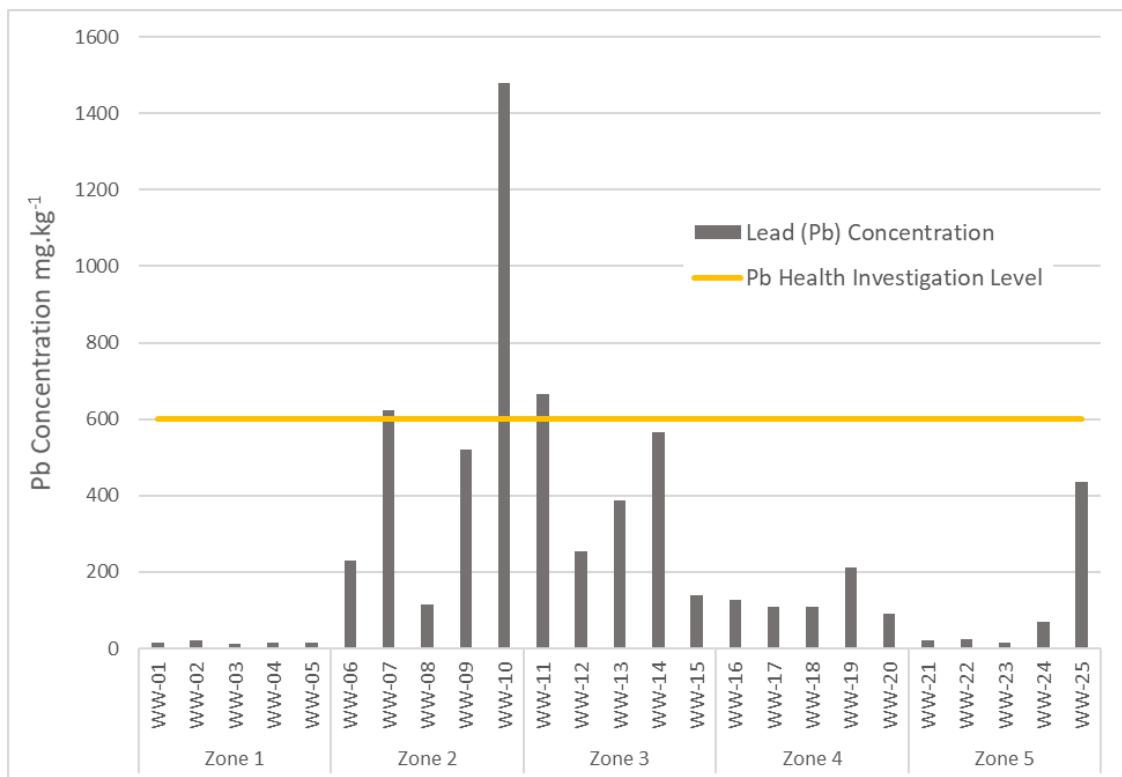
Comparison of the lead concentrations detected in soil with the HIL-C criterion of 600 mg.kg^{-1} (see Figure 6.1), indicate that several samples exceed or approach this health-risk based investigation level.

Figure 6.1: Comparison of Pb concentrations detected in surface soil samples from the Investigation area with the health-risk based investigation level.

The three locations where the lead concentrations in soil exceed the HIL are limited to Zone 2 and Zone 3. Since the contamination seems to be localised around these two Zones it is necessary to determine whether the Investigation Area, as a whole, can be considered contaminated. This is determined by statistical analysis of the measured lead concentrations through calculation of

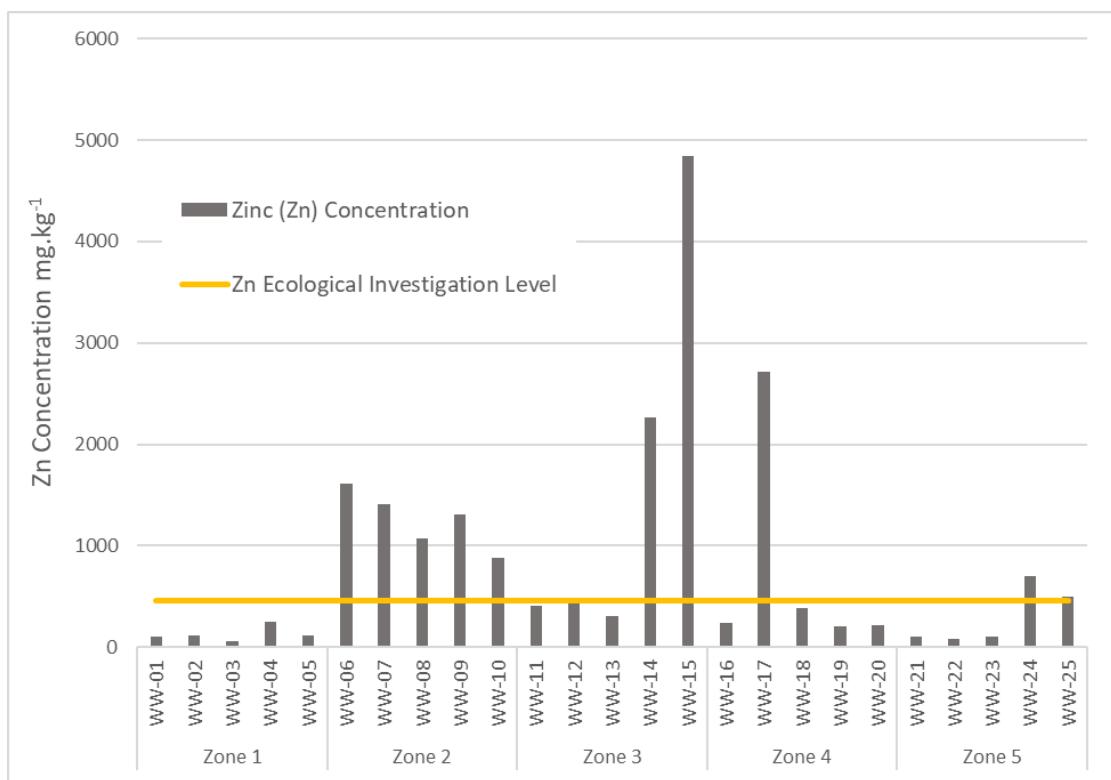
Figure 6.2: Comparison of Zn concentrations detected in surface soil samples from the Investigation area with the ecological-risk based investigation level.

The Investigation Area and indeed the Subject Site is not identified as an area of high ecological value, nor is the site located close to such an area. Given the low in-situ leachability of zinc oxide and sulphide compounds and the low infiltration rate and runoff potential of the Investigation Area soils and site, it is considered unlikely that the zinc present in the Area would represent any risk to the ecosystem.

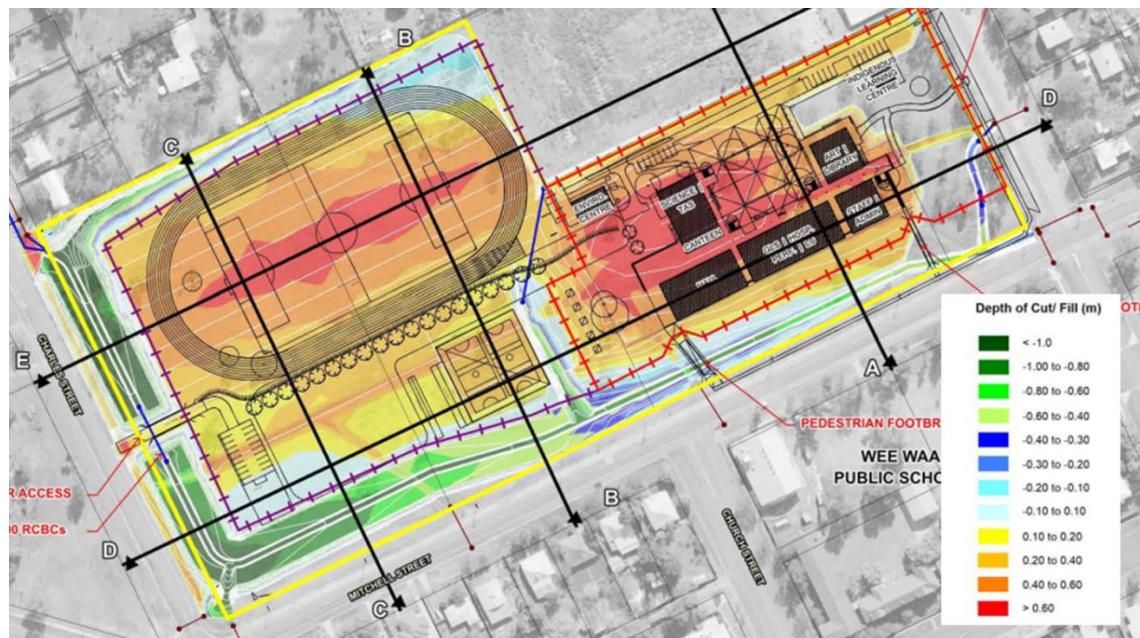
In the case of the Investigation Area, the proposed playing field that will be partially located over the contaminated areas will be constructed from fill brought in to raise and level the northern portion of the site. The proposed cut and fill strategy (see Figure 6.3) indicate that most of the investigation area will be filled to a depth ranging between 100mm to 600mm.

Figure 6.3: Excerpt from the proposed cut/fill strategy for the Subject Site (Lyall & Associates, 2021)

Based on the concentration of lead detected in the soil at the Investigation Area, following the removal of the demolition waste, the average concentration of lead is expected to be in the region of $140 \text{ mg Pb.kg}^{-1}$ with isolated maximum concentrations unlikely to exceed $2,000 \text{ mg Pb.kg}^{-1}$. Provided that the contaminated areas remain undisturbed during the earthworks, the proposed filling and grassing of the area for construction of the playing field is expected to provide a barrier that will eliminate the direct exposure of visitors to the site to the lead contaminated soil.

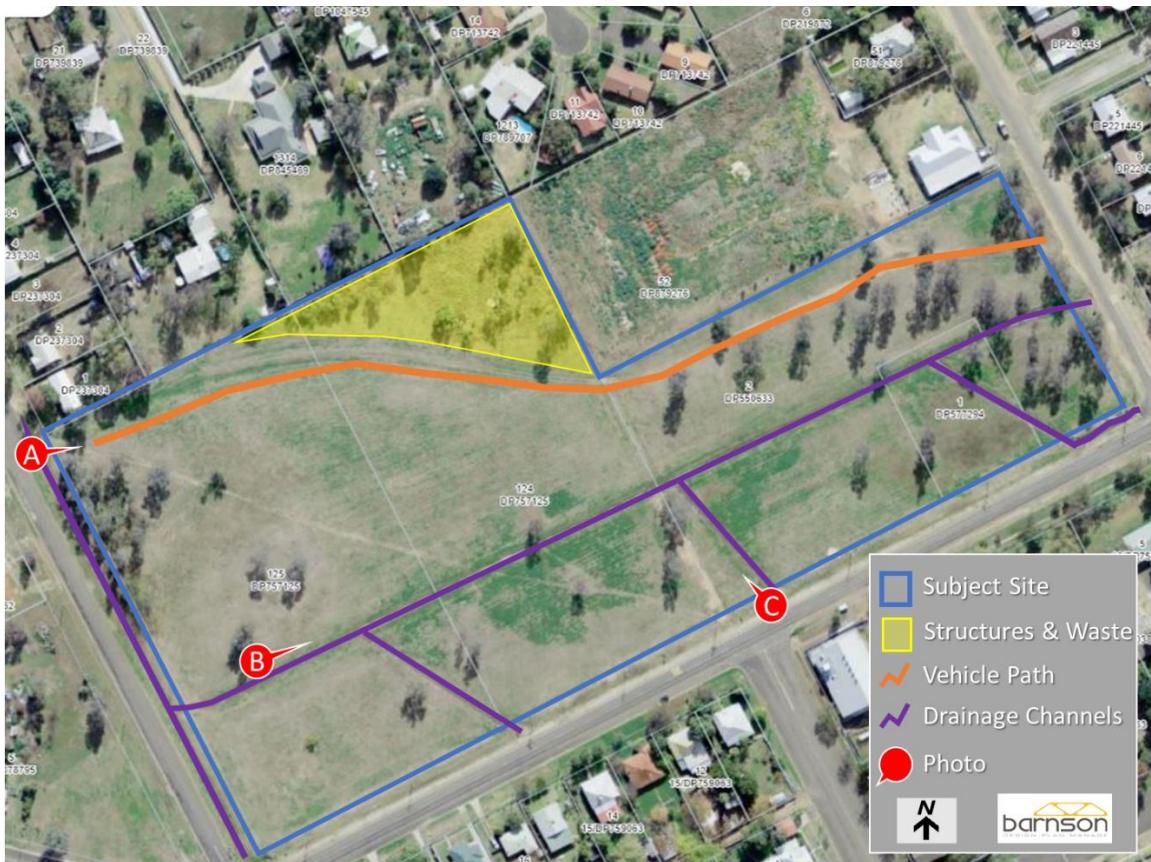
Figure 4.1: General site layout.

The site includes fencing on the boundary with the residential properties to the north. Near this boundary, in a corner formed with an adjoining paddock, there are remnants of former structures as well as piles of discarded building material.

Figure 4.1 presents a sketch plan of the basic layout of the Subject Site, supplemented with photographs showing the different elements of the Site (Figure 4.2 to Figure 4.3). Figure 4.1 includes markers indicating the vantage point and direction of the photographs.

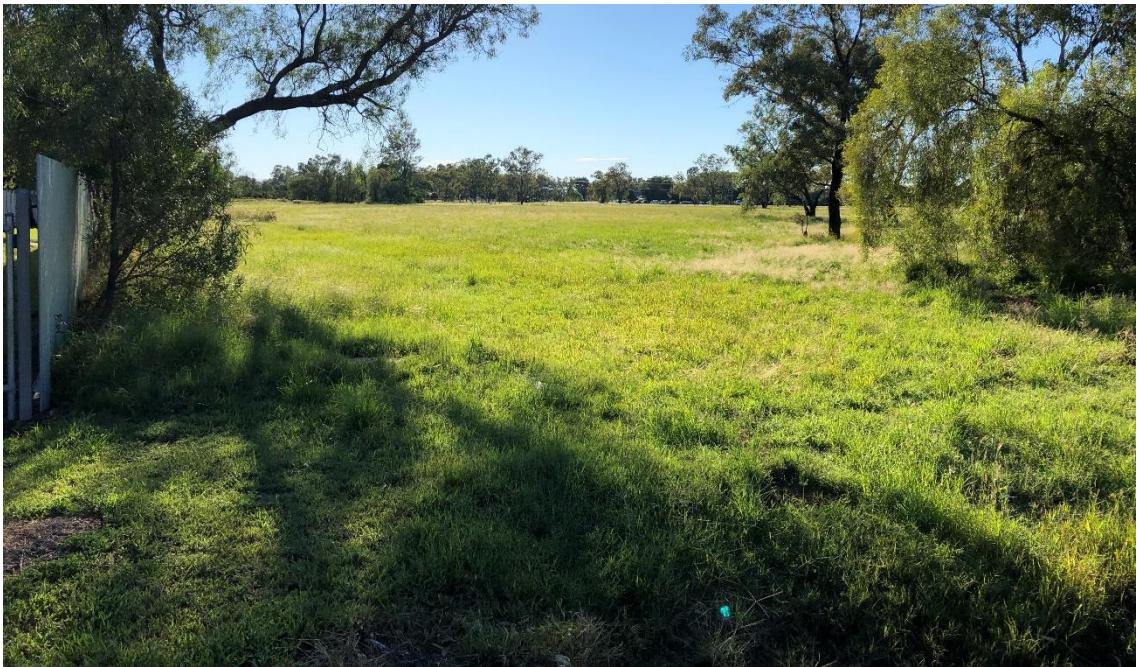
Figure 4.2: Photo A –View across the Subject Site from the north west corner of Lot 125
(see Figure 4.1 for location of photo).

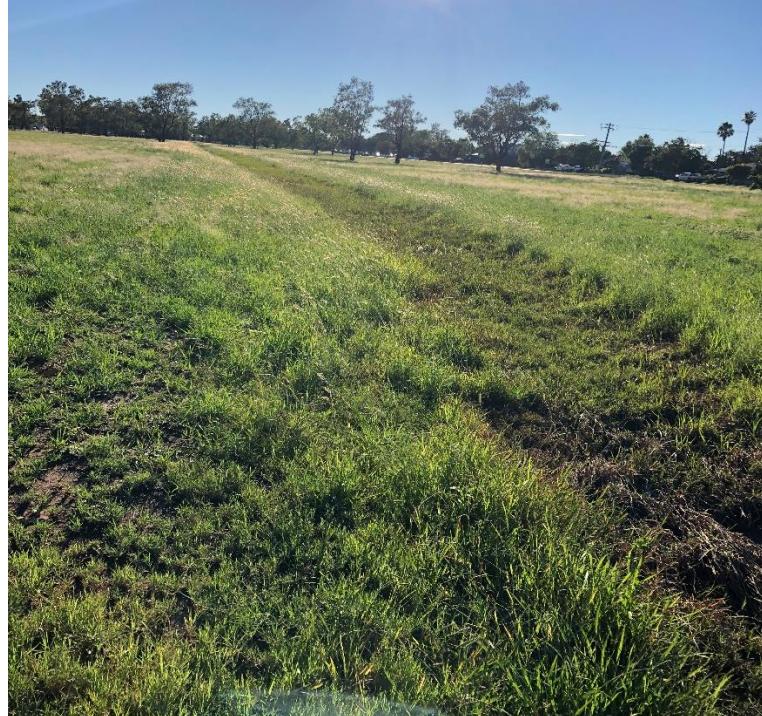
Figure 4.3: Photo B – Shallow drainage channel across the Subject Site (see Figure 4.1 for location of photo).

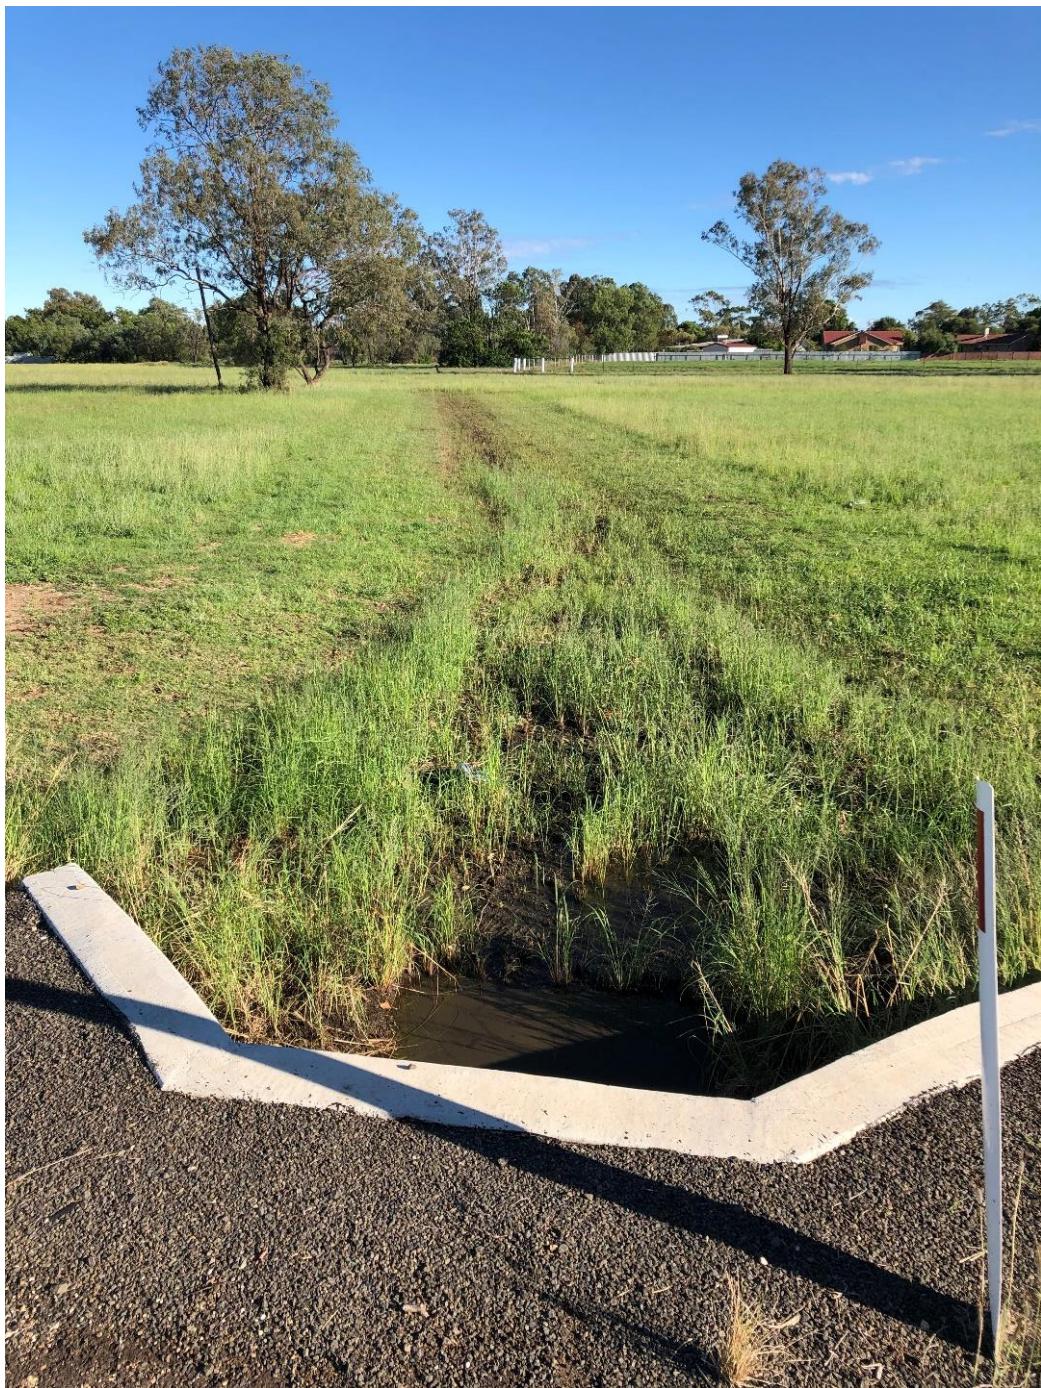
Figure 4.4: Photo C – Culvert and drainage channel north of Mitchel Street (see Figure 4.1 for location of photo).

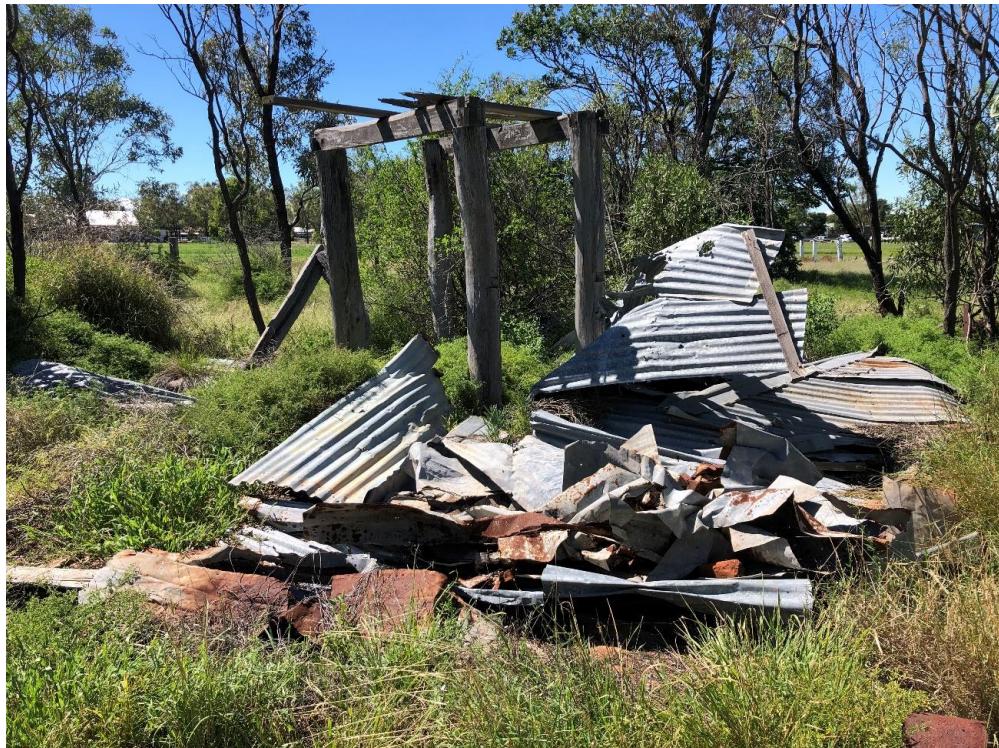
Figure 4.5: Photo D – Remnants of structures and demolition waste (see Figure 4.1 for location of photo).
