Detailed Site Investigation

Wee Waa High School
105-107 Mitchell Street
Wee Waa NSW

(Our Reference:35754 ERO2)

Project Name:	Detailed Site Investigation - Wee Waa High School, 105-107 Mitchell Street, Wee Waa, NSW
Client:	NSW Department of Education
Project No.	35754
Report Reference	35754 ER02
Date:	28/09/2021
Revision:	Final

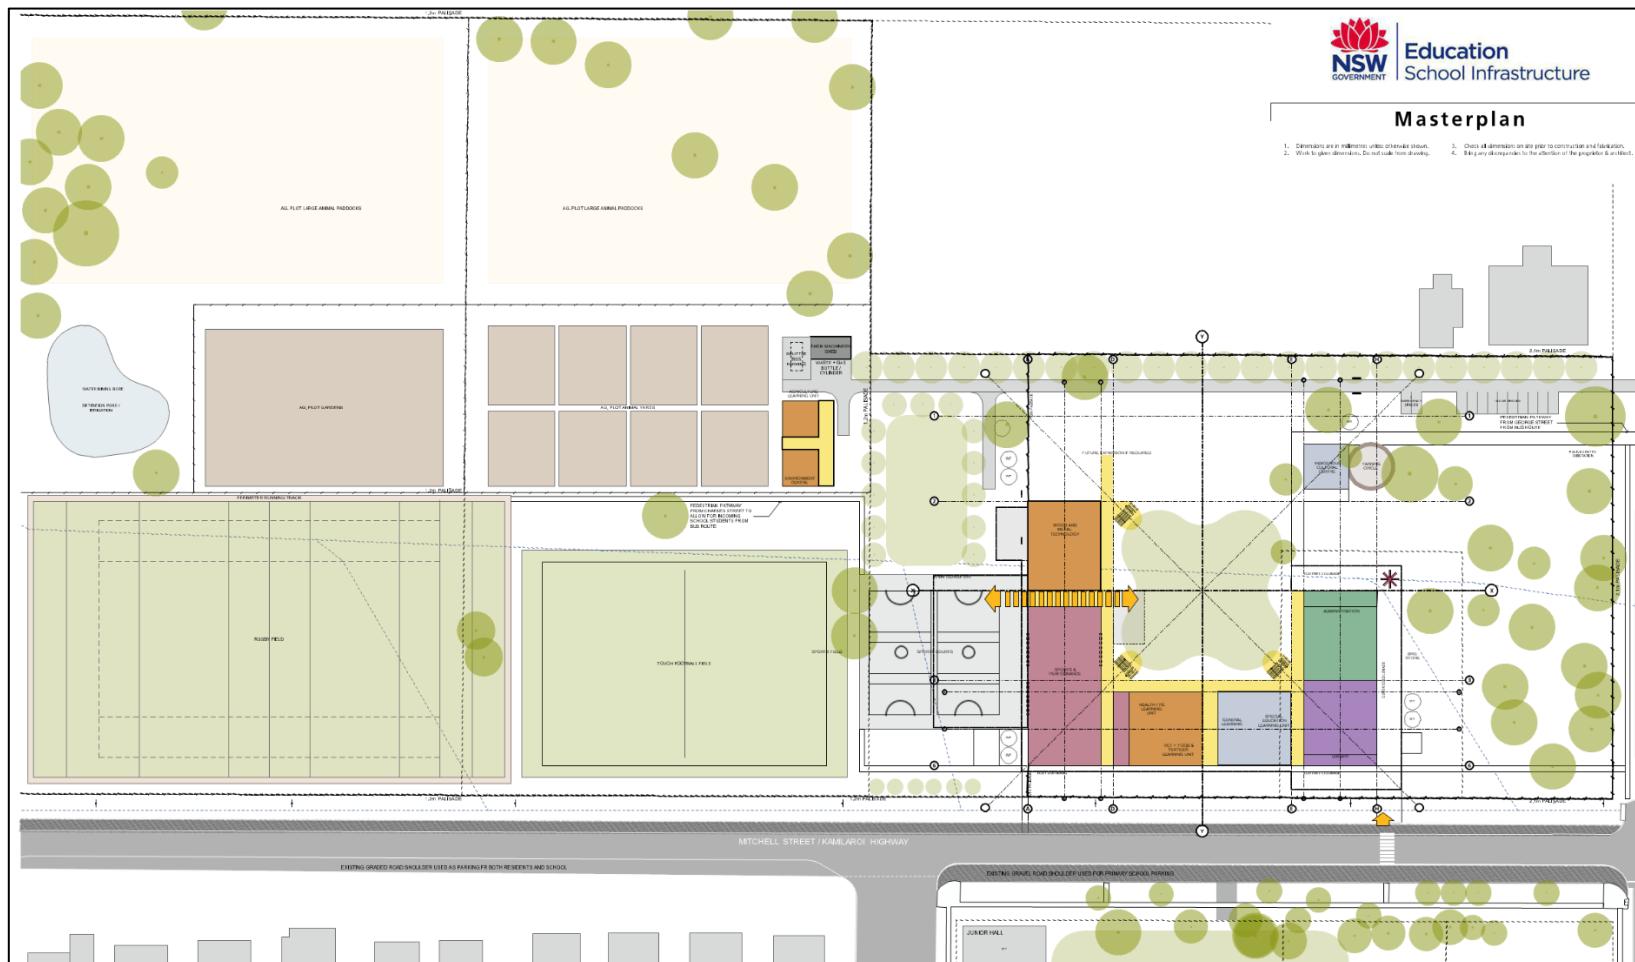
Figure 5.1: Proposed development masterplan, valid at the time of this report (April 2021).

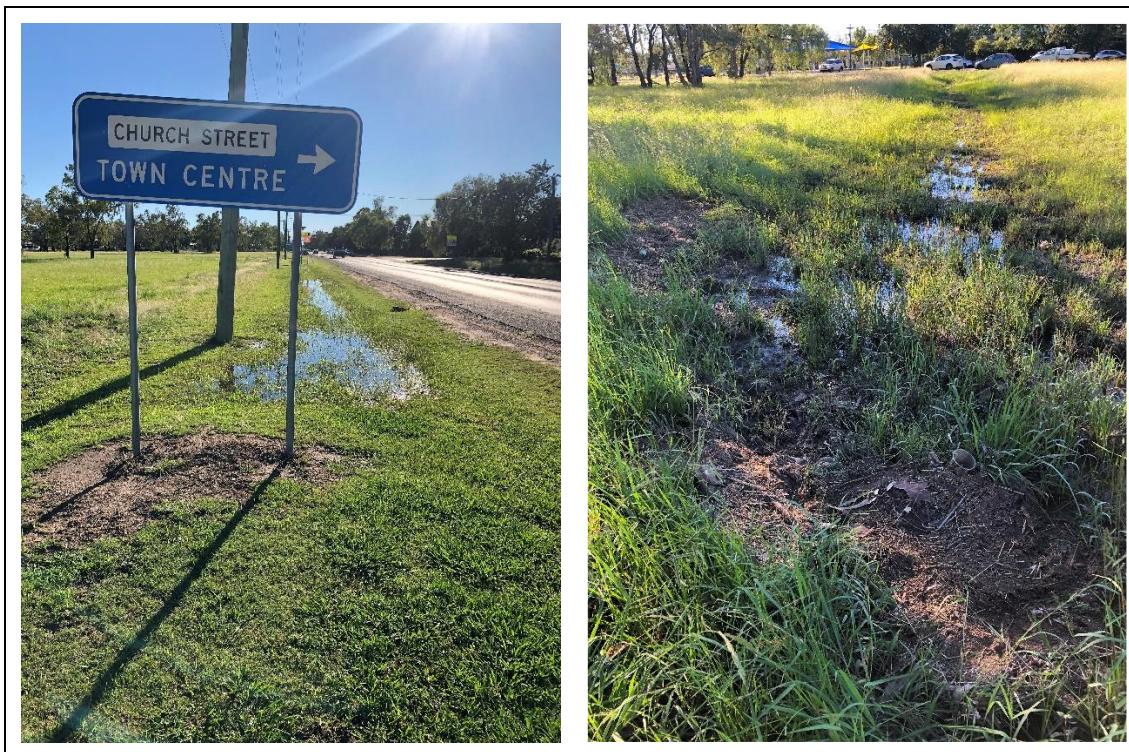
- The site is not fenced and access to the site is possible from all street frontages. There is an informal vehicle path traversing the northern part of the Subject Site between Charles and George Streets and there are several footpaths crossing the site.
- At the time Barnson conducted the site inspection, most of the Subject Site was covered with vegetation following seasonal rain. Most of the Site surface was also waterlogged and all drainage trenches contained standing water (see Figure 6.1).

Figure 6.1: Waterlogging near Mitchel Street and George Street frontage.

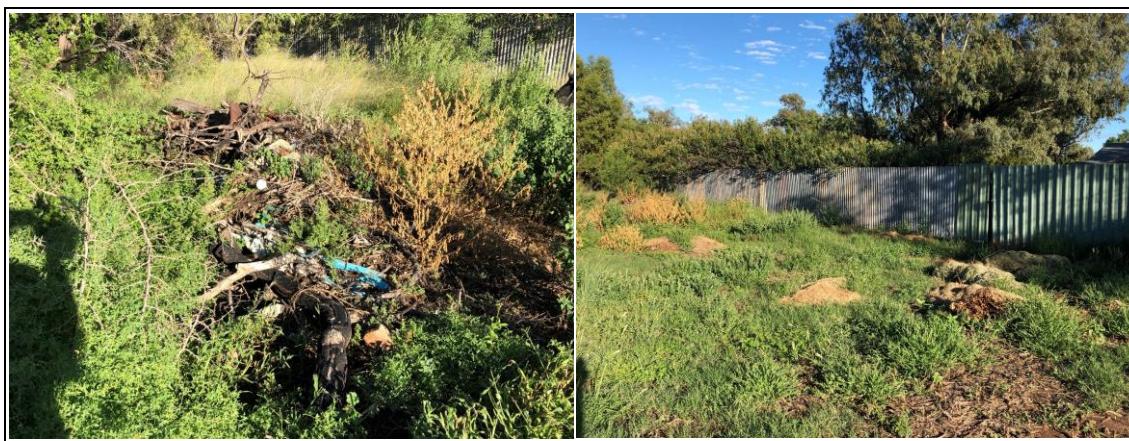
- The site was systematically walked over and all visible open ground was inspected. No visible discolouration or staining of open ground or soil, and no obvious discolouration or irregularities in the occurrence of vegetation was observed during the site inspection.
- Several small mounds of mostly garden waste (grass clippings) and some demolition and general waste were observed in the north eastern corner of Lot 124 (see Figure 6.2).

Figure 6.2: Demolition waste and grass clippings dumped in the vegetation in north eastern corner of Lot 124.

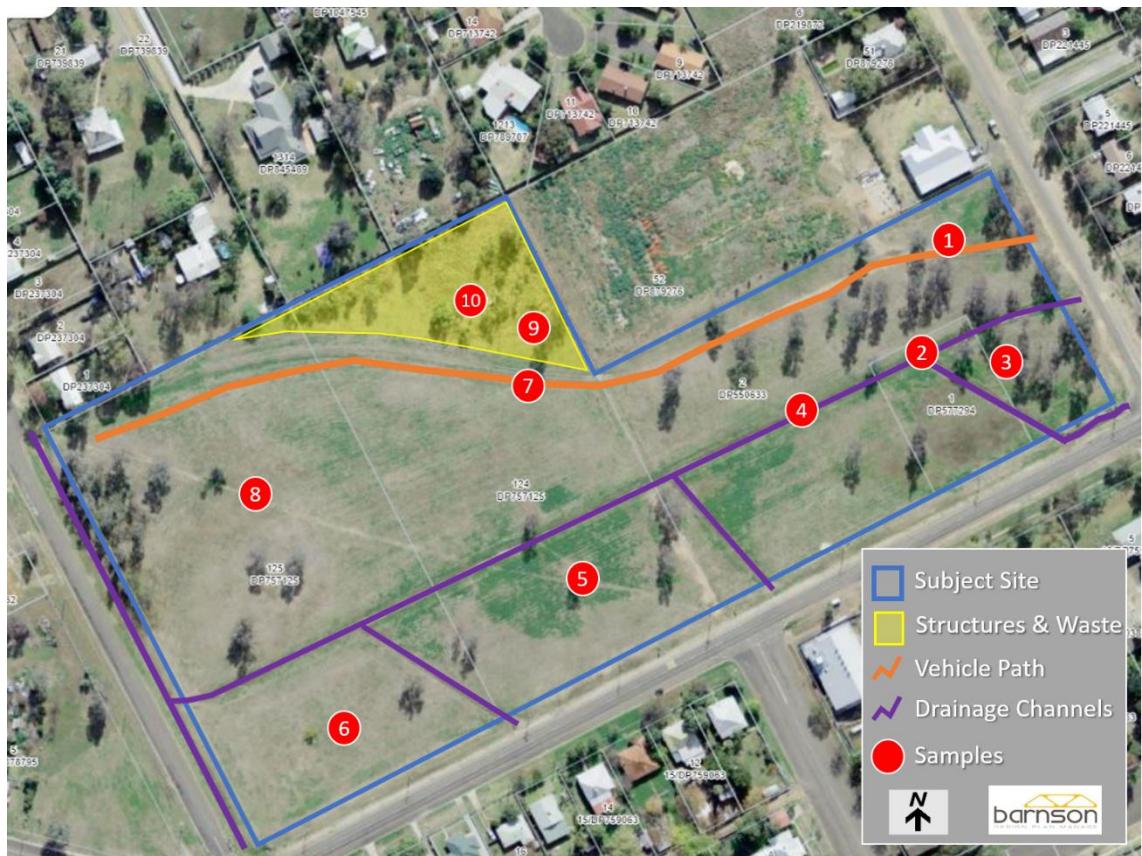
Figure 6.3 presents a map of the Subject Site with the locations of the surface soil samples indicated. Table 6.1 is a summary of the collected samples indicating which samples were included in composites for analysis.

Figure 6.3: Map indicating locations of confirmatory sample collection.
