Report on
Preliminary Geotechnical Investigation

Proposed Industrial Development
253 - 267 Aldington Road, Kemps Creek

Prepared for
RP Infrastructure Pty Ltd

Project 204098.00
October 2023

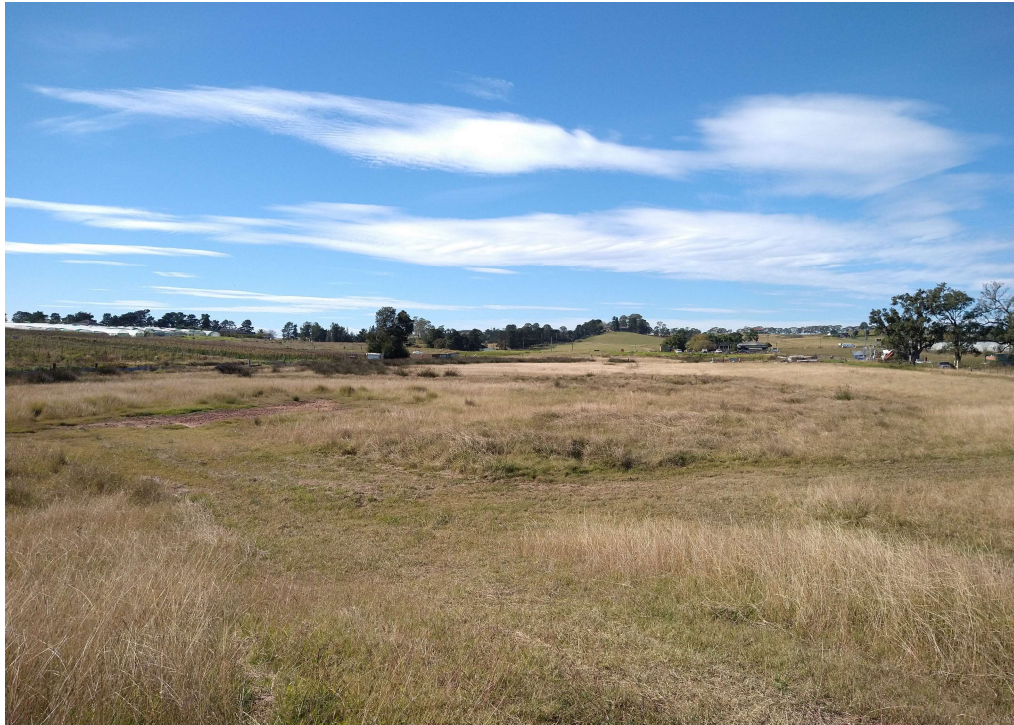
Photograph 8 - View of low-lying ground looking north-east from southern portion of site

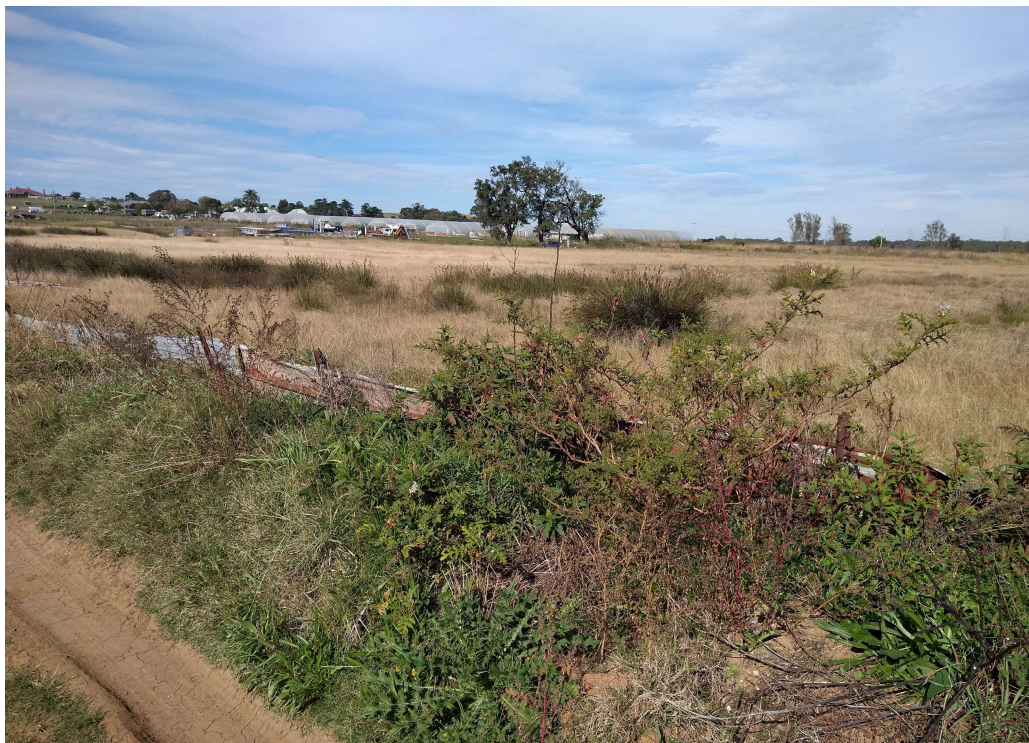
Photograph 9 - View of low-lying ground looking south-east from central portion of site

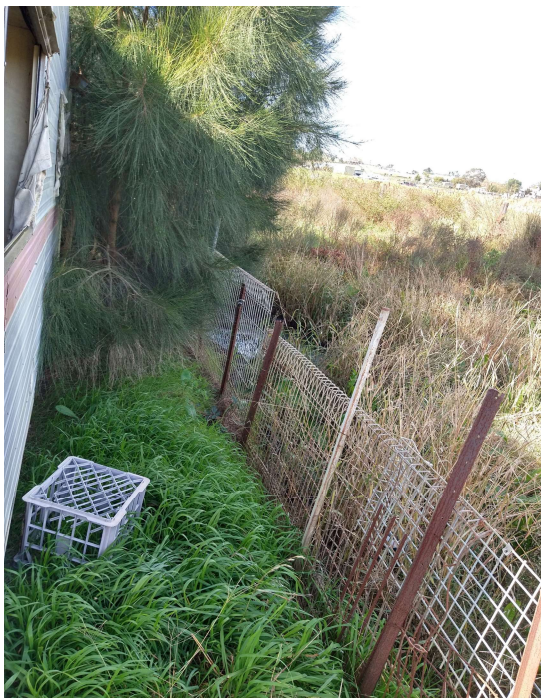
- Two areas were observed to be affected by water logging (MRPs and Photos 10 and 11). The water logging and heavy vegetation at MRP 10 appeared to be due to a channel originating from the Dam (MRP 5) which progressed east toward the centre of the site. The water logging and heavy vegetation at MRP 11 appeared to be due to a low-lying area without drainage;

Photograph 10 - Water Logged area in central portion of the site looking south east

Site observations have indicated low lying areas susceptible to water logging and subsurface material predominantly consists of silty clays which could potentially be affected by inclement weather and result in difficult trafficability conditions. If the site soils are reused, some moisture conditioning (wetting or drying) may be required for the earthworks and pavement subgrade construction. As a result, surface drainage that directs runoff away from work areas should be installed prior to construction, possibly in conjunction with the designation of construction equipment haul routes to minimise trafficking of stripped areas.

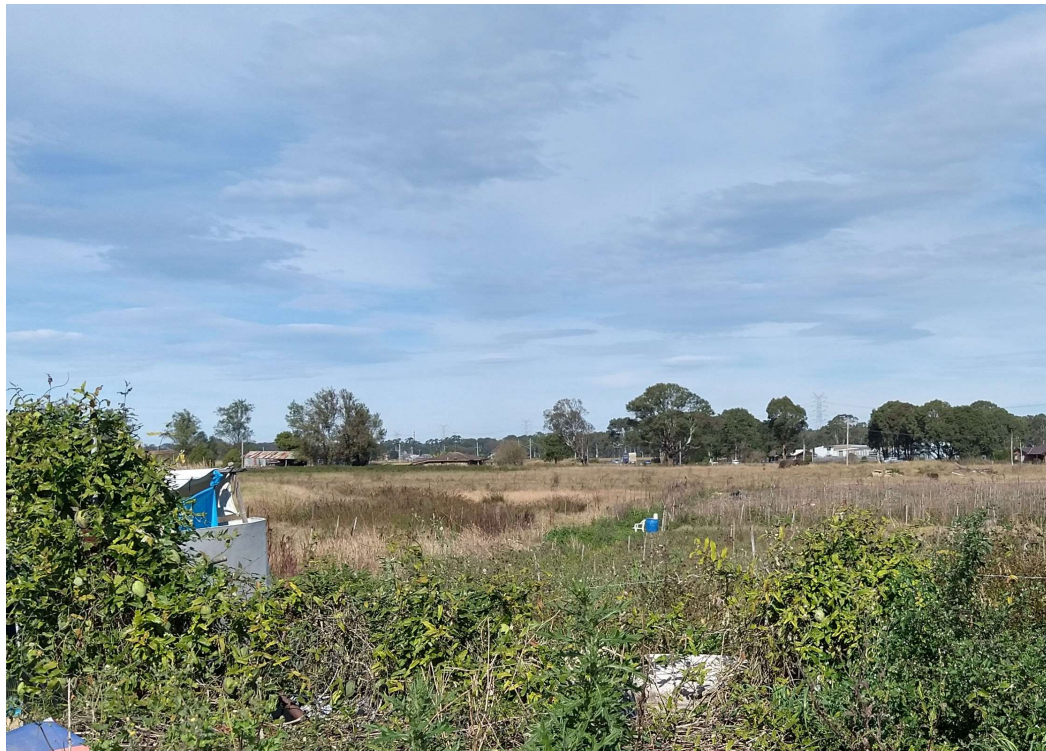
Photograph 11 - Water Logged area in western portion of the site, west of the dam, looking south
