Report on  
Geotechnical Investigation

Glenwood High School Upgrade  
85 Forman Avenue, Glenwood

Prepared for  
NSW Department of Education

Project 94626.00  
November 2021

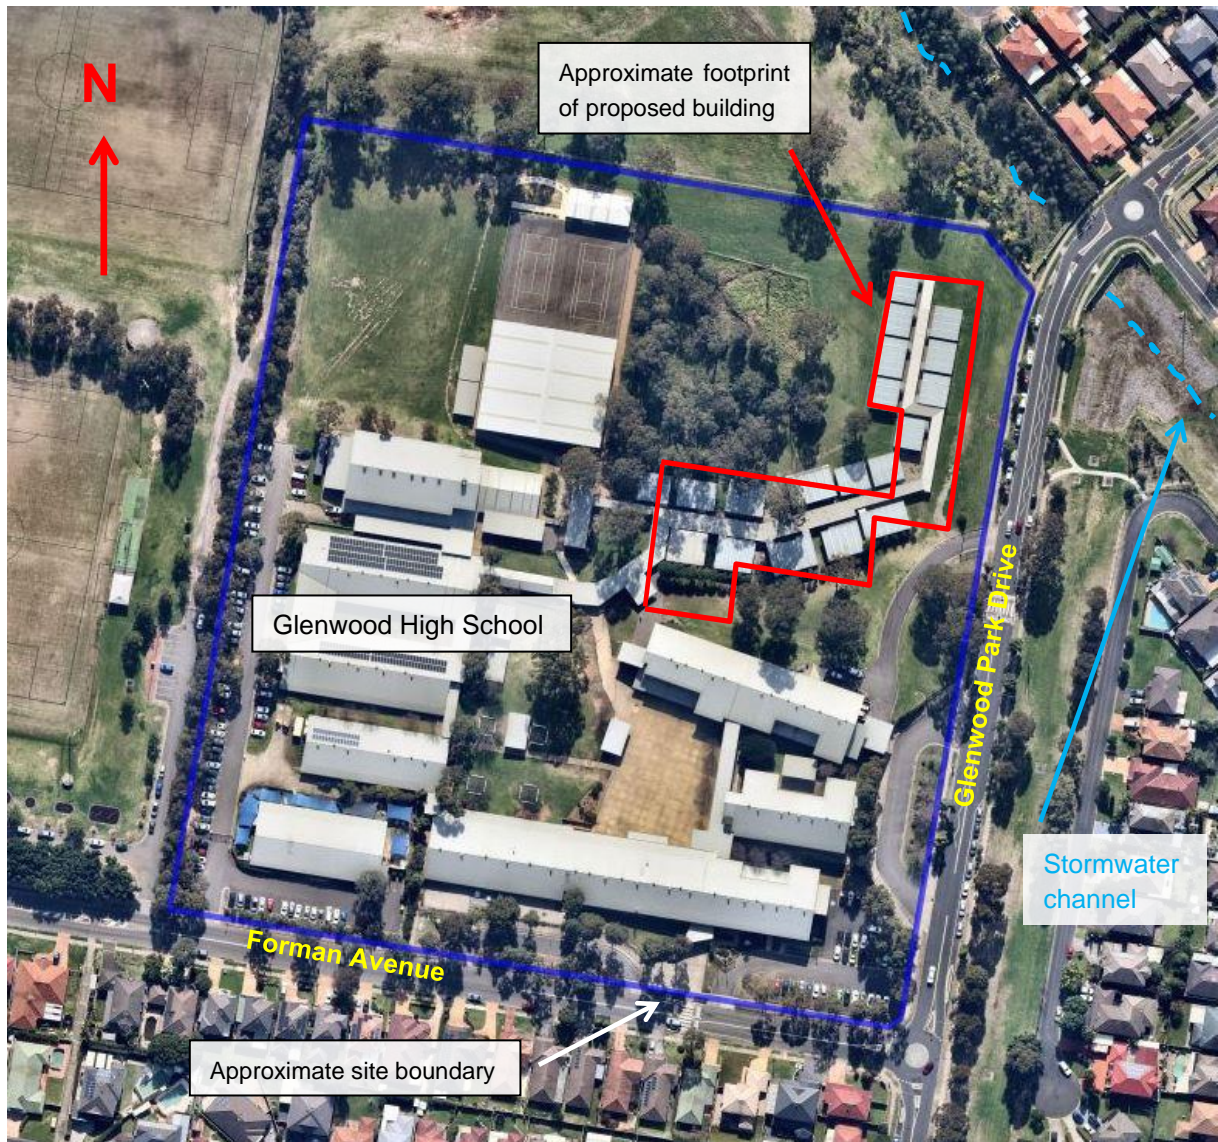
Figure 1: Site of New Three Storey Building (Source: Nearmap)

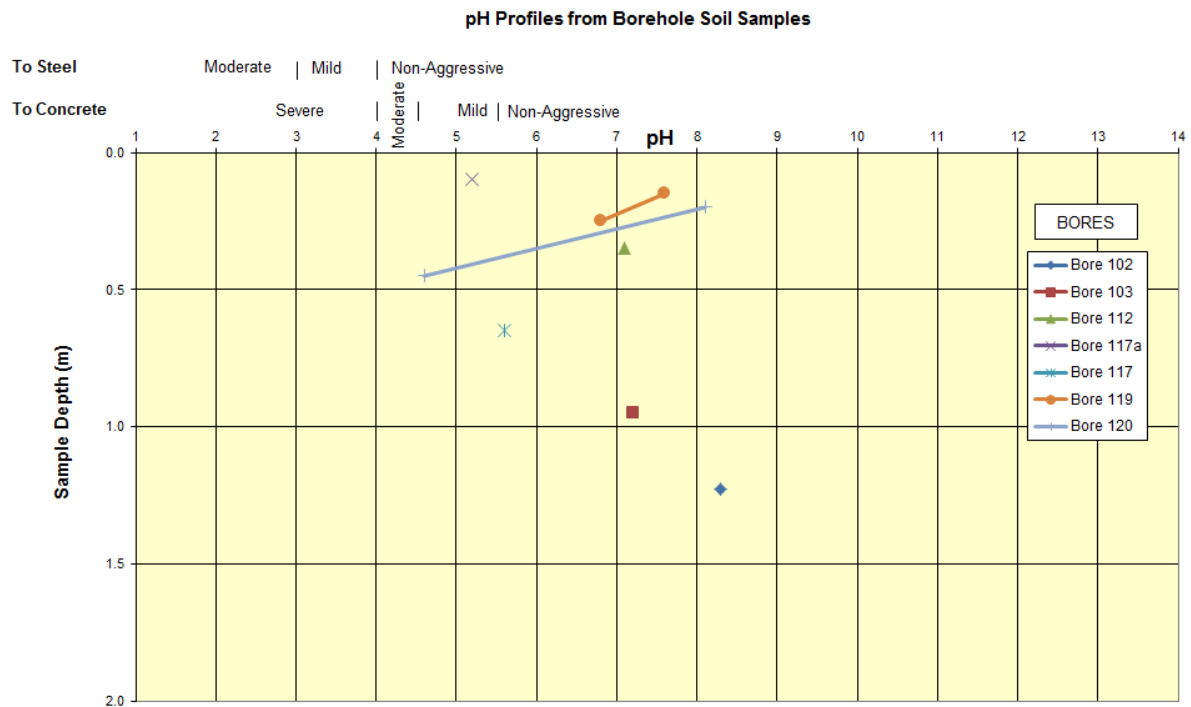
### Figure 2: Vertical pH Profiles

Test results showing the aggressivity assessed by pH, sulphate concentrations and chloride concentration criteria (of AS 2159) at the borehole locations, together with the aggressivity class ranges indicated in Australian Standard AS 2159 are given in Appendix D. The inferred very low permeability of the sampled clay-rich soils indicates that soils at all boreholes are in Condition “B” as defined by AS 2159.

The results show that the samples tested indicate the ground conditions are non-aggressive to mildly aggressive to concrete and non-aggressive to steel with reference to AS2159. The pH profiles with depth are shown in Figure 2 (following page).

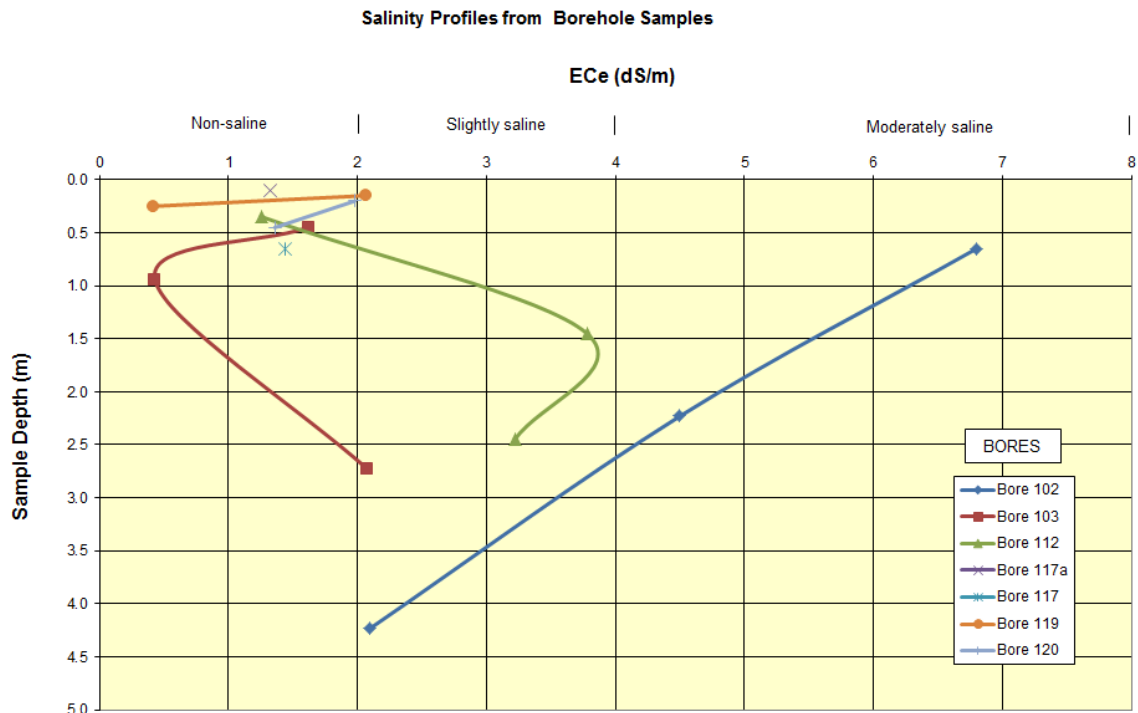
**Figure 3: Vertical Salinity Profiles and Salinity Classes**

Figure 3 (following page) shows the salinity classifications based on the electrical conductivity (ECe) at borehole locations, together with the salinity classifications of Richards (1954). Test results are provided in Appendix D.

The results indicate that the samples tested were varied ranging from non-saline to moderately saline.

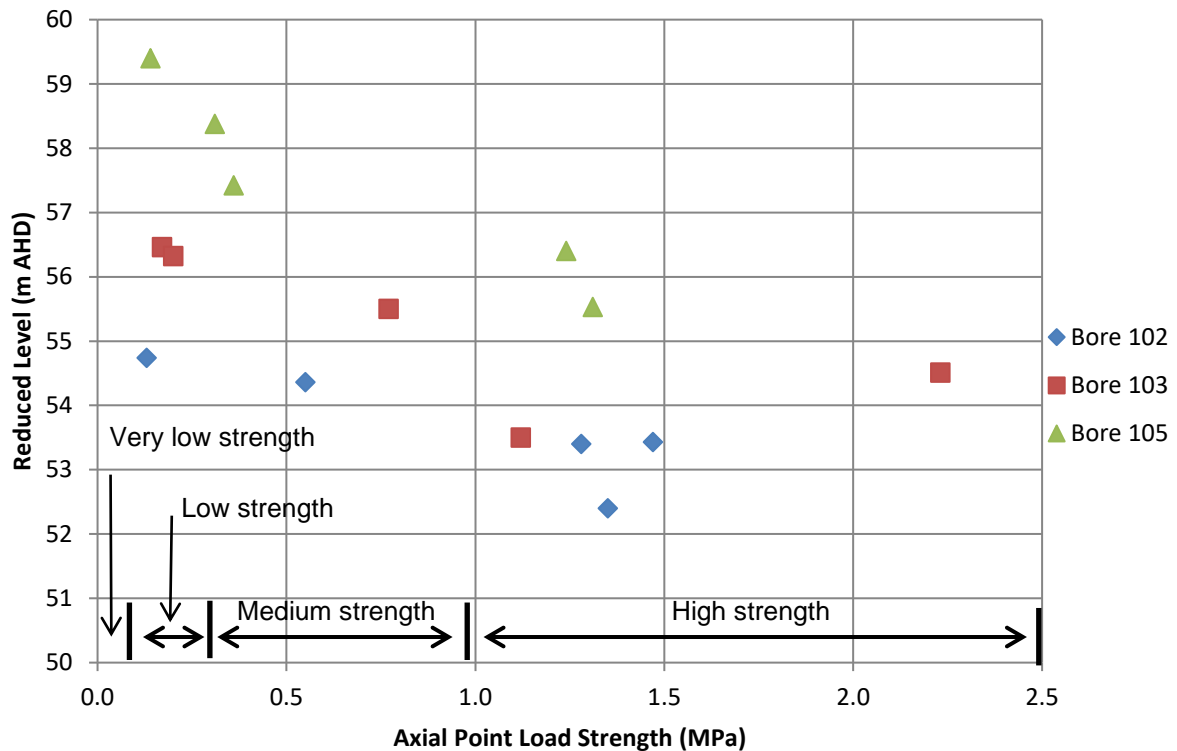
**Figure 4: Results of Axial Point Load Tests**

Point Load Strength Index ( $Is_{50}$ ) testing was carried out on selected rock core specimens. The results of the tests are shown on the borehole logs at the appropriate depths. Figure 4 (following page) shows the range of  $Is_{50}$  results at the various depths (shown as Reduced Levels relative to AHD).
