**Central Coast Quarter, 26 Mann Street
Gosford**

Geotechnical Interpretative Report

Our ref: SYDGE214942 Rev 3

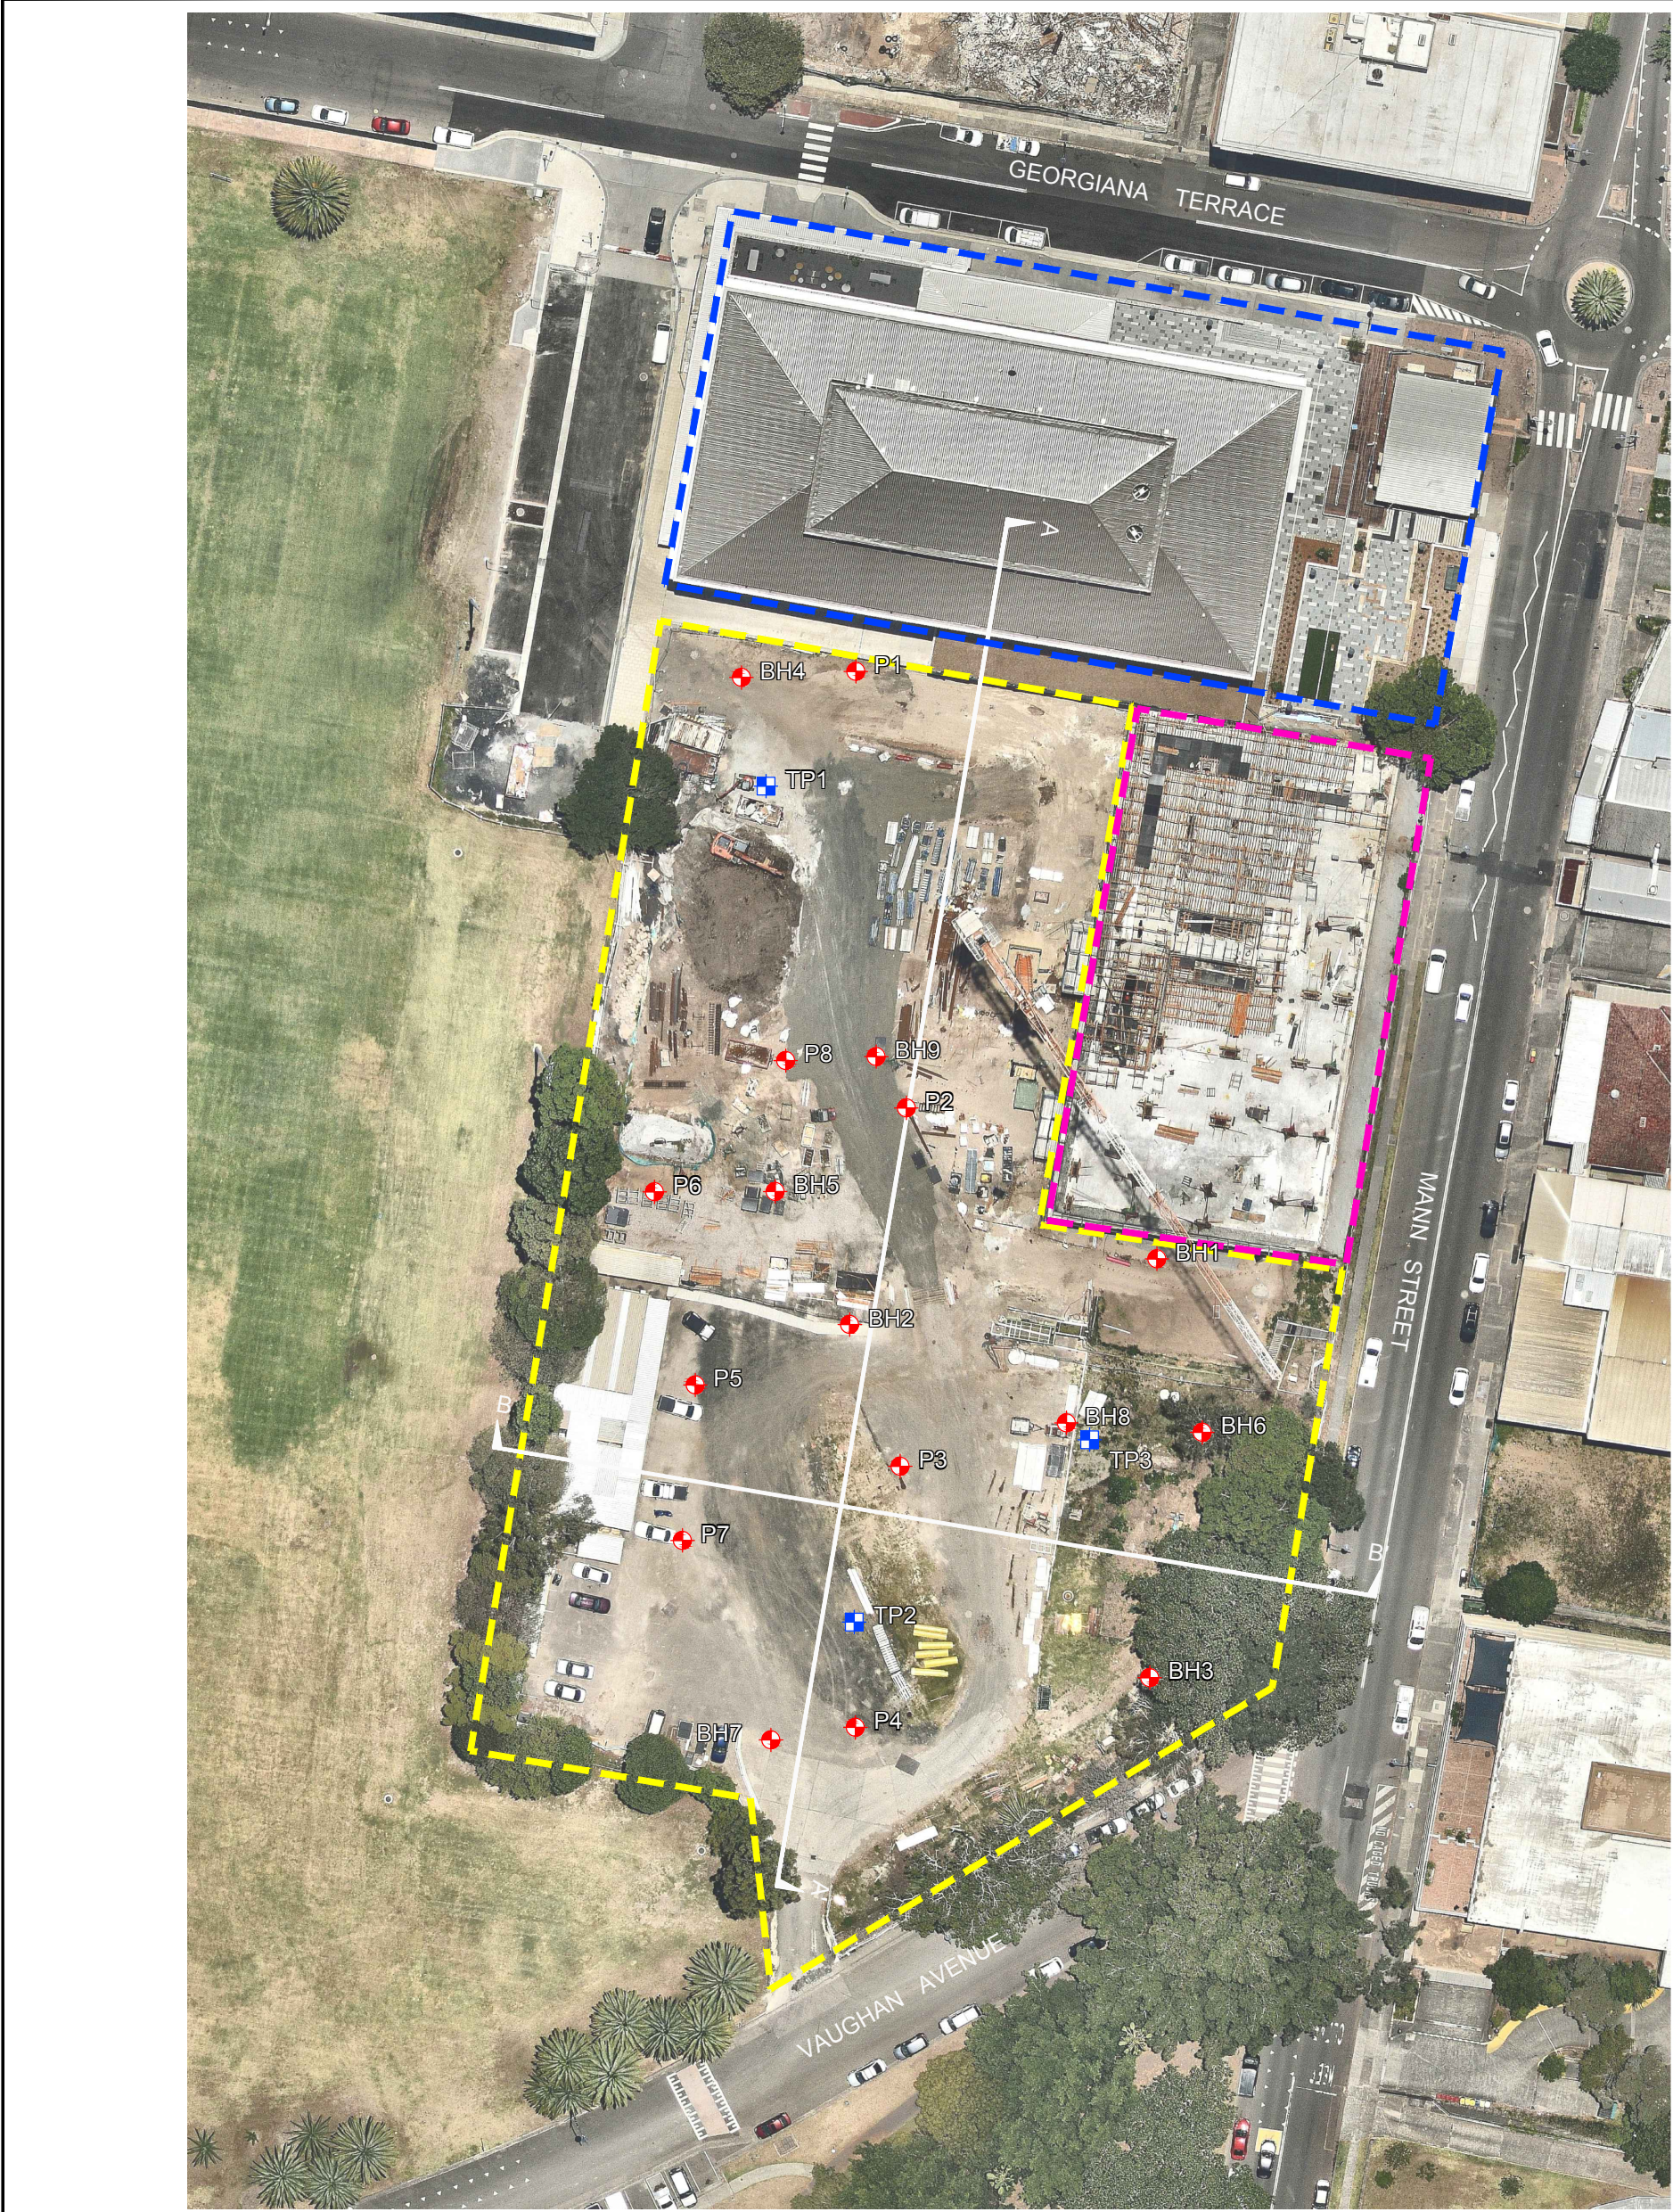
client: ST HILLIERS		
project: GEOTECHNICAL AND ENVIRONMENTAL ASSESSMENT 32 MANN STREET, GOSFORD, NSW		
title: BOREHOLE AND TEST PIT LOCATION PLAN		
project no: 754-SYD214942-AB	figure no: FIGURE 1	rev: A

A geotechnical engineer from Coffey carried out all fieldwork including logging of subsurface profiles, collection of samples and construction of piezometer wells. Approximate test locations are shown in Figure 1, attached in Appendix A. Subsurface conditions are summarised in Section 5.1 and detailed in the borehole and push tube logs attached in Appendix B together with the explanatory notes and rock core photographs.

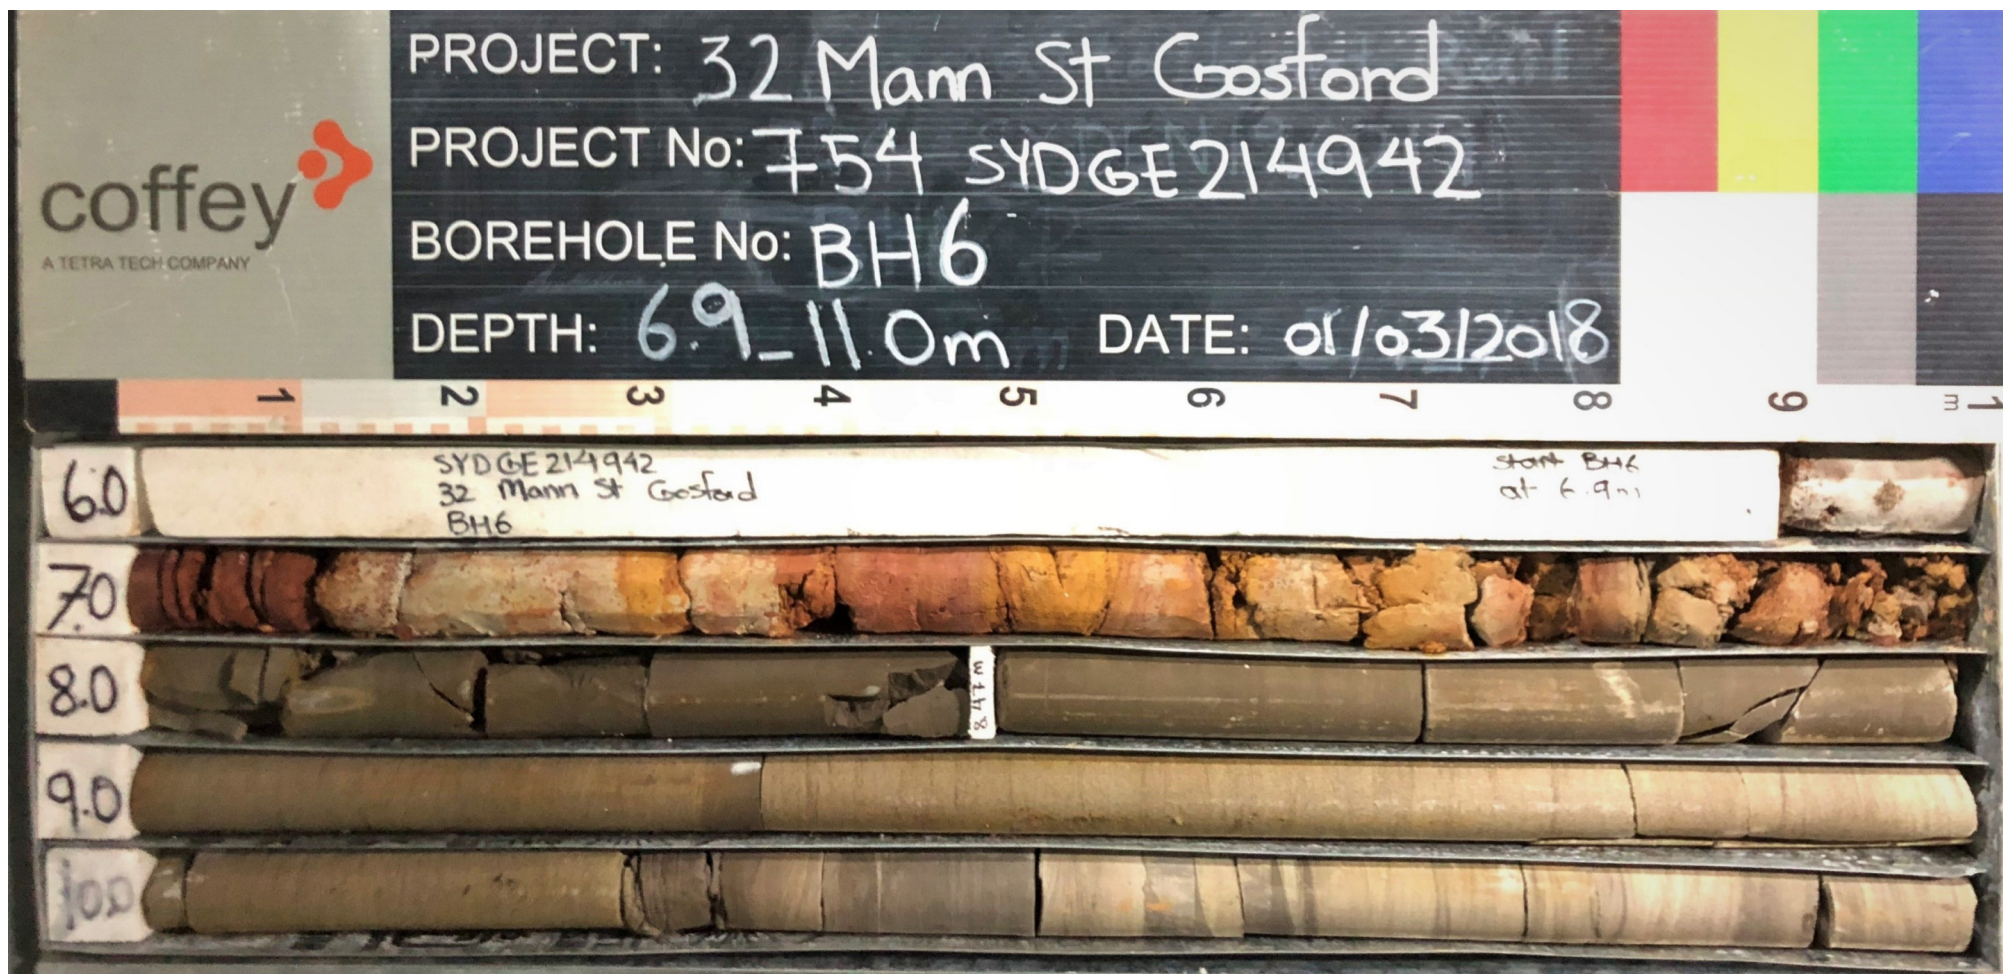
BH6 6.90 - 11.00 m

A TETRA TECH COMPANY	client:	St Hilliers		
approved	AM		project:	Geotechnical and Environmental Assessment 32 Mann Street, Gosford, nsw		
date	22/03/2018		title:	CORE PHOTOGRAPH BH6		
scale	N.T.S.		project no:	SYDGE214942	fig no:	FIGURE 1
original size	A4				rev:

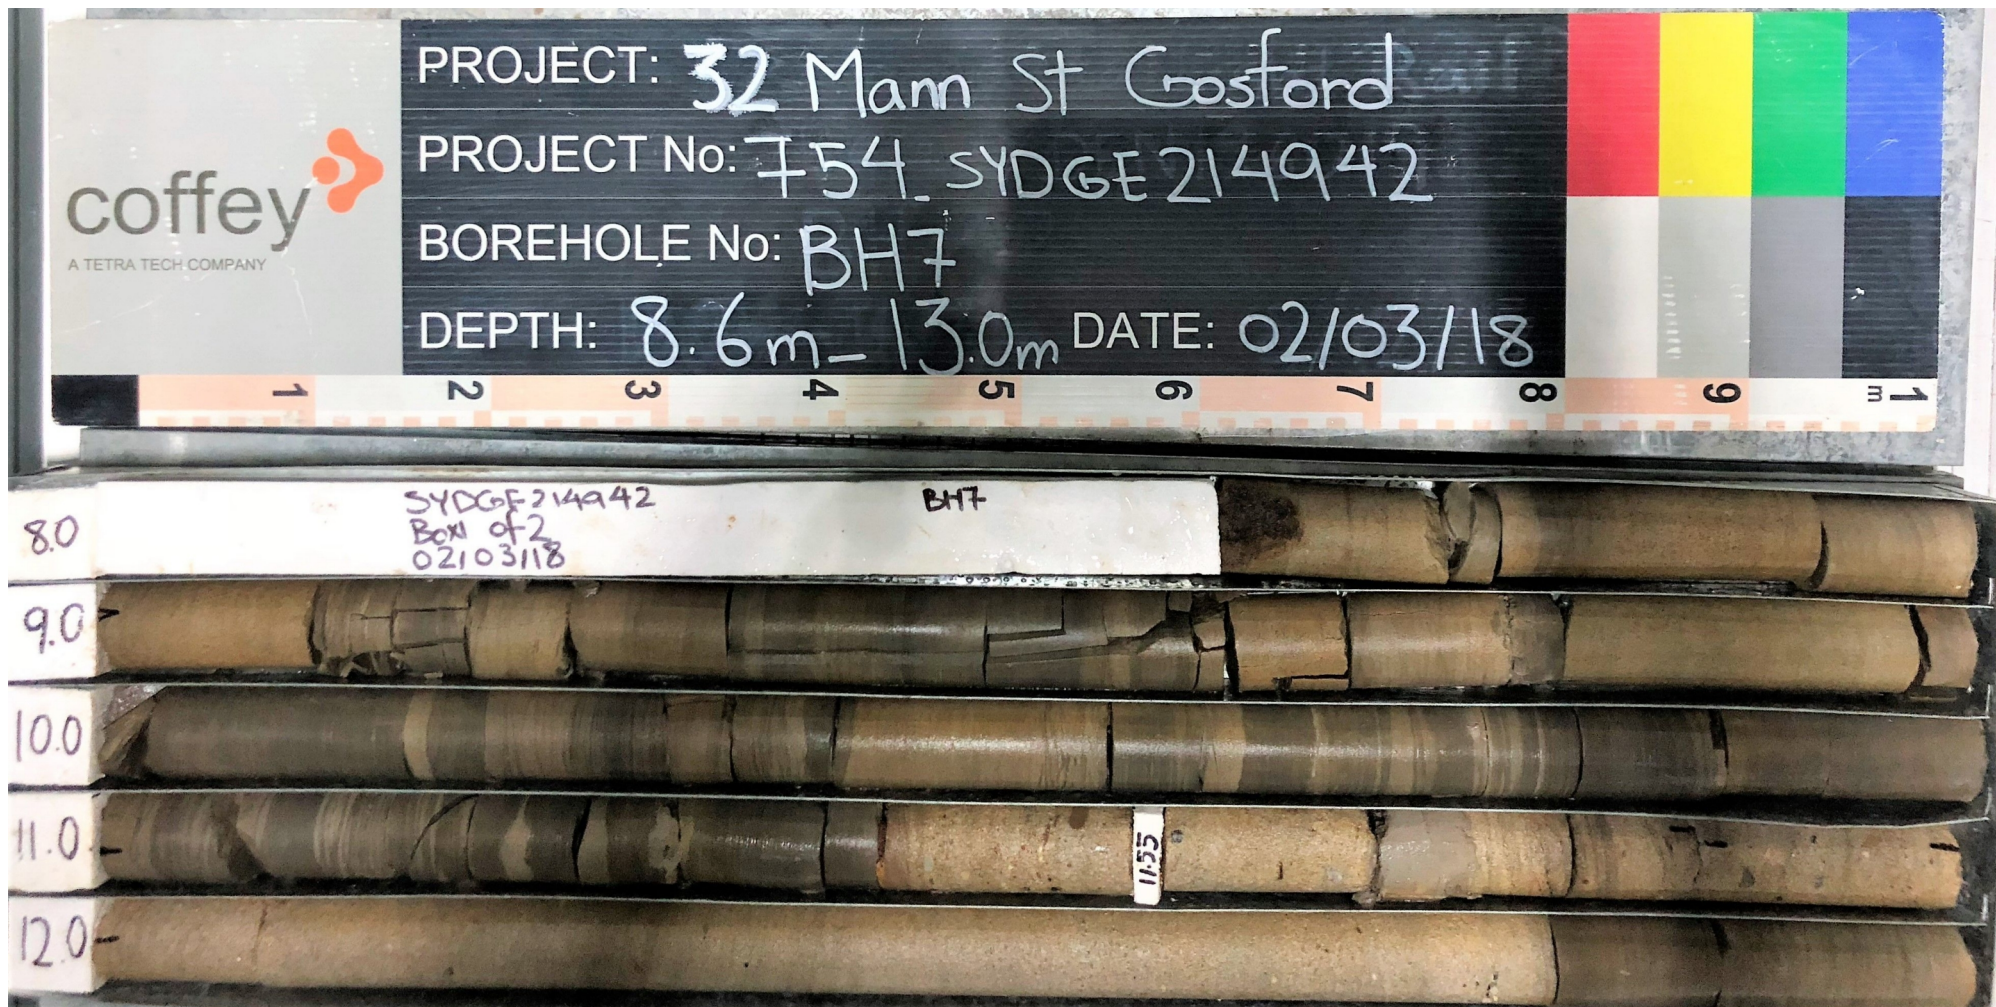
BH7 8.60 - 13.00 m

A TETRA TECH COMPANY	client:	St Hilliers		
approved	AM		project:	Geotechnical and Environmental Assessment 32 Mann Street, Gosford, nsw		
date	22/03/2018		title:	CORE PHOTOGRAPH BH7		
scale	N.T.S.		project no:	SYDGE214942	fig no:	FIGURE 1
original size	A4				rev:

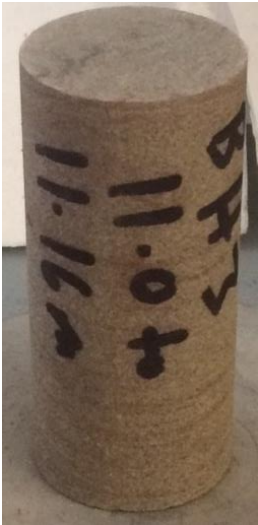
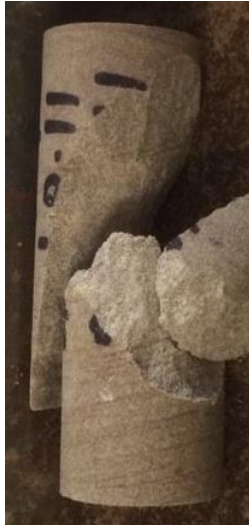
client:	COFFEY SERVICES AUSTRALIA PTY LTD			job no:	754-SYDS00113AA	
Principal:	ST HILL			laboratory:	Sydney	
project:	32 MANN STREET, GOSFORD NSW			report date:	29 March 2018	
location:	32 MANN ST GOSFORD			borehole:	BH3	
test procedure: AS 4133.1.1.1 and 4133.4.2.1				date received:		
test apparatus: Avery with 200 kN CAS load cell 4222				page 1 of 1		
The sample was cut short to remove existing damaged sections						
QESTLAB work order ID	height	uniaxial compressive strength	wet density	sample description		comments
depth	average diameter	MPa	moisture content	bedding/foliation		
QESTLab sample ID	test duration		height/dia ratio			
SYDS18W00047		119 mm	2.4 t/m ³	Sandstone		Tested in 'as received' moisture condition
BH3 11.00 to 11.16 m	23 Mar 18	51.9 mm	4.9 %	Bedding planes are at an angle of 80° to the axis of loading		
SYDS18S-00232	7.53 min	2.29:1				Shear

BH3
11.00 to 11.16 m
before testing

BH3
11.00 to 11.16 m
after testing

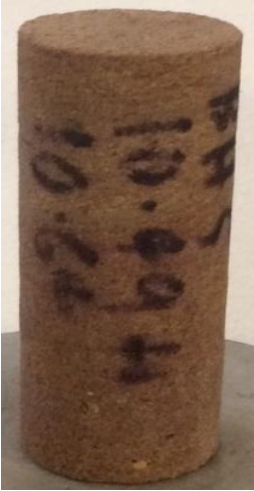
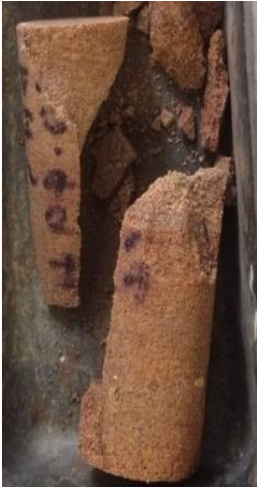
QESTLAB work order ID	height	uniaxial compressive strength	wet density	sample description	comments
depth	average diameter	MPa	moisture content	bedding/foliation	failure mechanism
QESTLab sample ID	test duration	height/dia ratio			
SYDS18W00047	136 mm	19.1	2.3 t/m³	Sandstone	Tested in 'as received' moisture condition
BH5 10.49 to 10.64 m	51.8 mm			Bedding planes are at an angle of 80° to the axis of loading	Shear
SYDS18S00233	2.62:1

BH 5
10.49 to 10.64 m
before testing

BH 5
10.49 to 10.64 m
after testing

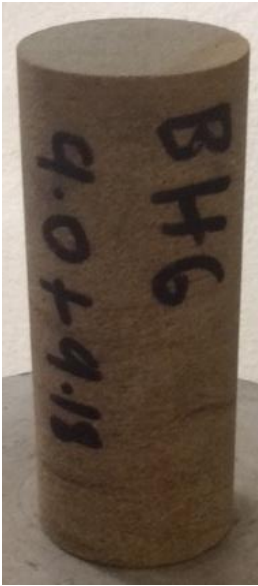
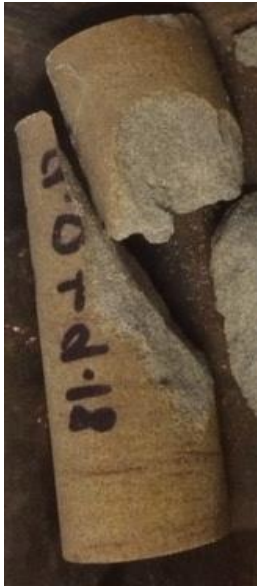
QESTLAB work order ID	depth	date tested	height average diameter	uniaxial compressive strength MPa	wet density moisture content	sample description bedding/foliation	comments failure mechanism
SYDS18W00047			145 mm		2.4 t/m ³	Sandstone	Tested in 'as received' moisture condition
BH6 9.00 to 9.18 m		22 Mar 18	51.9 mm	25.9		Bedding planes are at an angle of 80° to the axis of loading	Shear
SYDS18S00234		9.08 min	2.80:1

BH 6
9.00 to 9.18 m
before testing

BH 6
9.00 to 9.18 m
after testing

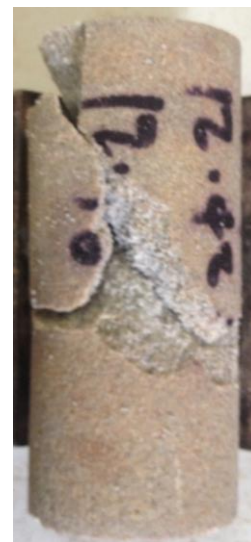
QESTLAB work order ID	depth	date tested	height average diameter	uniaxial compressive strength MPa	wet density moisture content	sample description bedding/foliation	comments
QESTLab sample ID	test duration	height/dia ratio					failure mechanism
SYDS18W00047		148 mm			2.3 t/m³	Sandstone	Tested in 'as received' moisture condition
BH7 12.42 to 12.55 m	22 Mar 18	51.8 mm	34.1			Bedding planes are at an angle of 85° to the axis of loading	Shear
SYDS18S00235	4.65 min	2.86:1

BH 7
12.42 to 12.55 m
before testing

BH 7
12.42 to 12.55 m
after testing
