Report on
Geotechnical Investigation

PNRL Centre of Excellence and Community Facility
corner Kennedy Avenue and Stone Mason Drive,
Kellyville

Prepared for
Paramatta National Rugby League Club Pty Ltd

Project 207155.00
March 2022

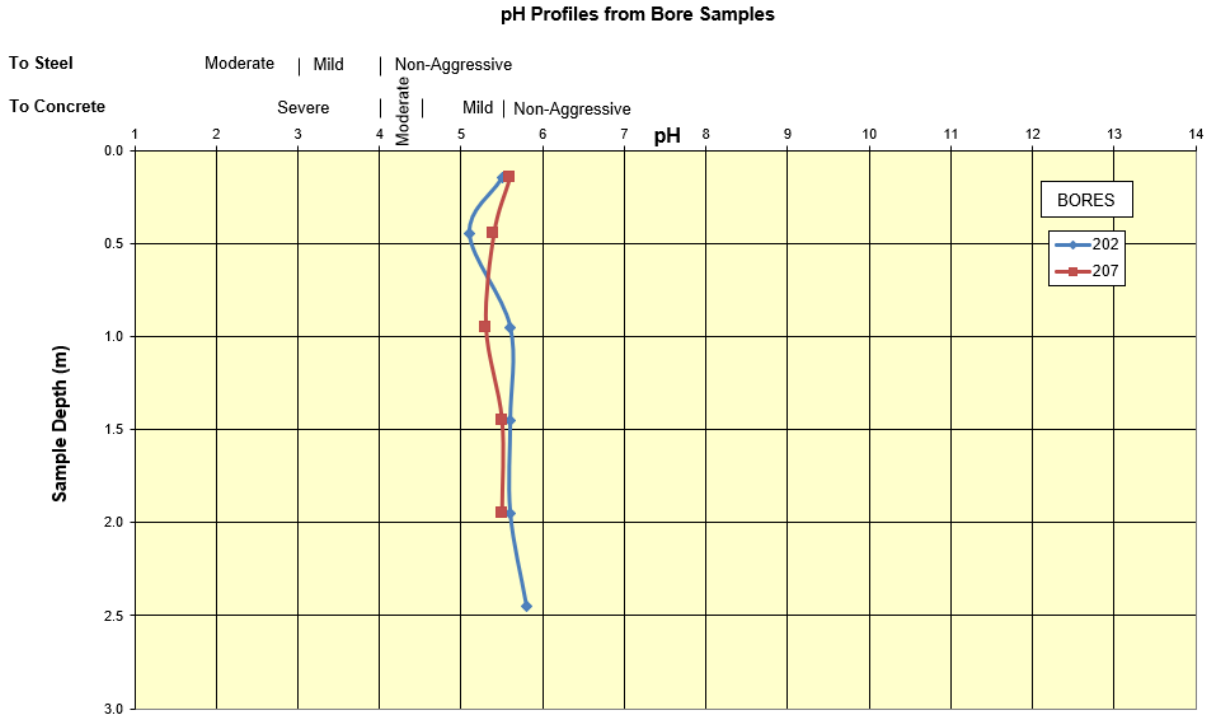
Figure 2: Vertical pH Profiles

The results show that the samples tested indicate the ground conditions are non-aggressive to mildly aggressive to concrete and non-aggressive to steel with reference to AS2159. The pH profiles with depth are shown in Figure 2 (following page).

Test results showing the aggressivity assessed by pH, sulphate concentrations and chloride concentration criteria (of AS 2159) at the borehole locations, together with the aggressivity class ranges indicated in Australian Standard AS 2159 are given in Appendix D. The inferred very low permeability of the sampled clay-rich soils indicates that soils at all boreholes are in Condition “B” as defined by AS 2159.

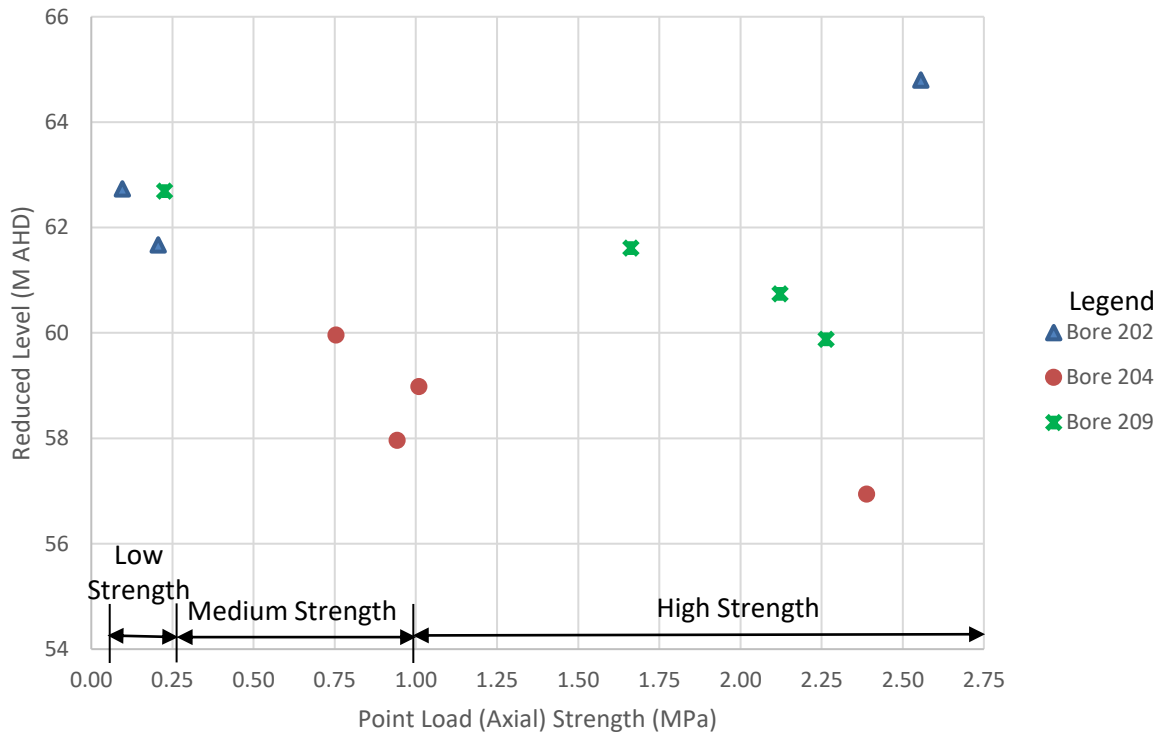
Figure 4: Results of Axial Point Load Tests

Point Load Strength Index (Is_{50}) testing was carried out on selected rock core specimens. The results of the tests are shown on the borehole logs at the appropriate depths. Figure 4 (following page) shows the range of Is_{50} results at the various depths (shown as Reduced Levels relative to AHD).

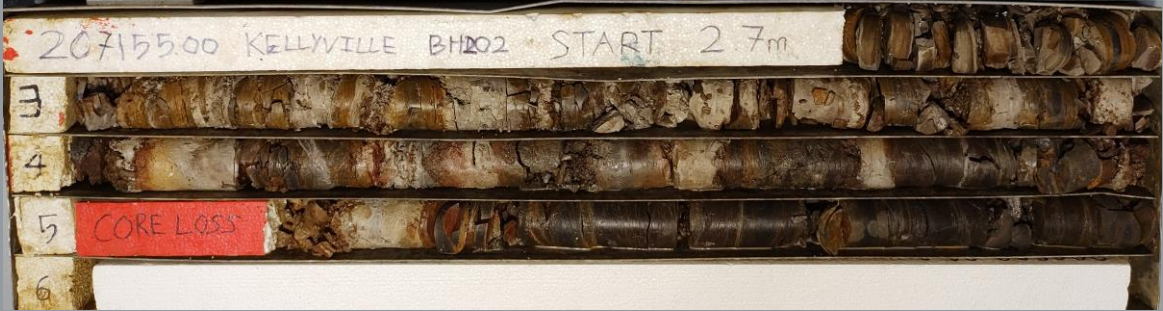
Project No: 207155.00
BH ID: 202
Depth: 2.7-6m
Core Box No.: 1/1

2.7 m - 6.0m

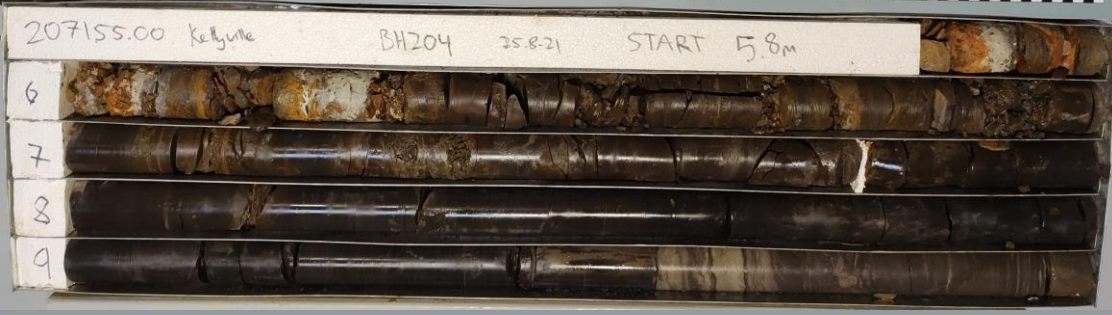
Project No: 207155.00
BH ID: 204
Depth: 5.8-10m
Core Box No.: 1/1

5.8m – 10.0m

- Medium and High Strength Siltstone
 - High strength, fresh stained to fresh, slightly fractured, dark grey, siltstone at depths of 3.6 m to 8.0 m in Bores 204 and 209.

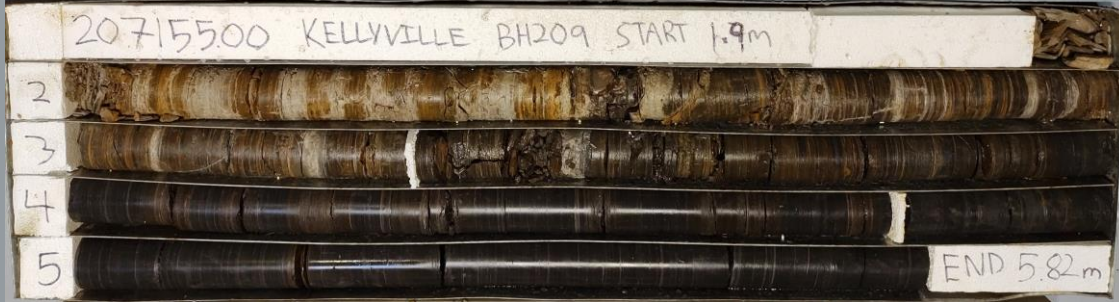
Project No: 207155.00
BH ID: 209
Depth: 1.9-5.82m
Core Box No.: 1/1

1.9m - 5.82m
