The Forest High School Relocation

Geotechnical Investigation Report

Reference: 754-SYDGE284698-AB

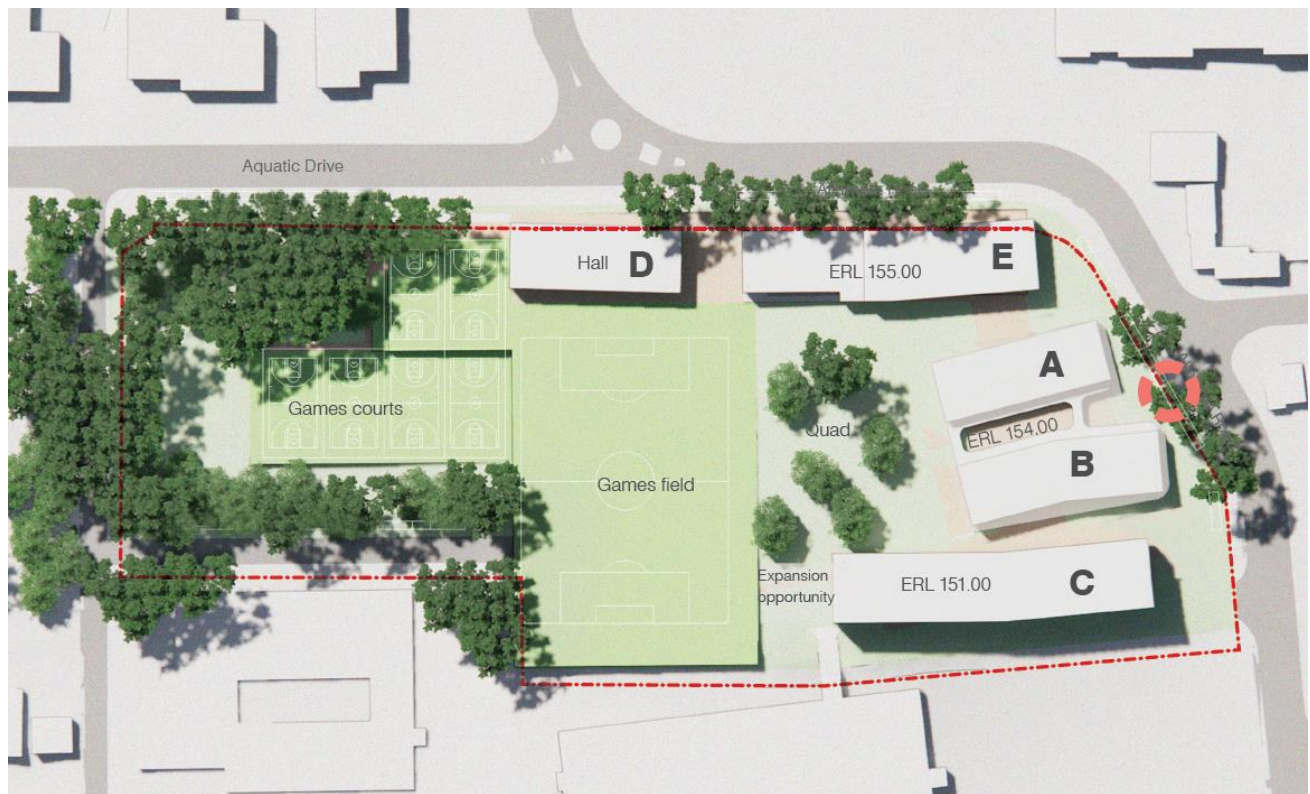
Figure 1: Proposed development layout from the Concept Design Report

Figure 1 below provides a general layout of the proposed development, which was sourced from the Concept Design Report.

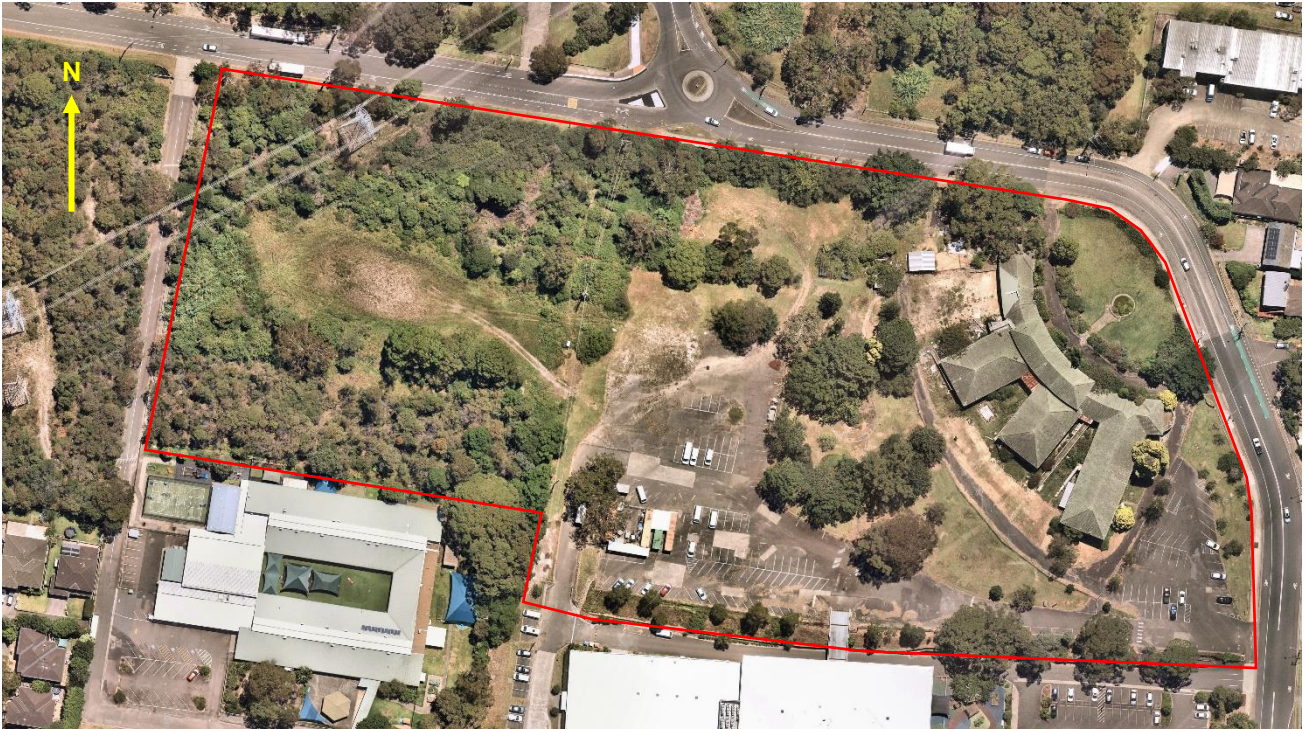
Figure 2: The Forest High School relocation site

The site is bounded by Allambie Road to the east, Allambie Road and Aquatic Drive to the north, The Cerebral Palsy Alliance (CPA) building to the south and the Arranounbai School with accompanying access road to the west and south-west. Figure 2 below illustrates the site boundaries and current surface conditions.

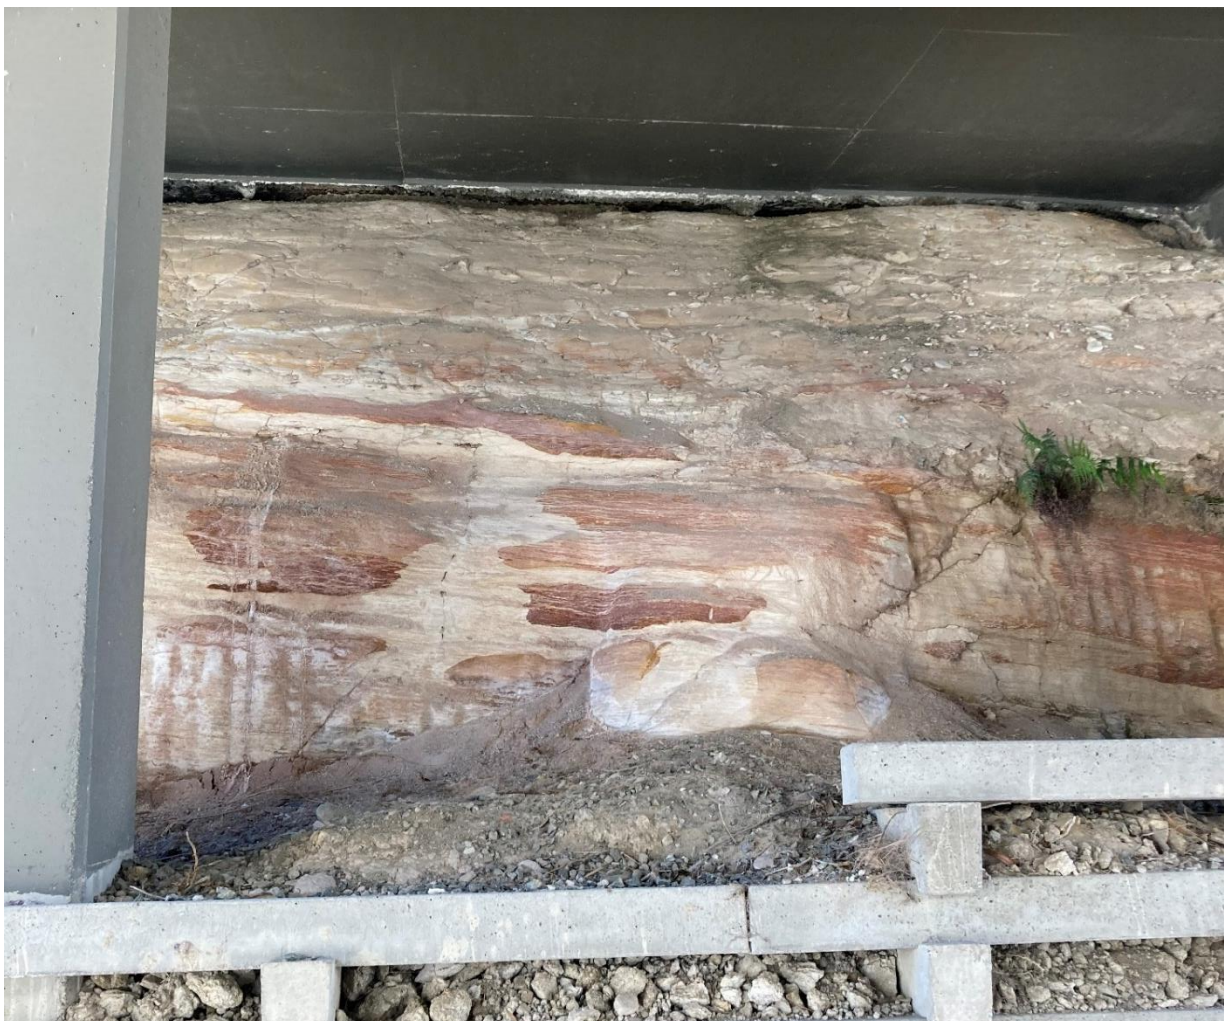
- Beneath the walkway connecting the carpark to the CPA building is a rock cutting (see Figure 3). The profile of this cutting generally comprised approximately 1.0-1.5m of extremely weathered siltstone/laminite, overlying high weathered siltstone/laminite.

Figure 3: Exposed rock cutting below walkway

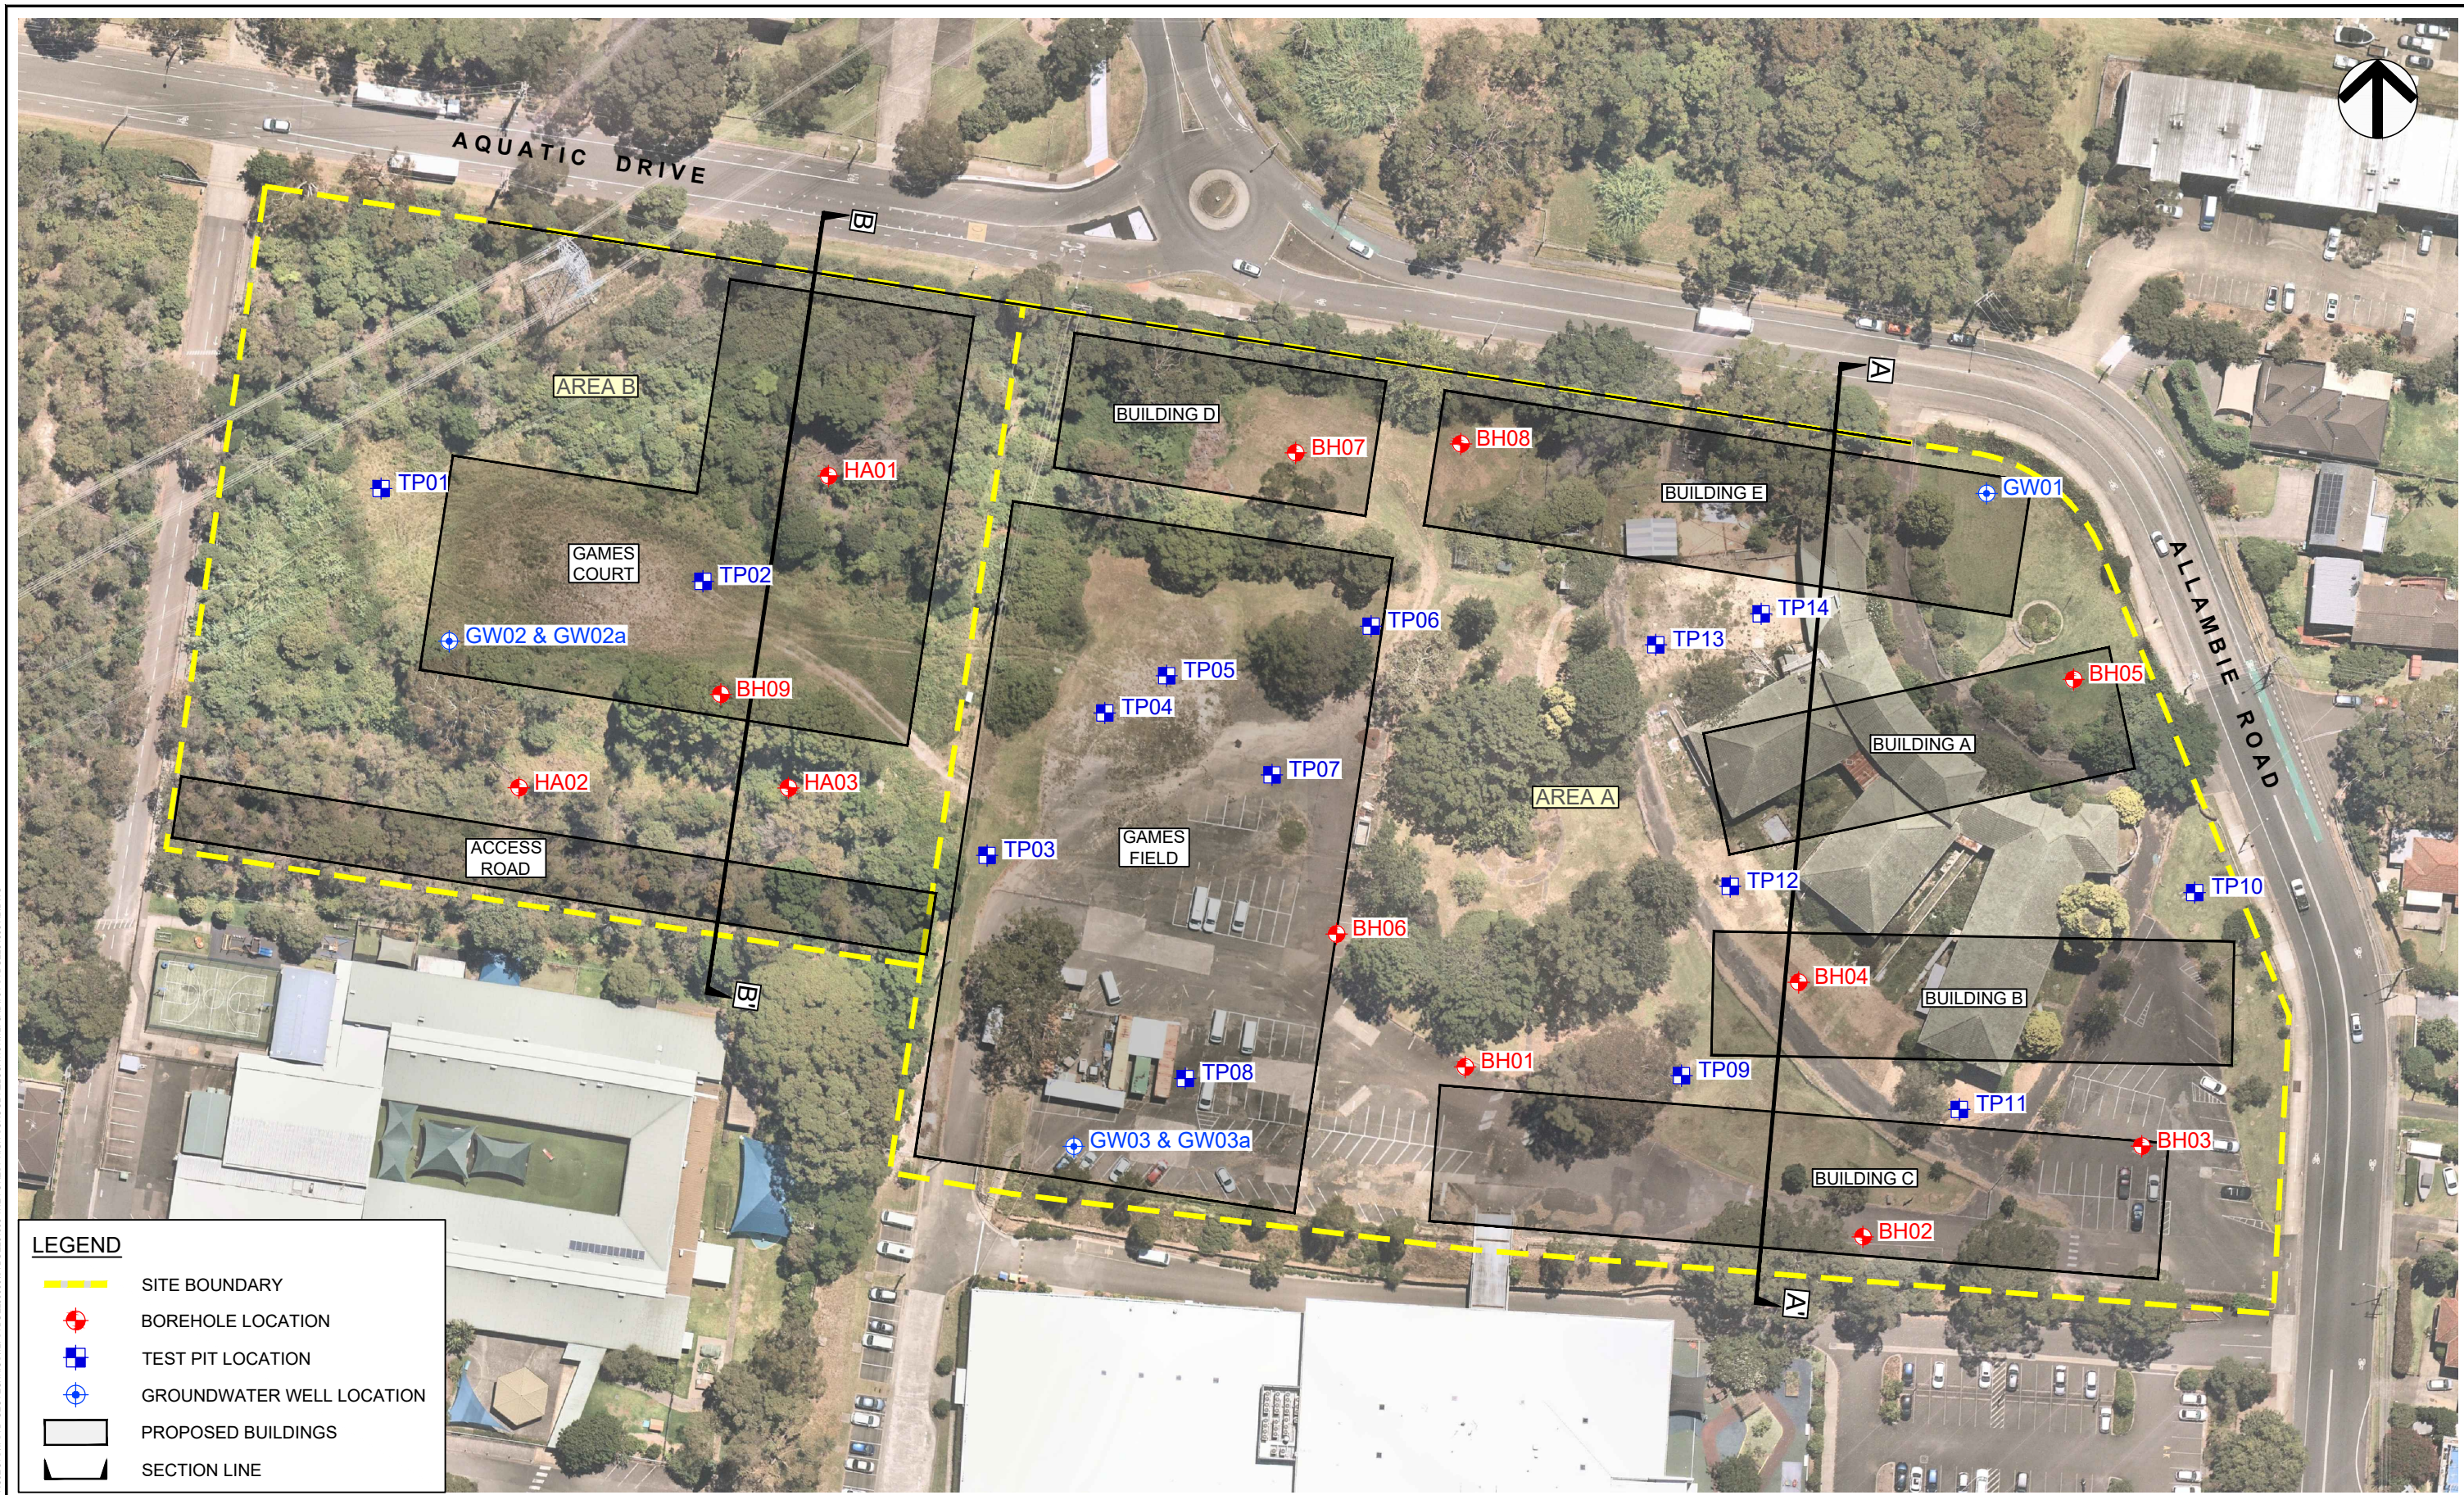
client:	SCHOOLS INFRASTRUCTURE NSW - DEPARTMENT OF EDUCATION		
project:	THE FOREST HIGH SCHOOL 189 ALLAMBIE ROAD, ALLAMBIE HEIGHTS NSW		
title:	SITE INVESTIGATION LOCATIONS		
project no:	754-SYDGE284698-AB	figure no:	FIGURE B1
			rev: A

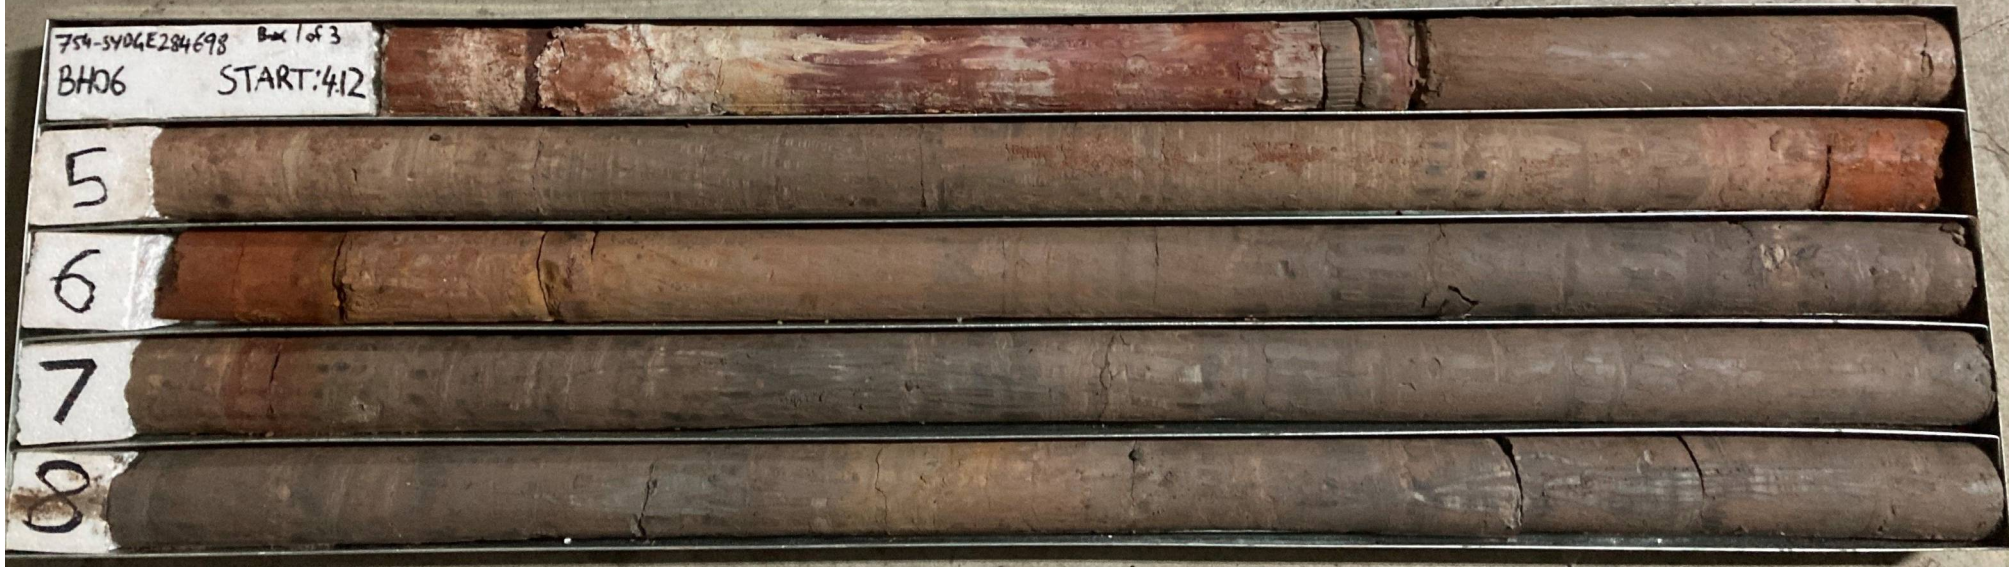
BH06 4.12 - 9.00 m

drawn	AC		client: Schools Infrastructure NSW - Department of Education		
approved	AC		project: The Forest High School 189 Allambie Road, Allambie Heights, NSW		
date	12/05/2021		title: CORE PHOTOGRAPH BH06		
scale	N.T.S.		project no: 754-SYDGE284698	fig no: FIGURE 1	rev:
original size	A4

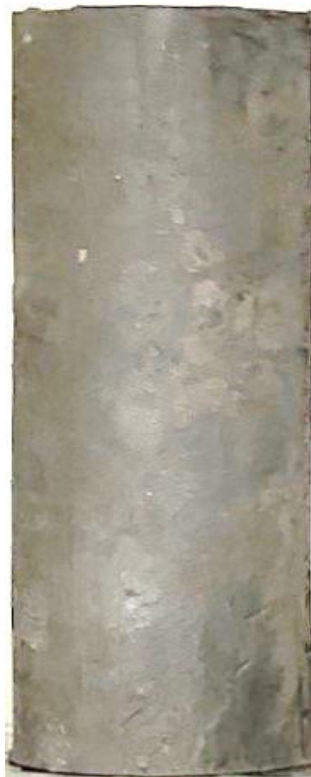
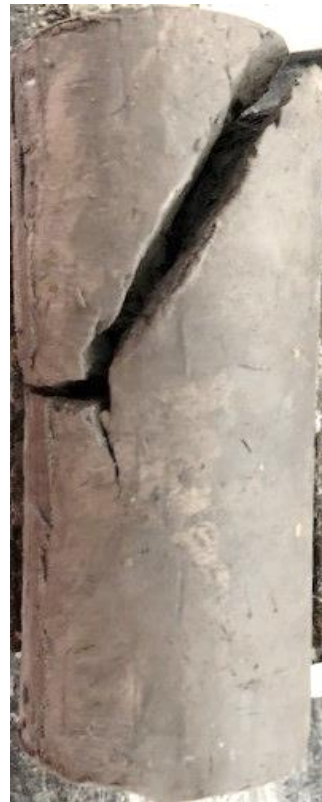
10.75 to 10.90 m

QESTLab work order ID	depth	date tested	height average diameter	uniaxial compressive strength MPa	wet density moisture content	sample description bedding/foliation	Client's Sample ID failure mechanism
QESTLab sample ID	test duration	height/dia ratio					
<i>SYDS21W00073</i>			<i>145 mm</i>	0.501	<i>2.2 t/m³</i>	<i>Laminite</i>	
<i>10.75 to 10.90 m</i>	<i>7 May 21</i>	<i>53.1 mm</i>	<i>15.8 %</i>		<i>Massive.</i>		
<i>SYDS21S00729</i>	<i>6.40 min</i>	<i>2.73:1</i>				<i>Shear</i>

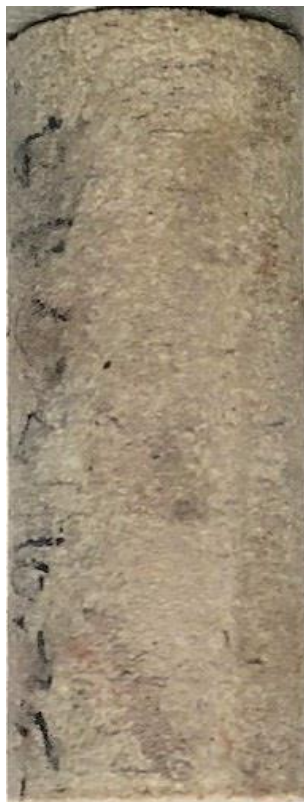
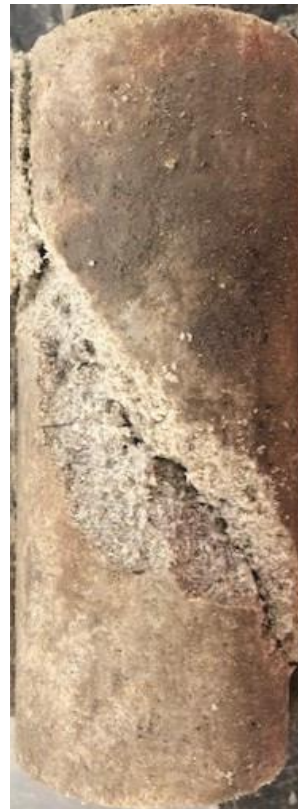
8.34 to 8.55 m

QESTLab work order ID	depth	date tested	height average diameter	uniaxial compressive strength MPa	wet density moisture content	sample description bedding/foliation	Client's Sample ID failure mechanism
<i>SYDS21W00073</i>	<i>8.34 to 8.55 m</i>	<i>7 May 21</i>	<i>145 mm 51.8 mm</i>	12.0	2.3 t/m³ 9.8 %	<i>Sandstone</i> <i>Bedding planes are at an angle of 90° to the axis of loading</i>	<i>Shear</i>
<i>SYDS21S00730</i>	<i>10.14 min</i>		<i>2.79:1</i>

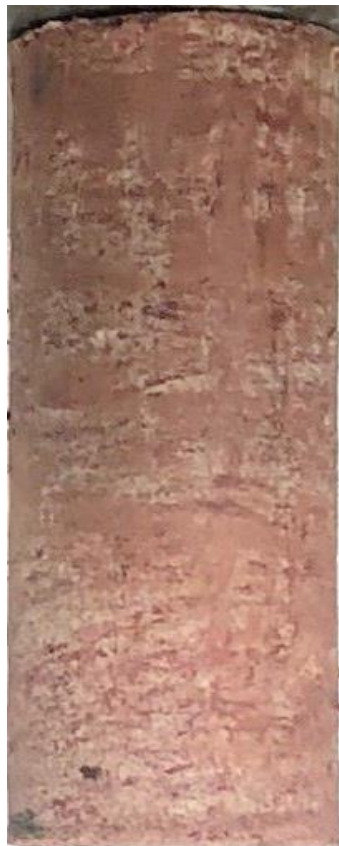
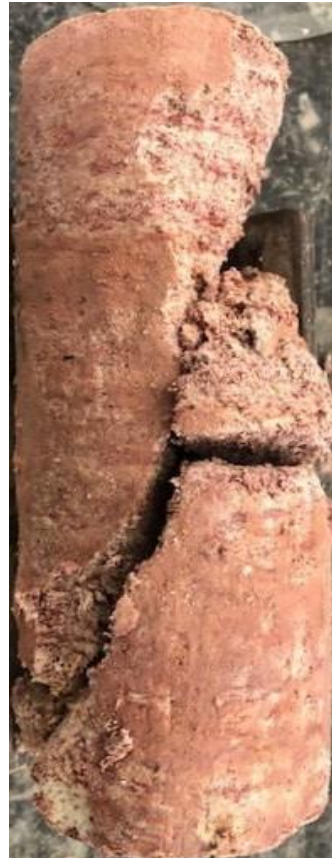
5.10 to 5.35 m

QESTLab work order ID	depth	date tested	height average diameter	uniaxial compressive strength MPa	wet density moisture content	sample description bedding/foliation	Client's Sample ID failure mechanism
<i>SYDS21W00075</i>	<i>5.10 to 5.35 m</i>	<i>11 May 21</i>	<i>143 mm 52.0 mm</i>	0.392	2.2 t/m³ 13.9 %	<i>Sandstone</i> <i>Bedding planes are at an angle of 85° to the axis of loading</i>	
<i>SYDS21S00732</i>	<i>7.10 min</i>	<i>7.10 min</i>	<i>2.75:1</i>				<i>Shear</i>
