## JUNCTION RIVERS WIND PROJECT

Land Use Conflict Risk Assessment

## **JUNCTION RIVERS WIND PROJECT**

Project Director: Paul Douglass  
Project Manager: Lachlan Sweeney  
Report No. 22601/R04  
Date: May 2024

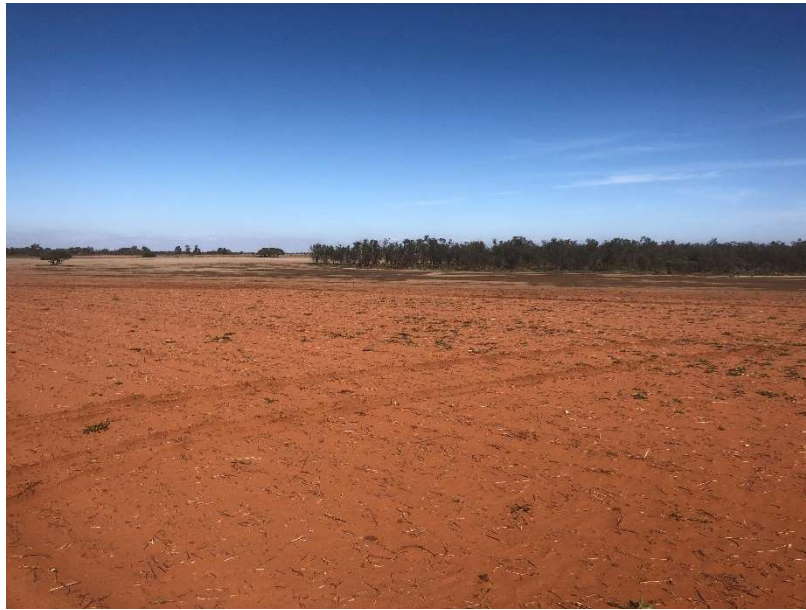
**Figure 2 – General Site Conditions at TP08, Northern End of site**

Figures 2 and 3 provides typical conditions encountered on site, with further site photographs provided in Appendix B.

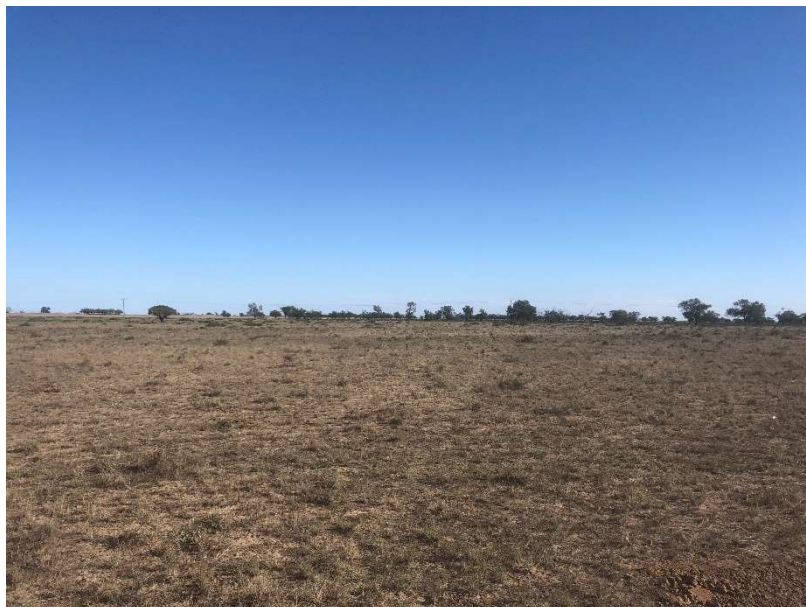
**Figure 3 – General Site Conditions at TP12, Southern End of site**

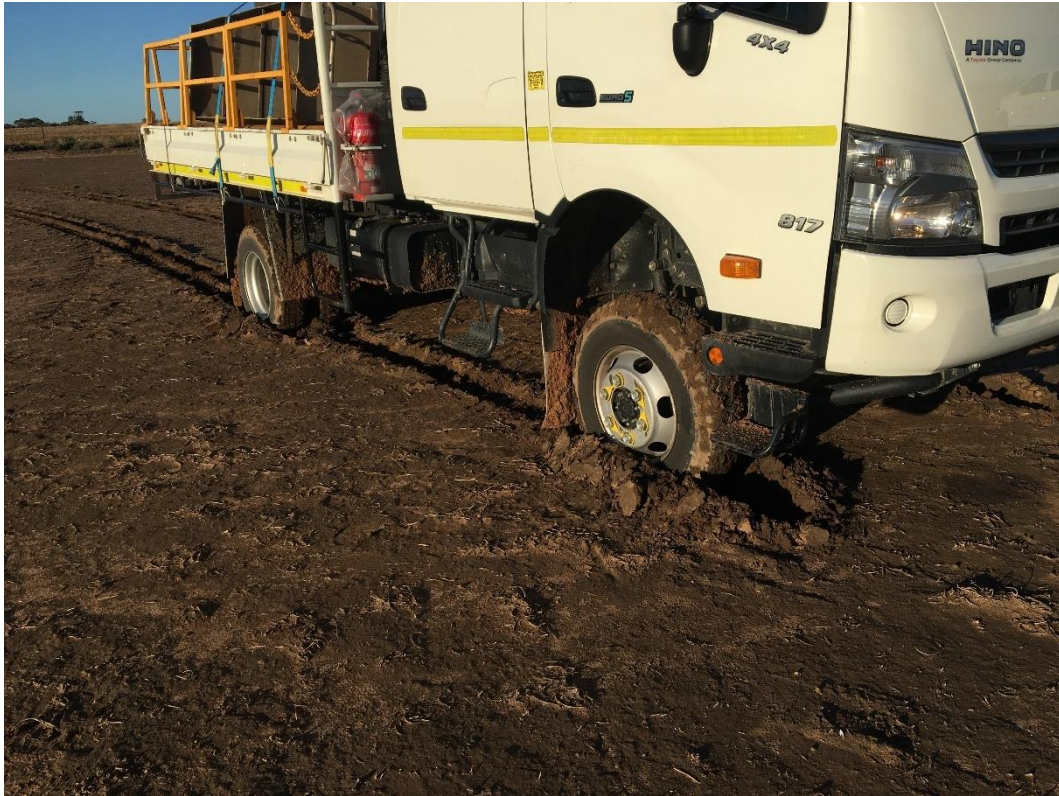
**Photo 23:** Boggy conditions encountered at BH03.
