Green Valley Islamic College Limited
C/- Midson Group Pty Ltd

Geotechnical Assessment: Minarah College – 268 & 278 Catherine Fields Road, Catherine Field, NSW

P2108320JR04V01
March 2022

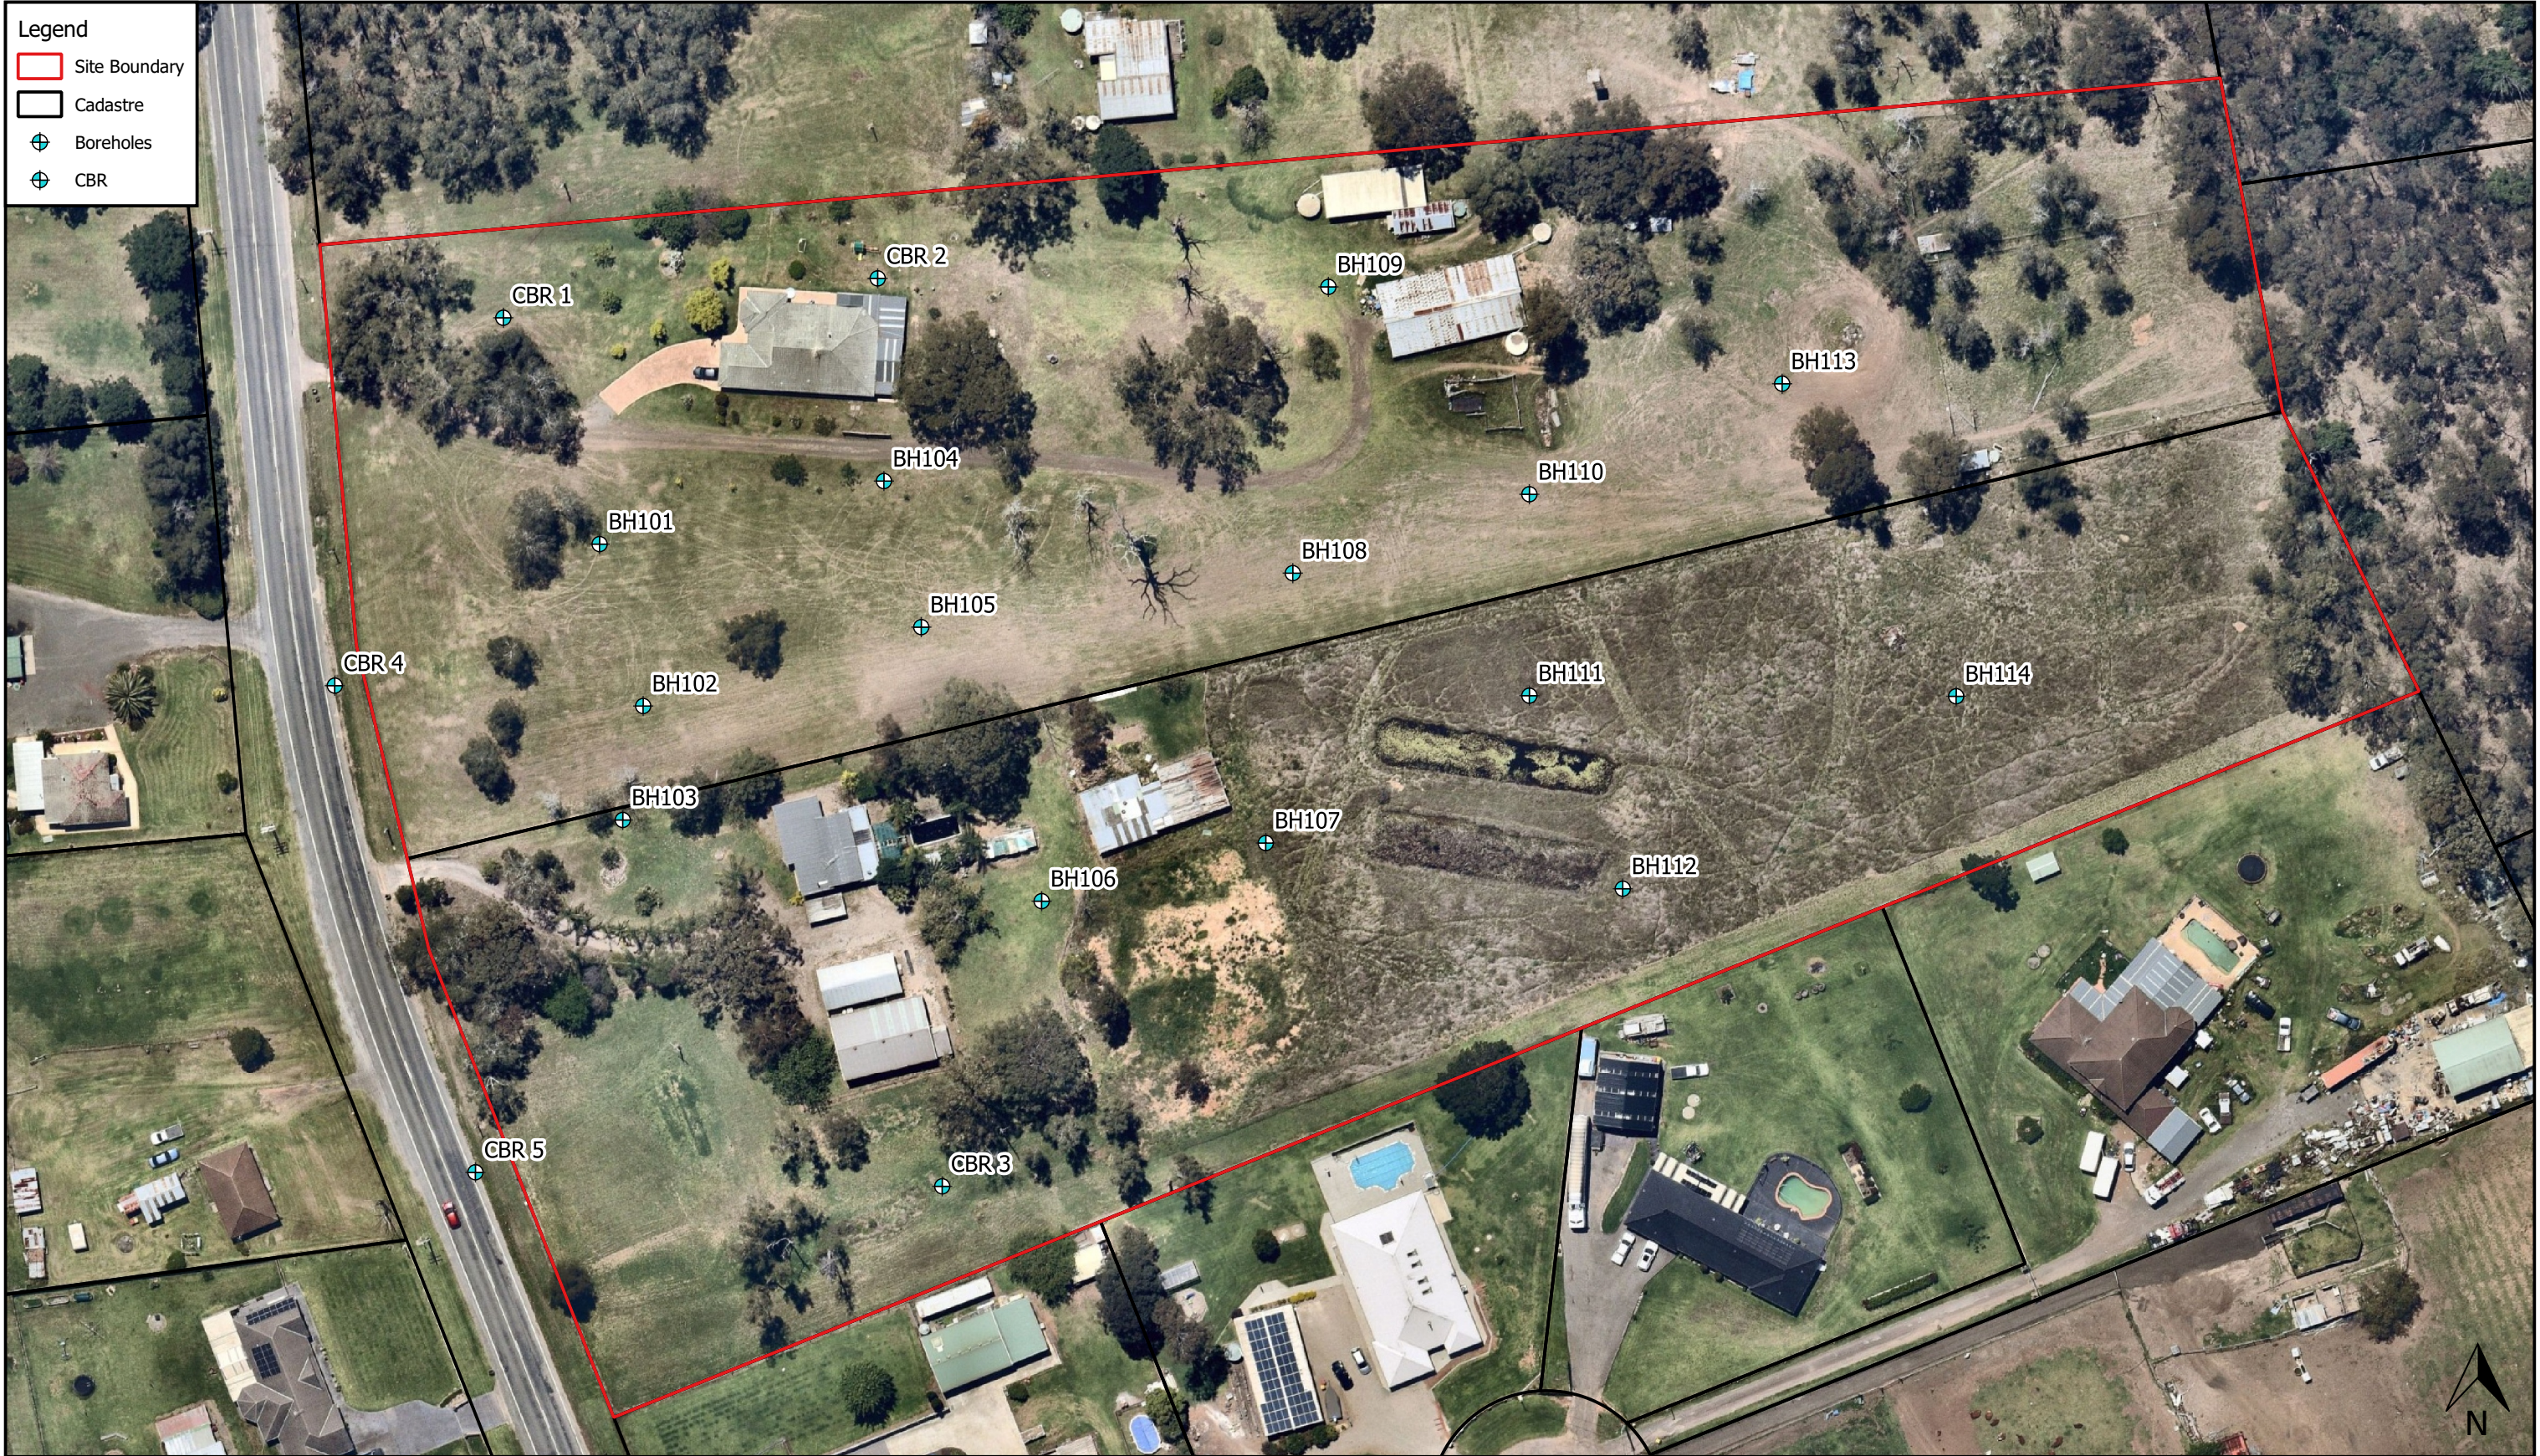
8 **Attachment A – Geotechnical Testing Plan**

- Site Boundary
- Cadastre
- Boreholes
- CBR

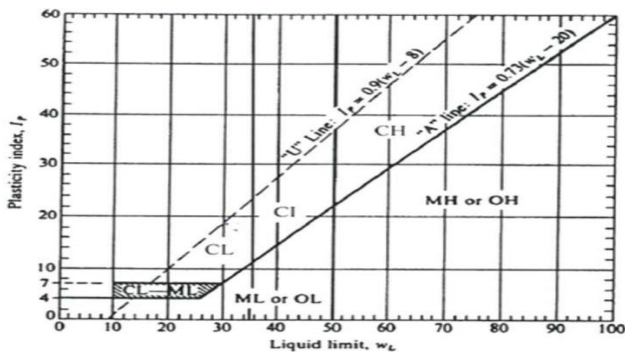
Plasticity Properties

Plasticity properties of cohesive soils can be assessed in the field by tactile properties or by laboratory procedures.
