Dam Dewatering Assessment
Minarah College,
268 & 278 Catherine Fields Road,
Catherine Fields, NSW

P2108320JR03V01
April 2022

Dam Dewatering Assessment Plan

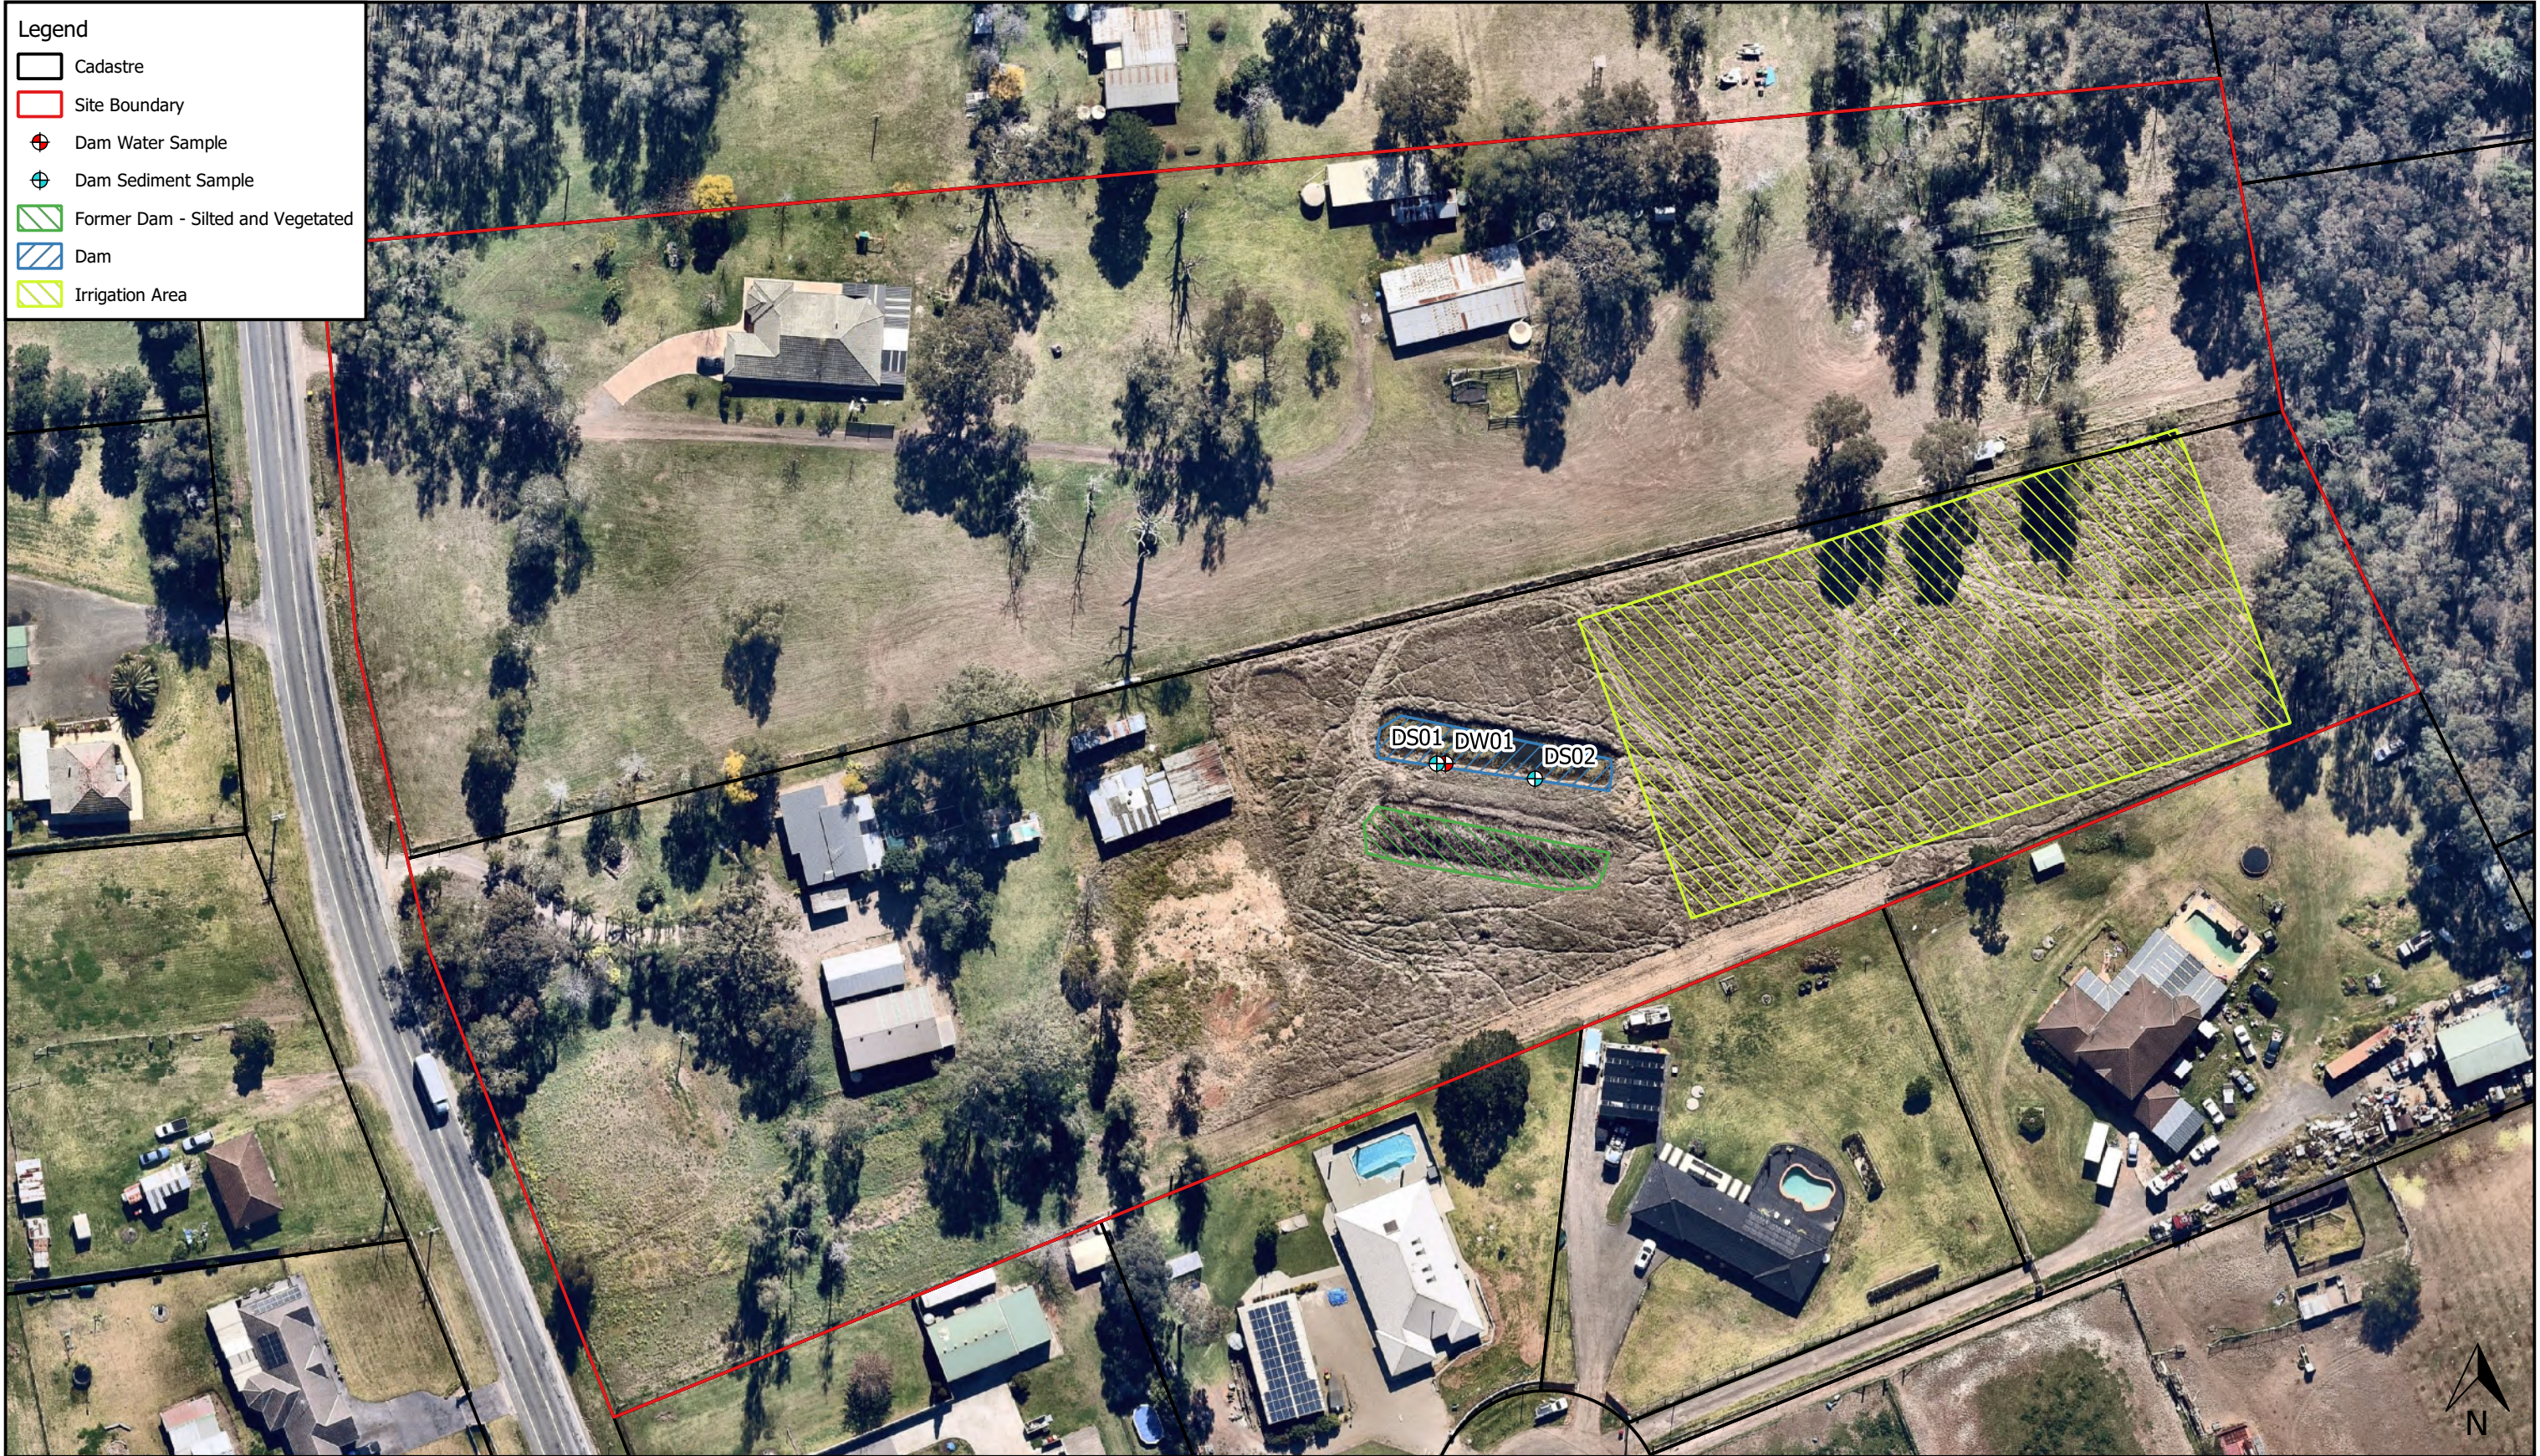
- Cadastre
- Site Boundary
- Dam Water Sample
- Dam Sediment Sample
- Former Dam - Silted and Vegetated
- Dam
- Irrigation Area

Sediment samples were collected using a hand spade whilst wading in the dam. Sampling locations are provided in Attachment A.

It is recommended that dewatering be undertaken via surface irrigation over the grassed area, to allow for absorption and evaporation of dam waters at the site. A nominal irrigation area of 5,000 m² is shown on the plan in Attachment A.

It is proposed that a single irrigation area (5,000 m²) to the east of the dam (as outlined in Attachment A) be used for dam water disposal. In order to appropriately irrigate the soil without creating run off or site pooling of water, it is to be irrigated at specified rates (Section 4.1.4).
