# Remedial Action Plan, Minarah College: 268 - 278 Catherine Fields Road, Catherine Field, NSW

P2108320JR07V01  
April 2022

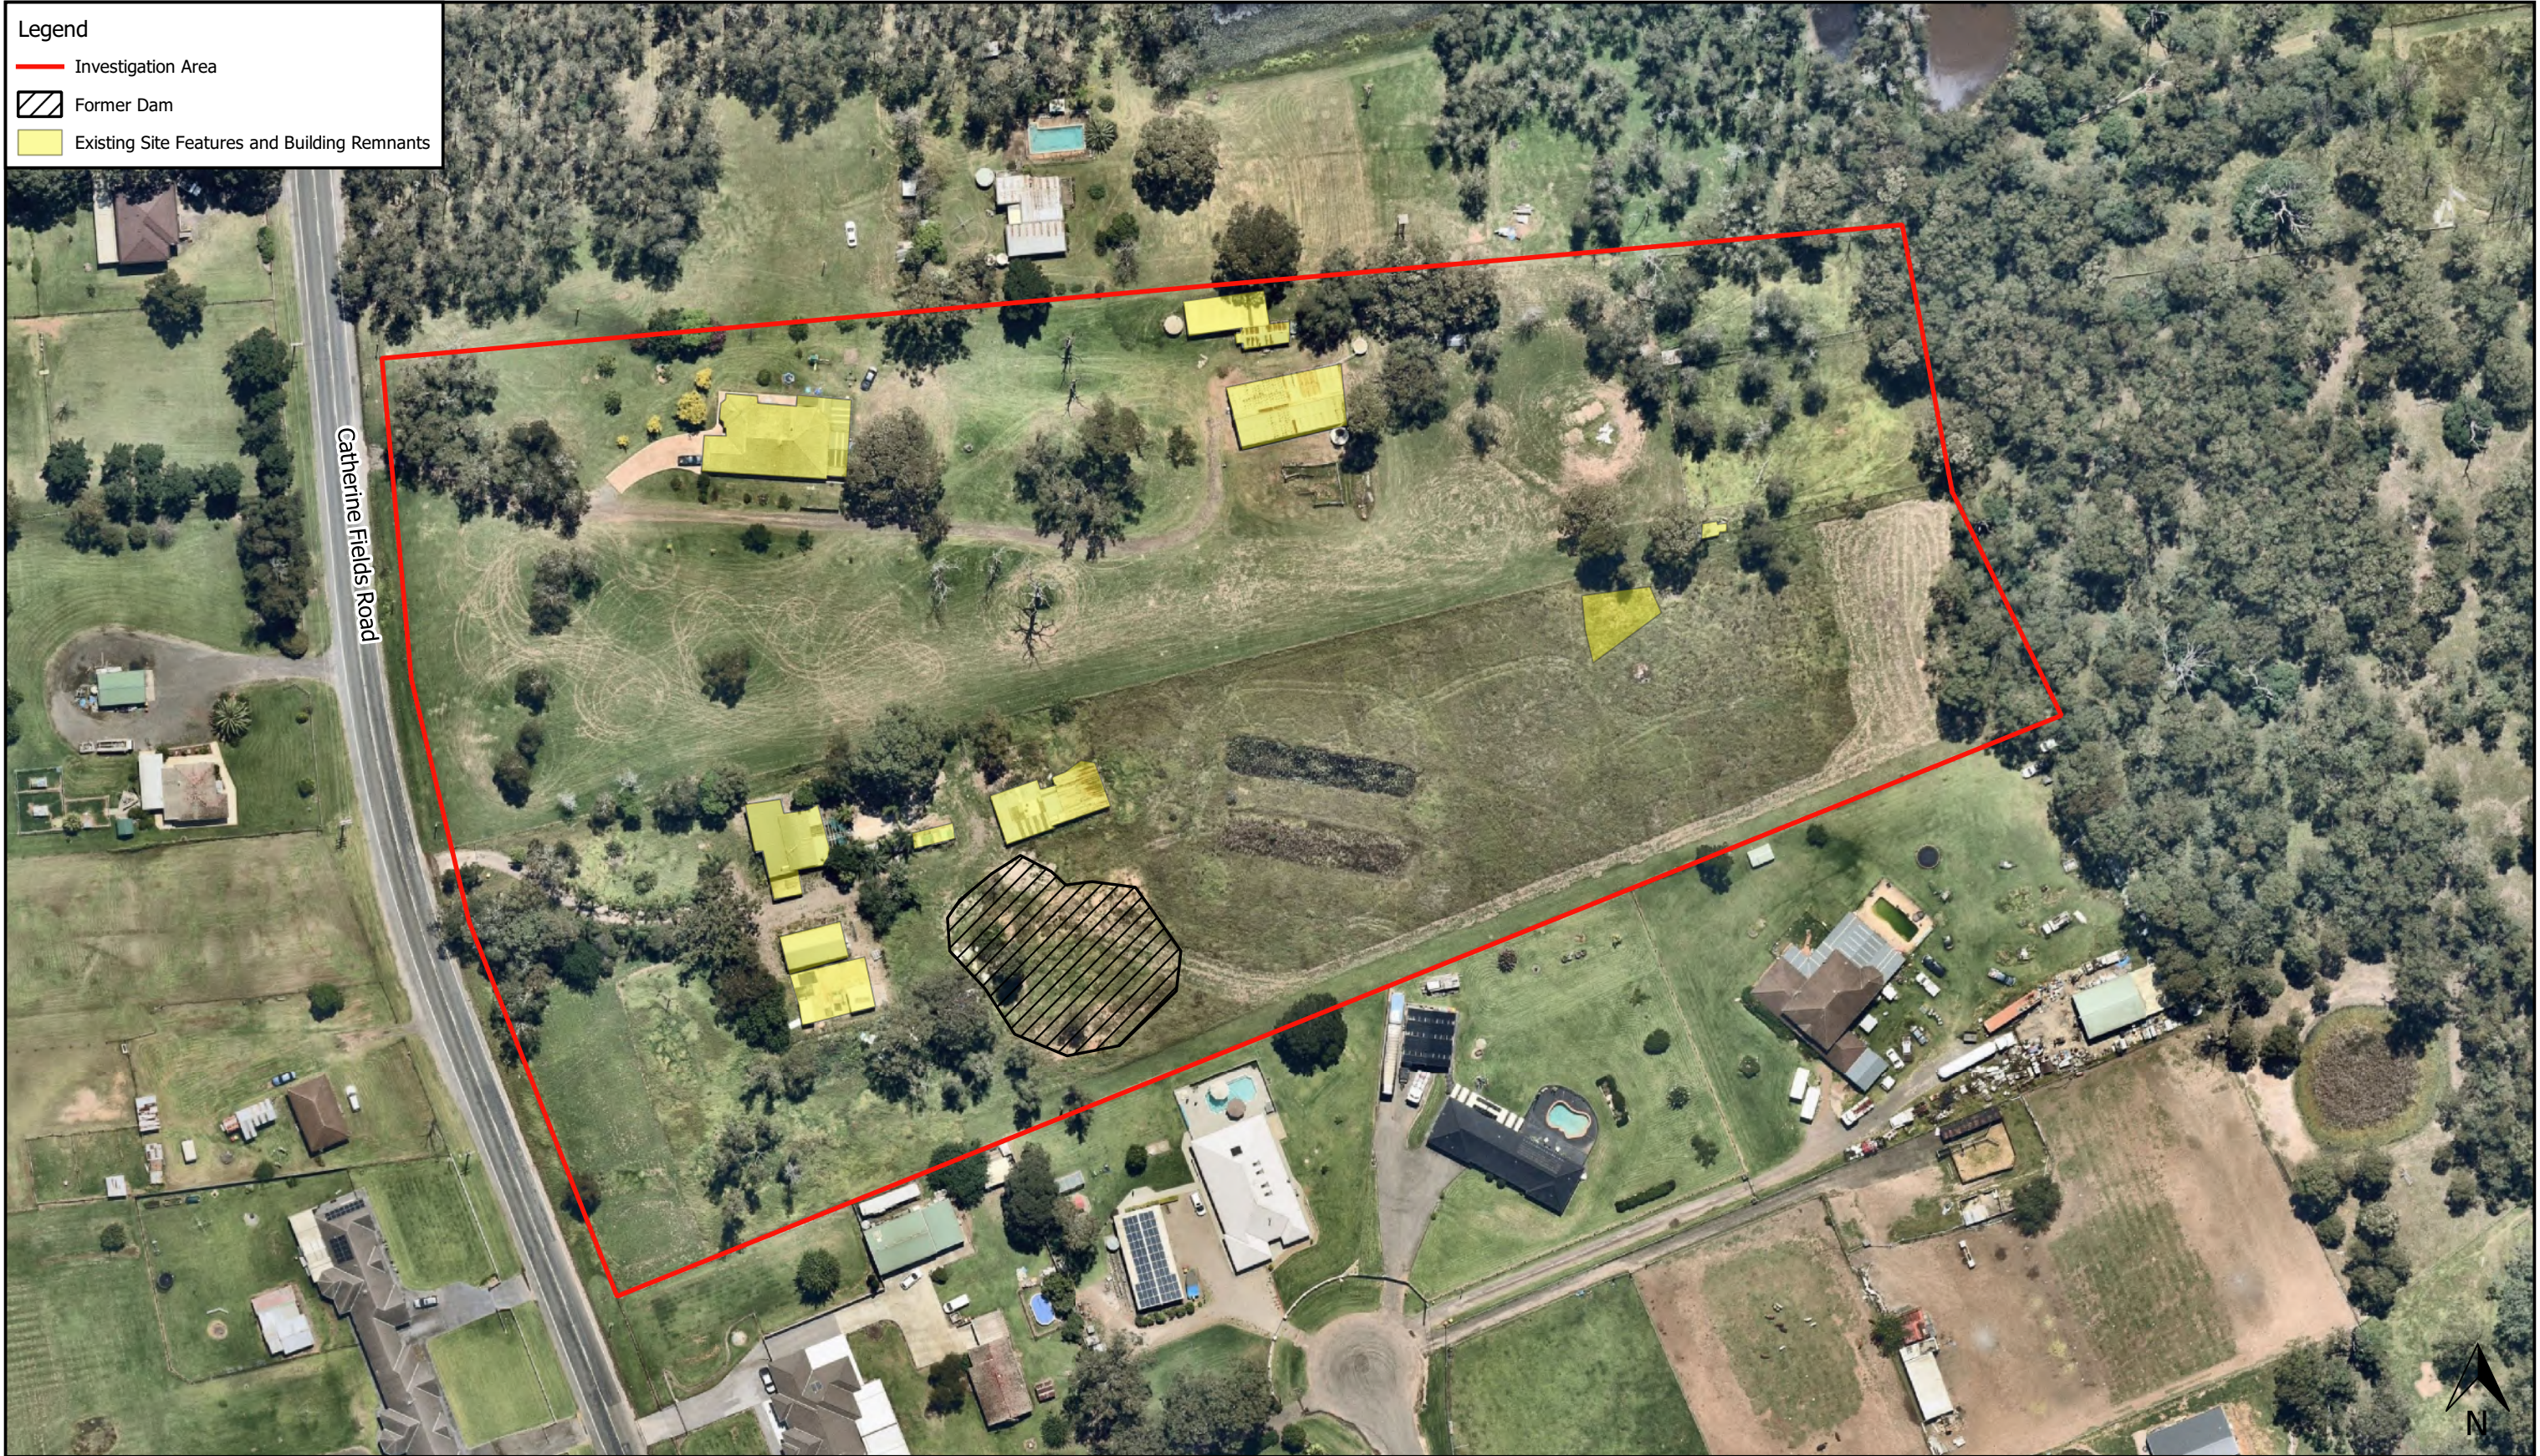
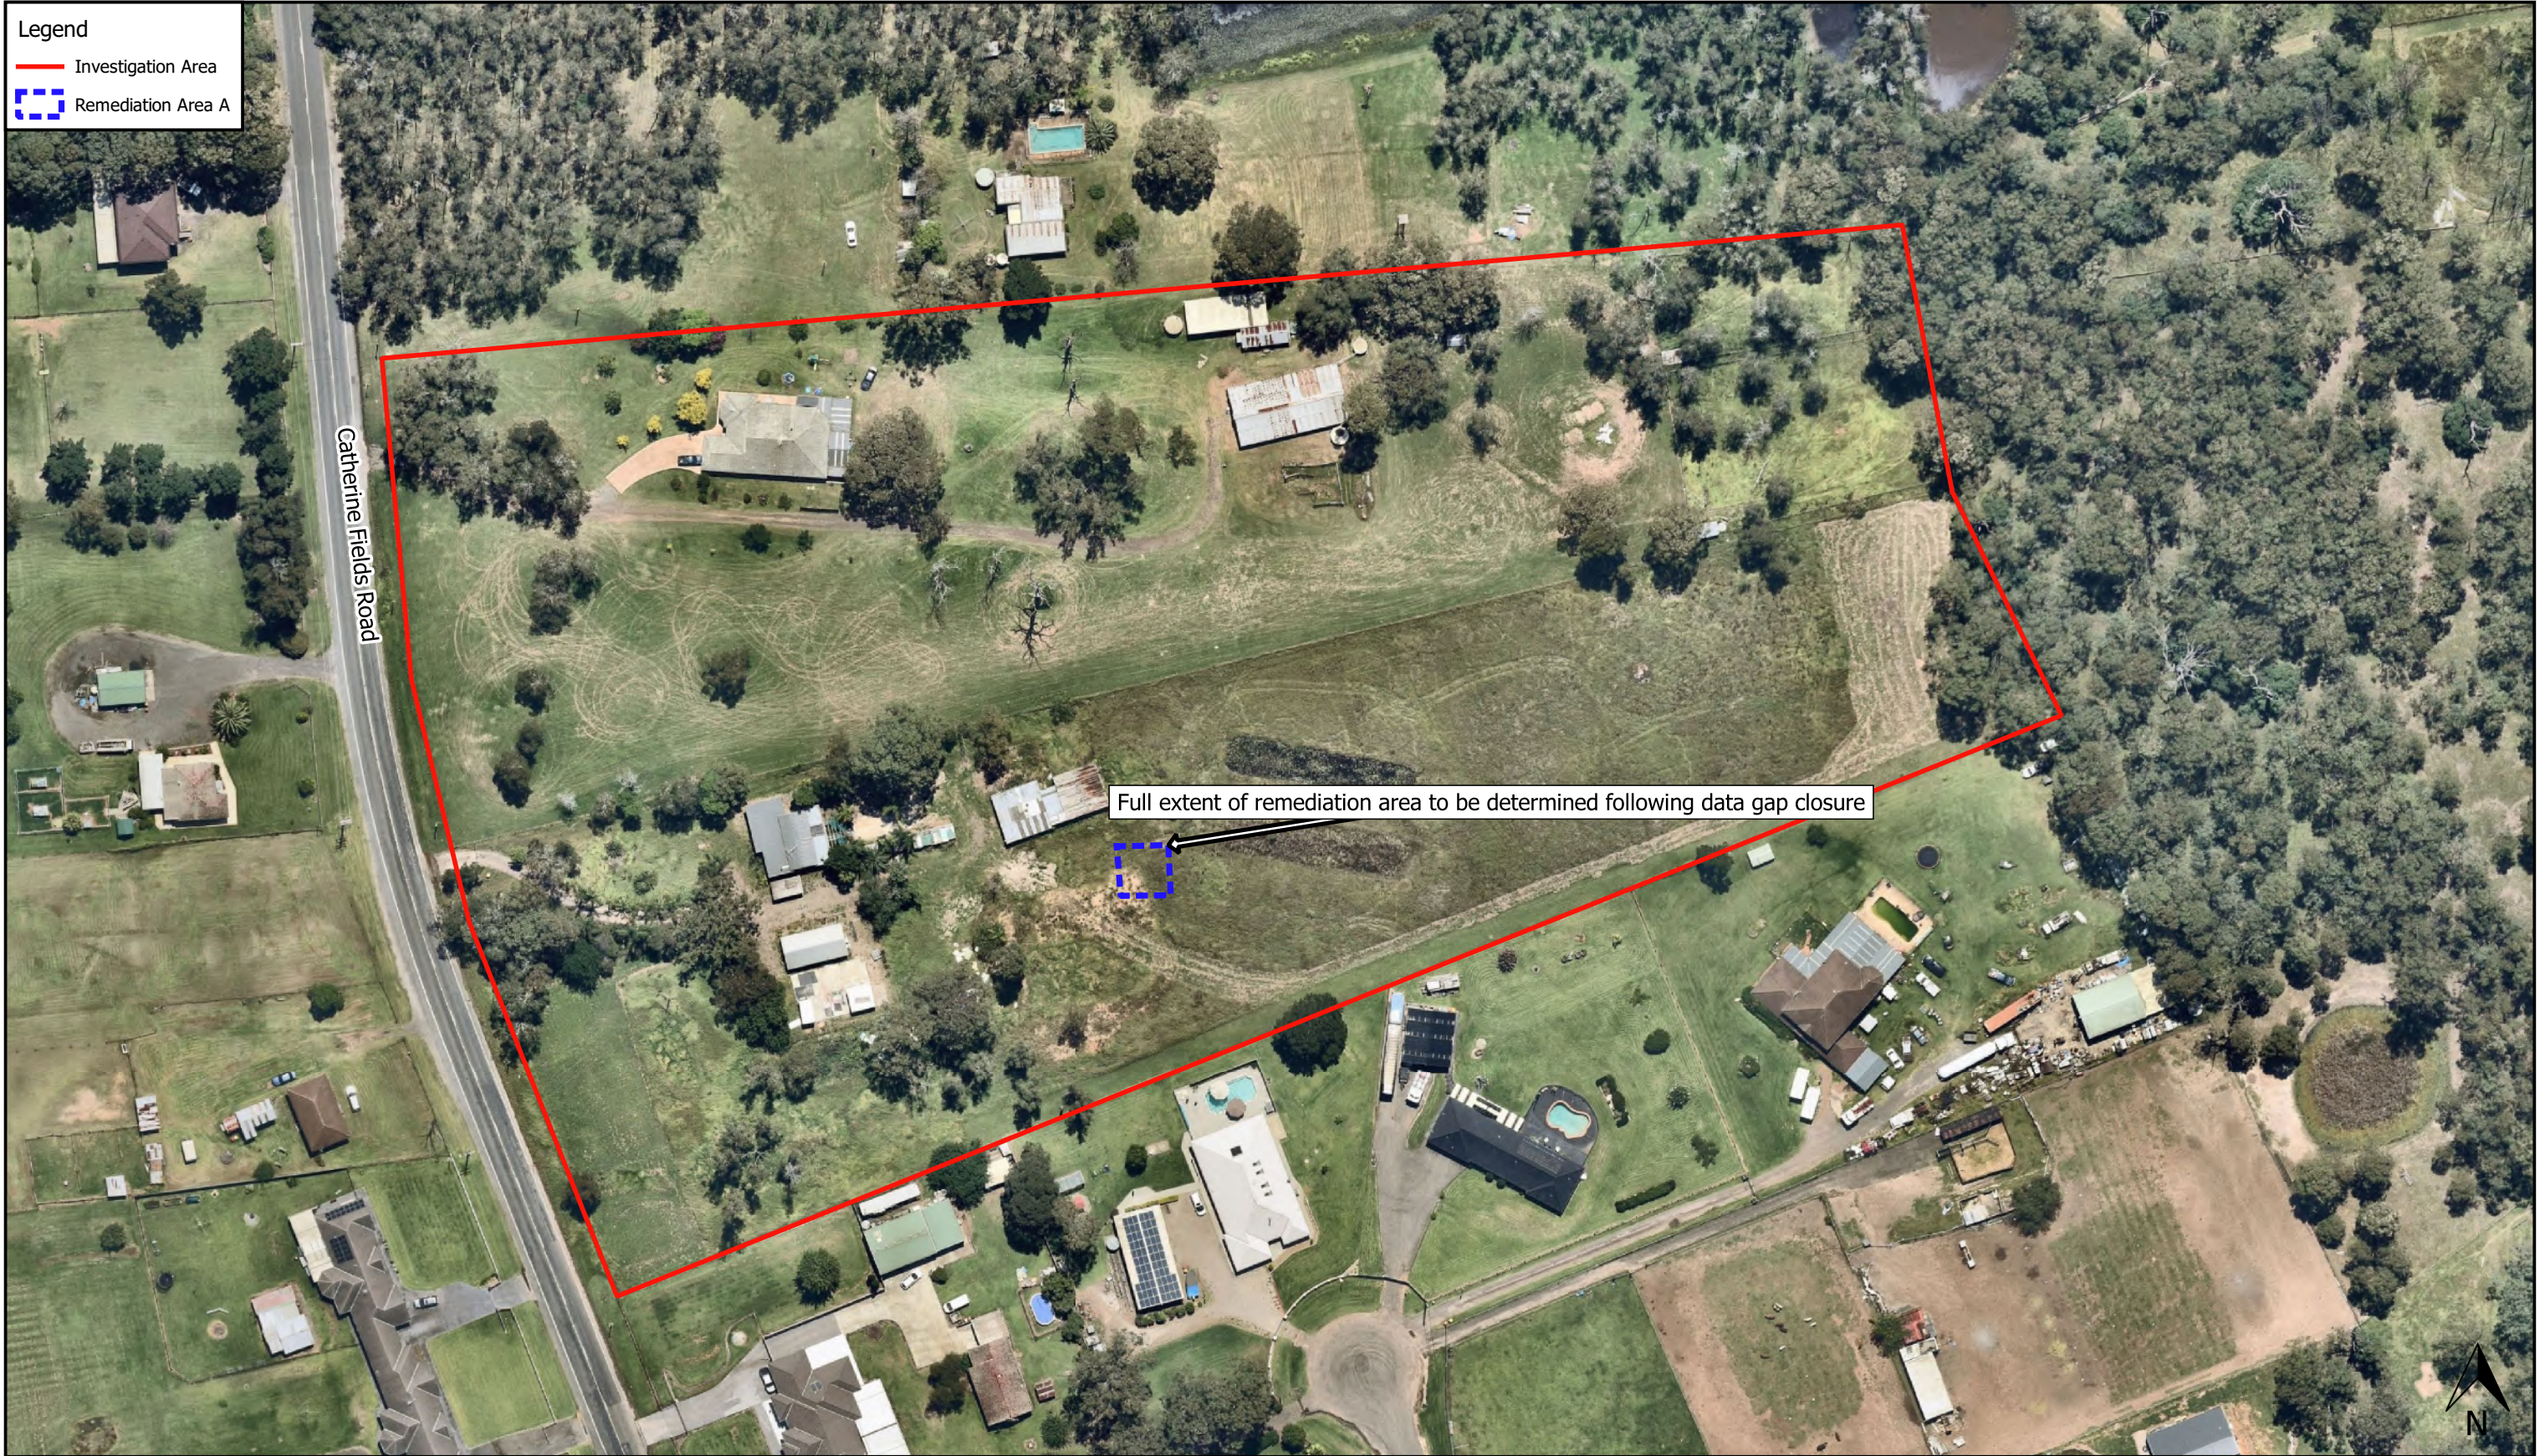
## Data Gap Closure Areas

- Investigation Area
- Former Dam
- Existing Site Features and Building Remnants

1. Excavation of an additional 6 test pits within the former dam footprint. Test pits are to extend a minimum of 0.5 m into natural material.
2. Each test pit is to be visually inspected by a suitability qualified environmental consultant for the potential presence of hazardous materials such as potential asbestos containing material (ACM).
