TO: Charter Hall Holdings Pty Ltd c/o Tactical Group Pty Ltd
FROM: Gareth Evans (Senior Principal Geotechnical Engineer)
SUBJECT: **Compass 2 Warehouse & Distribution Centre – Geotechnical Assessment compliance with Condition 12 of SEARs**
OUR REF: PS127384-GE-SYD-GEO-MEM-6331 Rev2
DATE: **8 February 2022**

EASTERN CREEK GEOTECHNICAL INVESTIGATION GEOTECHNICAL INTERPRETIVE REPORT

Eastern Creek Geotechnical Investigation Geotechnical Interpretive Report

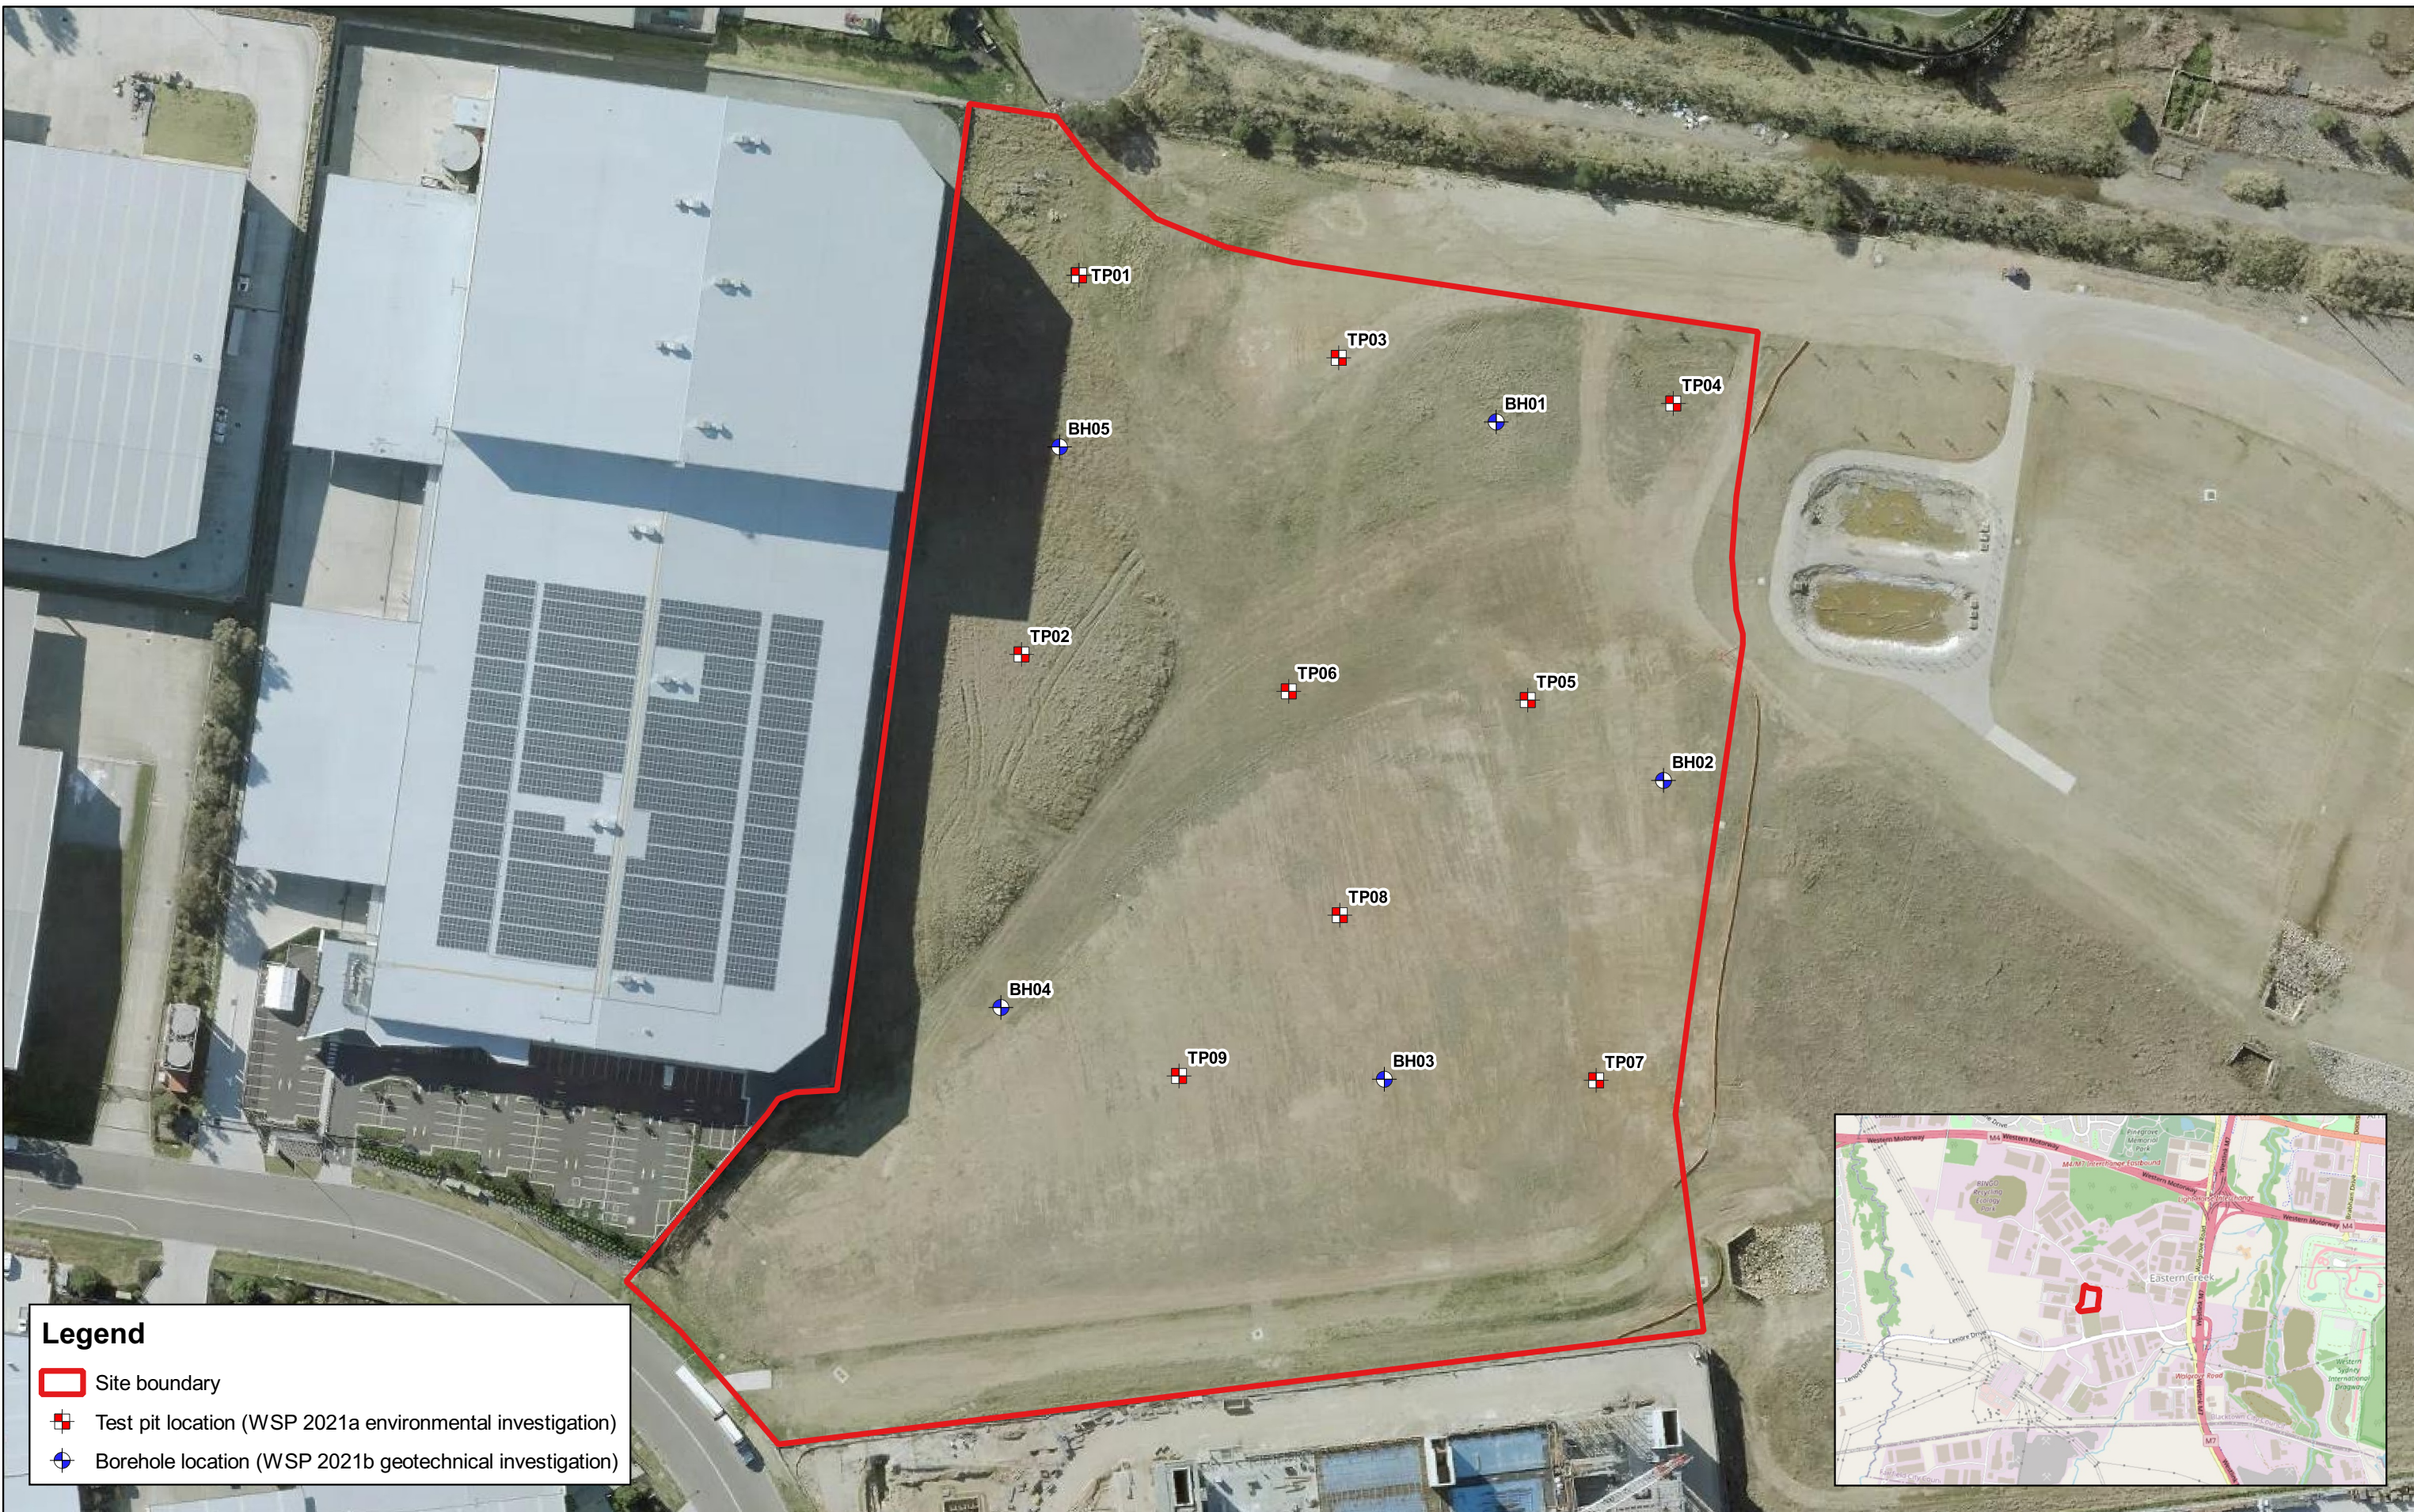
Figure 1.
Investigation Locations
Lot 1 Eastern Creek Drive, Eastern Creek NSW

- Site boundary
- Test pit location (WSP 2021a environmental investigation)
- ◆ Borehole location (WSP 2021b geotechnical investigation)

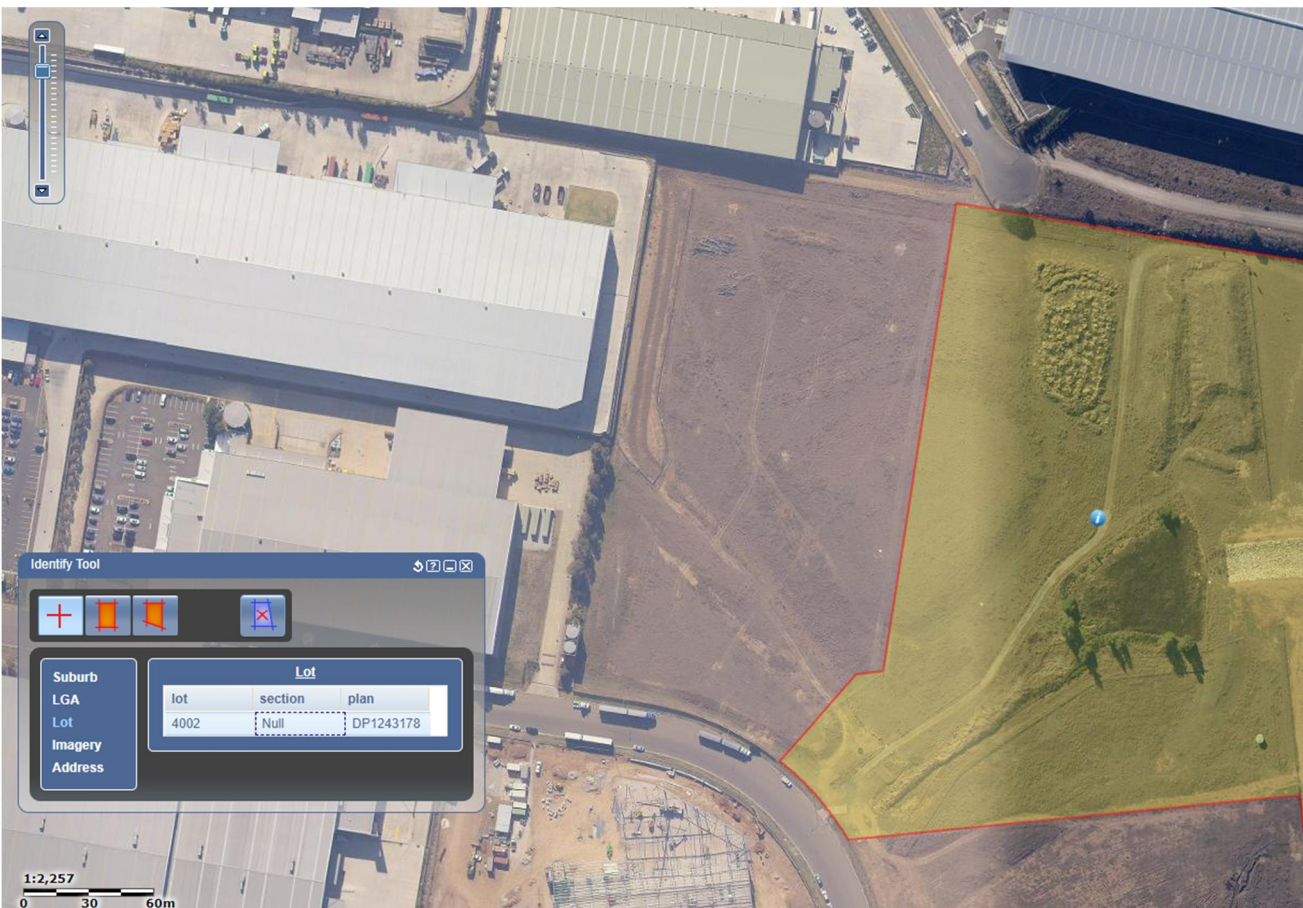
Figure 2.2 Site Location and local surrounds (SIX Maps, 2020)

The site comprising approximately 25,500 square metres is shown in Figure 2.2, and covers the area shaded yellow. Medium-scale industrial estate makes up a majority of the local surrounds (to the north and west of the property). Areas directly adjacent to the property are also empty; earmarked for future industrial development. At the time of undertaking this desktop study and based on photographs from a recent site visit by WSP, it appears that earthworks have been undertaken to de-vegetate the site and grade the ground surface to a moderately flat level.

Historically, a water detention basin or drainage catchment was situated in the middle of the site (shown in Figure 2.2) with access tracks running north-south.

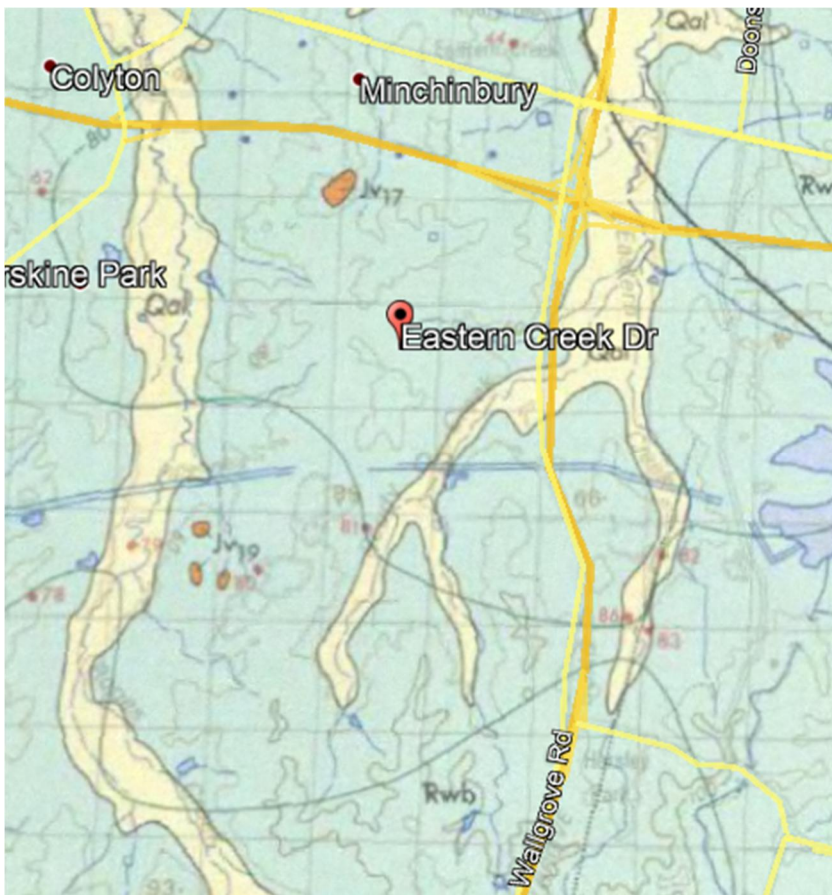
Figure 2.3 Geology in the Eastern Creek area (Penrith 1:100,000 Geological Map, 1991)

A nearby boundary between fluvial material (denoted as Qal) and the Bringelly Shale (denoted Rwb) is observed on the map. An extract from the geological map is shown in Figure 2.3; the approximate location of the site is denoted with a placemark.

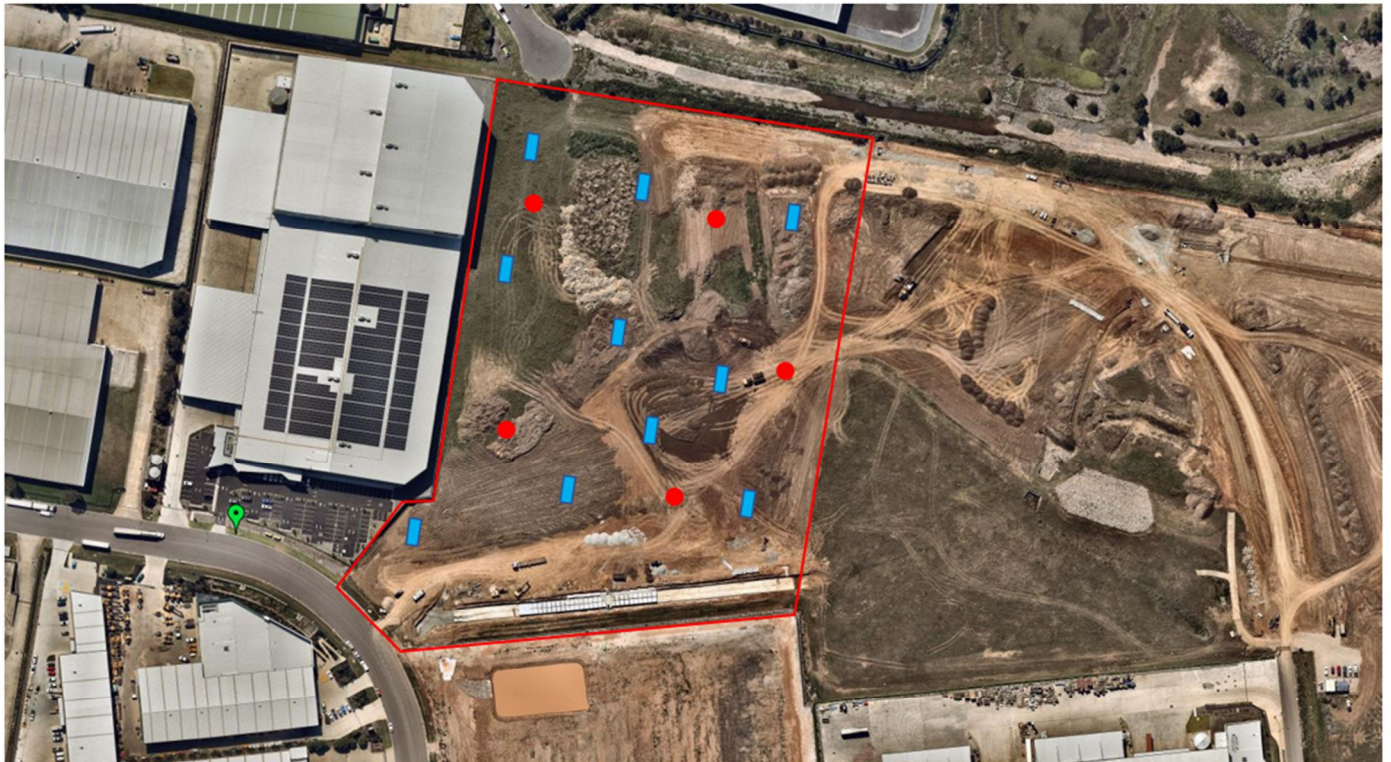
Figure 4.1 Proposed borehole and test pit locations

- Proposed test pit location (Environmental investigation)
- Proposed borehole location (Geotechnical investigation)

- Drilling of five (5) boreholes, approximately located as shown in Figure 4.1, drilled to around 5 m below ground level or until practical refusal, whichever comes first. This would provide broad confirmation of the ground profile and possible water table level.
- Standard Penetrometer Tests (SPTs) undertaken within each of the boreholes at approximately 1 m intervals (where appropriate) to assist with determination of soil strength characteristics to inform foundation design
