GREENCOAST ENVIRONMENTAL REHABILITATION - CRESCENT HEAD STOCKPILE

SITE SURVEY REPORT - FEBRUARY 2018

Project Title: Crescent Head stockpile site survey report

Prepared For: Greencoast Environmental Rehabilitation

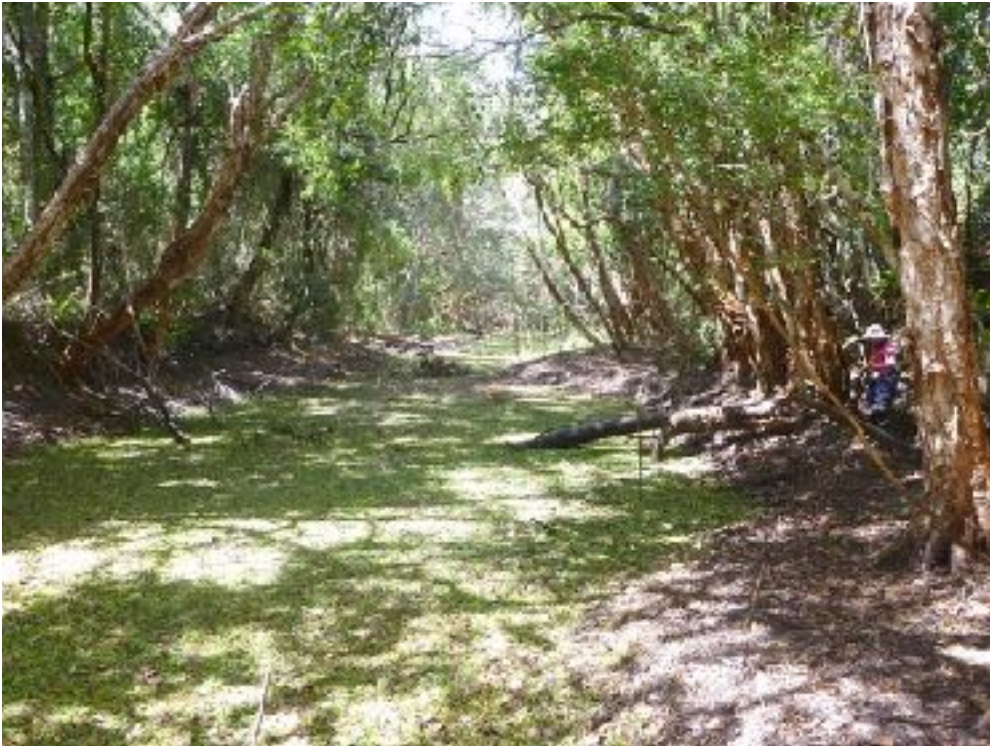
There is a shallow water filled trench or drainage channel that runs almost the entire length of the eastern side of the pile and this also wraps around the boundary of the Ilmenite pile to the north (all off stockpile).

The fringing bank of the trench has revegetated naturally to represent an establishing melaleuca woodland, with some other lowland coastal rainforest species establishing such as *Acmena smithii*, *Ficus spp.* and young *Melicope elleryana*. All of this is off the main stockpile area.

Plate One: Off stockpile looking south

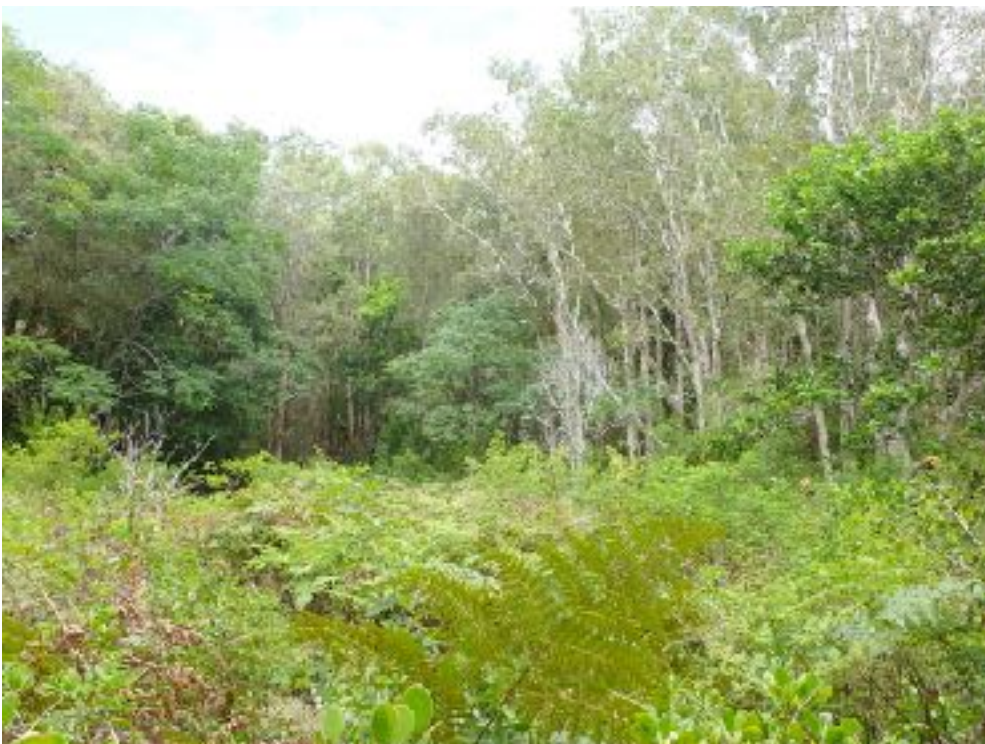
Plate Two: On stockpile looking off-stockpile to the south

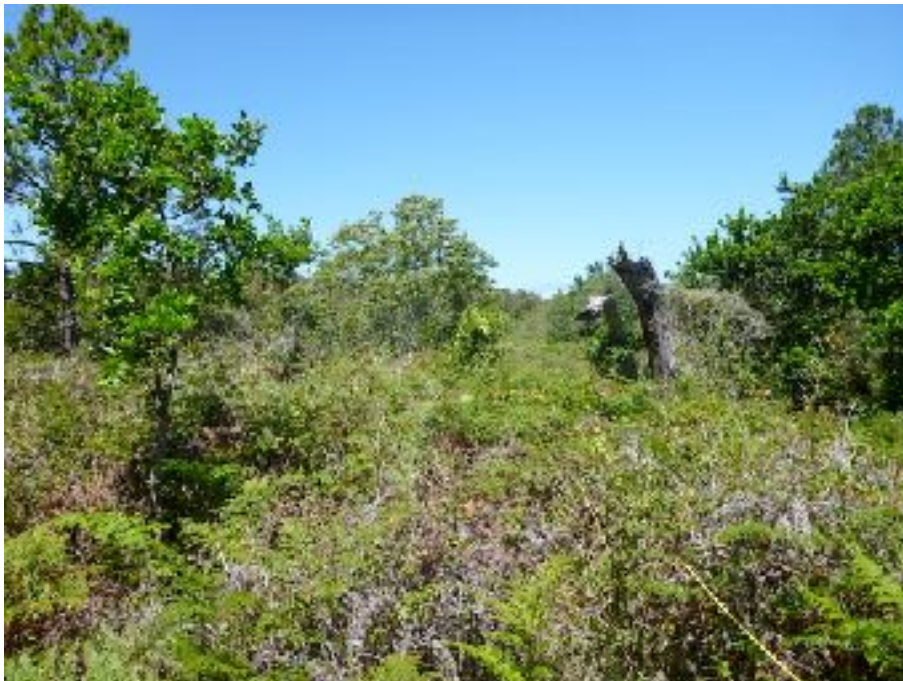
Plant establishment on the stockpile has been relatively limited and the tree species present on the pile are both sparse and relatively young. There are some a few tree species, such as *E. pilularis* and *B. integrifolia* that appear to have been planted as part of a previous unsuccessful revegetation program due to their relatively young age. There are some larger trees, that have either been present prior to the pile being placed (partially buried) or have established from seed (*Ficus spp.*). There are also a small number of *Pinus elliotii* present on the pile itself.

The mid and understory species characterise the pile vegetation type, notably due to their hardy nature (the pile is almost entirely devoid of topsoil) and their vegetative regrowth habitats. Native understory species are represented primarily by *Pteridium esculentum* and *Acacia sophorae*. Unfortunately the most dominate species present (dominant in both biomass and number) on the pile is *Lantana camara*. The second most dominant weed species present is *Chrysanthemoides monilifera rotundata* although this is not as dense as the Lantana.

Plate Three: On-stockpile looking east

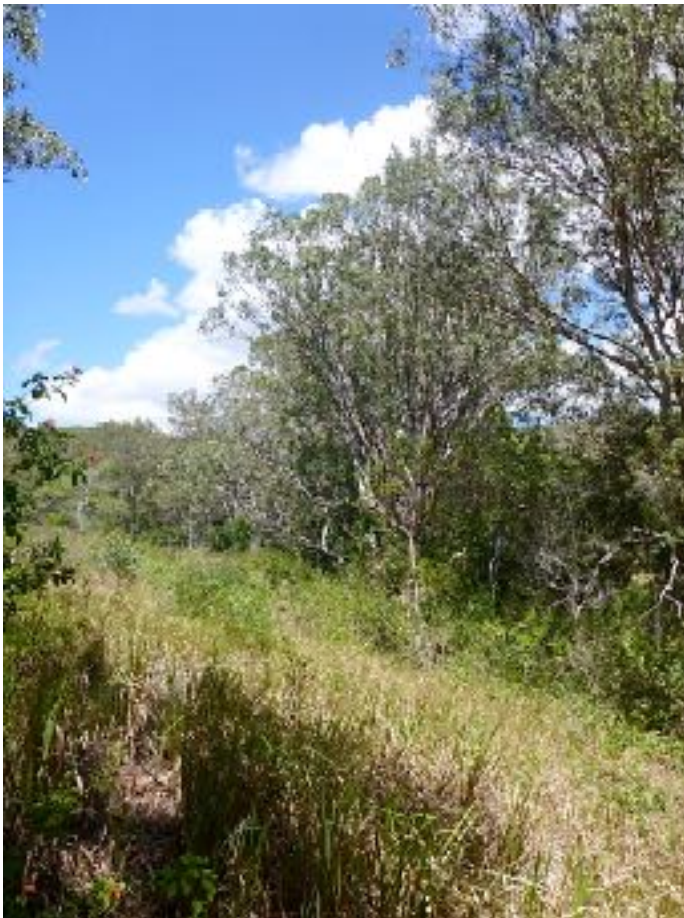
The roadside vegetation consists of a slashed grass edge, and a densely planted strip of *E. teriticornis*. These trees are growing at the edge of the pile and appear to have all been established as a single age class, possibly through roadside planting for koalas, or as a screening planting.

E. teriticornis is present elsewhere on the site, however, not in a single age stand such as the roadside. Koala use of these trees was evident with scats, scratches and scent markings present within these trees.

Plate Four: Roadside trees between the Point Plomer road and the stockpile looking south

Remnant vegetation found to the south west of the pile and along the roadside should be retained intact where possible, to provide a continuous corridor of Koala habitat trees and a pathway for arboreal fauna. Retention of the roadside trees is recommended, however it is noted that all the understory (mostly weed species) and some established trees could be removed to provide access if required.

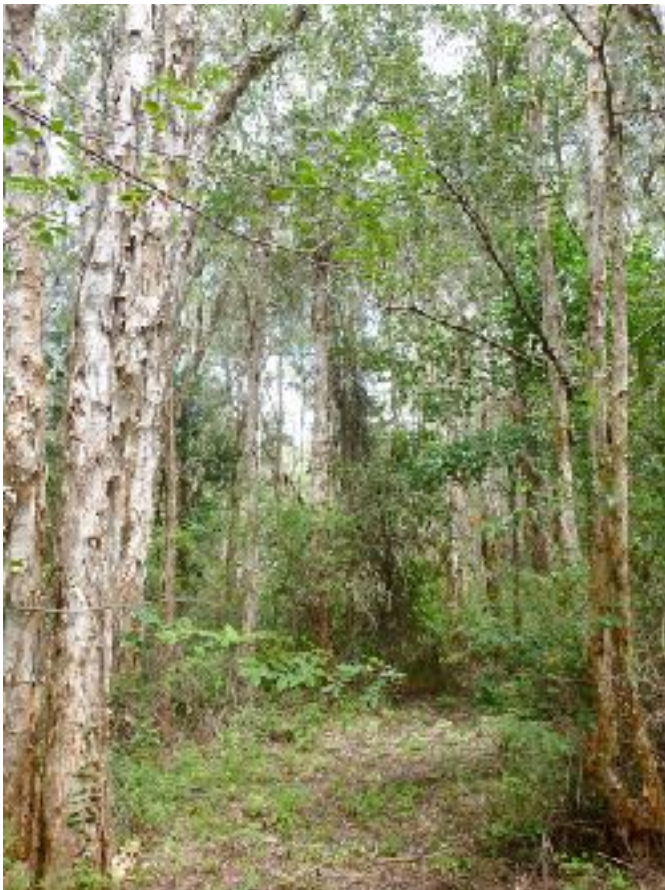
The southern region of the block and off the edge of the stockpile is similar to the Eastern Fringing wetland vegetation detailed in section 3.1.1 and is characterised by a very thick *Melaleuca* forest all of a similar age class.

However this area has a large number of remnant trees present which improve the floristic diversity of the site, and improve its habitat values.

Of note is the larger number of *Ficus spp.* and larger individuals of *E. robusta*. This area is also quite dense, with a number of coastal rainforest tree species.

Plate Six: Off-stockpile looking east

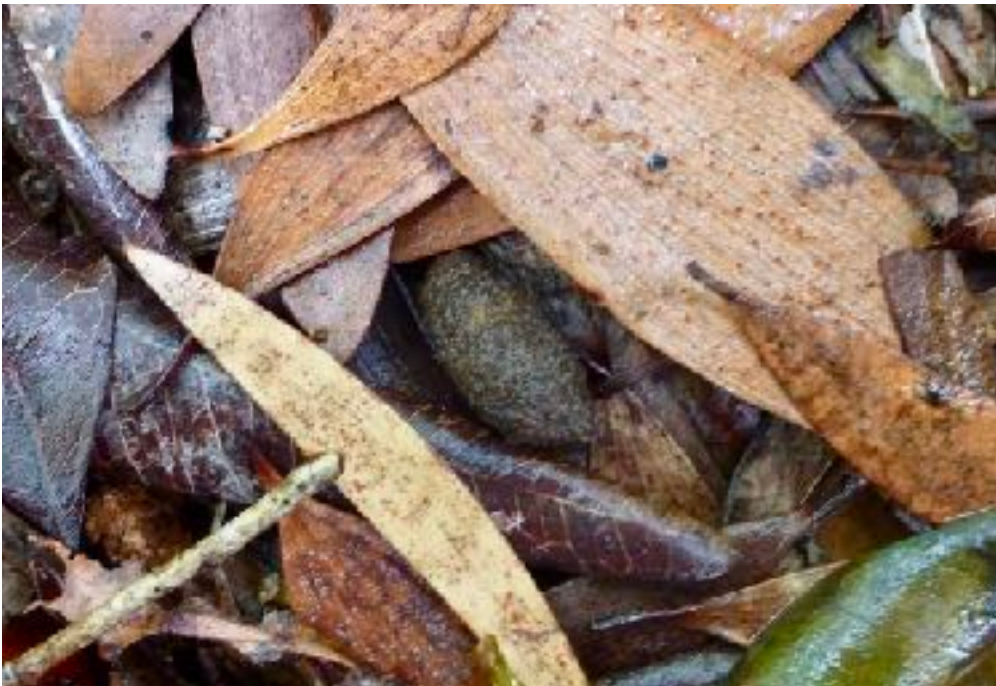
- The Koala (*Phascolarctos cinereus*): Koala scats were observed on site at three separate locations (Plate Seven) and scratch marks that could be attributable to a Koala were observed on a number of large remnant trees (Plate Eight). Whilst no Koala individuals were observed during the survey period, a strong musty odour, attributable to a male Koala scent marking was detected from a grove of *E. tereticornis* which contained the freshest scat recorded.

Plate Seven: Koala scat below roadside trees between stockpile and road

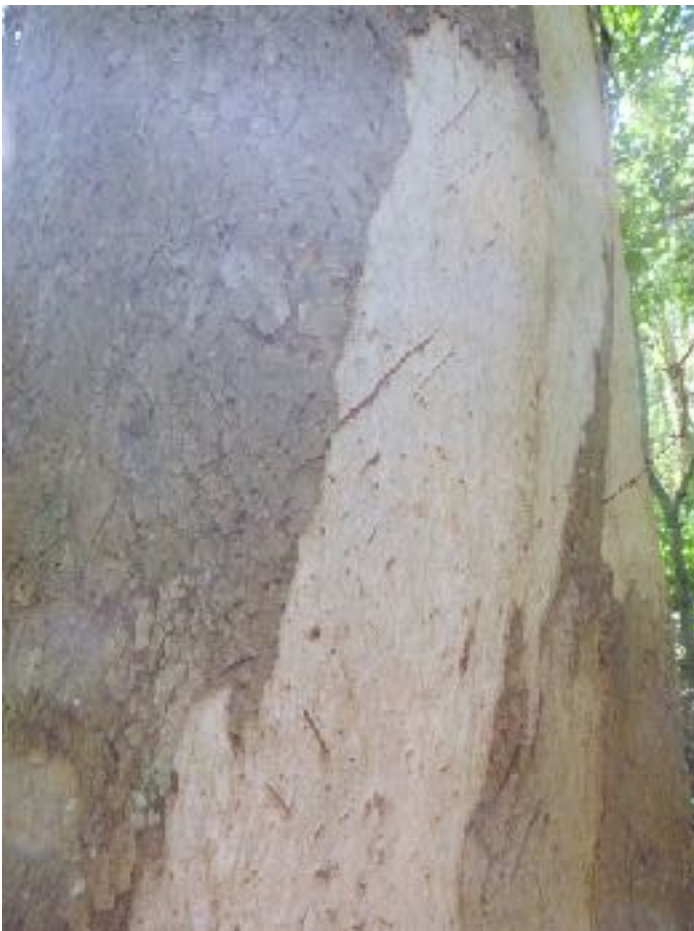
Plate Eight: Scratch marks (off-stockpile)

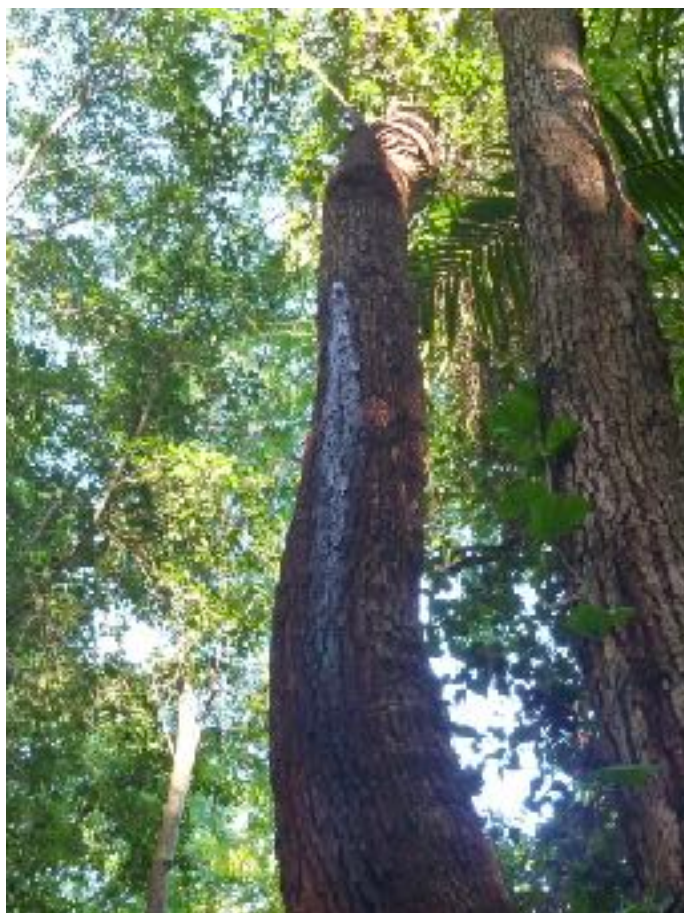
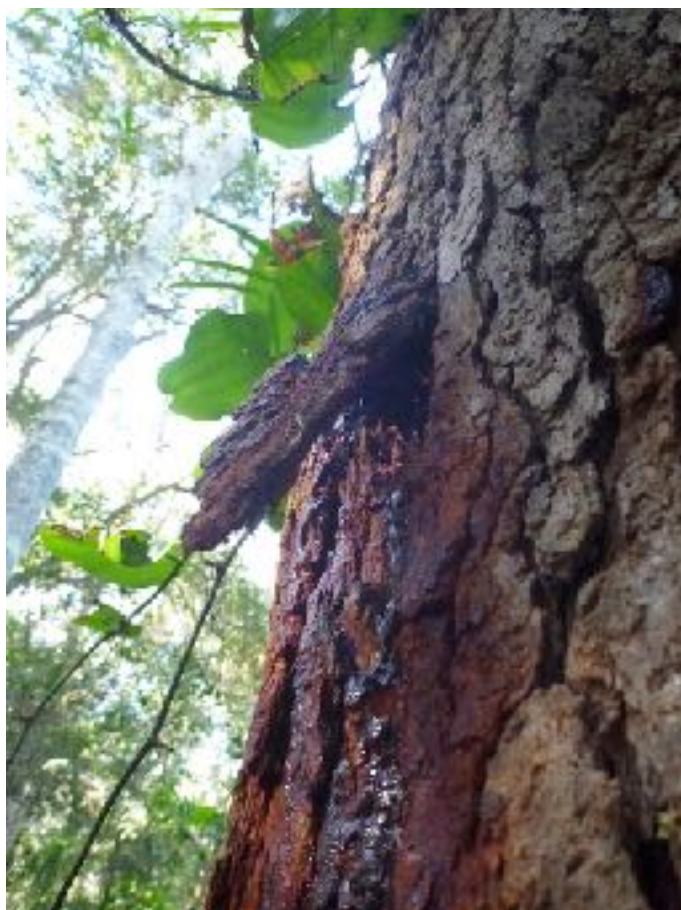
- Sugar Glider (*Petaurus breviceps*): No gliders were observed during the survey period however a number of potential sap feeding scars were observed on *E. robusta* trees (Plate Nine and Ten). The local area is known to provide habitat for both Sugar and Squirrel Gliders, although the Sugar Glider is expected to be the most common of the two.

Plate Nine and Ten: Sap feeding scars (off-stockpile)

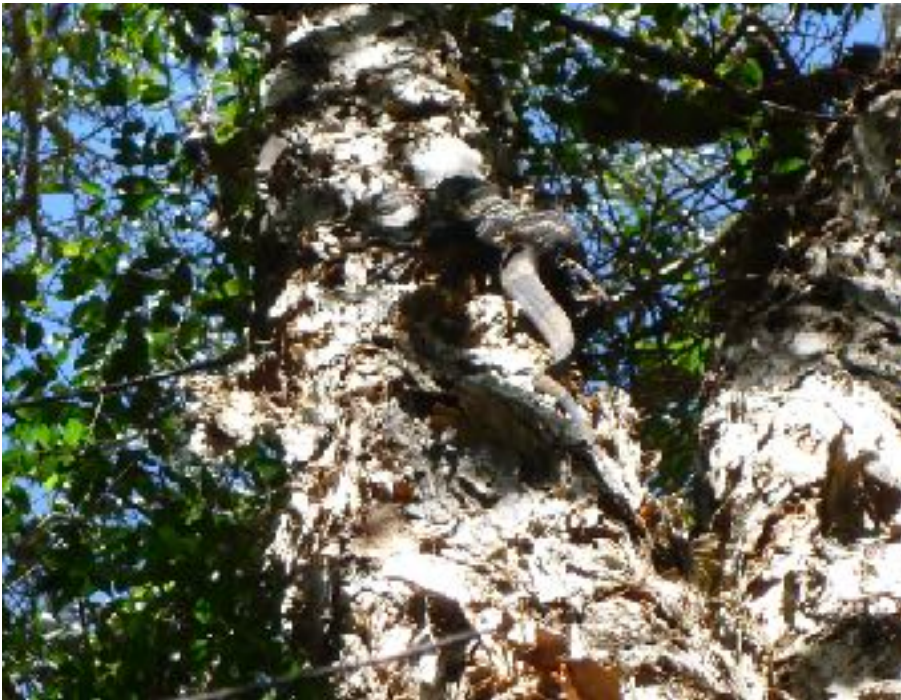
- A Lace Monitor (*Varanus varius*) observed climbing a tree (Plate Eleven),
- Bandicoot diggings (*Isodon macrourus*) (Plate Twelve), and
- Yellow Tailed Black Cockatoos (*Calyptrorhynchus funereus*) flying over the site

Plate Eleven: Lace Monitor climbing tree (off-stockpile)

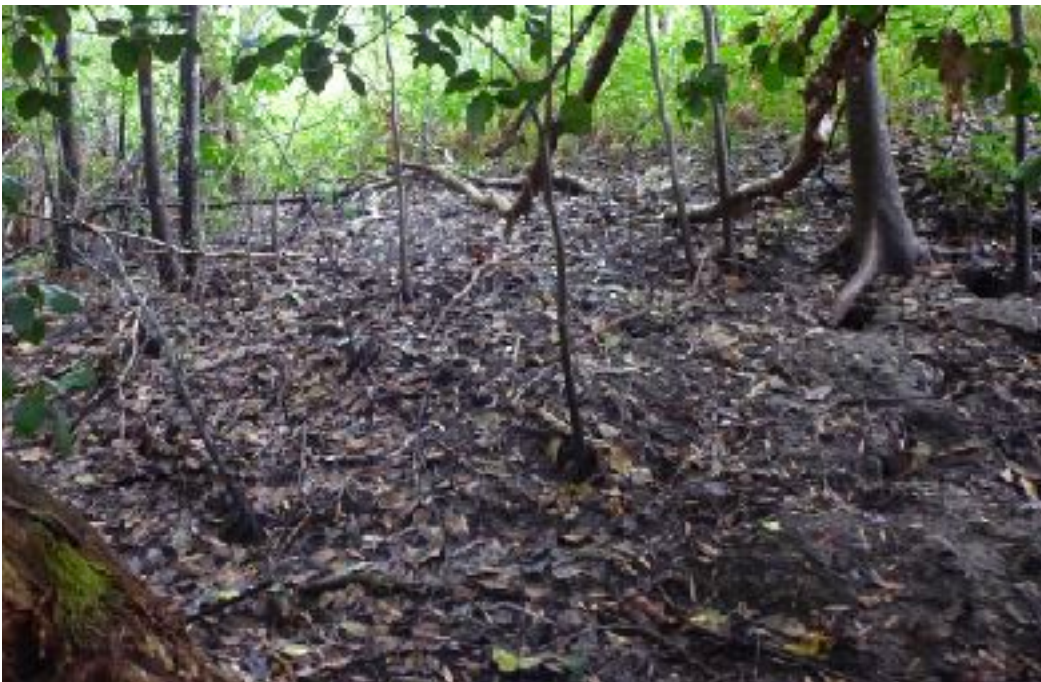
Plate Twelve: Bandicoot diggings

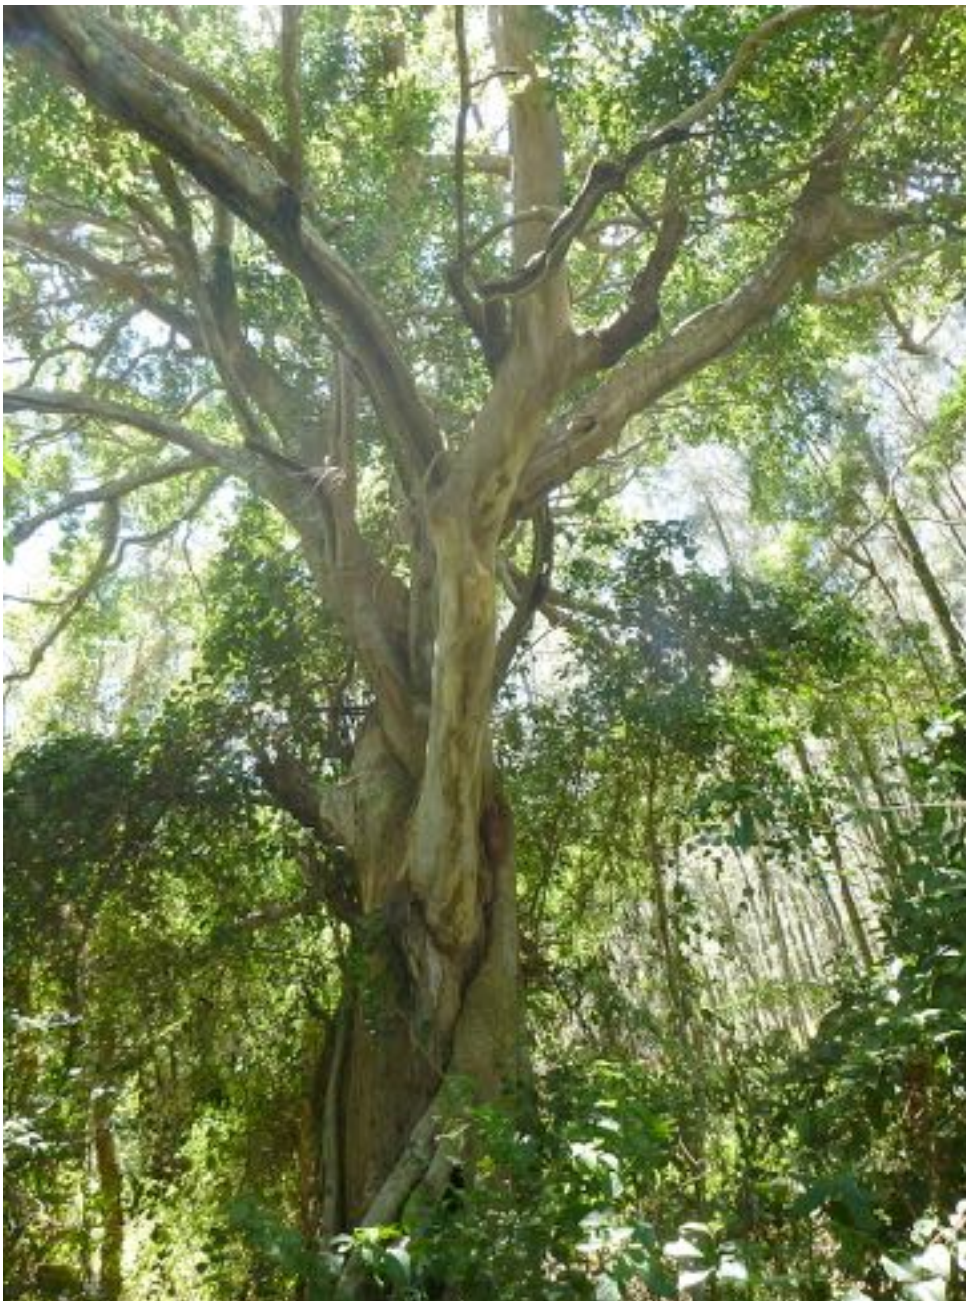
- Visible tree hollows, or epiphytes that may provide roosting or nesting potential (Plate Thirteen and Fourteen)
- Food trees for specific species through provision of leaves, fruit or sap, and
- Trees where animals were observed

Plate Thirteen: Habitat tree (Strangler fig and remnant Koala tree) off-stockpile

The key habitat trees listed in Table Three should be retained to provide habitat for returning fauna once the project is completed and all care should be taken to retain as many of these as possible during the removal of the pile material. It is recommended that the one habitat tree in the centre of the pile (the Ficus) could be removed and replaced once pile works are completed.

It is recommended that prior to clearing, all habitat trees listed be flagged with appropriate flagging tape colours and all site personnel informed of the need to retain these trees.

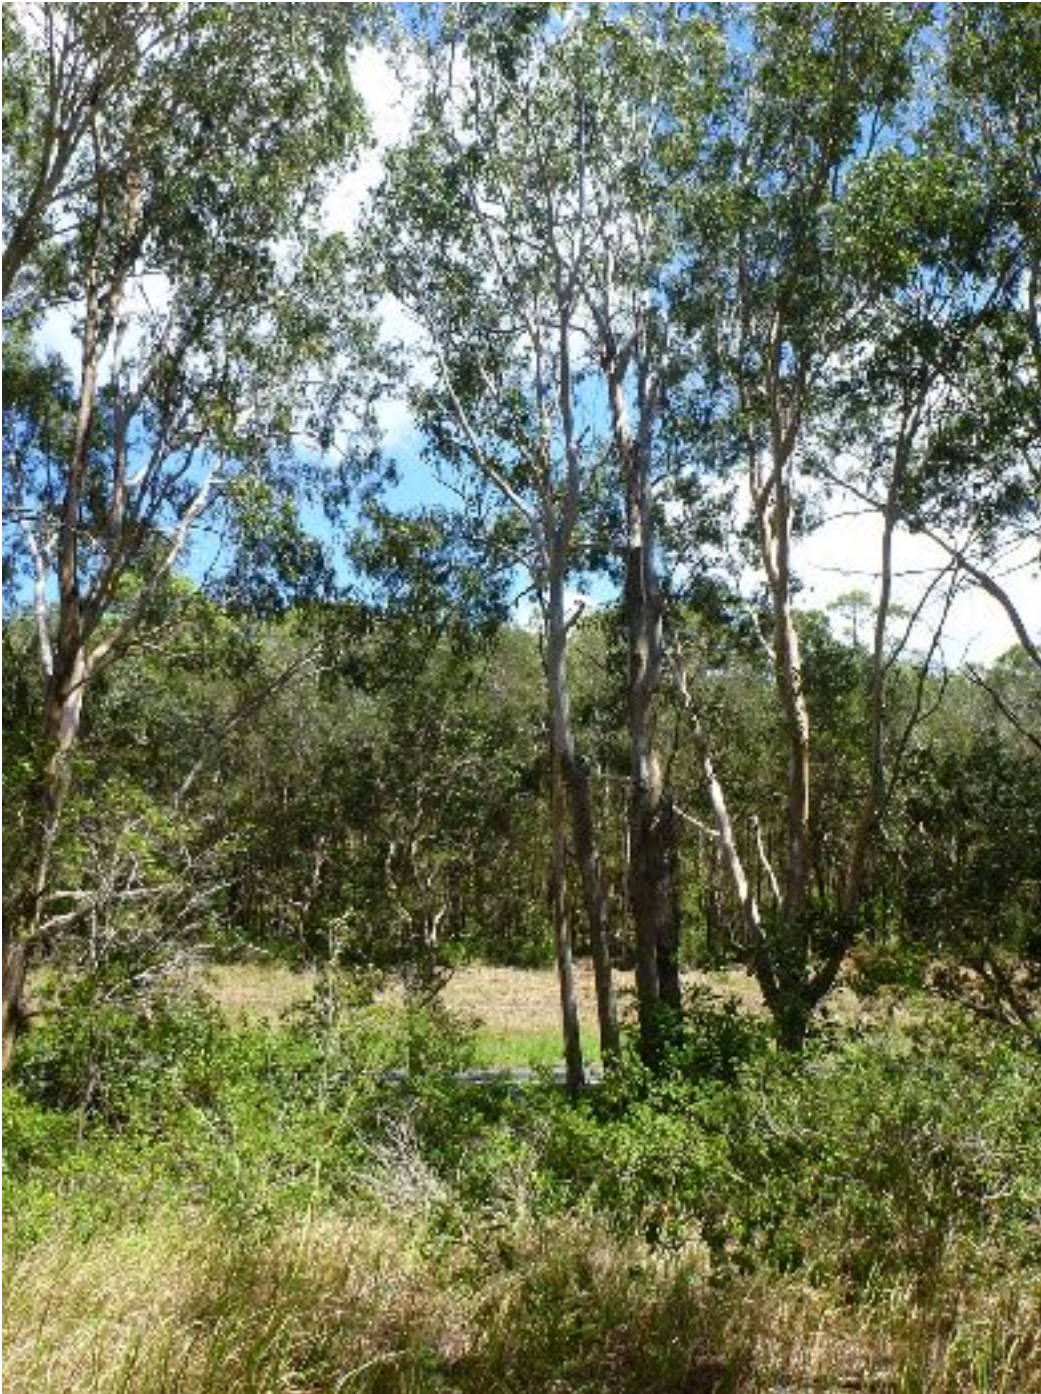
Plate Fourteen: Koala habitat trees between stockpile and road

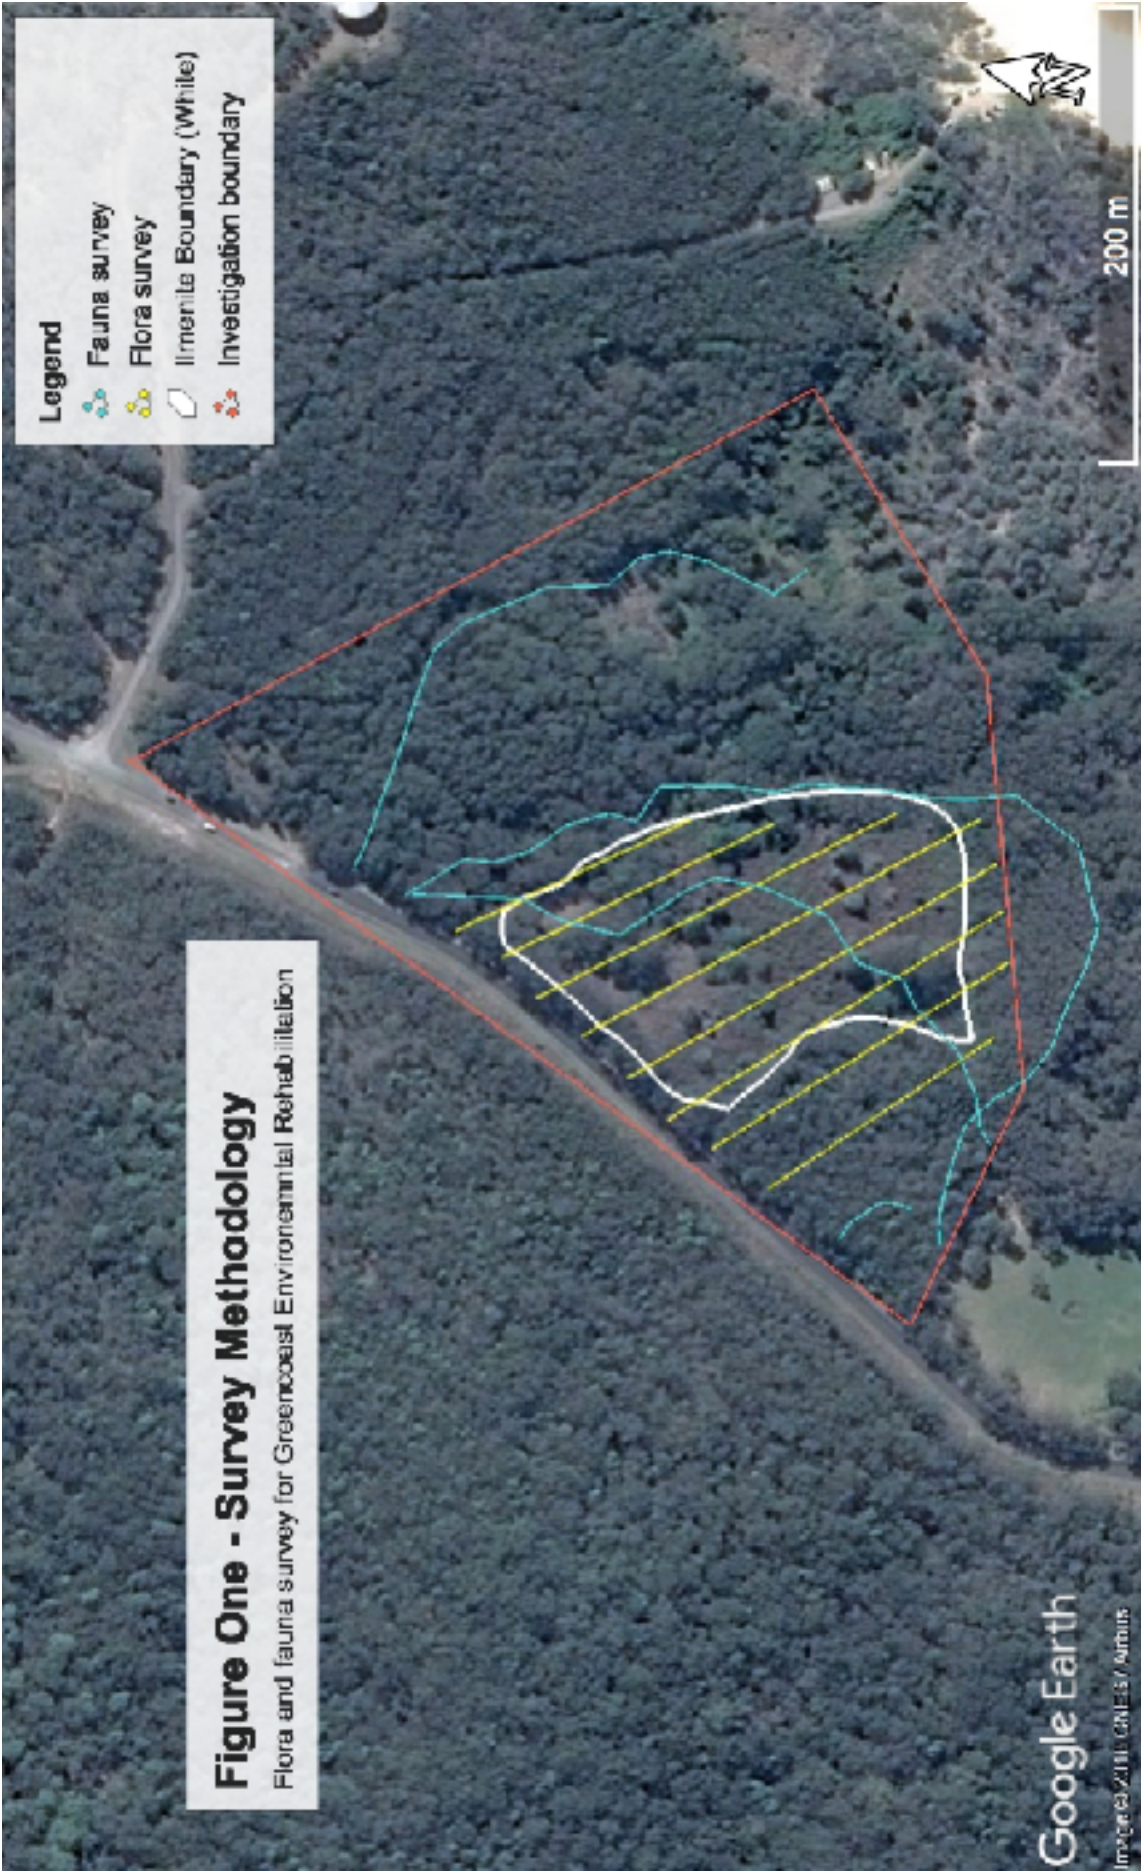
4.2.1. Habitat retention and preservation	28
4.2.2. Clearing precautions	28
4.3. Specific SEAR's Requirements	28
5. References	32
A. Site vegetation communities and survey transects - Figure One	33

Opportunistic surveys of the larger lot area also occurred during this period with the perimeter of the lot being traversed and points of interest (drainage trench) also being inspected. The grid, and perimeter walk locations are shown on Figure One.

Ground searches for fauna occurred concurrently with the vegetation assessment over the 25 metre grid (Figure One). Dawn and dusk observations and call listening was undertaken on the 4th, 5th and 6th of February, with one nighttime spotlighting walk conducted on the night of the 5th.

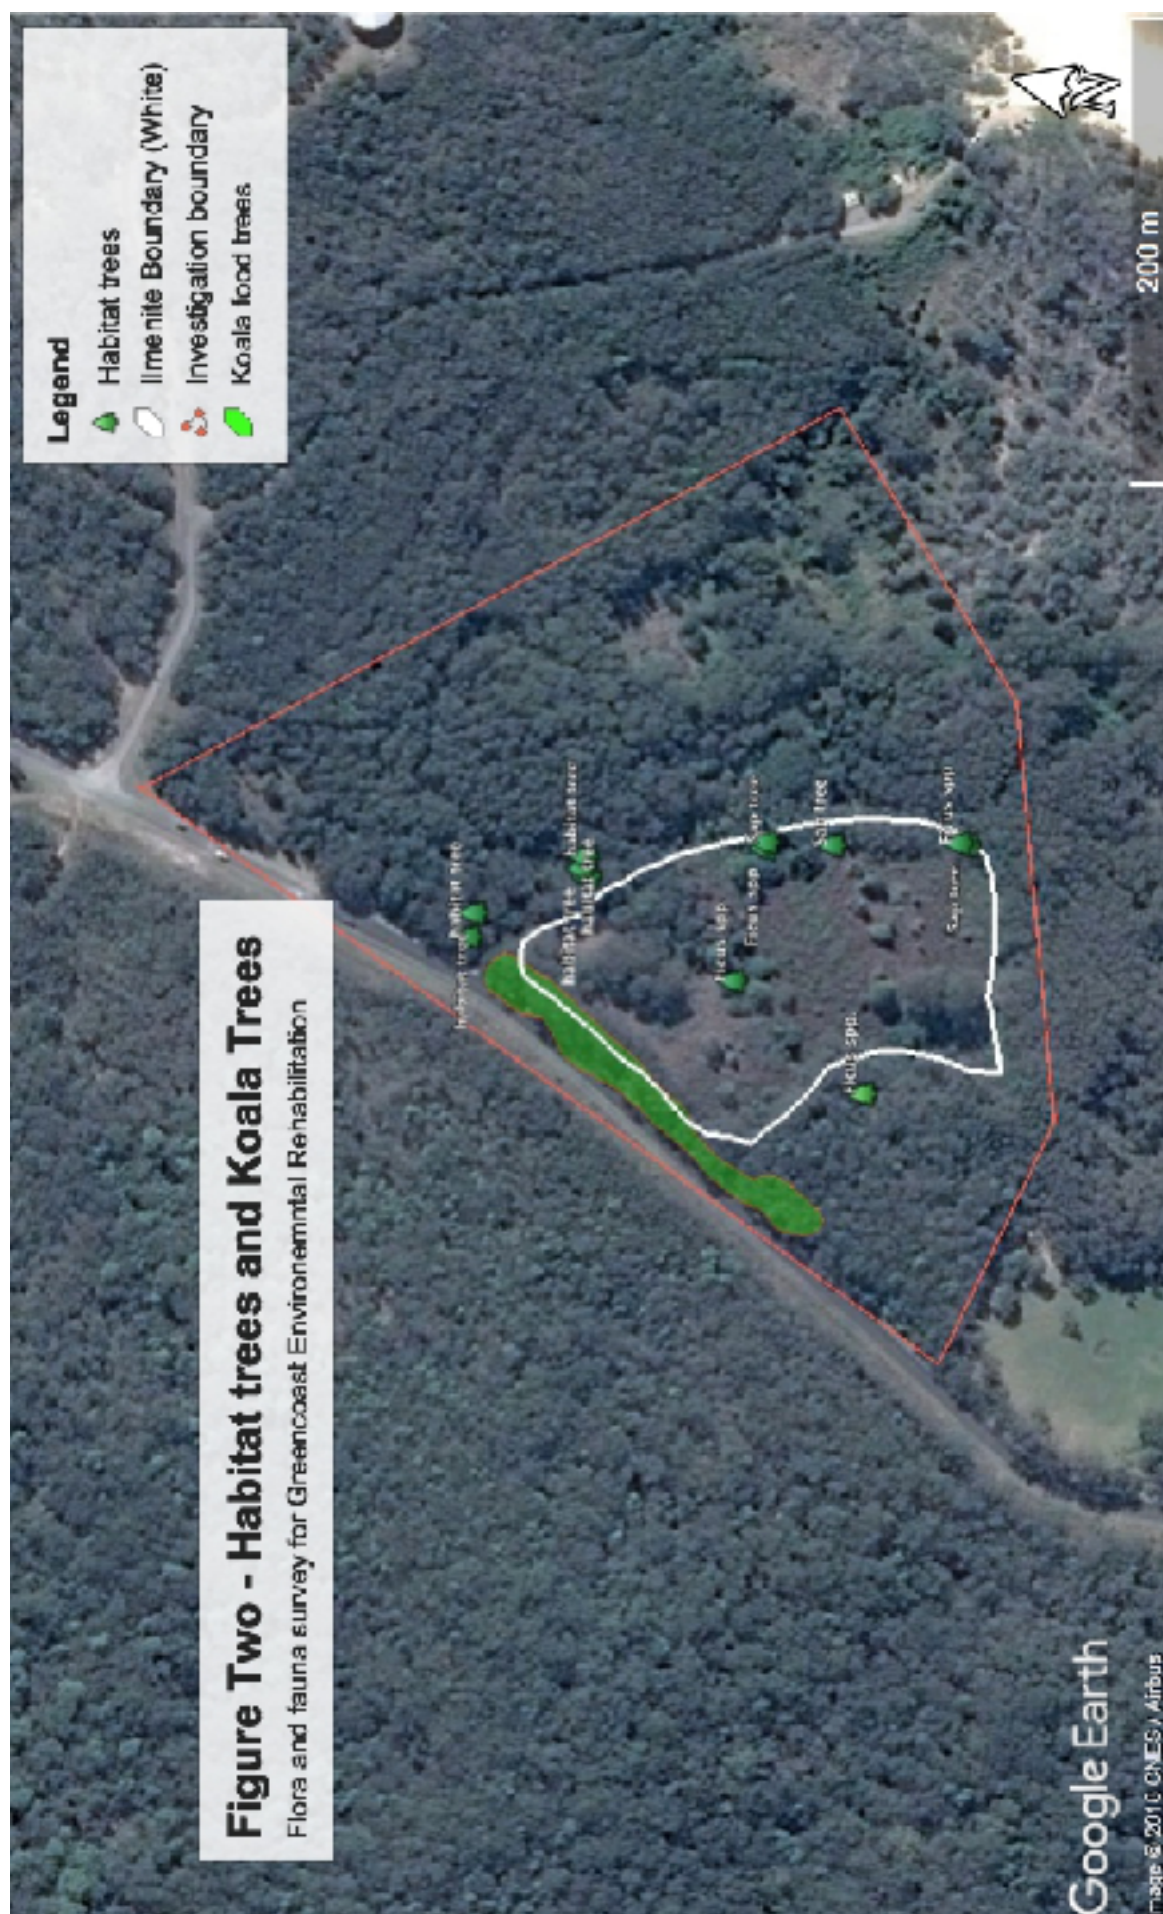
B. Habitat trees and remnant vegetation for retention - Figure Two	34

The areas recommended for retention and preservation are detailed in Figure Two

As recommended in the vegetation management section, the retention of the habitat trees outlined in Table Three and Figure Two, as well as restricting clearing activities to the stockpile footprint only should offset any temporary disruption to fauna that may occur during the life of the project.
