Geotechnical Investigation Report

Project
Proposed Mixed Residential & Commercial Development
2A Gregory Place,
Harris Park NSW

Date
21 February 2022

Report No
13091-GR-1-1

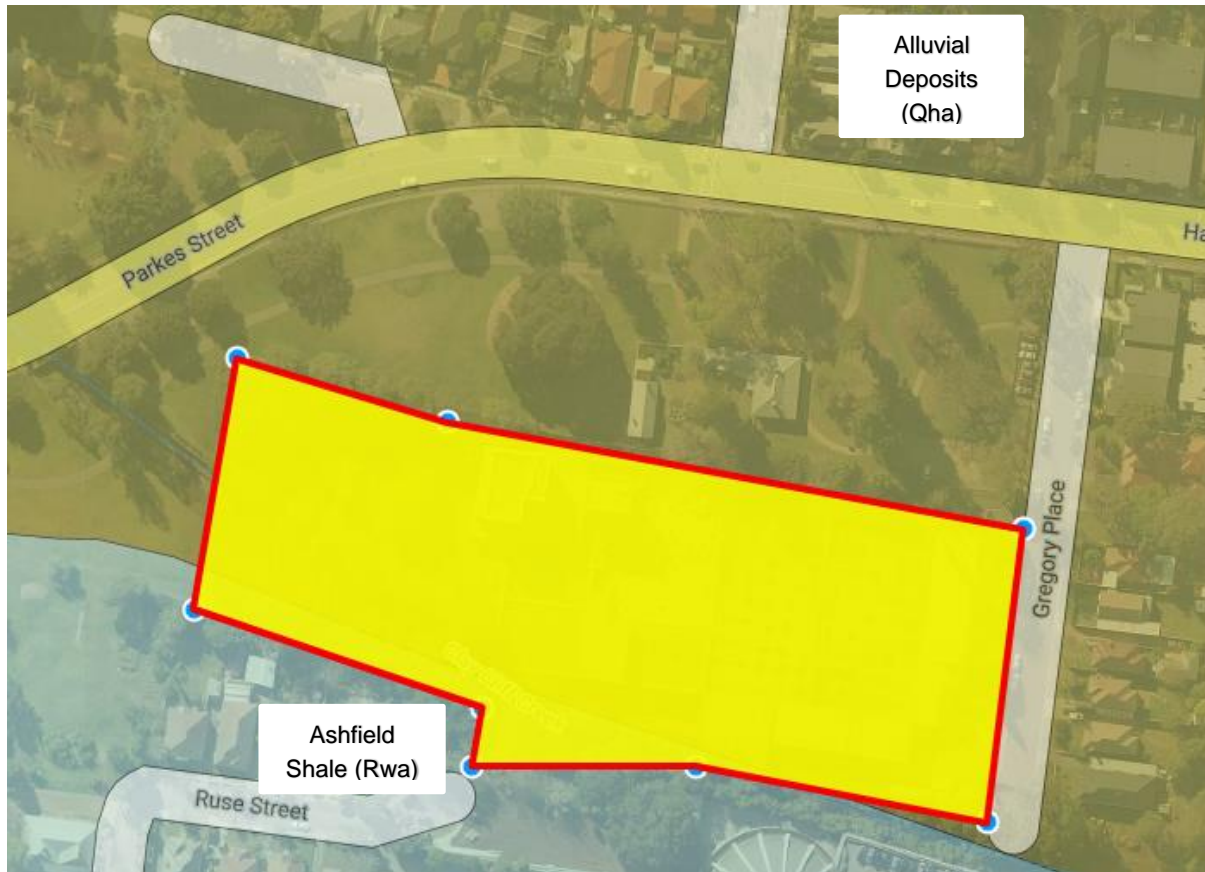
Figure 2 Site Location on Extract of Sydney Geological Map

Figure 2 shows the site location on an extract of 1:100,000 Sydney geological map.

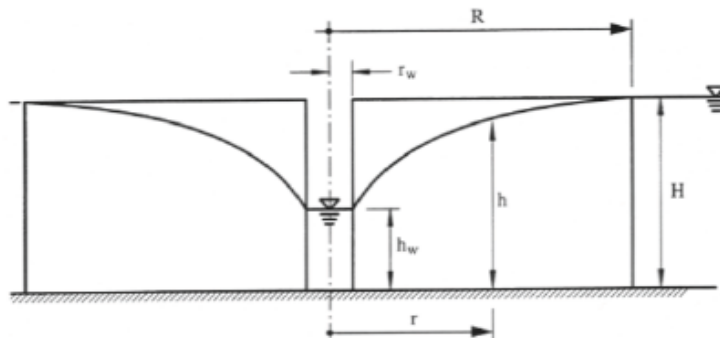
The flow rate into the proposed basement excavation assuming a basement area of 19,603m² was calculated in accordance with Dupuit-Thiem equation for steady-state unconfined flow using the following parametric equation for radial inflow through a uniform material under gravity conditions.

$$Q = \frac{\pi k (H^2 - h_w^2)}{\ln (R/r_w)}$$

Parameters		Description
K (m/s)	1.14x 10 ⁻⁶ ---> BH01 1.95 x 10 ⁻⁶ ---> BH02 9.97 x 10 ⁻⁶ ---> BH05	Worse-case soil/rock conductivity from the rising head test is at BH05
H (m)	4.88	Maximum excavation depth to the maximum observed groundwater level
h _w (m)	0	Assuming basement dewatering adequate to keep the groundwater level at the basement level
R (m)	137	Assumed based on basement dimensions
r _w (m)	91	Based on the equivalent radius of the basement area

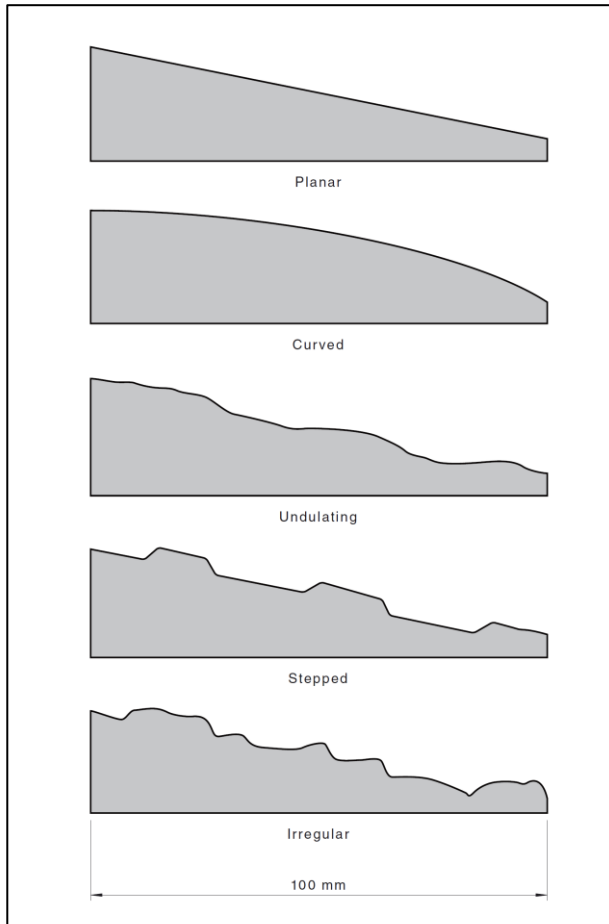
Surface Shape – At the medium scale of observation, description of the roughness of the surface shall be enhanced by description of the shape of the defect surface using the following terms, as illustrated below:

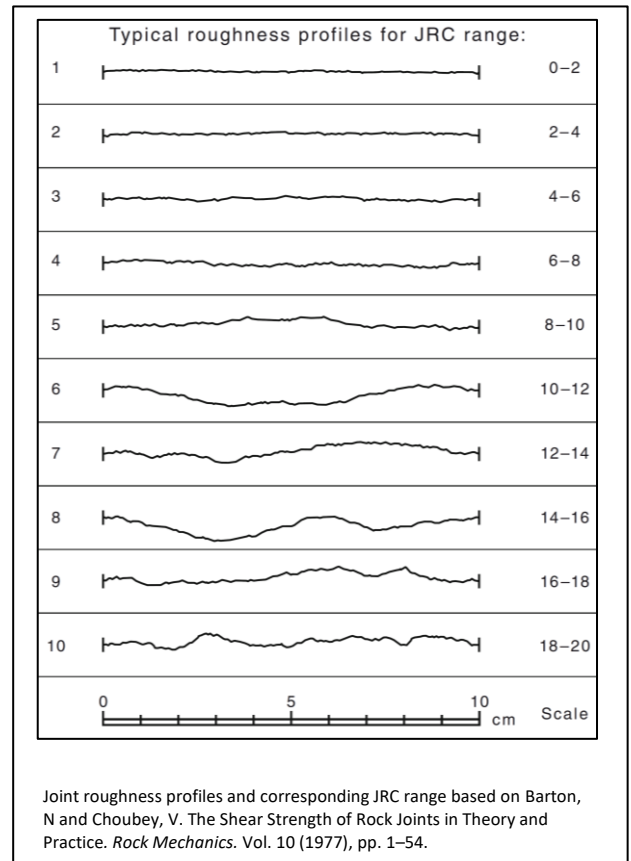
Where applicable Joint Roughness Range (JRC) is provided as follows:

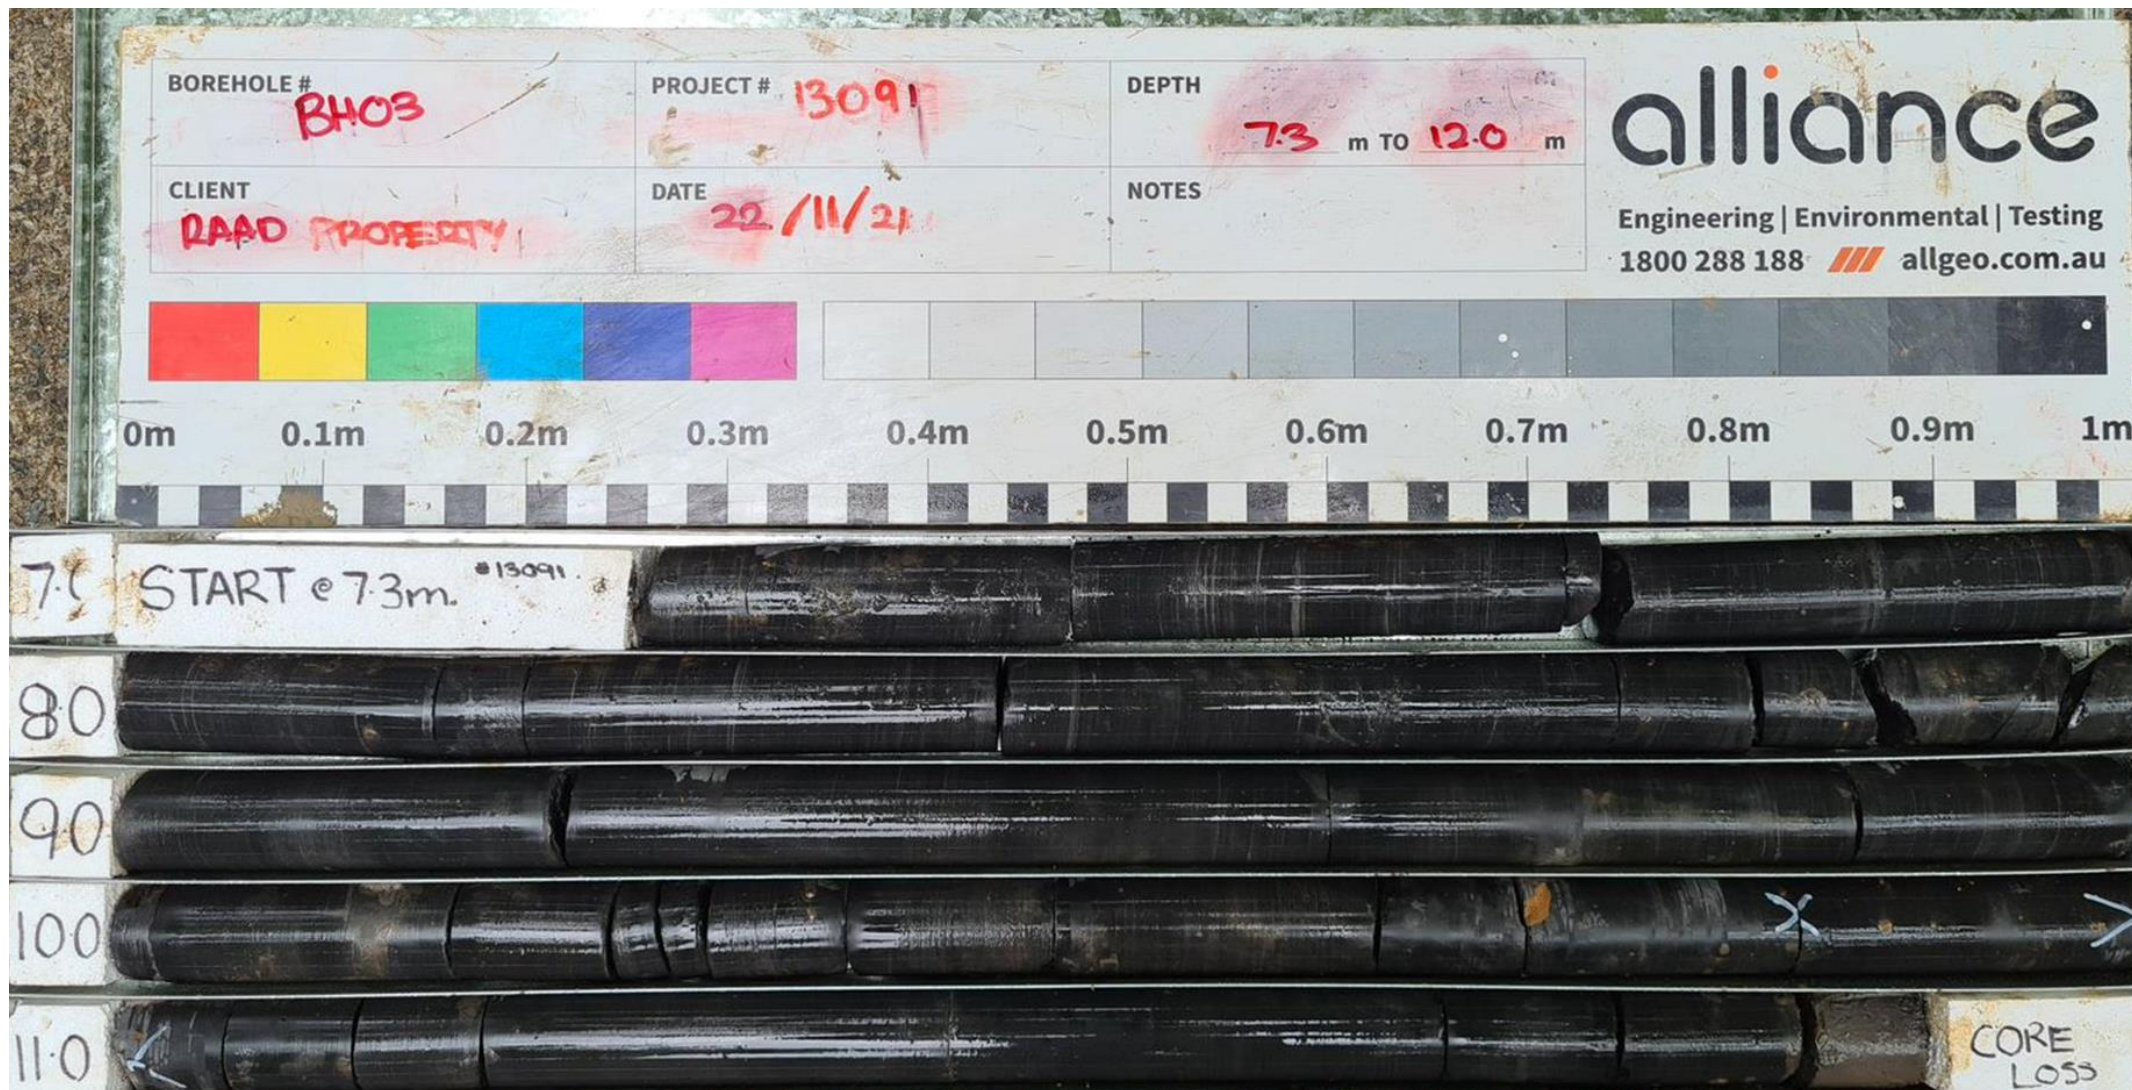
Figure / Drawing Number:	Corebox Photos
Figure / Drawing Date:	25/11/2021
Report Number:	13091-GR-1-1

Client: 2A Gregory Place Pty Ltd					Started: 22/11/2021					
Project: Proposed Mixed Development					Finished: 22/11/2021					
Location: 2A Gregory Place, Harris Park NSW					Hole Location: Refer Drawing: 13091-GR-1-A					
					Borehole Size: 110 mm					
Rig Type: Christie Engineering (CE180)			Hole Coordinates E, N			Driller: MW		Logged: KT		
RL Surface: 5.15m			Contractor: BG Drilling Pty Ltd			Bearing: ---		Checked: MS		
Method	Water	RL (m)	Depth (m)	Graphic Log	Material Description	Weathering	Estimated Strength ● Axial ○ Diametral	Is ₍₅₀₎ MPa D- diam- etral A- axial	Defect Spacing mm	Additional Data
NMLC		-5			SHALE: dark grey, laminated at 0°-10°, variable spacing. (continued)	FR				10.04 - BP, 0°, UN, RO, CN. 10.17 - BP, 0°, PL, RO, CN. 10.24 - BP, 0°, PL, RO, CN. 10.26 - BP, 0°, PL, RO, CN. 10.28 - BP, 0°, PL, RO, CN. 10.36 - BP, 0°, PL, RO, CN. 10.64 - BP, 0°, UN, RO, CN. 10.71 - JT, 5°, PL, RO, CN.

-6	11						74	11.06 - BP, 0°, PL, RO, CN. 11.12 - BP, 0°, PL, RO, CN. 11.18 - BP, 0°, PL, RO, CN.
		-7	12		Core Loss: 100mm. SHALE: dark grey, laminated at 0°-10°, variable spacing.	N/A SW		D A 0.6 0.62		11.75 - BP, 0°, UN, RO, CN. 11.84 - BP, 0°, UN, RO, CN. Core loss 100mm.
		-8	13						86	
		-9	14					D A 0.47 0.8 D A 0.37 0.82		
		-10	15		BH03 terminated at 14.9m					
		-11	16							
		-12	17							
		-13	18							
		-14	19							
		-15	20

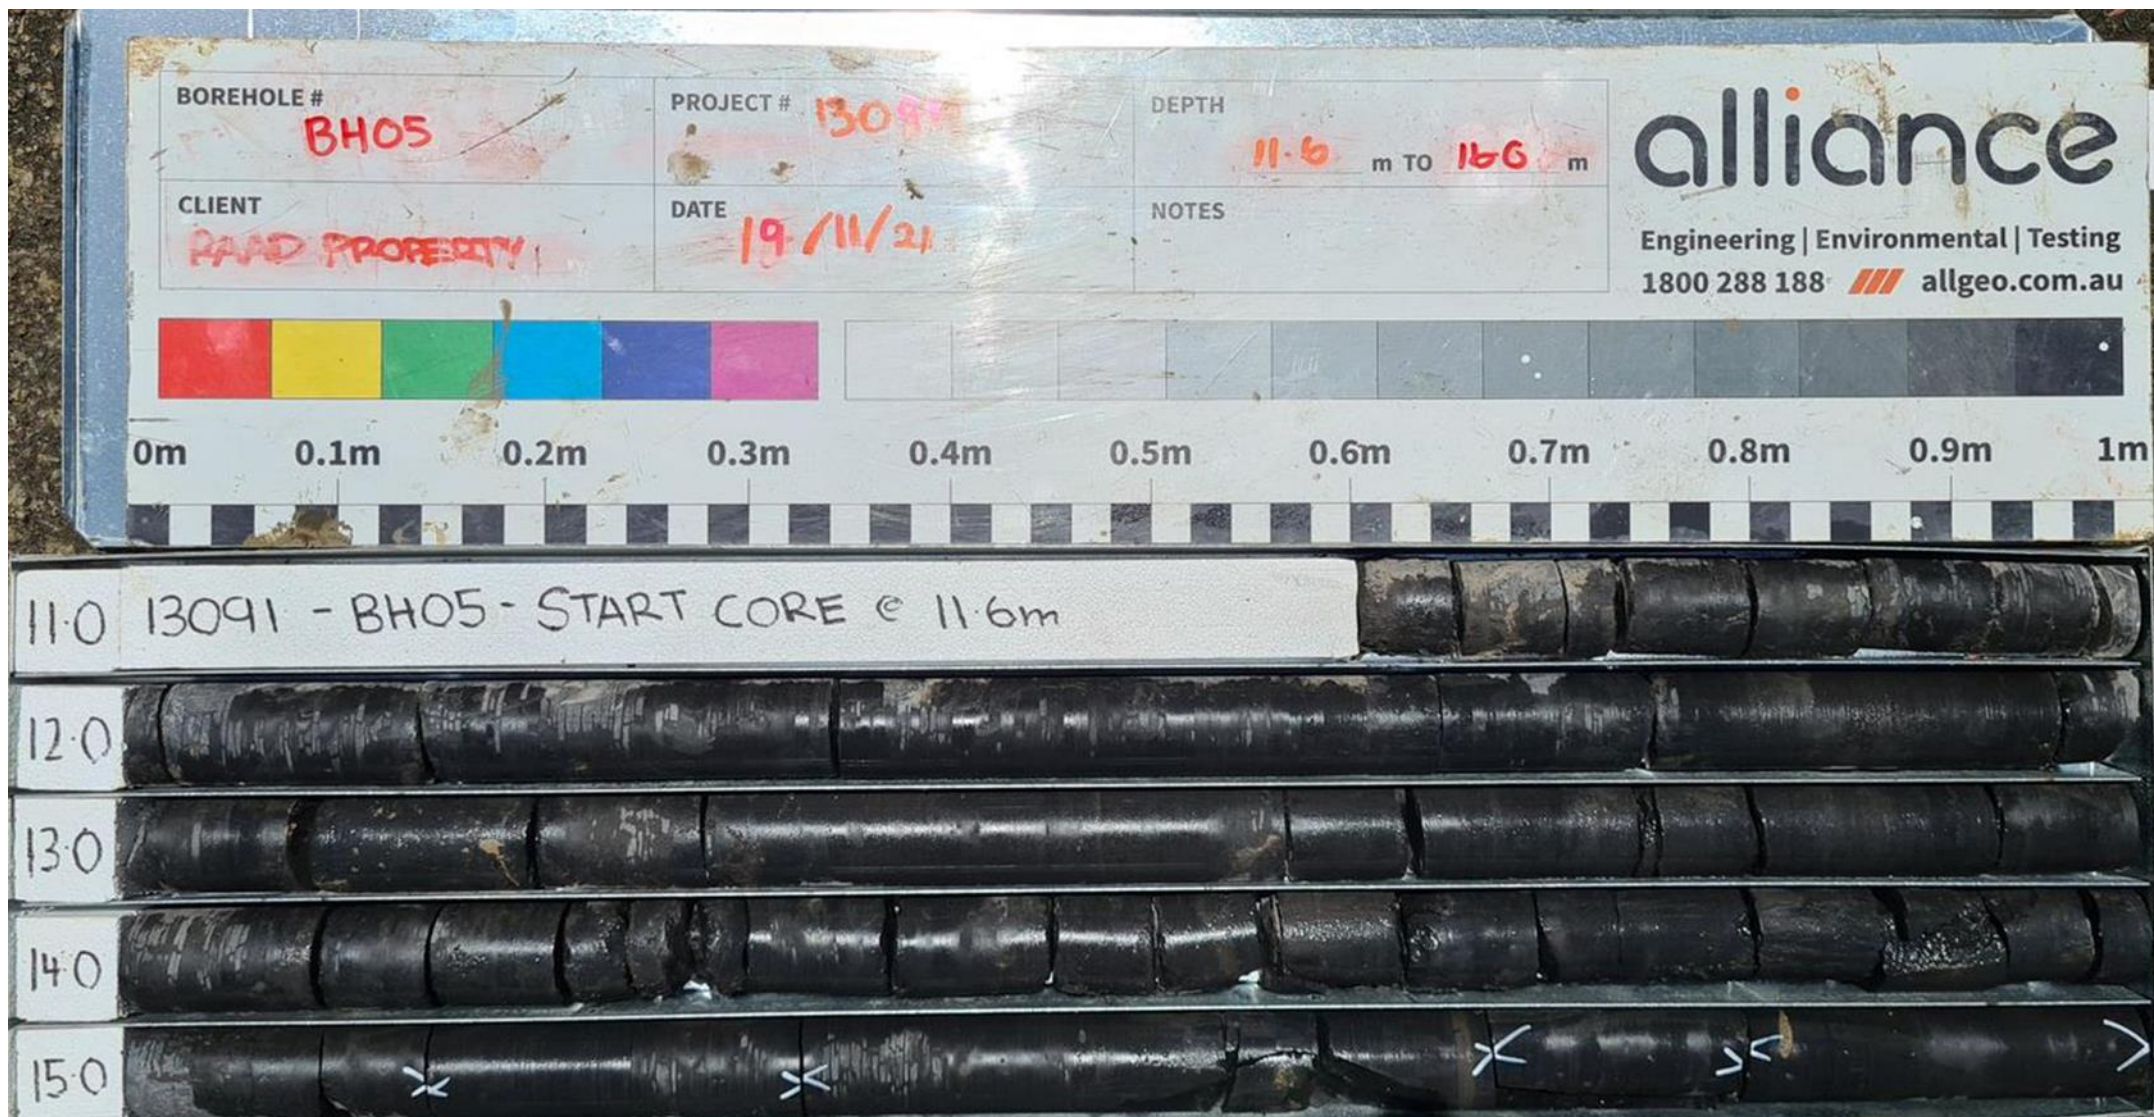
Figure / Drawing Number:	Corebox Photos
Figure / Drawing Date:	25/11/2021
Report Number:	13091-GR-1-1

-8	13				●	D 0.22 A 1.07			12.75 - BP, 5°, PL, RO, CN. 12.96 - BP, 0°, PL, RO, CN. 13.20 - BP, 0°, UN, RO, CN.
		-9	14						41		13.63 - BP, 0°, UN, RO, CN. 13.75 - SM. 13.80 - BP, 10°, UN, RO, CN. 13.92 - BP, 5°, PL, RO, CN. 14.09 - BP, 0°, UN, RO, CN. 14.15 - BP, 0°, UN, RO, CN. 14.21 - BP, 0°, UN, RO, CN. 14.24 - BP, 0°, UN, RO, CN. 14.27 - BP, 0°, UN, RO, CN. 14.30 - BP, 0°, UN, RO, CN. 14.37 - BP, 0°, UN, RO, CN. 14.45 - BP, 0°, UN, RO, CN. 14.55 - BP, 0°, UN, RO, CN. 14.56 - BP, 0°, UN, RO, CN. 14.57 - BP, 0°, UN, RO, CN. 14.63 - JT, 0°, UN, RO, CN. 14.69 - BP, 0°, UN, RO, CN. 14.80 - BP, 0°, UN, RO, CN. 14.87 - BP, 0°, UN, RO, CN. 14.93 - BP, 0°, UN, RO, CN. 14.96 - JT, 0°, UN, RO, CN. 15.09 - BP, 0°, UN, RO, CN. 15.55 - JT, 90°, CU, RO, CN. 16.13 - BP, 15°, PL, RO, CN.
		-10	15				●	D 0.18 A 0.83			16.72 - JT, 5°, PL, RO, CN. 16.81 - BP, 10°, PL, RO, CN. 16.95 - BP, 0°, UN, RO, CN.

-11	16				●	D 0.54 A 0.66			17.15 - BP, 0-5°, UN, RO, CN. 17.19 - JT, 80°, PL, RO, CN. 17.24 - BP, 0°, UN, RO, CN.
		-12	17						85		17.82 - BP, 0-5°, PL, RO, CN. 18.24 - BP, 0-5°, PL, RO, CN.
		-13	18		INTERBEDDED SANDSTONE/SHALE: sandstone (70%) pale grey and grey, fine grained, shale (30%), dark grey, bedded at 0°-10°, variable spacing.		●	D 0.63 A 1.7			18.80 - JT, 0-5°, PL, RO, CN.
		-14	19		BH05 terminated at 19m						
		-15	20

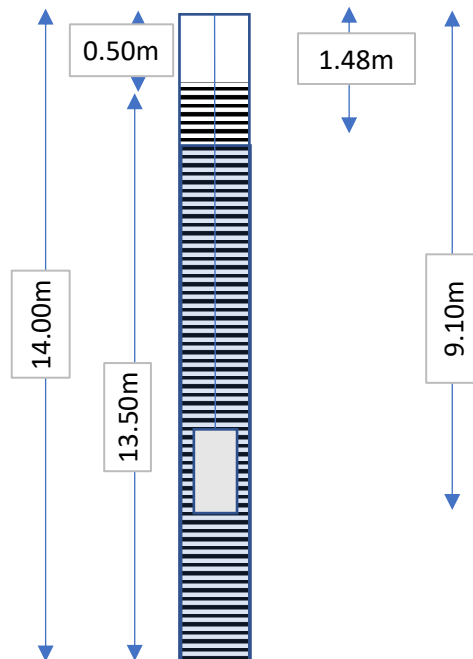
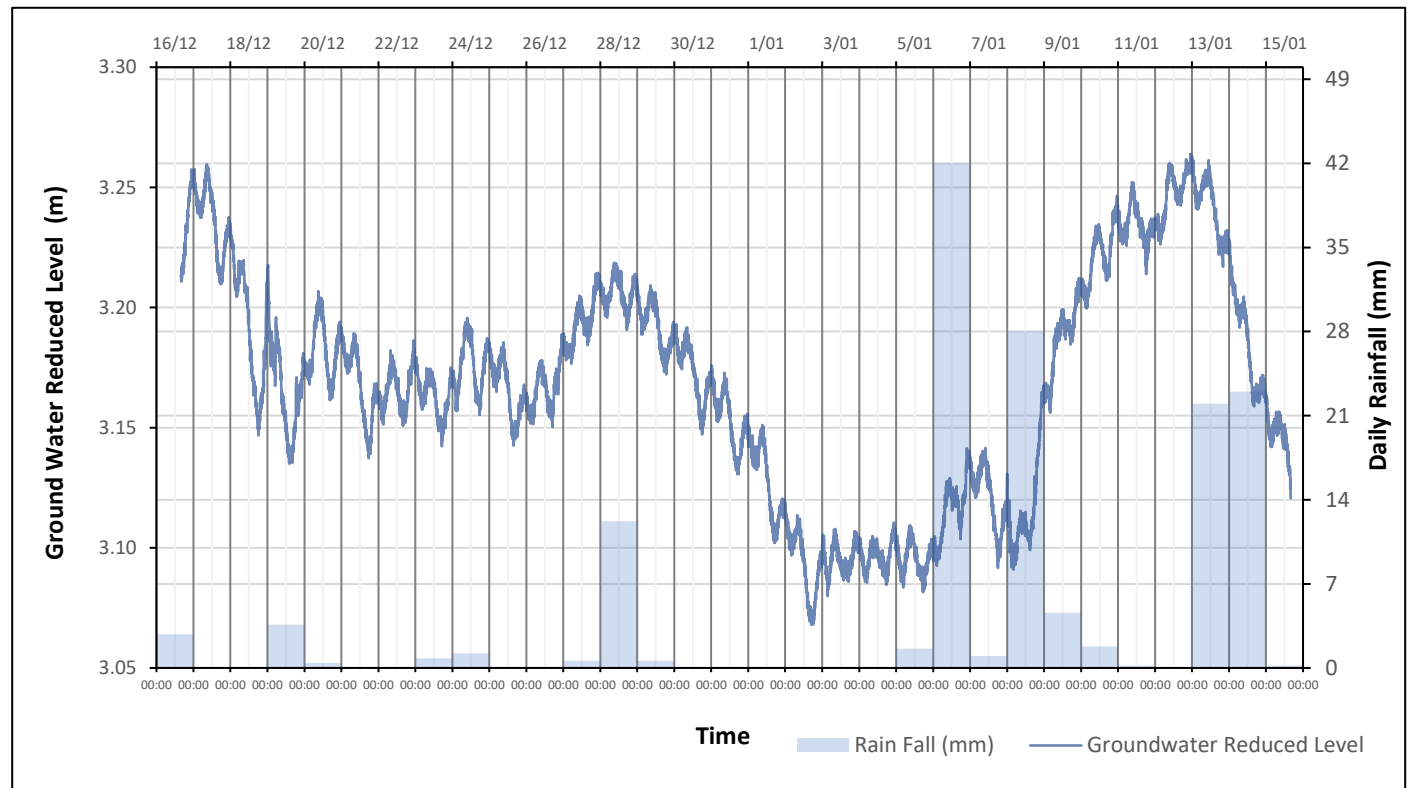
Test	BH01				
Borehole Data		Unit	Value	Borehole Data	
Initial Ground Water Depth (bgs)		m	1.48	Solid Casing Length(L)	
Casing Radius (r_c)		m	0.025	Screened Length (L_e)	
Borehole Radius (r_w)		m	0.05	Existing Ground RL

Scaled Well and Logger Details		
Ground RL	m	4.7
Solid Length	m	0.5
Slotted Length	m	13.5
Logger Install Depth	m	9.1
Initial Water Level	m	1.48

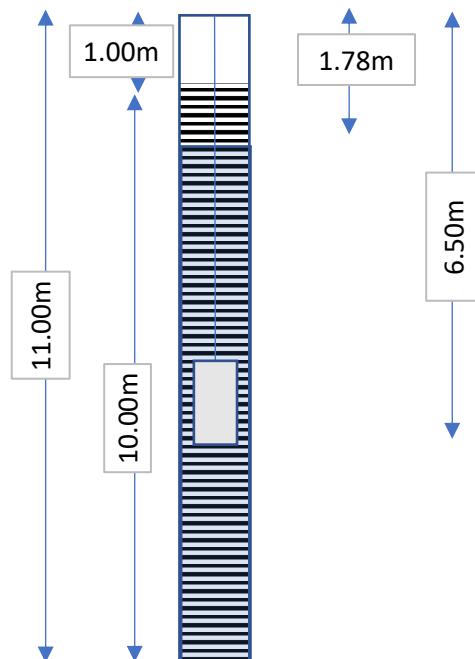
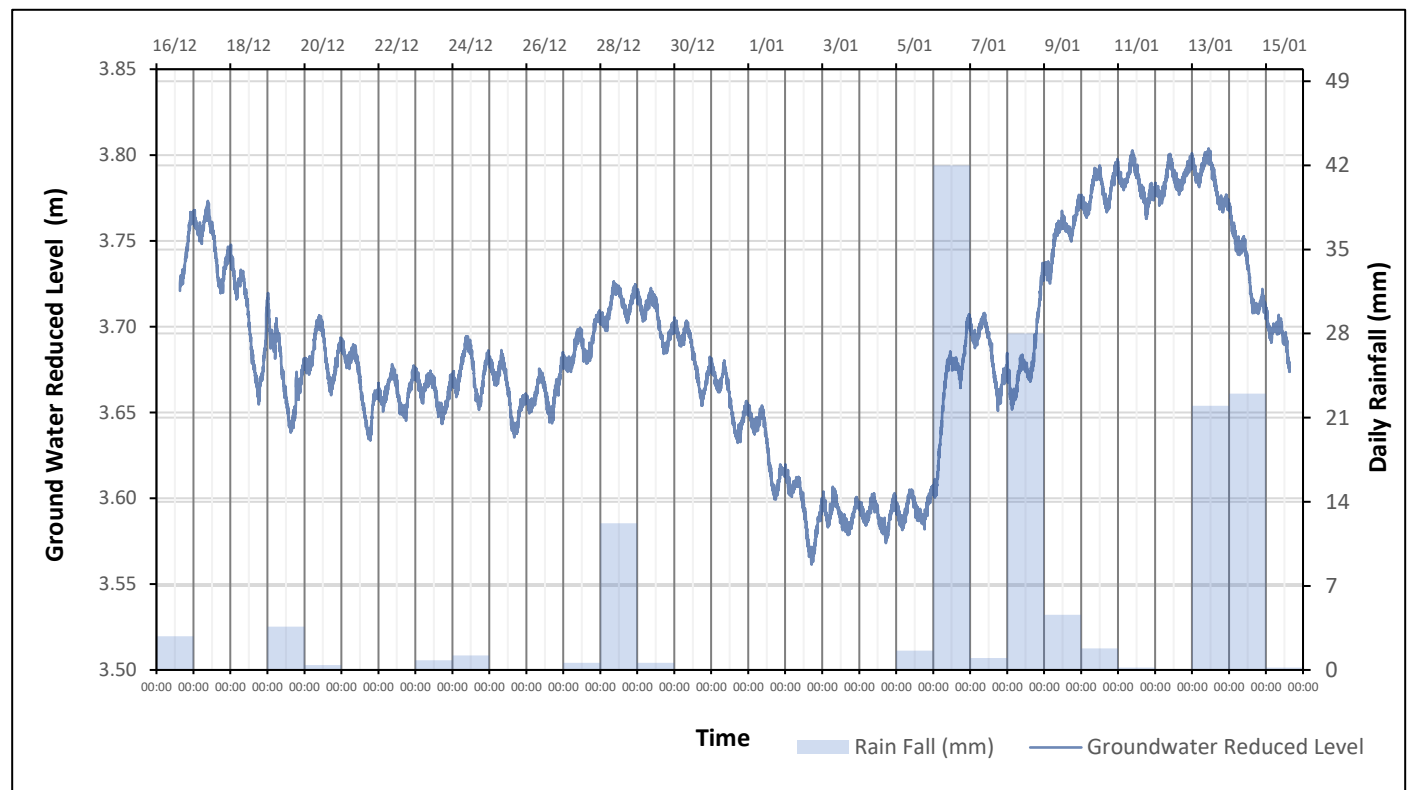
Test	BH02				
Borehole Data		Unit	Value	Borehole Data	
Initial Ground Water Depth (bgs)		m	1.78	Solid Casing Length(L)	
Casing Radius (r_c)		m	0.025	Screened Length (L_e)	
Borehole Radius (r_w)		m	0.05	Existing Ground RL

Scaled Well and Logger Details		
Ground RL	m	5.5
Solid Length	m	1
Slotted Length	m	10
Logger Install Depth	m	6.5
Initial Water Level	m	1.78

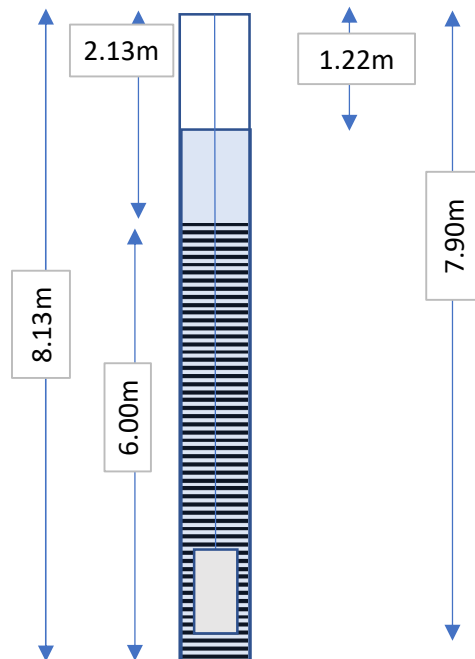
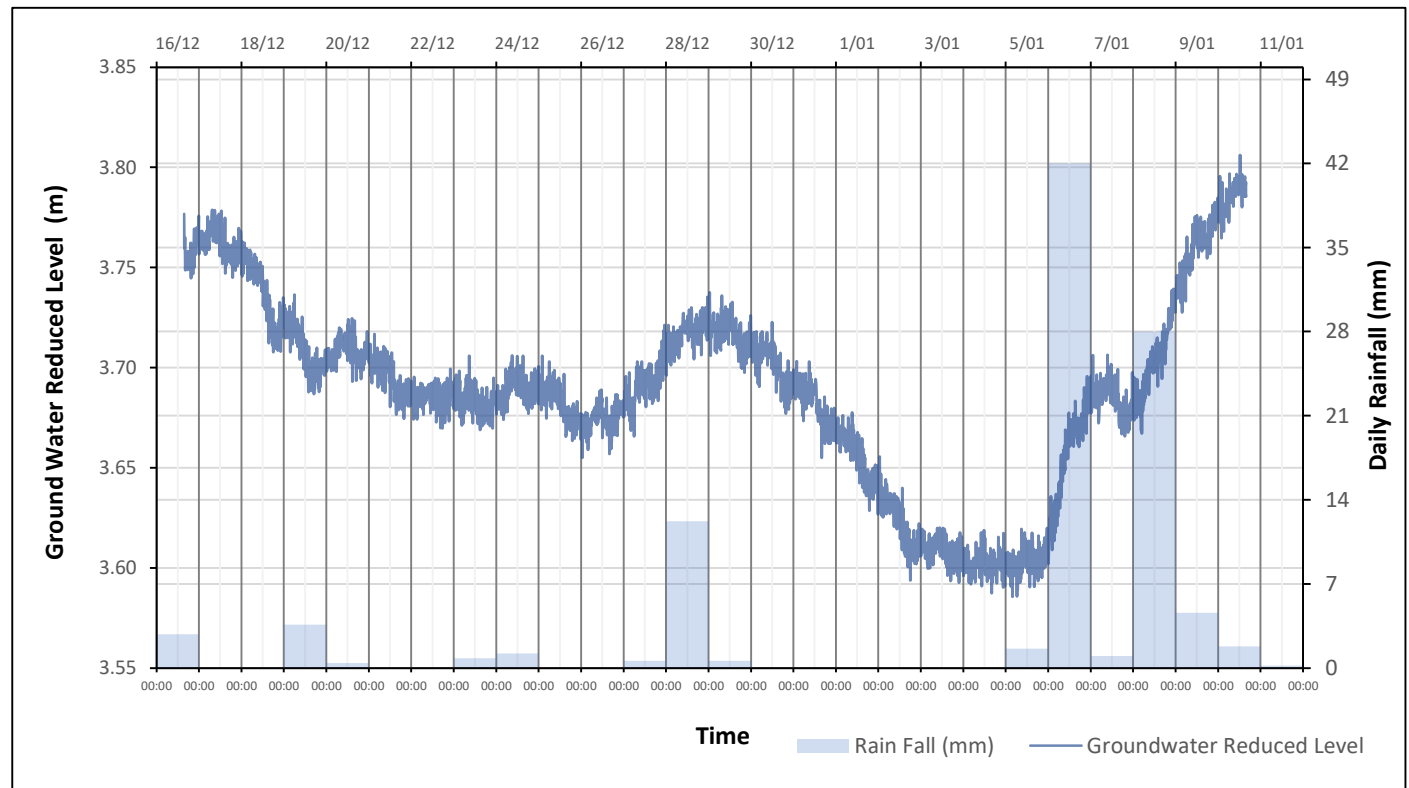
Test	BH05						
Borehole Data		Unit	Value	Borehole Data		Unit	Value
Initial Ground Water Depth (bgs)		m	1.22	Solid Casing Length(L)		m	2.13
Casing Radius (r_c)		m	0.025	Screened Length (L_e)		m	6
Borehole Radius (r_w)		m	0.05	Existing Ground RL		m	5

Scaled Well and Logger Details		
Ground RL	m	5
Solid Length	m	2.13
Slotted Length	m	6
Logger Install Depth	m	7.9
Initial Water Level	m	1.22

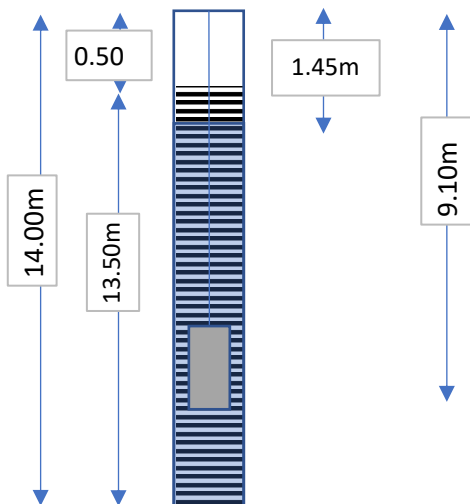
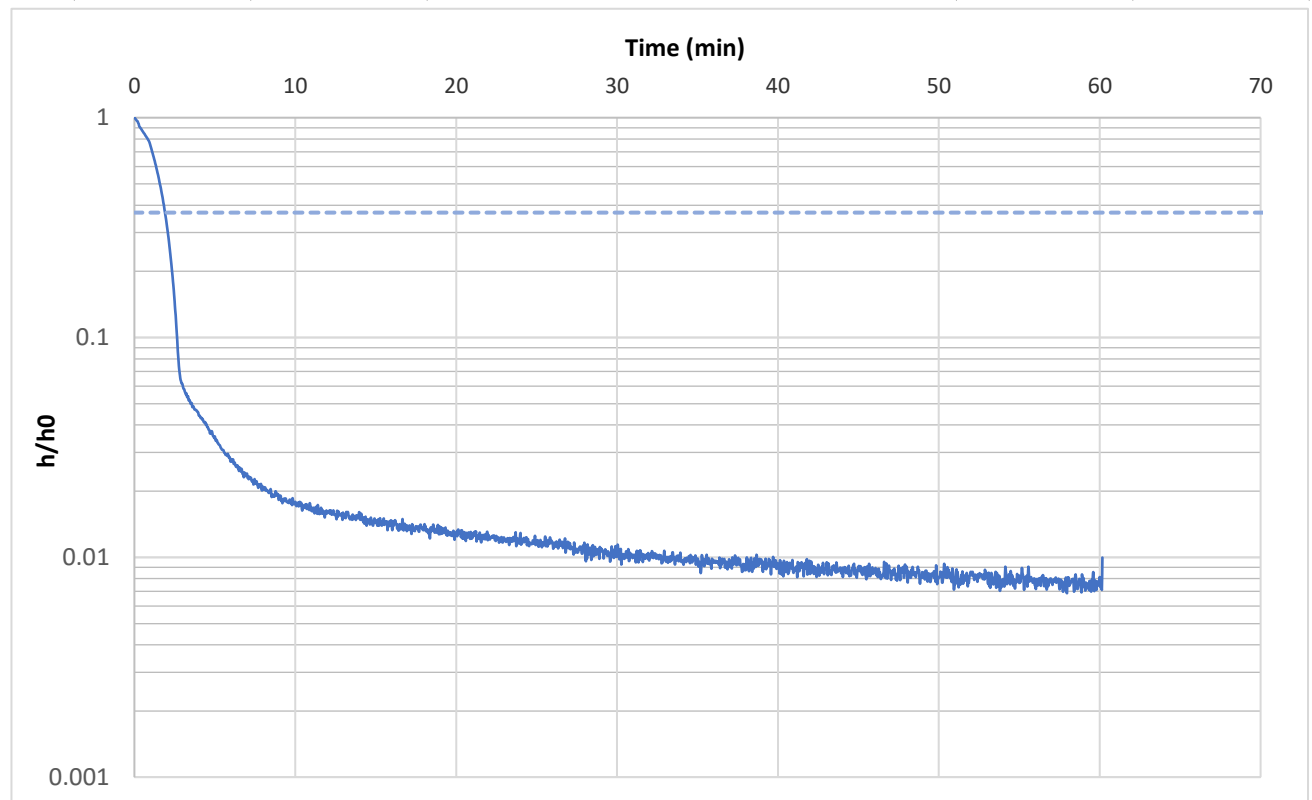
Client :	2A Gregory Place Pty Ltd	Location:	BH01
Project :	Proposed Mixed Residential and Commercial Development	Job Number :	13091
Test Location:	(refer to drawing 13091-GR-1-A)	Test Date :	24/01/2022
Test Method :	Hvorslev's Method (1951)	Tested By :	KT

Test	BH01				
Borehole Data			Unit	Value	
Initial Ground Water Depth (bgs)			m	1.45	
Groundwater Depth at t=0s			m	6.83	
Casing Radius (r _c)			m	0.025	
Borehole Radius (r _w)			m	0.05	
Borehole Data			Unit	Value	
Solid Casing Length (L)			m	0.5	
Screened Length (L _e)			m	13.5	
Characteristic Time (t ₀)			min	1.900016667	
Hydraulic Conductivity (k)			m/day	0.0982

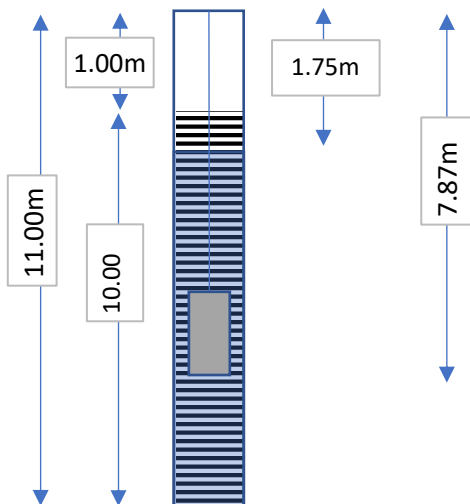
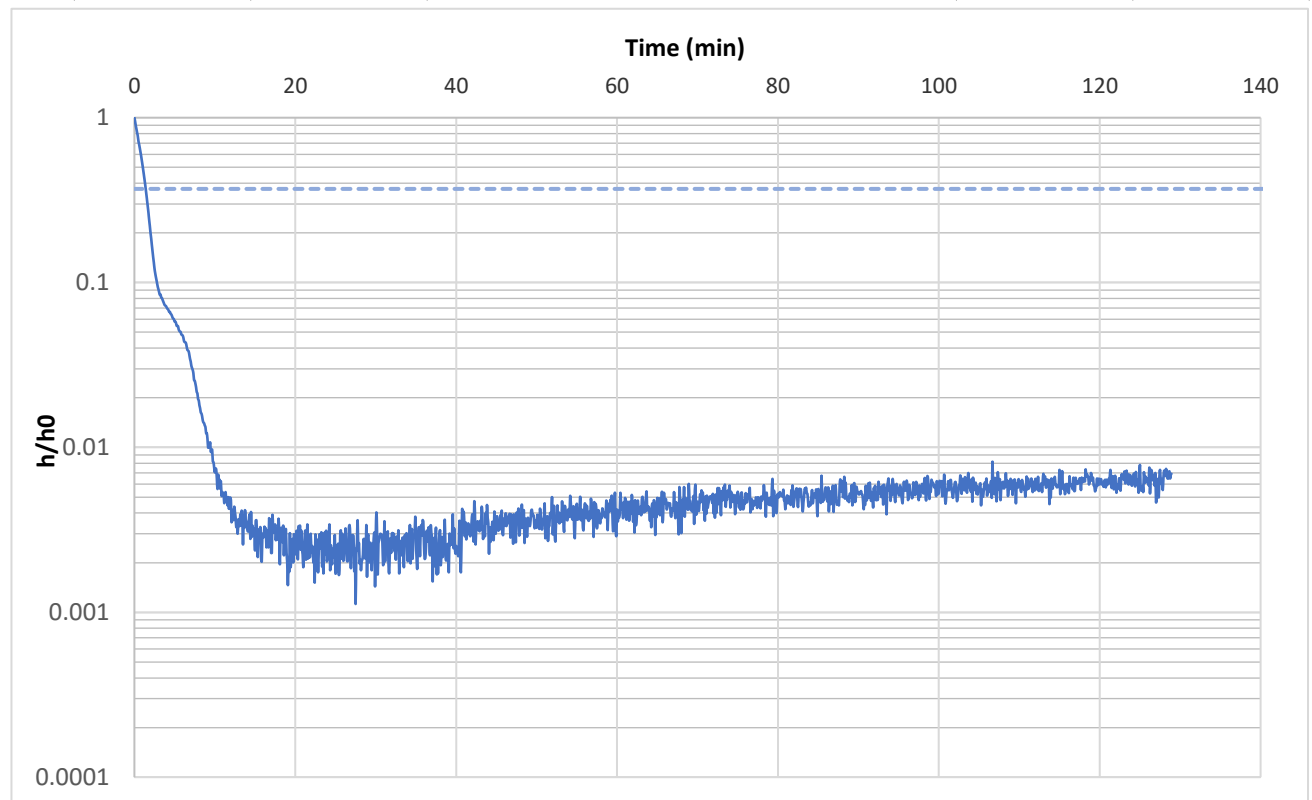
Client :	2A Gregory Place Pty Ltd	Location:	BH02
Project :	Proposed Mixed Residential and Commercial Development	Job Number :	13091
Test Location:	(refer to drawing 13091-GR-1-A)	Test Date :	24/01/2022
Test Method :	Hvorslev's Method (1951)	Tested By :	KT

Test	BH02				
Borehole Data		Unit	Value	Borehole Data	
Initial Ground Water Depth (bgs)		m	1.75	Solid Casing Length (L)	
Groundwater Depth at t=0s		m	5.67	Screened Length (L _e)	
Casing Radius (r _c)		m	0.025	Characteristic Time (t ₀)	
Borehole Radius (r _w)		m	0.05	Hydraulic Conductivity (k)	
				m/day	0.1683

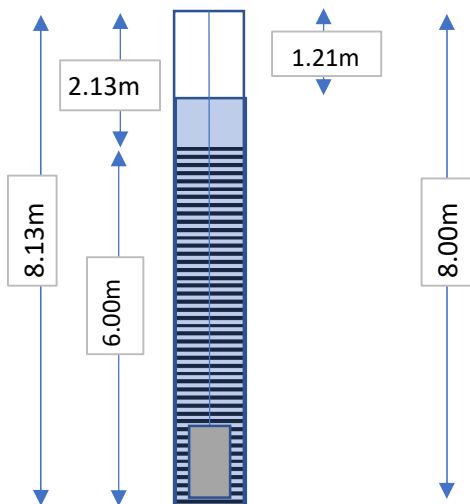
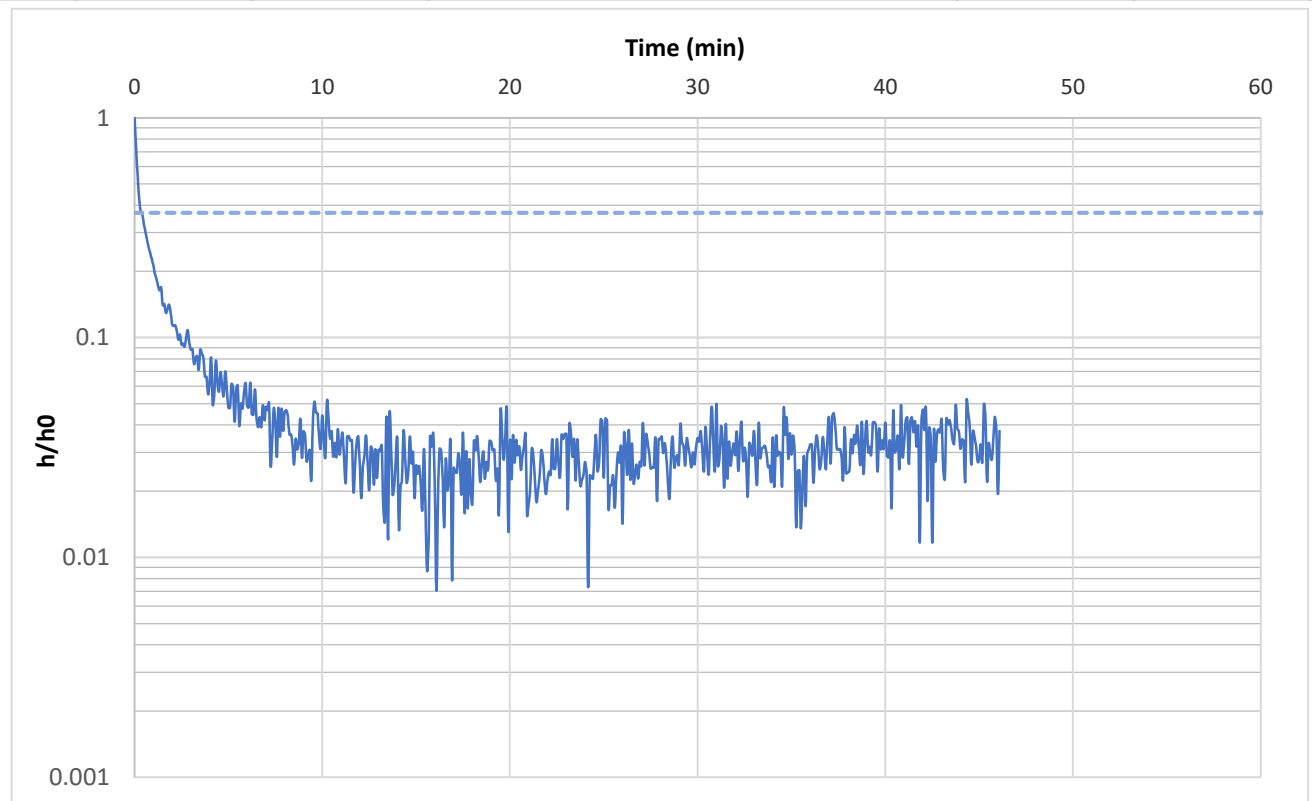
Client :	2A Gregory Place Pty Ltd	Location:	BH05
Project :	Proposed Mixed Residential and Commercial Development	Job Number :	13091
Test Location:	(refer to drawing 13091-GR-1-A)	Test Date :	24/01/2022
Test Method :	Hvorslev's Method (1951)	Tested By :	KT

Test	BH05				
Borehole Data		Unit	Value	Borehole Data	
Initial Ground Water Depth (bgs)		m	1.21	Solid Casing Length (L)	
Groundwater Depth at t=0s		m	1.96	Screened Length (L _e)	
Casing Radius (r _c)		m	0.025	Characteristic Time (t ₀)	
Borehole Radius (r _w)		m	0.05	Hydraulic Conductivity (k)	
				m/day	0.8617
