Historical Archaeological Heritage Impact Assessment

2A Gregory Place, Harris Park, NSW
(Lot 2 in DP 807801)

Report to
2A Gregory Place Pty Ltd

Dominic Steele Consulting Archaeology
June 2022

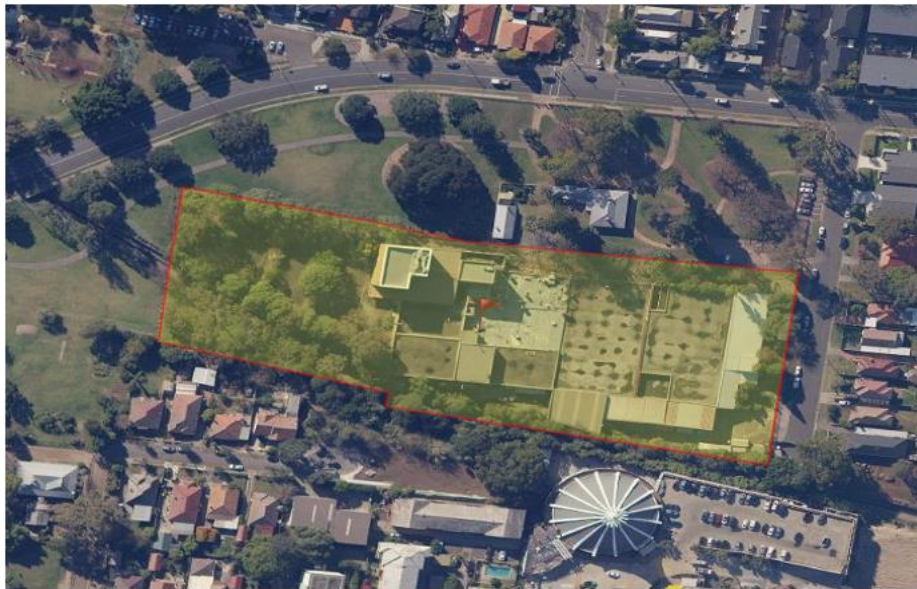
Figure 1.1: The 2A Gregory Place property (comprising Lot 2 in DP 807801) is approximately 19,500 sqm in size and comprises a former light industrial pharmaceuticals assembly complex that has been adapted for office use and storage (Six Maps 2021)

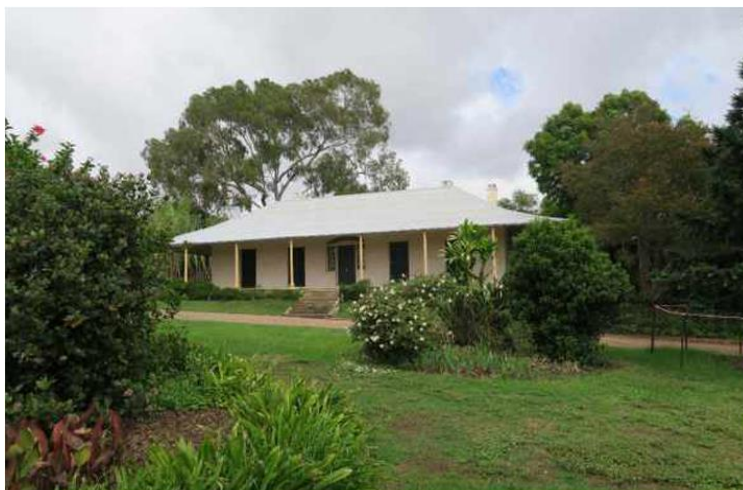
Figure 1.2: Experiment Farm cottage (Hector Abrahams Architects 2017: Figure 37)

Experiment Farm is of National significance as one of Australia's oldest standing properties that is on the site of the first British land grant in Australia. It was the first house purchased by the National Trust (NSW) in 1961 after which in 2000 the former Parramatta City Council acquired it and demolished suburban dwellings that encroached onto the cottage.

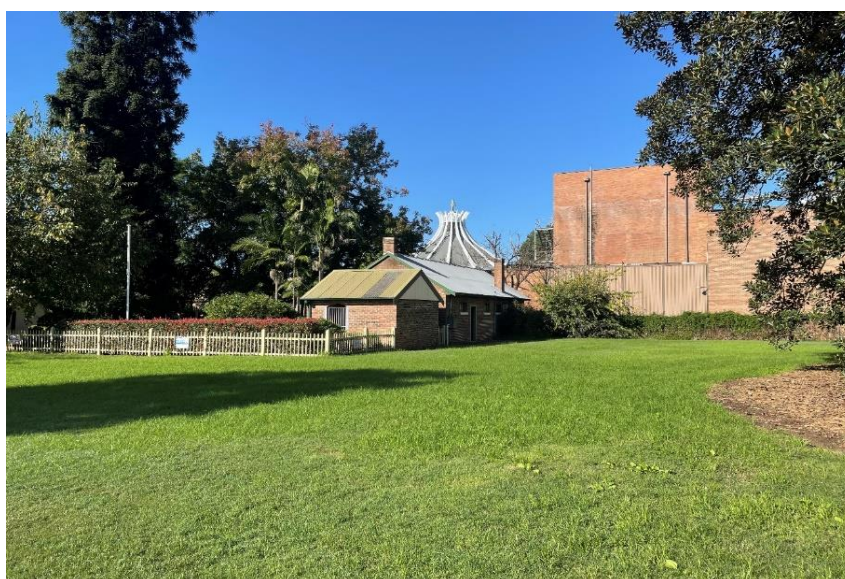
Figure 1.3: Hambledon Cottage and its surrounding ground levels that potentially preserve significant archaeological resources below ground with the built-form of the exiting factory on the 2A Gregory Place property in the background. The construction of these buildings in the 1950s cut-down the original ground levels across the footprint of the site to various depths, many areas by at least 1.0m and in some locations (below the main factory building shown for example) considerably deeper

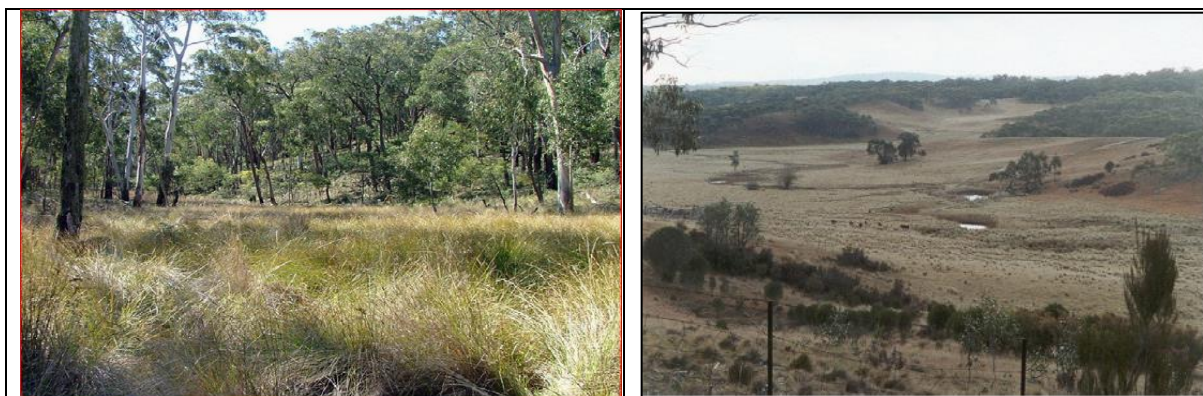
Figure 3.2: An example (left) of a swampy meadow located in a valley of the Upper Shoalhaven of NSW with disconnected pools. A typical swampy meadow (Neville State Forest) showing a valley floor vegetated with sedge and tussock grass (Mactaggart et al 2007: 462)

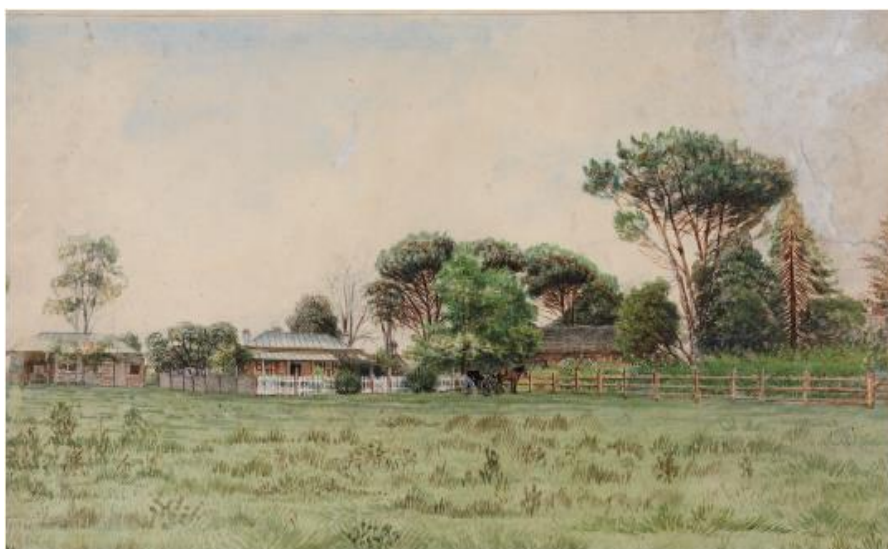
Figure 3.5: *A single fronted cottage facing east, enclosed by a semi-circular picket fence, with stables and outbuildings to the south. The well-established garden and coach house of Hambledon is seen to the north across a three railed hardwood fence' (HHT 2006)*

During the 1850s Experiment Farm was changed by Thomas Harris who established a dairy farm and fenced the land into paddocks and Edward MacArthur built a brick cottage between Hambledon cottage and Clay Cliff Creek for a long-term employee, George Neale.

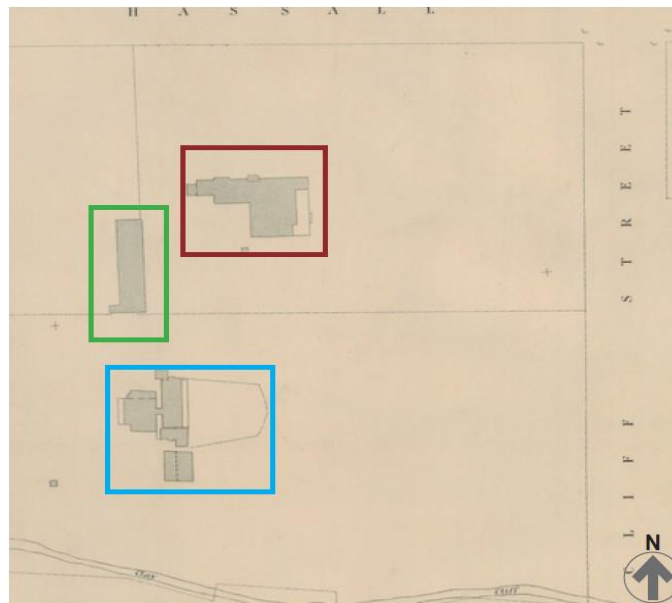
Figure 3.8: Detailed survey of Parramatta showing Neale's cottage with stable and outbuilding (blue) on the south side of Hambledon cottage (red) and coachman's cottage (green) on the southwest side of Hambledon Cottage (GBA Heritage 2021: Figure 2.22)

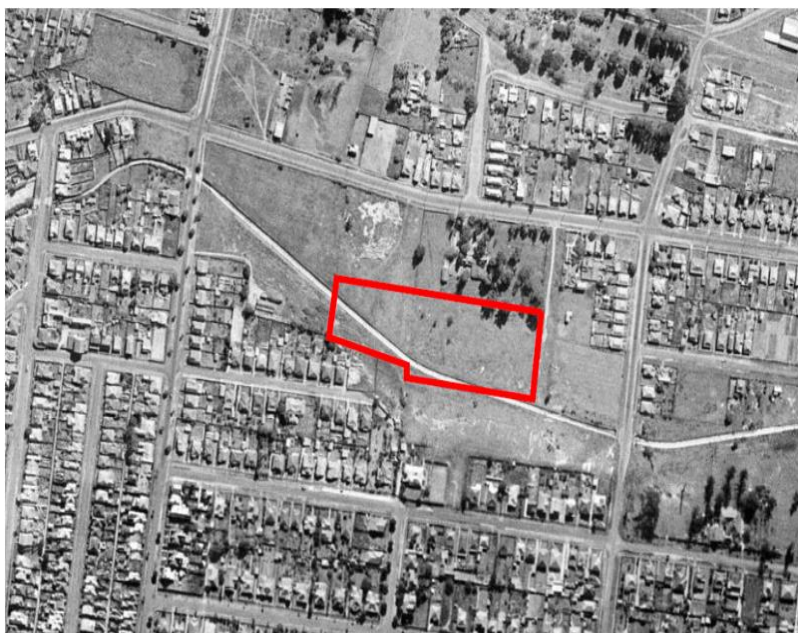
Figure 3.8: The 2A Gregory Place site shown as vacant land crossed by the stormwater channel of Clay Cliff Creek in 1943 (Sullivan-ES 2015)

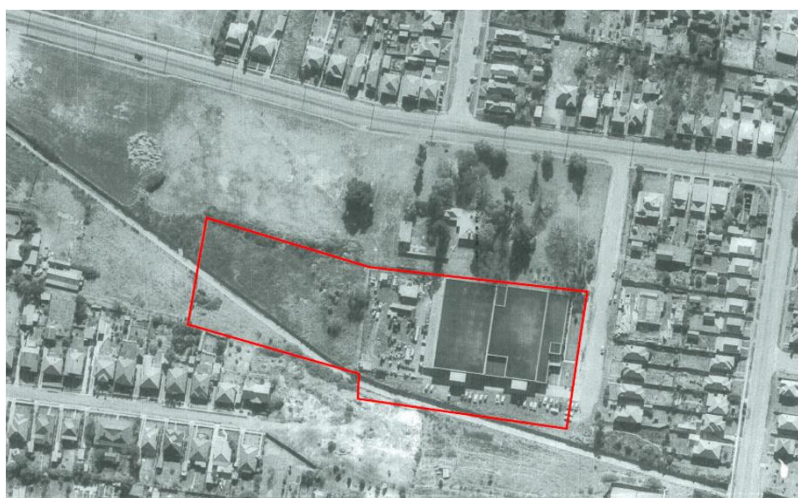
Figure 3.9: The study area in 1961 (Sullivan-ES 2015)

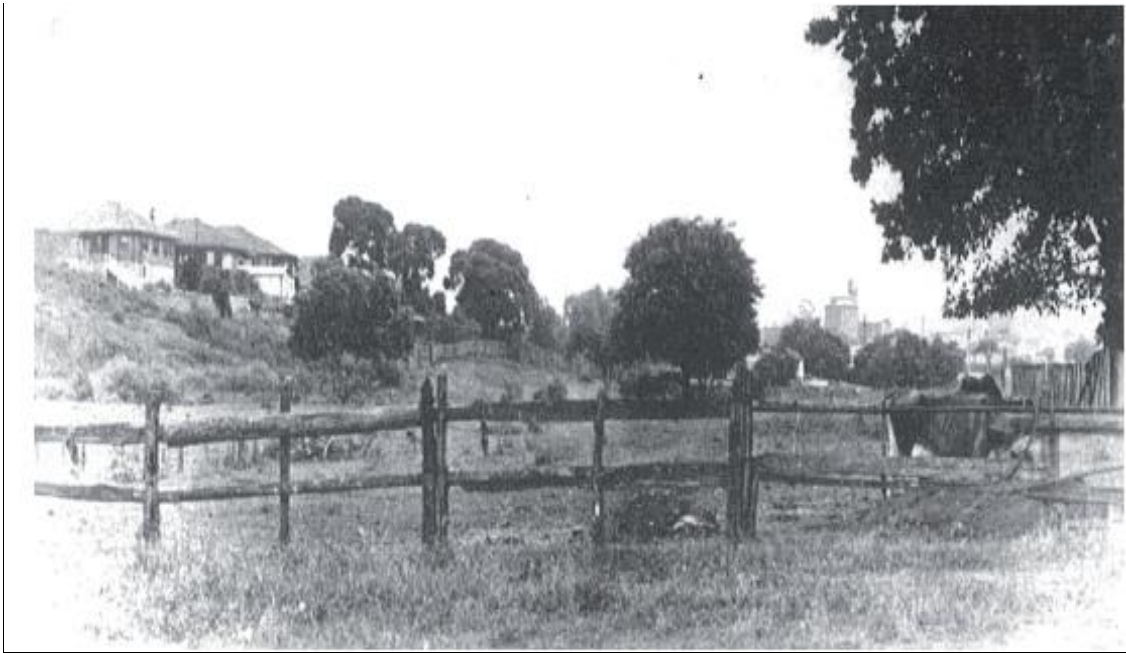
Figure 3.10: The 2A Gregory Place site prior to the construction of the existing factory in 1945 (GBA Heritage 2021: Figure 2.84)

The Statement of Heritage Impact prepared for the site (GBA Heritage 2021) details the early twentieth century land subdivision and purchases that led to the consolidation and creation of a large lot for the construction of the existing factory. The images below drawn from the SoHI show the nature of the ground surface and the coachman's cottage before the factory was built.

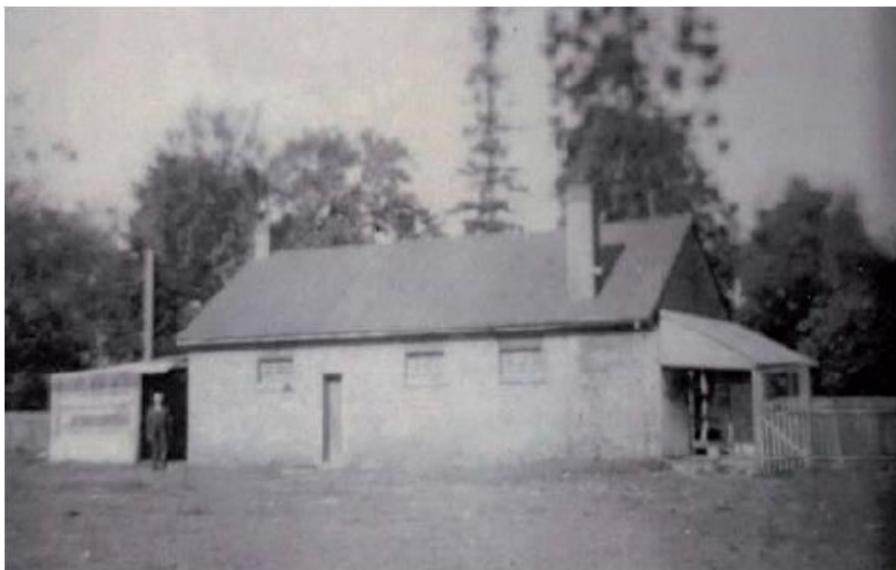
Figure 3.11: Looking west at the coachman's cottage located on the southwestern side of Hambleton cottage before the construction of the factory on the 2A Gregory Place site in 1945 (GBA Heritage 2021: Figure 2.85)

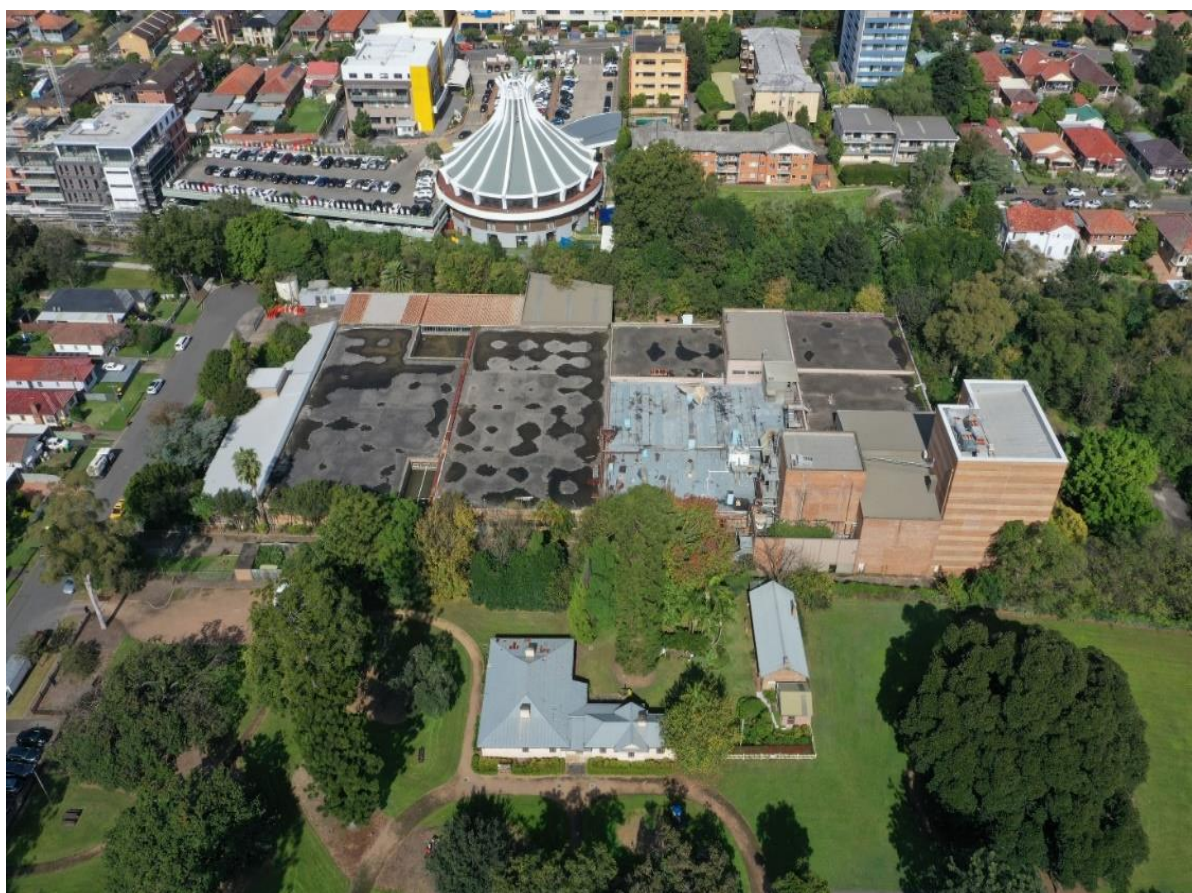
Figure 4.1: 2A Gregory Place context and setting and built form

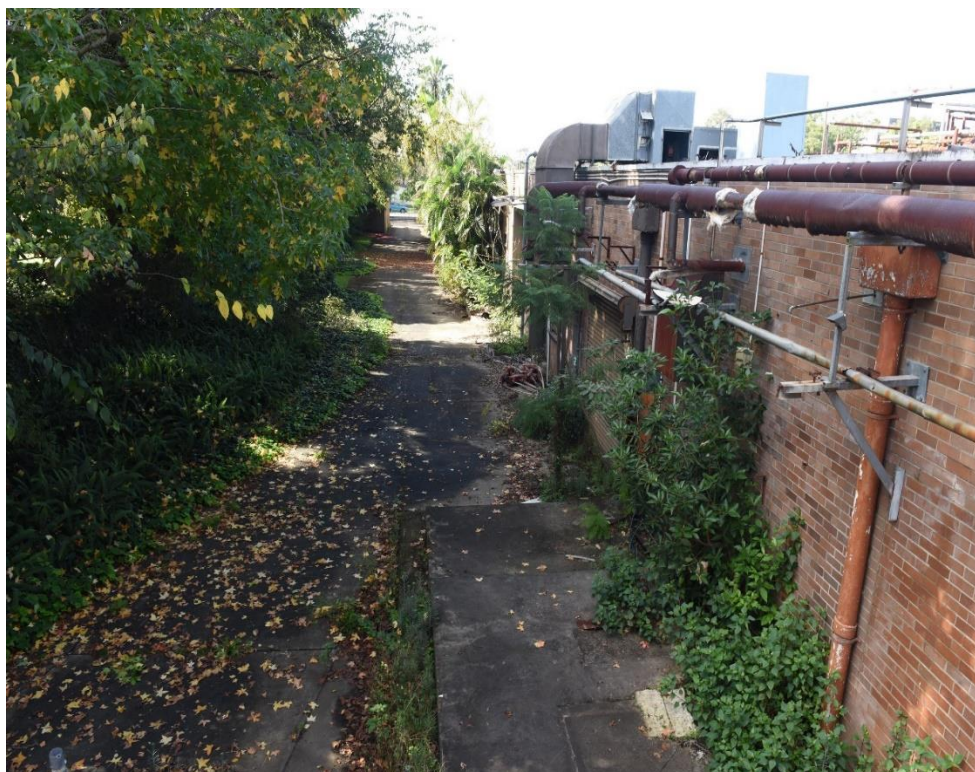
Figure 4.2: Indicative external building space along southern side of site (looking west) showing the boundary it shares with the grounds of Hambledon Cottage (left) and the extent to which the factory construction has lowered the ground here

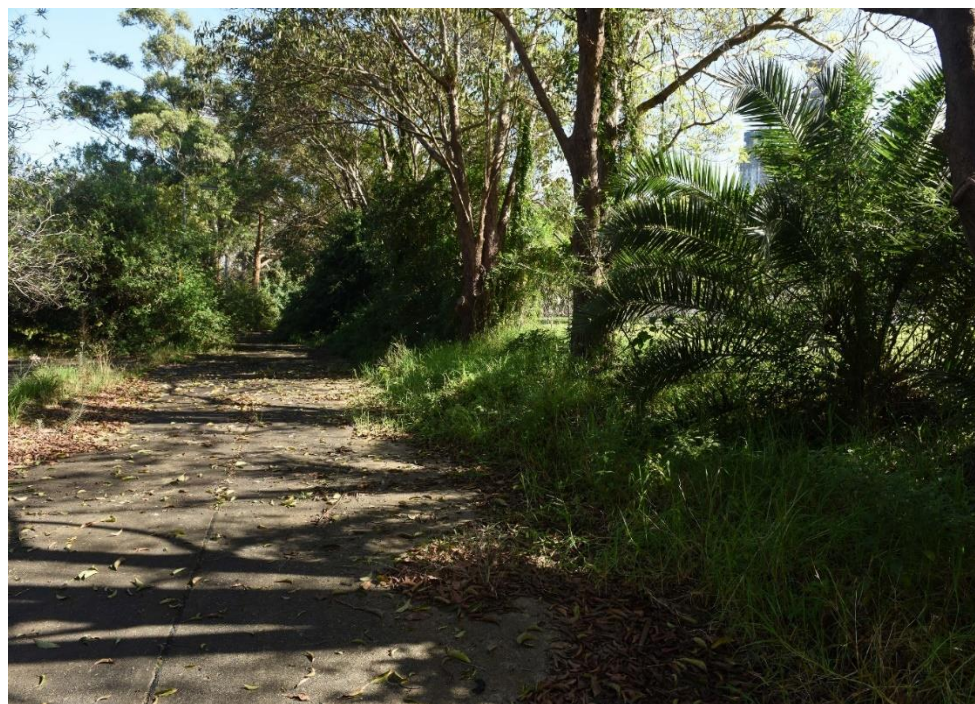
Figure 4.3: Indicative external space – southern side of building (looking east). Note to the right the difference in height between the existing (higher) ground on the adjacent Hambledon Cottage grounds and the bitumen surface

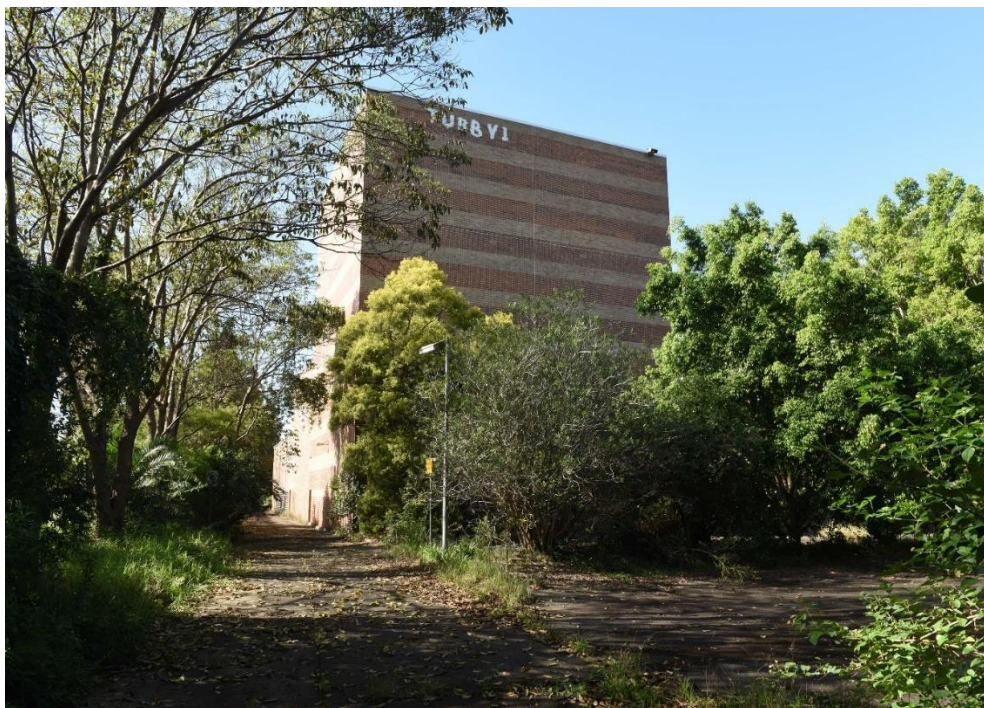
Figure 4.4: Building and carpark surface at the eastern side of the site

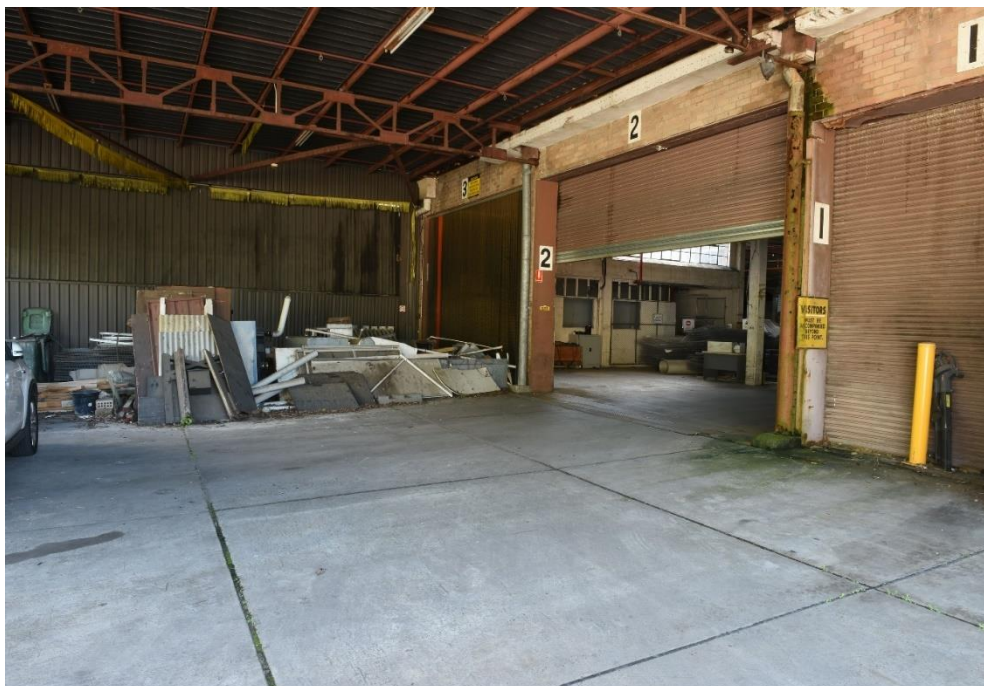
Figure 4.6: Indicative internal spaces (manufacturing and offices) in the western part of the site

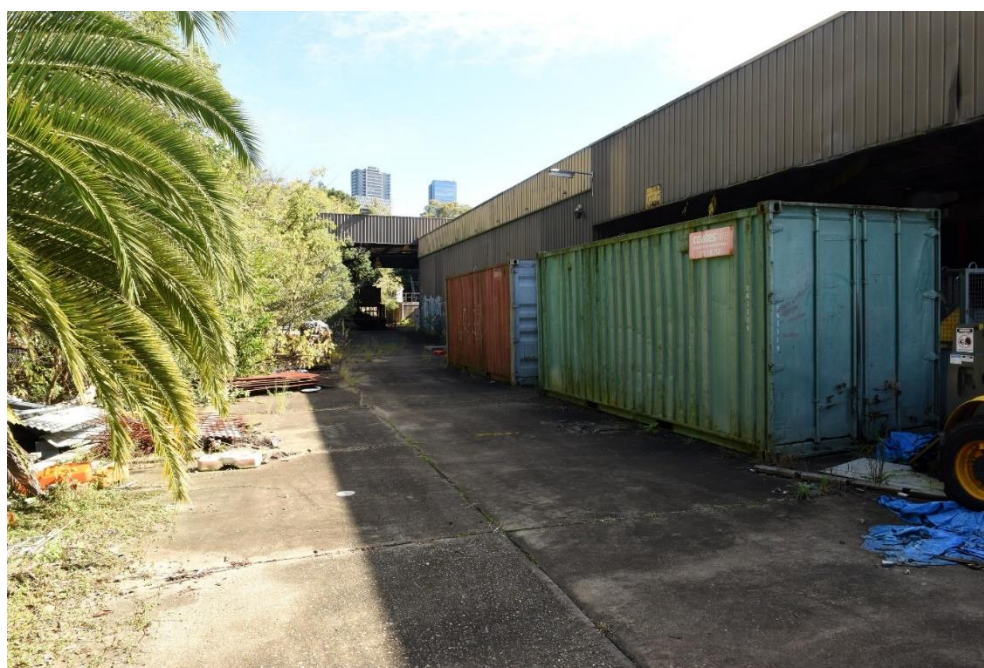
Figure 4.7: Indicative internal space in the northwestern part of the site (looking east). The canal for Clay Cliff Creek is about 6m to the right (obscured by vegetation)

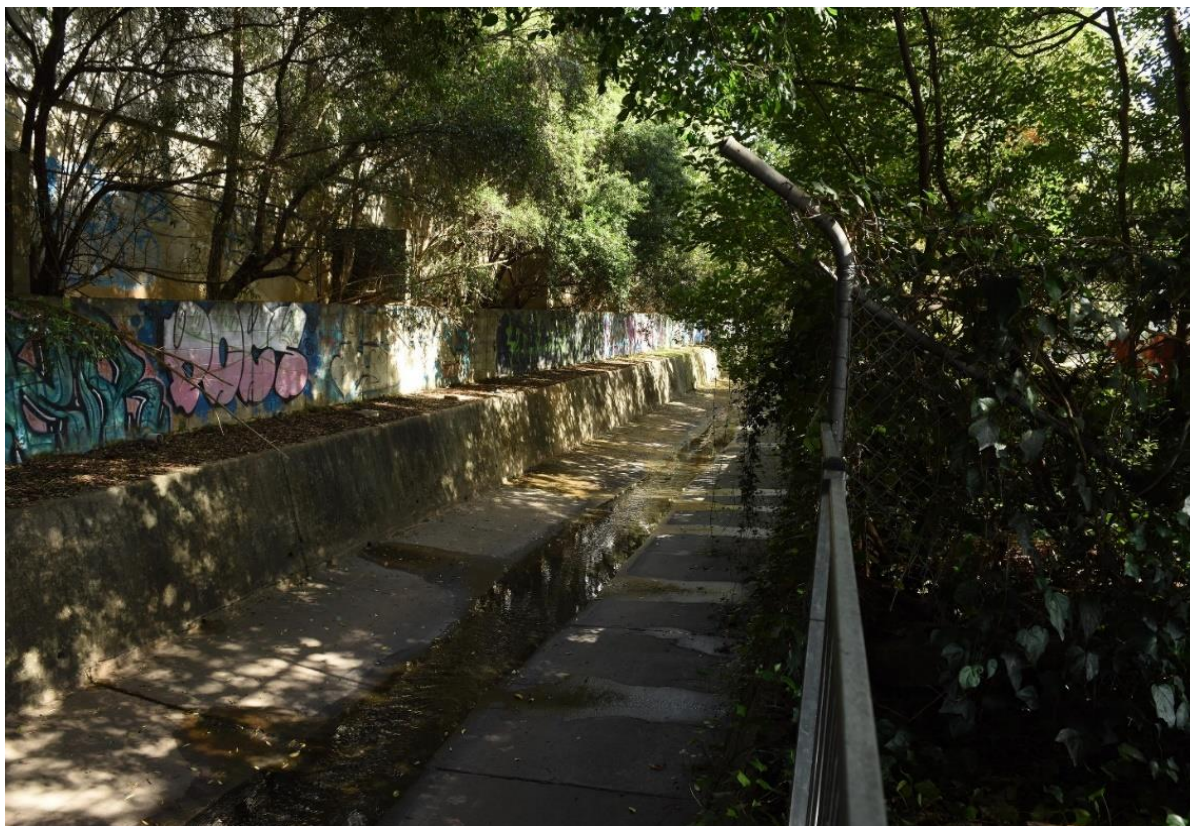
Figure 4.8: Indicative view of the canal for Clay Cliff Creek (looking east)

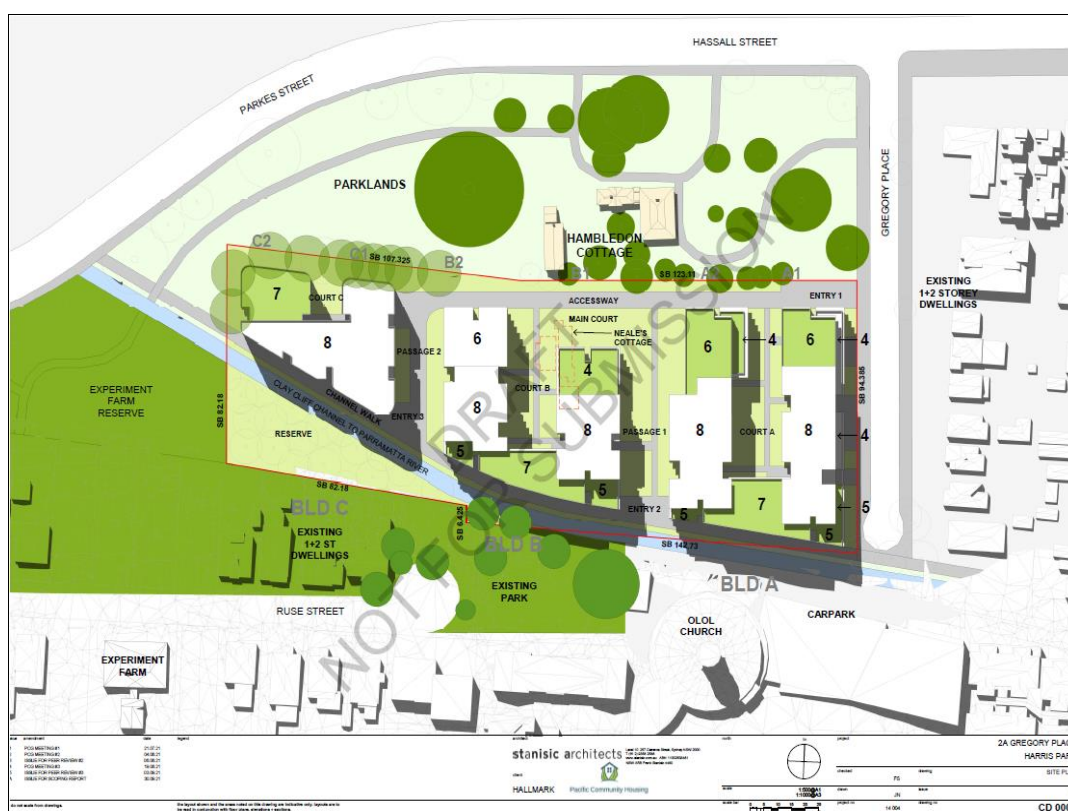
Figure 6.1: Assumed former location of 'Neale's cottage' within the proposed redevelopment (Stanisic Architects 2022)

This depth of potential subsurface impact below the footprint of the factory can be seen through comparison of the existing ground levels across the site with those recorded in the adjacent Hambledon cottage reserve and geotechnical information that provide building construction excavation depths.

For example, early twentieth century works for the construction of the Clay Cliff Creek stormwater channel extended over an area wider than just the 6m for the canal itself, and the depth of this feature is 3m below current ground-slab levels at the northern site boundary. Likewise, at the southern site boundary the factory shares with Hambledon cottage, geotechnical bore-logs in the vicinity of the assumed former location of the cottage (BH3 and BH4 for example in Attachment B) show that the original ground level has been lowered by at least 2.0m and deeper in places and the potential for substantial and intact historical archaeological features and deposits to survive is limited.

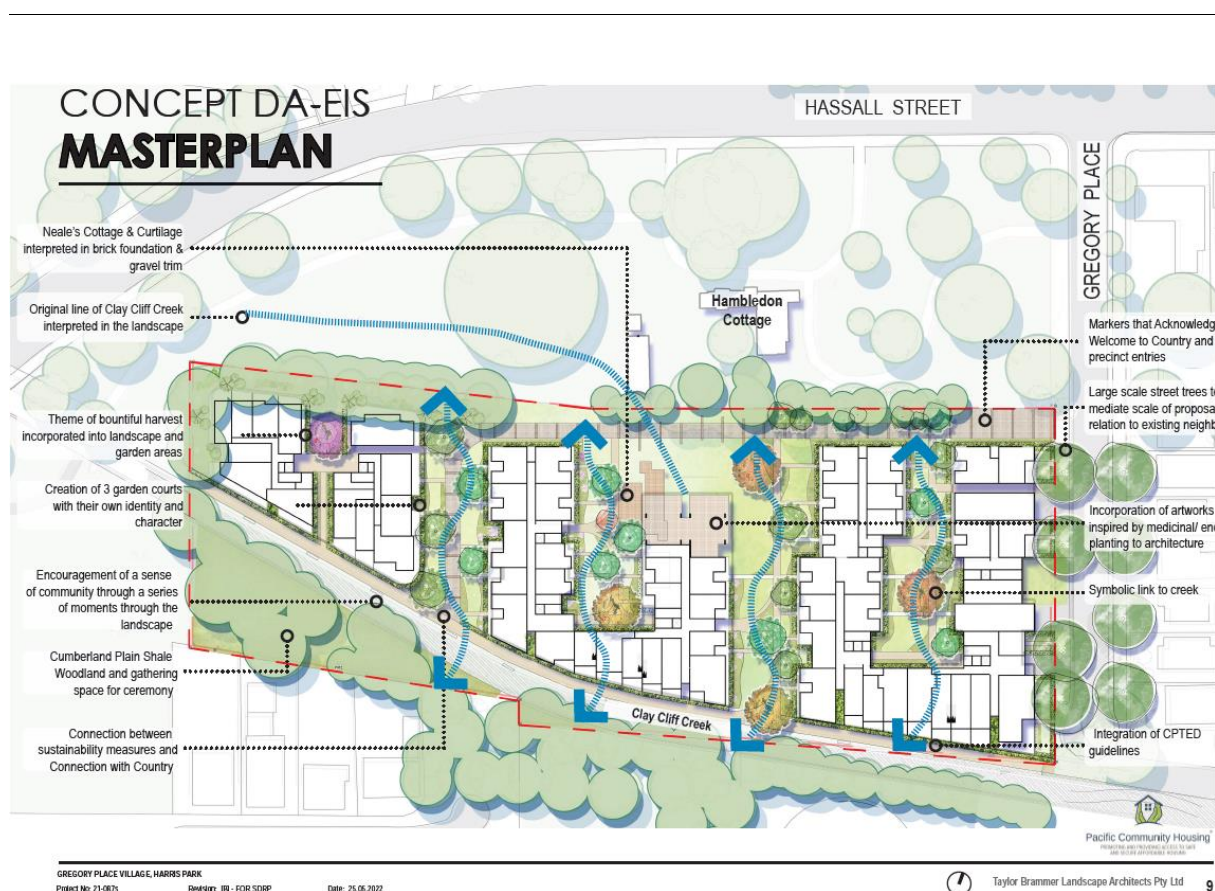
Figure 6.2: Future interpretation opportunities for the location of 'Neale's cottage' and Clay Cliff Creek within the proposed redevelopment (Taylor Brammer Landscape Architects Pty Ltd 2021)
