# **HERITAGE IMPACT STATEMENT**

42 Raymond Avenue  
Matrville

**HALE CAPITAL PARTNERS**

3 March 2022

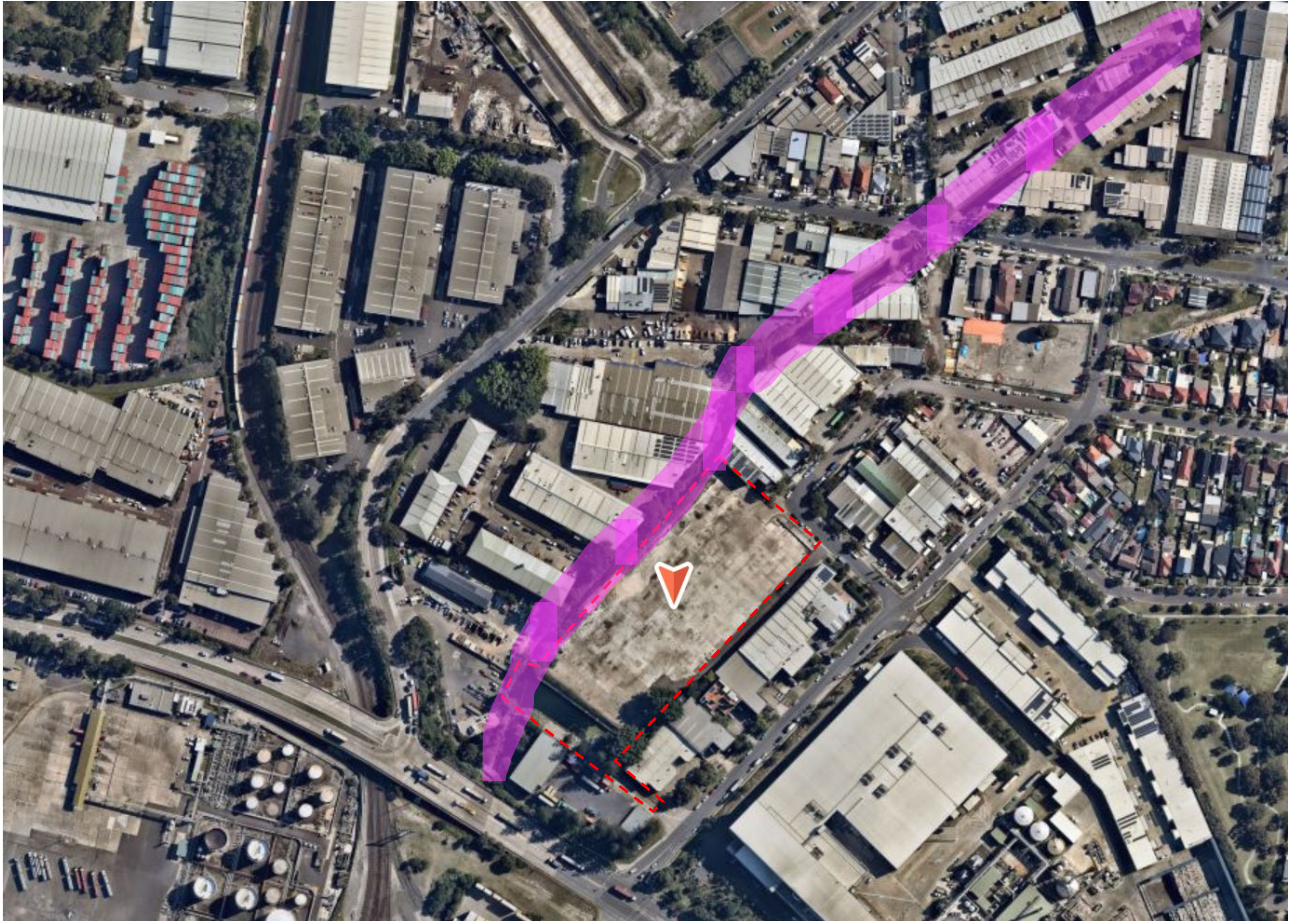
Figure 2 Extract of curtilage plan for the Bunnerong Stormwater Channel No 11 in magenta and subject site in red.

This heritage item is the storm water canal which extends along the subject area’s north-western boundary. The subject area is not located within the vicinity of any heritage items listed on an Environmental Planning Instrument or the NSW State Heritage Register.

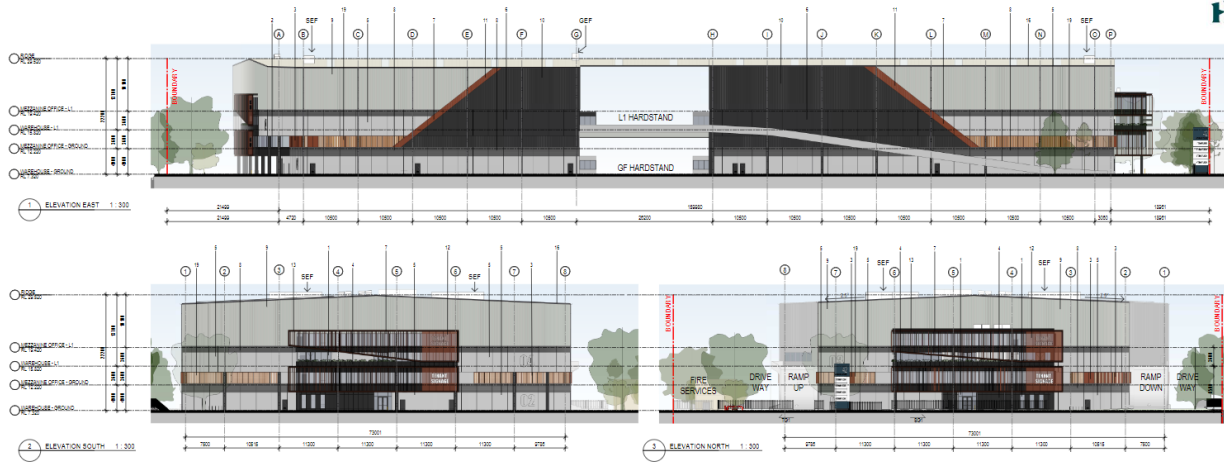
Figure 5 Extract from Elevations.

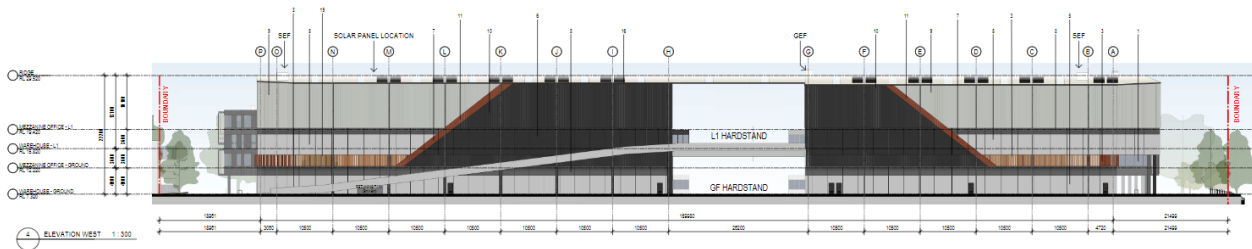
Figure 6 Extract from Elevations.

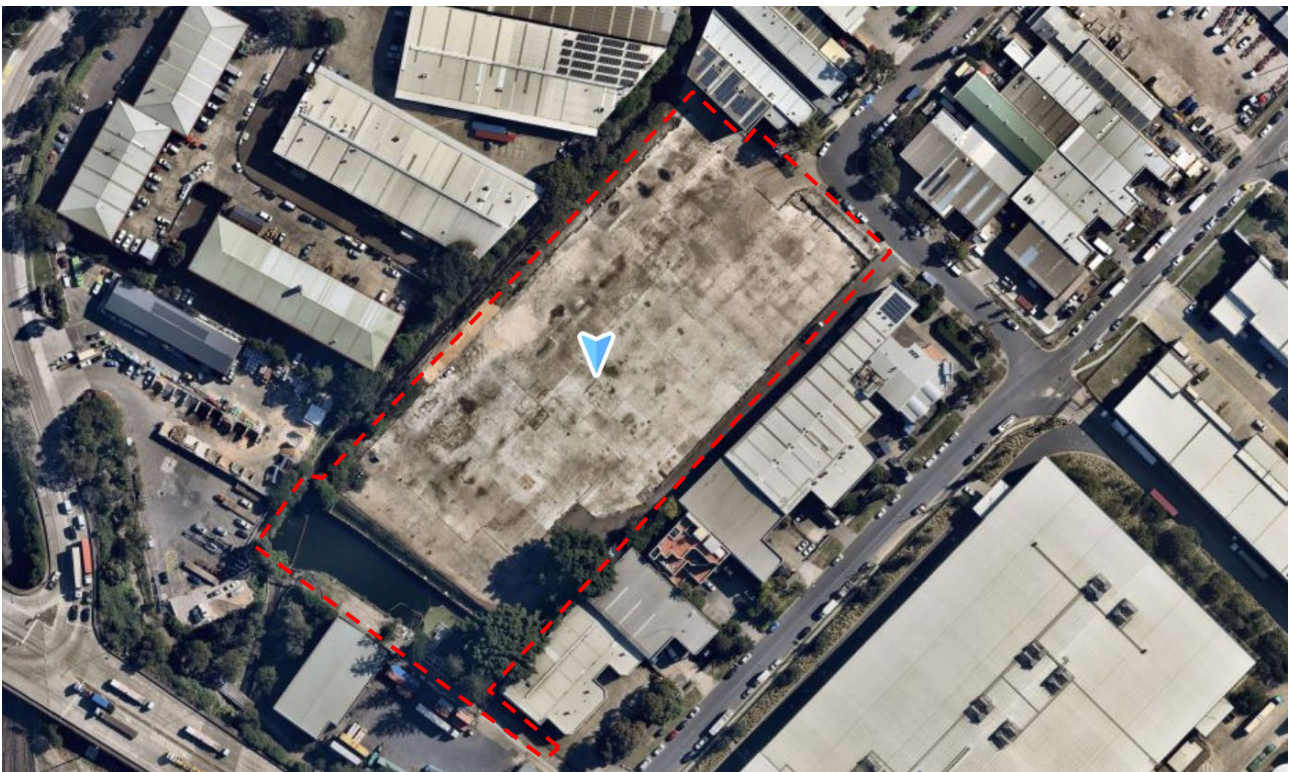
Figure 12 Recent aerial imagery of subject site, October 2021. Former warehouse has been demolished.

The subject site is currently a large, undeveloped vacant lot. The lot contains a sizeable hardstand area which occupies majority of the allotment. At the southern end of the allotment is a modest body of water that marks the end of the stormwater channel.

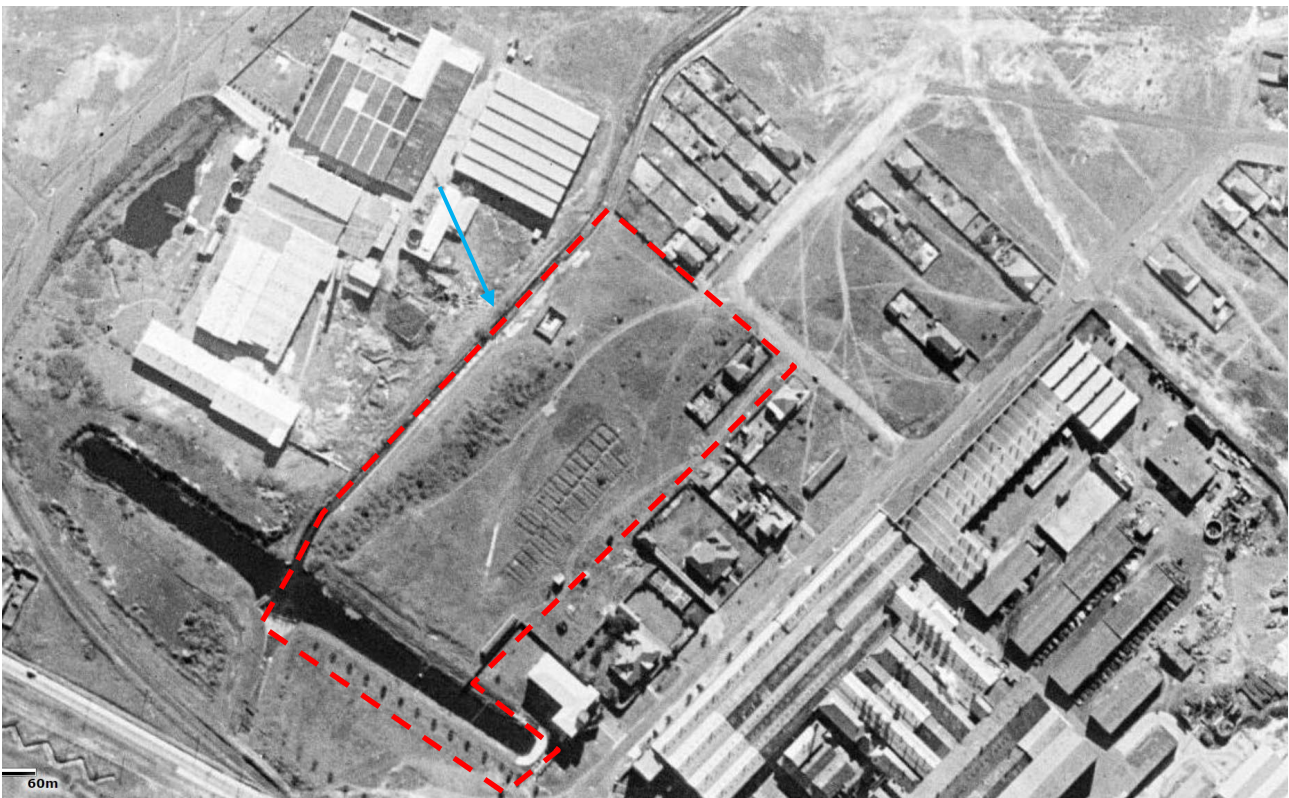
Figure 18 1943 aerial imagery of subject site. Approximate boundaries indicated in red. Bunnerong Stormwater channel indicated in blue.

In 1943, the site remained largely undeveloped with the exception of a few structures (Figure 18). By 1955, aerial imagery indicates a large warehouse had been developed on the site. Development on the subject site remained unchanged over the mid-to-late 20<sup>th</sup> century. The warehousing was demolished in 2021<sup>11</sup>.

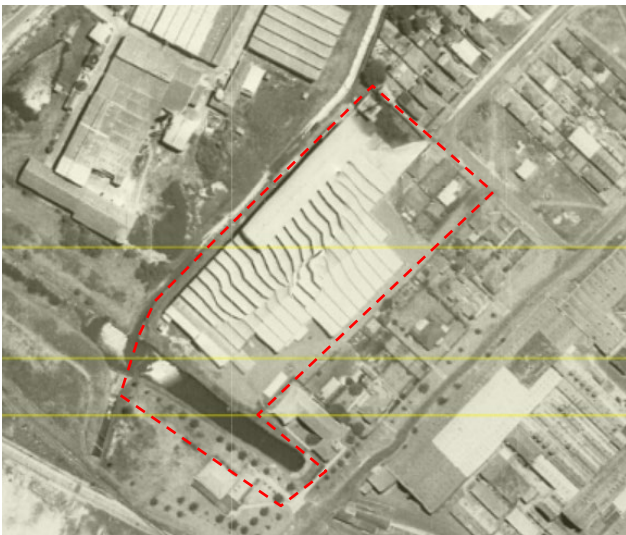
Figure 20 1955 aerial imagery of subject site. Approximate boundaries indicated.
