Remediation Action Plan

46-52 Raymond Avenue, Matraville NSW

March 2021

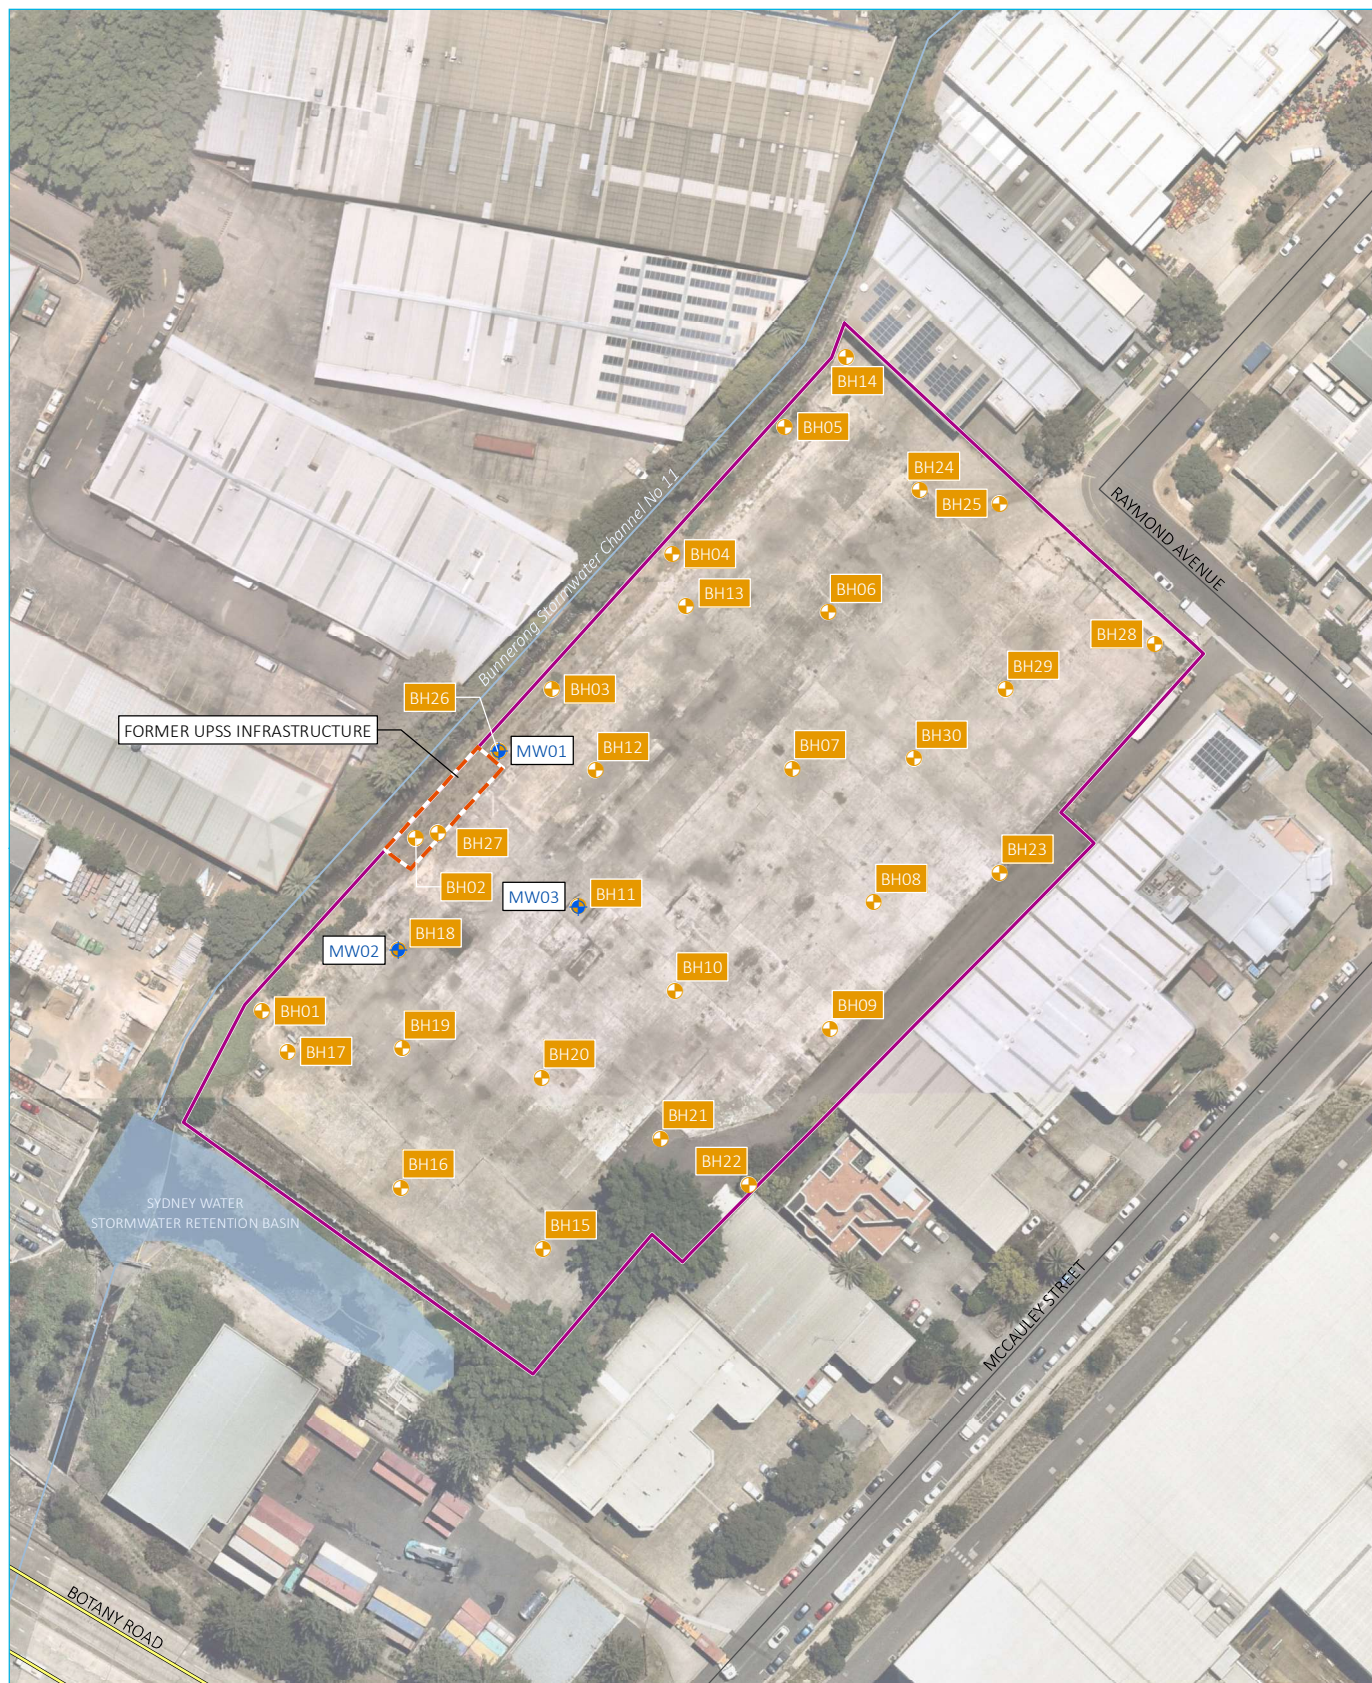
42-52 Raymond Avenue, Matraville NSW
Remediation action plan
Figure 2.1

Site layout and sampling locations

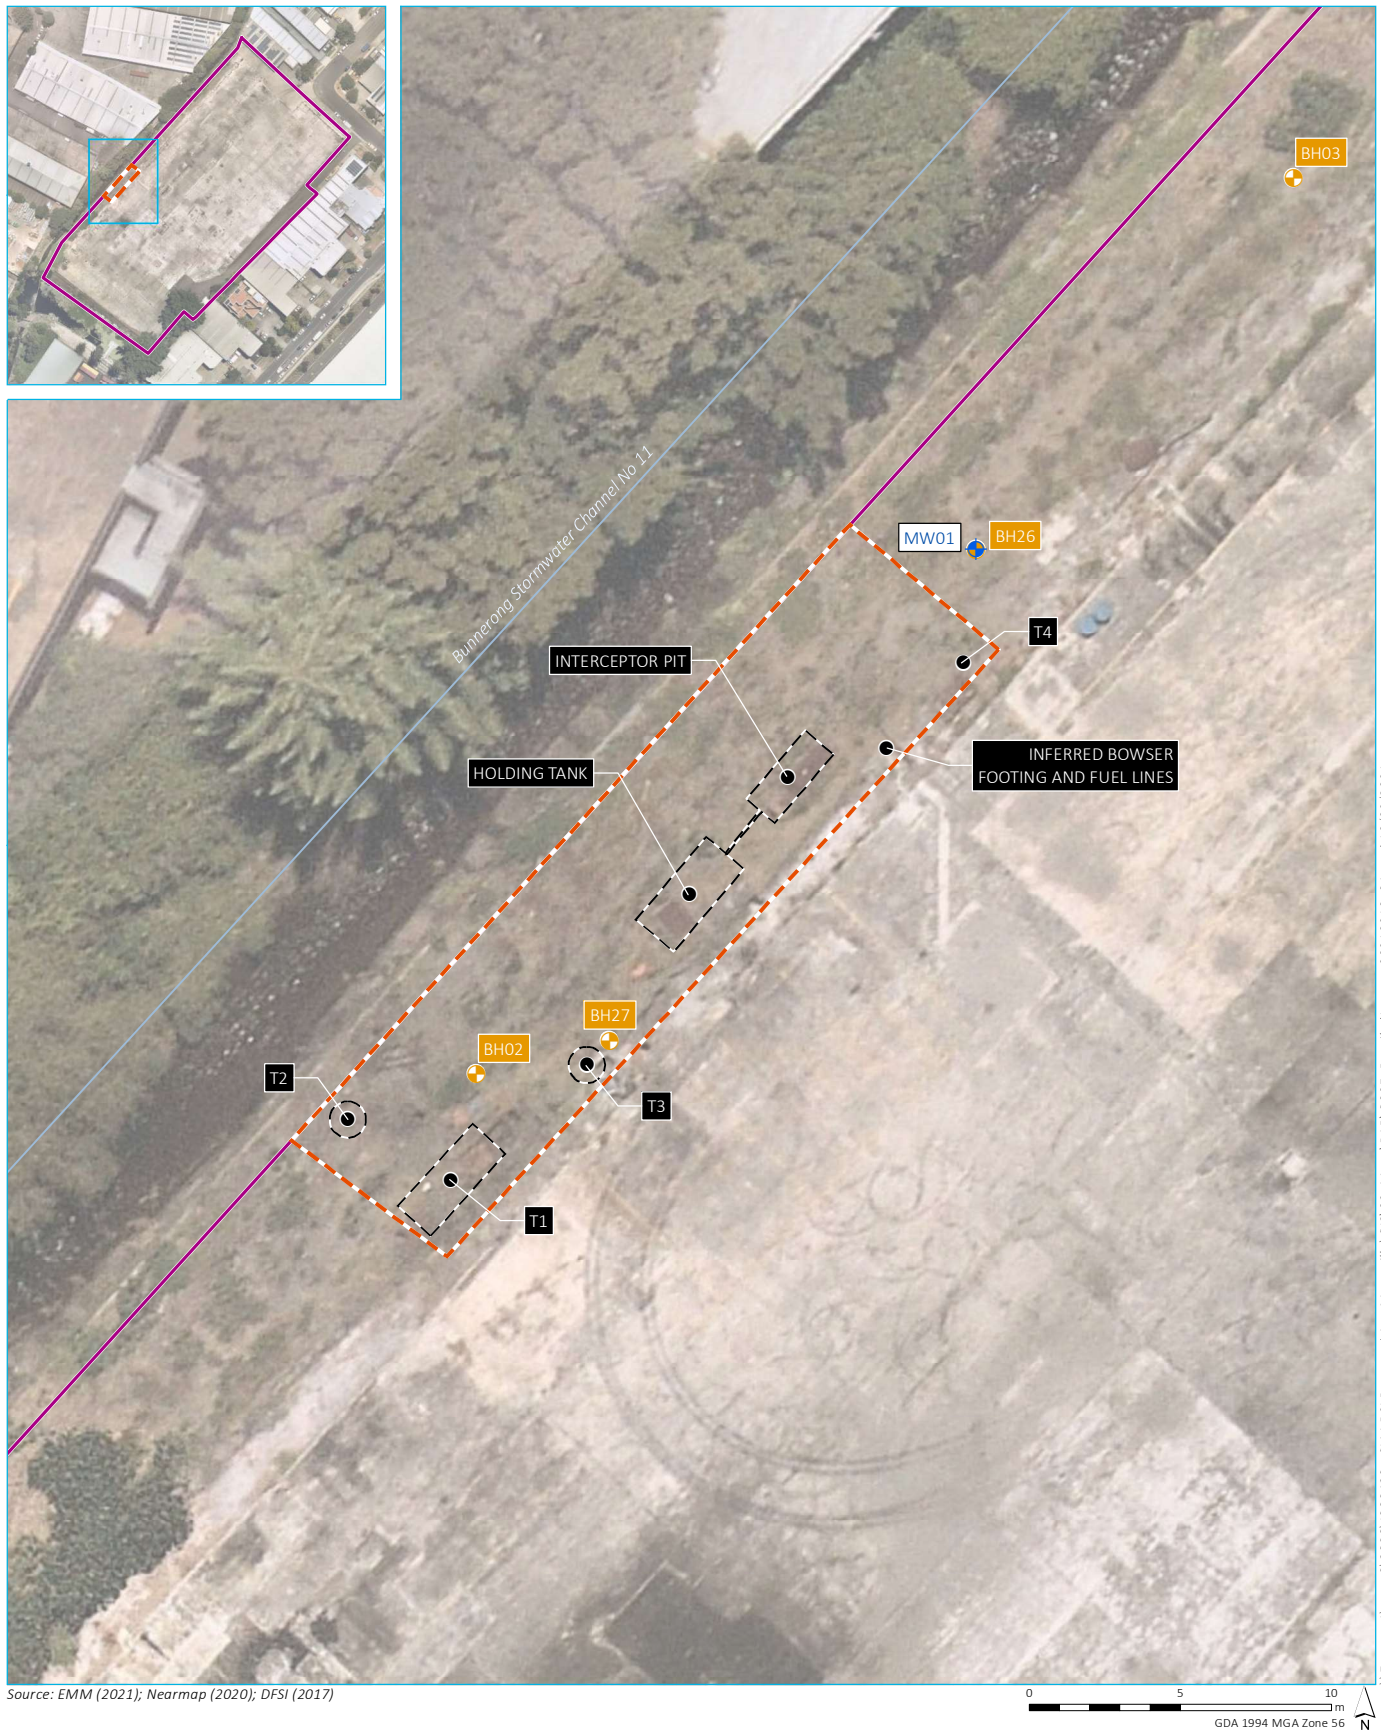
During the September 2020 DSI investigations, EMM located UPSS infrastructure along the western site boundary adjacent to the edge of the concrete slab and stormwater channel wall across an area of approximately 150 m². The infrastructure was visually observed between the concrete slab and drainage channel along the western boundary of the Site. The approximate layout of the observed UPSS infrastructure is summarised in Table 2.2 below and presented in Figure 2.2

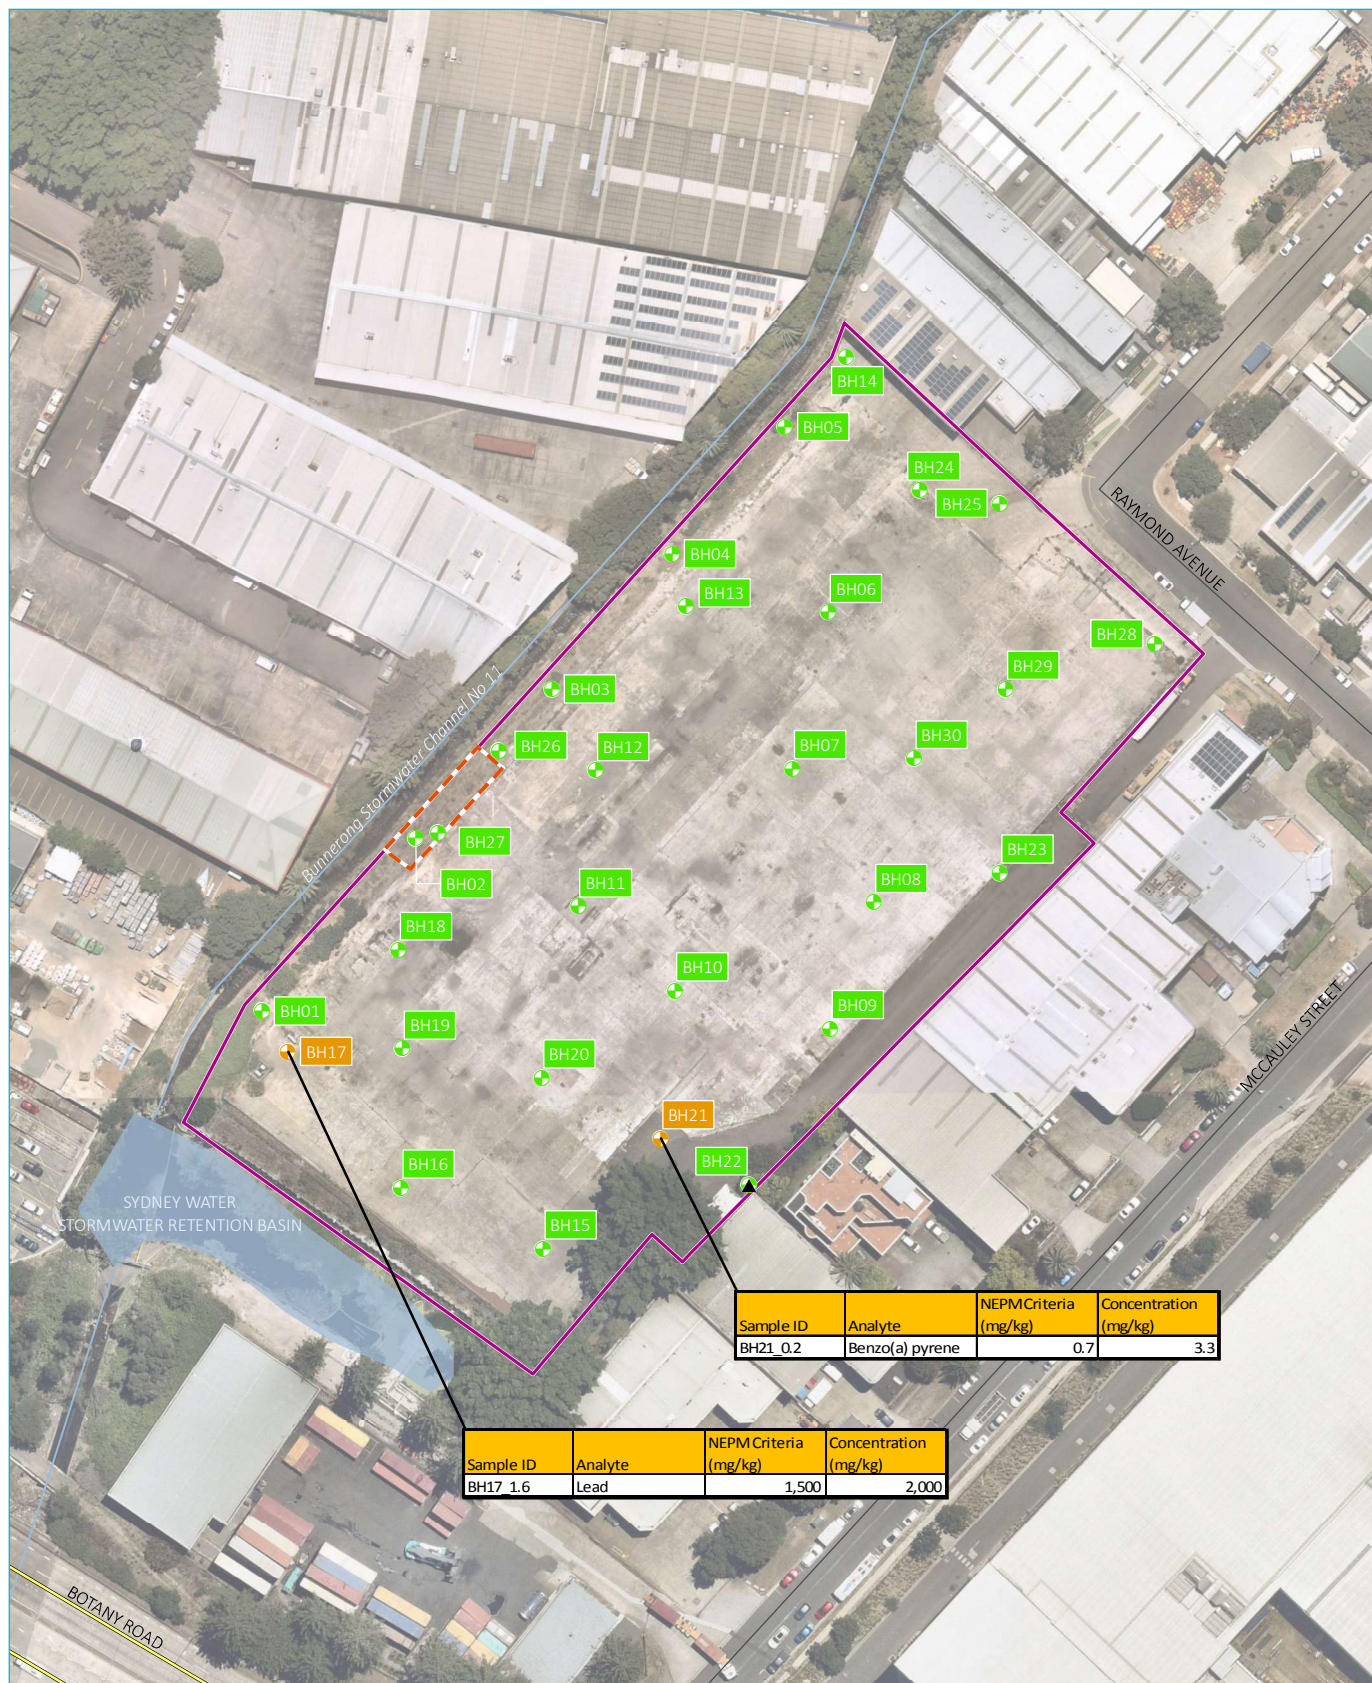
42-52 Raymond Avenue, Matraville NSW
Remediation action plan
Figure 3.1

Soil analytical results

- the 95% upper confidence limit (UCL) for both benzo(a)pyrene and lead was less than the relevant screening criteria;
- soil samples at BH02/0.5 m and BH03/0.9 m, located adjacent to the observed UPSS infrastructure, had the highest detections of TPH and TRH during the DSI investigations but did not exceed the adopted criteria¹. These results indicate potentially elevated petroleum hydrocarbons in soil within proximity to the UPSS:

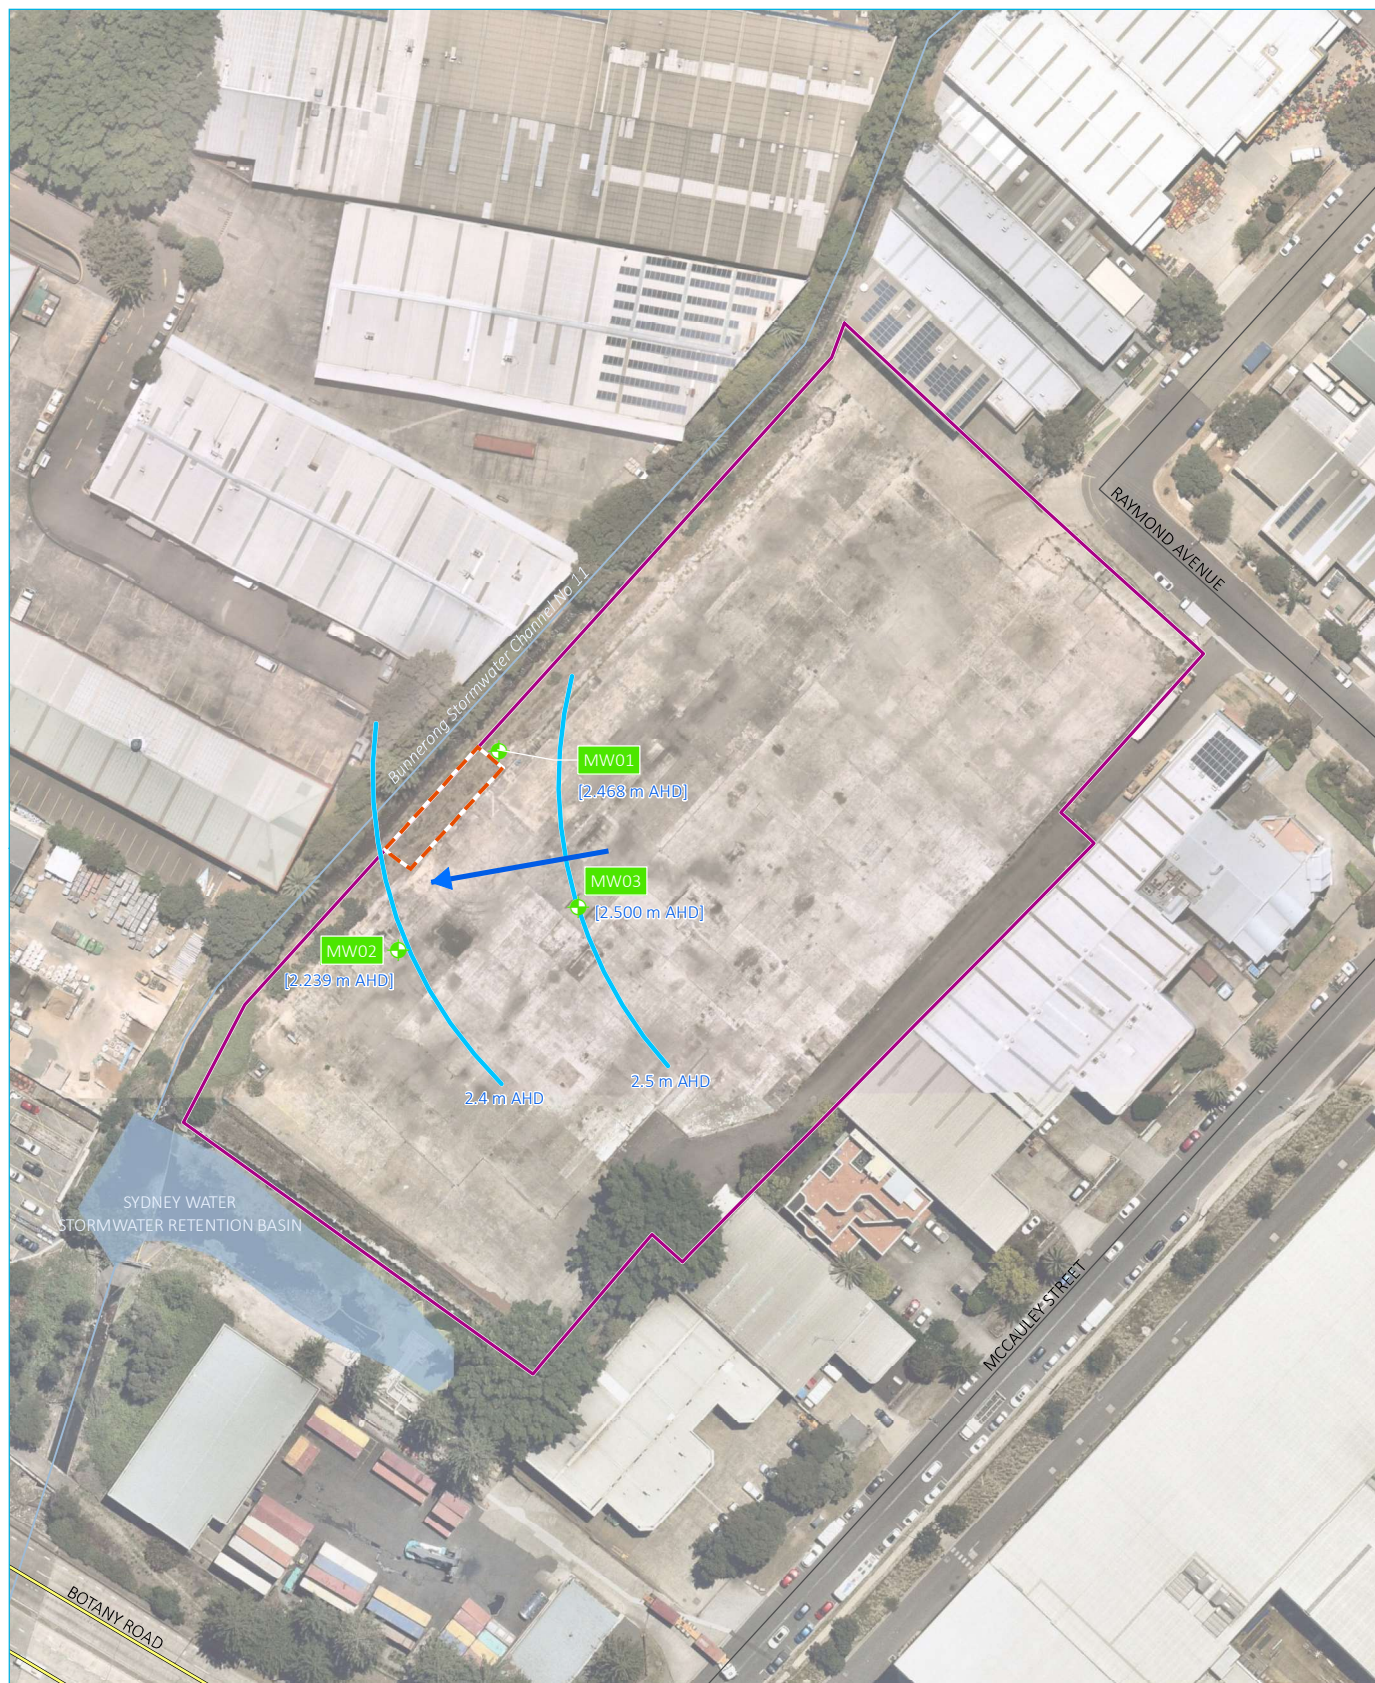
Three groundwater wells were installed (MW01, MW02, MW03) with samples collected and analysed for CoPC associated with the identified source of potential contamination (Figure 3.2). The following observations and analytical results are noted:

- groundwater levels at the site ranged from 3.286 to 3.130 m bgl (2.439 to 2.5 m AHD) and the inferred groundwater flow direction was towards the west;
- the three groundwater monitoring wells were installed in accessible locations close to the UPSS, noting steep and uneven terrain along the western Site boundary (between the UPSS and the stormwater channel). The wells were located either up or across hydraulic gradient of the observed UPSS infrastructure;
- there were no odours detected or notable PID results to indicate hydrocarbon impact in groundwater (<2 ppm); and
- there were no exceedances of the adopted criteria for the groundwater assessment. Benzene was reported at a concentration of 3 µg/L and TRH C₆-C₁₀ was reported at 40 µg/L in a groundwater sample collected at MW02.
