Hale Capital Partners
Interim Environmental Management Plan

42-52 Raymond Avenue
Matraville, NSW

15 December 2021
60654/142642 (Rev B)
JBS&G

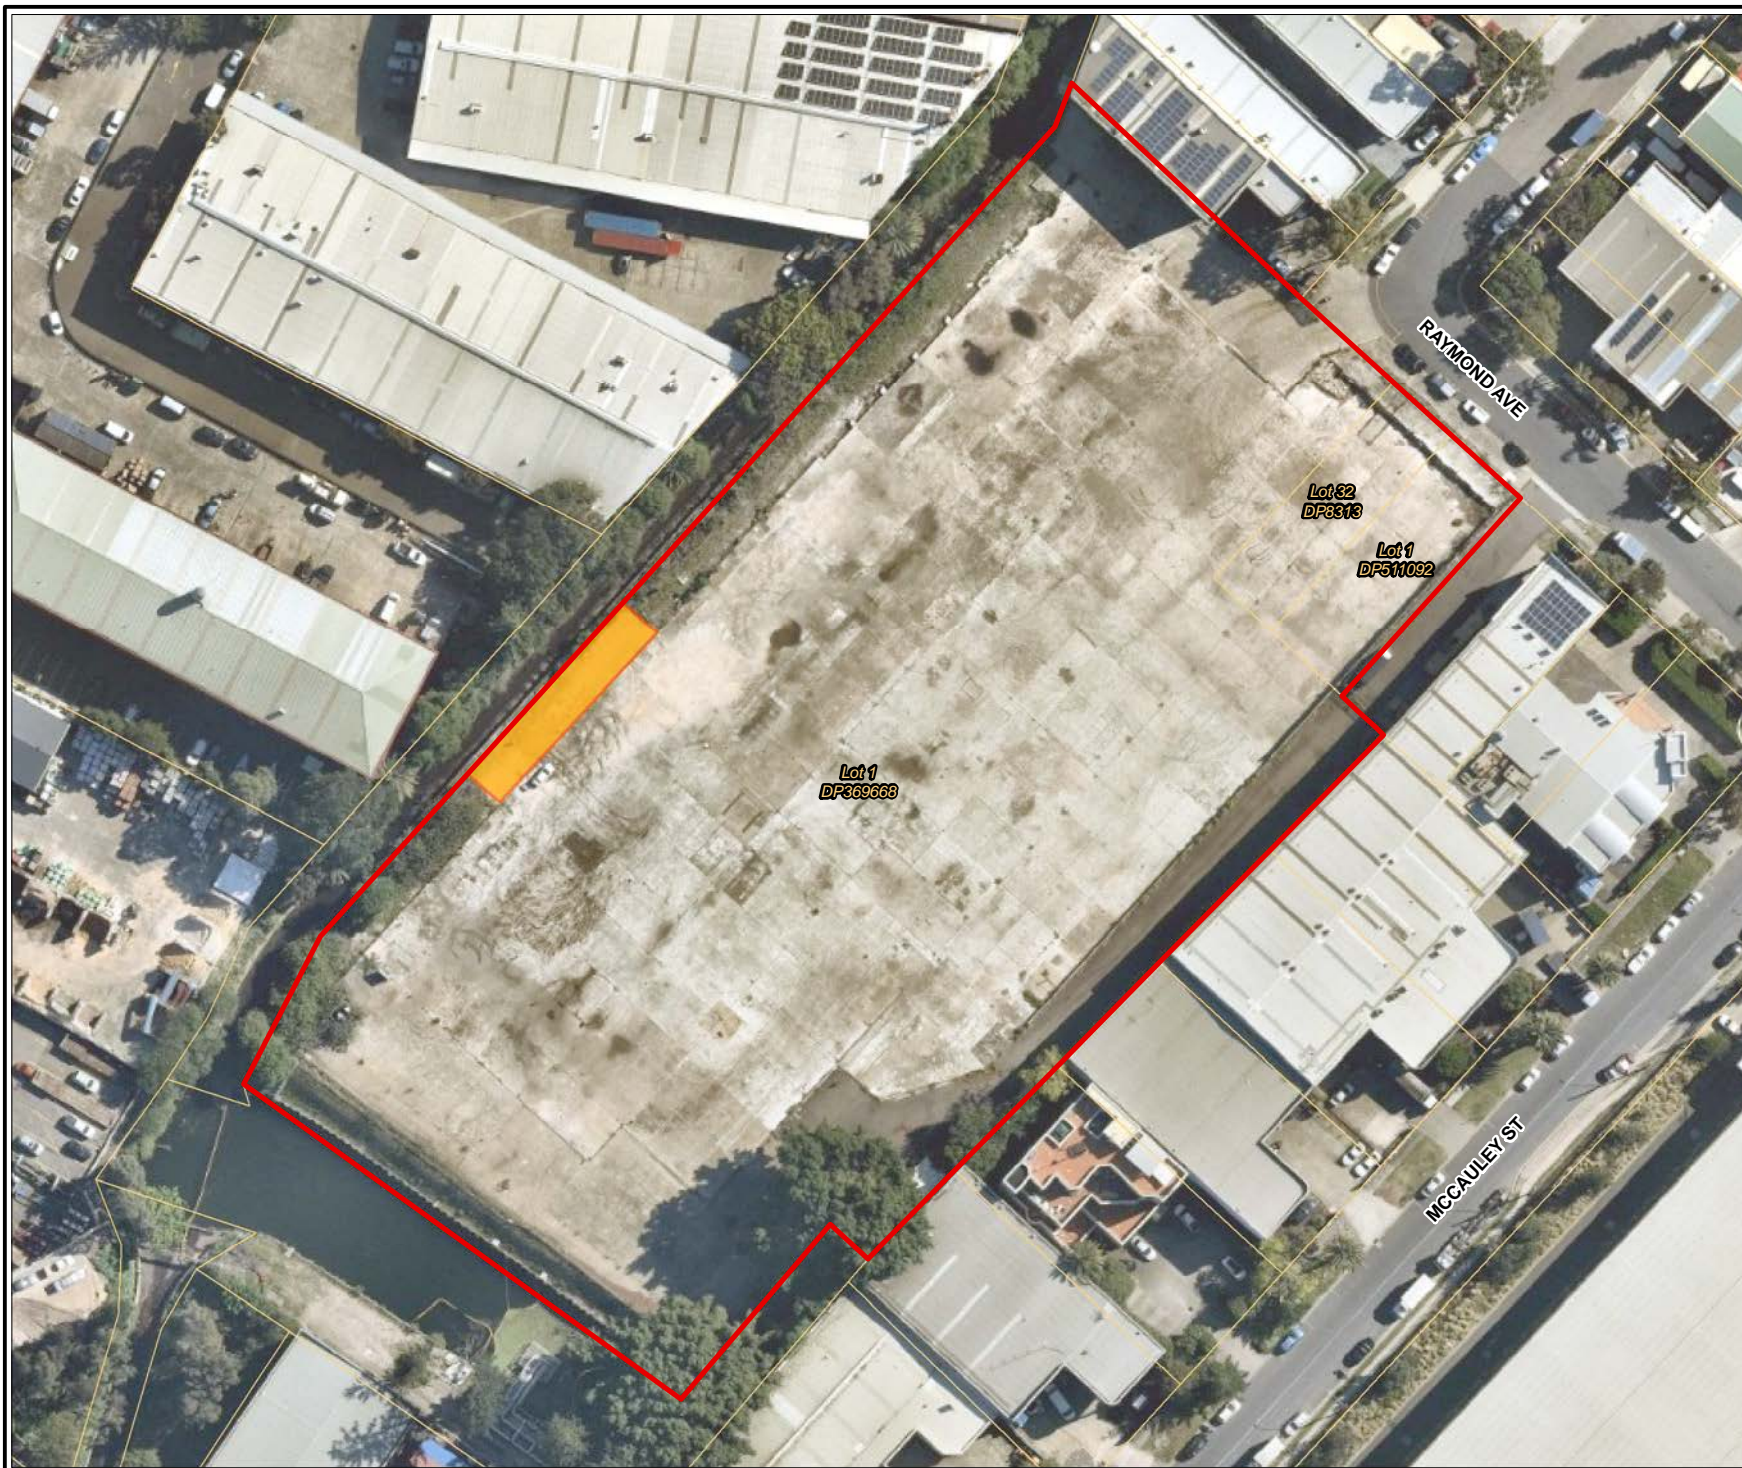
Most of the site is occupied by concrete pavement from former site buildings with unpaved strips of land along the western and southern boundaries. The western strip of the site adjoining a Sydney Water Stormwater channel is unpaved and is covered with some vegetation. The southern strip of the site adjoins a dam, is unpaved and is covered with some vegetation. Asbestos impacted soils in the former UST remediation area, in the southern half of the unpaved strip of land in the western extent of the site, and in-situ TRH impacted soils in this area were covered with a black plastic builder's film and clean imported material at the time of remediation works in 2021 (s shown on **Figure 2**).

Asbestos impacted fill, assumed to comprise both bonded and friable unless proven otherwise, is present across the whole site, beneath concrete pavement across most of the site, and beneath clean imported soil and temporary black plastic marker layer in the former UST remediation area. In addition, TRH impacted soils and TRH impacted groundwater remain in the former UST remediation area, in the southern half of the unpaved strip of land in the western extent of the site adjoining the Sydney water stormwater channel. The extent of the temporarily capped material is shown on **Figure 2**.

- ▬ Approximate Site Boundary
- ▬ NSW Cadastre (DFSI, 2021)
- ▬ Former UST Remediation Area - Temporary Capping of Marker Layer

Concrete pavement or a temporary marker layer and capping is present overlying the extent of the identified asbestos impacted soils, although it should be assumed that asbestos impacted fill is present across the whole site. The extent of the temporary marker and capping layers is shown on **Figure 2**.

The extent of the capped asbestos impacted soils within the western portion of the site is covered by a temporary black plastic marker layer and capping consisting of clean imported soils, which must be maintained to prevent site users, visitors and contractors, accessing the site prior to redevelopment, from being potentially exposed to the retained environmentally impacted soils prior.

These provisions for shallow intrusive works apply to works above the temporary marker layer (black plastic film) in the former UST remediation area in the western portion of the site shown on **Figure 2**.

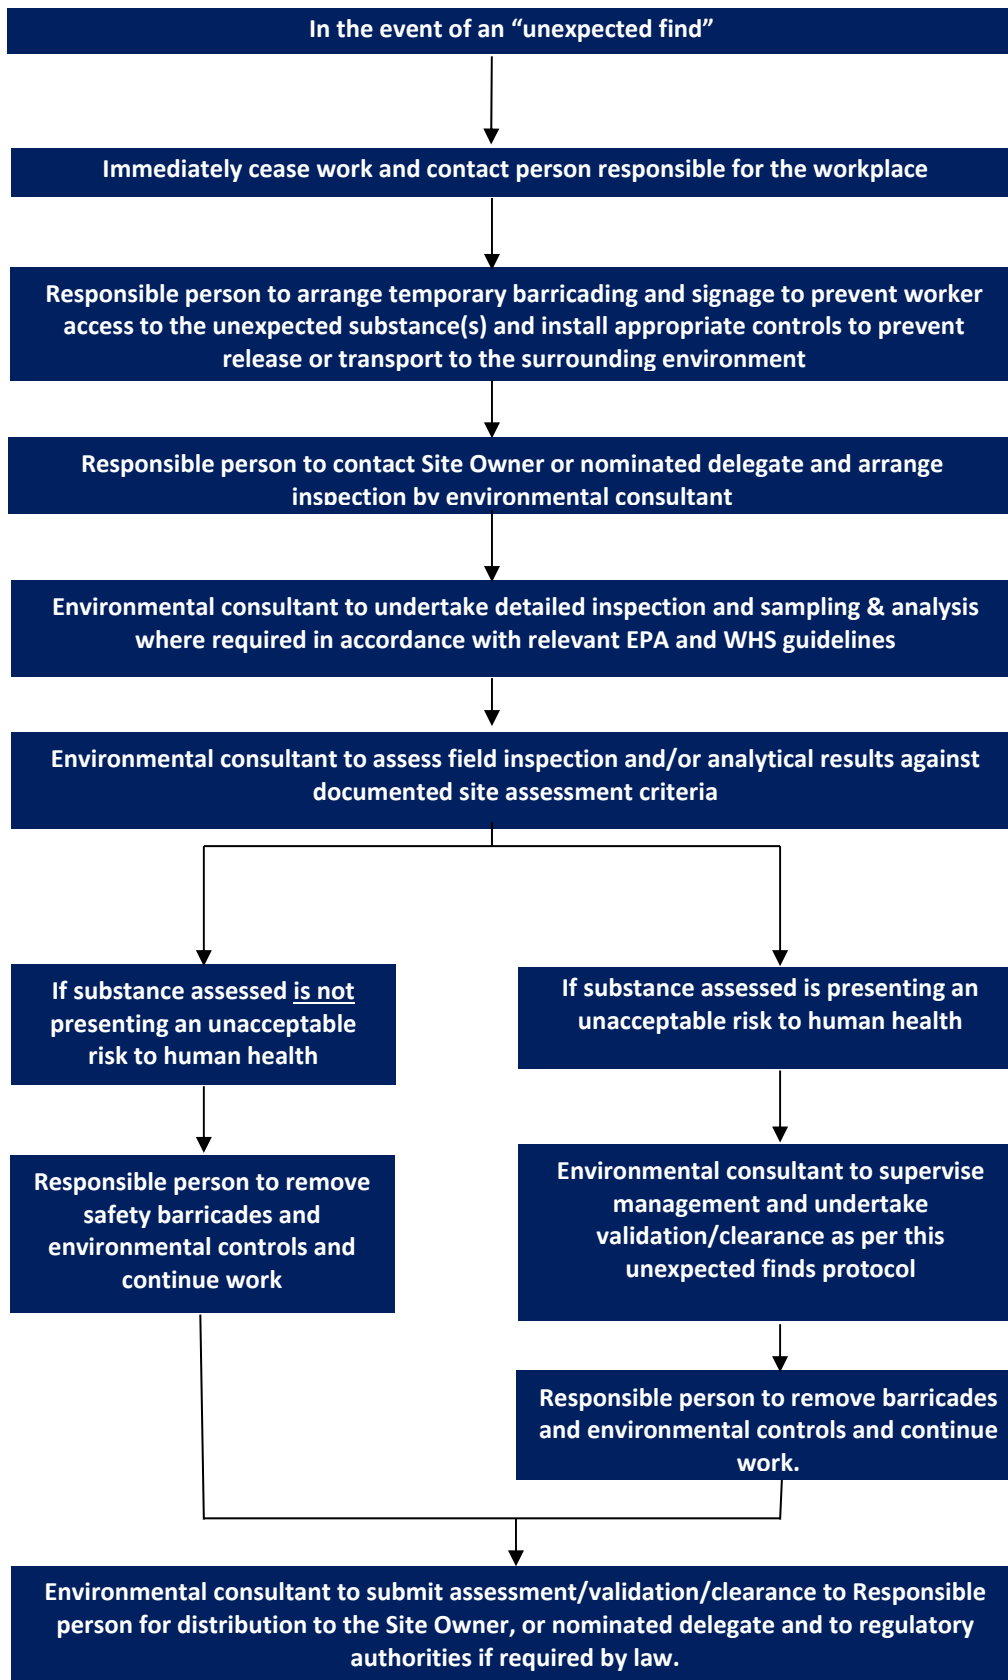
Appendix D Unexpected Finds Protocol

As a precautionary measure to ensure the protection of the workforce and surrounding community, should any of the abovementioned indications of potential contamination (or any other indications of the presence of potentially hazardous substances) be observed, the procedure summarised in the Flowchart provided in **Appendix D** is to be followed.
