Arboricultural Impact Assessment Report regarding three hundred and thirty-four (334) trees located within the grounds of Barker College, NSW

We are pleased to provide the following Arboricultural Impact Assessment Report for three hundred and thirty-four (334) trees located within the vicinity of the Concept proposal and Stage 1 SSDA at Barker College, 91 Pacific Highway, Hornsby.

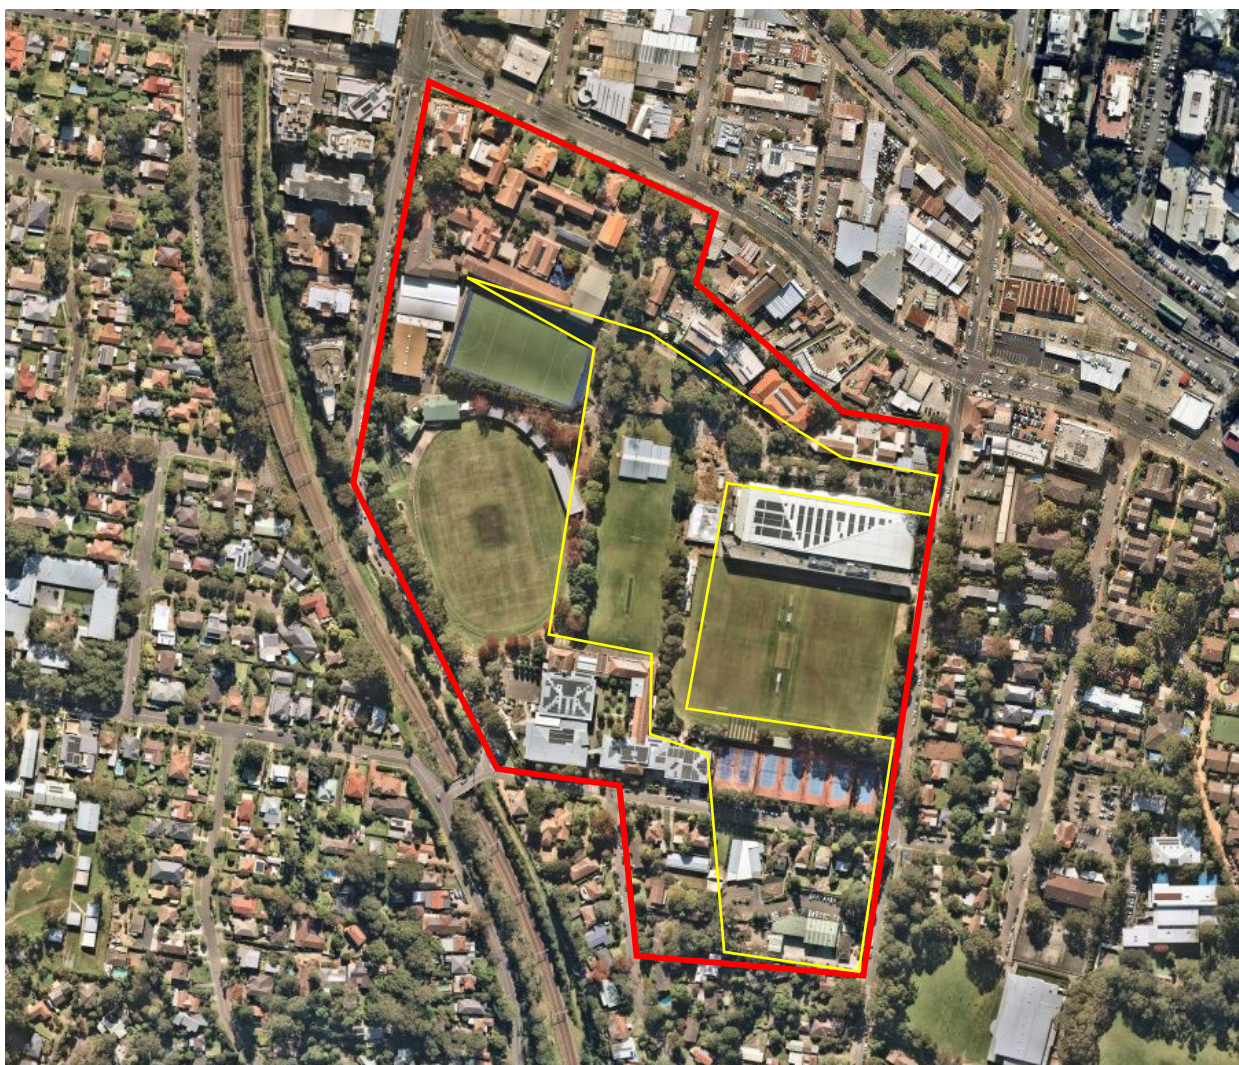
Figure 1. Whole site image (location). Red lines delineate the site, while the yellow line shows approximate area of containing the subject trees that are to be impacted by the proposed development. (Nearmap, May 2022).

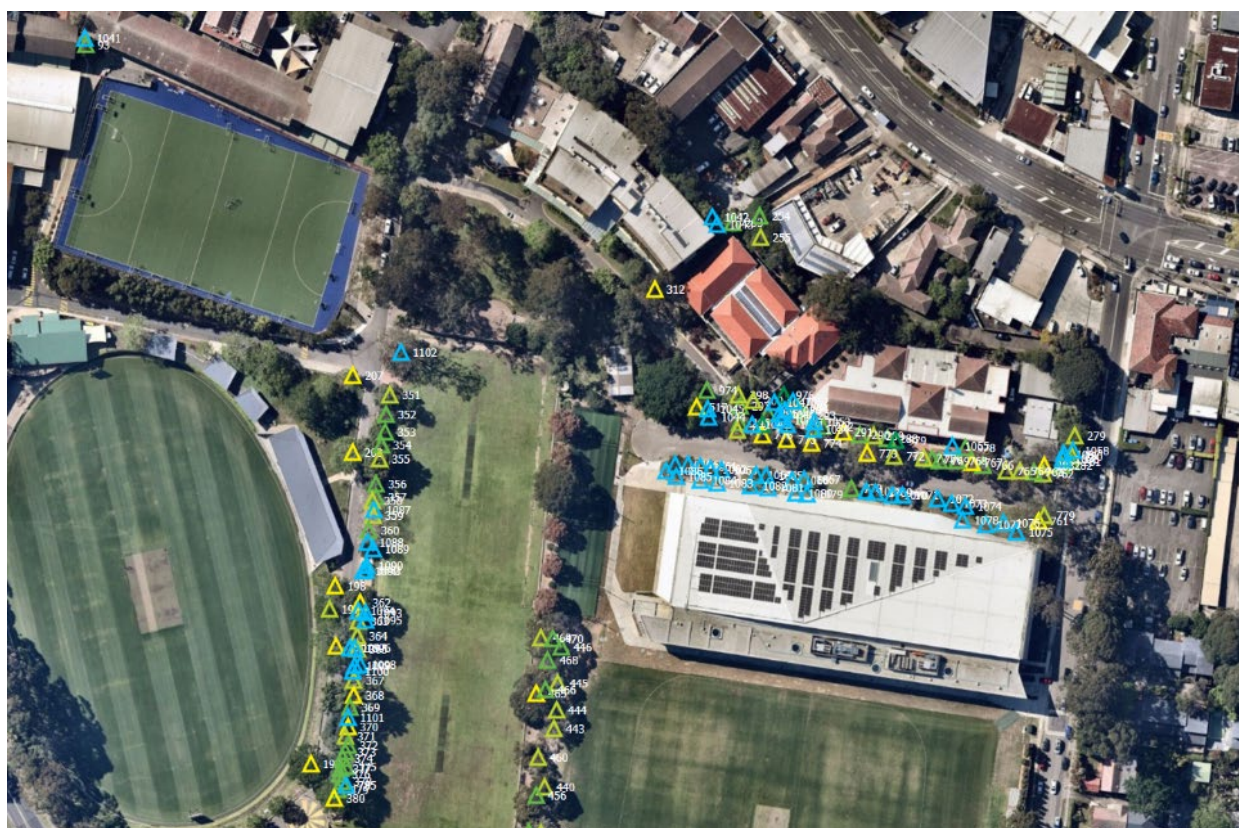
Figure 2. Trees are subject to this report as represented in the ArborPlan Tree Management system (north section of site). Refer to Appendix E for more detailed mapping. Note tree icon colour represents existing risk status (not Retention Value). (ArborPlan, June 2022).

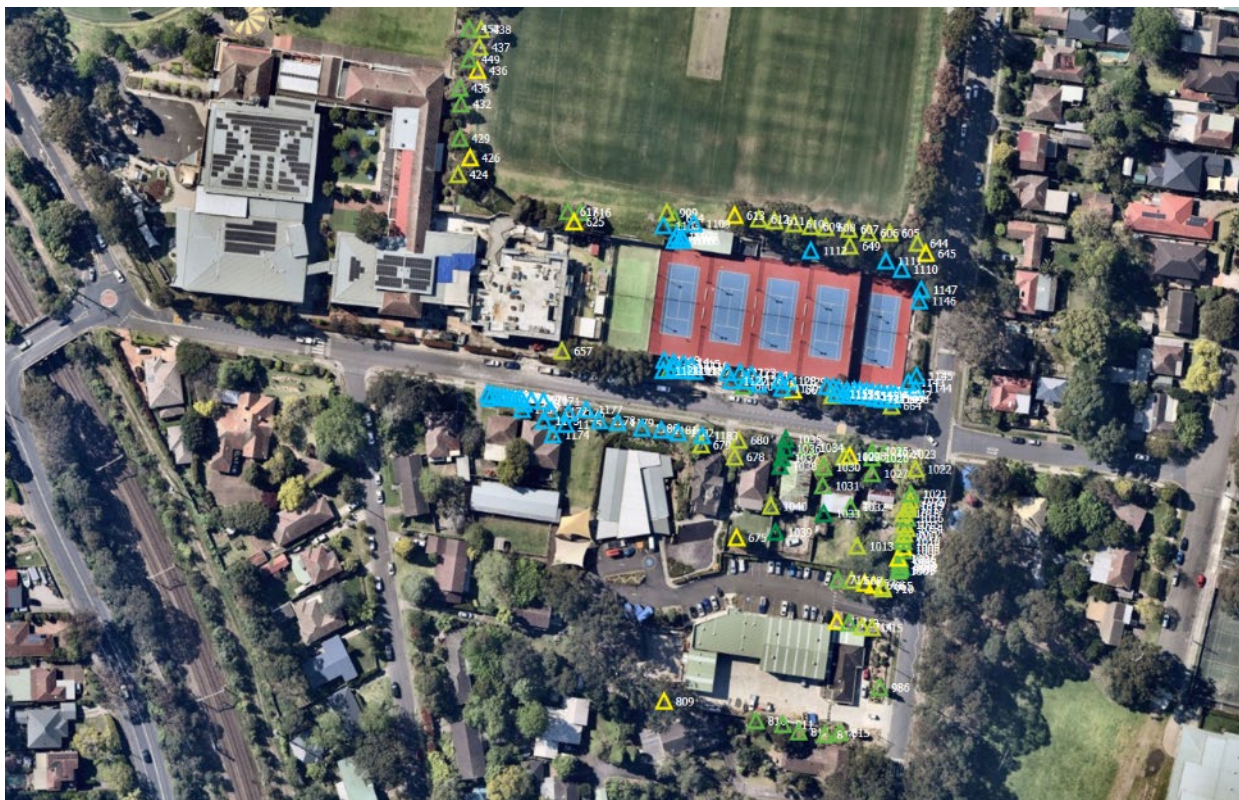
Figure 3. Trees subject to this report as represented in the ArborPlan Tree Management system (south section of site). Refer to Appendix E for more detailed mapping. Note tree icon colour represents existing risk status (not Retention Value). (ArborPlan, June 2022).

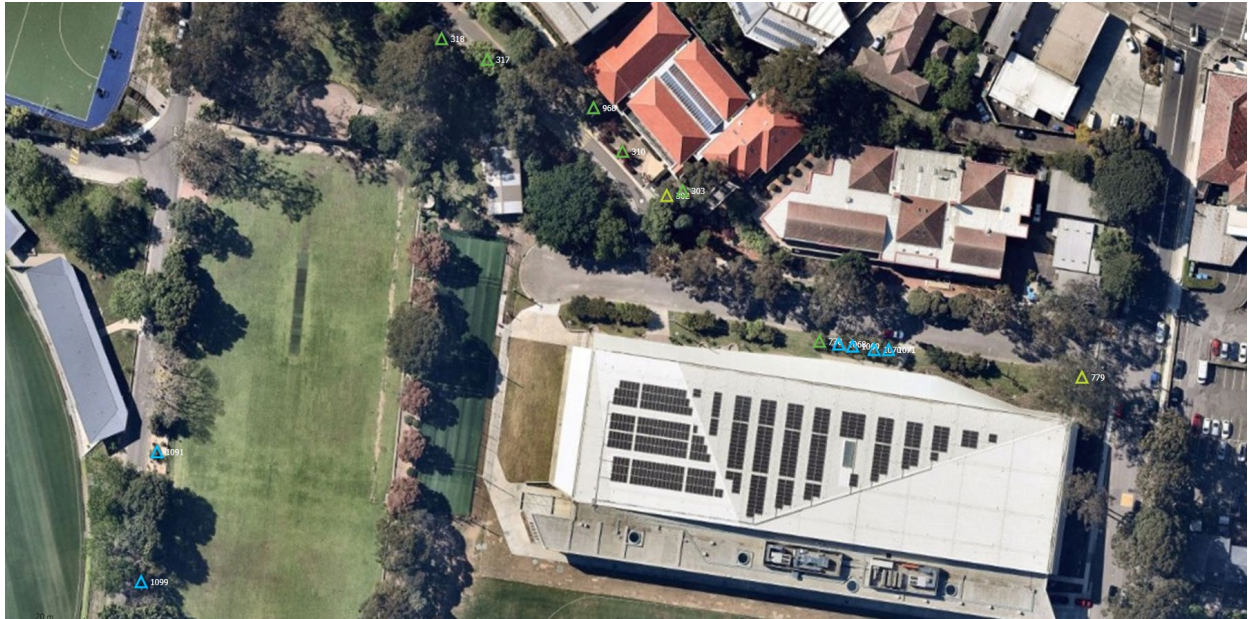
Figure 7. Site map showing trees recommended for removal due to development impacts (North). (ArborPlan, June 2022).

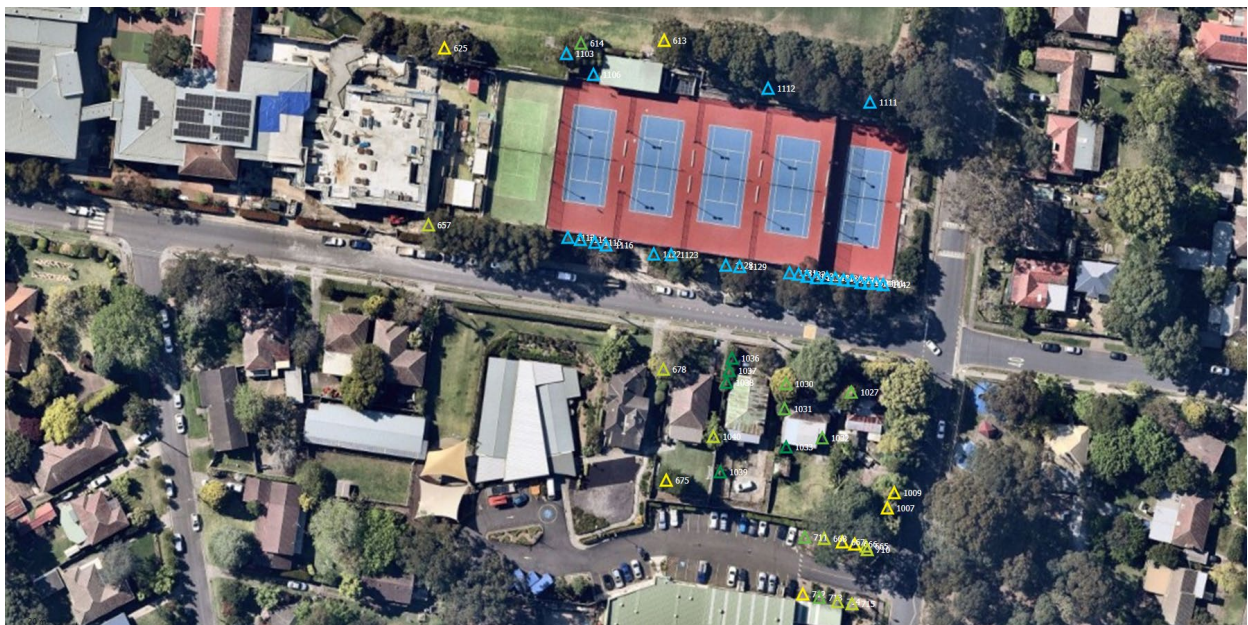
Figure 8. Site map showing trees recommended for removal due to development impacts (South). (ArborPlan, June 2022).

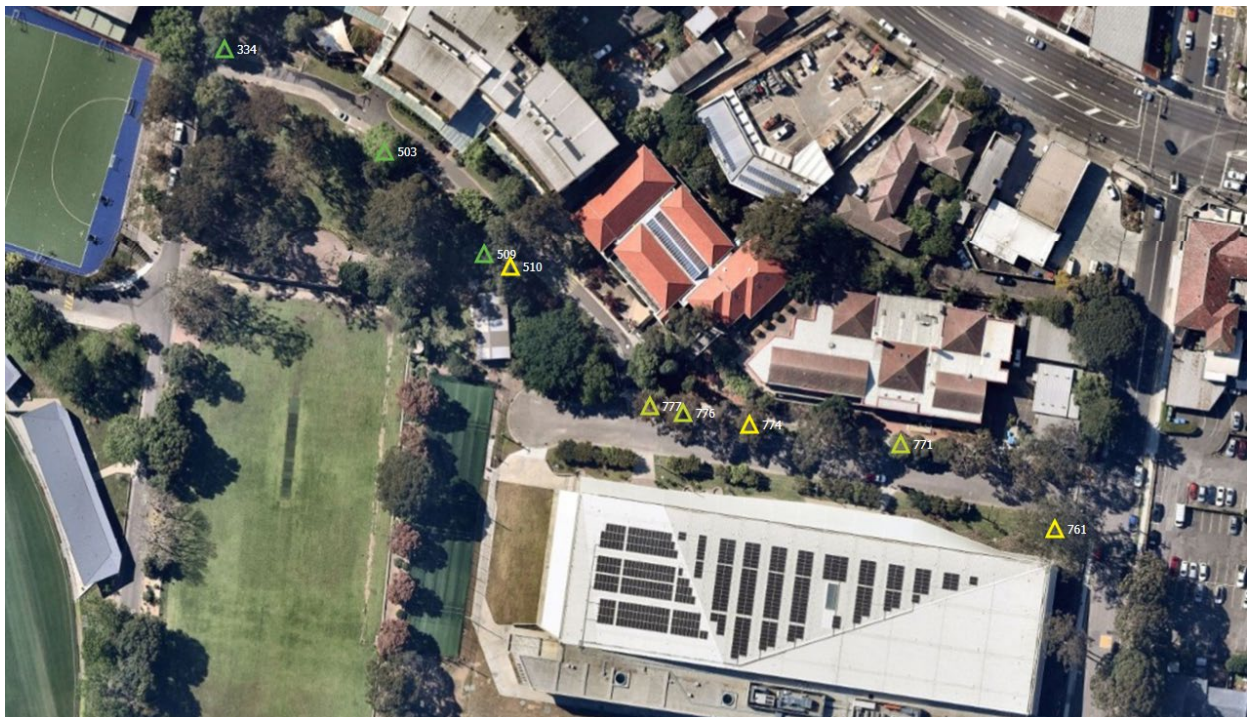
- 7.3.1 Trees 334, 503, 509, 510, 761, 771, 774, 776 and 777 are larger trees located in close proximity to proposed access way upgrades (Figure 9).
- 7.3.2 Kerb demolition within the TPZ of these trees is to be carried out only under arborist supervision. It is recommended that the proposed kerb stone extraction commence at the outer extent of the TPZ and move inwards to minimise root damage to the trees.

Figure 9. Site map showing tree requiring specific protection measures. (ArborPlan, June 2022).

- 7.3.3 Demolition works should be undertaken using techniques that are sensitive to tree roots to avoid unnecessary damage. Such techniques include:
- Machines sitting on the existing road/path hardstand and using an additional spotter when working within the TPZ.

- 7.3.5 Targeted management options are to be discussed and finalised with the supervising arborist, on a tree-by-tree basis, based on findings following kerb demolition and the proposed plans. Any alterations to the standard construction plan (design/work methodology/construction material) are to be documented by the supervising arborist and relayed to site management (in writing).

- 7.3.6 Sub-surface foundation material is to be retained along all access ways, especially within the TPZ of these trees.

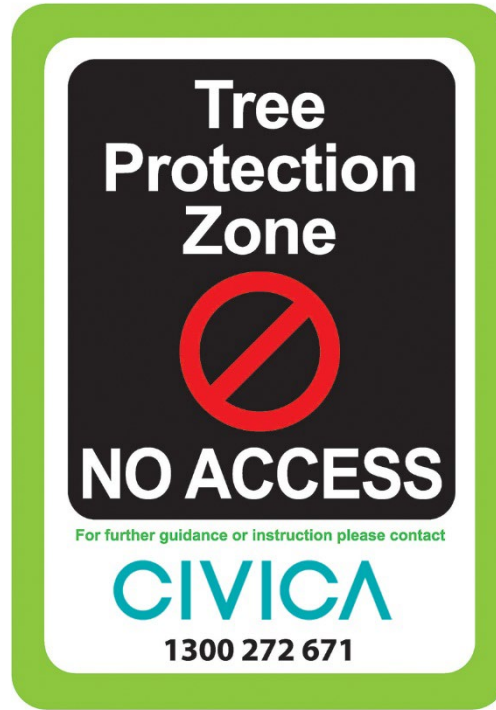
- 7.7.1 Signs identifying the TPZ (Figure 12) should be placed at 10m intervals around the edge of the TPZ and should be visible from within the development site.

Figure 12. Depicts standard fencing techniques. (AS 4970–2009).

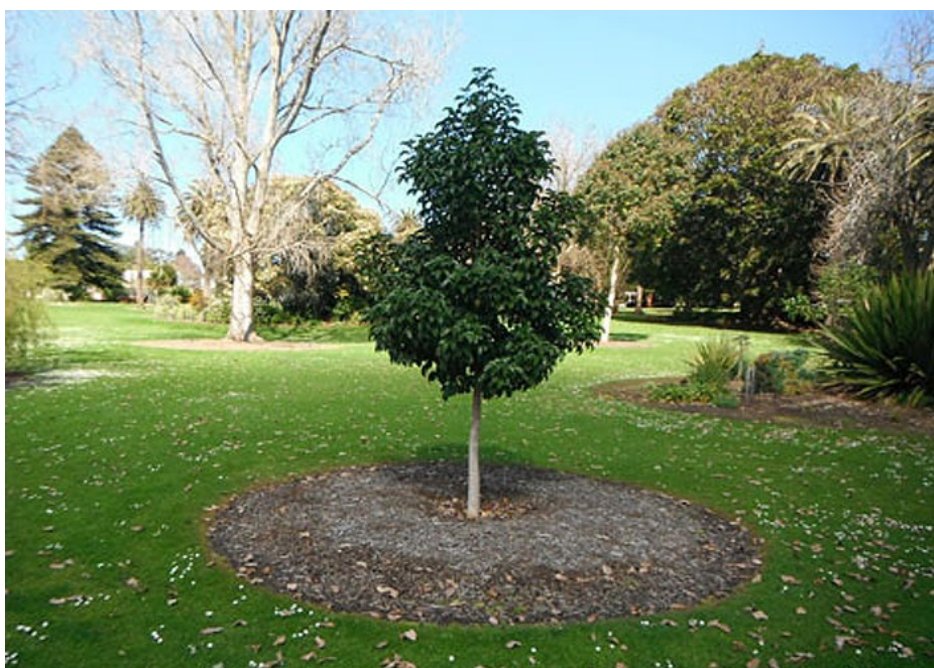
Figure 13. An excellent example of how to mulch a young tree. (Lachlan Andrews, September 2015).

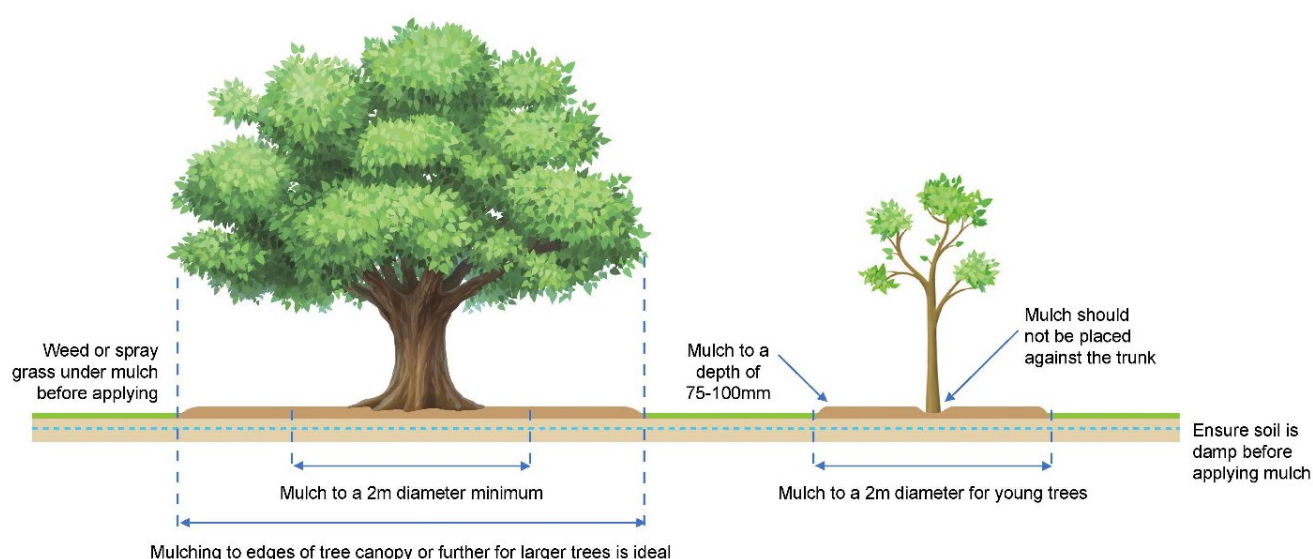
Figure 14. Mulching established and young trees (ArborSafe Australia, 2020).

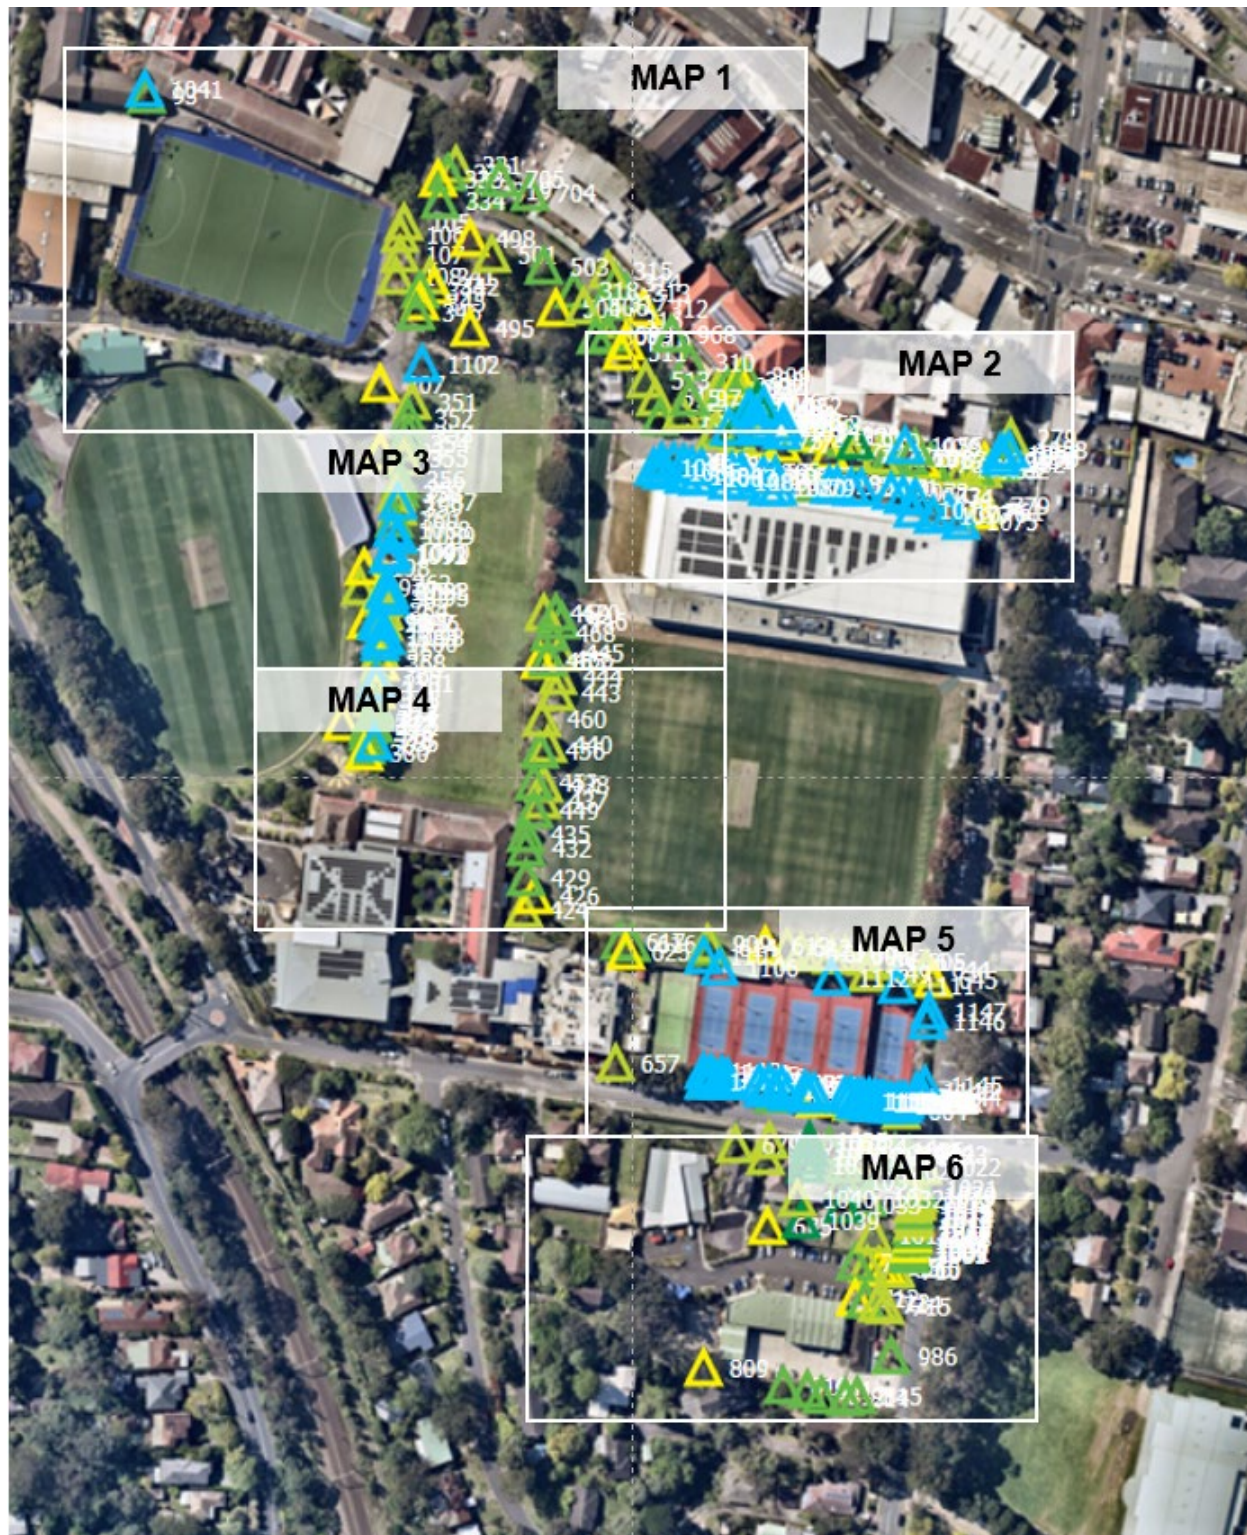
Figure 17. Trees subject to this report as represented in the ArborPlan Tree Management system. Note tree icon colour represents existing risk status (not Retention Value). (ArborPlan, June 2022).

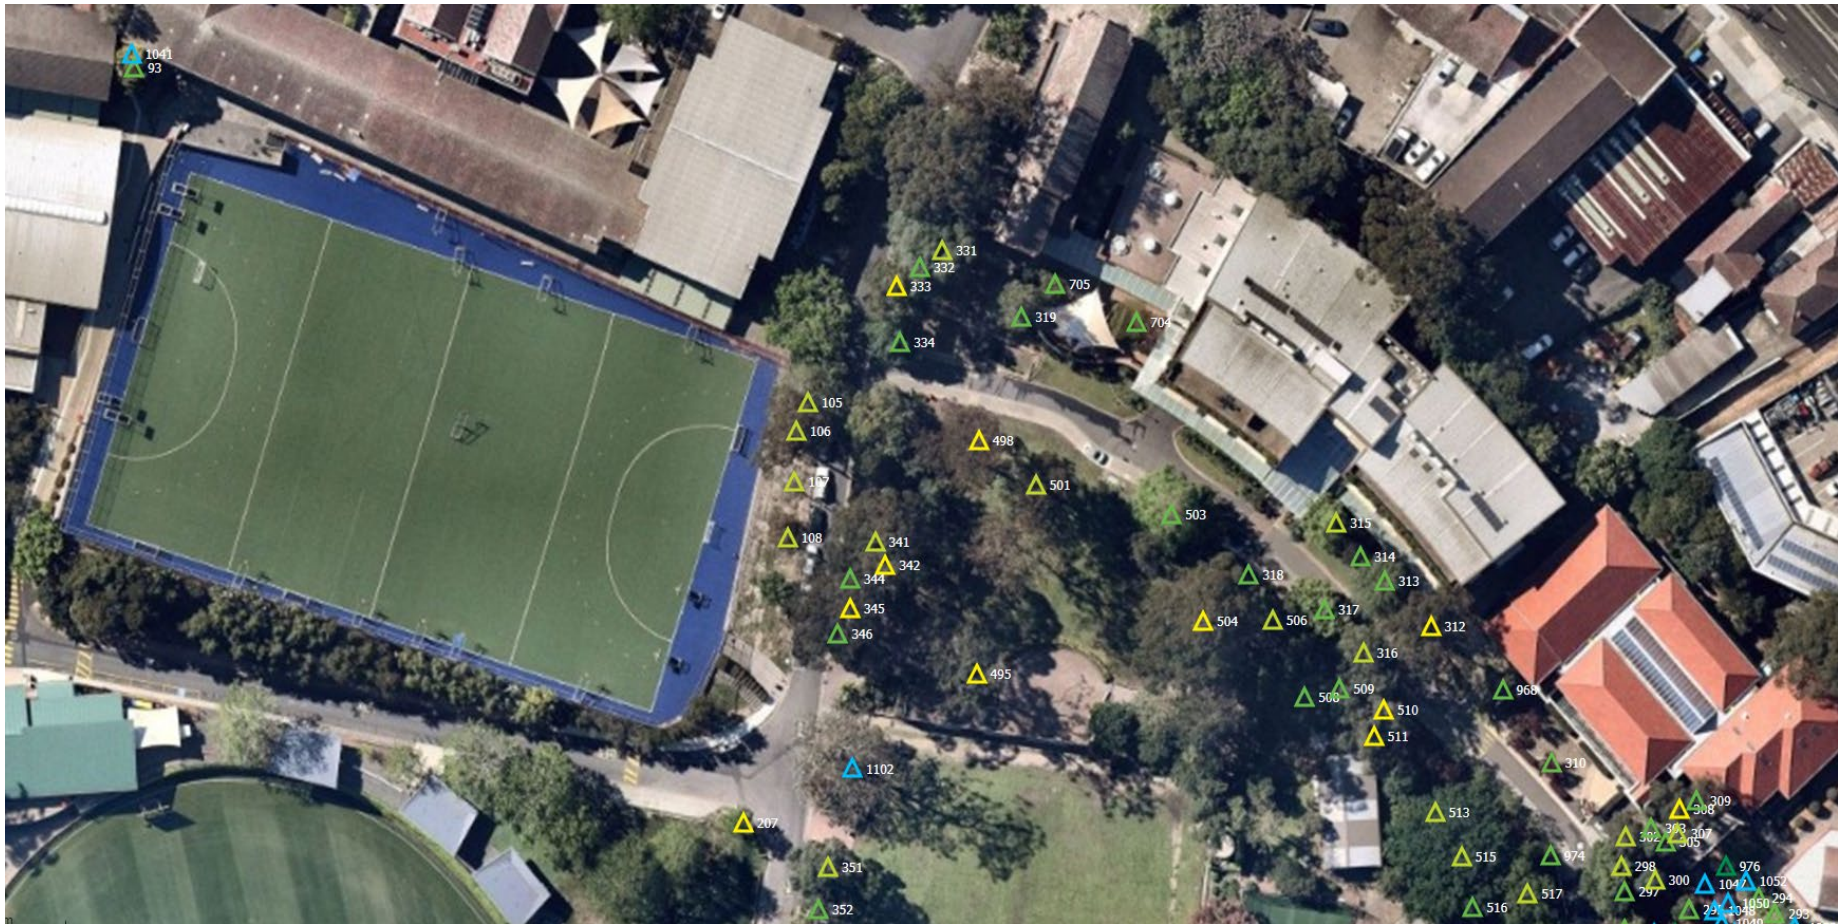
Figure 18. MAP 1 - Trees subject to this report as represented in the ArborPlan Tree Management system. Note tree icon colour represents existing risk status (not Retention Value). (ArborPlan, June 2022).

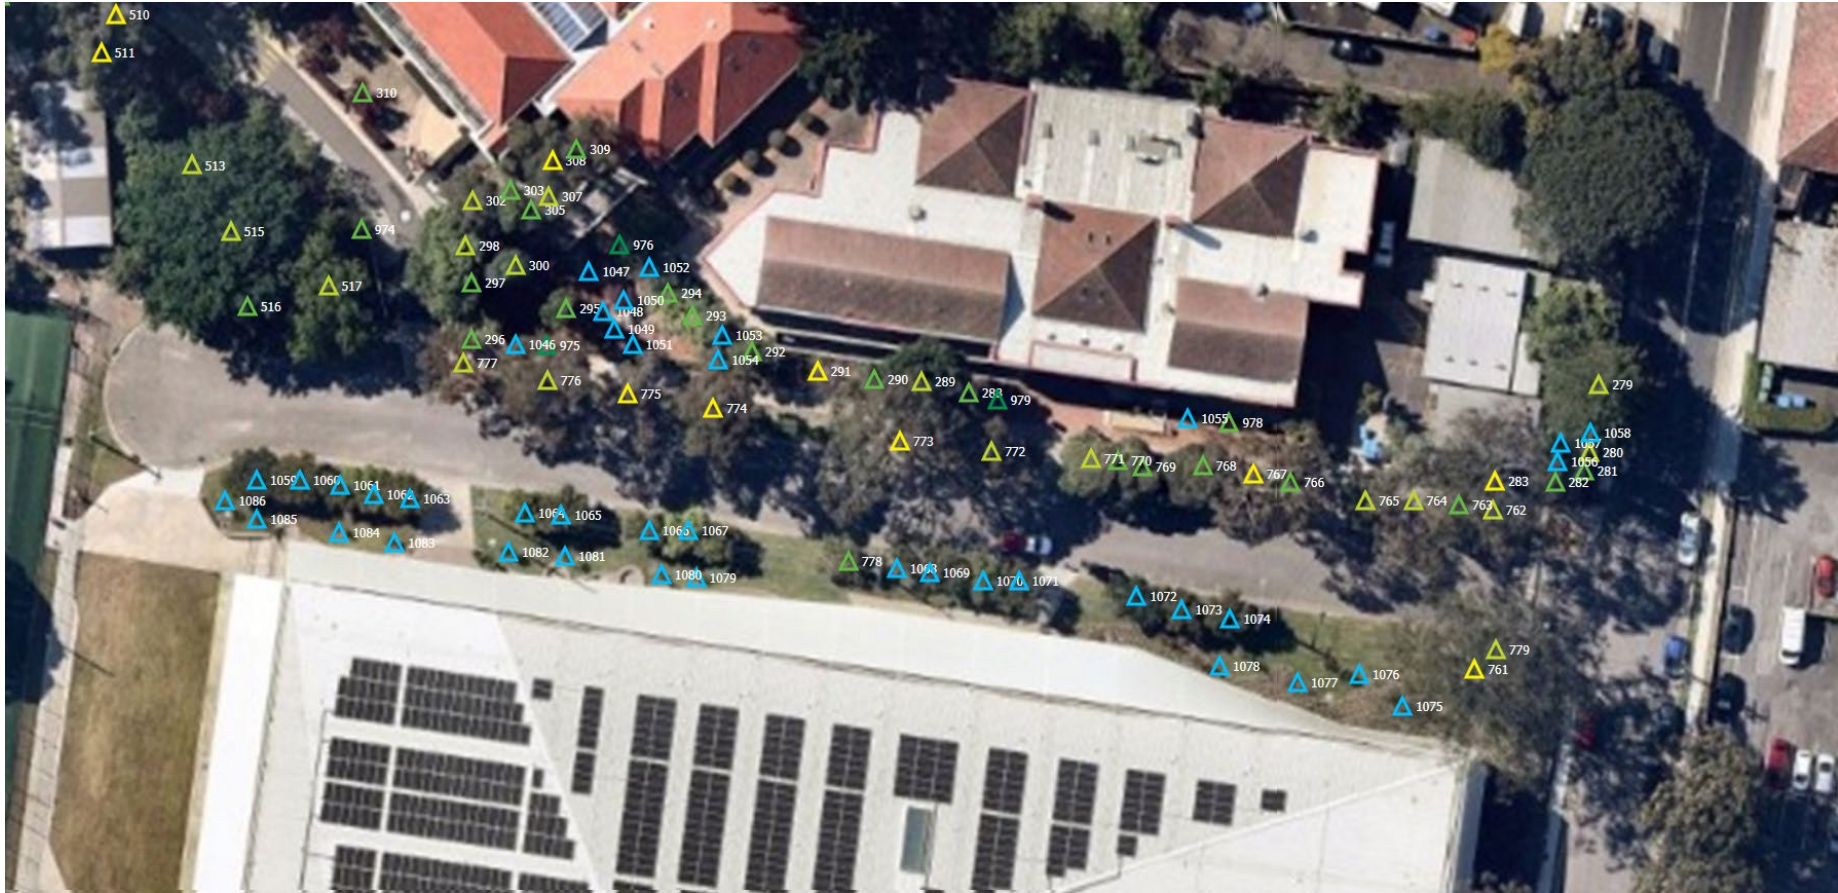
Figure 19. MAP 2 - Trees subject to this report as represented in the ArborPlan Tree Management system. Note tree icon colour represents existing risk status (not Retention Value). (ArborPlan, June 2022).

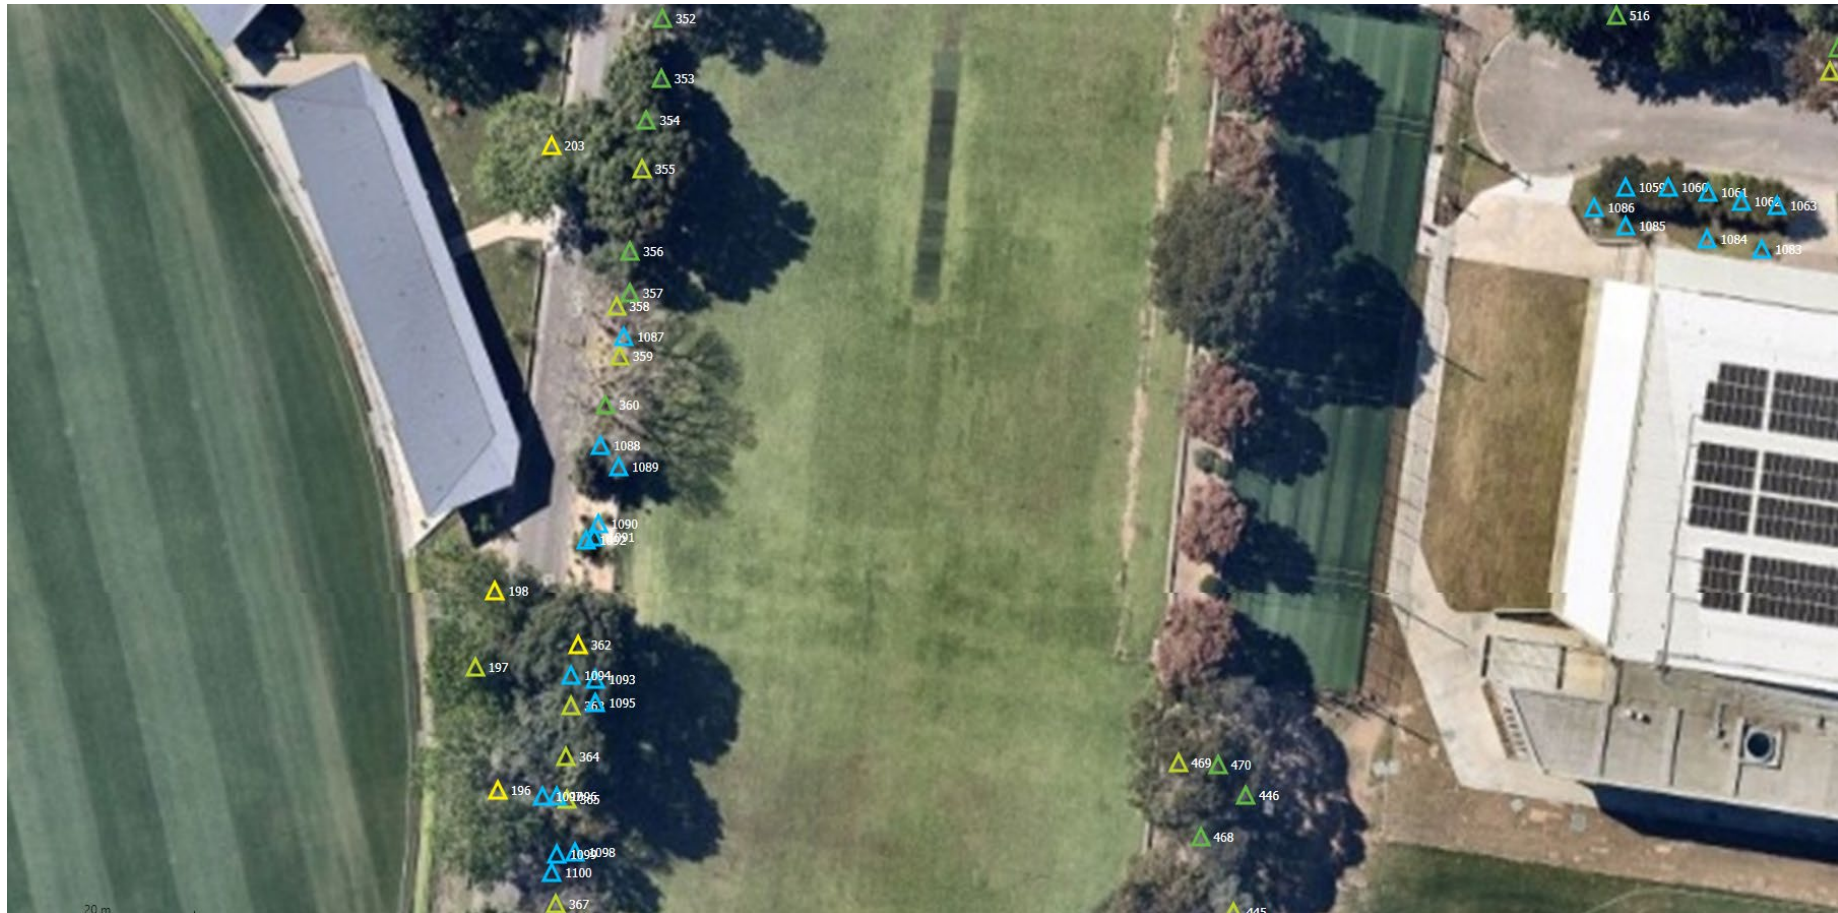
Figure 20. MAP 3 - Trees subject to this report as represented in the ArborPlan Tree Management system. Note tree icon colour represents existing risk status (not Retention Value). (ArborPlan, June 2022).

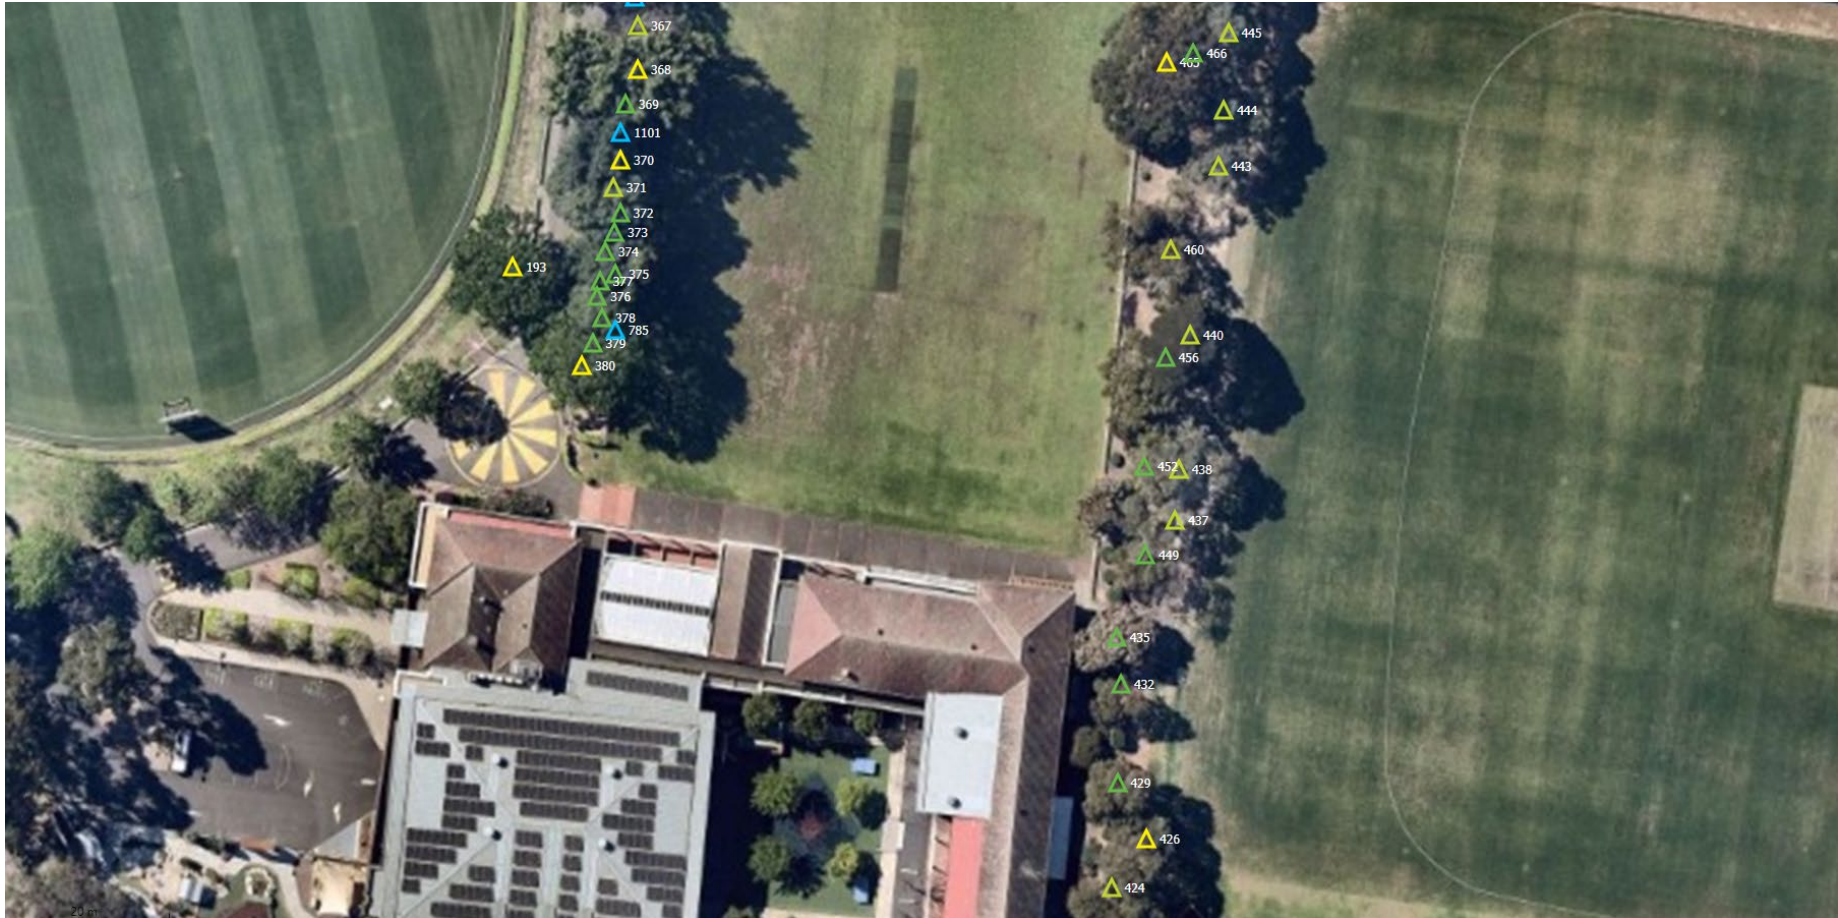
Figure 21. MAP 4 - Trees subject to this report as represented in the ArborPlan Tree Management system. Note tree icon colour represents existing risk status (not Retention Value). (ArborPlan, June 2022).

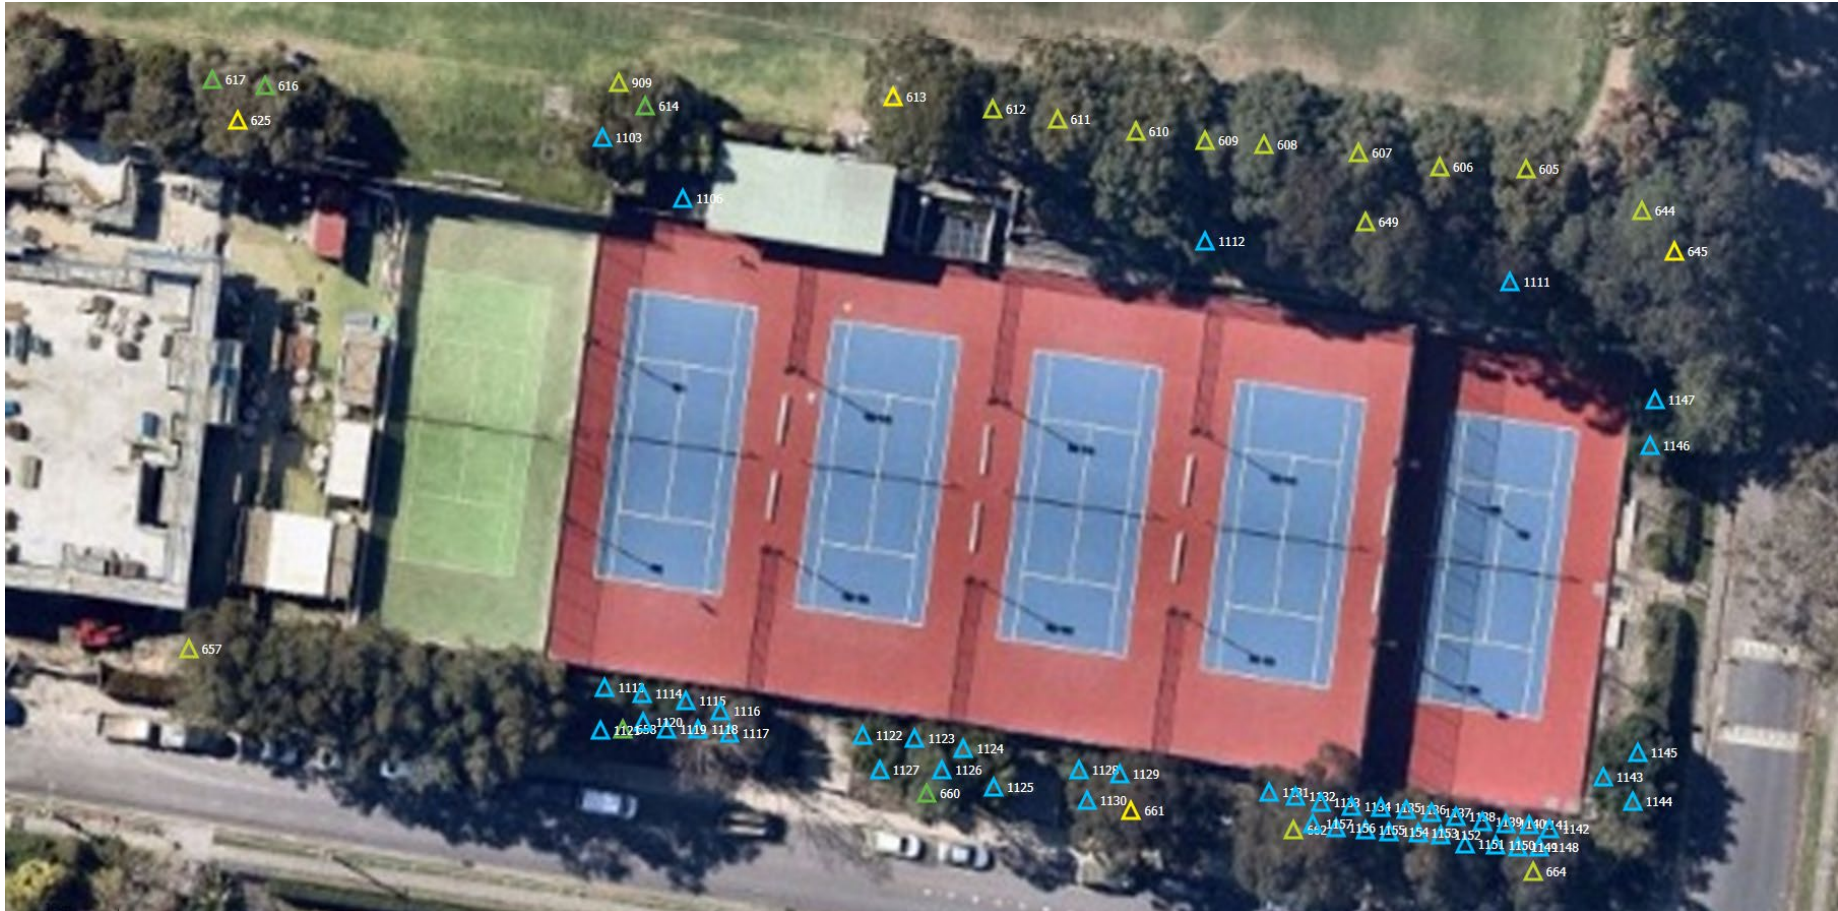
Figure 22. MAP 5 - Trees subject to this report as represented in the ArborPlan Tree Management system. Note tree icon colour represents existing risk status (not Retention Value). (ArborPlan, June 2022).

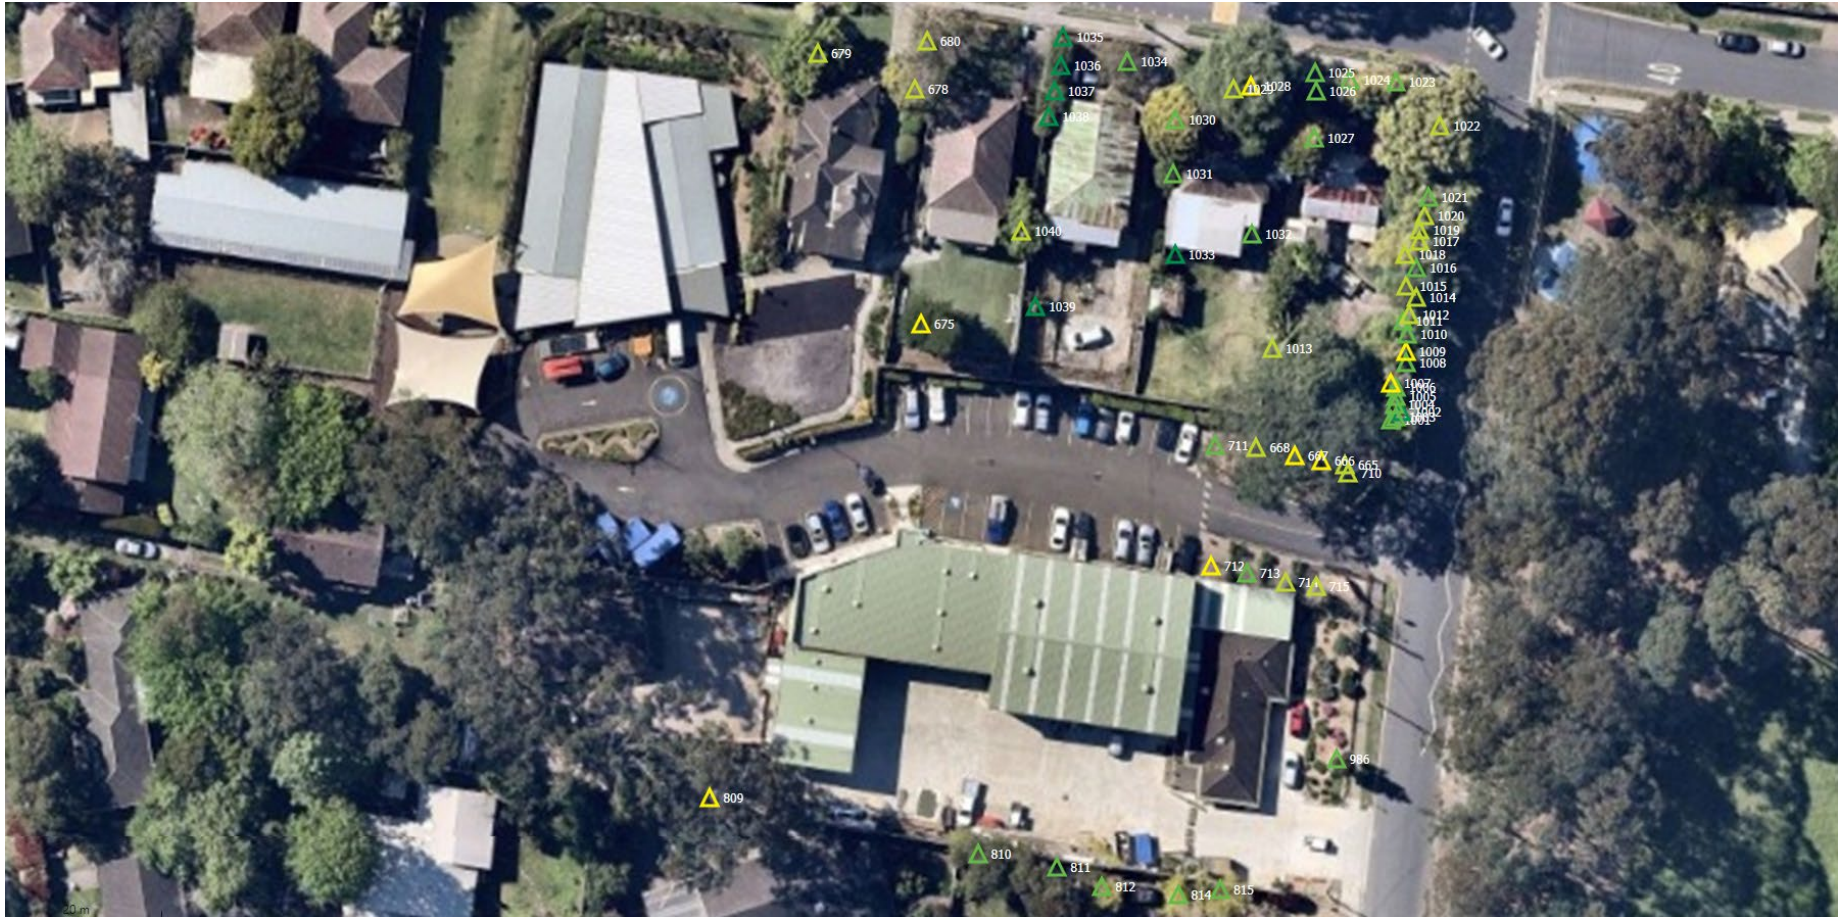
Figure 23. MAP 6 - Trees subject to this report as represented in the ArborPlan Tree Management system. Note tree icon colour represents existing risk status (not Retention Value). (ArborPlan, June 2022).
