1 March 2021  
E22434.E09.001\_Rev0

## **Detailed Site Investigation & Remediation Action Plan Review Proposed Co-Living Development 175-177 Cleveland Street, Redfern NSW**

**DETAILED SITE INVESTIGATION REPORT  
PROPOSED MIXED USE DEVELOPMENT  
1-5 WOODBURN STREET, REDFERN**

Report E22434 AA  
18 September 2015

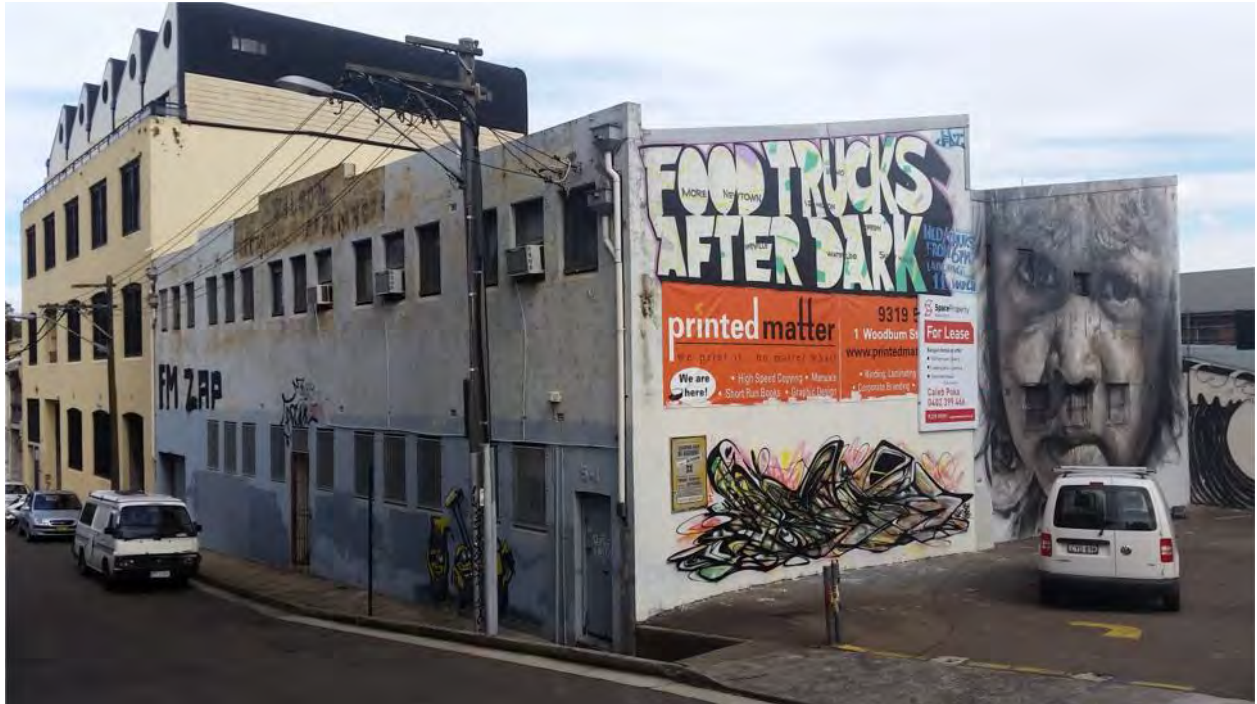
- The site is currently occupied by a two-storey concrete and steel building in average condition, occupying the entire area of the site (Photo 1);
- The site slopes towards the south, with storm water discharging into the local storm water system;

Photo 1: Site buildings located at 1-5 Woodburn Street, Redfern NSW.

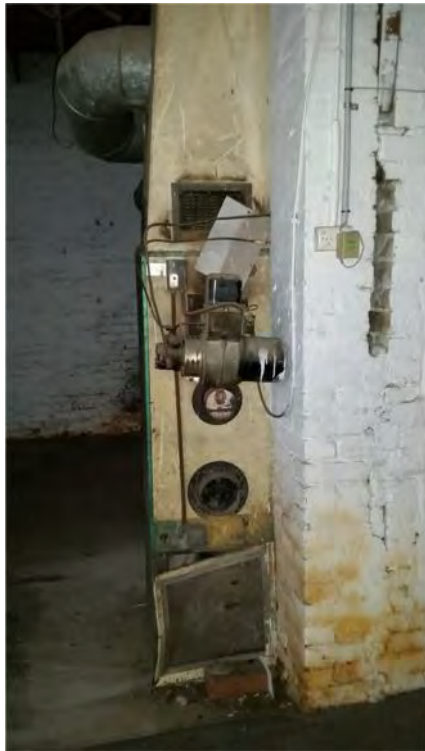
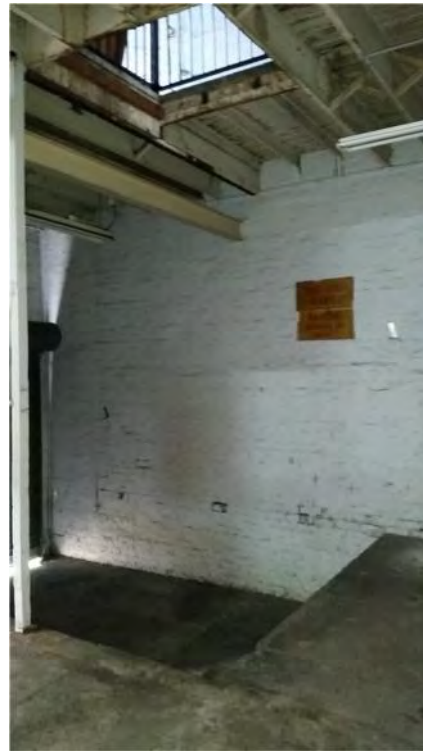
- A hoist system is present which was previously used to lift equipment onto the top floor through an opening (Photo 3 and Photo 4);
- Site pavements were in average condition;

Photo 3 and Photo 4: Hoist system located on the ground floor which was used to lift equipment onto the top floor via an opening (Photo 4).

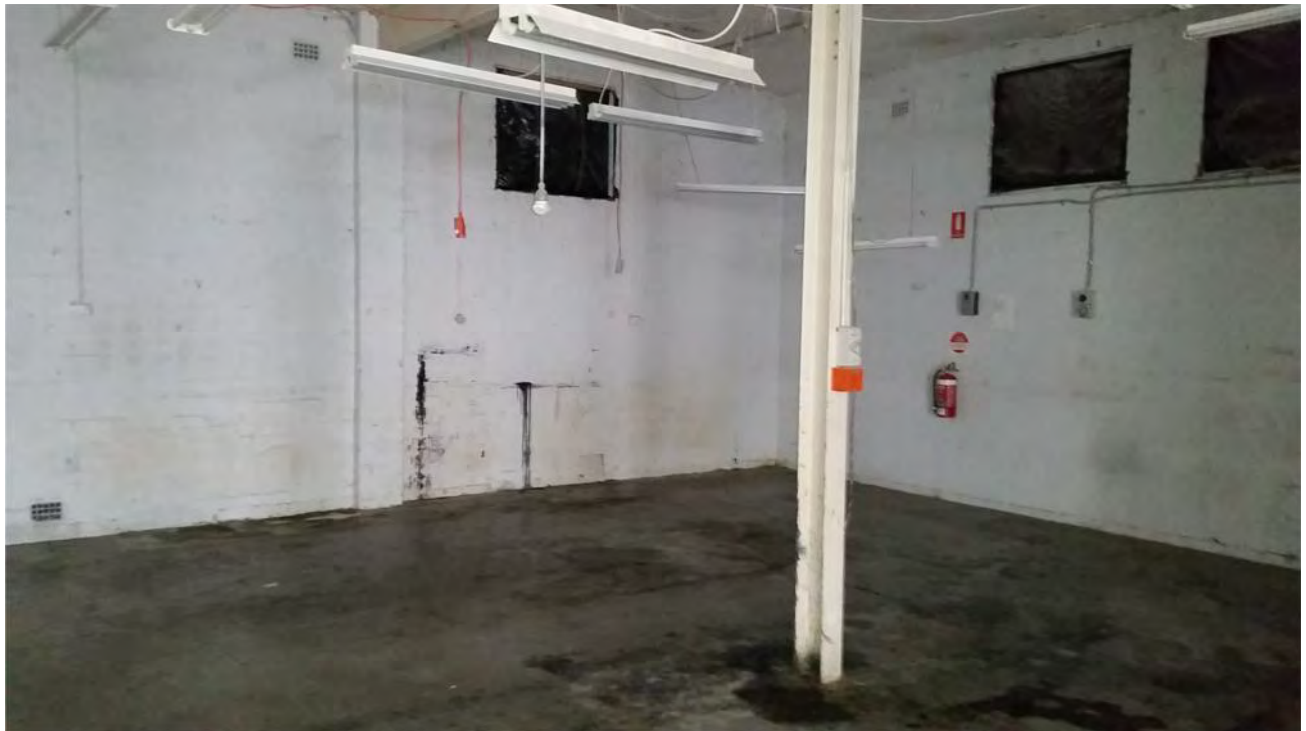
- Visible stains associated with previous printing activities (i.e. ink or oil) were evident in places across the concreted floor and walls on the ground level (Photo 5 and Photo 6);

Photo 5: Staining present on the ground floor level.

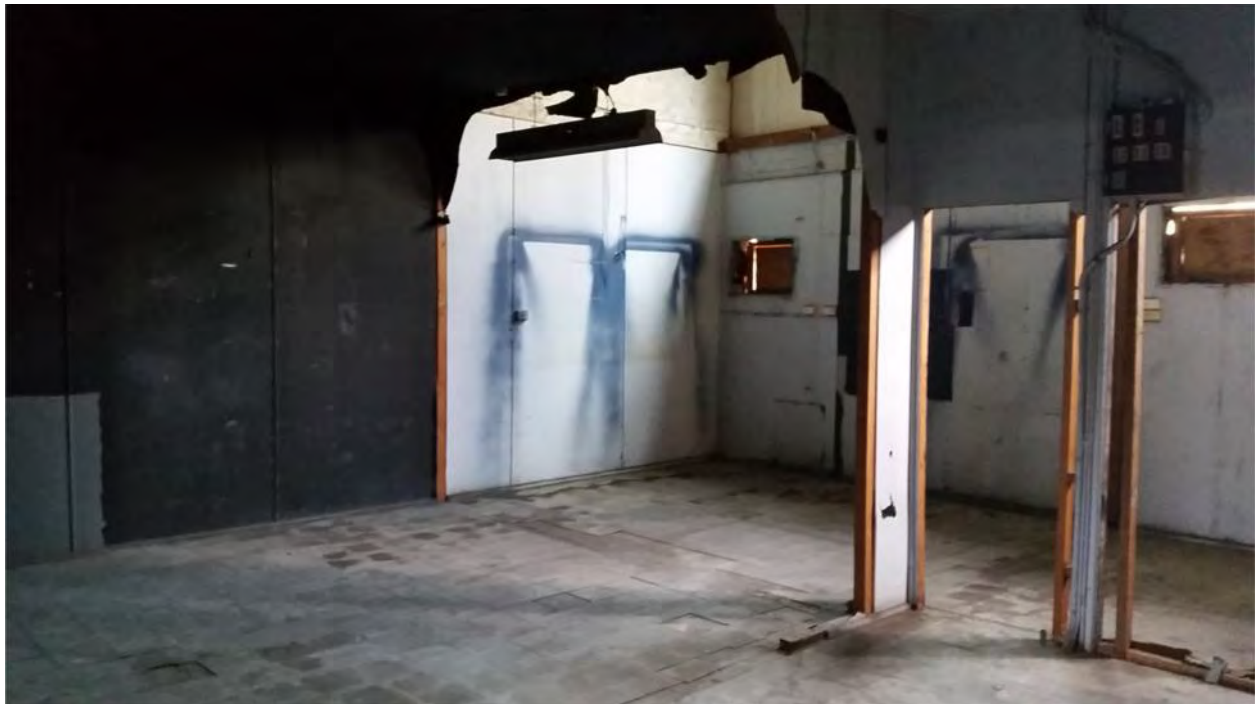
Photo 5: Staining associated with previous printing operations on the ground floor level.

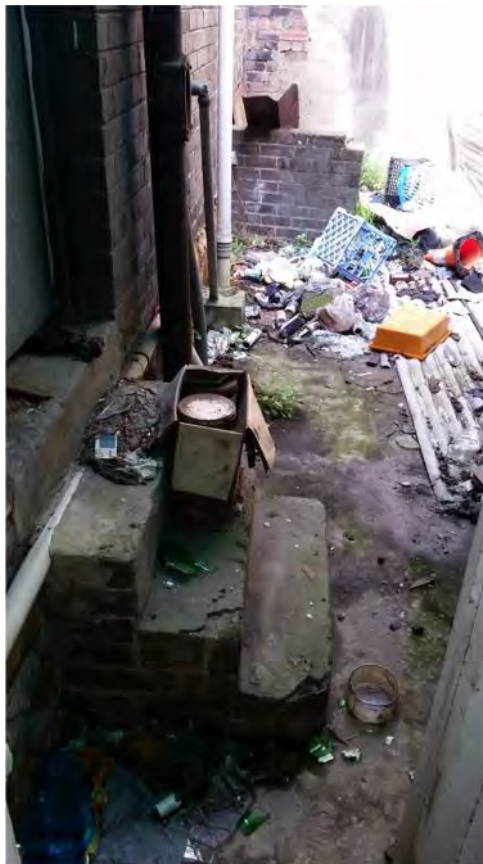
Photo 5: Outdoor area located within the south west corner of the site, occupied by various waste materials.
