Geotechnical Investigation

175-177 Cleveland St & 6-8 Woodburn Street, Redfern,
NSW

Report No: E25342.G03

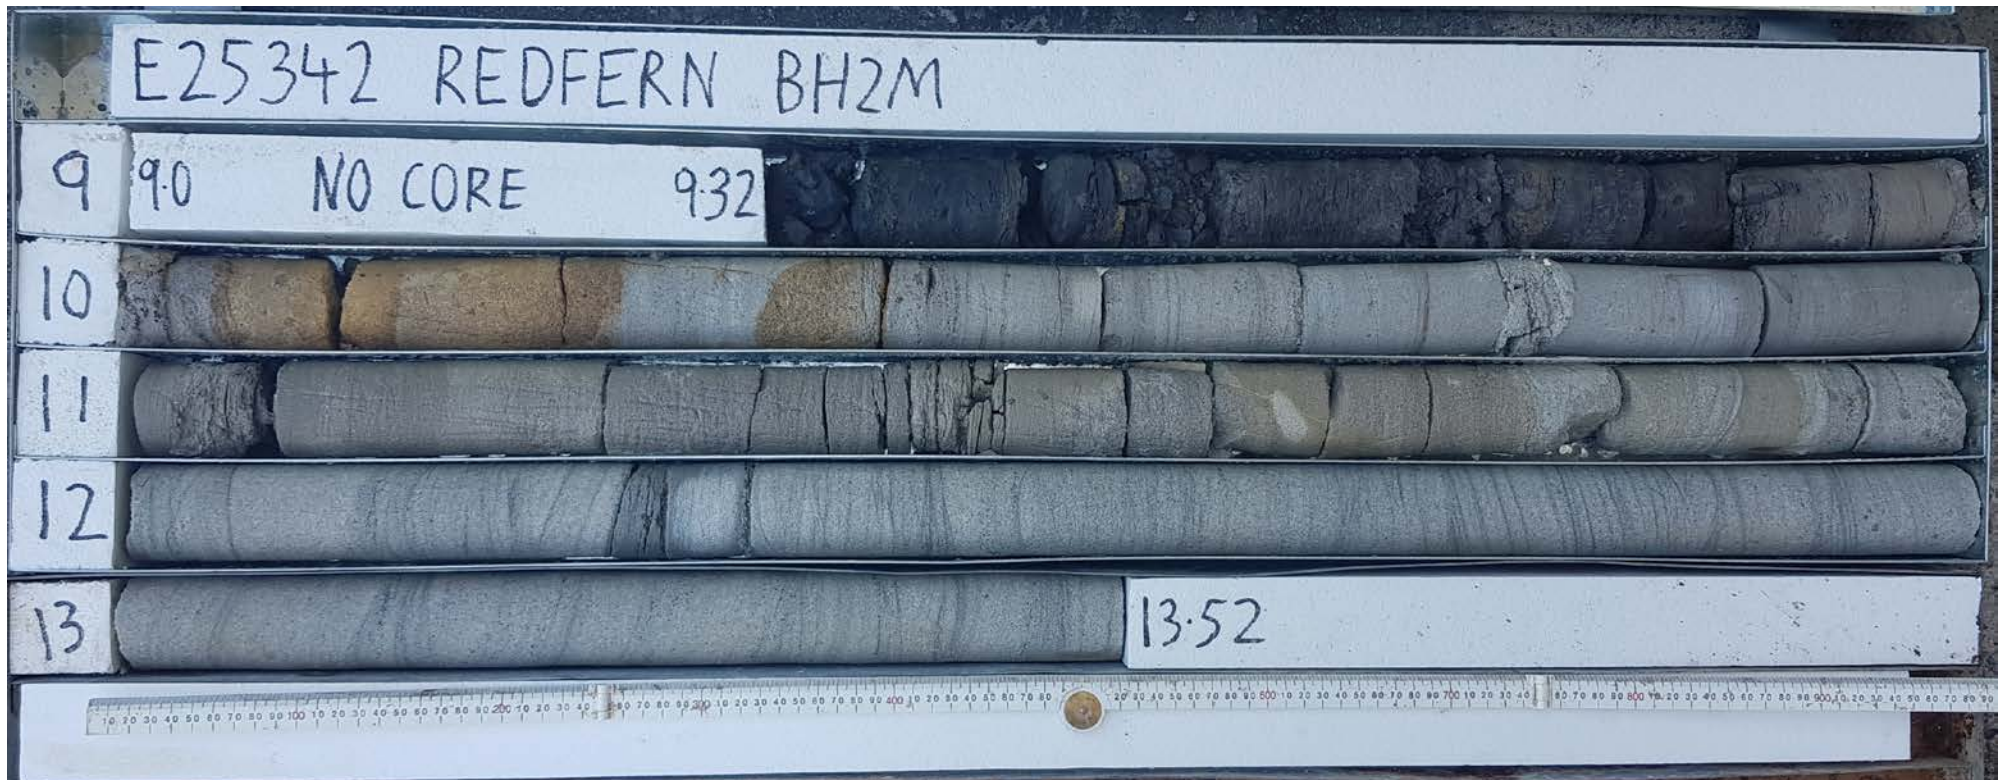
CORE PHOTOGRAPH OF BOREHOLE: BH2M

Project	Proposed Boarding House Development	Depth Range	9.0m to 13.52m BEGL	
Location	175-177 Cleveland St & 6-8 Woodburn Street, Redfern, NSW	Contractor	BG Drilling	
Position	See Figure 2	Drill Rig	Rig CE 180	
Job No.	E25342.G03	Logged	DS	Date 5 / 10 / 2021
Client	YPI2B Ownership Trust No 6	Inclination	-90°	Date 2 / 8 / 2022
		Box	1 & 2 of 2	
		Checked	SK

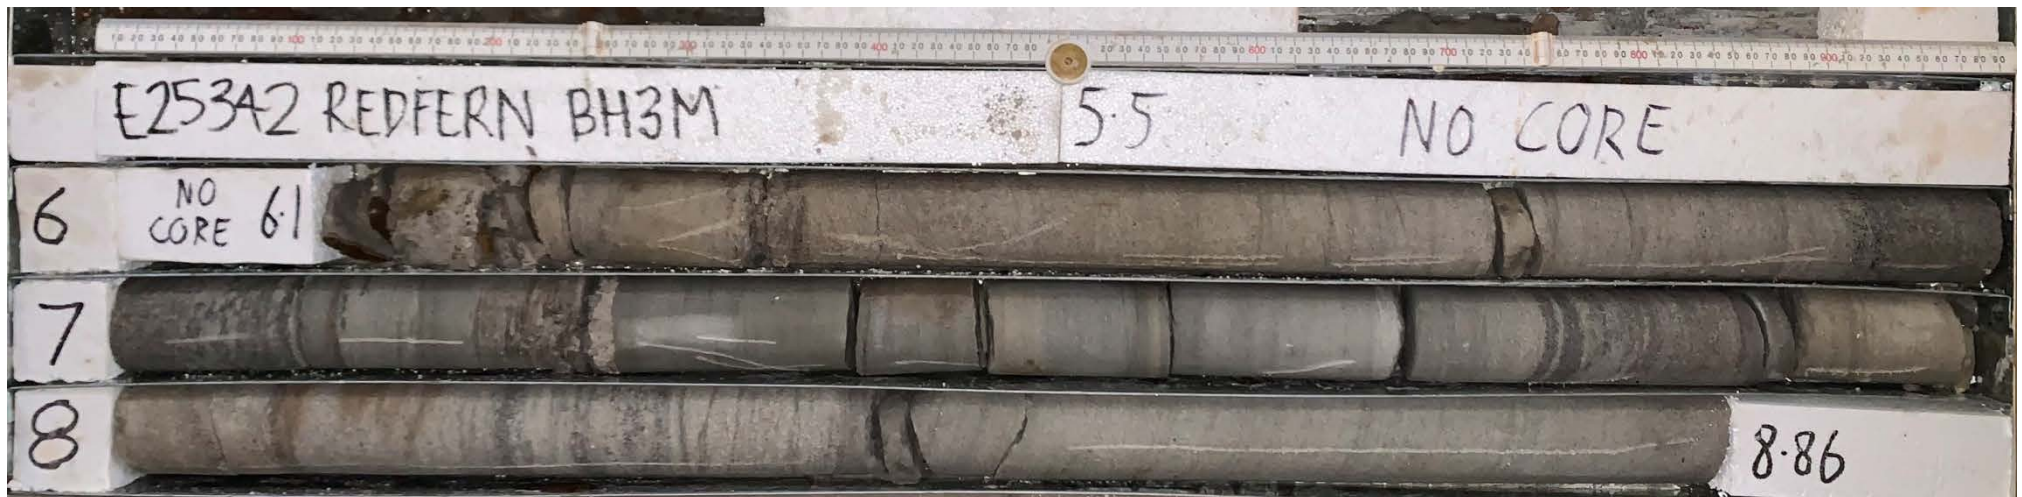
CORE PHOTOGRAPH OF BOREHOLE: BH3M

Project	Proposed Boarding House Development	Depth Range	6.10m to 8.86m BEGL	
Location	175-177 Cleveland St & 6-8 Woodburn Street, Redfern, NSW	Contractor	BG Drilling	
Position	See Figure 2	Drill Rig	Rig CE 180	
Job No.	E25342.G03	Logged	EM	Date 07 / 11 / 2021
Client	YPI2B Ownership Trust No 6	Box	1 of 1	Checked SK Date 2 / 8 / 2022
Surface RL		≈ 17.50m		
Inclination		-90°

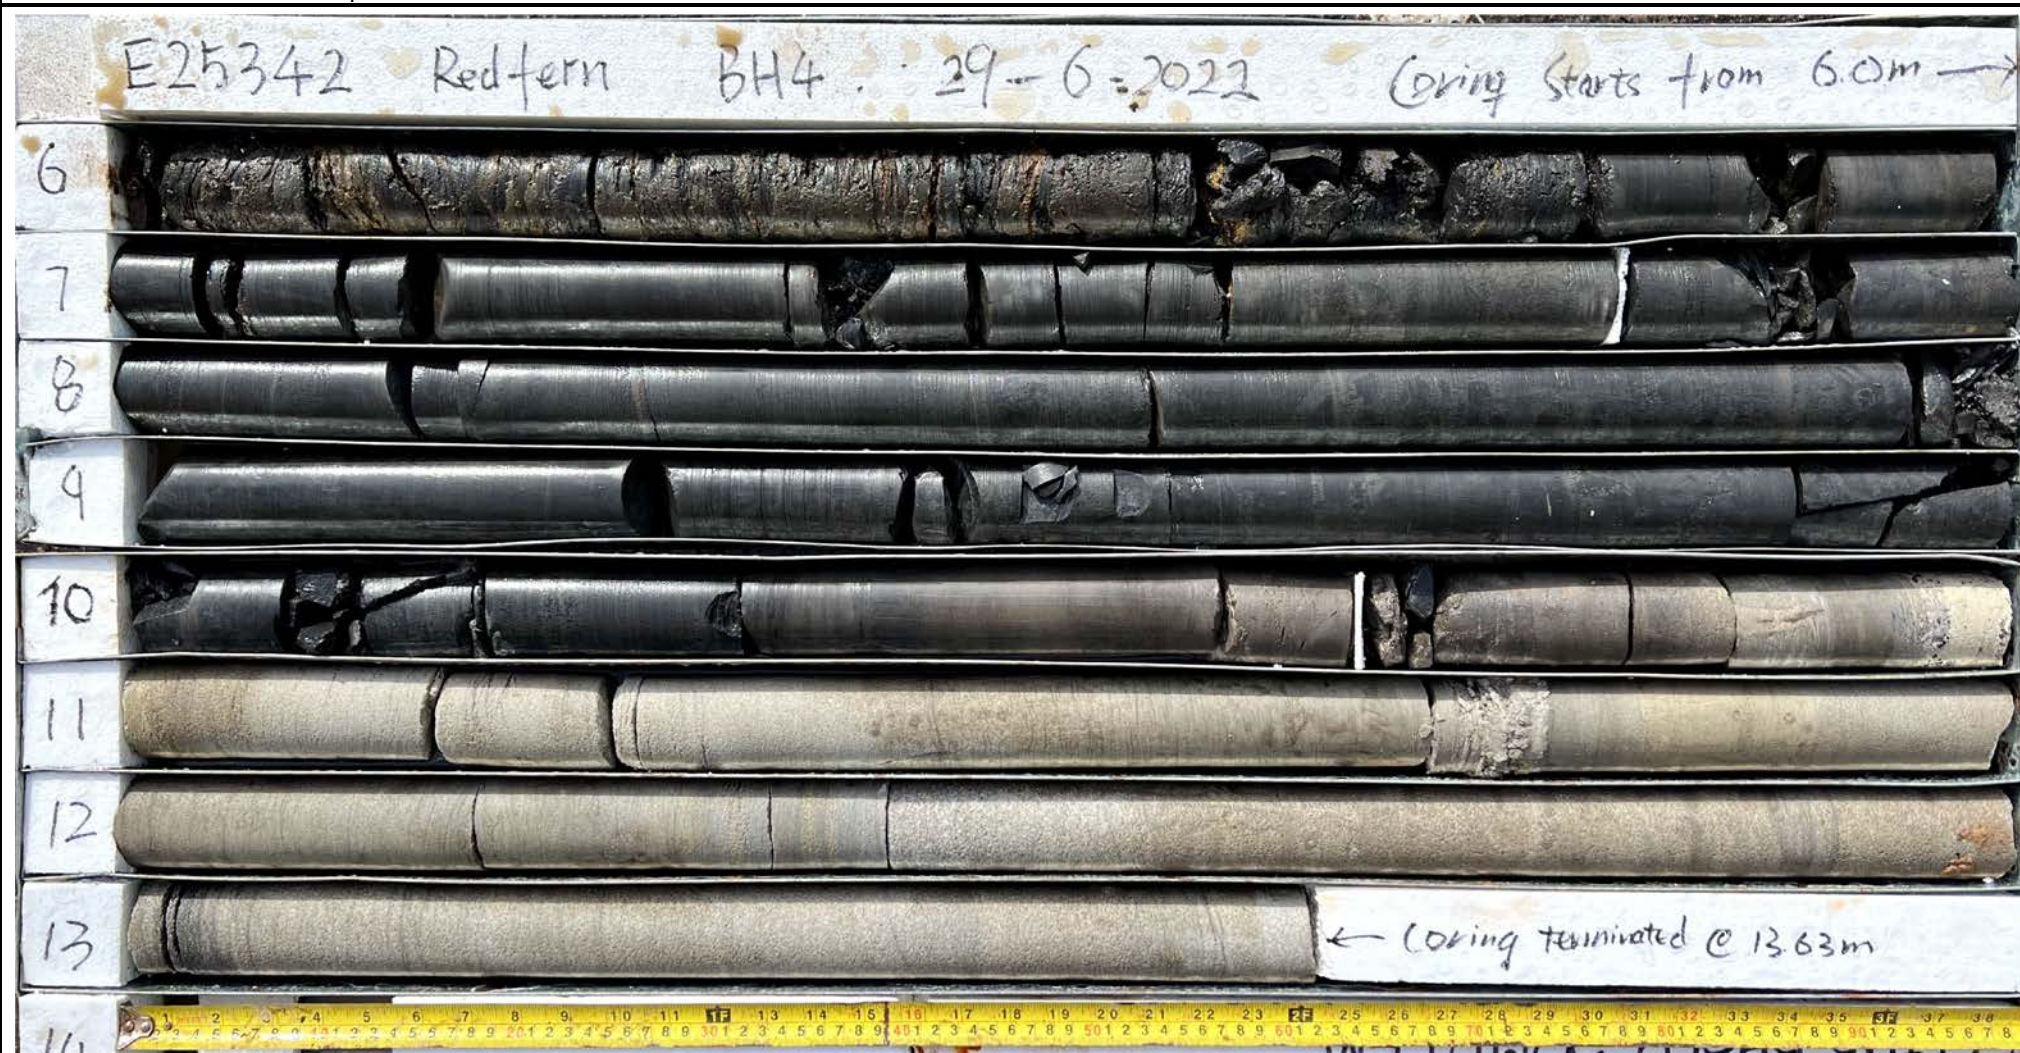
CORE PHOTOGRAPH OF BOREHOLE: BH4

Project	Proposed Boarding House Development			Depth Range	6.0m to 13.63m BEGL		
Location	175-177 Cleveland St & 6-8 Woodburn Street, Redfern, NSW			Contractor	Geosense Drilling Pty Ltd		
Position	See Figure 2	Surface RL	≈ 22.20m	Drill Rig	Comacchio Geo 205		
Job No.	E25342.G03	Inclination	-90°	Logged	LL	Date	07 / 11 / 2021
Client	YPI2B Ownership Trust No 6	Box	1 & 2 of 2	Checked	SK	Date	2 / 8 / 2022

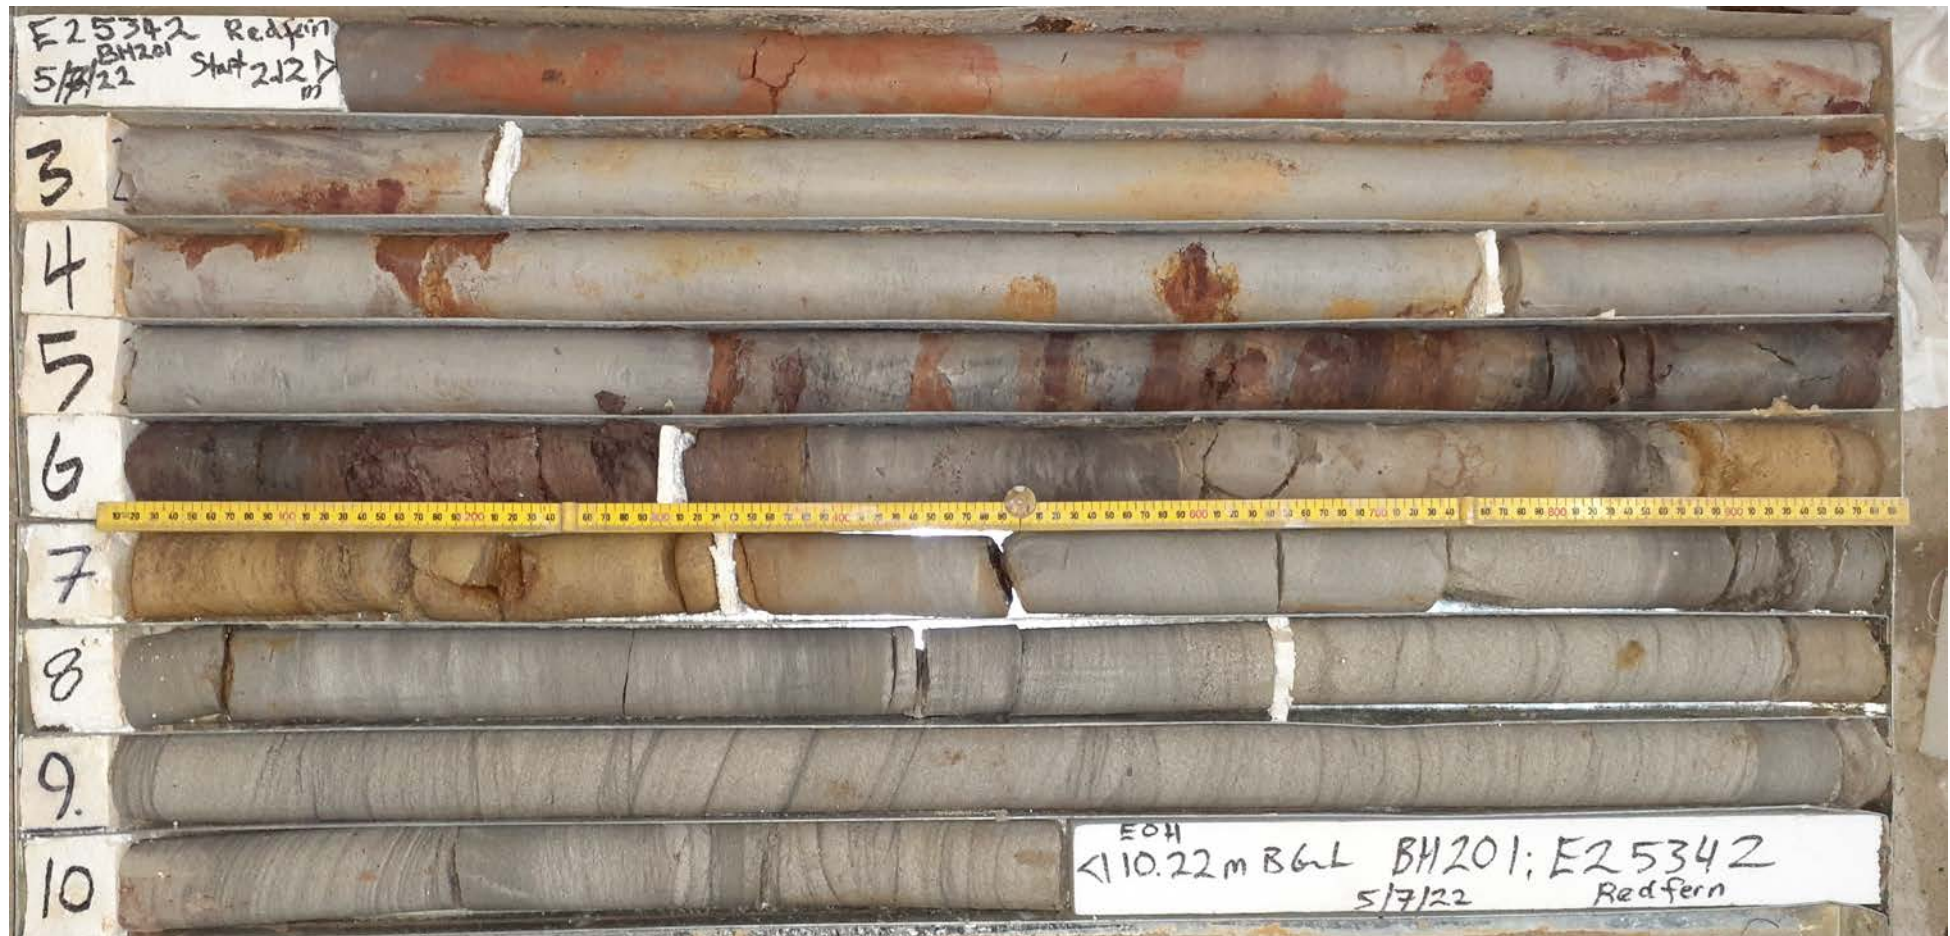
CORE PHOTOGRAPH OF BOREHOLE: BH201M

Project	Proposed Boarding House Development	Depth Range	2.12m to 10.22m BEGL	
Location	175-177 Cleveland St & 6-8 Woodburn Street, Redfern, NSW	Contractor	Tight Site Drilling	
Position	See Figure 2	Drill Rig	Hand Portable Rig	
Job No.	E25342.G03	Logged	DD	Date 07 / 07 / 2022
Client	YPI2B Ownership Trust No 6	Inclination	-90°	Date 2 / 8 / 2022
		Box	1 & 2 of 2	
		Checked	SK

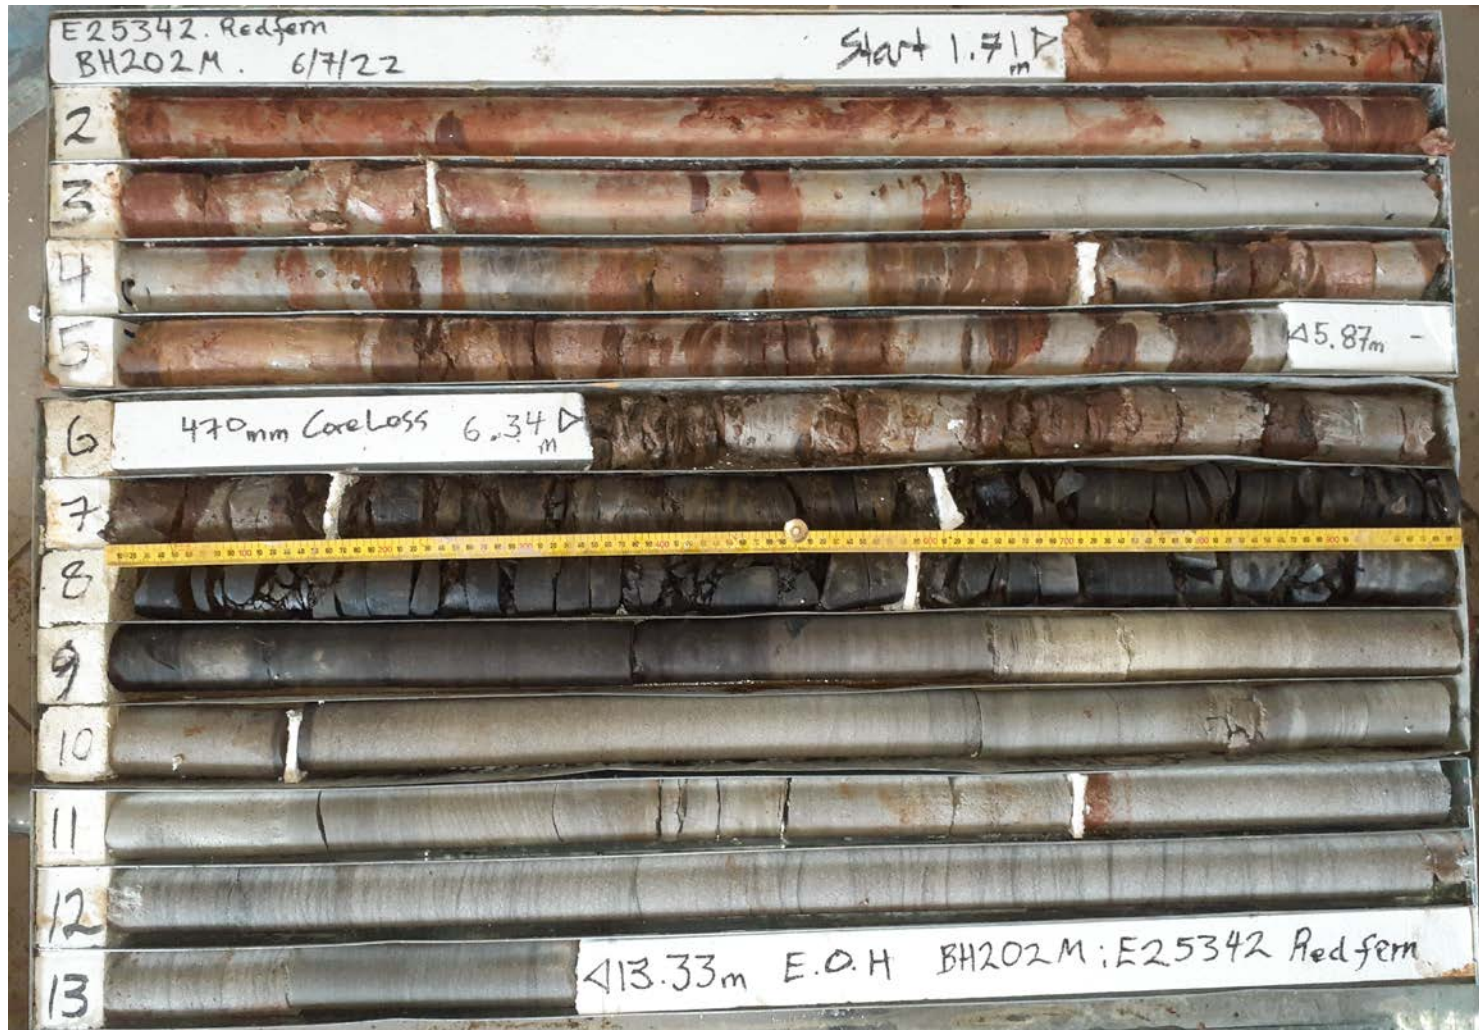
CORE PHOTOGRAPH OF BOREHOLE: BH202M

Project	Proposed Boarding House Development	Depth Range	1.71m to 13.33m BEGL	
Location	175-177 Cleveland St & 6-8 Woodburn Street, Redfern, NSW	Contractor	Tight Site Drilling	
Position	See Figure 2	Drill Rig	Hand Portable Rig	
Job No.	E25342.G03	Logged	DD	Date 07 / 07 / 2022
Client	YPI2B Ownership Trust No 6	Box	1, 2 & 3 of 3	Checked SK Date 2 / 8 / 2022
