**RE: SEARS ITEMS RELATING TO 520 GARDENERS ROAD, ALEXANDRIA -
RESULTS OF GEOTECHNICAL INVESTIGATION (PSM4029.103L)**

- PSM4029-103L REV.01: 520 Gardeners Road, Alexandria – Results of Geotechnical Investigation – dated 19 January 2022.

Our Ref: PSM4029-103L REV1

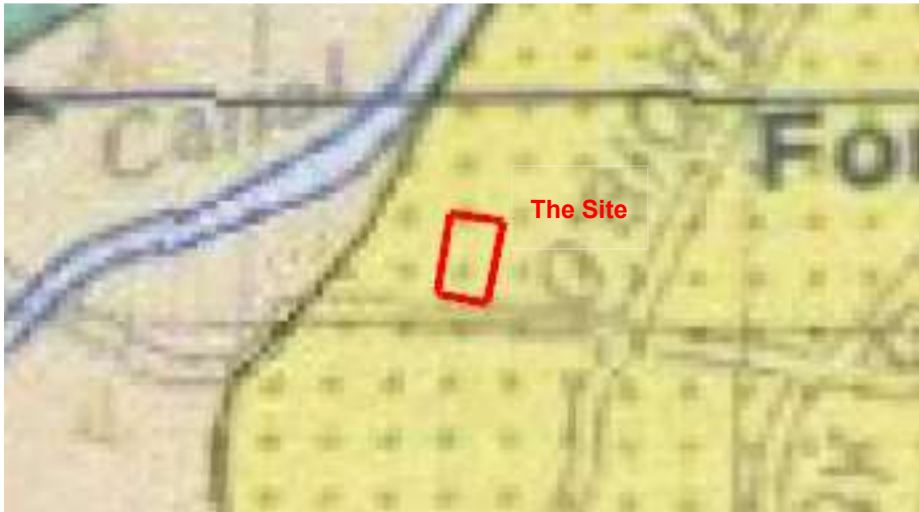
The 1:100,000 Sydney Geological Map indicates that the site is underlain by medium to fine-grained 'marine' sand with podsols. This is presented in Inset 1.

Inset 1: Geological setting as shown on 1:100,000 Sydney Geological Map

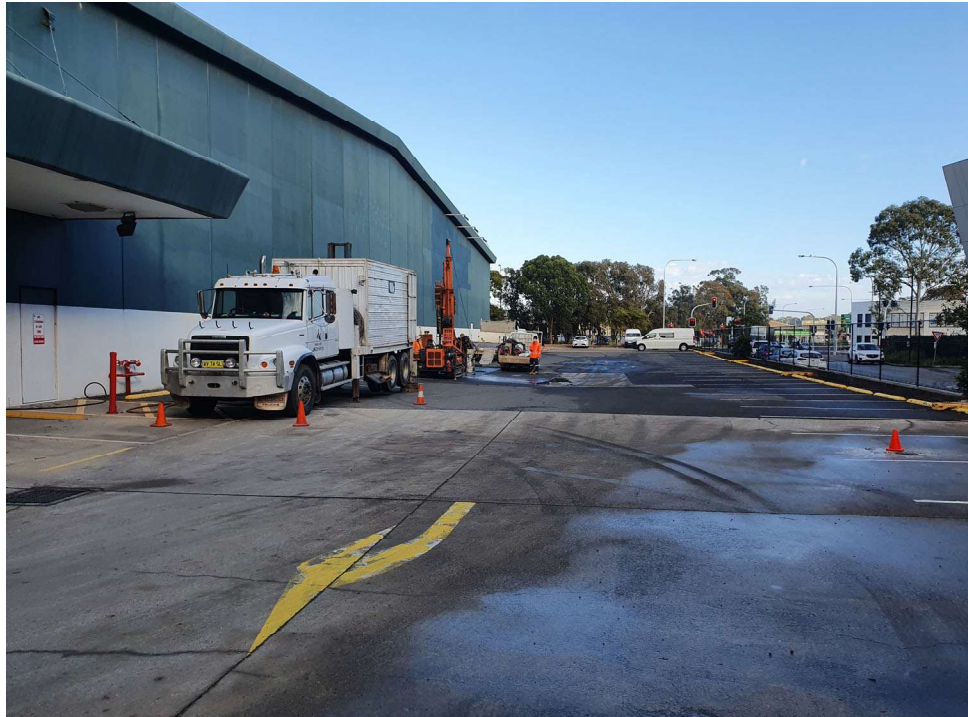
Photo 1 - Site general conditions facing west showing CPT01 & BH01 locations

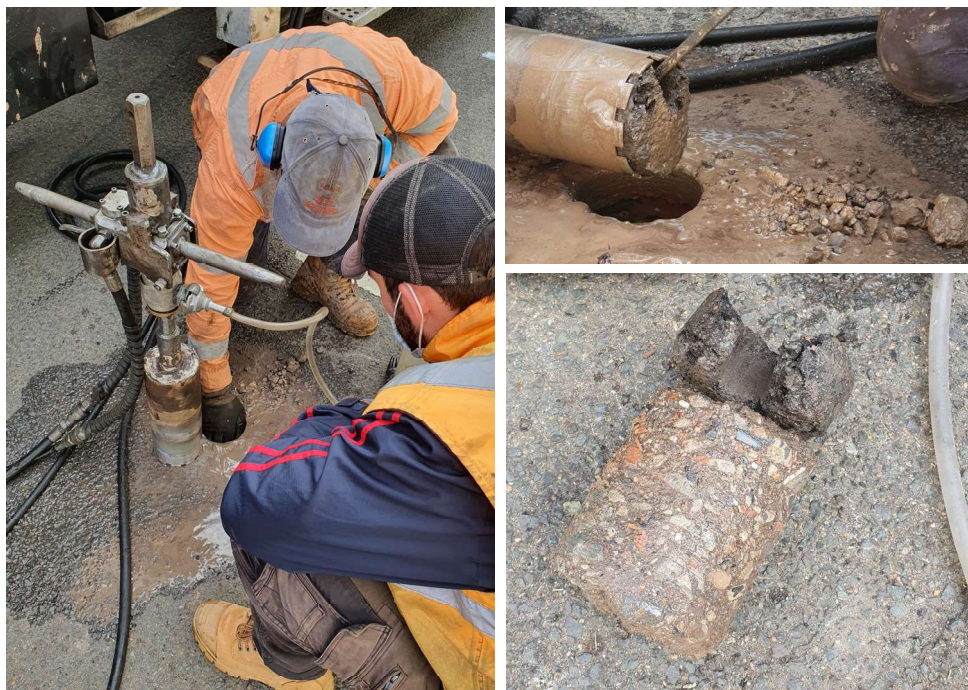
Photo 2 - Diatube coring in the location of CPT01

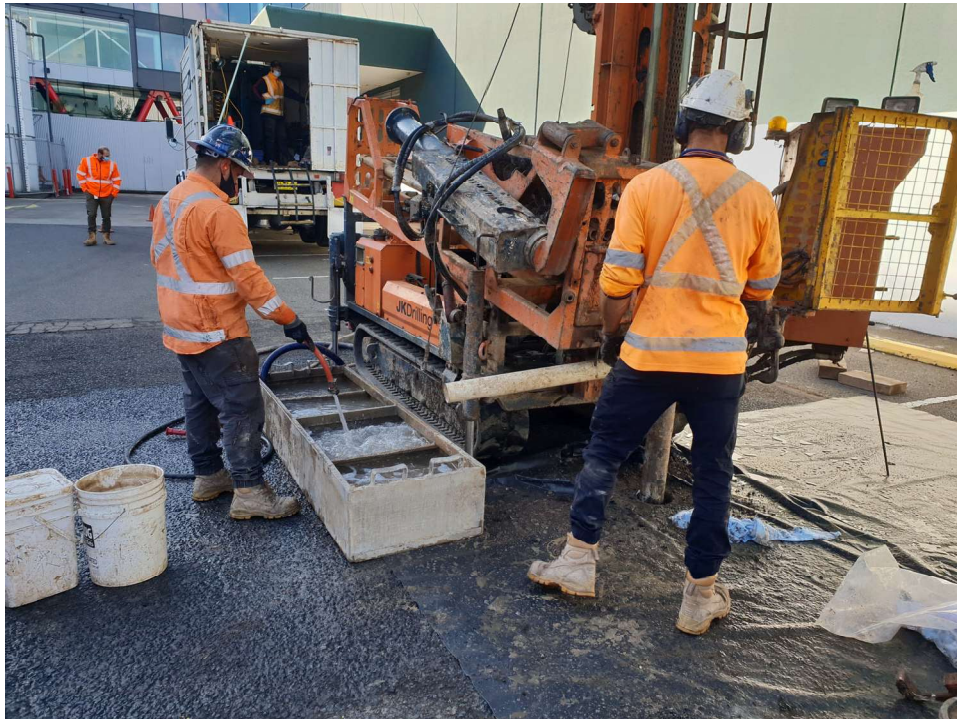
Photo 3 - BH01 location with the CPT truck in the background at CPT01 location

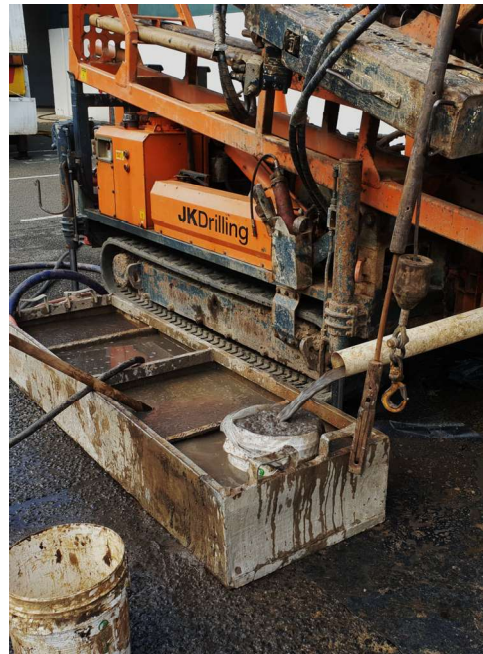
Photo 4 - Washout material colour at 5m (on the left - SAND) and 16m (on the right - CLAY) at BH01

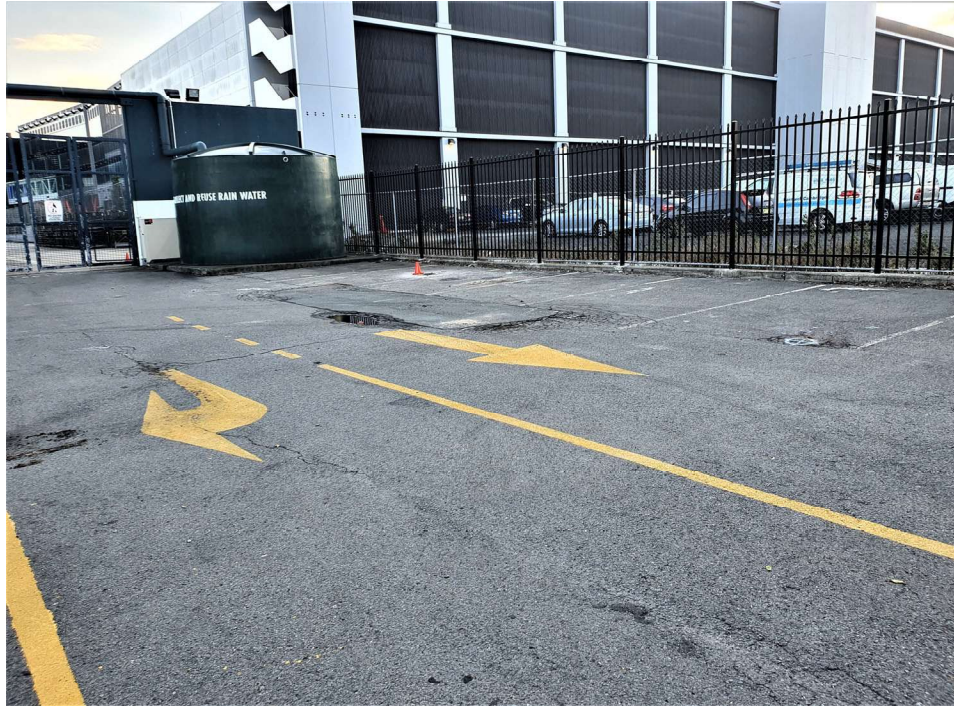
Photo 5 - General site conditions facing north on the eastern end showing CPT03 location

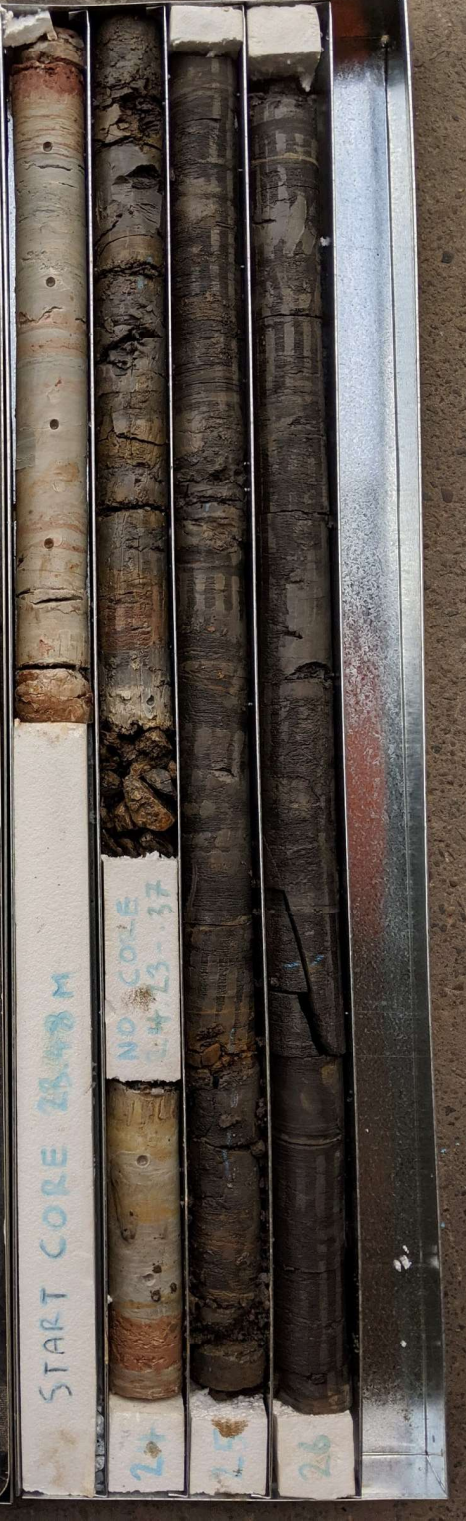
Charter Hall
 520 Gardeners Rd Alexandria
 Alexandria NSW
 BH-01
 CORE PHOTO

BH ID: BH-01
 FROM: 2348
 TO: 2696
