Project No: POWERHOUSE/ULTIMO/22 Report No: POWERHOUSE/ULTIMO/PREL/D

# PRELIMINARY ARBORICULTURAL REPORT

## Powerhouse Ultimo Renewal 500 Harris Street Ultimo

3<sup>rd</sup> May 2022  
Revision D

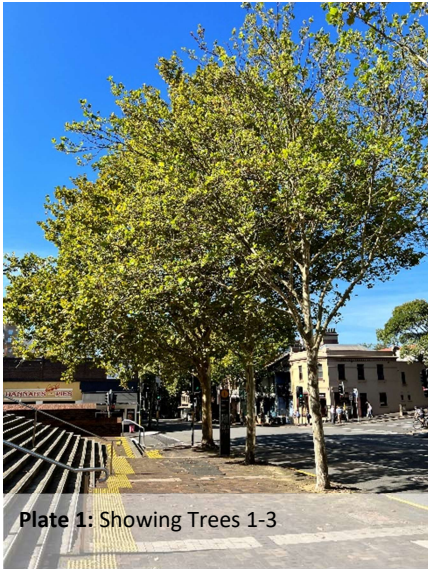
**Plate 1:** Showing Trees 1-3

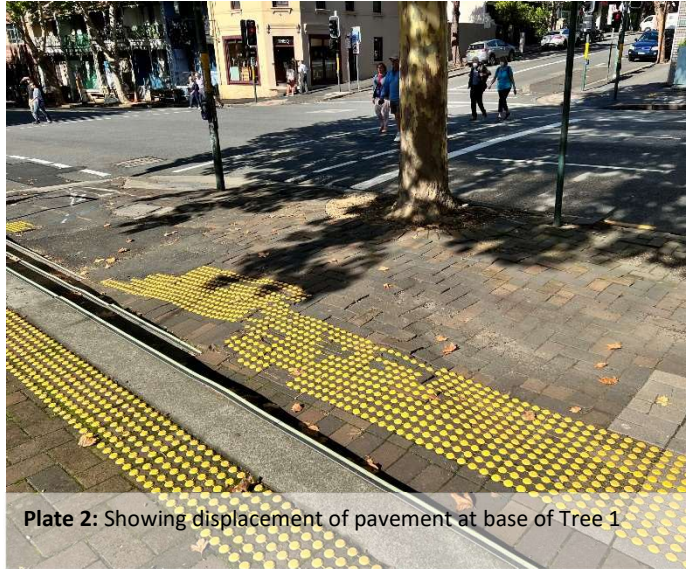
**Plate 2:** Showing displacement of pavement at base of Tree 1

- 4.1.3 The Reference Design shows Trees 1-15 and 17 are to be retained. New pavements areas surrounding the trees should consider their root systems when determining finished levels. There is likely to be roots immediately below the existing pavement surface surrounding the trees. Root pruning for pavement repairs or the installation of new pavements at existing levels will not be possible as the roots are located in SRZ areas. The SRZ is defined as the minimum area required for the stability of the tree. Increasing the size of the garden beds surrounding the trees or raising pavement (and subbase) will be required.

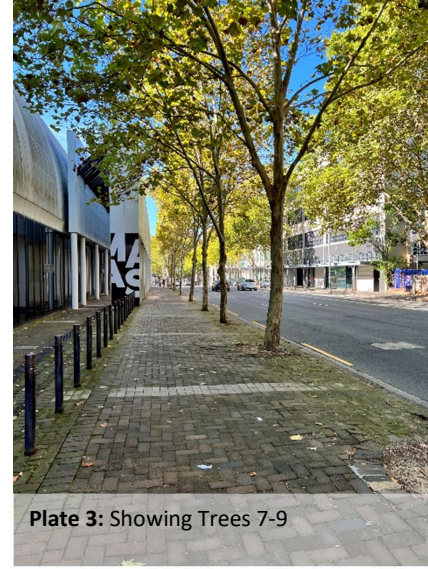
**Plate 3:** Showing Trees 7-9

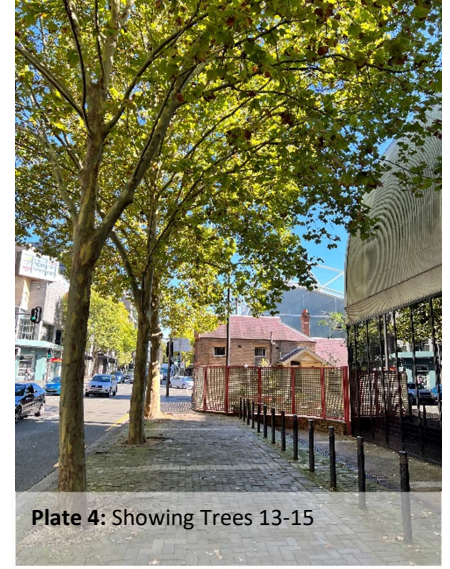
**Plate 4:** Showing Trees 13-15

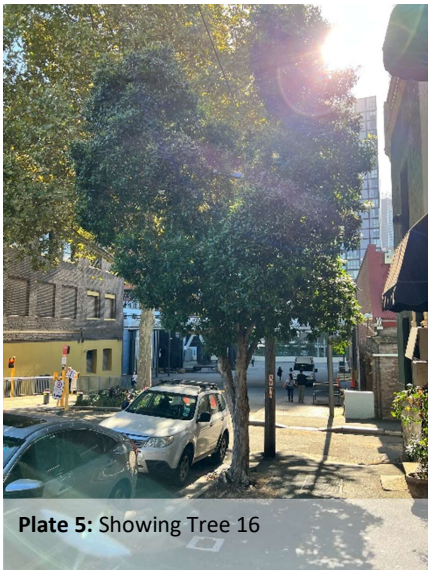
Tree 16 was identified as *Tristaniaopsis laurina* (Water Gum) and is located within the southern Macarthur Street road reserve. The tree is in good health and structural condition. Tree 16 is of low Landscape Significance and has been allocated a Retention Value of *Consider for Removal*.

**Plate 5:** Showing Tree 16

- 4.1.4 The Reference Design shows Trees 16 and 18-22 are to be removed. Tree 16 is of low Landscape Significance and has been allocated a Retention Value of *Consider for Removal*. A new tree planting using a healthy, advanced-sized specimen could replace the loss of amenity from tree removal within a short timeframe. Trees 18-22 are of moderate Landscape Significance and have been allocated a Retention Value of *Consider for Retention*. From a tree management perspective they are the most difficult trees to retain. These trees are likely to be more vulnerable to destabilisation through root loss or damage, altered wind loading from removal of trees within the group or changes to the form of surrounding buildings which may alter wind tunnelling or wind vortices effects. In addition, where containerisation of a tree's root plate causes a congested root mass to develop at the base of the tree, vascular constriction can occur which can impact tree health and ULE.

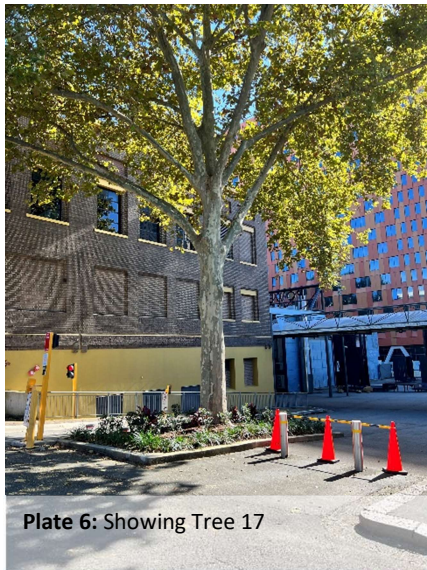
Tree 17 was identified as *Platanus x acerifolia* (London Plane Tree) and is an in-road planting located at the eastern end of Macarthur Street. The tree is in good health and structural condition, and with a crown which extends over the entire carriageway, is considered the best tree on site. Tree 17 is of high Landscape Significance and has been allocated a Retention Value of *Priority for Retention*.

**Plate 6:** Showing Tree 17

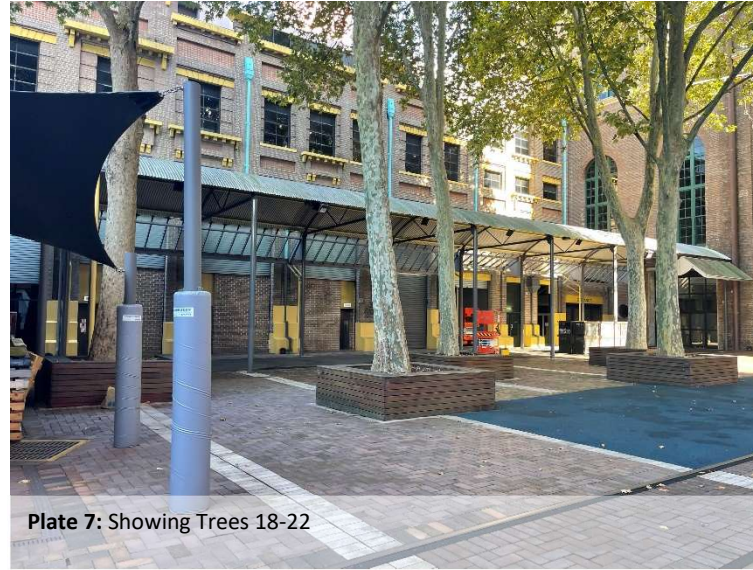
Trees 18-22 were identified as *Platanus x acerifolia* (London Plane Tree) and are located within a courtyard area to the south of the Powerhouse. The trees are large specimens which have been extensively Crown Lifted and have developed asymmetrical crown forms due to mutual suppression. The trees are of moderate Landscape Significance and have been allocated a Retention Value of *Consider for Retention*.

3.1.5 Although the trees were assessed as being in good health and structural condition, the trees are located in small, raised planters which are likely to have influenced the root architecture of the trees. It can be assumed that roots have developed out of the bottom of these planters as is evidenced by the lifting of areas of the surrounding pavement. However, it is also likely that some roots have been developed within the confines of the raised planter resulting in congested root mass which provides limited structural stability to the root plate as a whole.

**Plate 7:** Showing Trees 18-22
