Report on
Geotechnical Investigation

Powerhouse Ultimo Renewal
Powerhouse Ultimo, 500 Harris St, Ultimo

Prepared for
Create NSW, Department of Enterprise, Investment
and Trade

Project 86874.03
May 2022

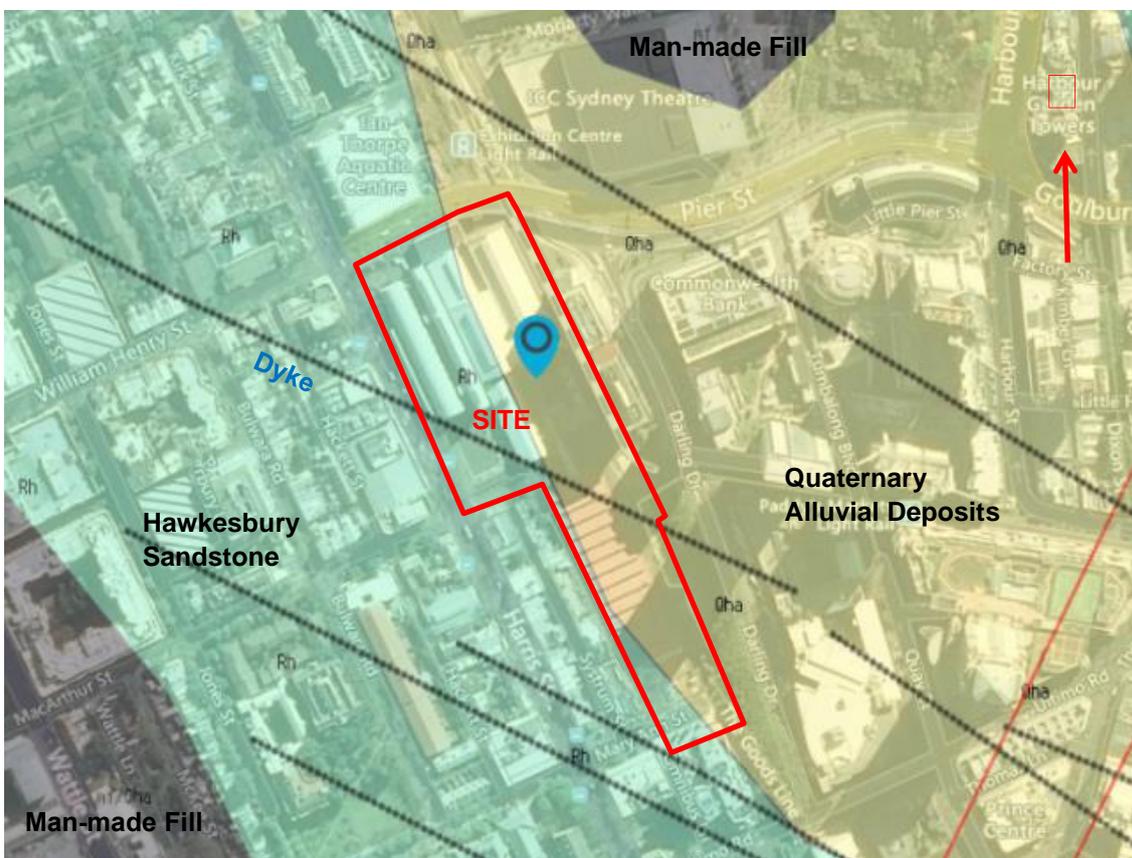
Figure 1: Extract from Sydney 1:100 000 Geological Series Sheet

Reference to the Sydney 1:100 000 Geological Series Sheet 9130 (Geological Survey of NSW) indicates that the upper / western part of the site is underlain by Hawkesbury Sandstone of Triassic age, whereas the lower / eastern part of the site is underlain by Quaternary alluvium (from approximately the interface between the Boiler Room and the Turbine House). An intrusive igneous dyke is inferred to pass obliquely through the south-eastern corner of the building, striking at approximately 110 degrees. This

feature is observed elsewhere nearby to have a sub-vertical dip and is likely to be completely weathered to clay. Figure 1 above presents an extract of the geological map showing the site.

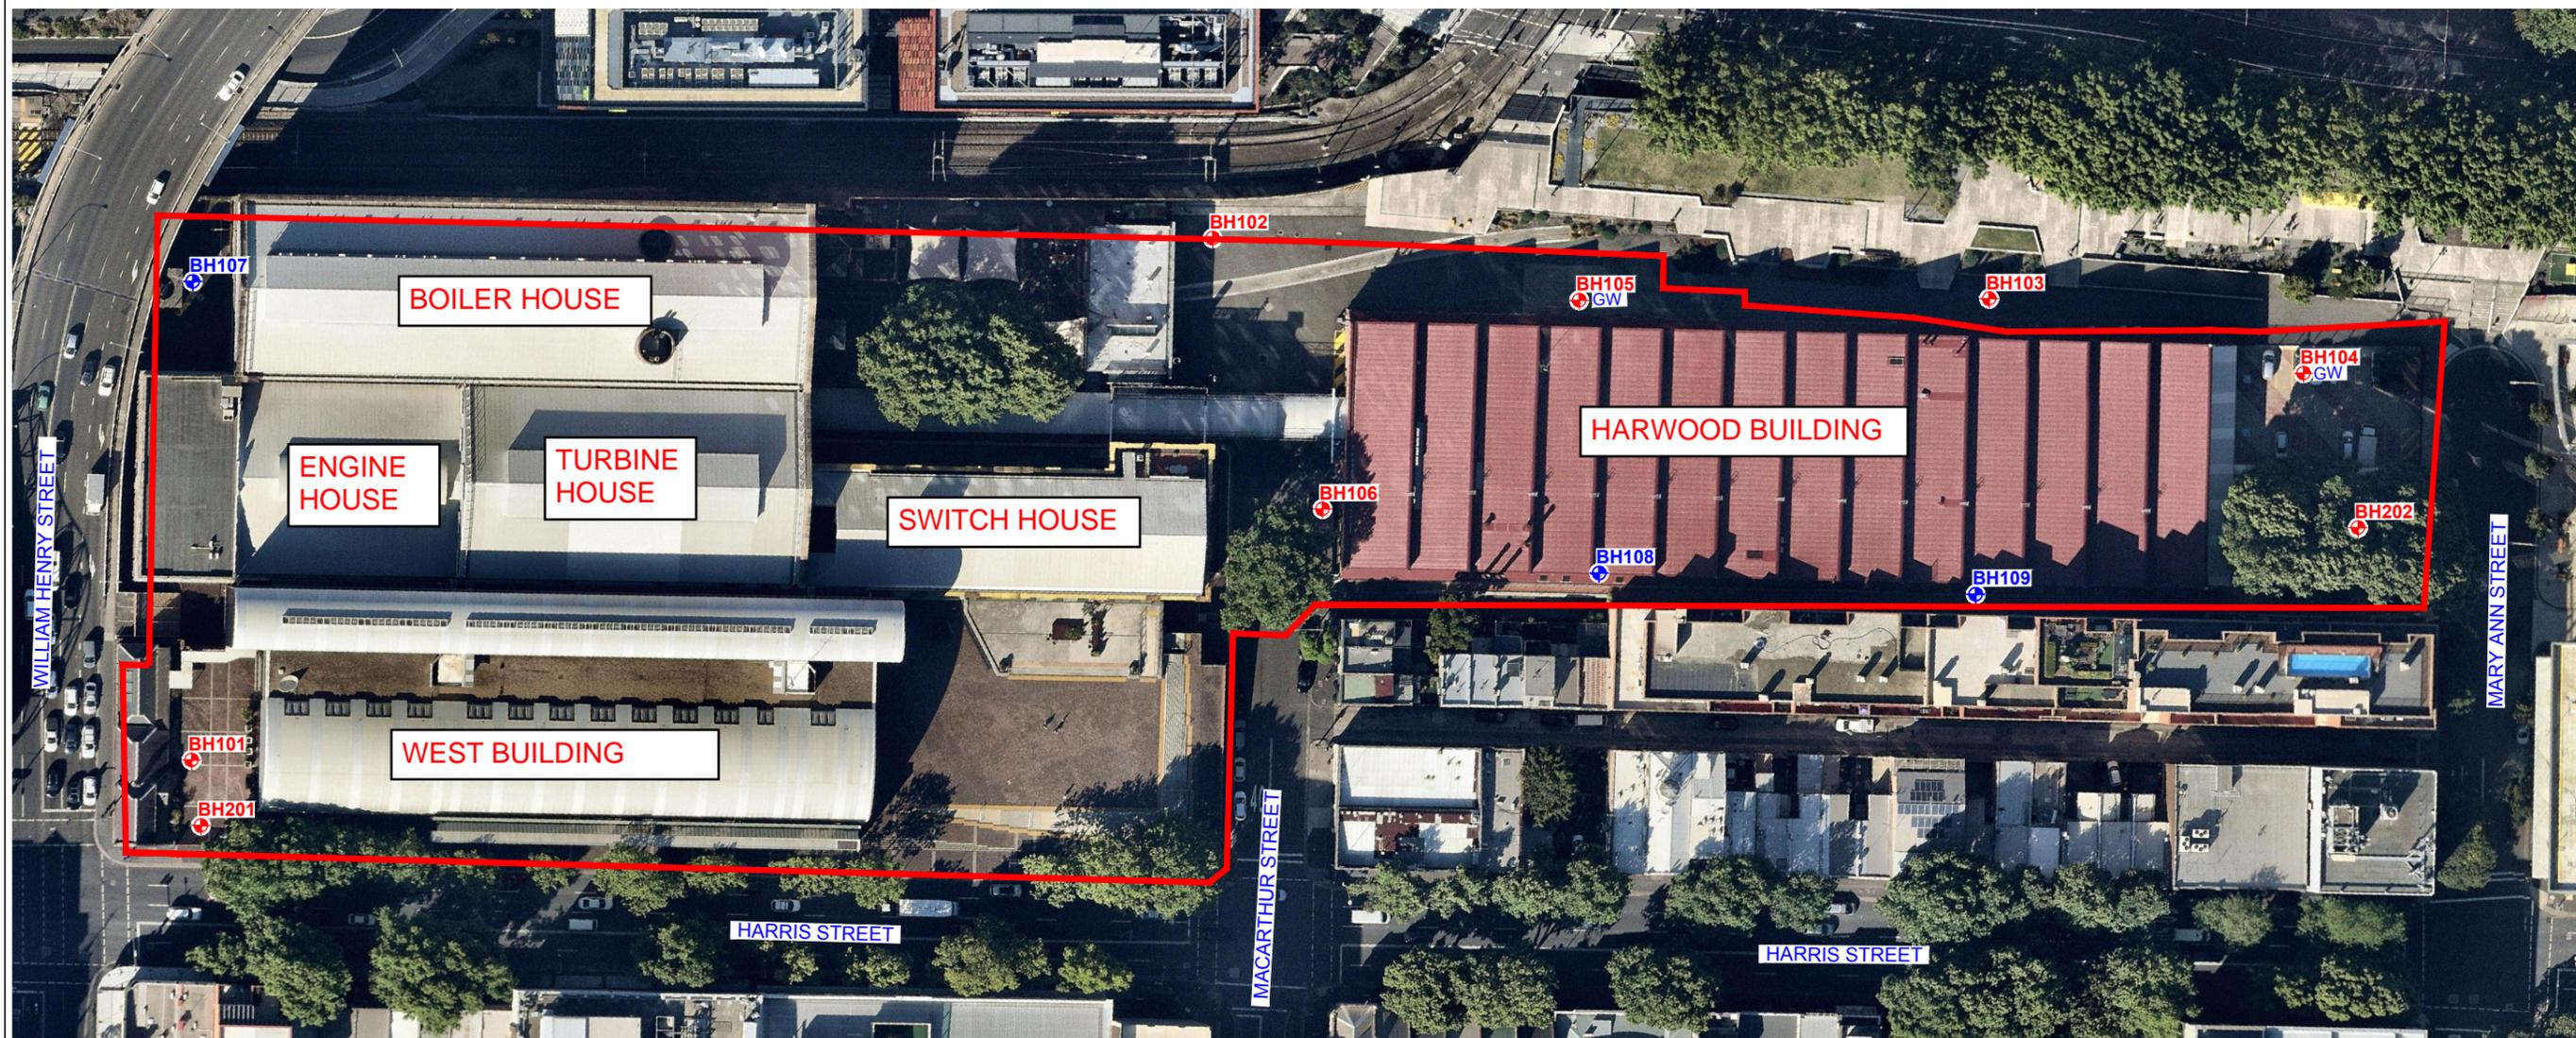
- 1: Base image from Nearmap.com (Dated 22.10.2019)
- 2: Test locations are approximate only and are shown with reference to existing features.

The approximate locations of the buildings are annotated on Drawing 1, Appendix B.

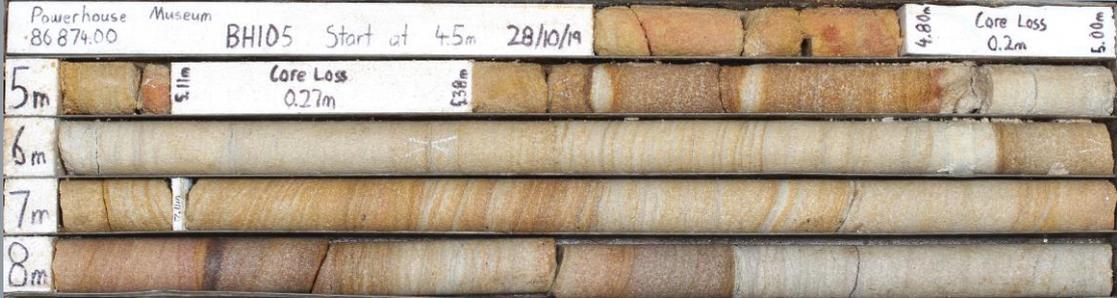
4.50 - 9.00m

Project No: 86874.00
BH ID: BH 105
Depth: 4.50 - 9.00 m
Core Box No.: 1

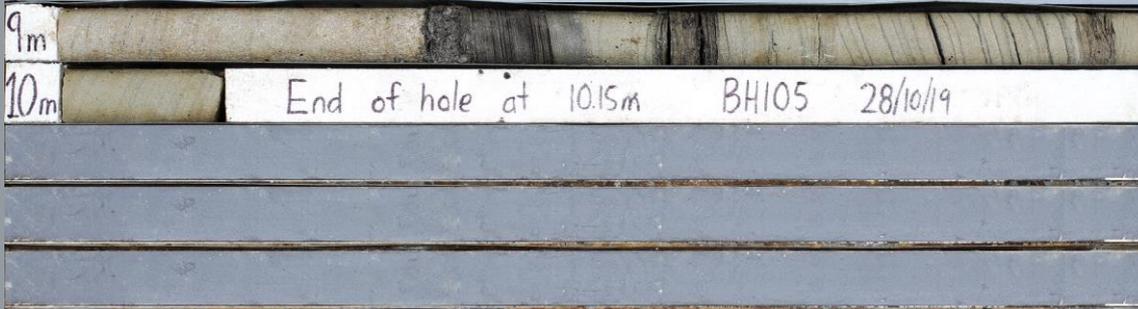
9.00 - 10.15m

Project No: 86874.00
BH ID: BH 105
Depth: 9.00 - 10.15 m
Core Box No.: 2

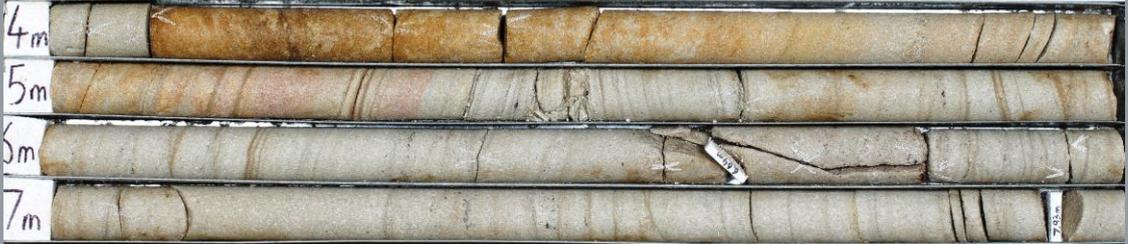
4.00 - 8.00m

Powerhouse Museum 86874.00 BH106 Start at 4.00m 28/10/19

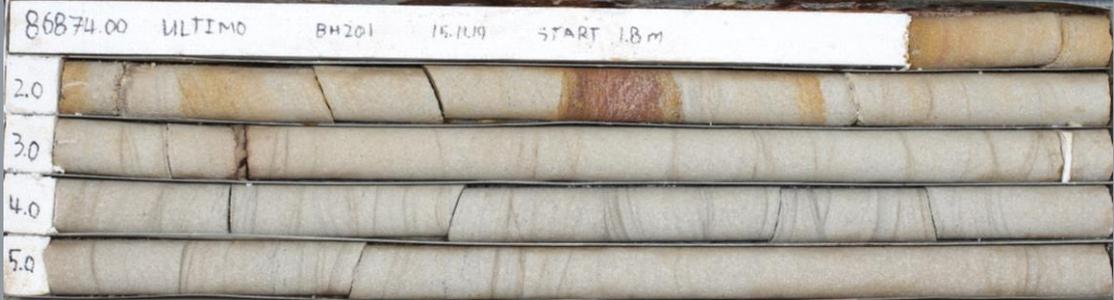
1.80 – 6.00m

Project No: 86874.00
BH ID: BH201
Depth: 1.8-6.0m
Core Box No.: 10F2.

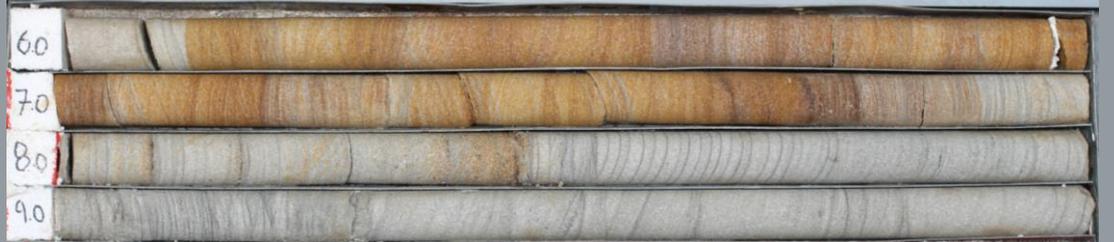
6.00 – 10.00m

Project No: 86874.00
BH ID: BH201
Depth: 6.0-10.0m.
Core Box No.: 20F2.

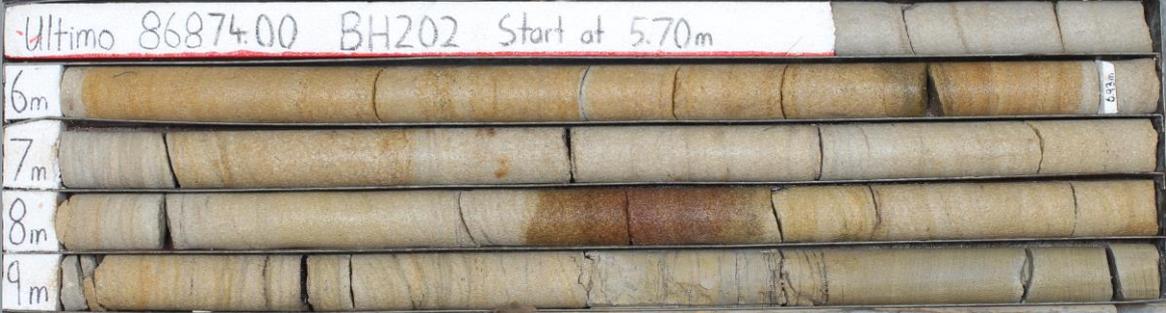
5.70 - 10.00m

Project No: 86874.00
BH ID: BH202
Depth: 5.70-10.00
Core Box No.: 1/1
