MANILDRA Port Kembla

Piling Test Noise and Vibration Measurements

| Document Title | Piling Test Noise and Vibration Measurements |

| Revision | Date | Document Reference | Prepared By | Checked By | Approved By |
|---|---|---|---|---|---|
| 0 | 5/11/2021 | 20211358.1/0511A/R0/TB | TB | | VF |

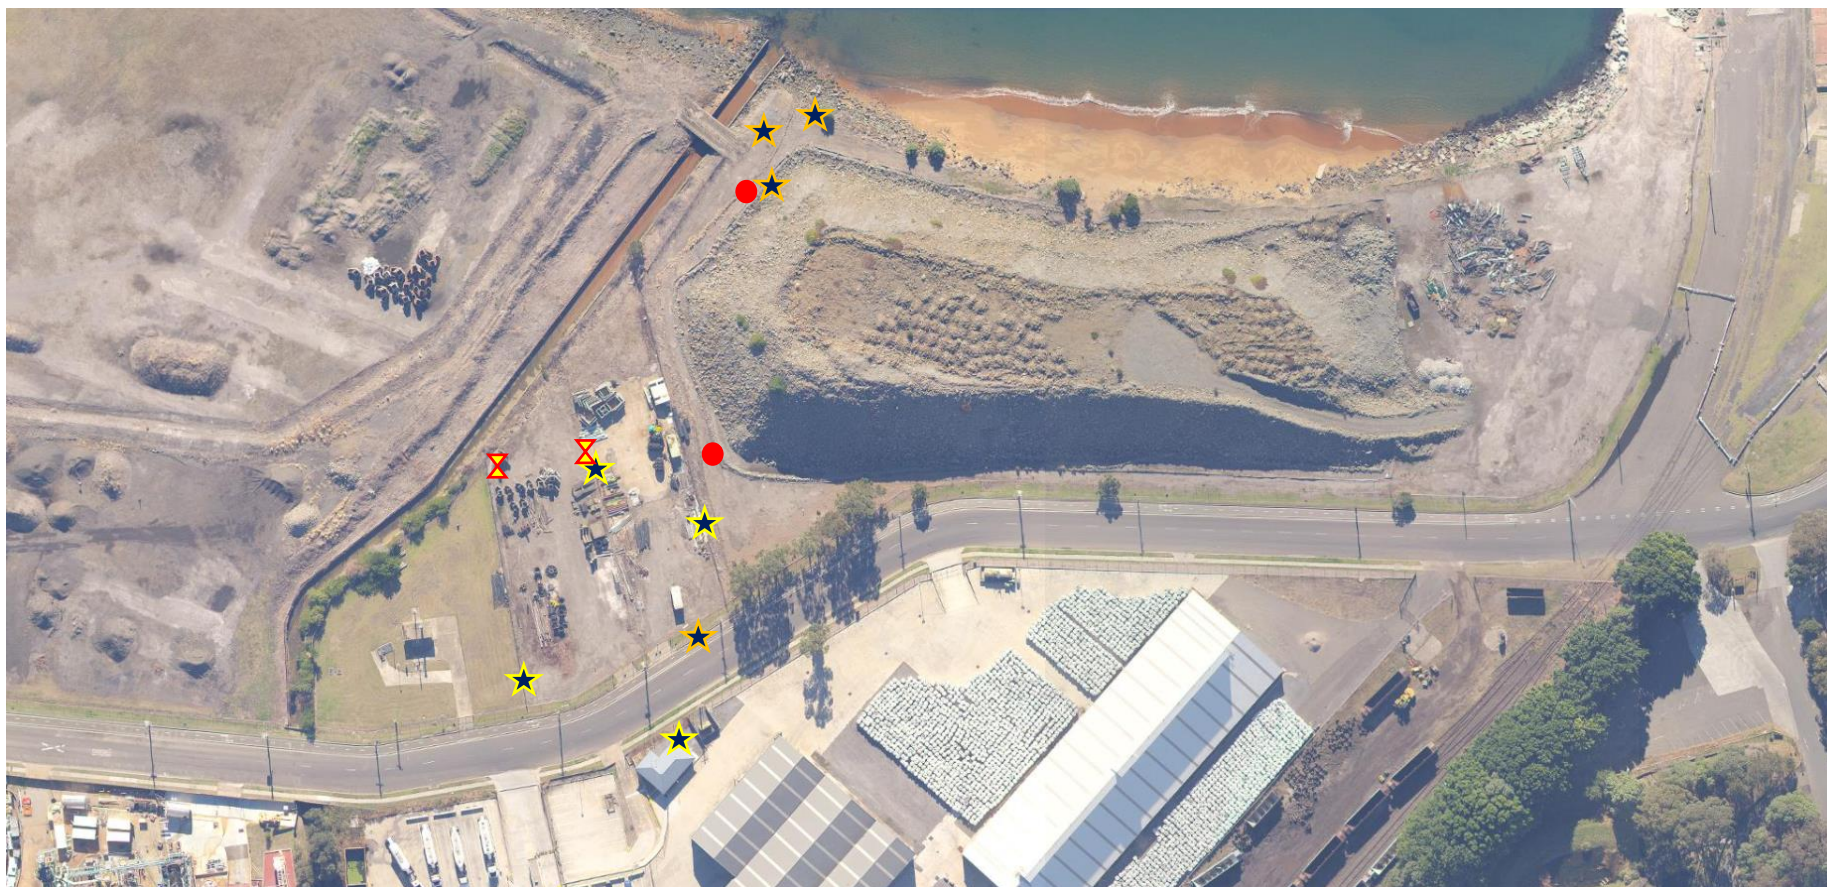
Figure 1 - Site Map – Piling and Monitor locations for the Tests

Figure 1 shows the locations of the test pile locations and the noise and vibration monitoring stations on the day. Only roadside vibration monitor was relocated to the second piling location.

- ★ Vibration Monitor location
- ✕ Noise monitor location
- Test Pile Location

An unattended noise monitors were installed on the ground with the microphones 1.5m above ground. The locations are shown on Figure 1.

The unattended vibration monitors were installed on the ground at the locations shown in Figure 1. The geophone for the monitor stationed at the commercial premises on the other side of foreshore drive was adhered to the building's foundation slab, the preferred monitoring position for the nominated standard.

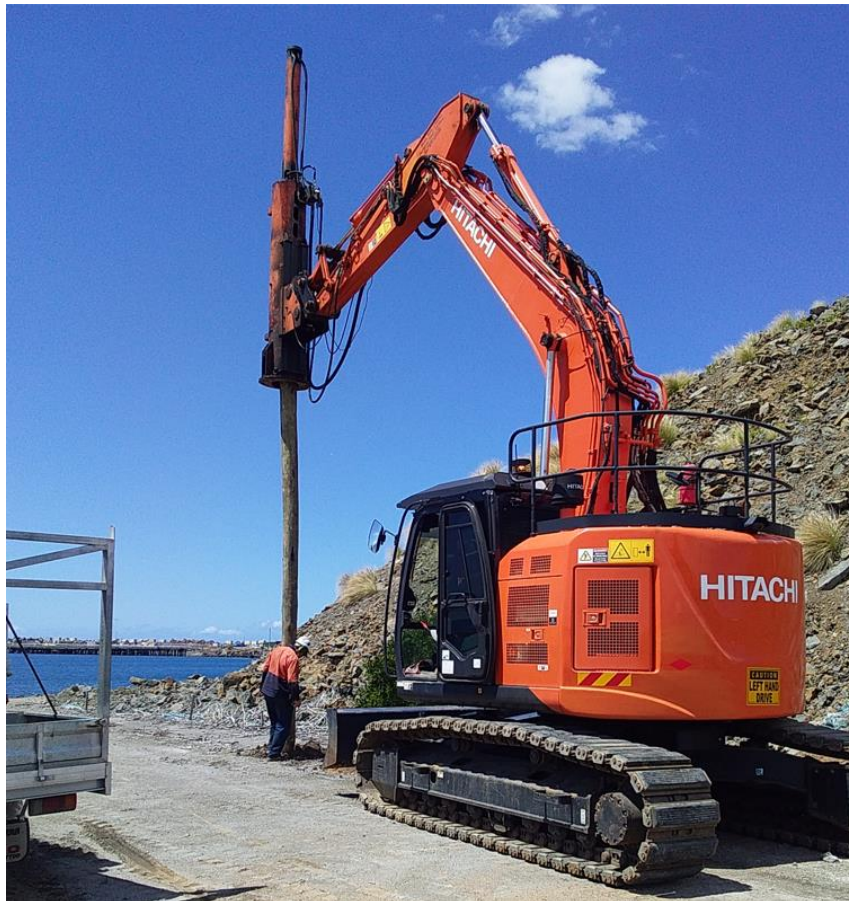
Figure 3 Impact Piling rig with Pile

The piling machine used for the testing is a custom build hydraulic impact driver that is attached to an excavator. The rig is shown in Figure 3.

The piling head specifications were provided to Acoustic Logic by the owner Adam and are as follows:

- 1.8t drop weight
- 1500mm drop height
- Hit rate is 15 blows/minute up to 21 blows/minute

For prediction purposes the energy per blow is 18.6kJ (assuming a 30% loss for hydraulic drop hammer). We were informed the impact frequency ranges from 0.25-0.35Hz. We measured 0.42Hz on the day.

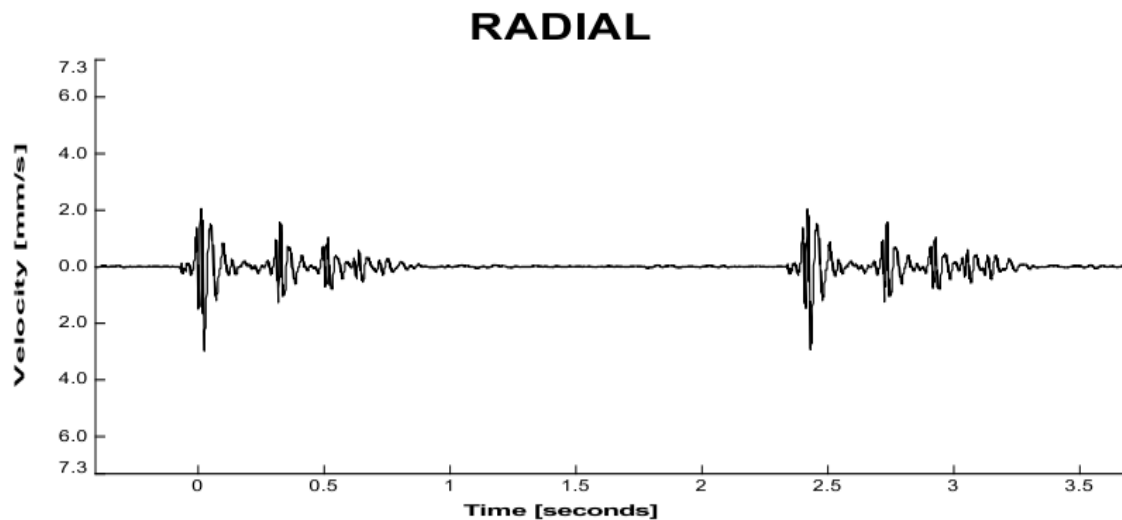
Figure 7, Vibration vs Time waveform from Impact Piling

- The vibration levels from impact piling can be considered to be intermittent and transient vibrations as shown in Figure T for most building structures. However as there is a very tall chimney in an adjacent property so the low frequency vibrations at the impact frequency could be considered to be continuous

vibrations. A quick natural frequency analyses assuming the concrete stack was 70m tall, 6m diameter at the base, 3m diameter at top and was 200mm thick on a rigid foundation found the first 3 bending modes are in the frequency ranges of 0.8 to 1.1Hz, 4.4 to 5.5Hz and 10 to 12.6Hz and a column mode at 14 to 17.8 Hz.

A spectrum analyses was carried out on a typical vibration waveform at the nearest vibration monitor to the pile which had a low frequency (2Hz) geophone. The majority of energy from impact piling is between 10Hz and 35Hz. The geophone is less sensitive to low frequency vibration, at 0.4Hz impact frequency it is 96% less sensitive based on generic sensitivity curves for 2Hz geophones. The chimney is sensitive to low frequency vibrations in the ground plane. To predict the vibration level at the base we use Rayleigh attenuation and the maximum radial vibration level and the scaling factor to account for the geophone sensitivity at that frequency. The predicted in-plane ground vibration level at the chimney from piling at the retaining wall 193m away is $0.015\text{mm/s} \times (100/4) \times \sqrt{\frac{19}{193}} = 0.12\text{ mm/s}$. This resultant vibration is well below the heritage building criteria so it would be reasonable to assume a modern reinforced concrete structure is unlikely to be adversely affected. It is also noted that a canal that divides the properties and this discontinuity will further reduce vibration levels.

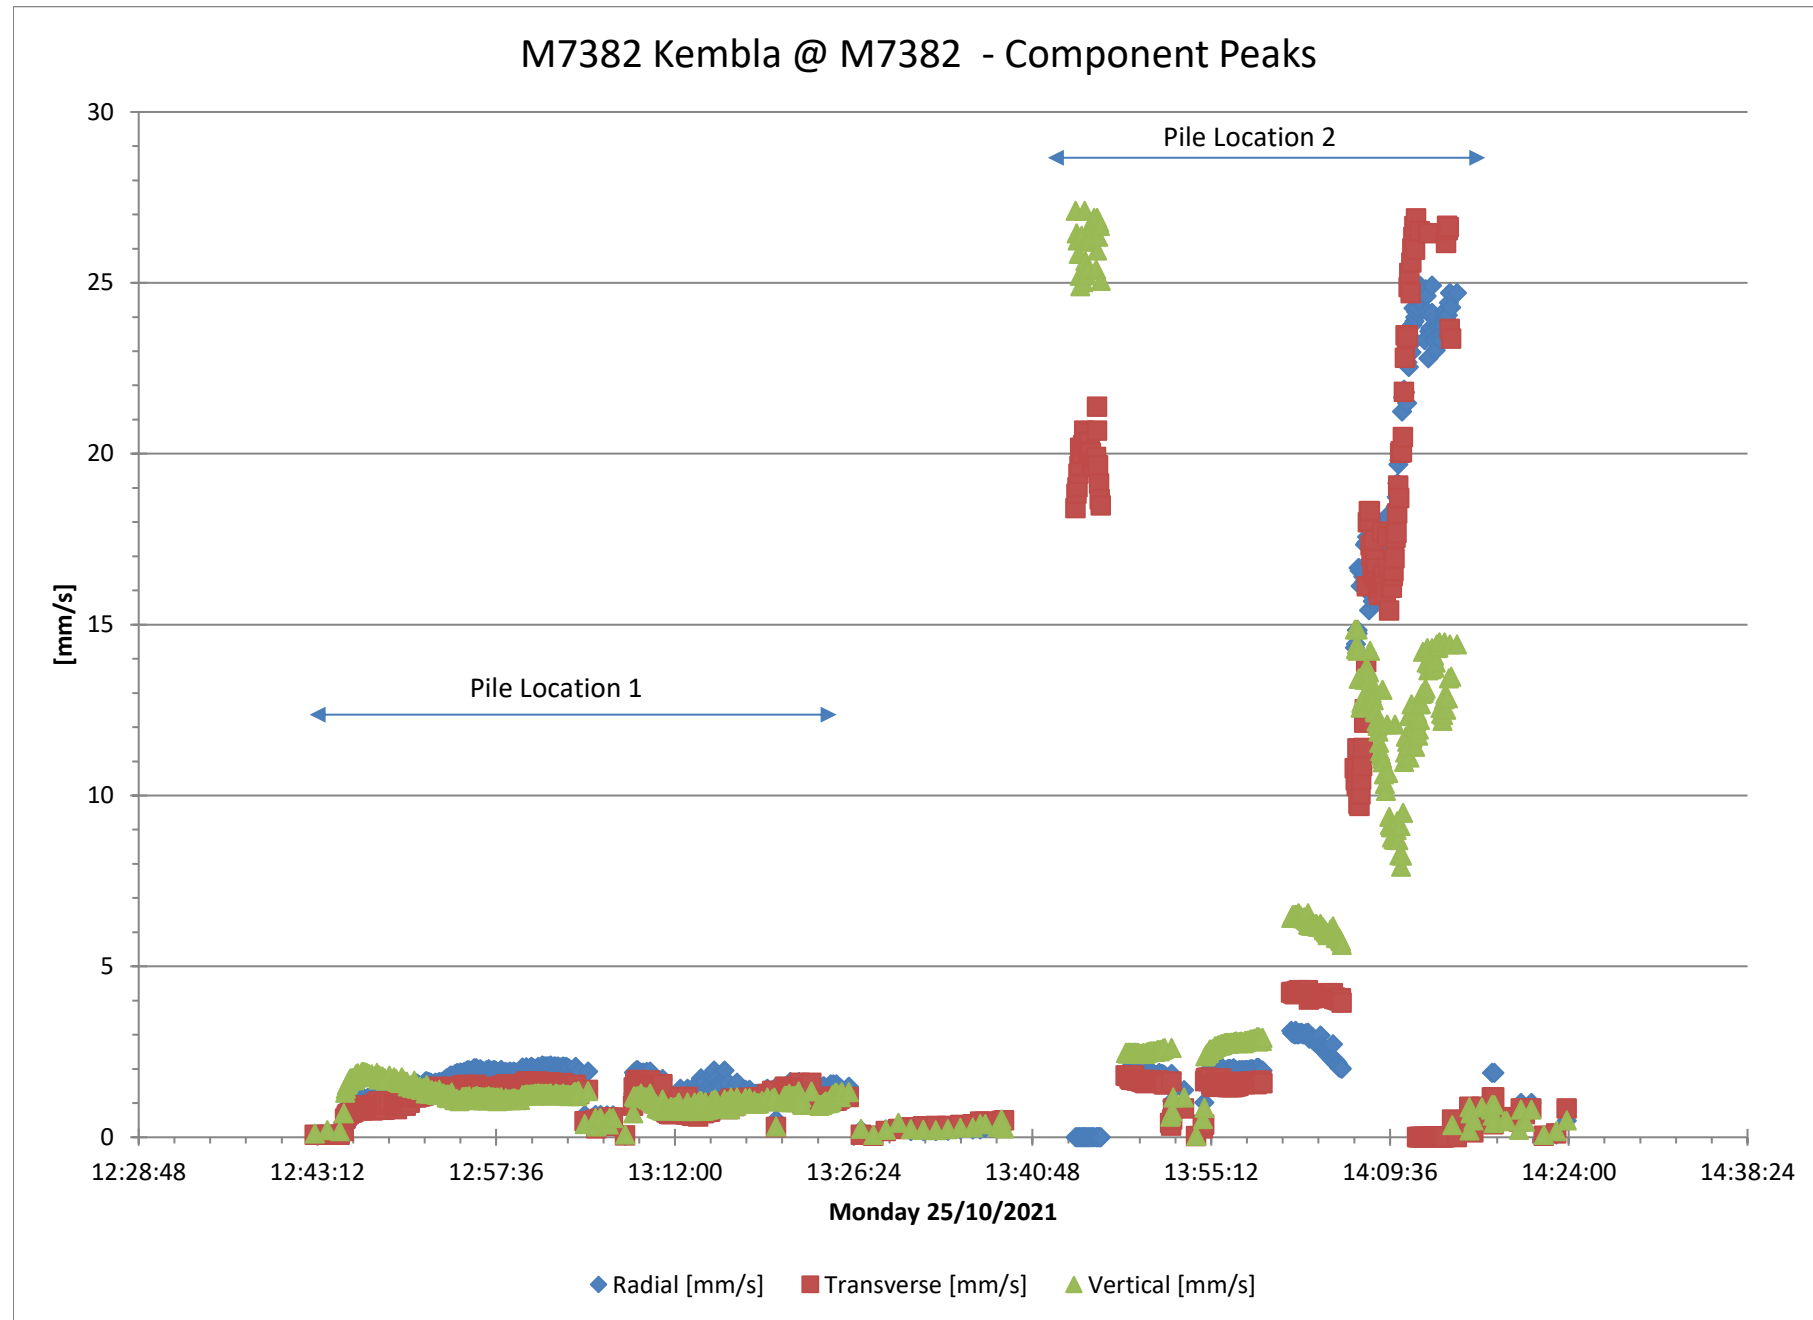
Daily Monitored Vibration Levels at ETM 7382, Foreshore Road Boundary (45m from Pile1) on 25-10-2021
