Report on
Preliminary Site Investigation (Contamination) with
Limited Sampling

Taronga Wildlife Hospital, Sydney

Prepared for
Taronga Conservation Society Australia

Project 99931.00
August 2022

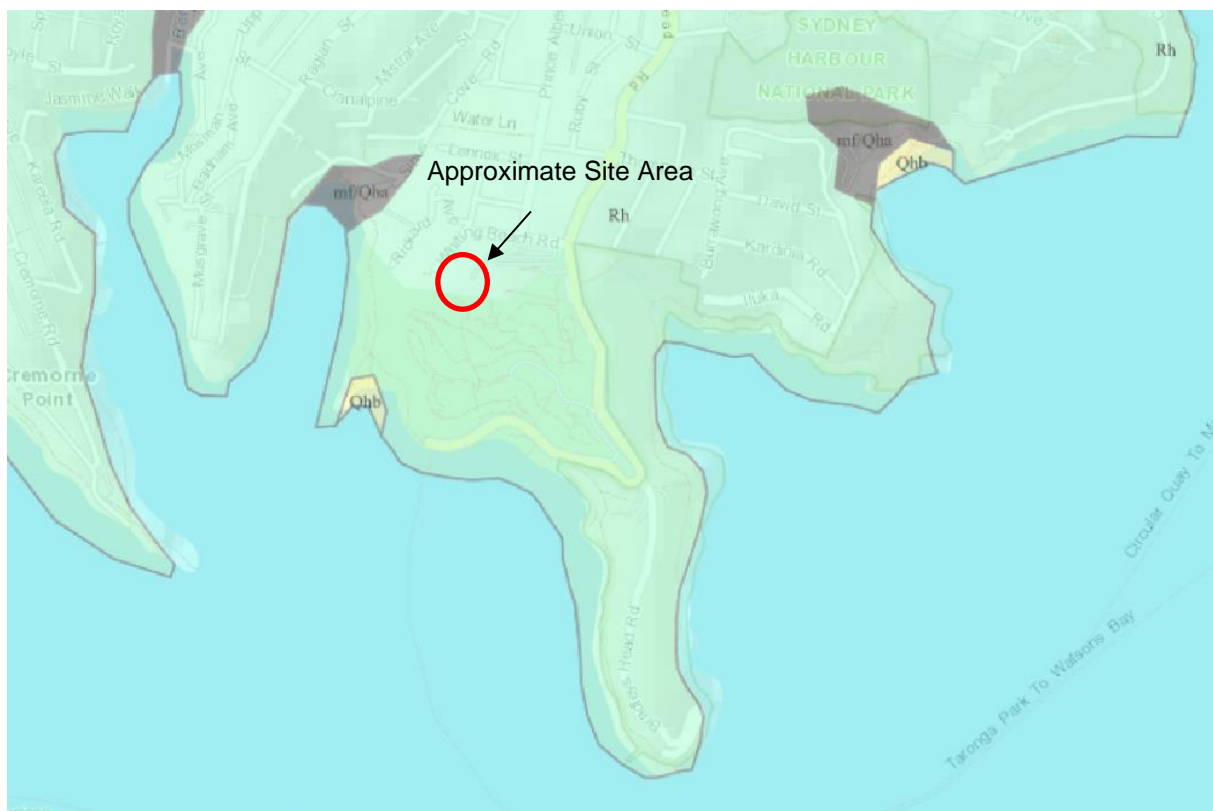
Figure 1: Extract from geological map

The *Sydney 1:100 000 Geological Series Sheet* shows that the site is underlain by Hawkesbury Sandstone which typically comprises medium to coarse-grained quartz sandstone with minor shale and laminite lenses. An extract from the geological map is shown in Figure 1.

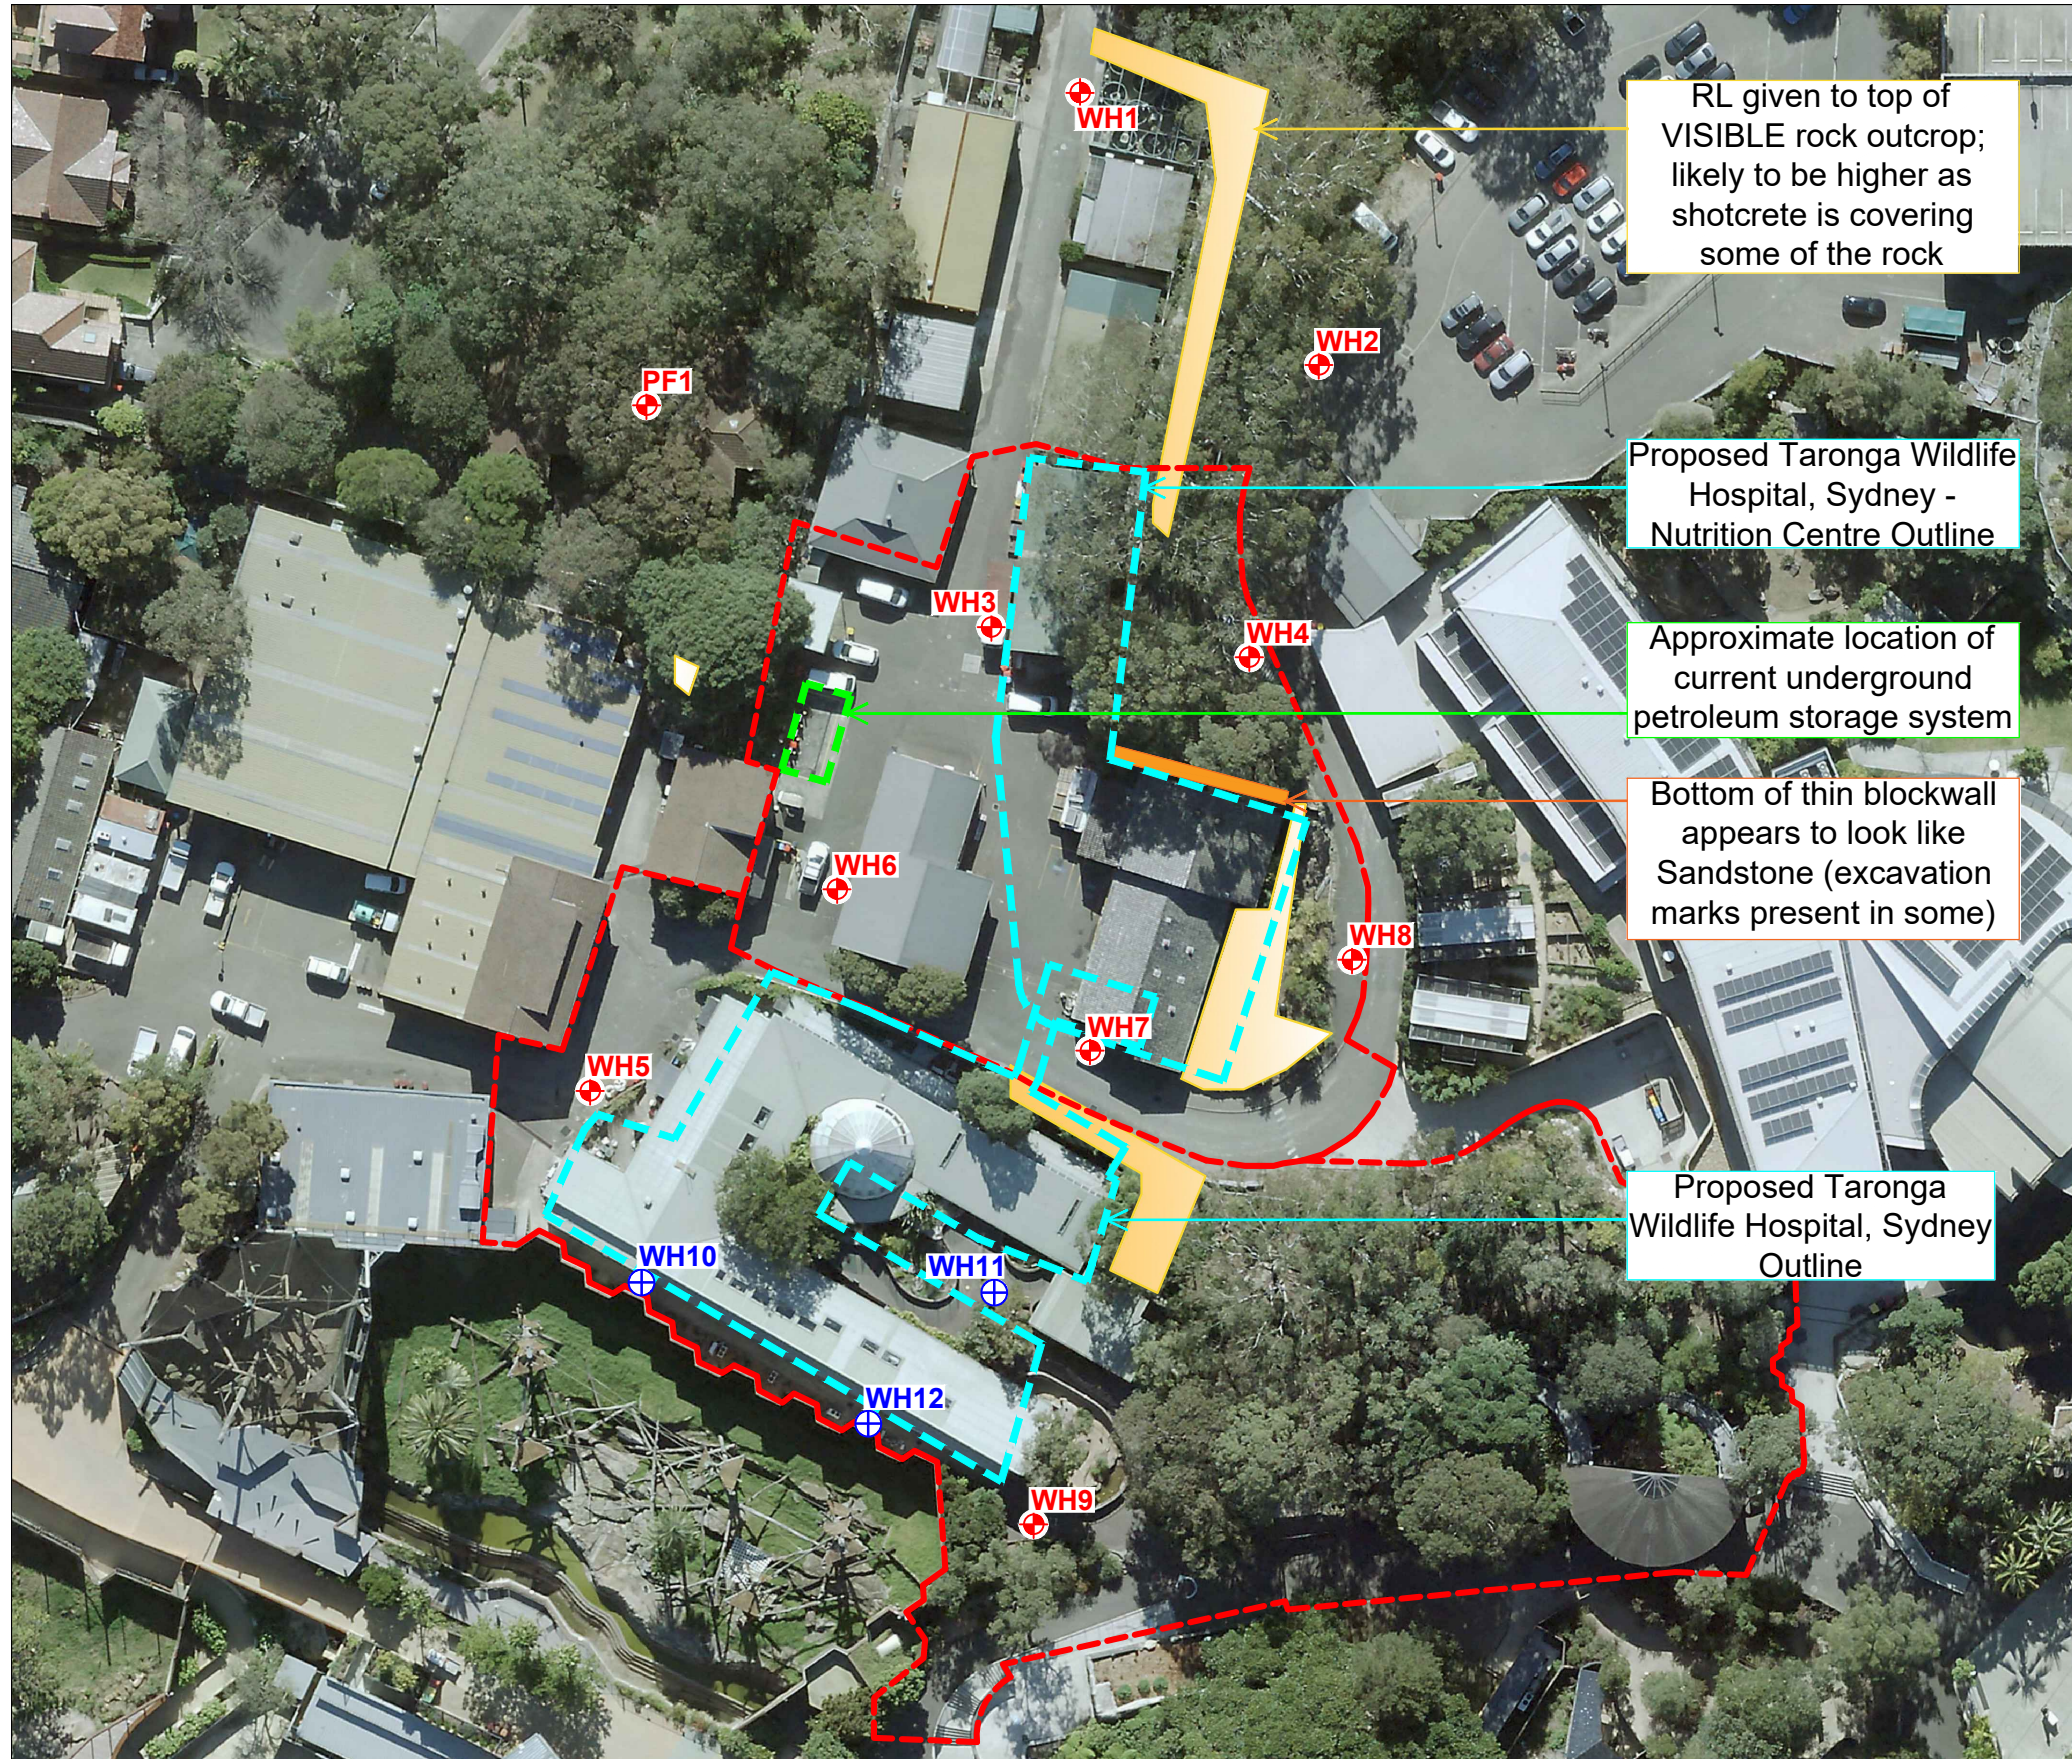
Proposed Taronga Wildlife
Hospital, Sydney -
Nutrition Centre Outline

RL given to top of
VISIBLE rock outcrop;
likely to be higher as
shotcrete is covering
some of the rock

Bottom of this blockwall
appears to look like
Sandstone (excavation
marks present in some)

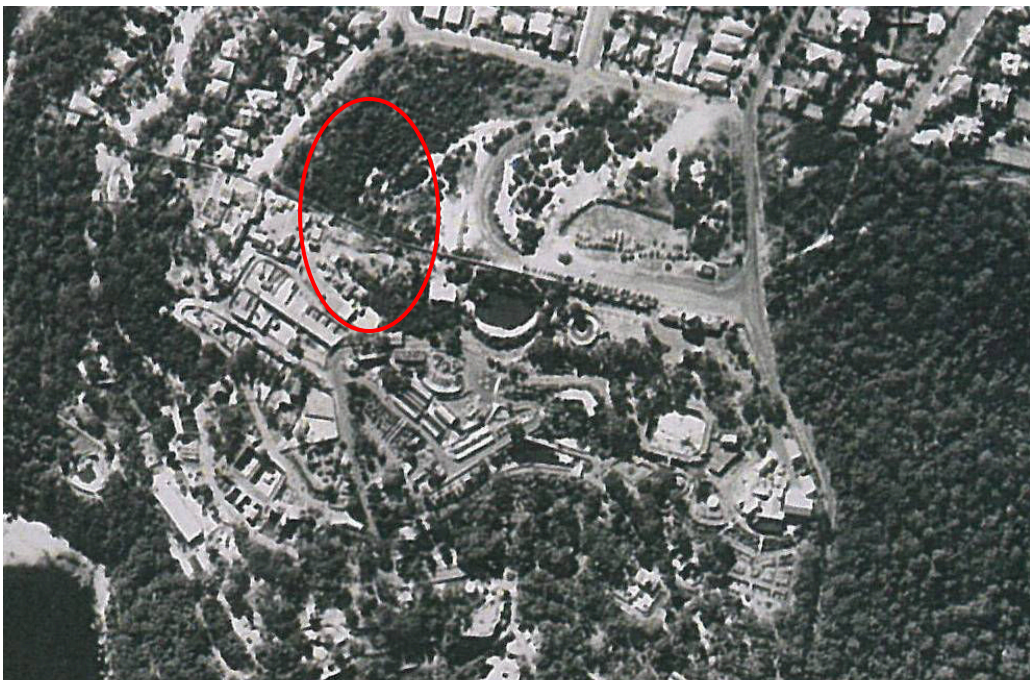
Photo 2 – Aerial photograph from 1951

The 1951 photograph shows some development on and adjacent to the site. Numerous buildings are evident including what may be a pool-type structure to the east. The 1961 photograph shows similar conditions although some of the vegetation in the north-east of the site has been cleared.

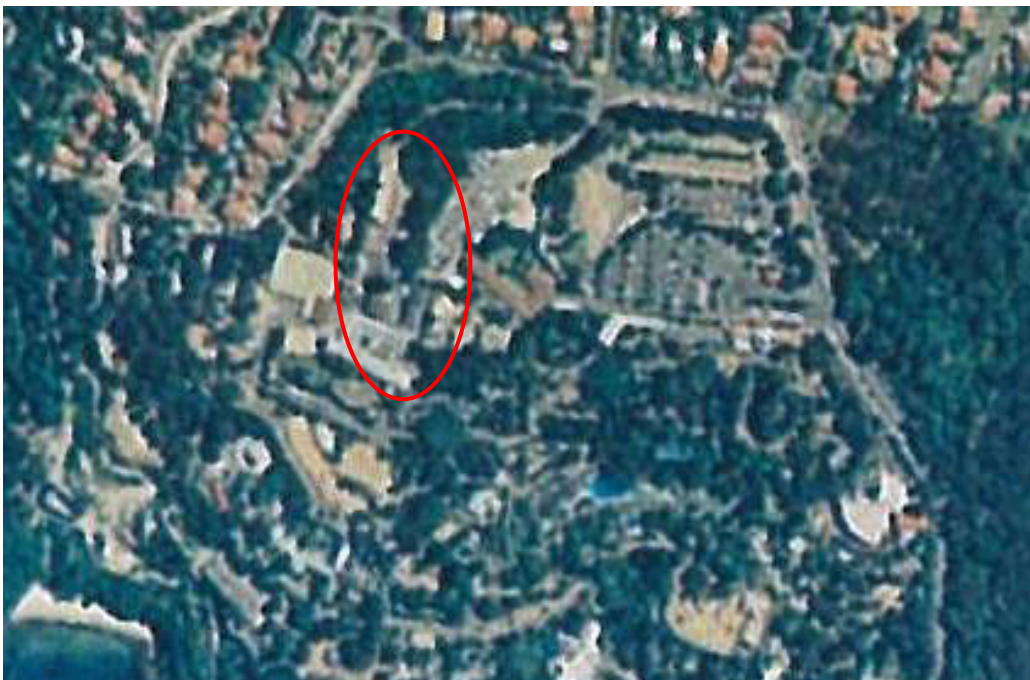
Photo 4 – Aerial photograph from 1994

The 1994 photograph shows several of the smaller back-of-house buildings and pavements within the site. On-grade vehicle parking facilities also exist to the east of the site. Due to the resolution of the 1994 photograph it is hard to make out individual buildings, but the site appears similar between the 1994 and 2005 photograph. The 2018 photograph shows similar conditions to the 2005 photograph although the building to the east of the site appears to have been demolished and reconstructed.
