# *Proposed Taronga Wildlife Hospital Heritage Impact Assessment*

*FINAL REPORT*

July 2022

for the Taronga Conservation Society Australia

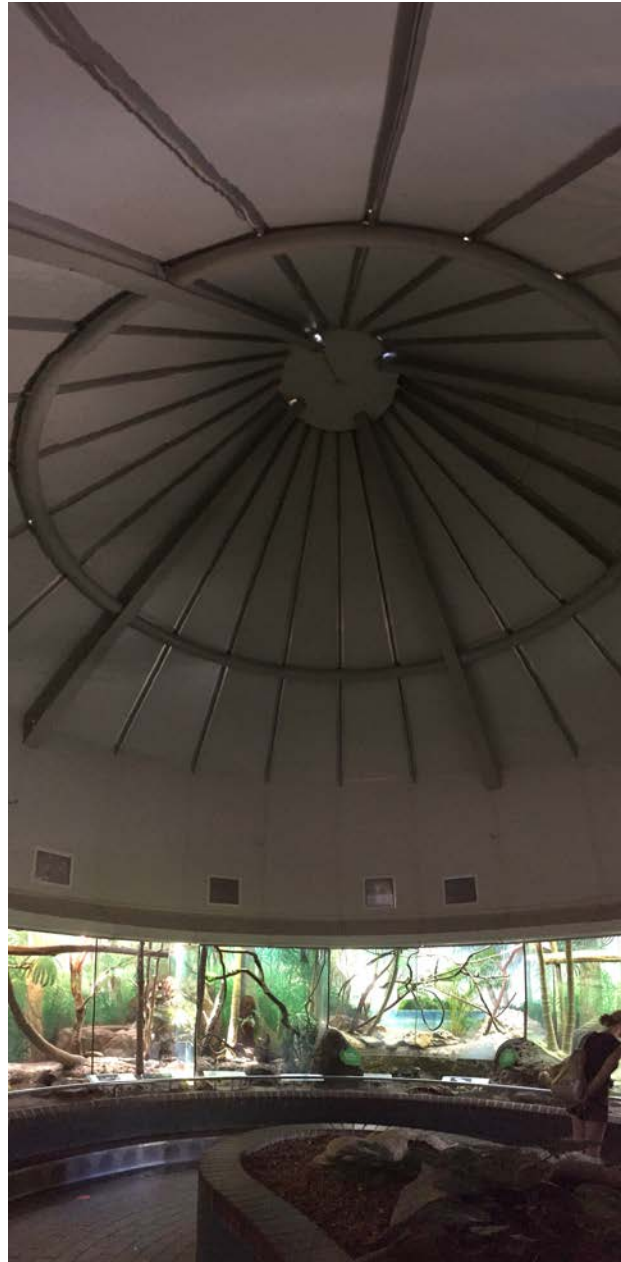
A view of the distinctive conical space near the end of the visitor loop within the existing 1990s Serpentaria building that is a principal subject of this heritage impact assessment report. (*Photograph by Geoffrey Britton, March 2021*)

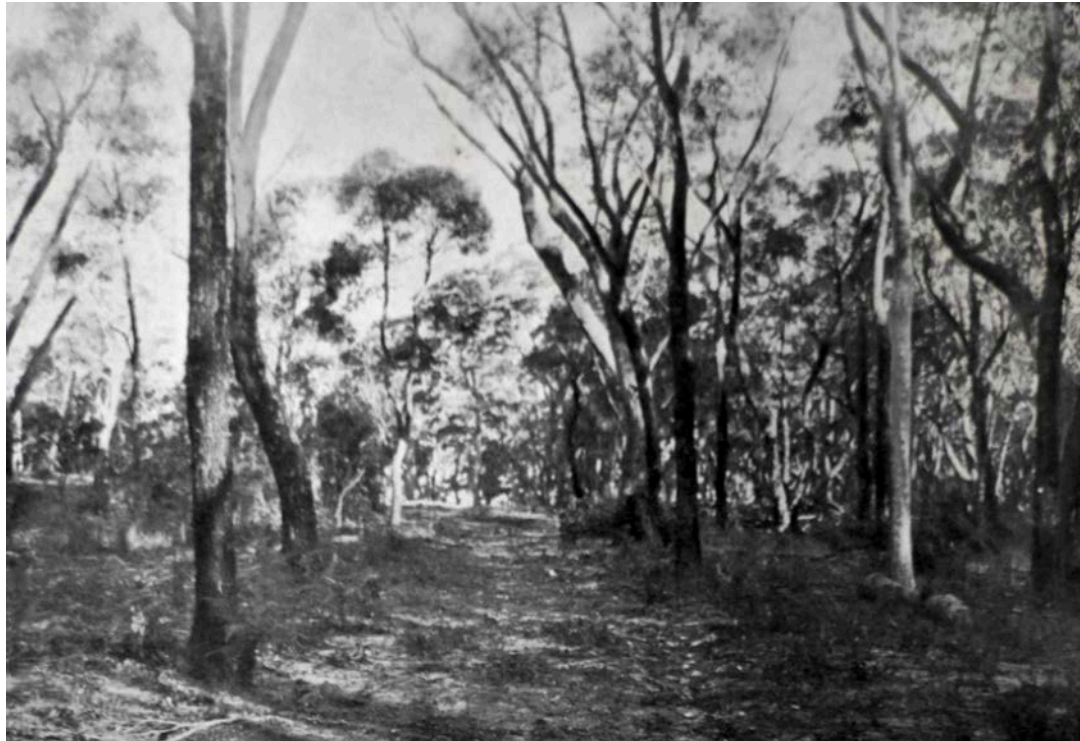
**Figure 7** ABOVE A photograph taken of the natural state of the Zoo site prior to implementation of the works program. (Source: *Taronga Zoological Park Trust, Report for 1916*, p. 9) **Figure 8** BELOW Another early view (early 1910s) with distinctive rock outcropping and relatively intact vegetation structural layers. (Source: *TCSA Archives* and also reproduced in the *2006 Landscape Management Plan*)

An outstanding intrinsic feature of the Taronga Zoo landscape is the layered embedded sandstone benching and intermittent outcropping. The characteristic Hawkesbury Sandstone outcrops and cliffs have featured in many zoo exhibits since 1913 (**Figure 8**) and within the study area the pervasive presence of the underlying sandstone bedrock is evident to the east of the existing Serpentina building (**Figure 42**).

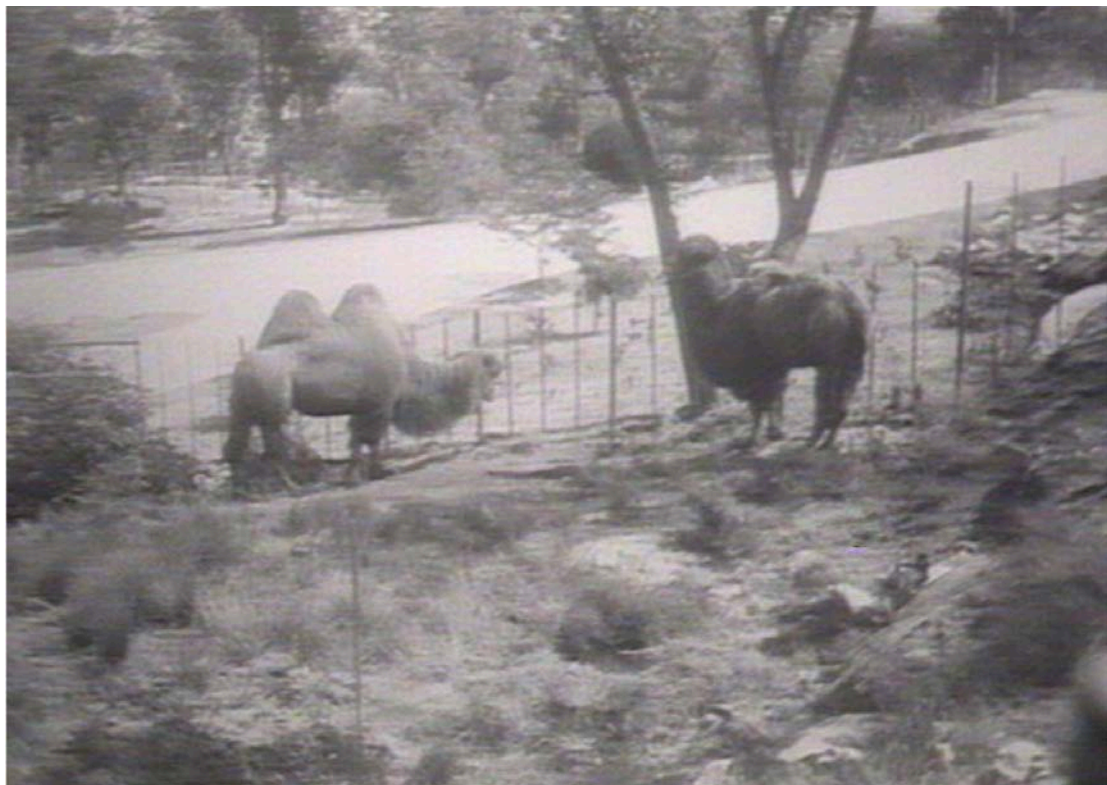
**Figure 12** ABOVE The Camel yard in 1924 showing surviving woodland vegetation beyond with an edging garden to the western end of the large ungulates section (now Chimpanzee Park). The image suggests that the present surviving Bangalay may have been planted (or retained) within a decade earlier. (Source: Government Printing Office, 1 February 1924, GPO 1-19169 TCSA Archives) **Figure 13** BELOW Looking north into the Camel yard a year later showing some of the remnant *Angophora* woodland at the back of the enclosure. (Source: Government Printing Office, 1 June 1925, GPO 1-15945 TCSA Archives)

This Bangalay (*Eucalyptus botryoides*) (Figures 49 and 50) does occur naturally within the zoo site however archival evidence (see Figure 12 for instance) may even suggest that this particular tree had been planted in the 1910s as part of the initial development of the zoo. Whether this is the case or the bedding area shown in Figure 12 simply enveloped an existing sapling or a volunteer seedling grew here, the tree is now a centenarian and should be conserved as a significant site asset. The same tree is clearly visible through various archival images from the 1910s to the 1990s (Figures 12, 15, 19, 21, 22, 33 and 34).

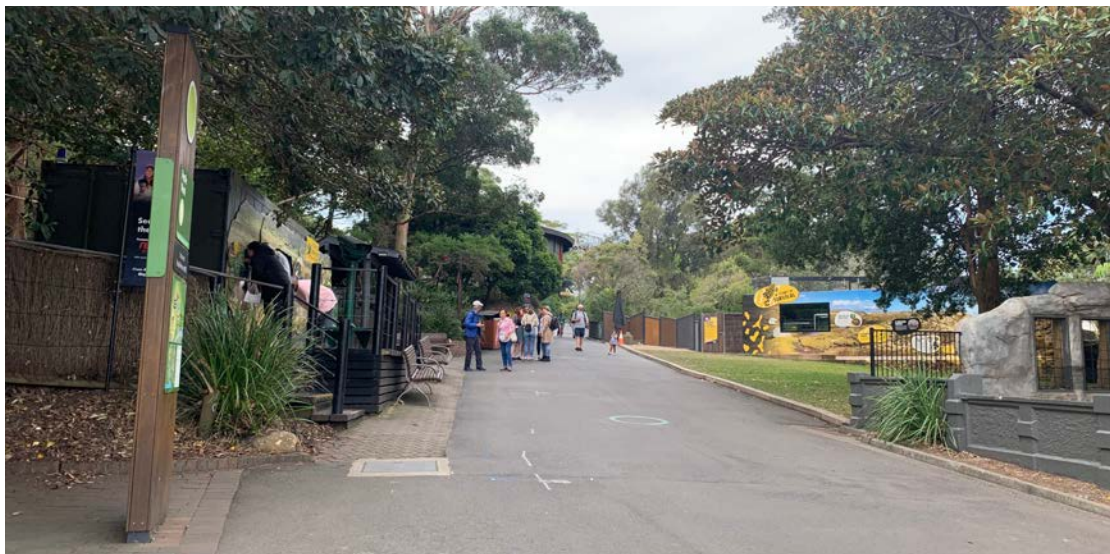
**Figure 36** View east towards the Koala House with the Southern Corroboree Frog interpretive container and shelter to the left. Another colourful display – for the Northern Corroboree Frog – has been added to the lawn (right). Yet another notable feature in view here, though far less conspicuous, is the otherwise overlooked central path that still follows the original 1910s alignment and formed part of the Zoo's original circulation network (s170 Item 99L). (Photograph: Geoffrey Britton, 2021)

Located between the Koala House and the Serpentaria entrance, the former reptile house (later shelter structure then finally converted to an experimental nocturnal house and noted at **Figure 22**) was replaced by a food vending machine and a relocatable metal shipping container used to promote the conservation of endangered Southern Corroboree Frogs (**Figure 36**).

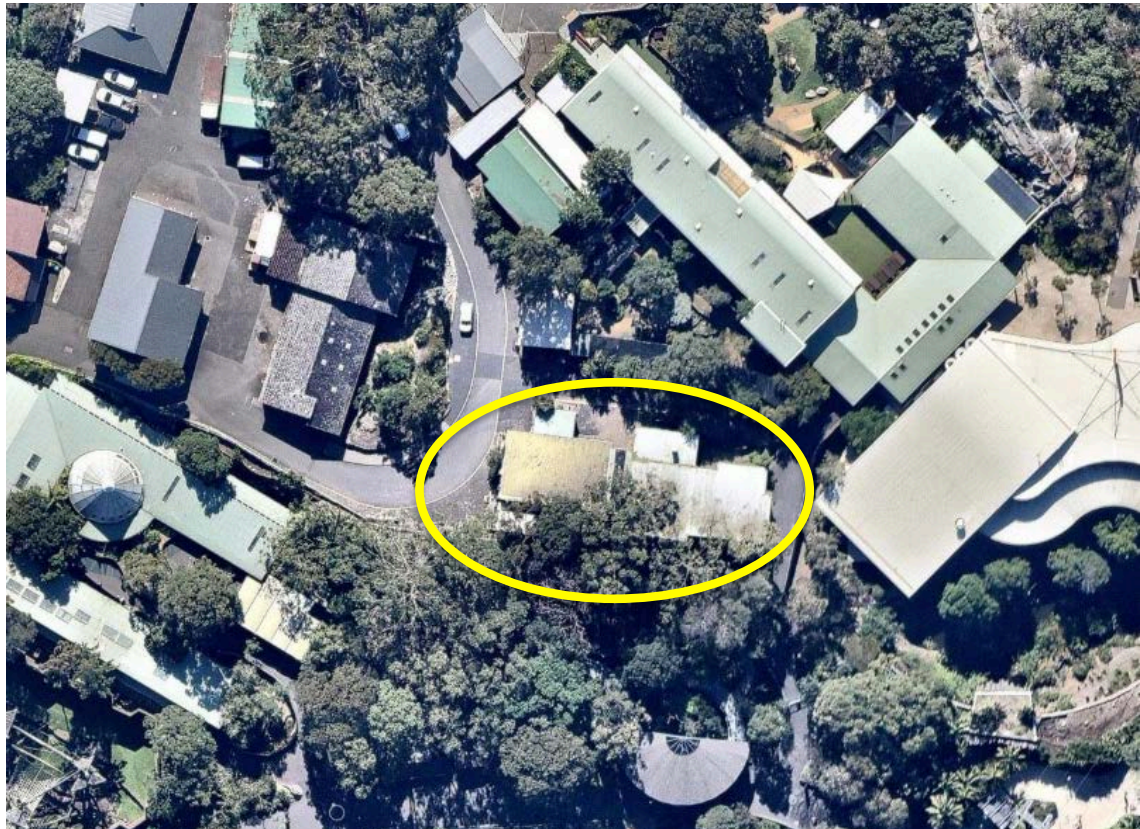
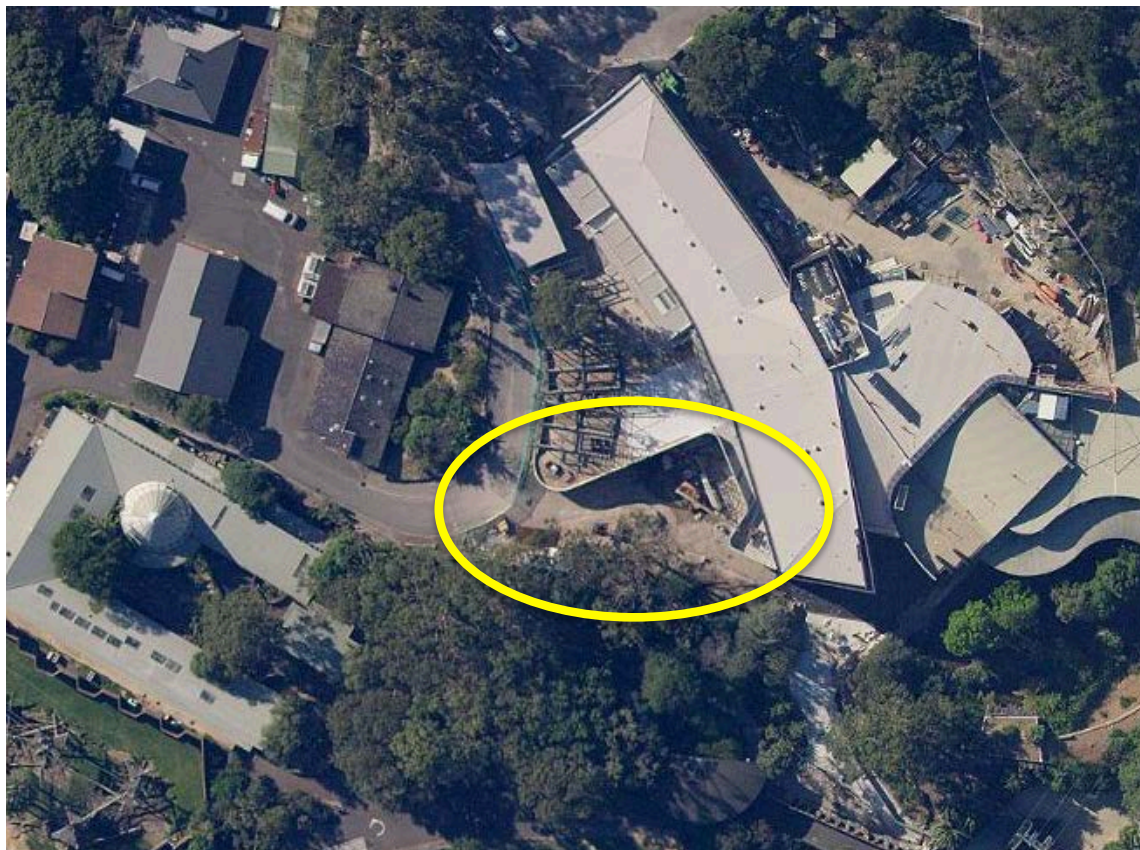
**Figure 37** TOP 2015 aerial photograph showing the former amenities buildings (circled) to the north of the Koala House and remnant woodland area. (Source: TCSA Archives) **Figure 38** 2020 photograph of the same area with the same buildings removed. (Source: NSW Land & Property Information SIX Viewer)

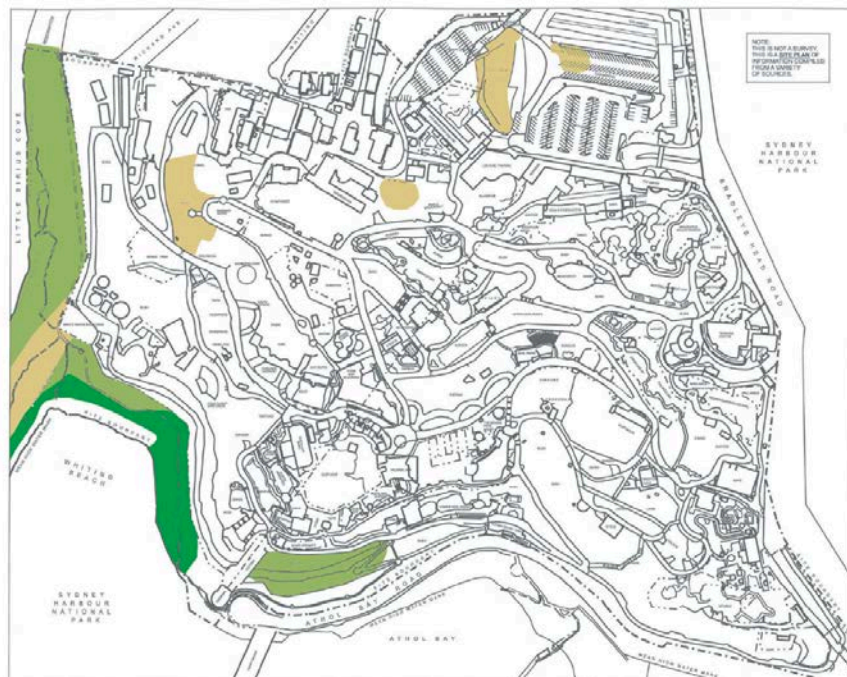
**Figure 44** ABOVE Approximate areas of significant remnant indigenous vegetation within the zoo. The area of *Angophora* woodland in proximity to the Koala House is probably more extensive than indicated on this plan originally drawn in 2006 from initial basic mapping by botanist Dr Ben Wallace. Since 2006 though, the same woodland may be less well represented with key indicator species. Similar woodland shown to the north has been impacted (reduced) by the multi-storey car park development (Source: Design 5 et al LMP, 2006) **Figure 45** BELOW Dr Wallace's conjectural mapping of the extent of the three main pre-European vegetation communities across the zoo site. A comparison between this and the previous Figure poignantly indicates how very little of the locally indigenous vegetation remains and the critical importance of conserving the few surviving remnants. That remaining between the Koala House and the Serpentina complex, although now reduced in its intactness, assumes particular significance in this context. Rehabilitation and conservation should be high priorities. (Source: Design 5 et al LMP, 2006)

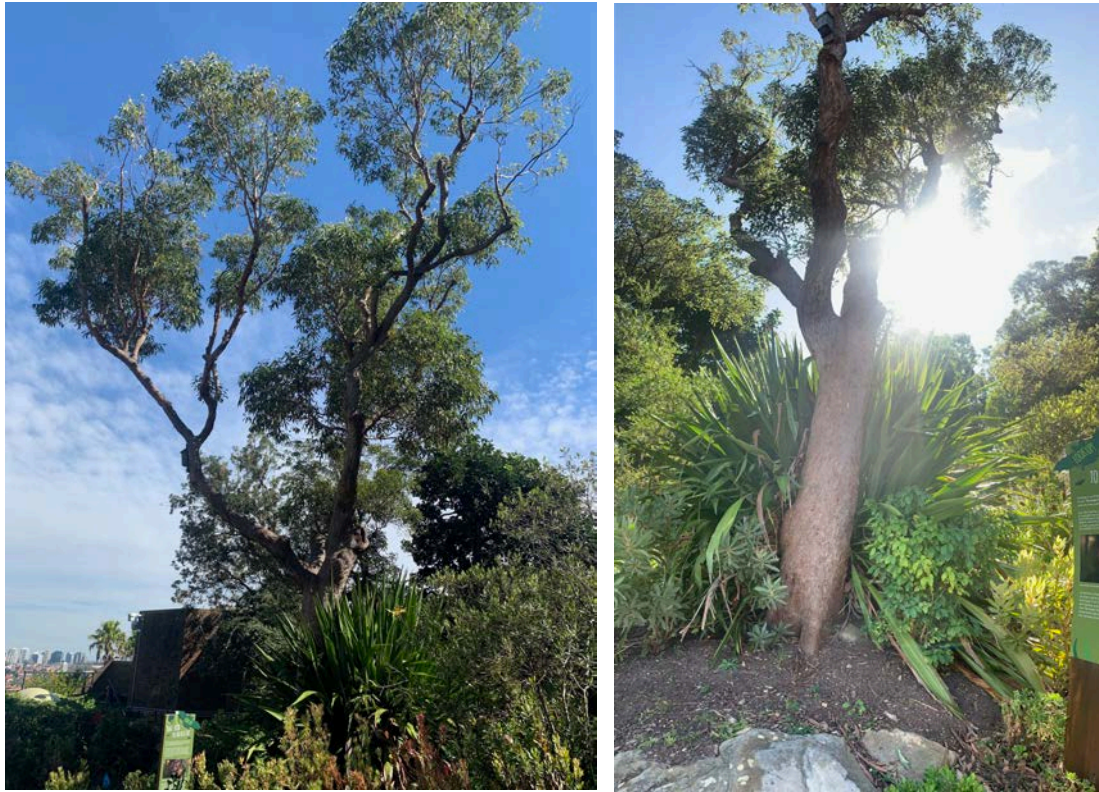
**Figure 49** ABOVE LEFT The large Bangalay between the present reptile & amphibian complex and the Chimpanzee Park frames one of the classic views from the zoo to Sydney Harbour and the city. **Figure 50** ABOVE RIGHT Detail of the same tree where the original stone edging (shown in **Figure 12**) has been removed. **Figure 51** BELOW The main path providing public access to the proposed Taronga Wildlife Hospital site looking east to the Koala House. (Photographs: Geoffrey Britton, 2021)

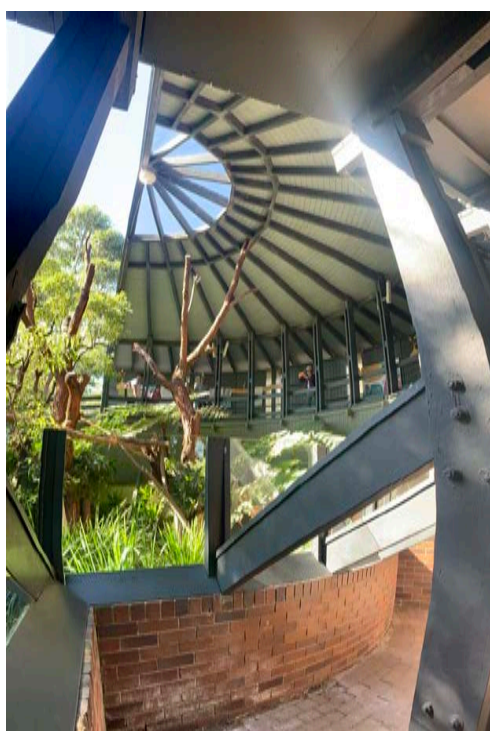
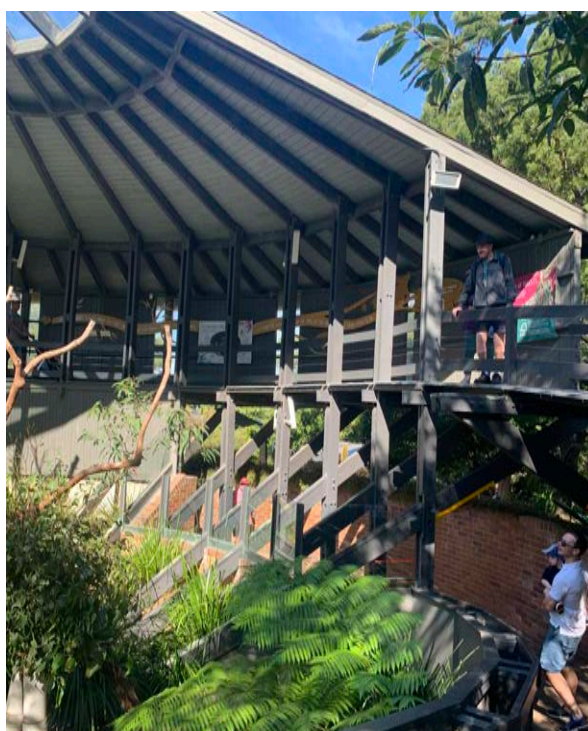
**Figures 57 LEFT and 58 RIGHT** Views from within the Koala House showing part of the double helical walkway system that enables views of the koalas from different perspectives. The sophisticated, yet compact cantilevered timber structure supporting and unifying the deck and roof is plainly visible, its minimal, earthy materials and vertical rhythms engaging with the surrounding trees. Owing to budgetary constraints, parts of the structure were even built by Taronga Zoo employees. (Geoffrey Britton, 2021)

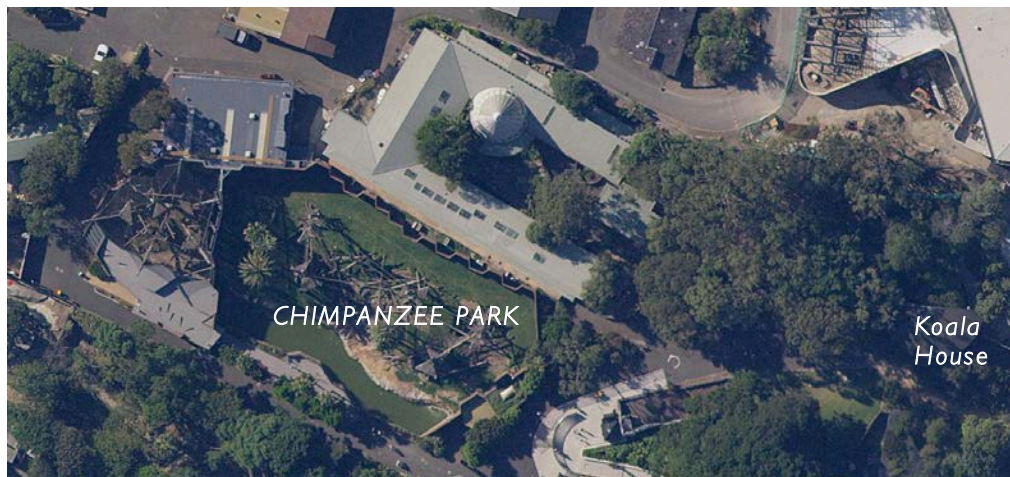
**Figure 59** ABOVE Recent aerial photography showing the Chimpanzee Park with its 2010-2011 additions at the lower left side, the original Chimp House above left and the current Serpentina site immediately to the north (above). **Figure 60** BELOW A closer detail from the same photography showing the signature articulated high brick wall separating the Chimpanzee Park site and the current Serpentina building as the site of the proposed new Taronga Wildlife Hospital. Interestingly, this is the same site of the second hospital at Taronga Zoo – the 1934 complex before it moved further to the west to the current purpose-built facility in 1978. (Source: NSW Land & Property Information SIX Viewer)

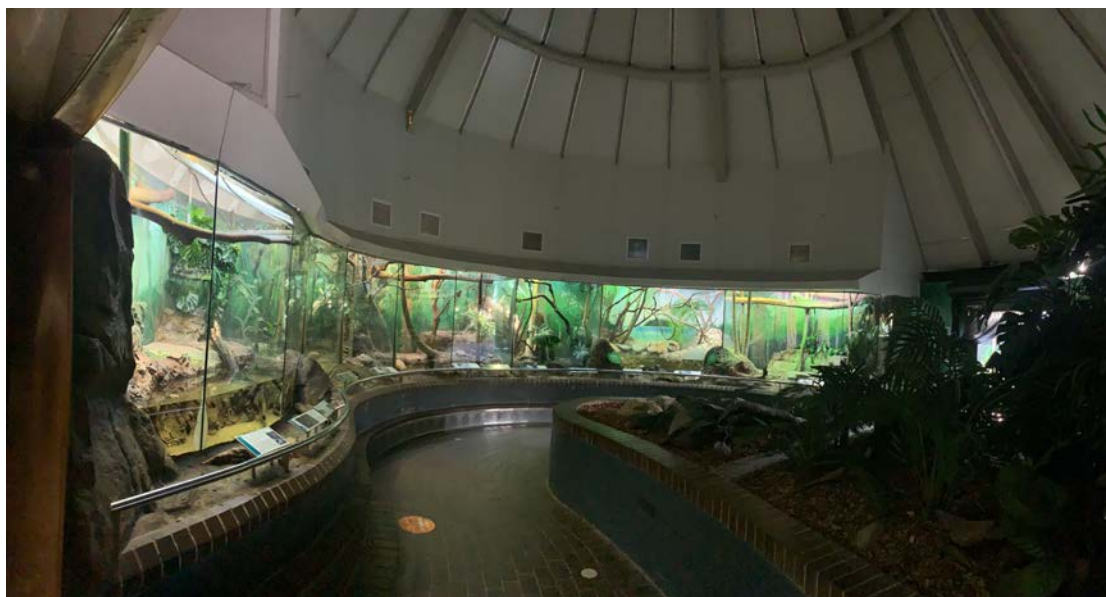
**Figure 61** ABOVE View of the distinctive conical space of the existing reptile/amphibian complex with part of the circuitous, convoluted circulation system evident. The brick paving and brick and painted/bagged plinth and dwarf walling are used as unifying devices throughout the building. **Figure 62** LEFT A view of the small open teaching area with the natural bedrock and some of its associated indigenous vegetation evident beyond. The compact 'U'-plan arrangement of the building was basically dictated by the site's spatial constraints wedged between the Chimpanzee Park, the rock outcrop and the service access road to the north. (Geoffrey Britton, 2021)

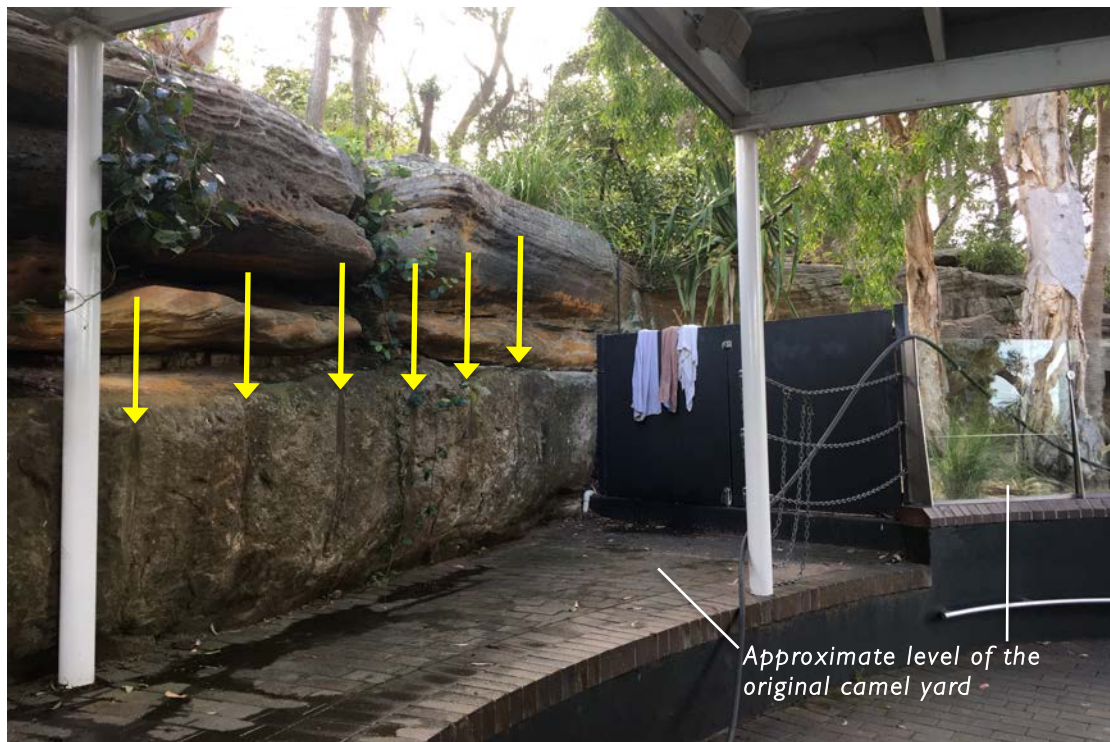
**Figure 63** View of the northeastern teaching space looking into the back of the Freshwater Crocodile enclosure showing the retained approximate level of the former camel yard with the 1910s drill marks in the rock outcropping (arrows) to blast away the former stone projections. (Photograph: Jean Rice, 2022)

Further illustrating the retention of the rock cutting discussed above in **Section 3.2.3** and noted in **Figures 52 to 55**, the approximate original level of the former camel yard level is evident at the raised 'stage' area used as an outdoor teaching space (**Figures 62 and 63**) and behind the pond for the Freshwater Crocodile (at the entry to Serpentaria). The circulation system surface used throughout the Serpentaria site - brick stretcher-pattern pavers (**Figure 64**) - provides a thematic link to that used consistently in the main Australian sections further to the east during the formative 1970s and 1980s period.

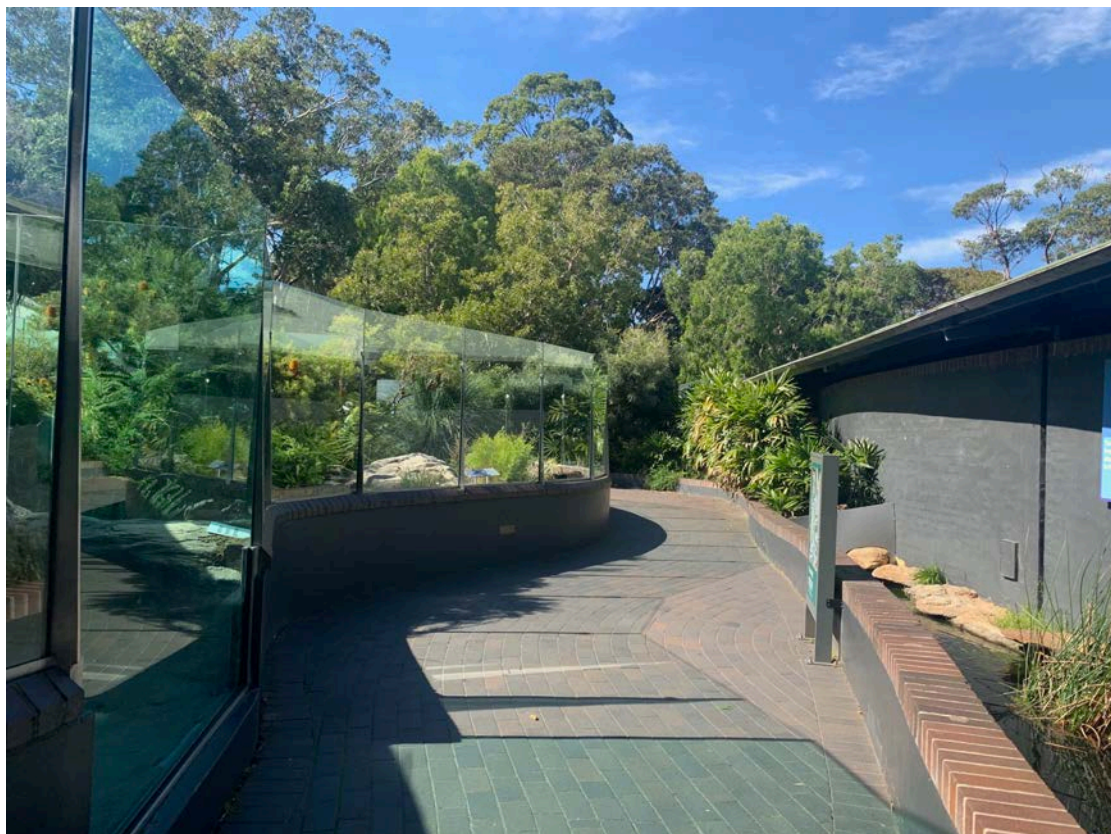
**Figure 64** View of the courtyard area of the existing reptile/amphibian complex looking to the remnant woodland vegetation between this space and the Koala House beyond. (Photograph: Geoffrey Britton, 2021)

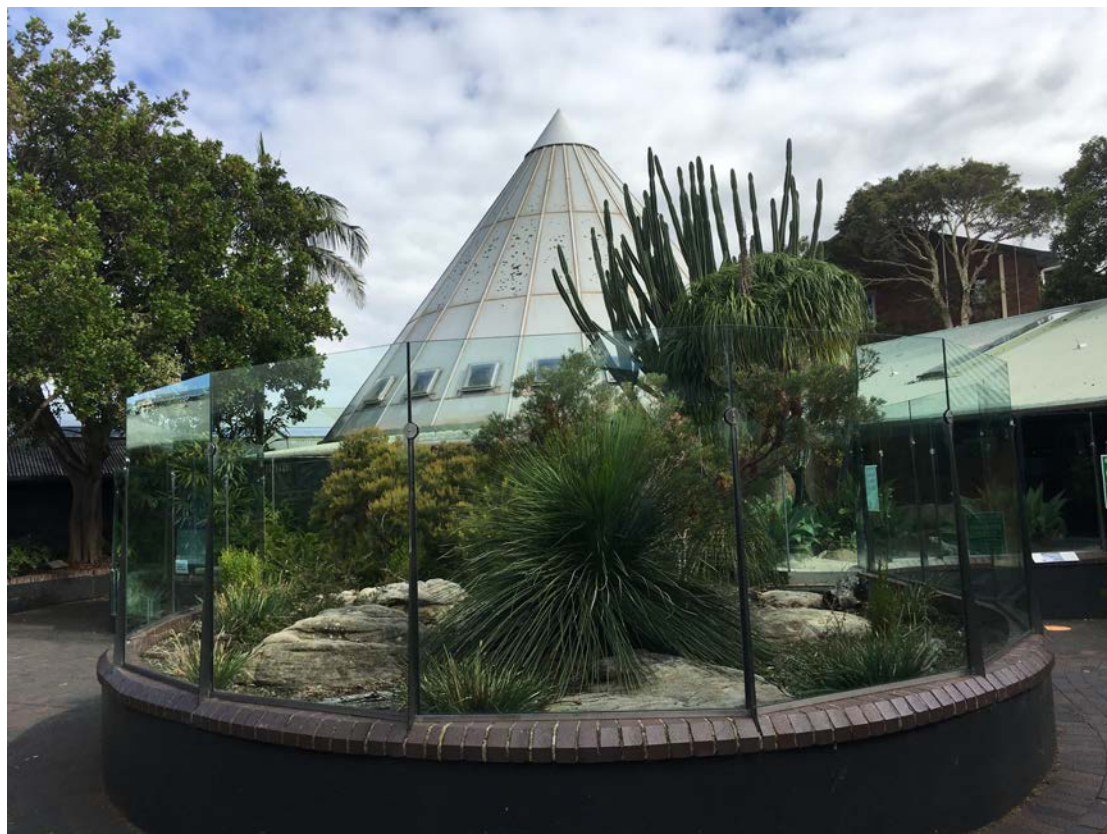
**Figure 65** The courtyard of the Serpentaria site contained various valuable plantings included this group within a central enclosure featuring a *Beaucarnea* sp., *Xanthorrhoea* sp. and a cactus. Beyond these is the distinctive cone and the northern wing of the Serpentaria building. (Photograph: Jean Rice, 2022)

There are various mature plantings within the Serpentaria site that are valuable and also worth salvaging for reuse elsewhere within the Zoo. These include the large Screwpine (*Pandanus* sp.) and rock orchids (*Dendrobium speciosum*) within or near the Freshwater Crocodile enclosure and the large *Beaucarnea* sp., *Xanthorrhoea* sp. (grass tree) and cactus within the central courtyard area (**Figure 65**). Also throughout the courtyard are many *Raphis* sp. (palms) that are useful and readily transplanted.

Also within the current Serpentaria site are a number of valuable plantings. Although most of these are relatively recent introductions, they are valuable on account of their commercial replacement value as well as having amenity value because of their size and usefulness in a number of potential applications elsewhere within the Zoo. These include the large Screwpine (*Pandanus* sp.) and large rock orchids (*Dendrobium speciosum*) within or near the Freshwater Crocodile enclosure, the large *Beaucarnea* sp., *Xanthorrhoea* sp. (grass tree) and cactus group within the central courtyard area and the many *Raphis* sp. (palms) throughout the central courtyard. All of these plantings would be readily transplantable.

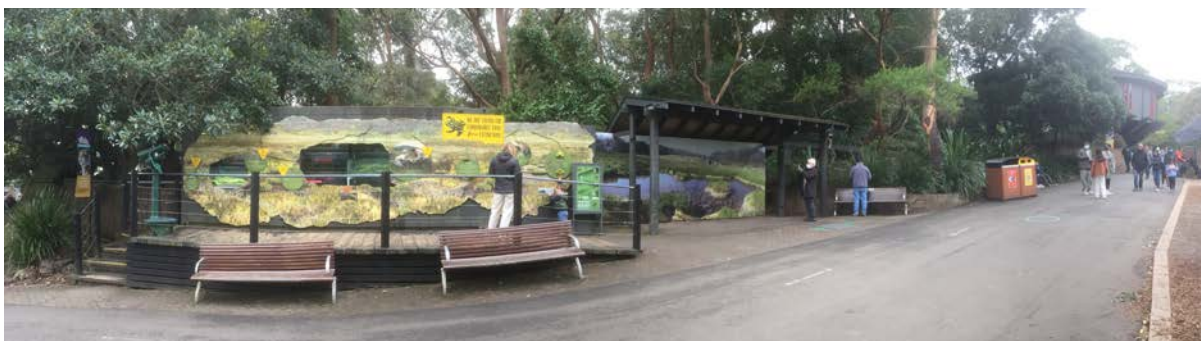
**Figure 68** Panoramic sweep across the main access path looking to the Southern Corroboree Frog interpretation display and its associated shelter structure with the Serpentaria entry out of picture to the left and the Koala House to the right. (Photograph: Geoffrey Britton, 2022)

The 2010 Zoo guide map shows that by this time an interpretive display for endangered Corroboree Frogs had been installed just to the east of the Serpentaria entry. A repurposed shipping container with an access ramp, steps and an associated (repurposed?) shelter structure remain in this location featuring Southern Corroboree Frogs. A similar, and much more recent, display has been installed in another shipping container on the other side of the main Zoo access path for Northern Corroboree Frogs.

The remnant *Angophora* woodland area (s170 240L) is proposed for retention as is the Bangalay (s170 187L) near the Chimpanzee Park at the southern entry point to the study site. The existing Southern Corroboree frog display and shelter structure are also proposed for retention as part of this SSDA.

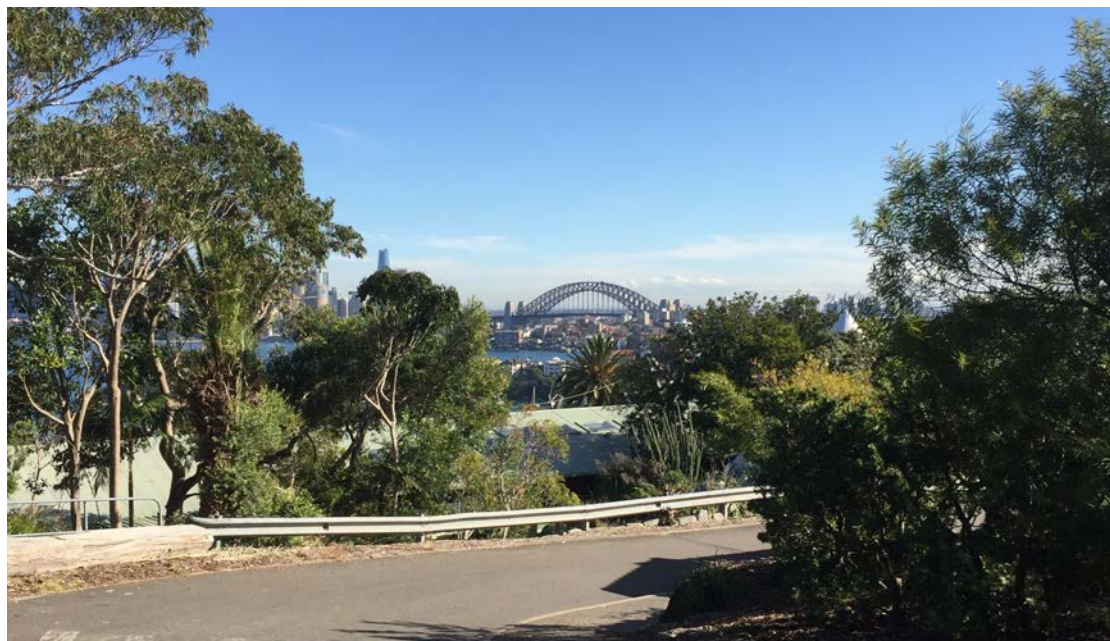
**Figure 70** An unexpected, incidental vista from along the back-of-house access north of the reptile and amphibian complex. The access is a well-used road to the Zoo's service areas and remains an important delivery access route supporting the Zoo's critical functions. This view is a continuation of similar views noted in the 2006 LMP as Views 34 and 35 (or 534V and 535V on the s170 Register). (Geoffrey Britton, 2021)

Some of the existing incidental views out to the harbour, bridge and the Sydney CBD from the back-of-house access road (**Figures 40 and 41**) will be lost as will related views from further up the same road (Views 34 and 35 shown in **Figure 69**). Of these latter views both are listed on the s170 register (Views 534V and 535V respectively). View 534V would be affected by the proposed new Nutrition Centre project (a separate SSDA) while View 535V would be lost to the present project proposal.

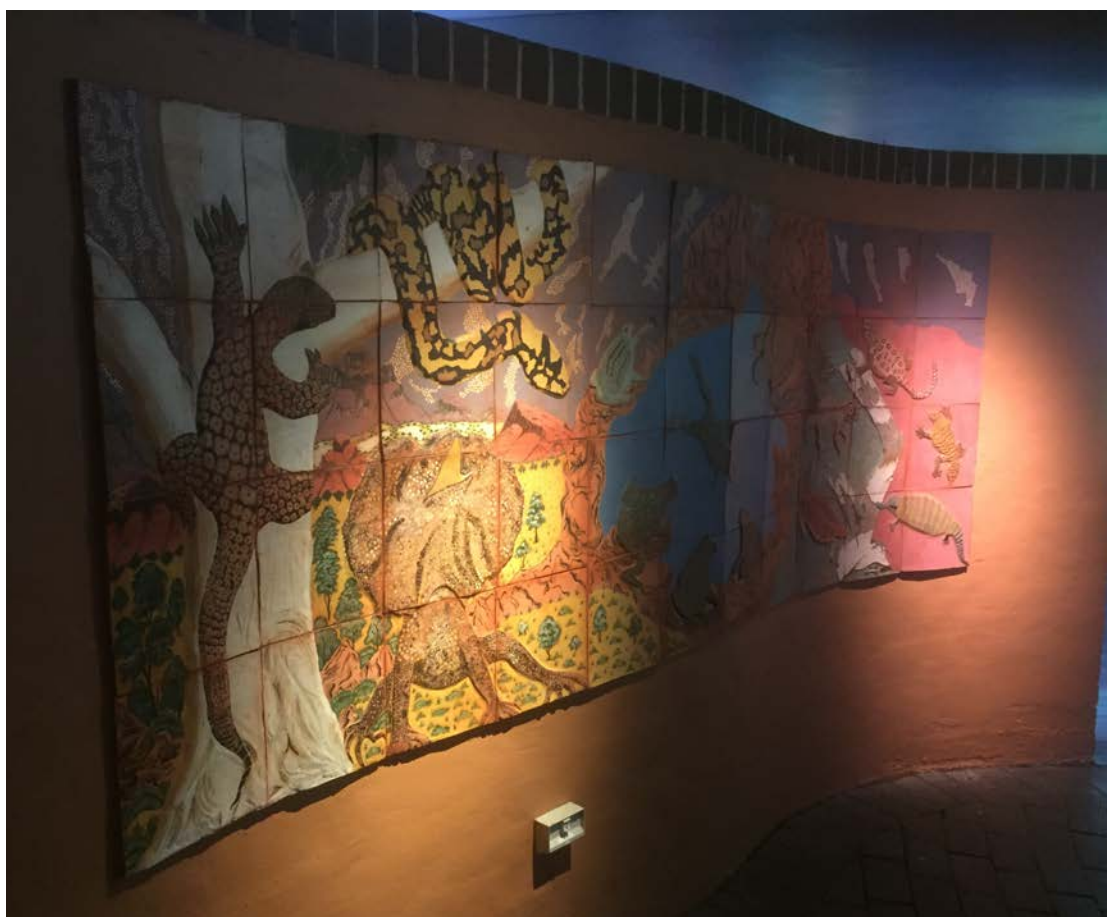
**Figure 73** Forty-four ceramic panels comprising the extramural mosaic depicting desert wildlife in central Australia made especially for Taronga Zoo in 1994 by artists of the Hermannsburg Potters, Northern Territory. A large perspex panel (**Figure 74**) installed next to the work explains its imagery and includes a list of the contributing artists (**Figure 75**).

- \* A large extramural ceramic mosaic 'Ntaria Our Country' made especially for Taronga Zoo in 1994 by artists from Hermannsburg, Northern Territory and its integral perspex interpretive details including the names of all of the contributing artists under the direction of Naomi Sharp (**Figures 73 to 75**);
- \* Various fibreglass, stainless steel and sandstone sculptures of thematically related reptilian and amphibian animals (none with acknowledged artist details)(**Figures 67, 76 to 79**); and
- \* An artwork of coloured hand stencils and dots across one of the bagged-brick internal dividing walls by children of La Perouse Public School (no date but, presumably, 1990s)(**Figure 80**).

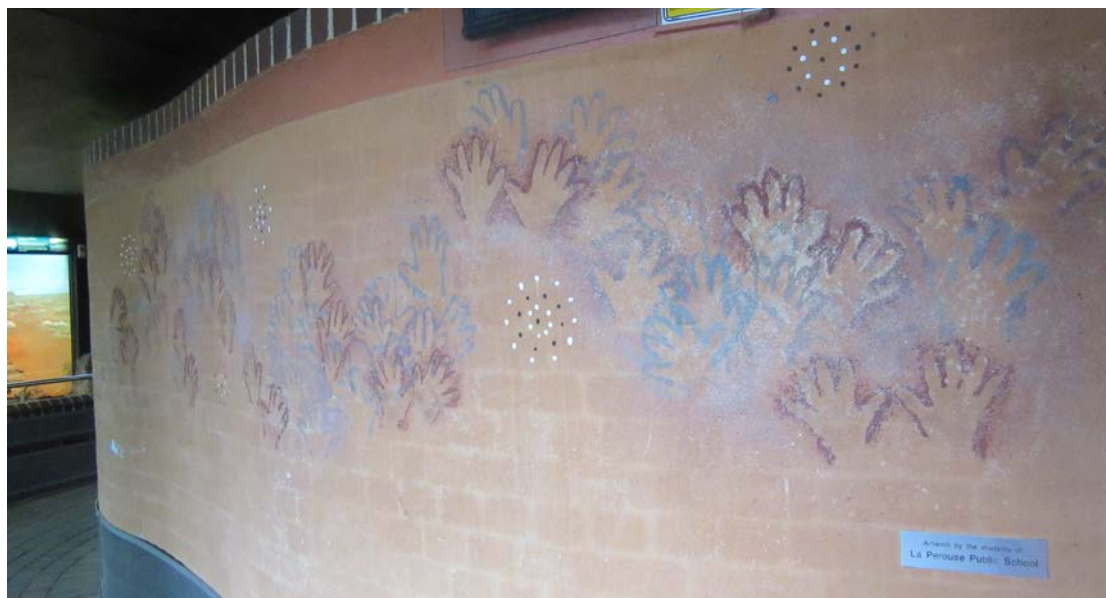
**Figure 80** BELOW A section of a bagged dividing wall within the existing reptile centre featuring the La Perouse Public School artwork of hand stencils and dot motifs. (1990s?) In this case the work would hold mainly social value as a point of engagement between the La Perouse Public School students and community with the Zoo. Salvage would not be possible though a similar exercise elsewhere within the Zoo could be considered. In the meantime archival recording would be expected. (Photograph: Geoffrey Britton, 2021)

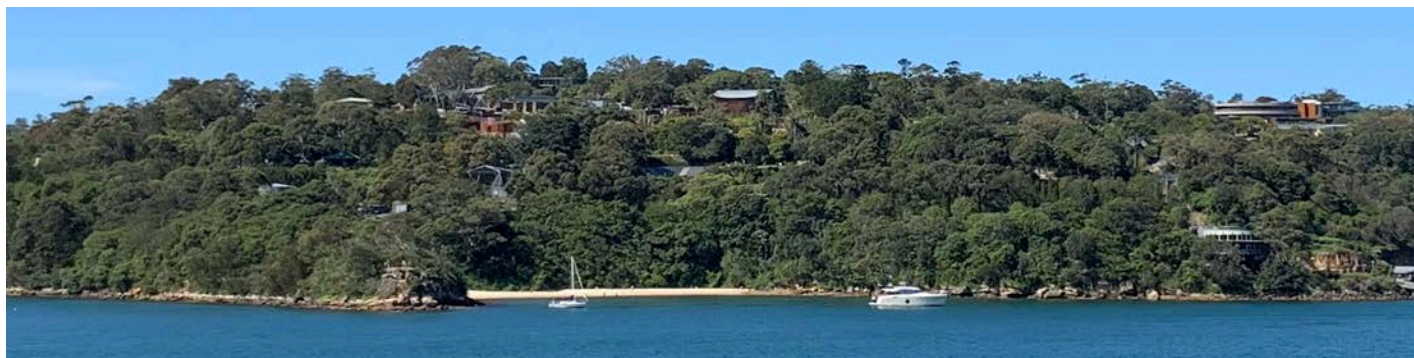
**Figure 81** ABOVE View of western side of the zoo campus from Cremorne Reserve (towards the end of Cremorne Road). **Figure 82** BELOW View from Robertson Point, Cremorne Reserve showing an increasing prevalence of buildings within the erstwhile forested landscape setting of the zoo campus. Both of these views illustrate the importance of existing mature site vegetation as part of the setting of the zoo and the need to reinforce this vegetation wherever possible. (Images courtesy of Dr Anna Britton)

Views **to** the project site from outside of the Taronga Zoo lands, particularly the west (such as from parts of Cremorne Point – note **Figures 81** and **82**) through to the south (from the harbour) are particularly important. These would normally be addressed in a heritage impact assessment such as this however, in this case, they are discussed in more detail by others in separate reports.

Considering each of these aspects at a time, it is clear from **Figures 81** and **82** that the western side of Taronga Zoo still 'reads' as a mostly well vegetated landscape with locally indigenous vegetation communities strongly evident and with a considerable amount of exotic (non-locally indigenous) plantings introduced to the Zoo over many decades. Many of the structures visible (and identified) in **Figure 81** are relatively recent buildings suggesting that there has been an incremental increase in recent years in the number of new structures emerging above the traditionally wooded character of the landscape. On the basis of the DA sheets AA-H9050 to AA-H9052, it appears that the new Taronga Wildlife Hospital will also be apparent from areas beyond the Zoo lands. In this case the new building is likely to have some impact on the broader Taronga Zoo landscape setting. As this likelihood was anticipated by the architectural design team, the new building has been designed to reduce the extent of visibility as part of its mitigatory treatments.

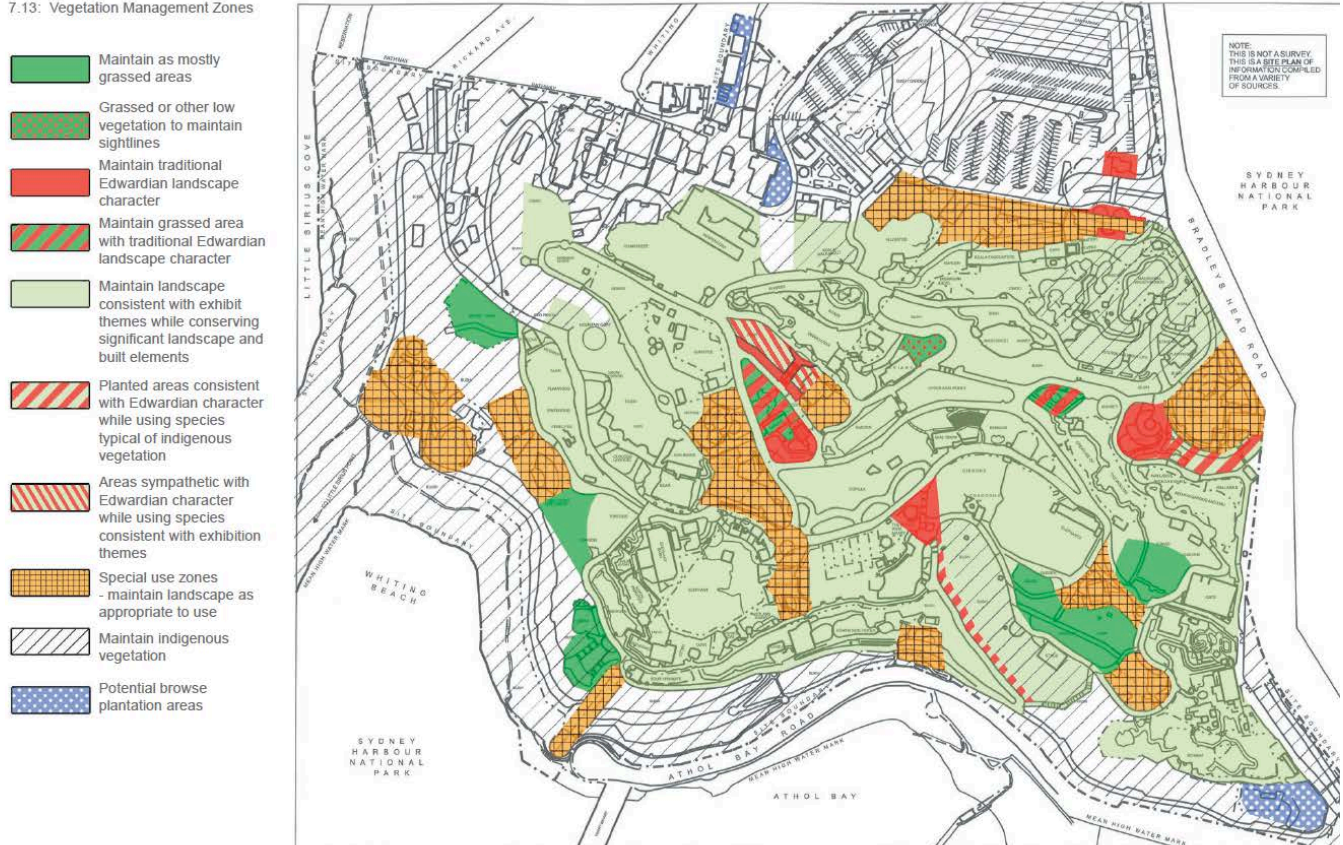
**Figure 84** Extract from the 2006 Landscape Management Plan indicating policy recommendations for the various landscape management zones throughout the Zoo campus. Of particular relevance to the proposed Taronga Wildlife Hospital site is the need to maintain a high level of site coverage for the locally indigenous vegetation communities (open hatched areas). (Courtesy Design 5 architects et al)

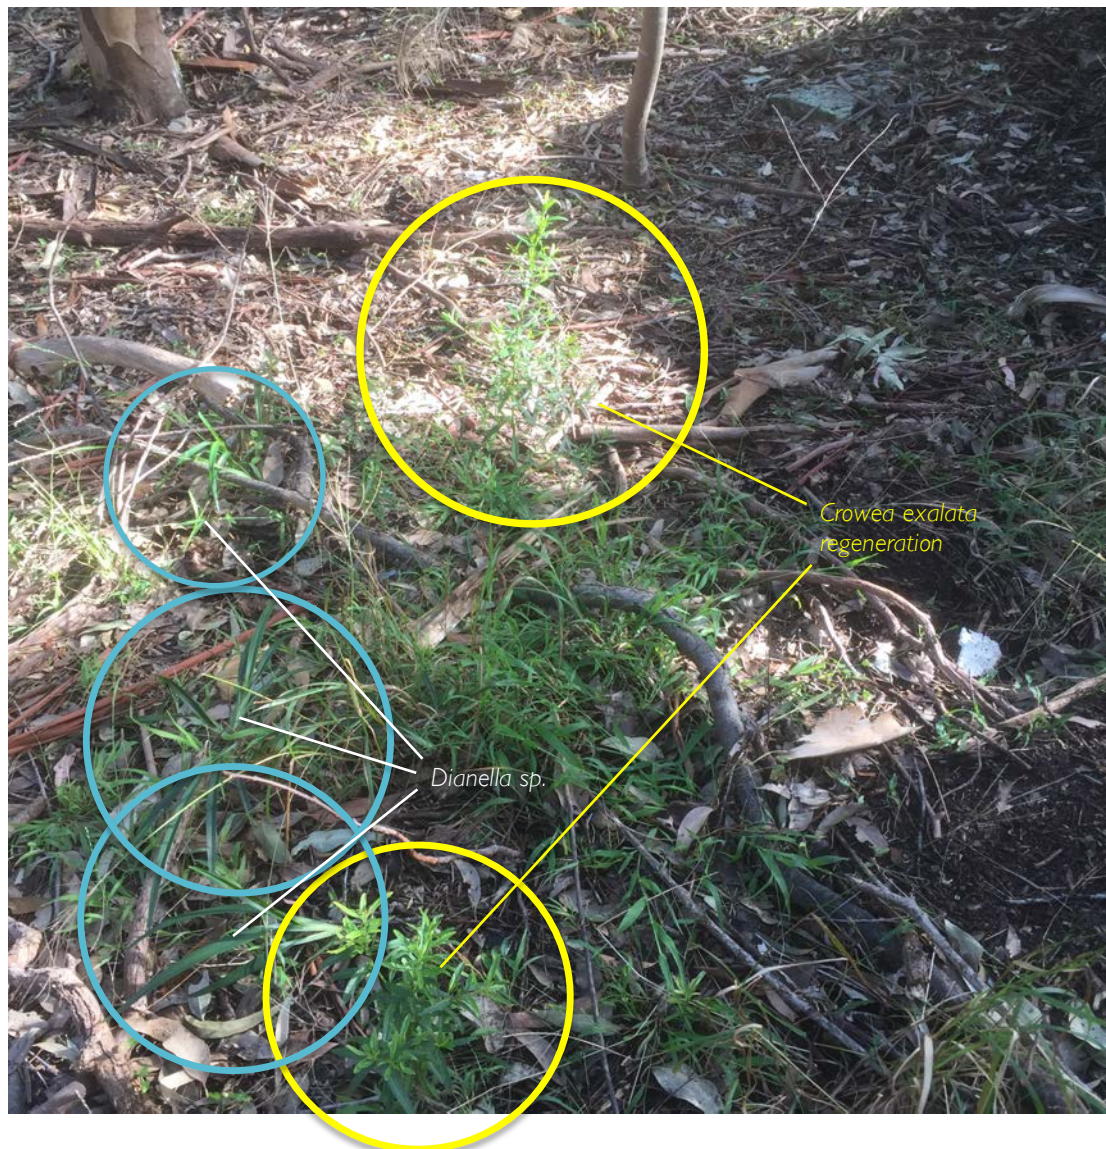
**Figure 85** ABOVE An area of recent regeneration of the locally indigenous woodland shrub *Crowea exalata* within the remnant woodland area (Item 240L). These individual plants appear to be very close to where the new boardwalk is proposed to link the TISL building with the proposed TWVH building.

**Figure 86** BELOW An extract from SSDA drawing AA-HI204 showing the approximate location of the area (circled in blue) of *Crowea exalata* regeneration noted above. (Courtesy of **dwp** architects)

The *Crowea* population is now less than was the case in 2006 but it is persisting as **Figure 85** shows. That the present few seedlings of this species have germinated spontaneously points to a continuing viable seed bank within the upper soil level that needs to be carefully protected from further disturbance.

- 7(xi) Where there is currently important regeneration of the highly desirable *Crowea exalata* (see **Figures 85** and **86**) within the 240L area, ensure the effective protection of all individuals where these coincide with the proposed boardwalk route through the area. Protection in some cases may mean relocating individual plants away from the direct construction zone and strict management of construction activities and access. Disturbance to the topsoil layer containing the viable seed bank should be minimised and strictly controlled.

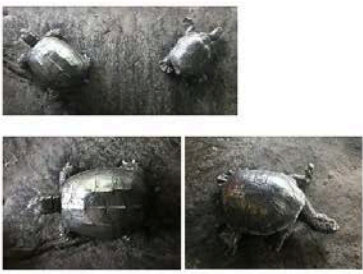
| <p>Turtle &amp; Tortoise Sculptures<br/>X 2</p> | | <p>Forest species path<br/>- exhibit side</p> | <p>Approx. dimensions<br/>Both 200mm X 150mm</p> <p>Material<br/>Stainless Steel</p> |

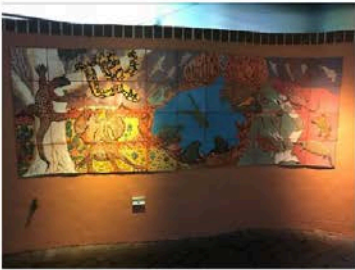
| Ntaria Our Country ceramic tile mural | | Desert species path<br>- exhibit side | Approx. dimensions<br>Each tile 170mm X 170mm<br>Mural 3020mm X 1100<br><br>Material<br>Ceramic |
