# **ABORIGINAL CULTURAL HERITAGE ASSESSMENT**

Taronga Wildlife Hospital,  
Taronga Zoo, Mosman, NSW,  
Cammaraigal Country.

**TARONGA CONSERVATION SOCIETY AUSTRALIA**

17 August 2022

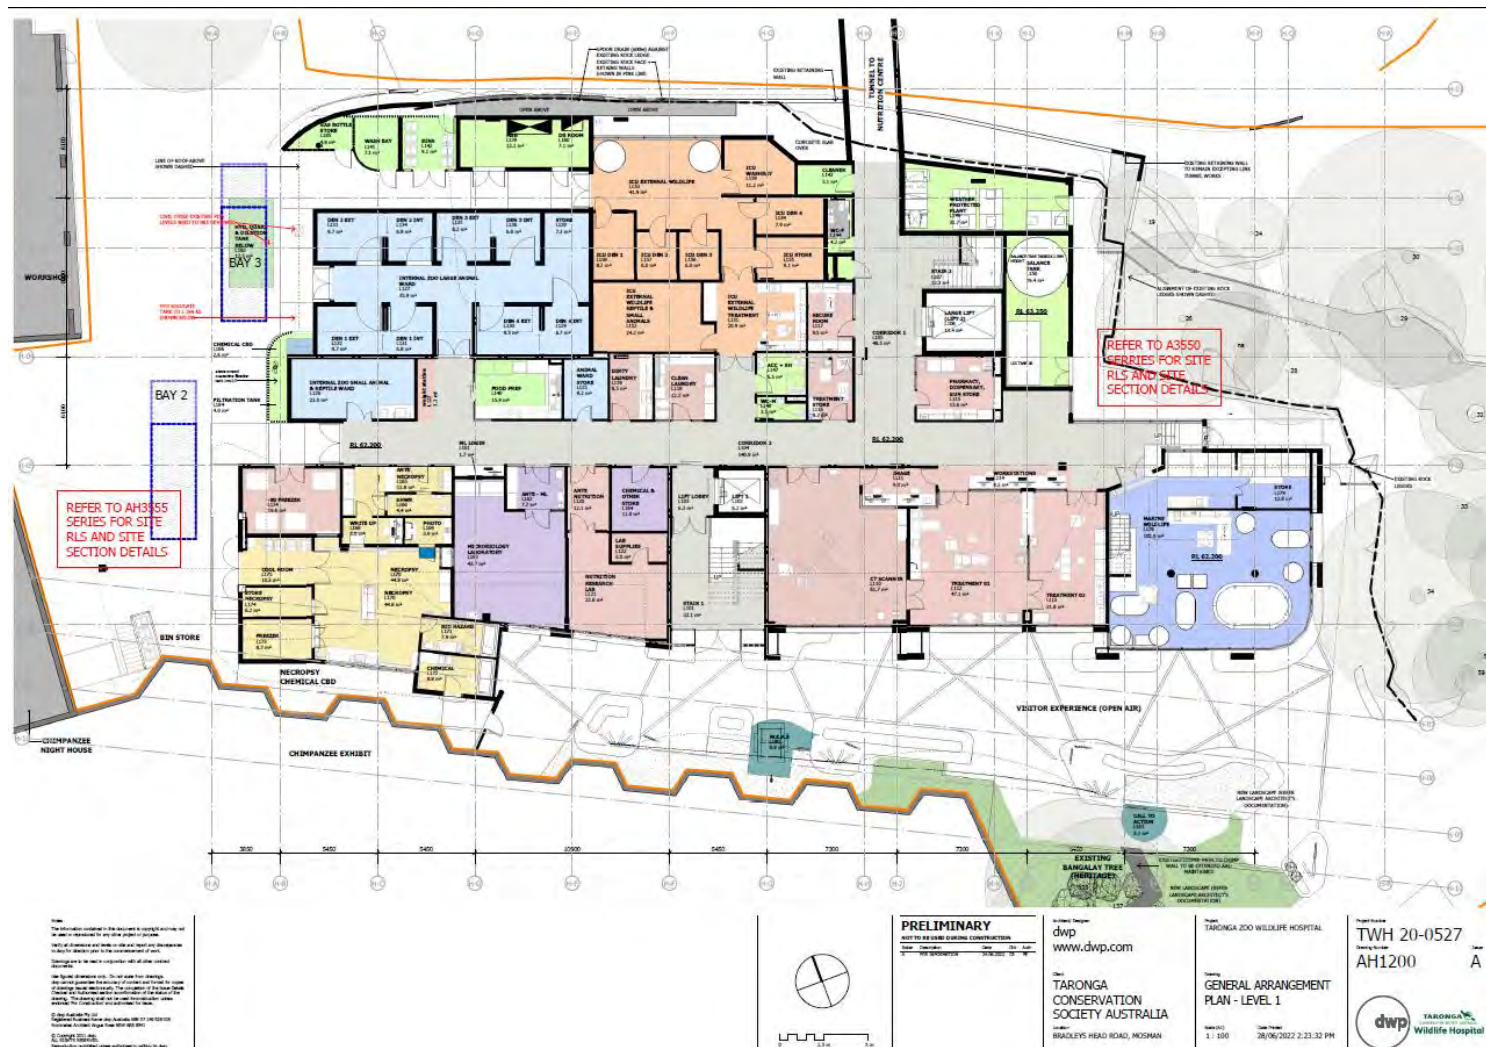
Figure 1 – General arrangement plan of level 1 for the proposed Wildlife Hospital.

- The demolition of the existing buildings on site and the construction of a new Wildlife Hospital (Figure 1 to Figure 4). The Wildlife Hospital will include rehabilitation facilities (including wildlife intensive care and Marine turtle facilities), surgeries, necropsy room/s, pathology labs, medical equipment and supplies storage, medical equipment and quarantine facilities to replace existing facilities on site.
- It is intended that the new Wildlife Hospital will be connected to the Taronga Wildlife Hospital Nutrition Centre which is currently being assessed under a separate SSDA (SSD-17655146).
- Vegetation removal and landscaping.

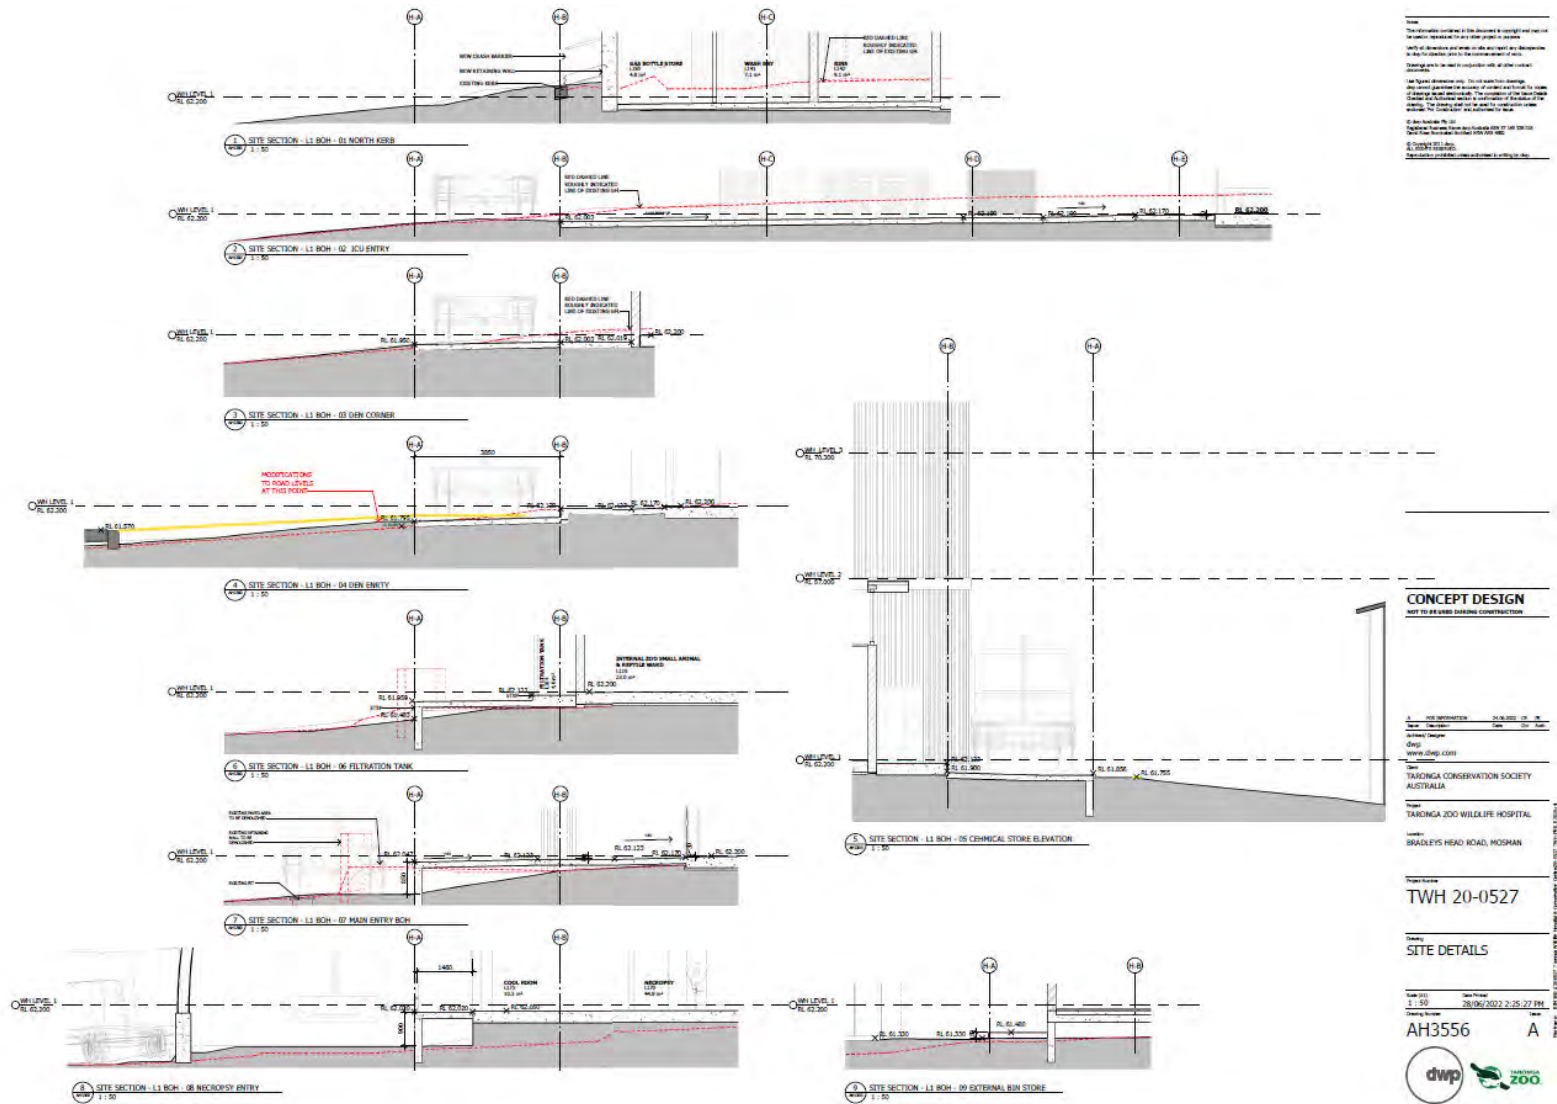
Figure 3 – Close up section views of the proposed Wildlife Hospital.

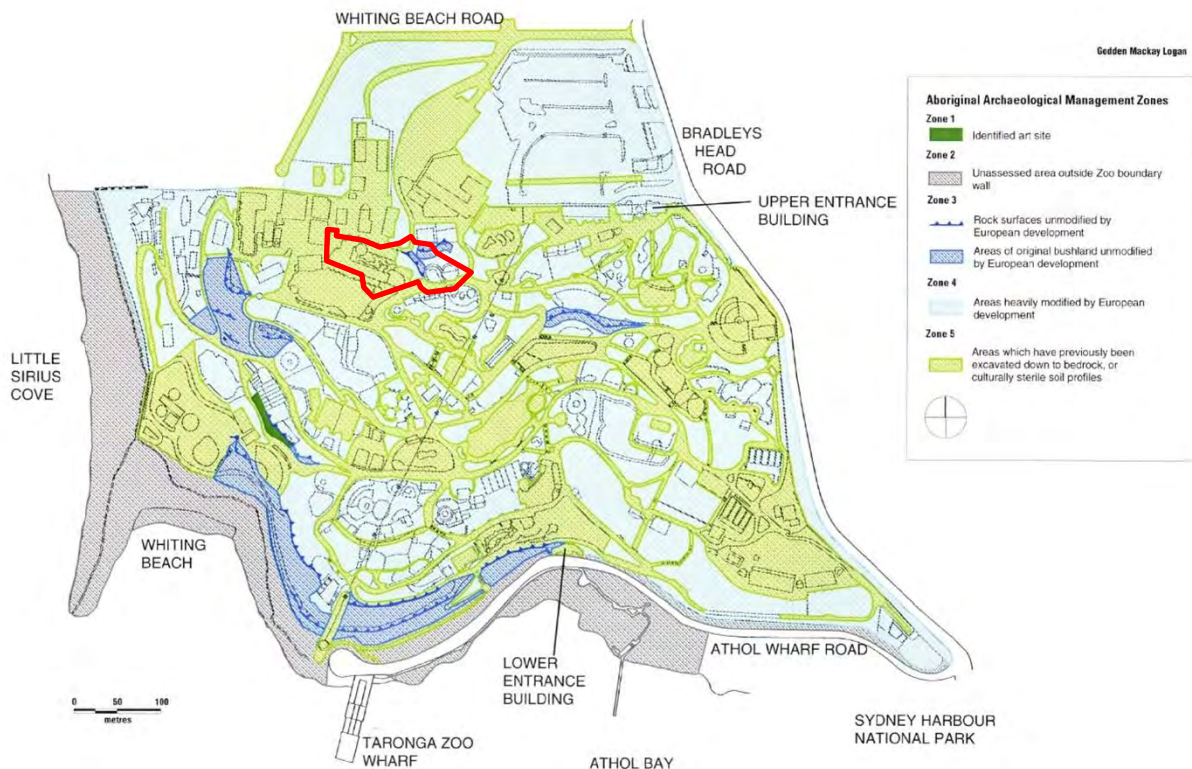
Figure 11 – Aboriginal Archaeological Management Zones.

Accordingly, the subject area is registered as having nil-moderate Aboriginal archaeological potential in the area proposed for the Taronga Wildlife Hospital and high Aboriginal archaeological potential in the area proposed for public domain works according to this assessment. Management strategies identified for these zones include preliminary test excavation in Zone 3 where disturbance is proposed, and an AHIP to be obtained if relics identified. Management strategies for Zones 4 and 5 include an Archaeological Induction for all contractors if subsurface disturbance is proposed and a chance find procedure developed.

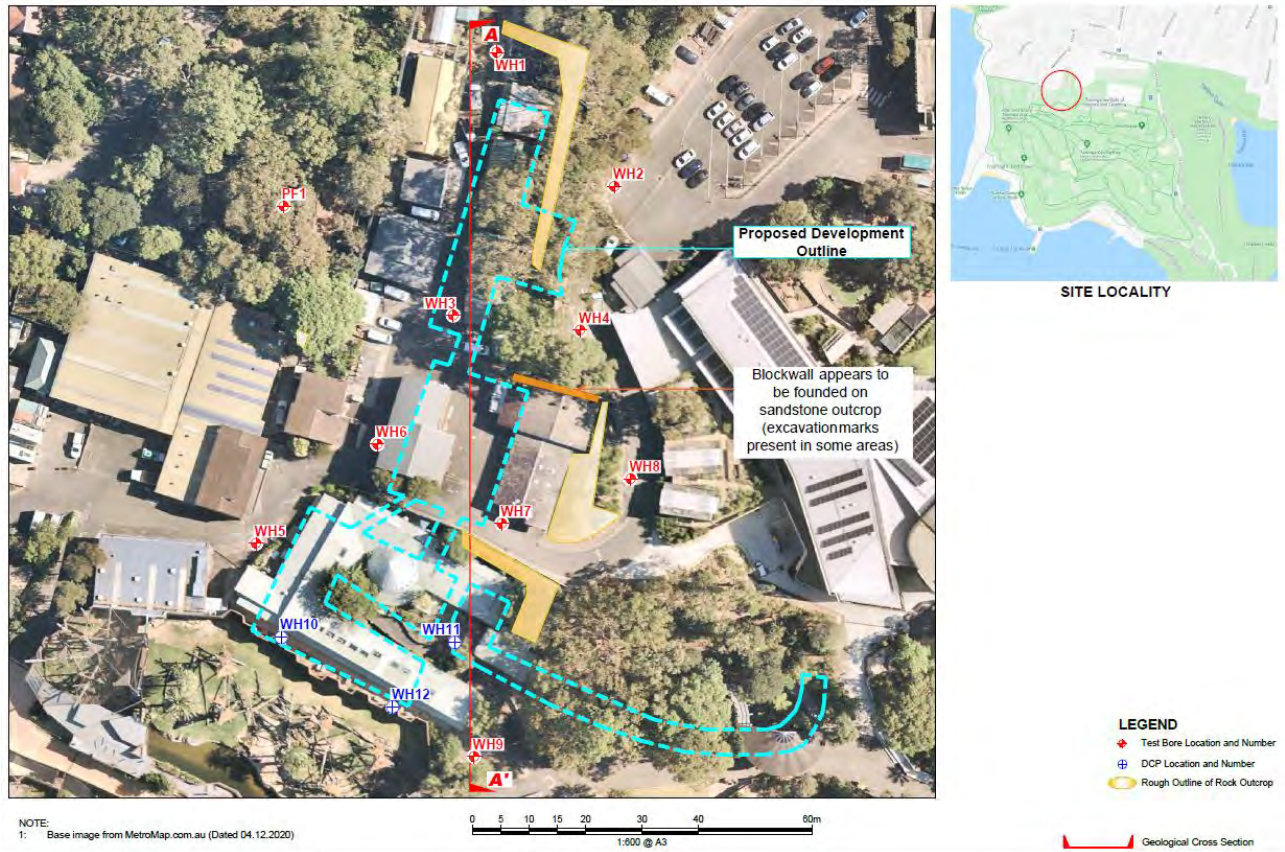
Figure 12 – Geotechnical Investigation – Borehole locations.  
Source: Douglas Partners, 2021.

The geotechnical investigations identified the subsurface conditions as being primarily fill overlying sandstone bedrock. Fill materials included asphalt, gravelly or clayey sand and road base to depths of between 0.34-1.23m in 8 of the boreholes, with fill extending to depths of 3.1m in the remaining two boreholes. Deeper fill included concrete, timber and asbestos containing fibre cement.

**No natural soils** were encountered during the geotechnical investigation. It should be noted that the terminology 'fill' does not always describe imported soils and the source of the fill may need to be further confirmed by geomorphological investigation. The results of the geotechnical analysis are discussed below. Notably, the geotechnical investigation did not include the area of natural vegetation but was restricted to other portions of the site.

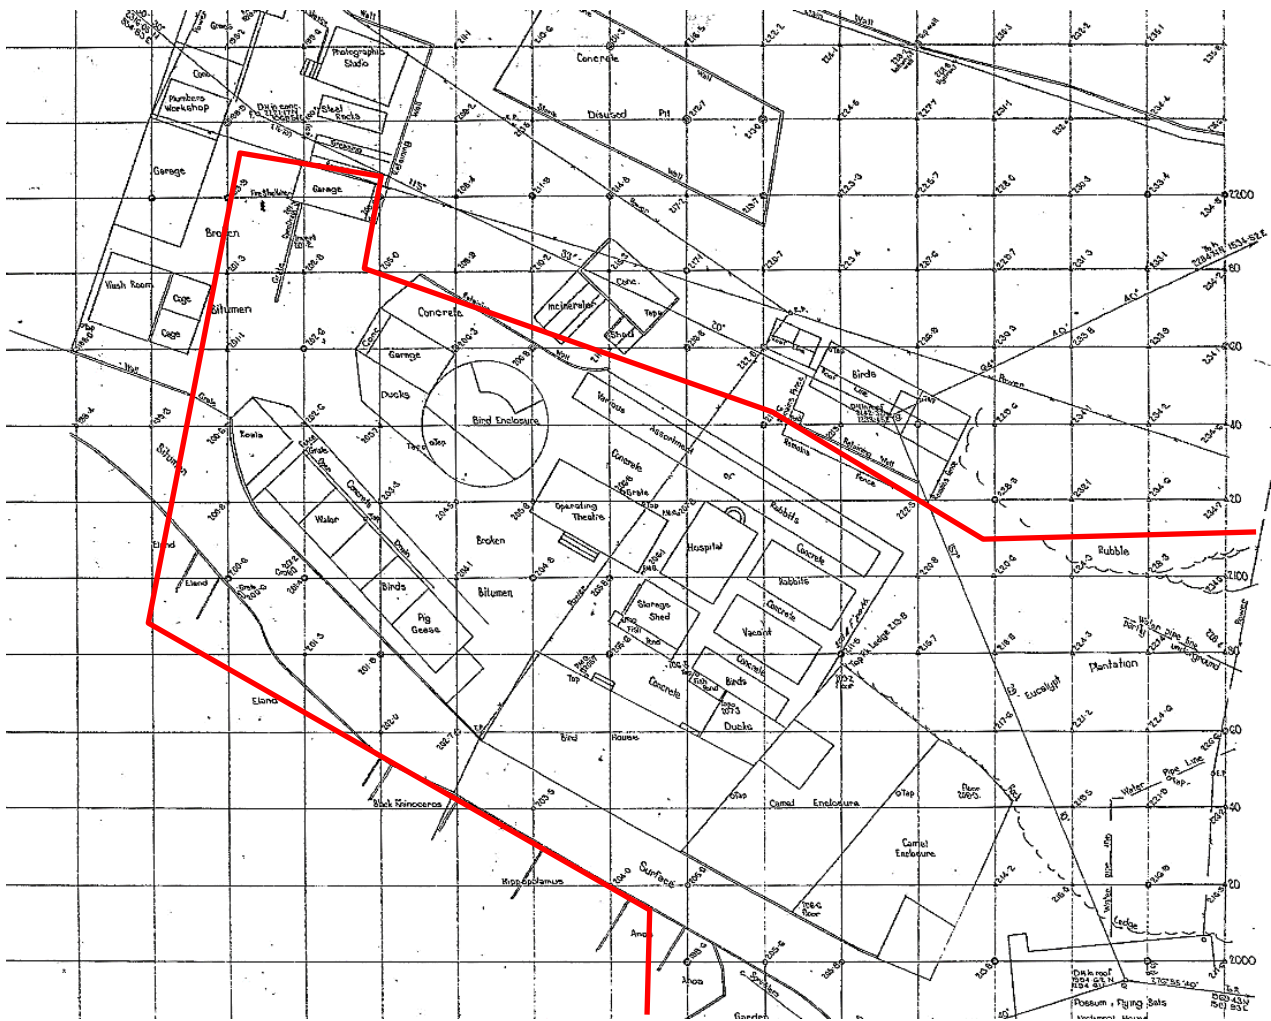
Figure 19 – 1969 survey indicating the location of structures within the subject area including the Camel enclosure, hospital, bird enclosure and incinerator. The eastern component of the subject area remained vegetated at this time.  
Source: Taronga Zoo Archives

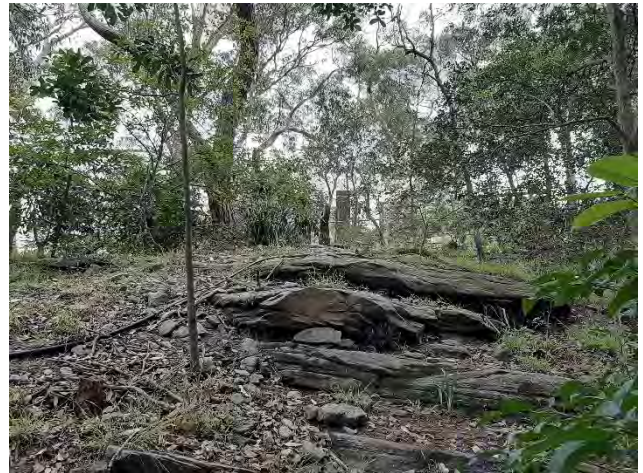
Figure 22 – Sandstone outcrop within the subject area.

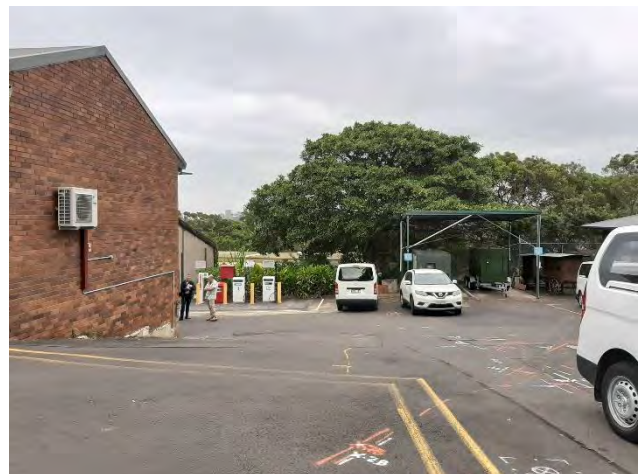
Figure 24 – Low visibility due to back of house facilities including asphalt coverage.

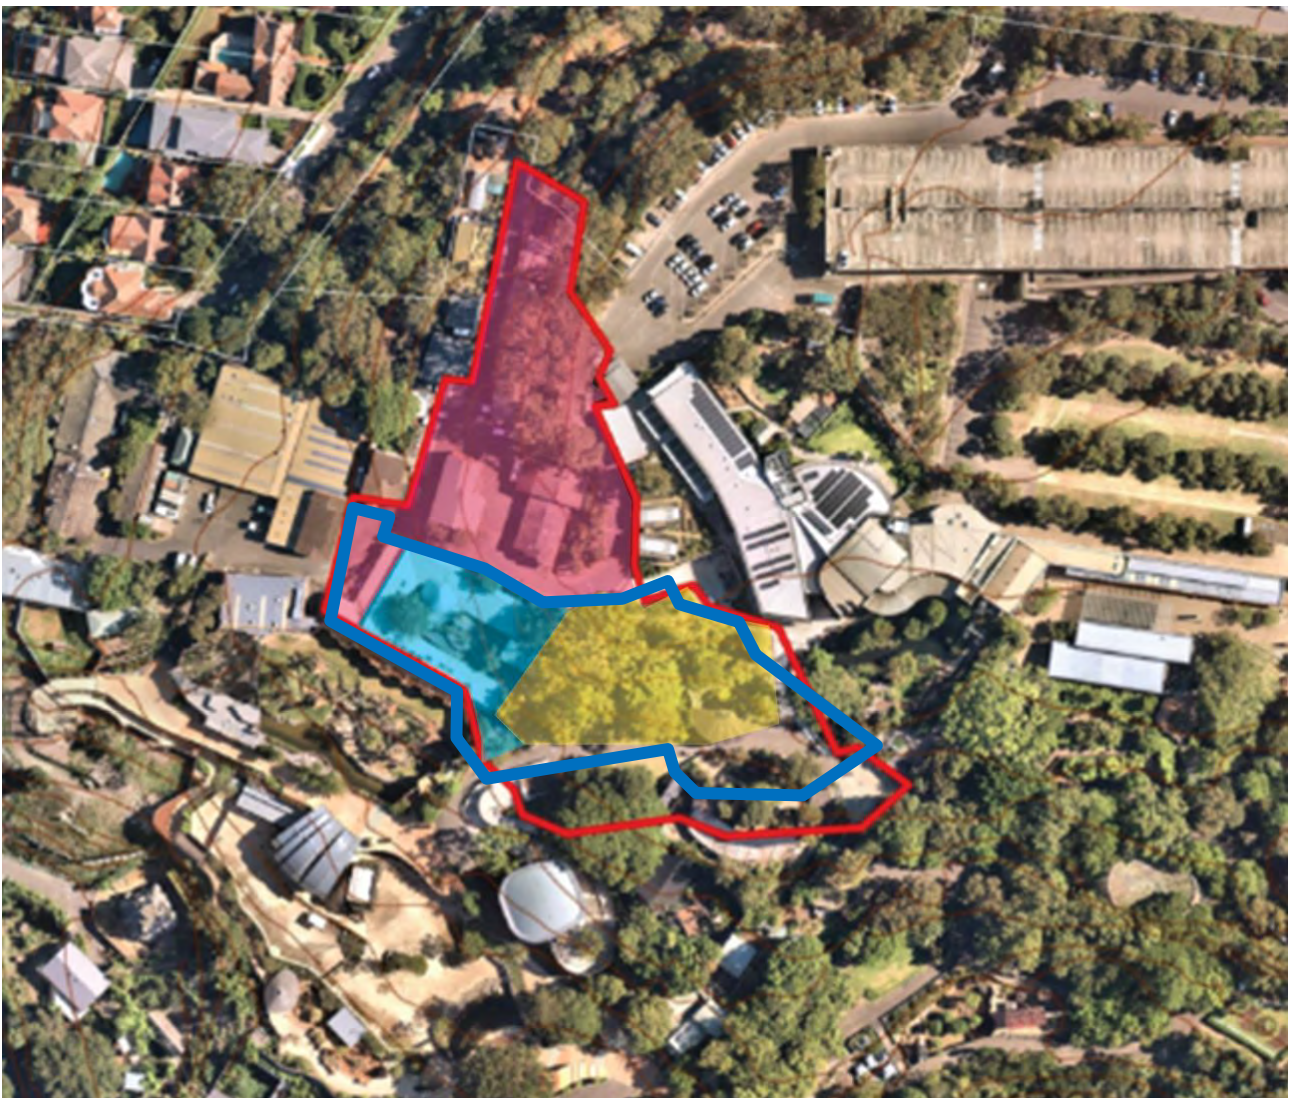
Figure 25 – Site plan. Approximate location of subject area outlined in dark blue. Survey unit 1 indicated in pink, survey unit 2 indicated in blue and survey unit 3 indicated in yellow.

The site visit concluded that the Wildlife Hospital and elevated footpath were the most appropriate place for any interpretation materials as they will be public facing areas, while the back of house facilities will be restricted access only.

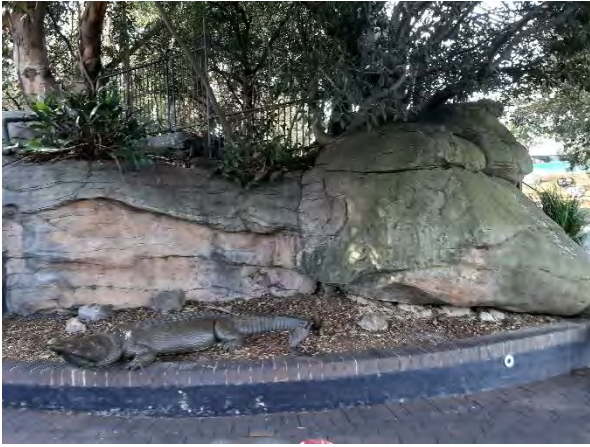
Figure 32 – Natural sandstone with mock rock intrusion (to be removed). Aspect: north.

The site visit concluded that SU3 represents one of the only intact landscape areas across the Zoo and is of cultural significance. As such, the following is recommended for SU3:

- No major works are to occur in this area and rock platforms are to be avoided.
- Inspection of the rock platforms should occur once the area is made safe (exhibits decommissioned and access restricted) to identify any potential markings which could then form part of an interpretation plan for the site.
- The elevated footpath is highly supported to allow visitors to immerse themselves in the natural environment. This should be supported by interpretation plaques across the footpath which detail the Aboriginal history of the area as well as providing information on native vegetation. An interpretation strategy should be developed in conjunction with the Taronga Aboriginal Advisory Committee (TAAG).
- Monitoring of the footing installation should occur for the elevated footpath.

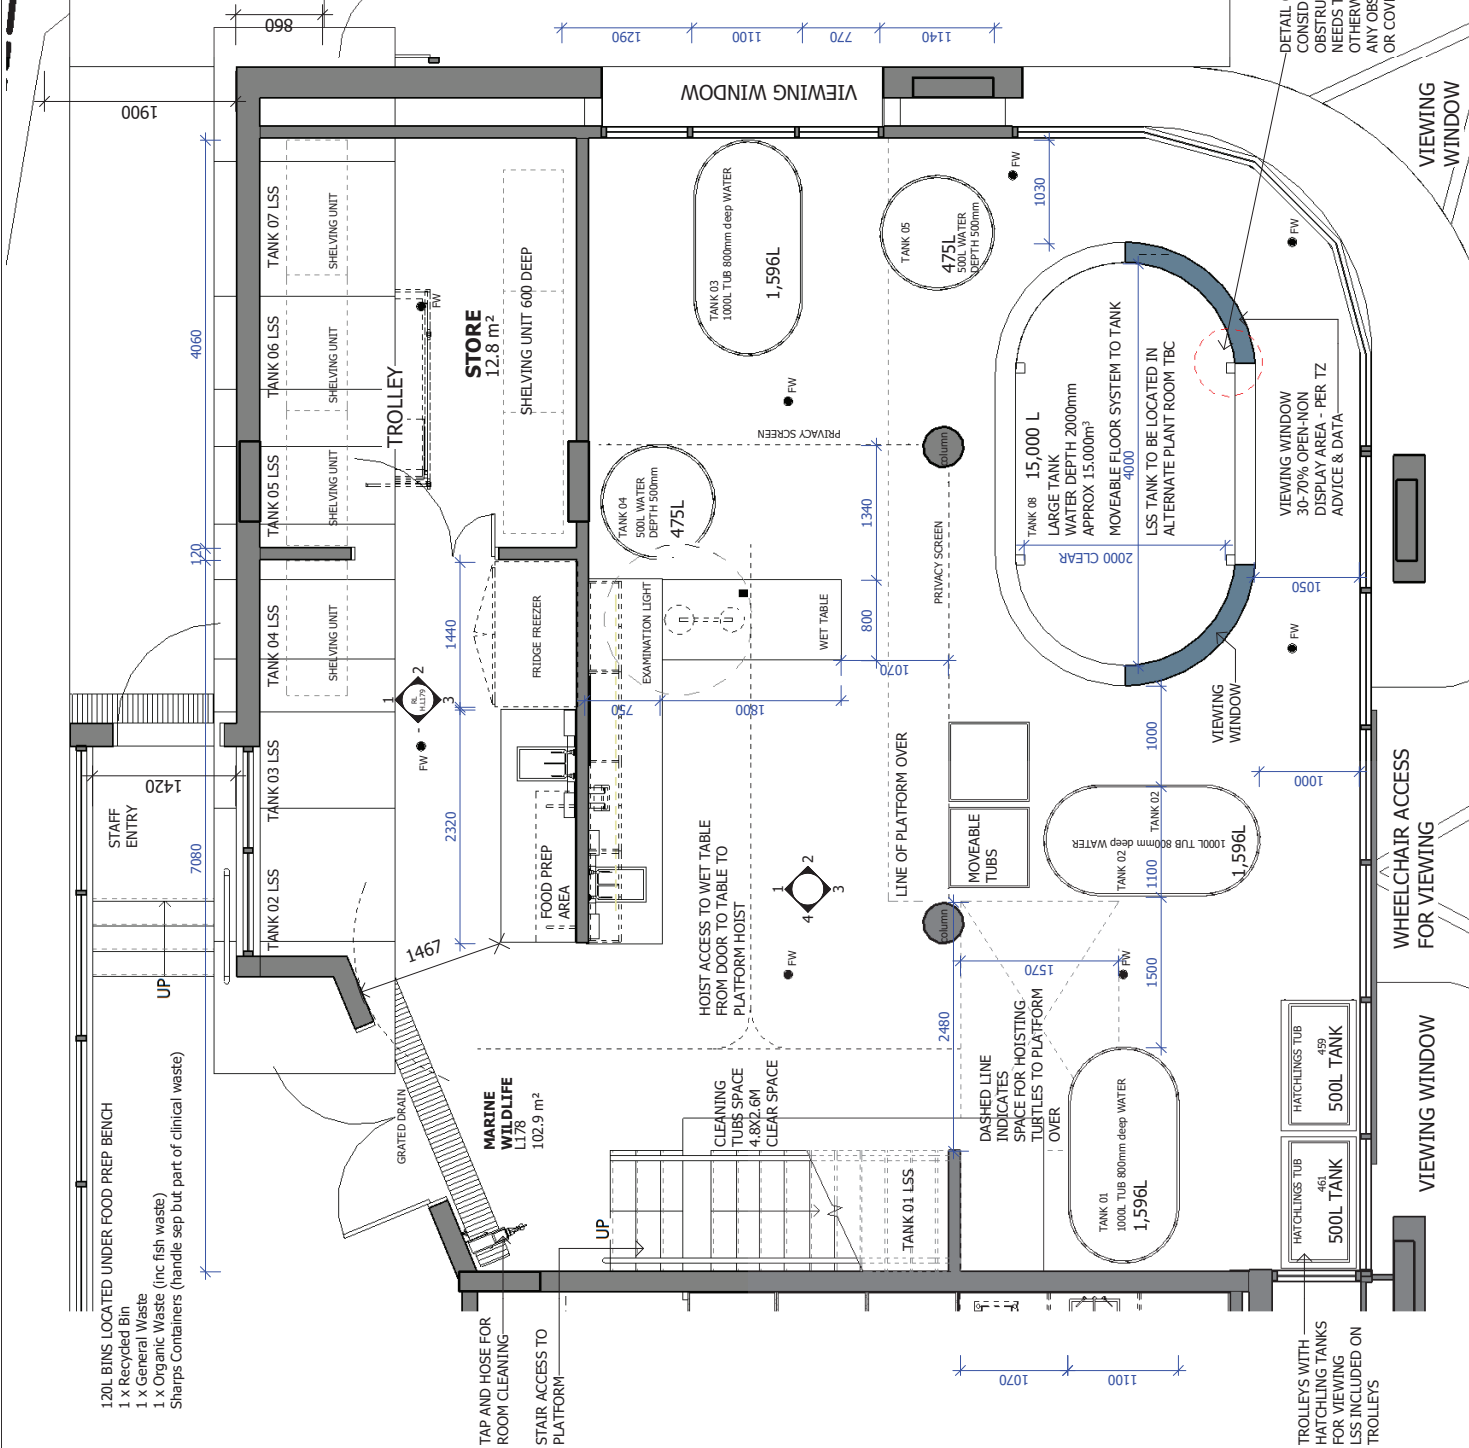
DETAIL OF PLATFORM STRUCTURE NEEDS CONSIDERATION TO PREVENT ANY OBSTRUCTIONS IN TANK INSIDE FACE OF TANK NEEDS TO BE SMOOTH FOR TURTLES OTHERWISE THEY WILL KNOCK THEMSELVES ON ANY OBSTRUCTIONS - MAYBE COLUMNS ROUND OR COVERED? TBC

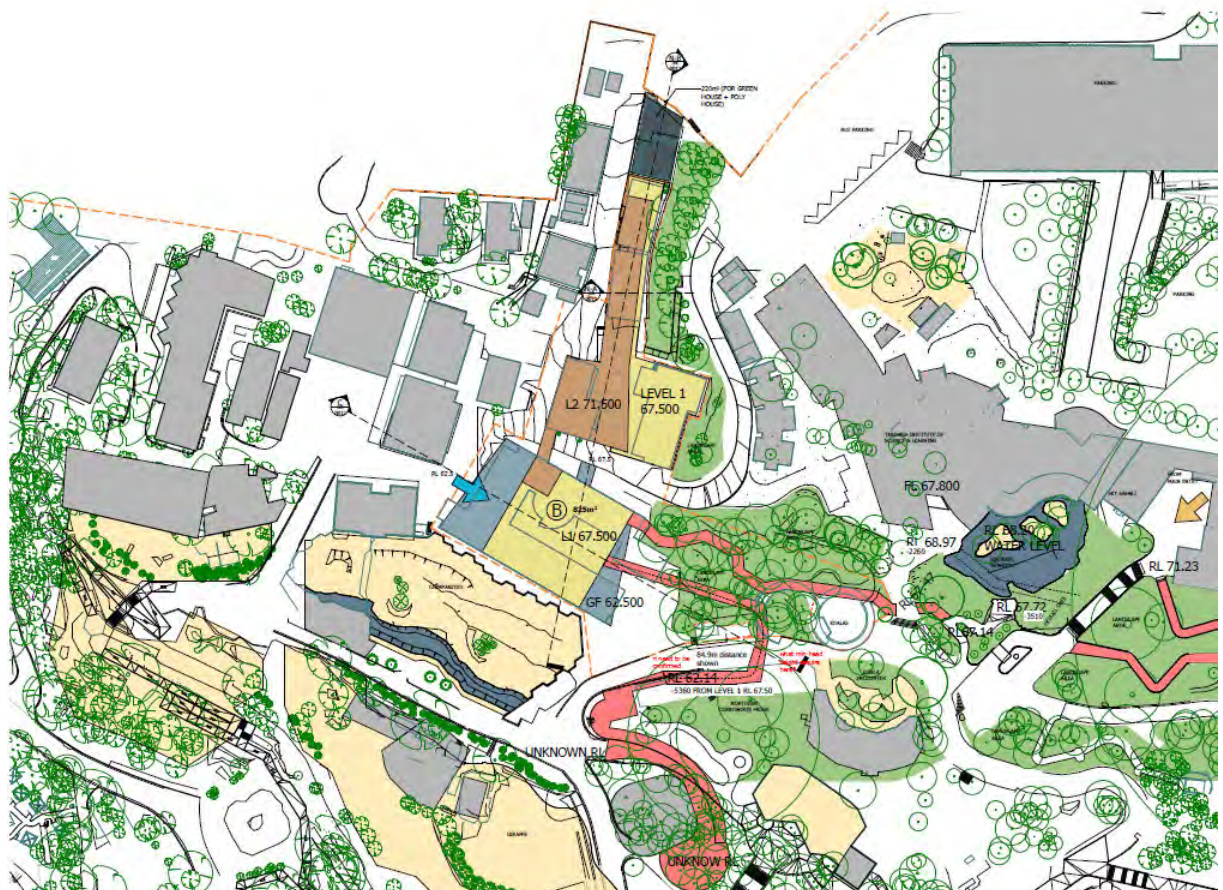
Figure 1 – Proposed works footprint including building and public domain works. Building marked by blue arrow and inclusive of the light green building footprints and the brown building footprint. proposed footpath marked by red.

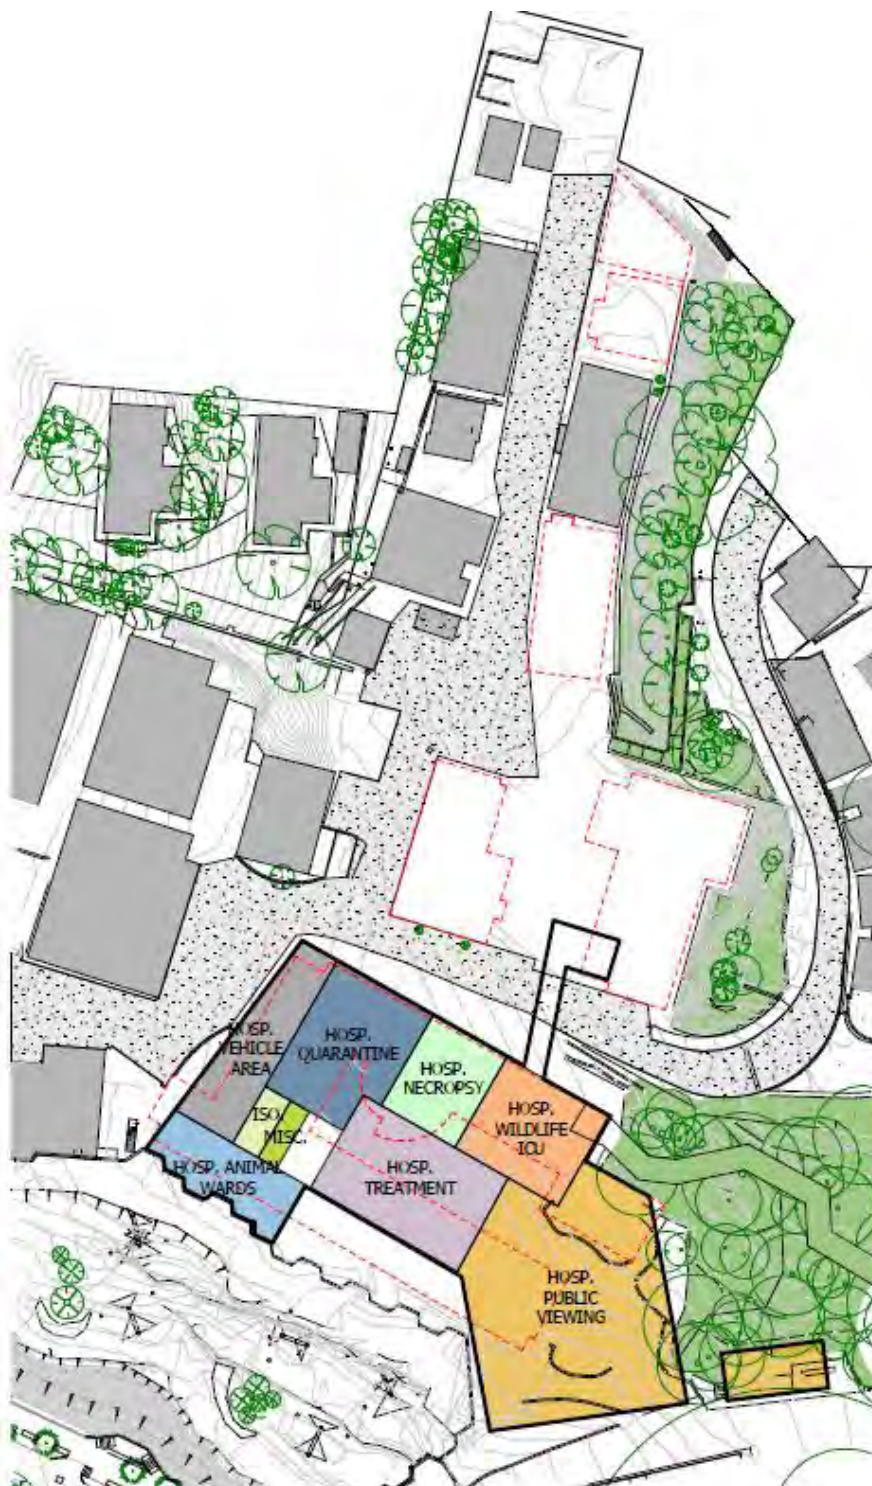
Figure 2 – Proposed building footprint and demolition plan.

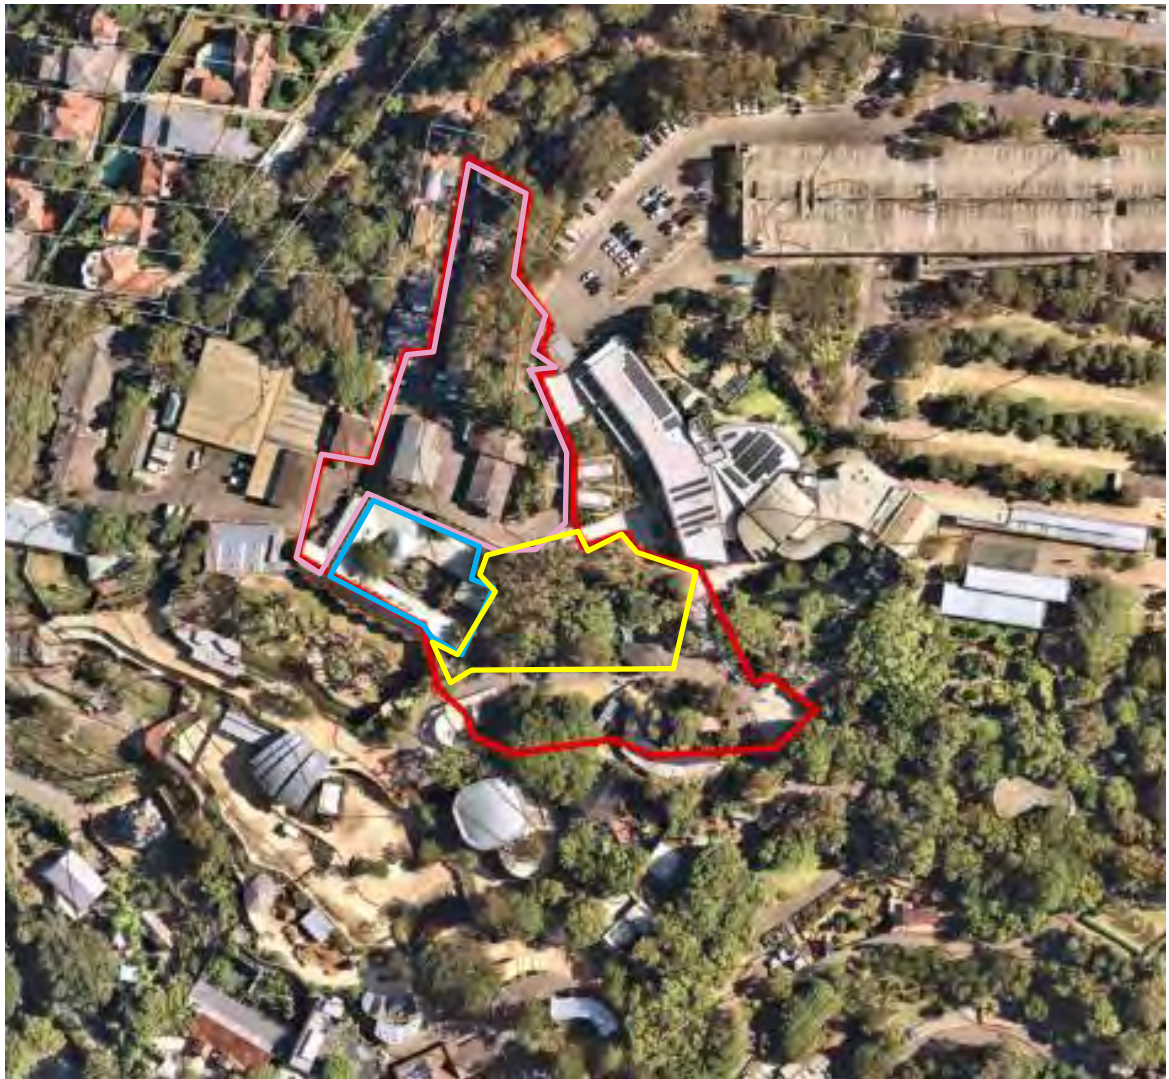
Figure 2 – Site plan. Subject area indicated in red. Back of house area indicated in pink, reptile house indicated in blue and natural vegetation area indicated in yellow.

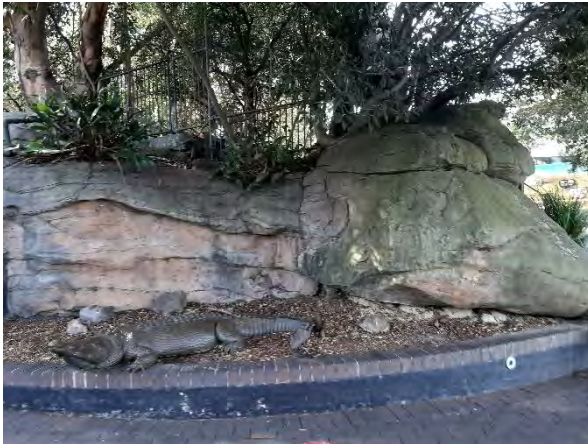
Figure 9 – Natural sandstone with mock rock intrusion (to be removed). Aspect: north.

- No major works are to occur in this area and rock platforms are to be avoided.
- Inspection of the rock platforms should occur once the area is made safe (exhibits decommissioned and access restricted) to identify any potential markings which could then form part of an interpretation plan for the site.
- The elevated footpath is highly supported to allow visitors to immerse themselves in the natural environment. This should be supported by interpretation plaques across the footpath which detail the Aboriginal history of the area as well as providing information on native vegetation. An interpretation strategy should be developed in conjunction with the Taronga Aboriginal Advisory Committee (TAAG).
- Monitoring of the footing installation should occur for the elevated footpath.

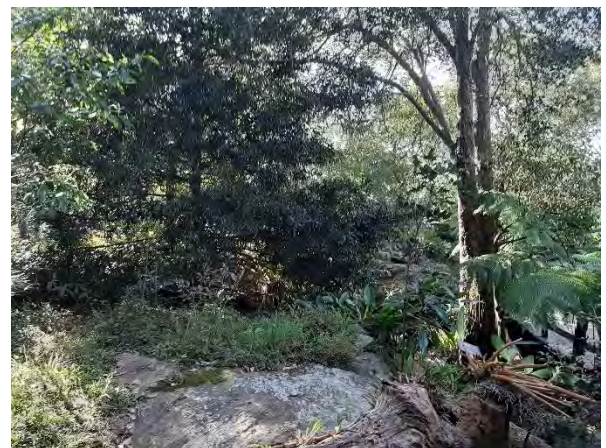
Figure 12 – Rock outcrops and unmodified vegetation, with Koala Walkabout footpath to right of frame (proposed for demolition). Aspect: north.
