Report on
Geotechnical Investigation

Proposed Commercial Development
2-8a Lee Street, Haymarket

Prepared for
Toga Development and Construction Pty Ltd

Project 86884.02
July 2022

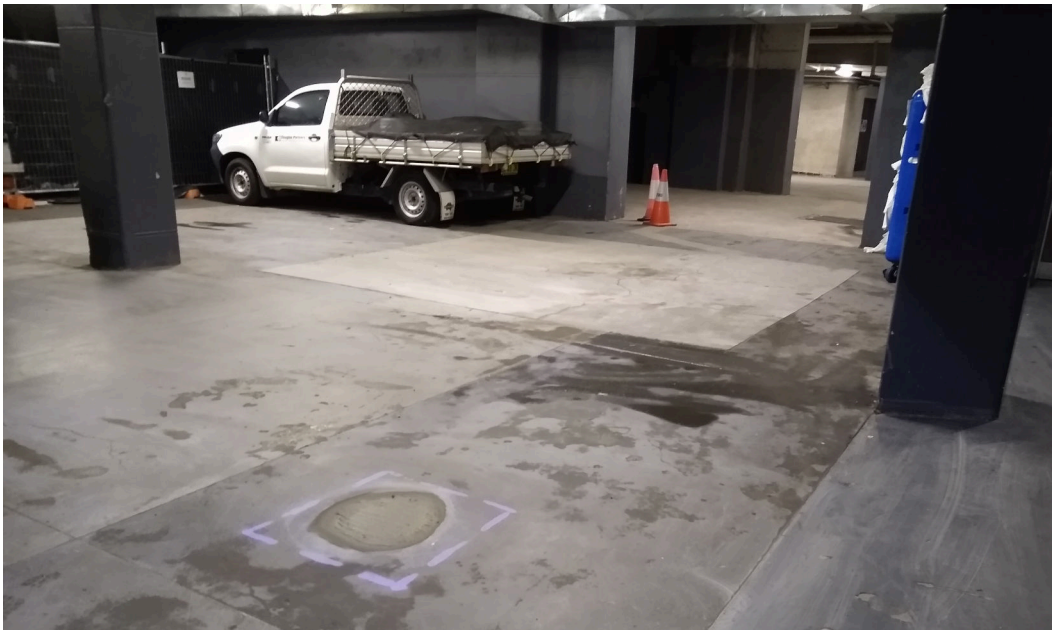
Photo B2 – View north-east at the location of Borehole BH1001, within the Adina Hotel basement.

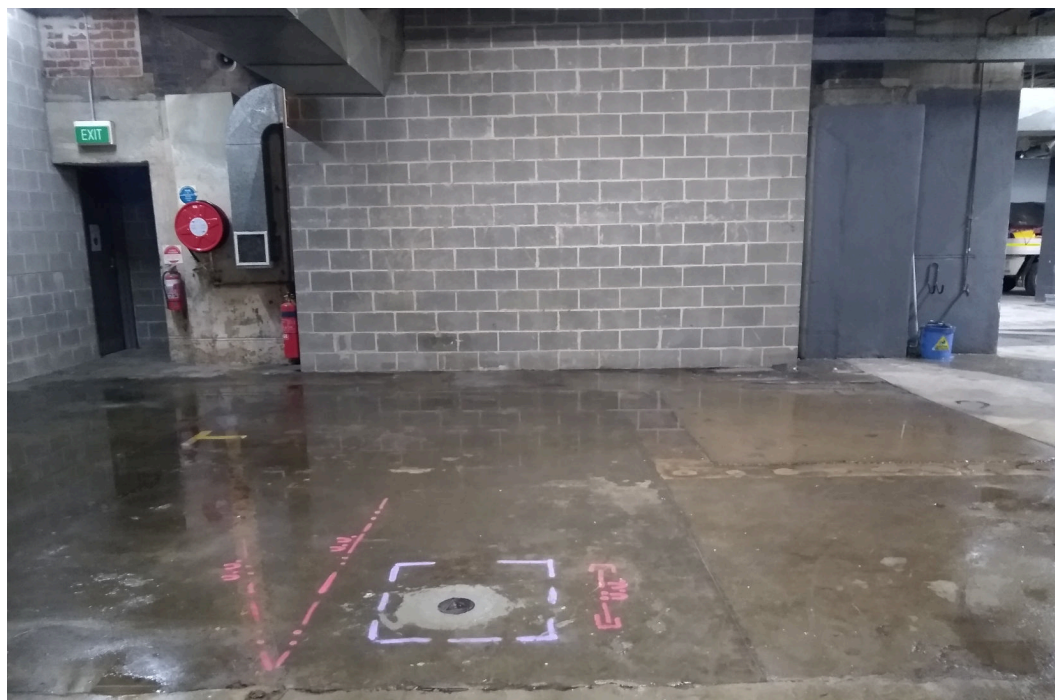
Photo B4 – View north-west at the location of Borehole BH1002, within the Adina Hotel basement.

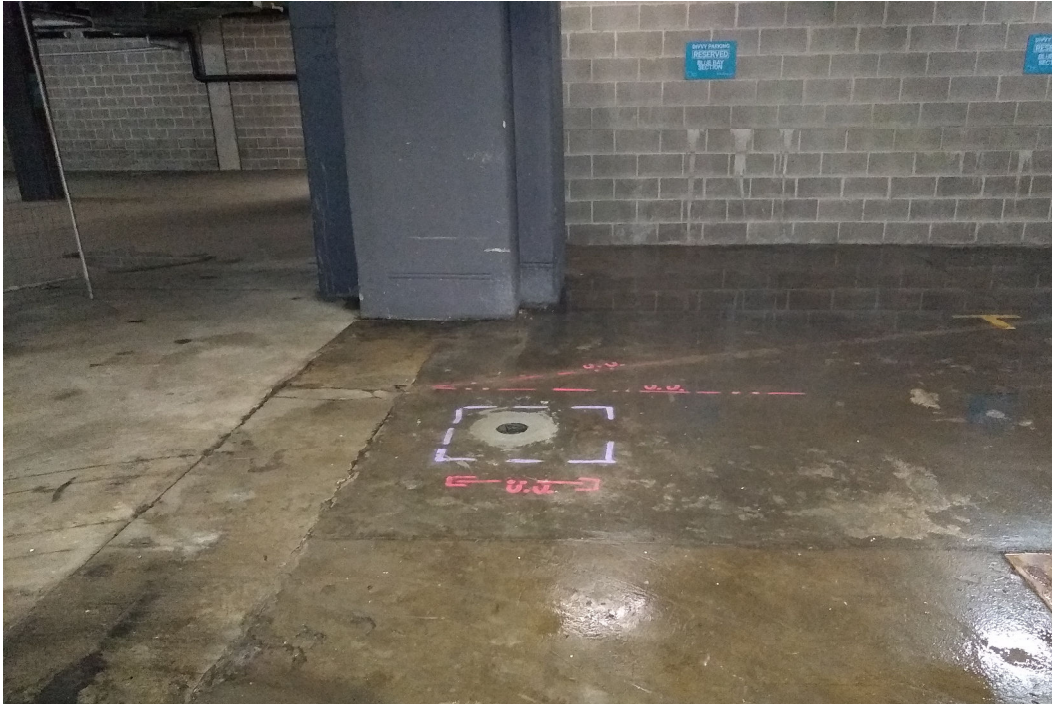
Photo B5 – View south-west at the location of Borehole BH1002, within the Adina Hotel basement during drilling.

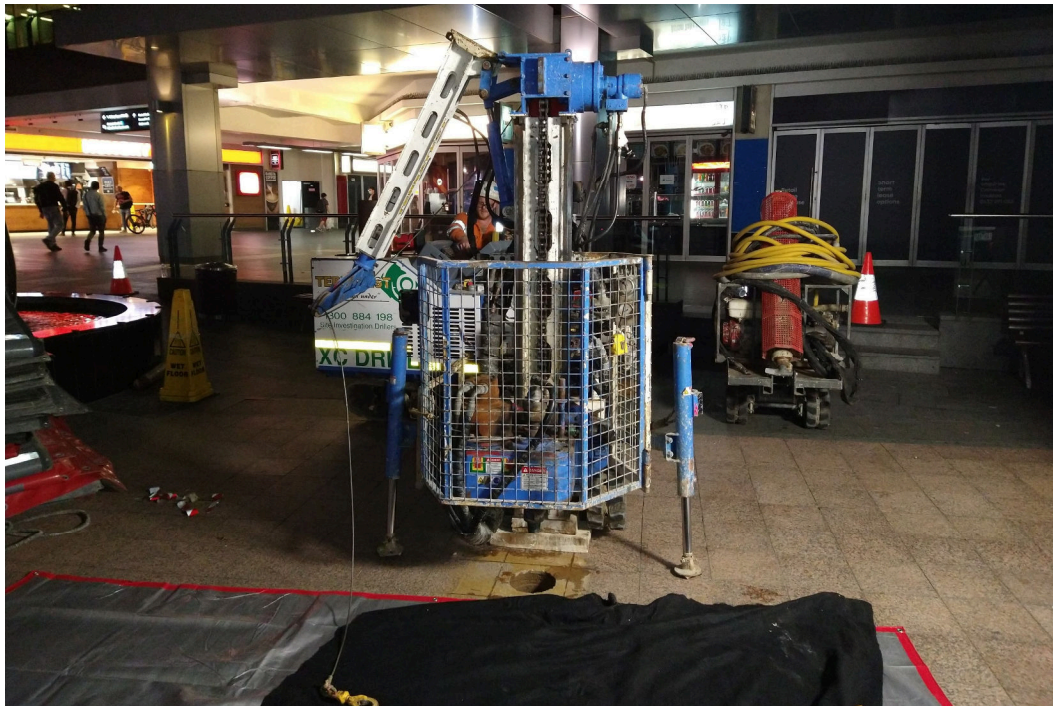
Photo B8 – View east towards the Devonshire Street Pedestrian Tunnel at the location of Borehole BH1005, on the southern side of the Henry Deane Plaza.

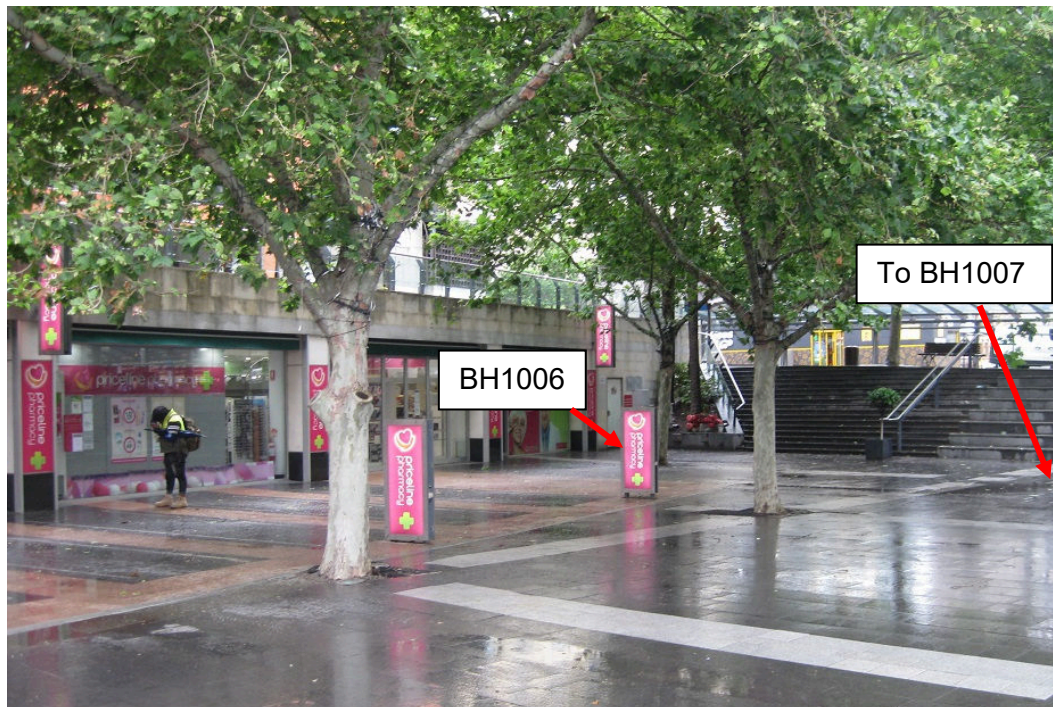
Photo B9 – View south-west across the Henry Deane Plaza towards Lee Street. The locations of Boreholes BH1006 and BH1007 are indicated as shown.

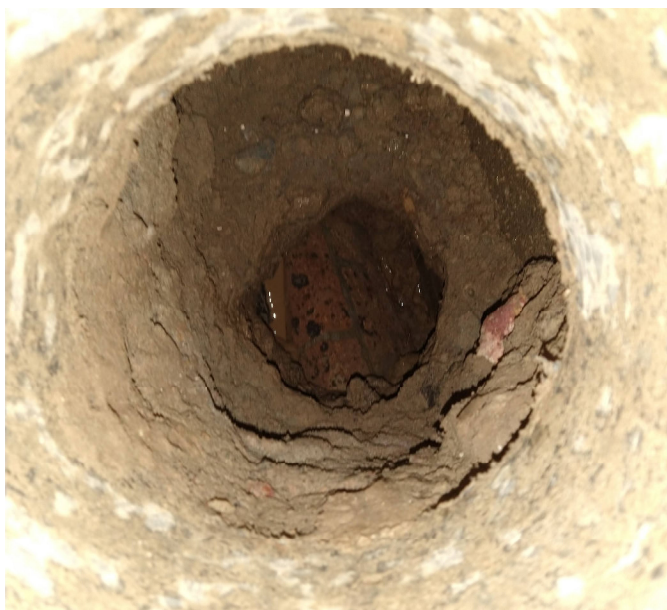
Photo D3 – View down Borehole BH1003 at the borehole refusal depth, showing a section of mortared brick rubble.

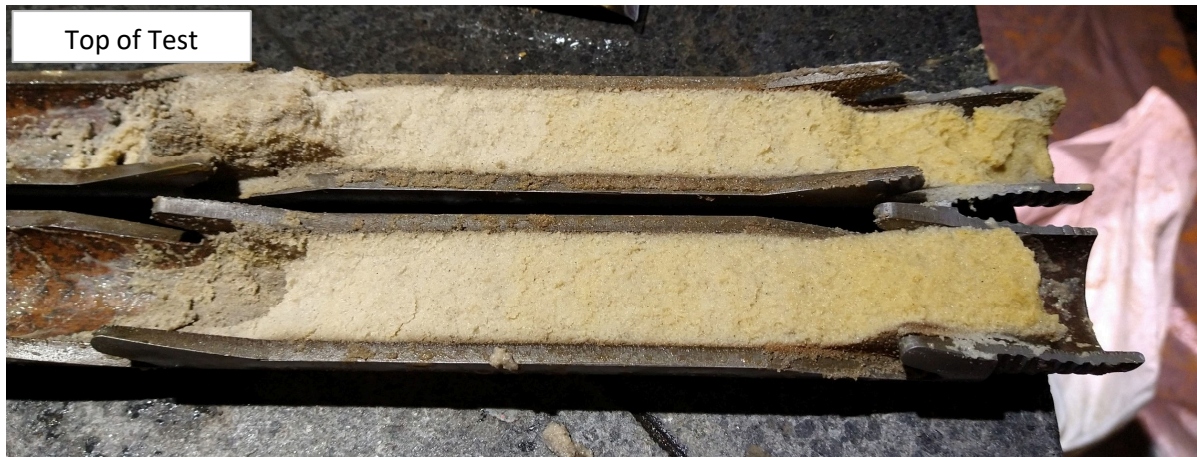
Photo D4 - SPT test from Borehole BH1003A, depth interval 2.5-2.95m. Top of test indicated as shown.

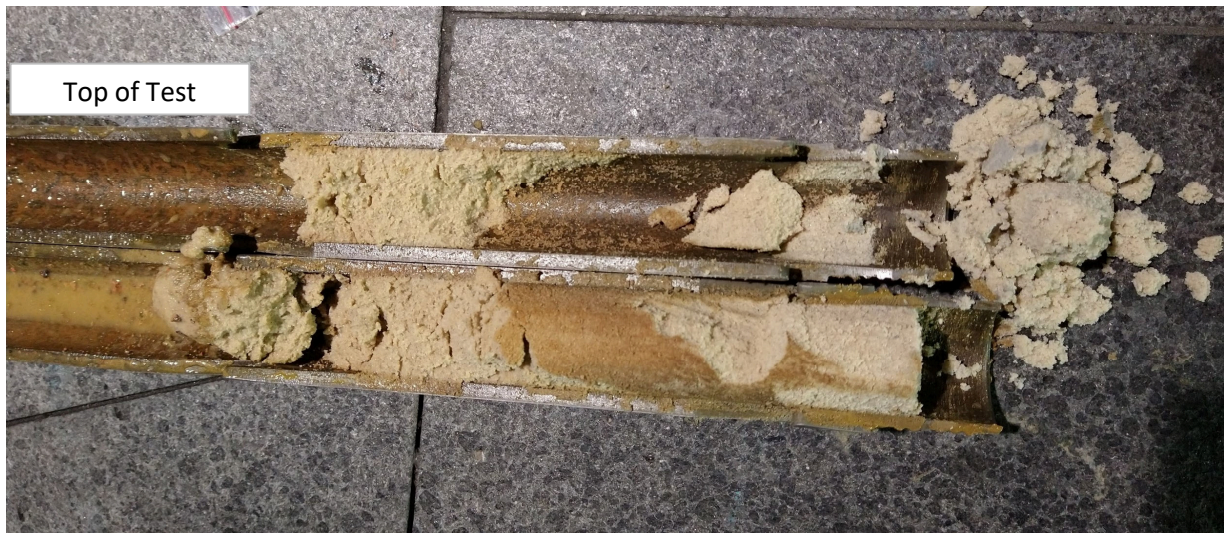
Photo D5 - SPT test from Borehole BH1004A, depth interval 3.1-3.55m. Top of test indicated as shown.

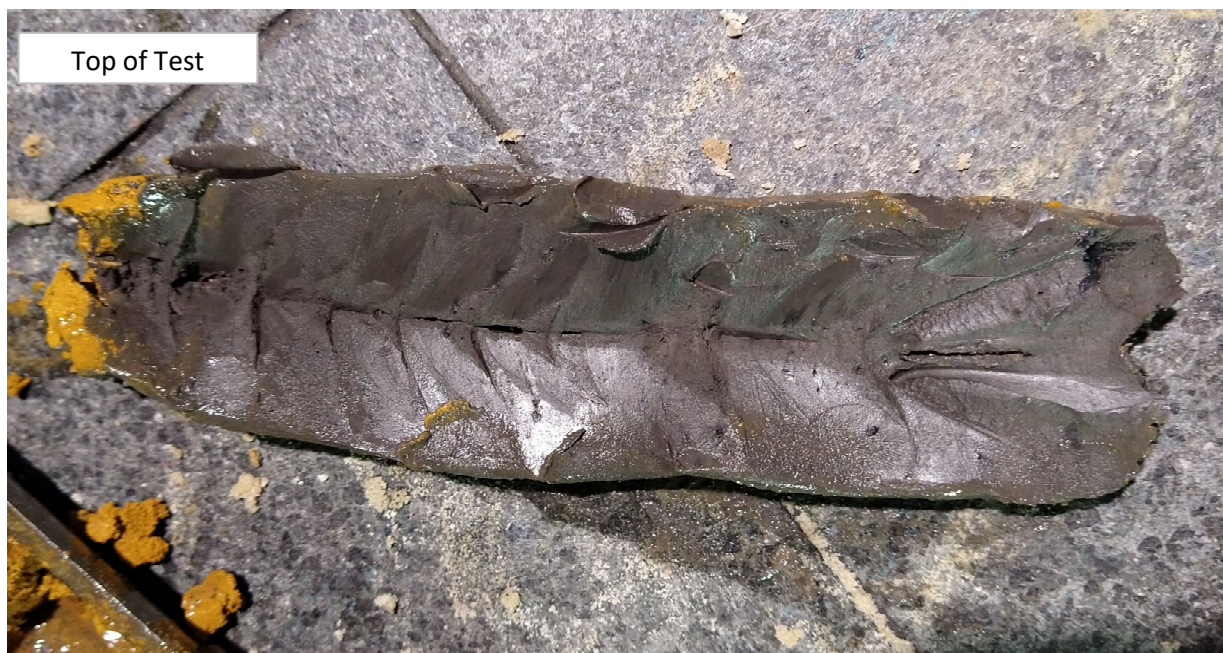
Photo D6 - SPT test from Borehole BH1004A, depth interval 4.5-4.95m. Top of test indicated as shown.

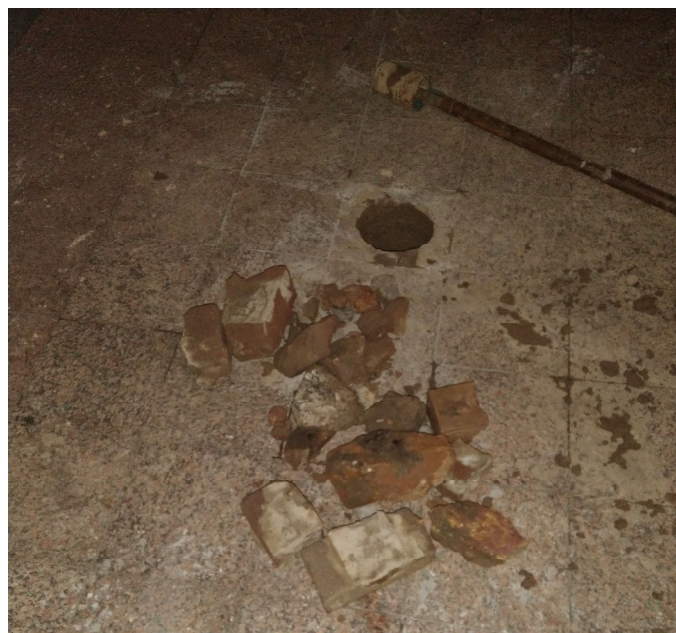
Photo D8 – View of rubble retrieved from Borehole BH1005 during non-destructive digging through the upper part of the borehole.

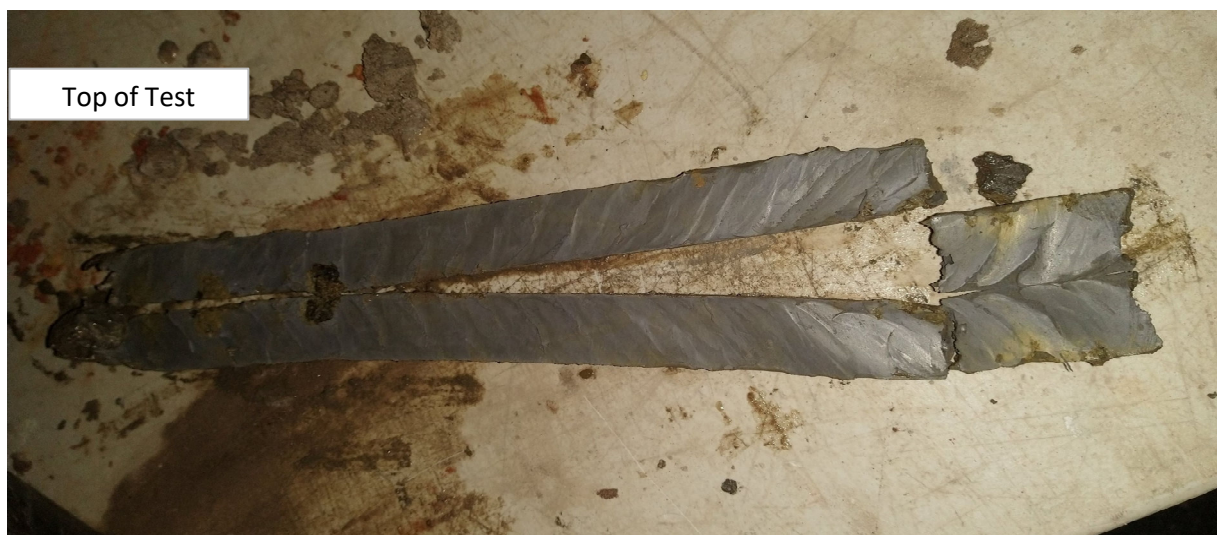
Photo D9 - SPT test from Borehole BH1005, depth interval 5.5-5.95m. Top of test indicated as shown.

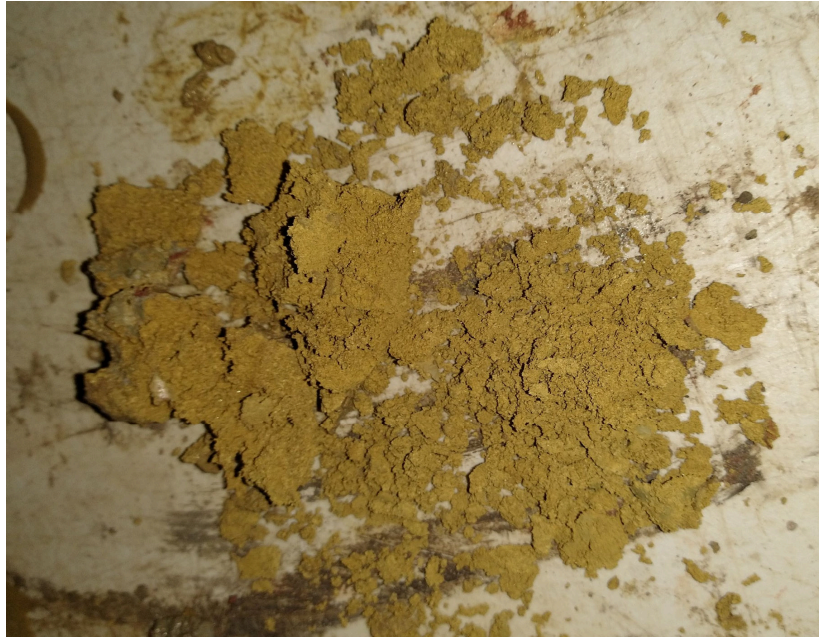
Photo D11 - SPT test from Borehole BH1005, depth interval 8.5-8.6m.

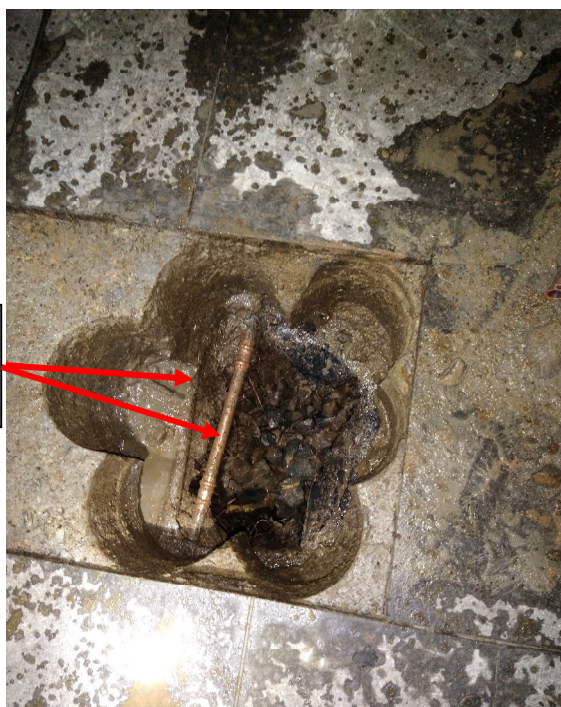
Photo D12 – View of copper water pipes and igneous rail ballast rubble beneath the surface at Borehole BH1006.

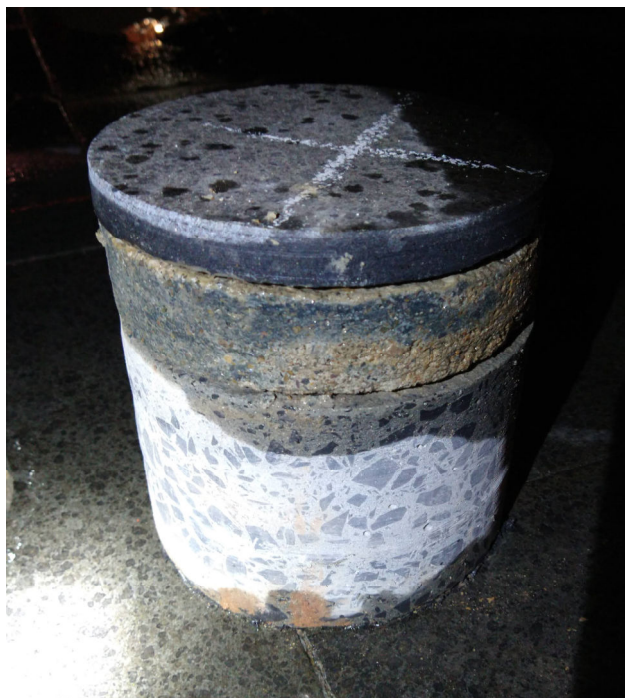
Photo D14 – View of concrete core obtained from Borehole BH1007. Steel reinforcement was observed within the concrete slab at 0.14-0.15m depth.

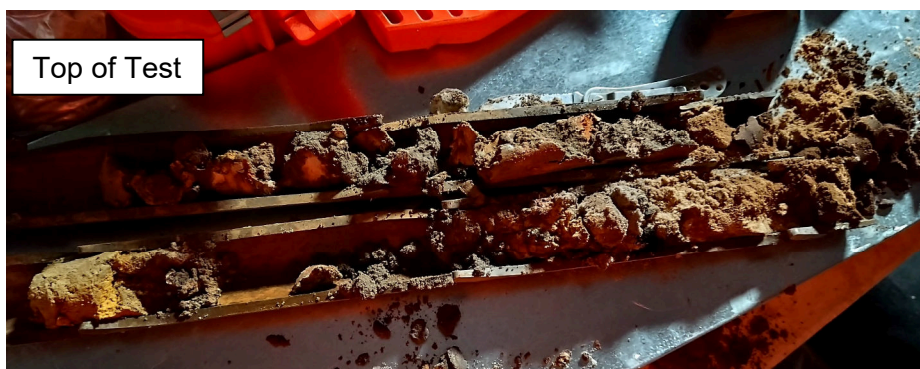
Photo D15 - SPT test from Borehole BH1007, depth interval 2.5-2.95m. The top of test indicated as shown.

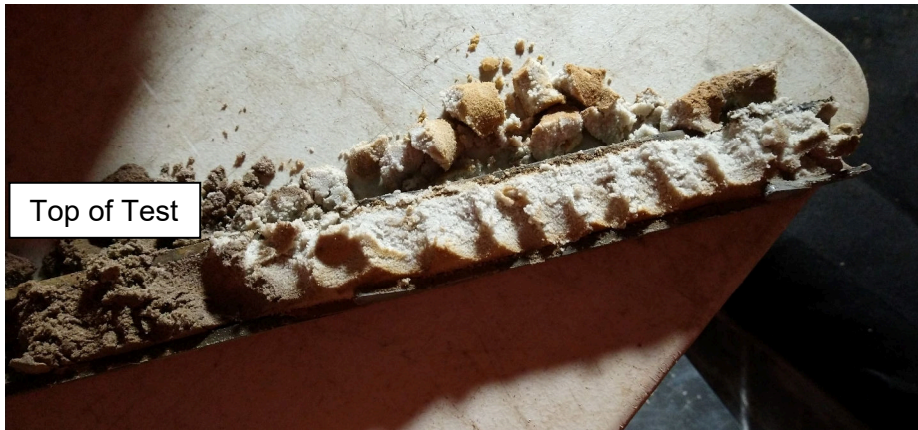
Photo D16 – SPT test from Borehole BH1007, depth interval 4.0-4.45m. The top of test indicated as shown.

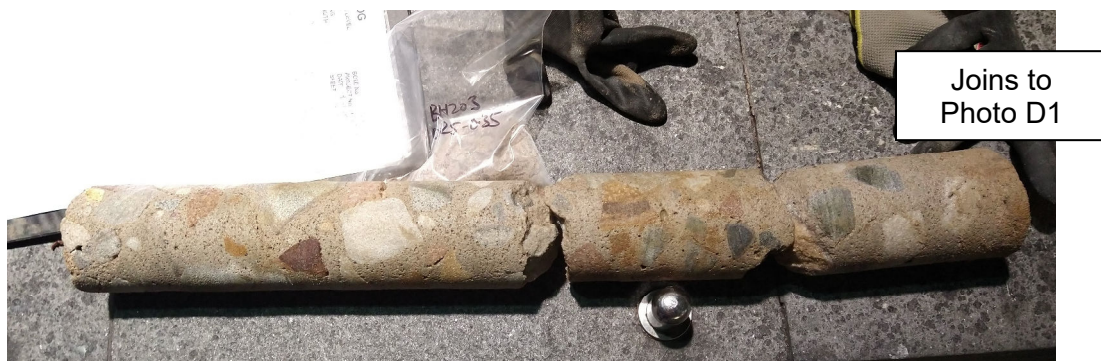
Photo D2 – View of lower part of concrete core from Borehole BH203, with sub-rounded sandstone aggregate.

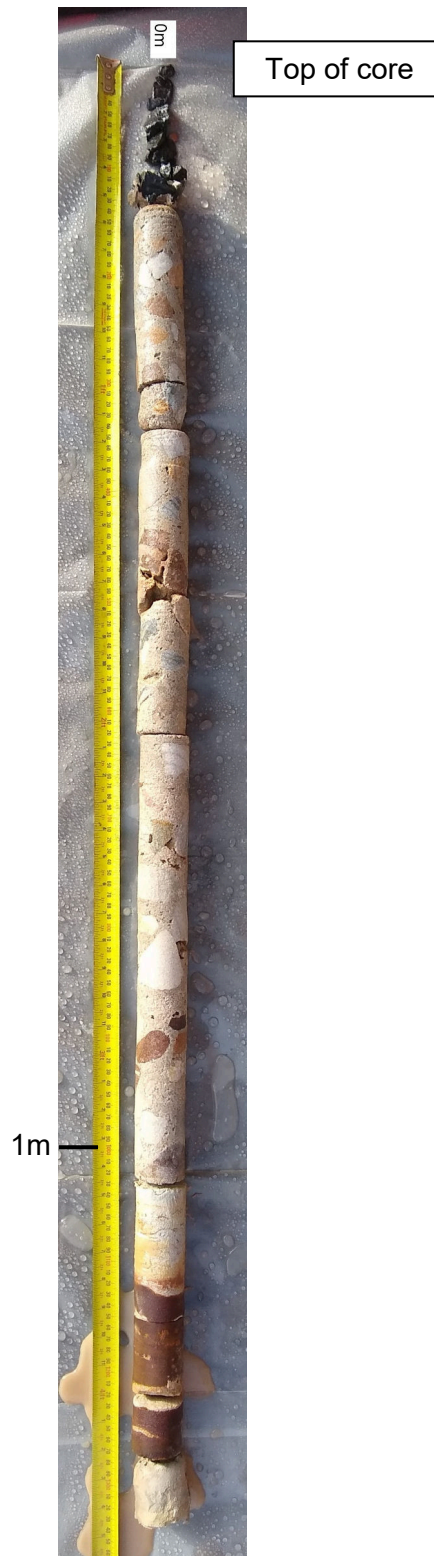
Photo W2 – View of core obtained from Borehole W2.

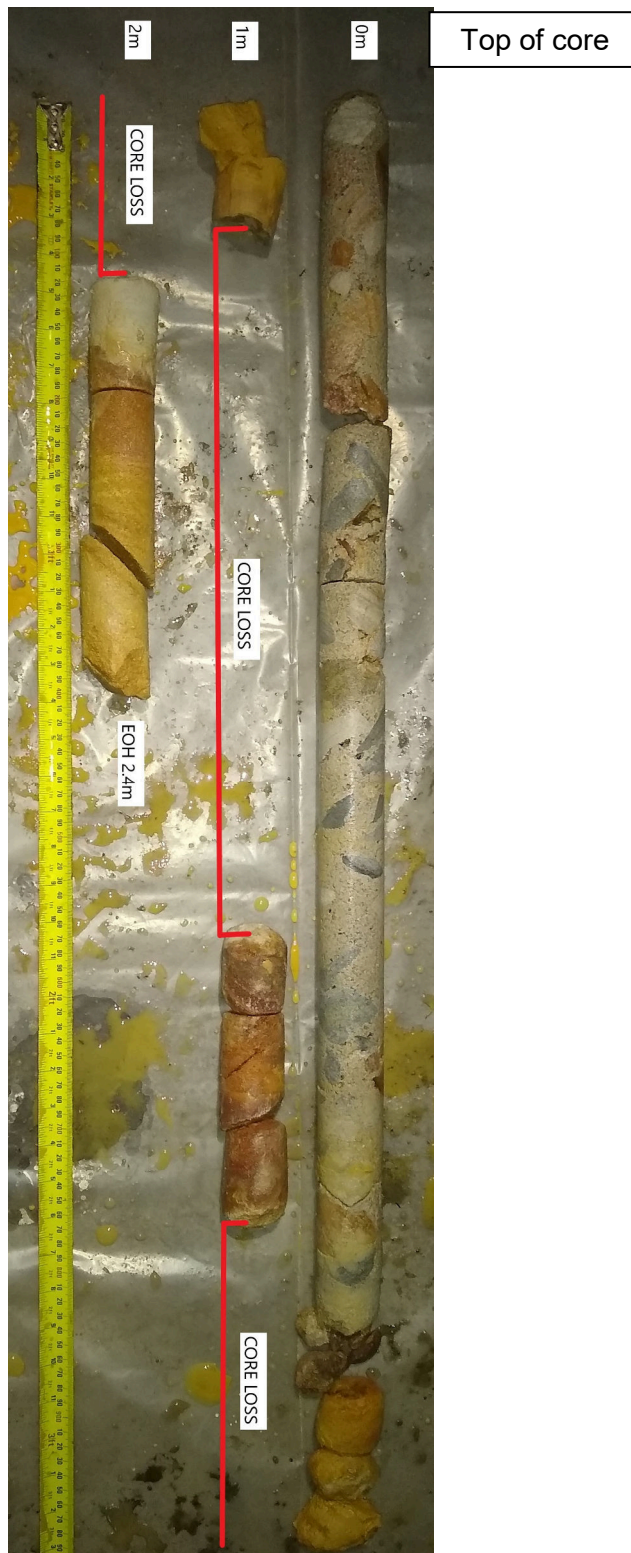
Photo W4 – View of core obtained from Borehole W4.
