Remediation Action Plan

BaptistCare Seniors Housing Project  
1 Martins Lane and 3A Homelands Avenue,  
Carlingford

Prepared for  
TSA Management Pty Ltd

Project 92284.09  
October 2022

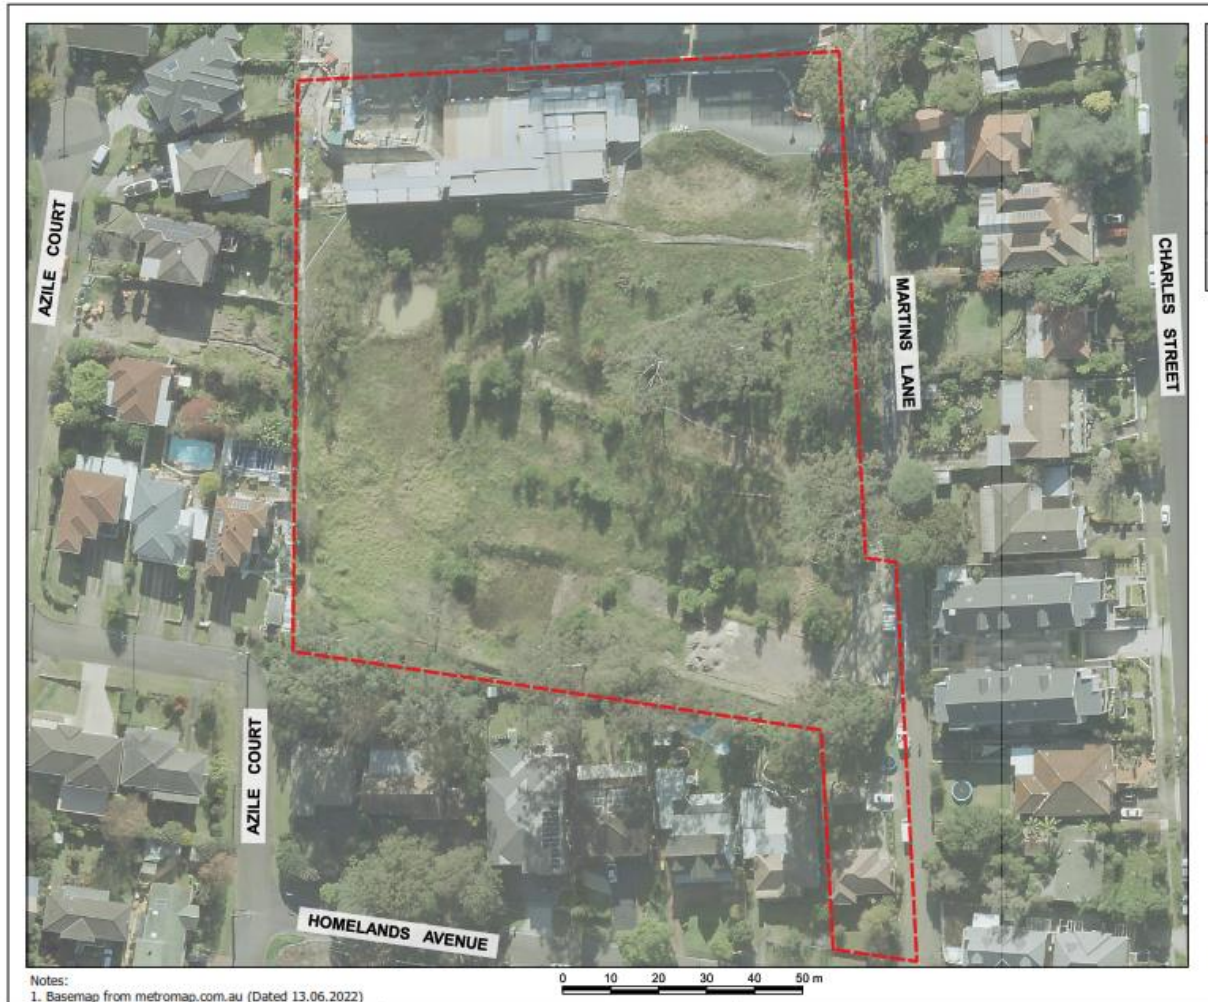
Figure 1: Site Location (boundary shown in red dashed line)

The site boundary is shown in Figure 1 below and on Drawing 1 in Appendix A.

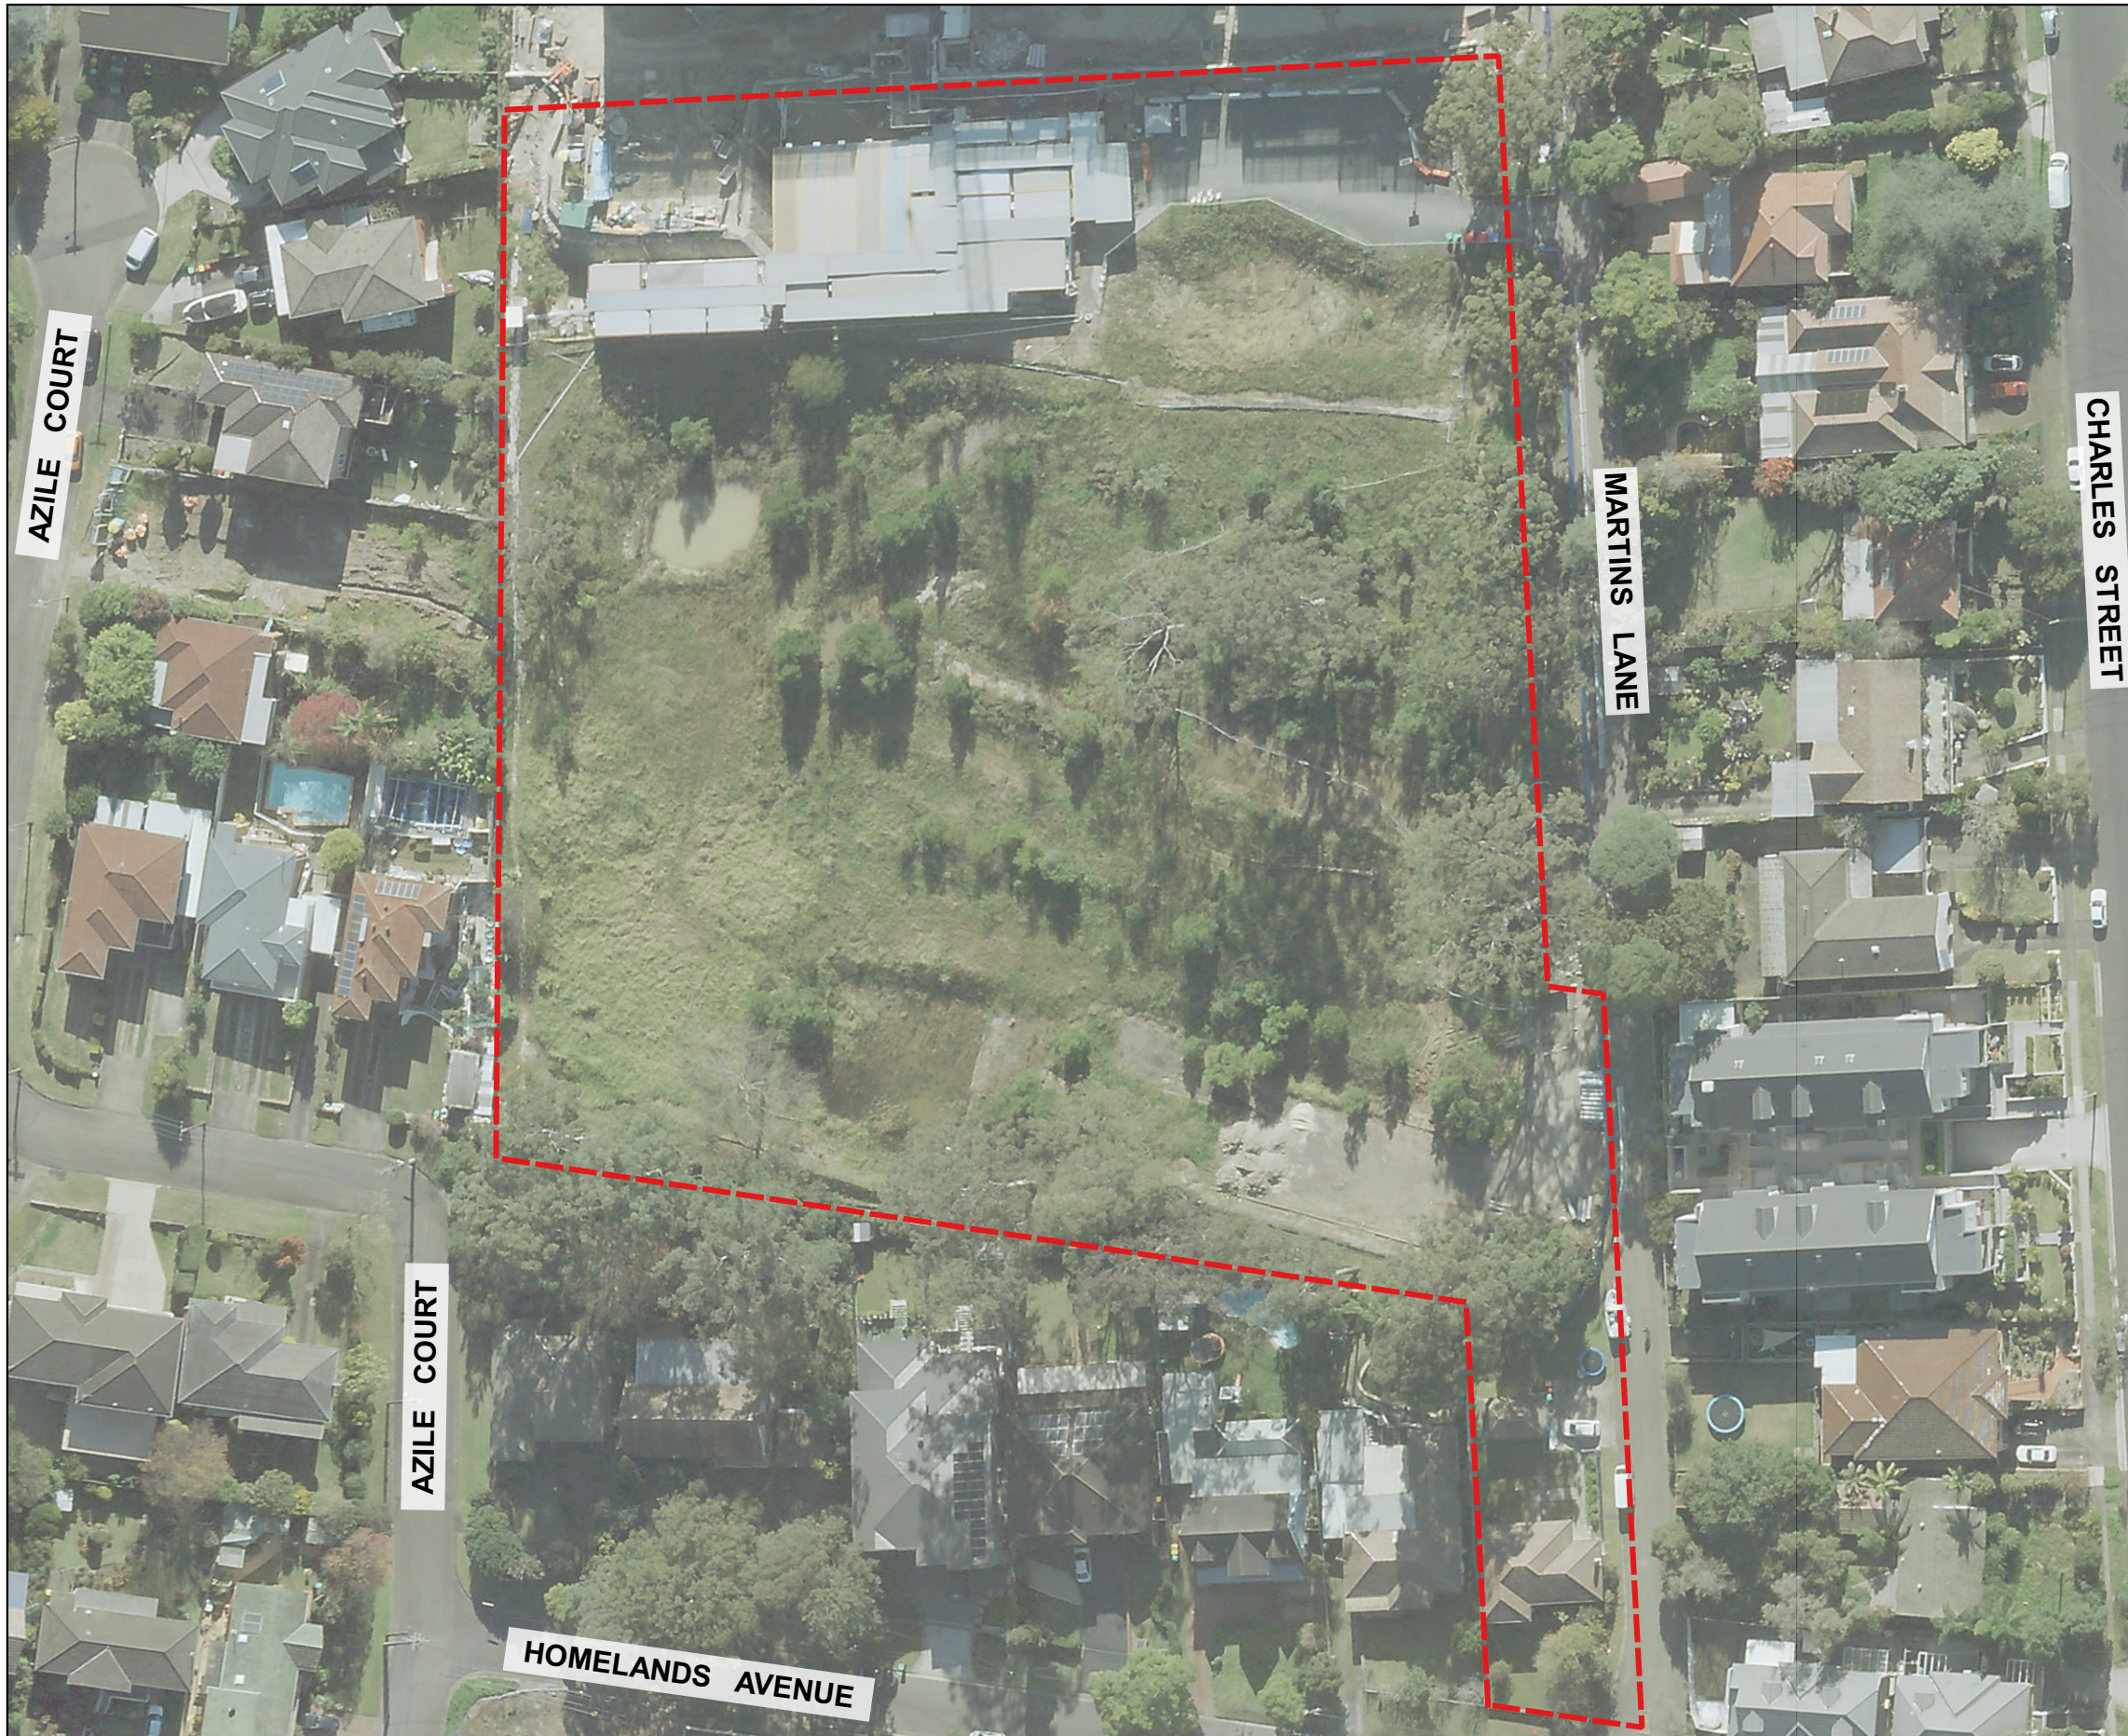
PROJECT No: 92284.09  
DRAWING No: 1  
REVISION: 0

Locality Plan

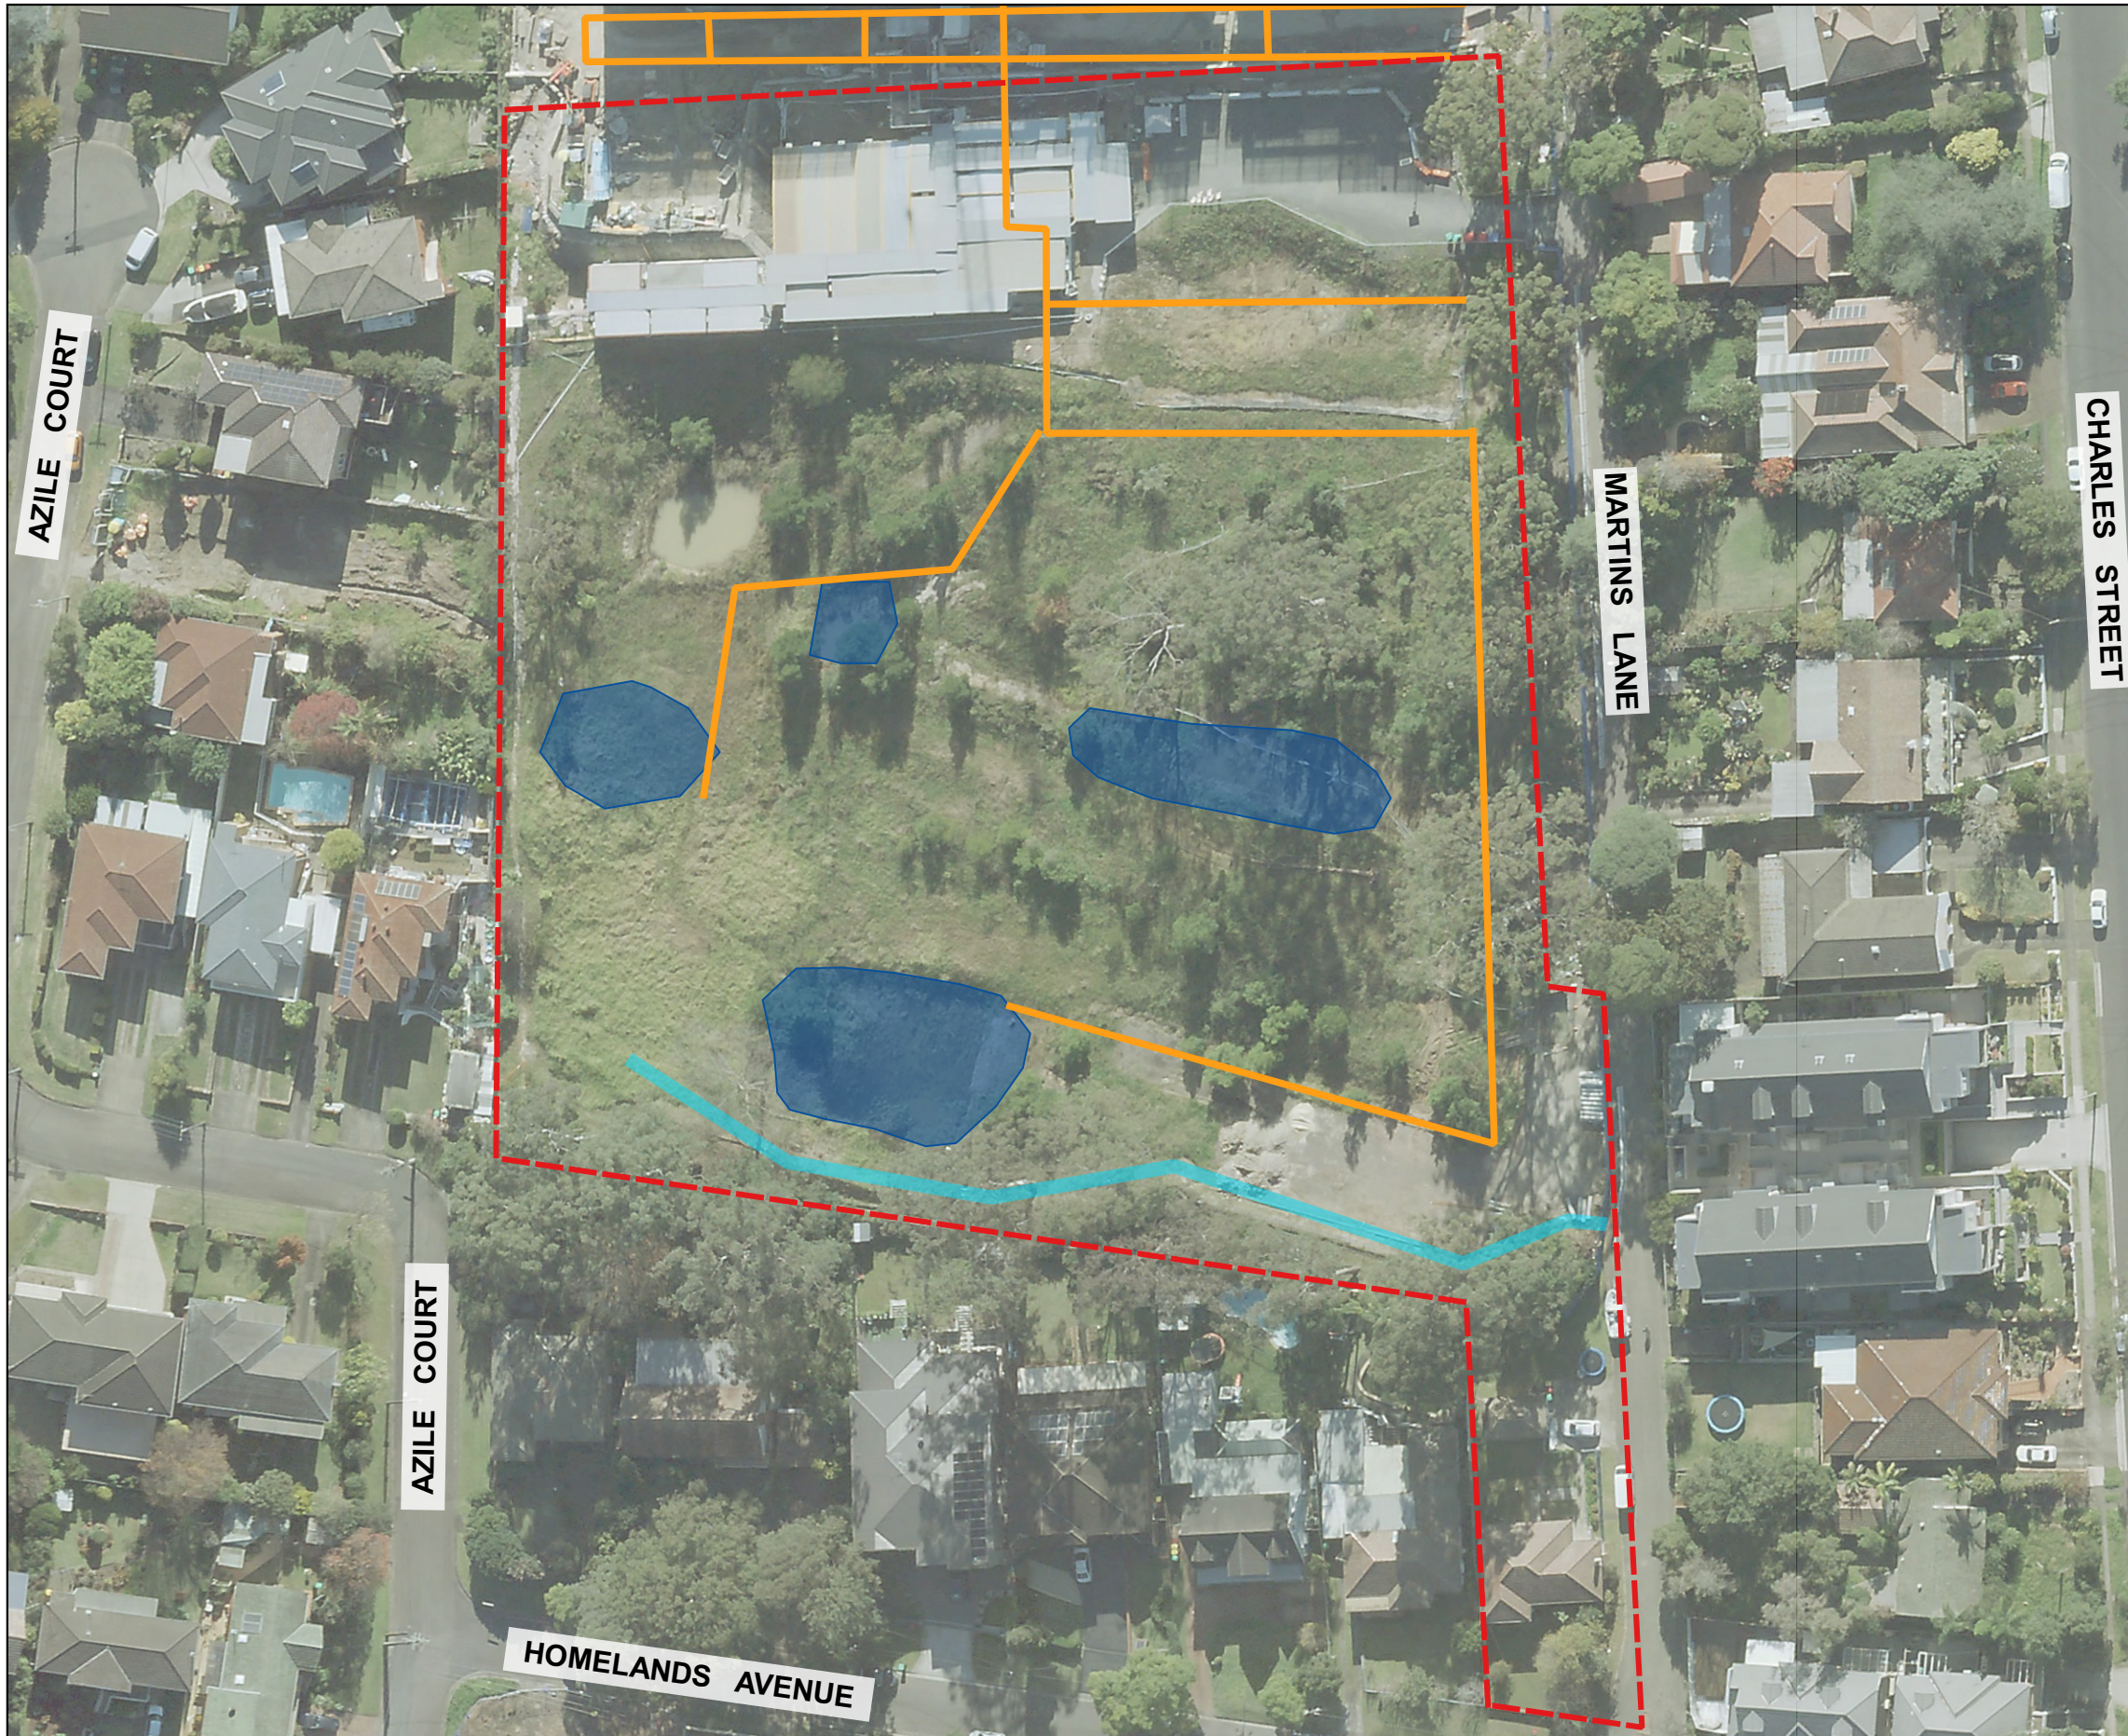
PROJECT No: 92284.09  
DRAWING No: 2  
REVISION: 0

**Locality Plan**

*It was a requirement of the SCI that disposal dockets for the disposed hazardous waste excavated from BH6 (Drawing 2) was [were] provided to DP for the purposes of validation. A review of Transport Certificate (No. 2T00978765) provided in Appendix F, reported that 22.98 of Hazardous waste was disposed to Environmental Treatment Solutions Pty Ltd, 79 Marshals Lane, Blayney on 16 April 2019. DP considers that the volume disposed is consistent with the volume excavated from BH6.*
