# GEOTECHNICAL REPORT

**Woolworths Wyong Regional Distribution Centre**  
**11 Warren Road,**  
**Warnervale NSW 2259**

**Woolworths Group – 22 March 2022**

### GEOTECHNICAL REPORT

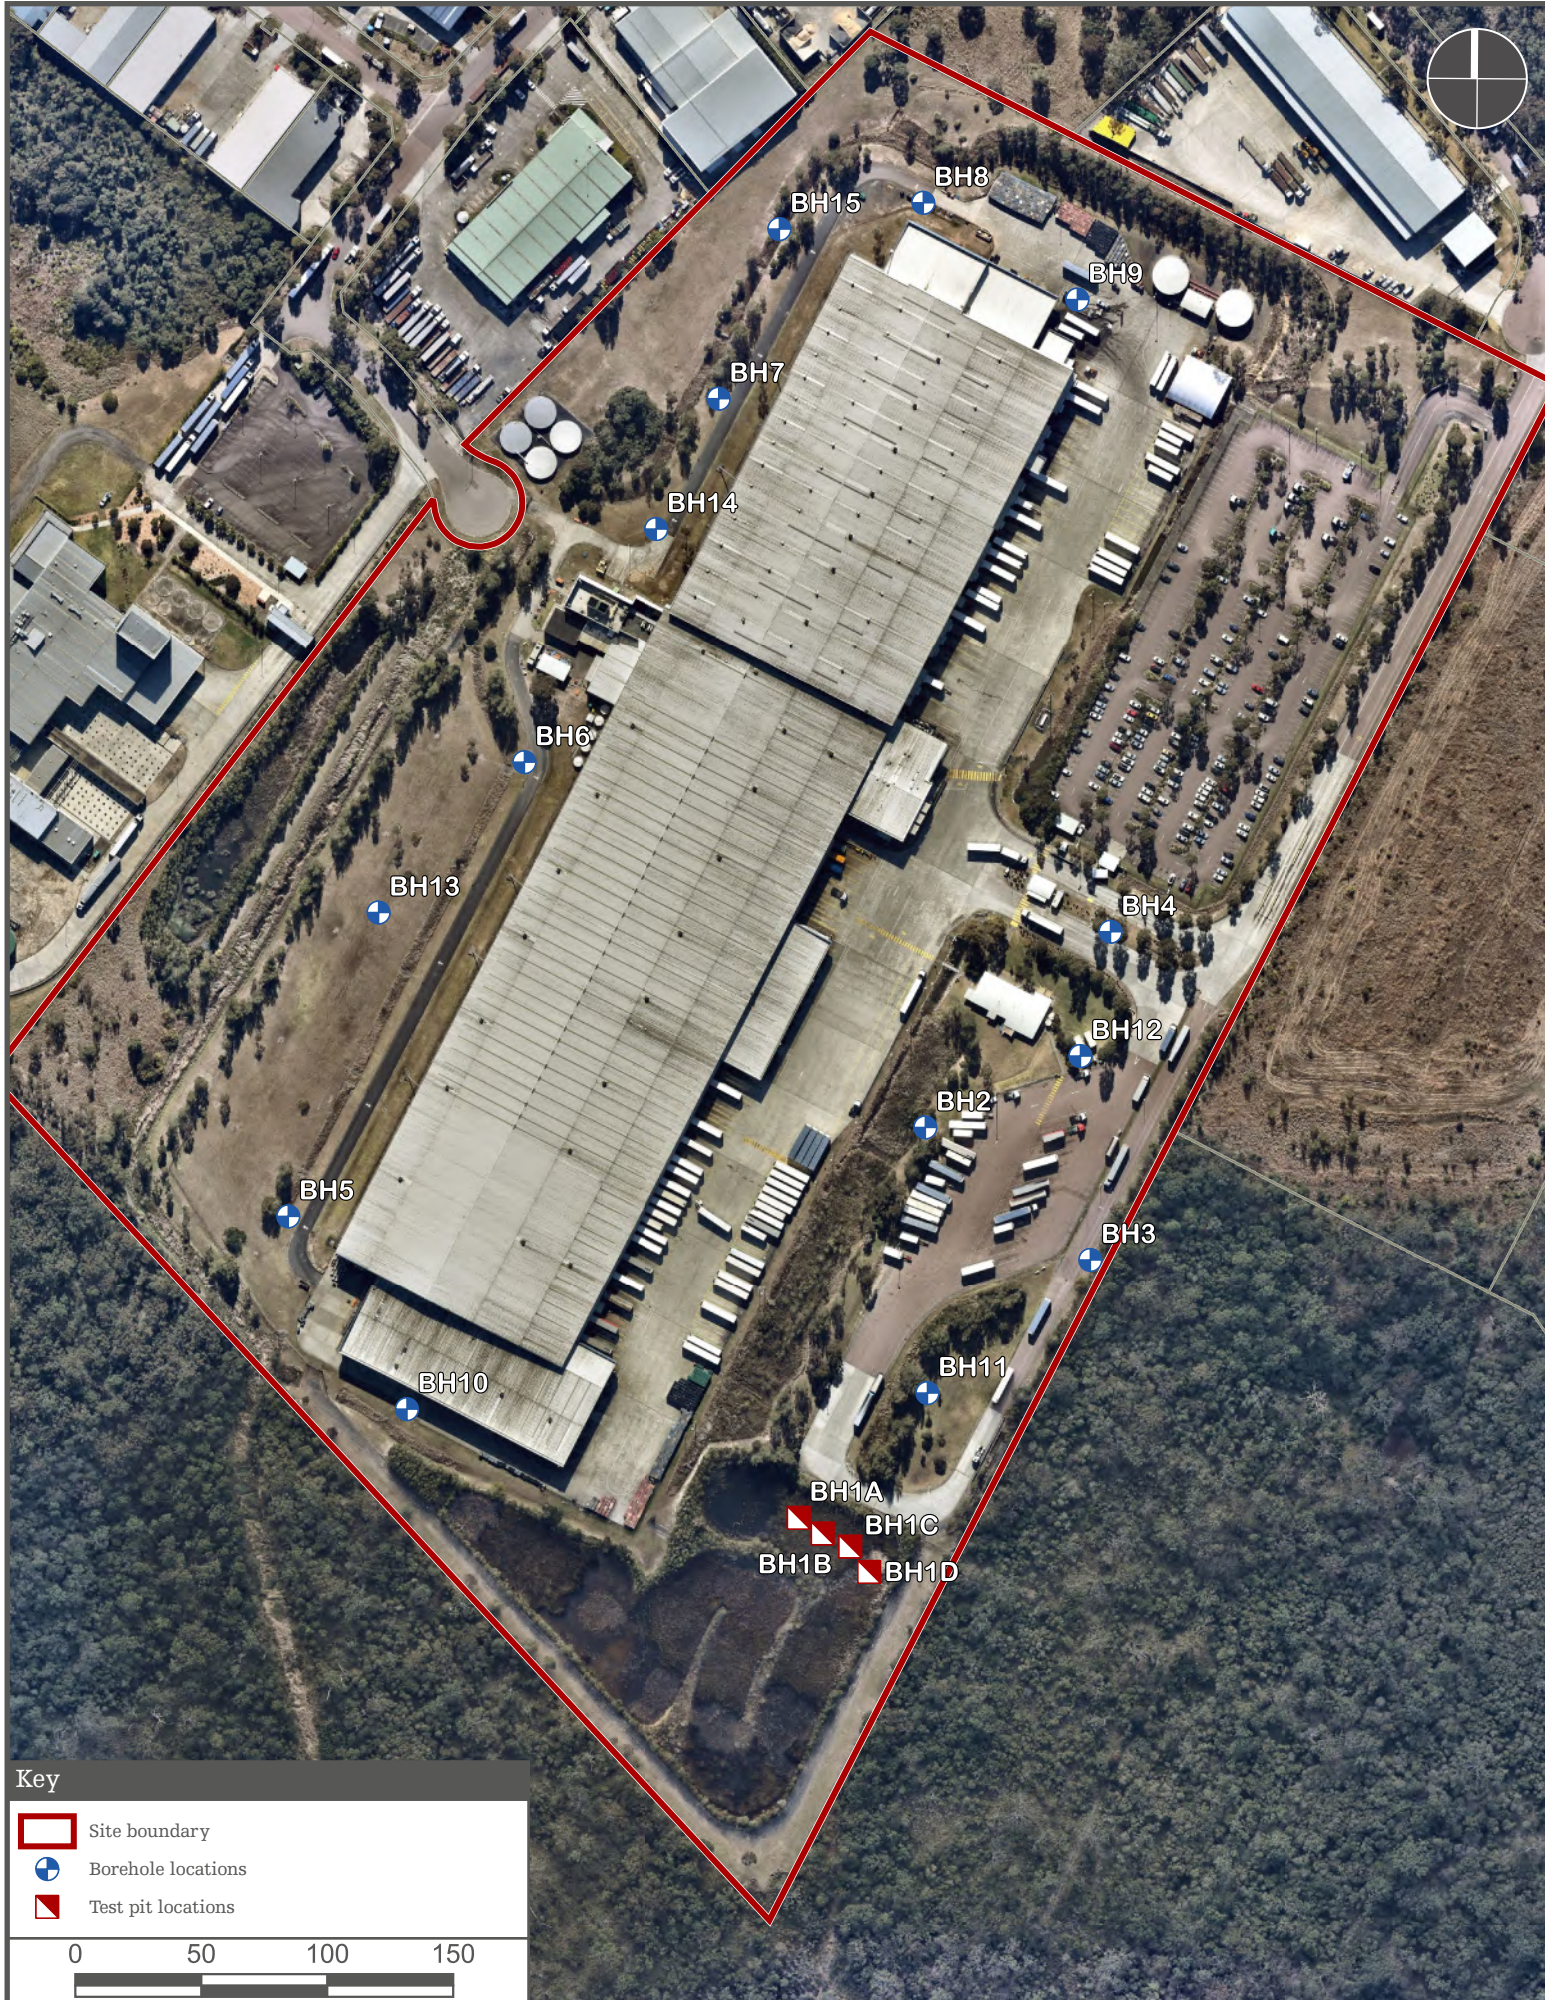
Key

- Site boundary
- Borehole locations
- Test pit locations

- Review of soils and geological maps for the area;
- Visual appraisal of the site conditions and locality;
- Completion of 14 soil bores (BH2–BH15) spread across the site to target proposed development locations to a maximum depth of 6 meters below grade (mbg) (Figure 2);

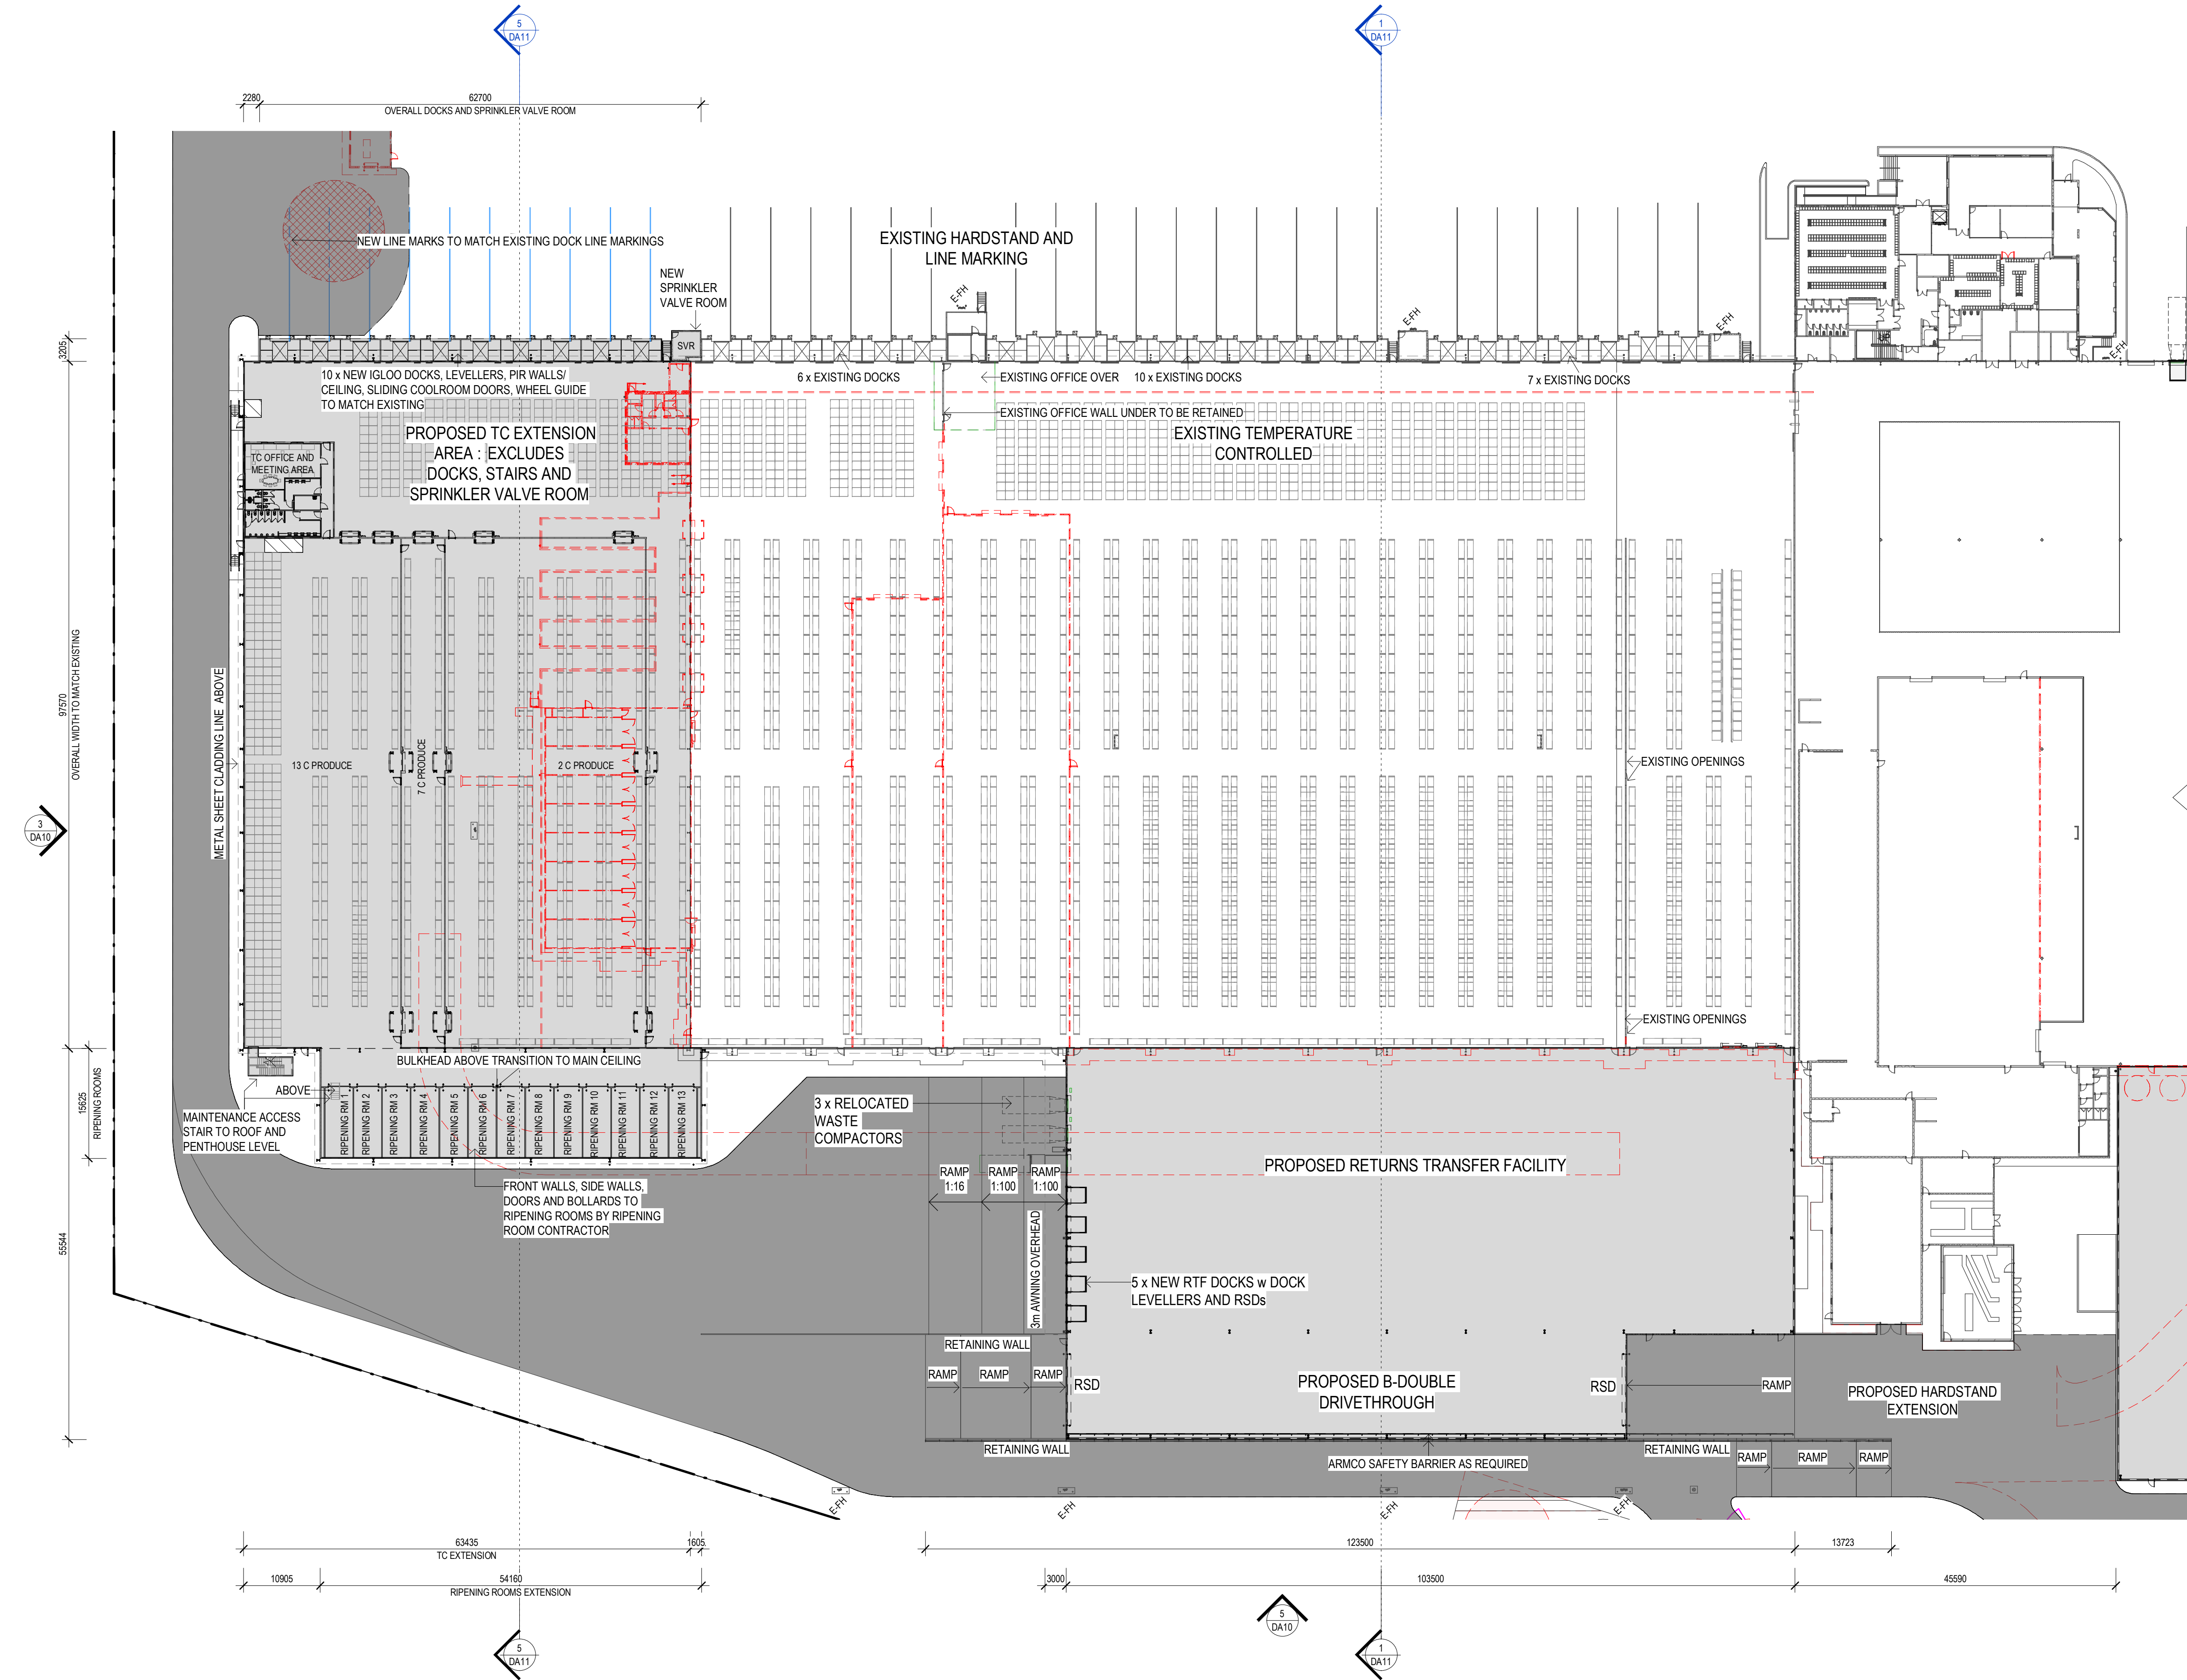
PROPOSED FLOOR PLAN - PART 1  
SCALE: 1 : 500

PROJECT:  
PROPOSED EXTENSION TO WYONG RDC  
11 WARREN ROAD, WARNERVALE

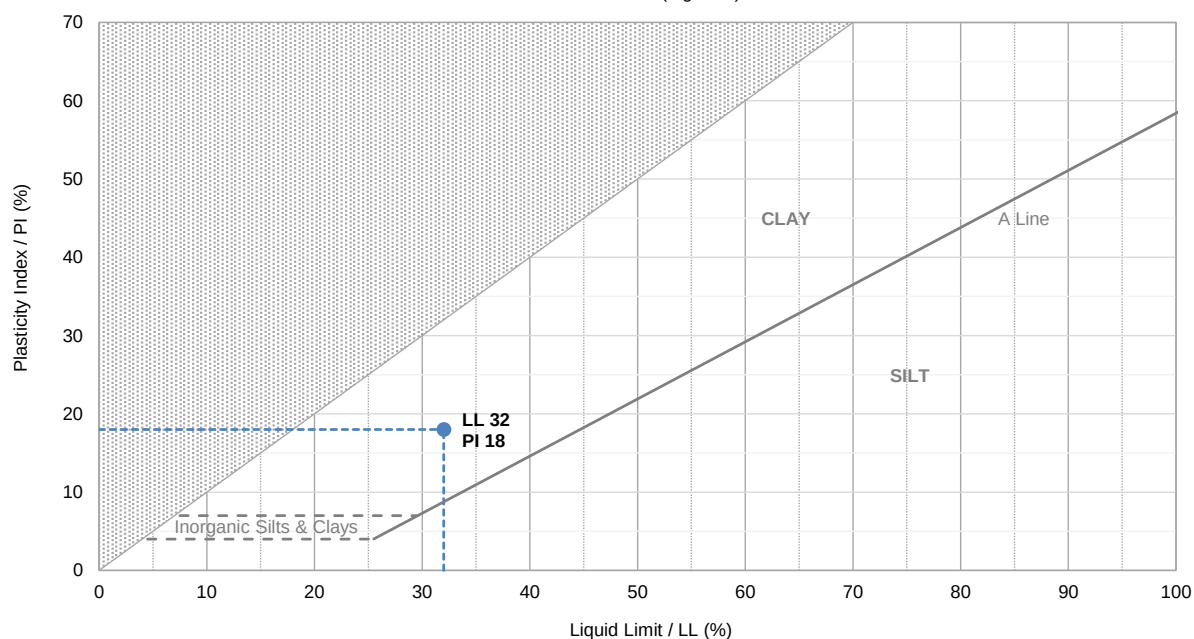
## Plasticity Chart for Classification of Fine-Grained Soils

AS 1726:2017 Clause 6.1.6 (Figure 5)

The Atterberg Limits and Linear Shrinkage test results indicate whether the fine grained component of the samples may be classified as Silt or Clay as well as the reactivity of the material. The potential for surface movement based on the reactivity of the soil to changes in moisture is discussed in Section 5.7.

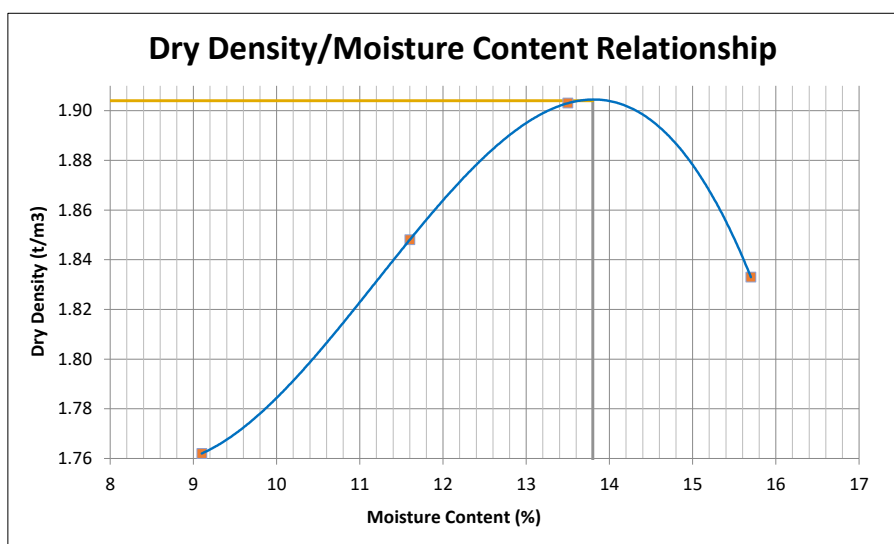
# DRY DENSITY / OPTIMUM MOISTURE CONTENT REPORT

| <b>Maximum Dry Density (t/m³)</b> | 1.904 |
| <b>Optimum Moisture Content (%)</b> | 13.8 |

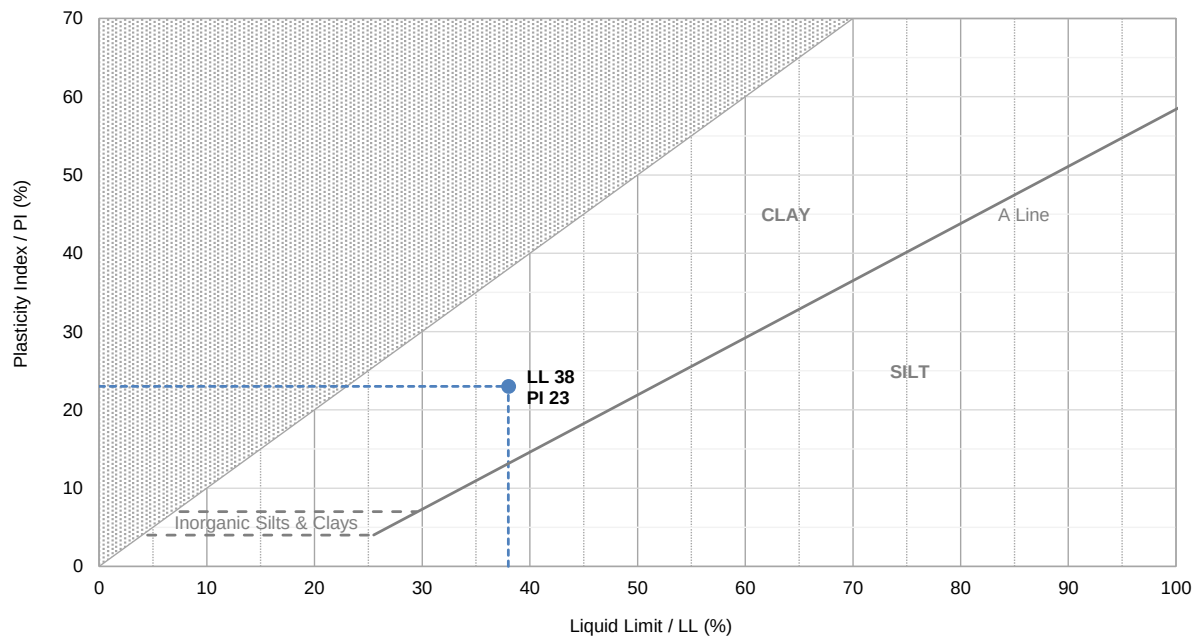
## Plasticity Chart for Classification of Fine-Grained Soils

AS 1726:2017 Clause 6.1.6 (Figure 5)

| Method of Preparation | <b>Dry Sieved</b> | Liquid Limit / LL (%) | <b>38</b> |

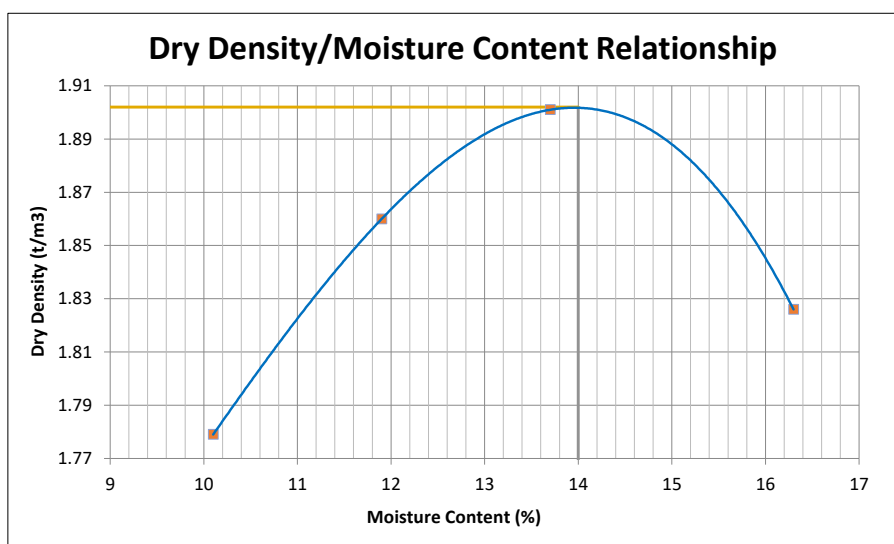
| <b>Maximum Dry Density (t/m³)</b> | 1.902 |
| <b>Optimum Moisture Content (%)</b> | 14.0 |

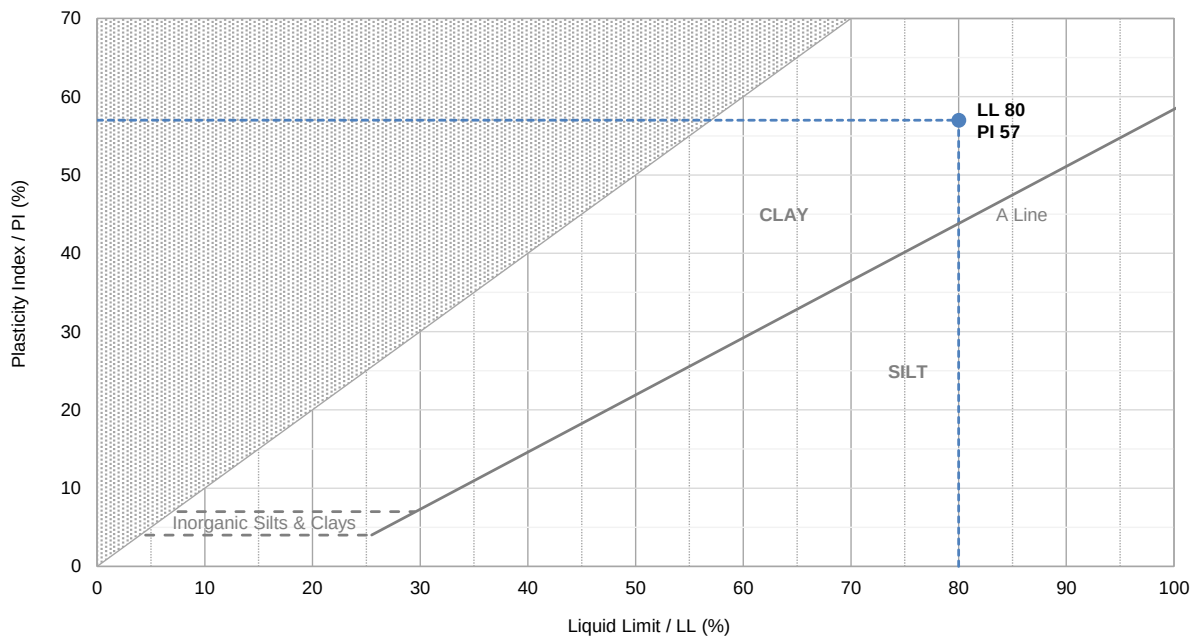
## Plasticity Chart for Classification of Fine-Grained Soils

AS 1726:2017 Clause 6.1.6 (Figure 5)

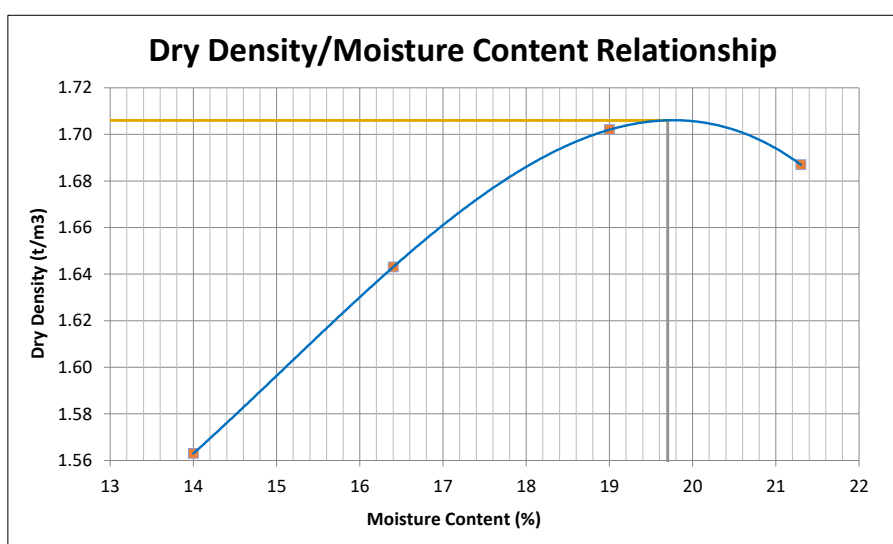
| <b>Maximum Dry Density (t/m³)</b> | 1.706 |
| <b>Optimum Moisture Content (%)</b> | 19.7 |

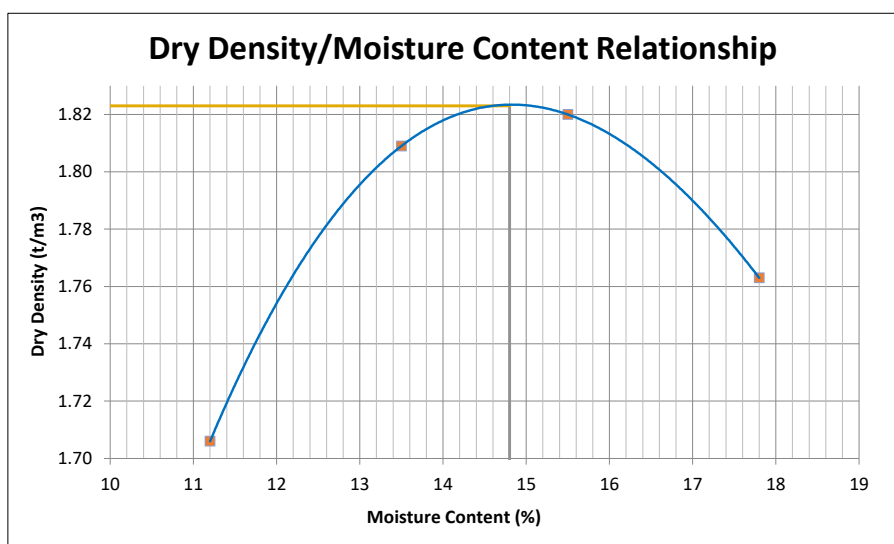
| <b>Maximum Dry Density (t/m³)</b> | 1.823 |
| <b>Optimum Moisture Content (%)</b> | 14.8 |

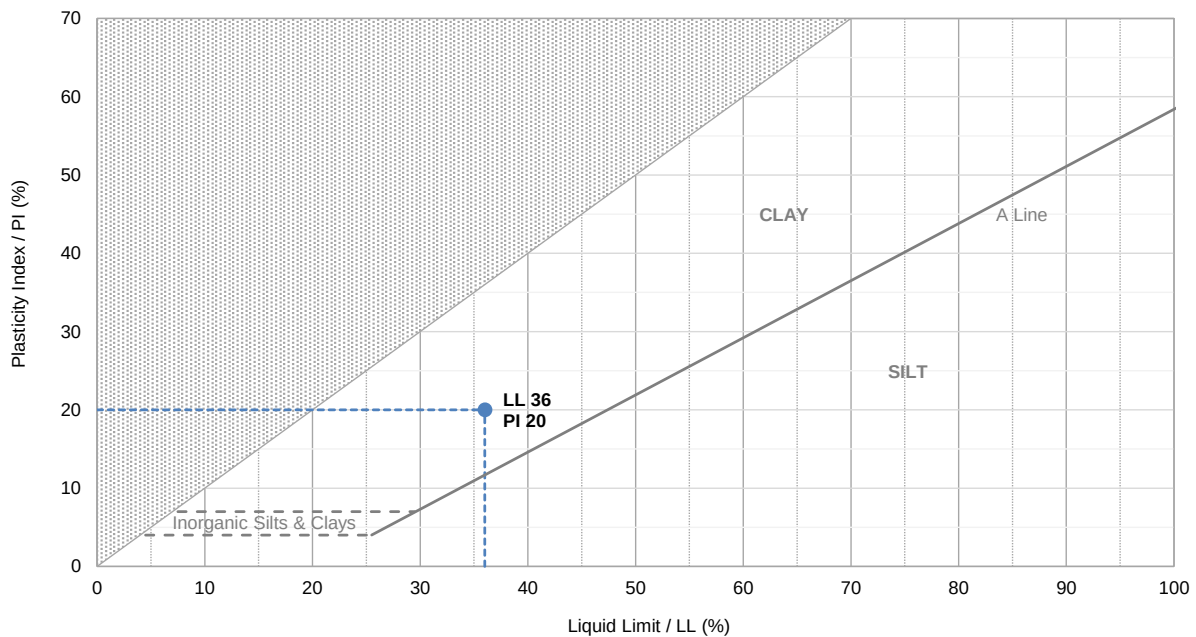
## Plasticity Chart for Classification of Fine-Grained Soils

AS 1726:2017 Clause 6.1.6 (Figure 5)

| Method of Preparation | <b>Dry Sieved</b> | Liquid Limit / LL (%) | <b>36</b> |

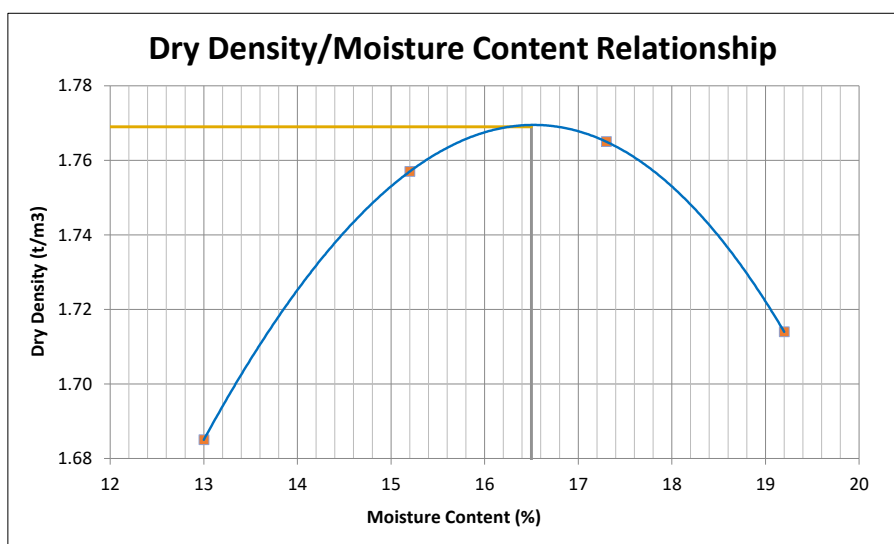
| <b>Maximum Dry Density (t/m³)</b> | 1.769 |
| <b>Optimum Moisture Content (%)</b> | 16.5 |

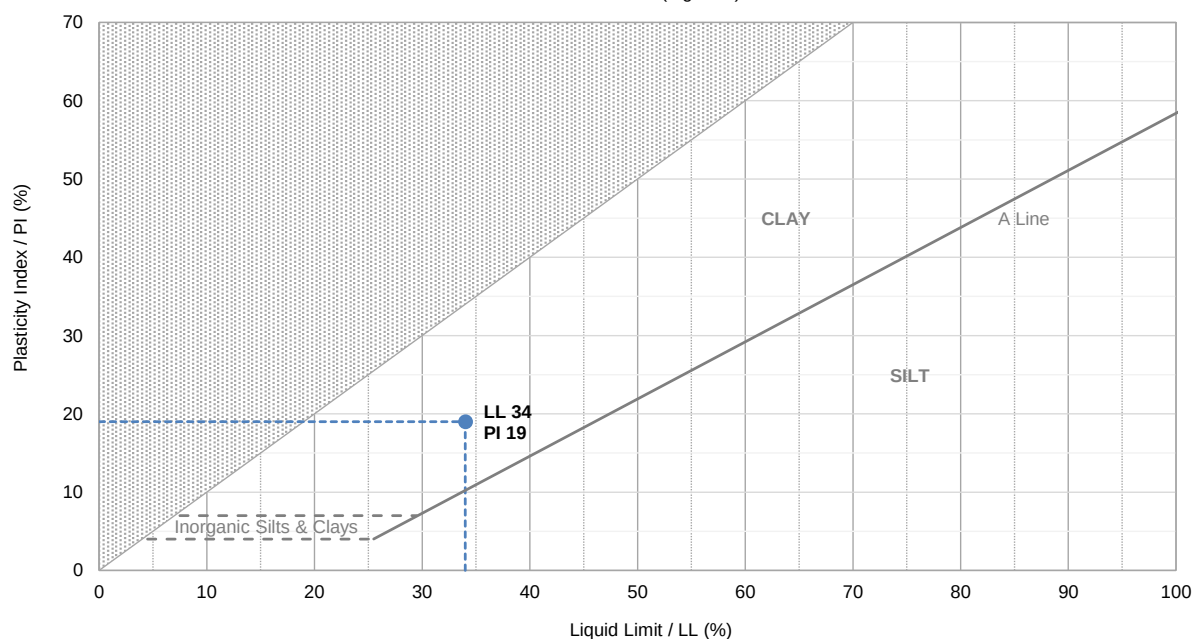
## Plasticity Chart for Classification of Fine-Grained Soils

AS 1726:2017 Clause 6.1.6 (Figure 5)

| Method of Preparation | <b>Dry Sieved</b> | Liquid Limit / LL (%) | <b>34</b> |

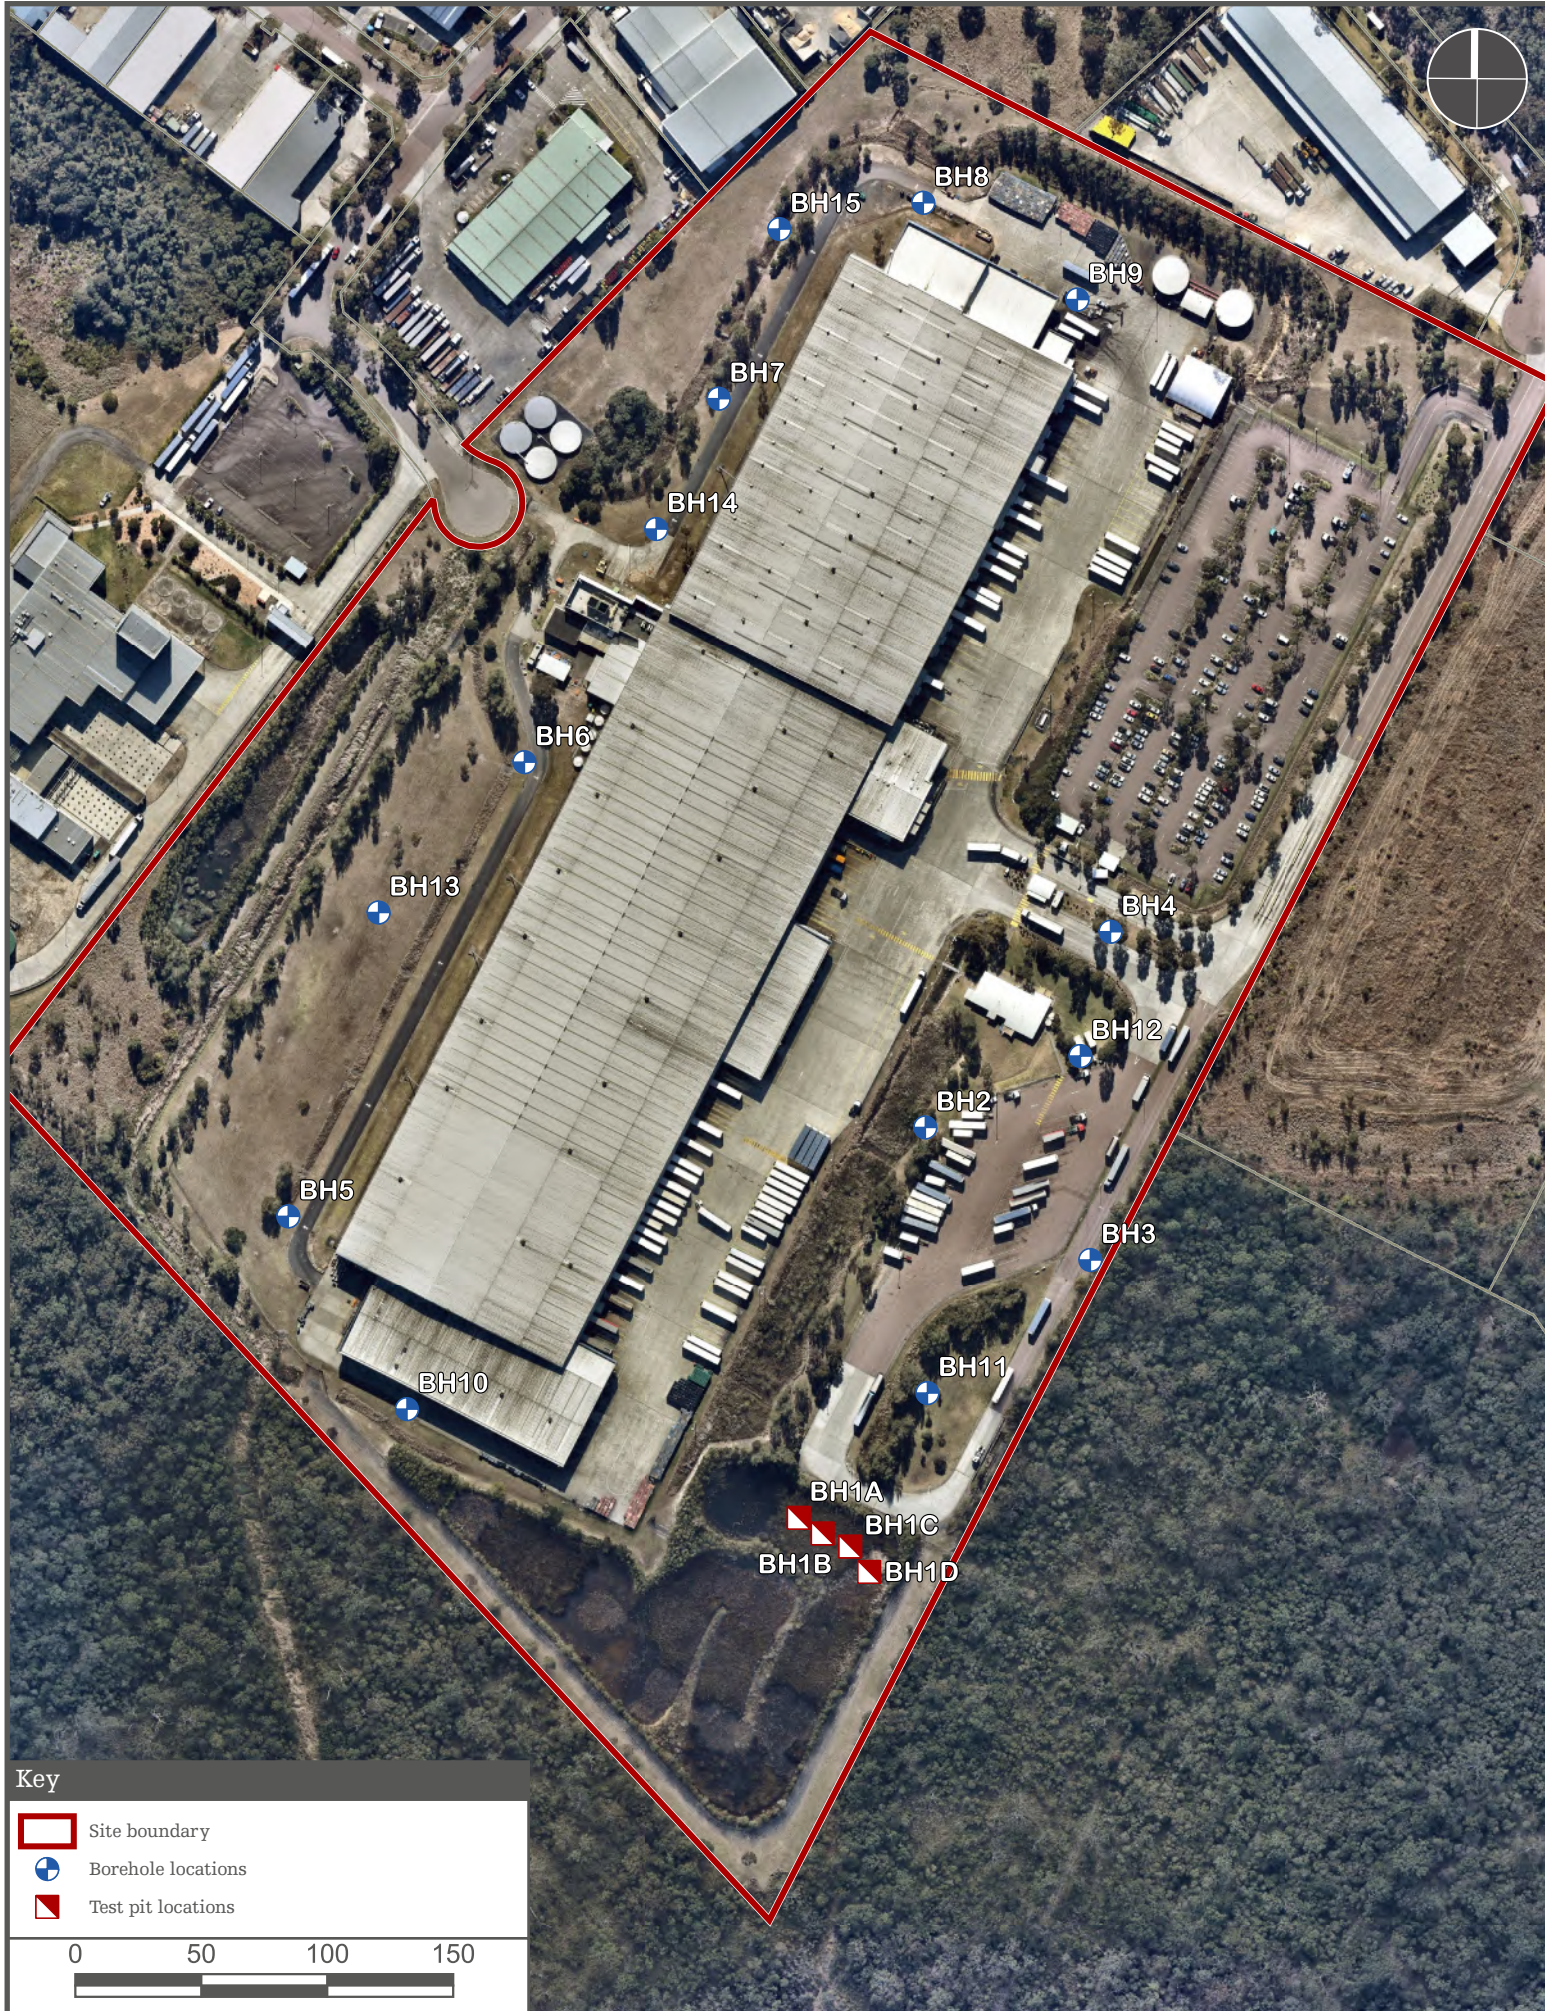
Geotechnical Bore Locations

- Site boundary
- Borehole locations
- Test pit locations
