Report on  
Detailed Site Investigation (Contamination)

Uniting Charlestown Development  
27 Tiral Street, Charlestown

Project 102007.01  
May 2020

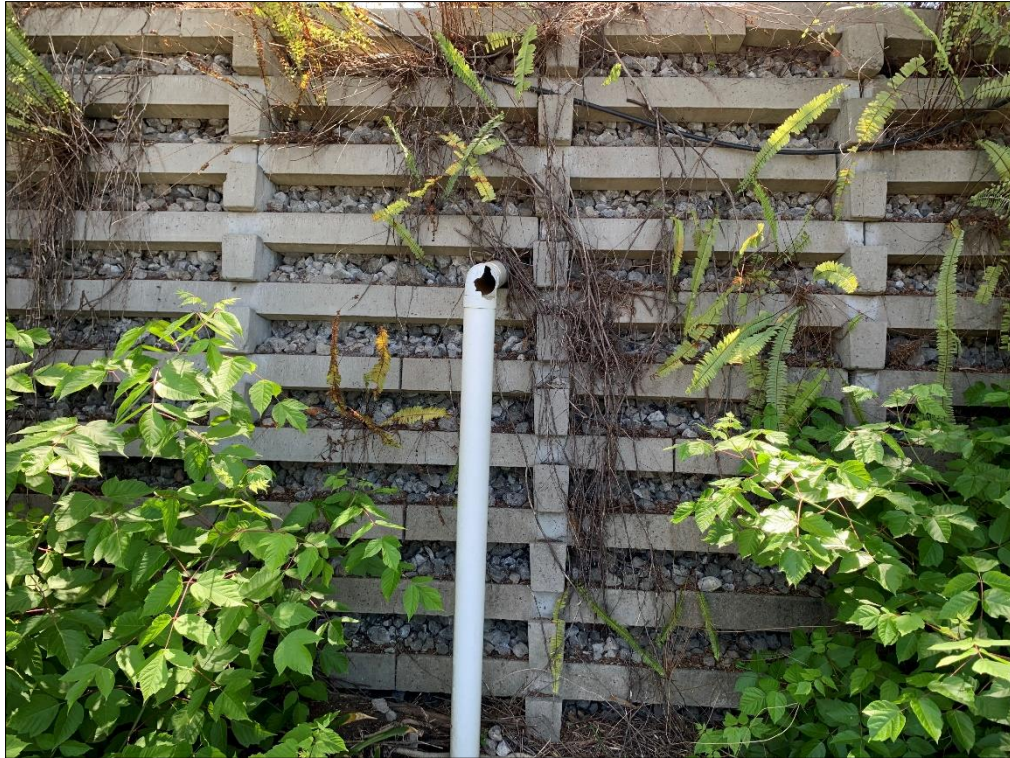
**Photo 1: Western crib-lock retaining wall comprising blast furnace slag, looking west.**

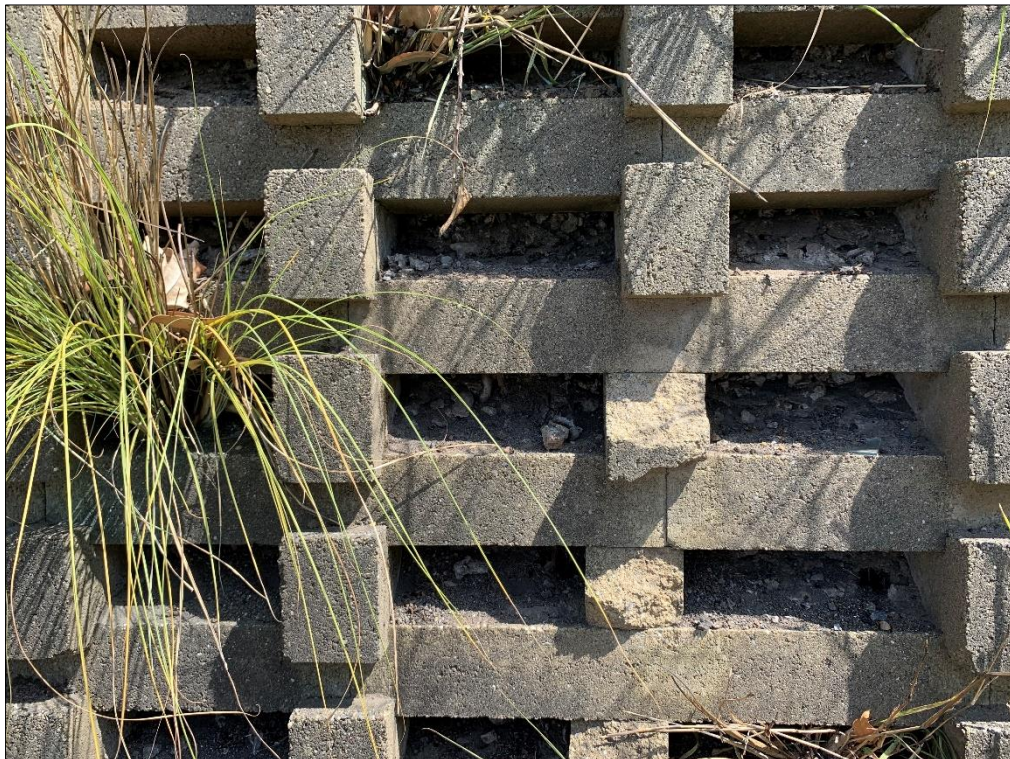
**Photo 2: Southern crib-lock retaining wall comprising soil and ash, looking south.**

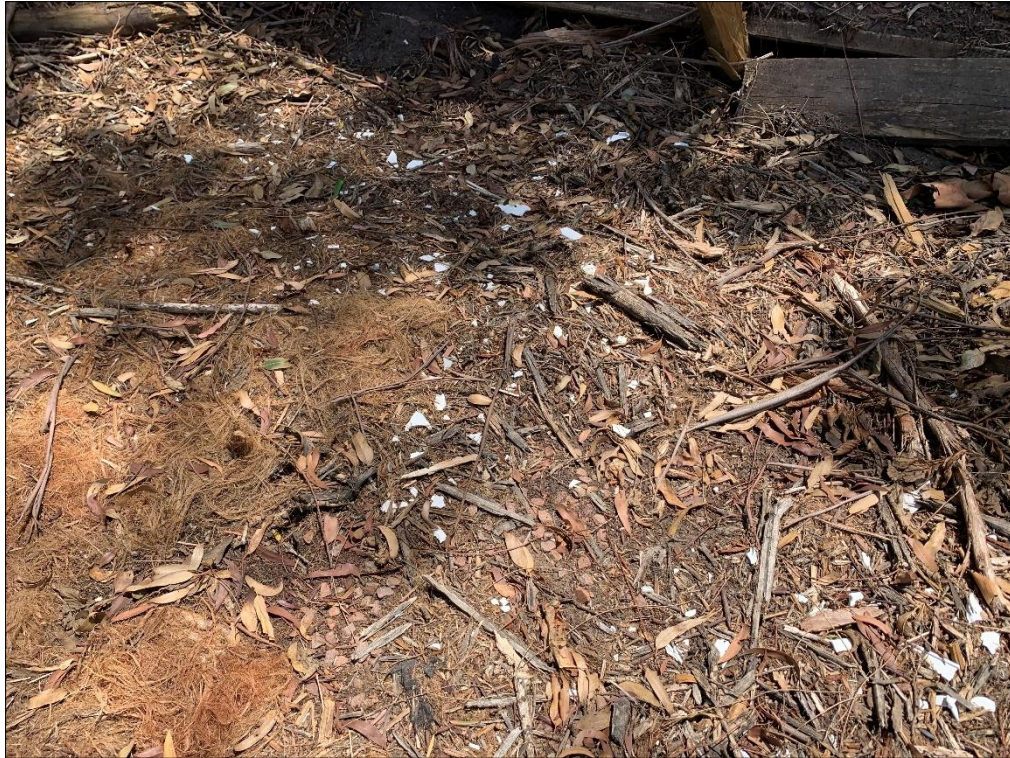
**Photo 5: Fibro fragments at the base of the retaining wall adjacent to the former bowling green.**

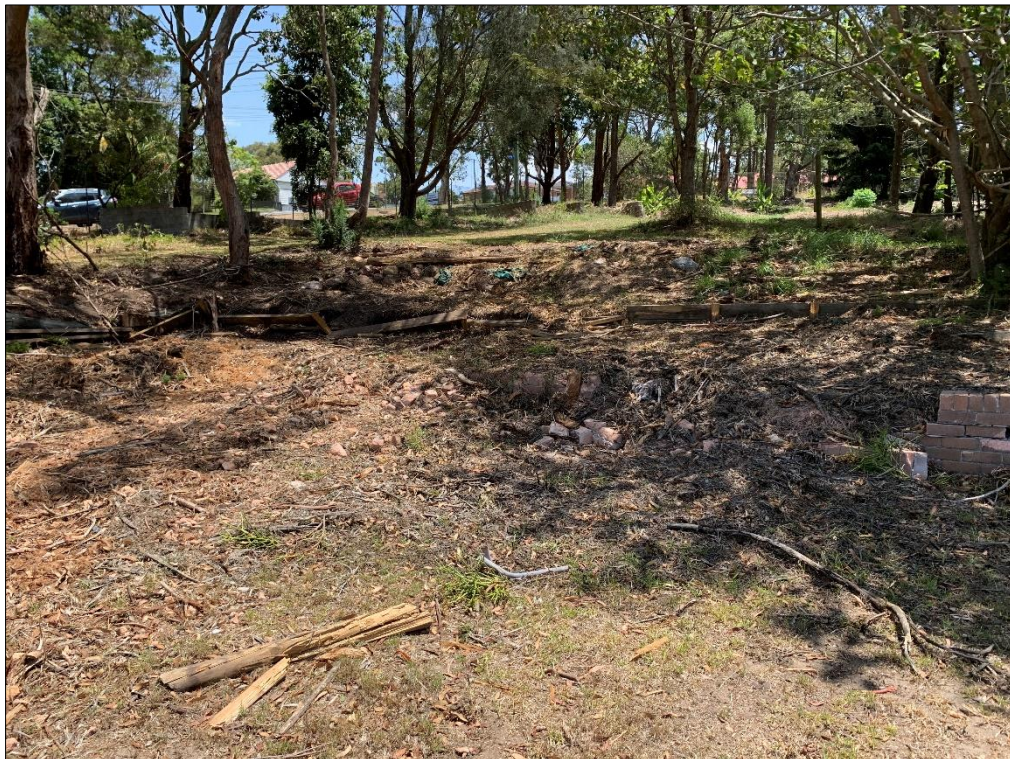
**Photo 6: Bricks, timber and metal (demolition waste) scattered adjacent to retaining wall and former bowling green, looking south west.**

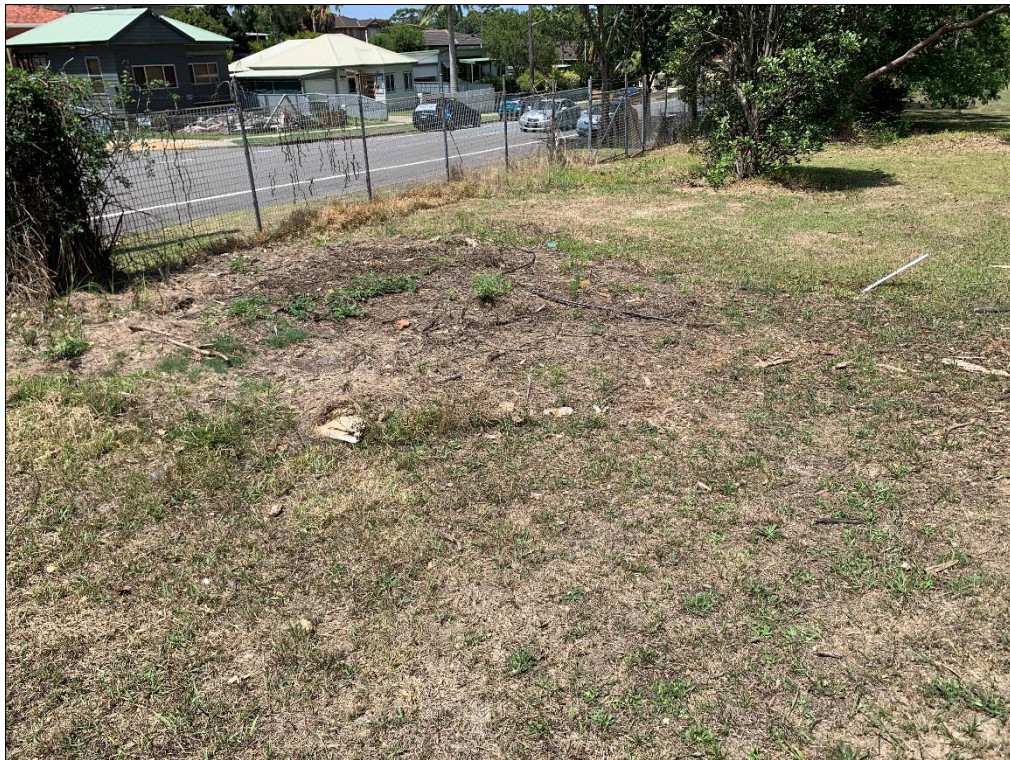
Photo 8: A disturbed area north of the former bunker, comprising silty sand fill intermixed with timber, vegetation waste, bricks, agricultural pipe, and PVC pipe.

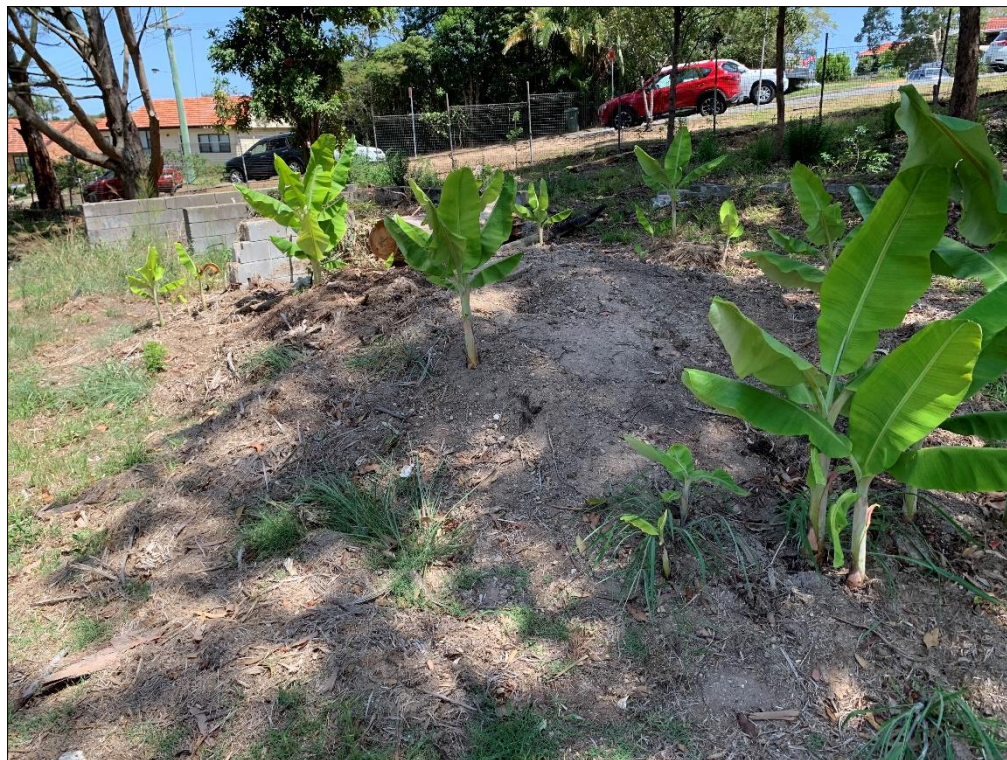
Photo 11: Soil bays and surrounding fill stockpiles in south western portion of site, looking south.

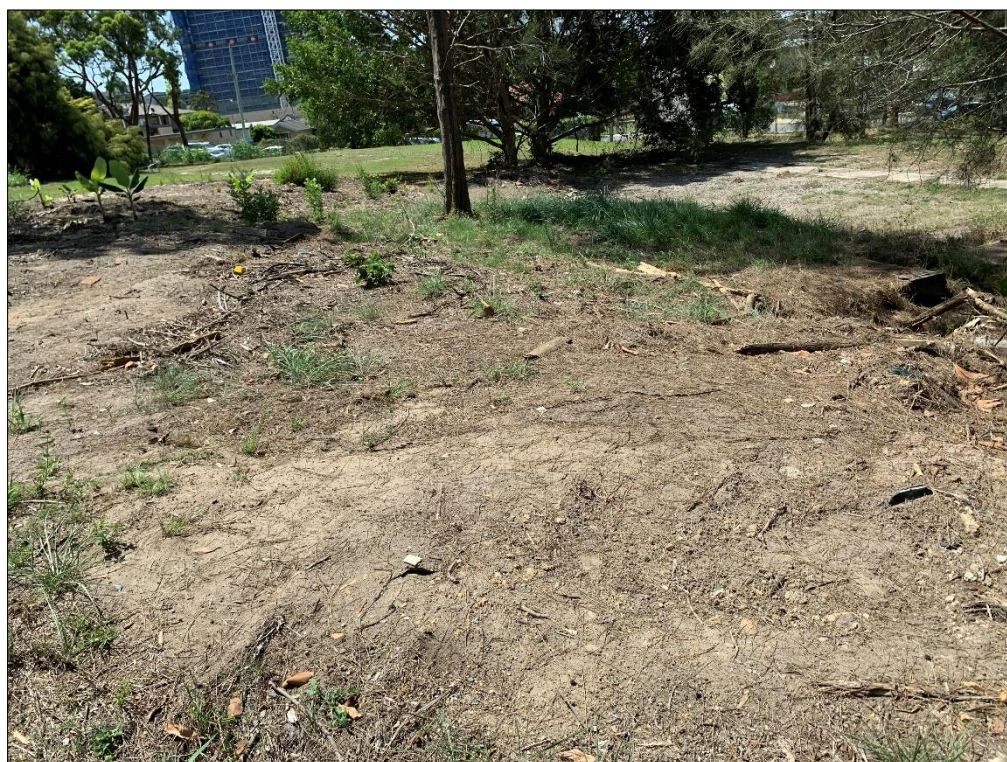
A water tank and several concrete block walled soil bays were present within the south western corner of the site. The soil bays were partially filled with various sands, silty sand and organic materials. The soil bays were surrounded by small stockpile of fill (gravelly silty sand with trace clays) and some anthropogenic materials including concrete and brick fragments (Photo 11). Fill materials to the east of the water tank also comprised scattered fibro sheeting fragments - potential ACM (generally in sound condition) of various types (Photo 12).

Photo 12: Fill materials to the east of the water tank comprising scattered fibro sheeting fragments of various types, looking north east.

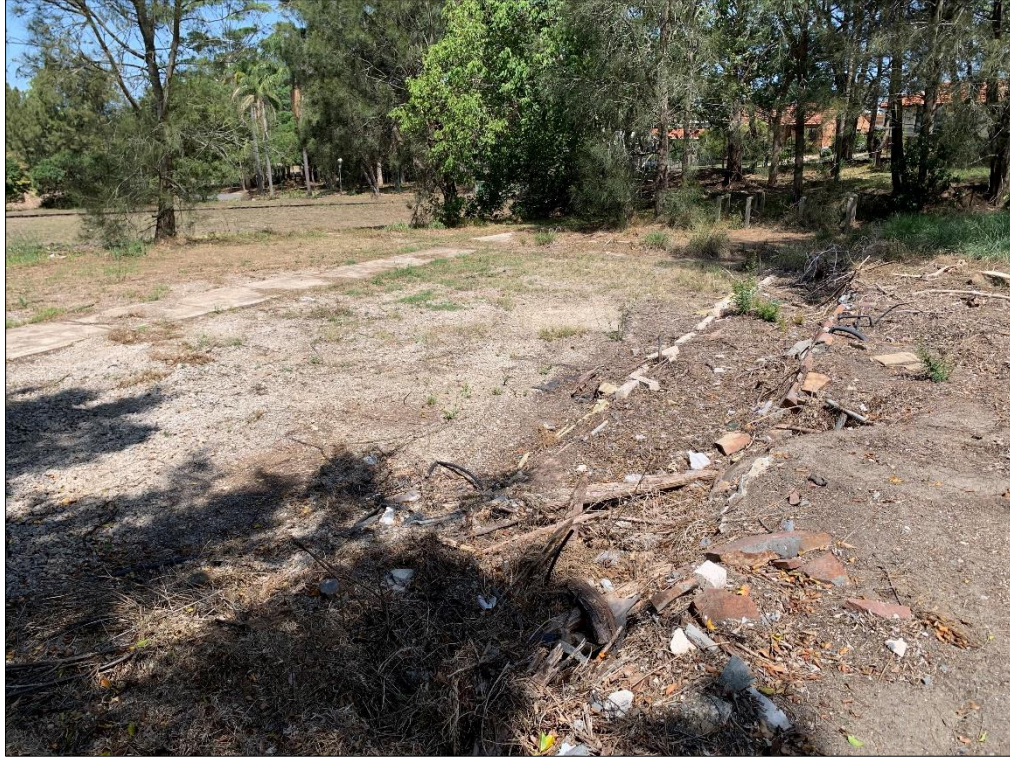
Photo 13: Former greenhouse area comprising blast furnace slag and gravel, looking east.

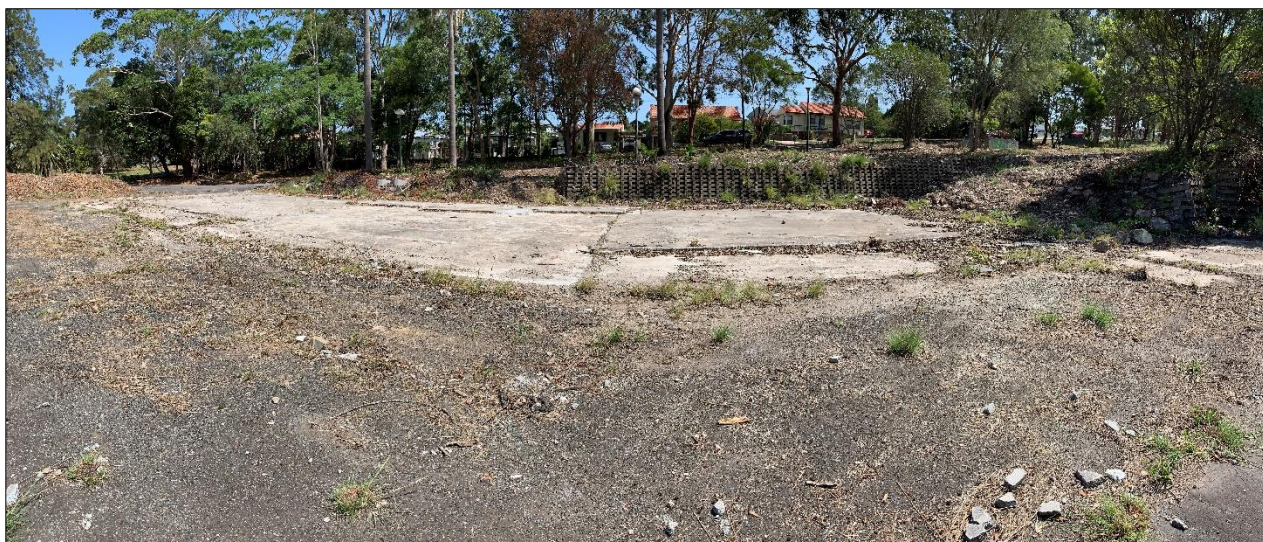
The central portion of the site contains a relatively flat concrete and asphalt sealed hardstand area associated with the former Chemical shed, Potting shed and Machinery shed (Photo 15 and 16). The former buildings were situated on concrete slabs which were generally in good condition, although some cracking / displacement was evident in the western end of the former Potting shed and eastern end of the former Chemical shed (Photo 17). The central hardstand areas between the former buildings comprised an asphalt sealed pavement leading back up to the driveway entrance road. The pavement in this area was in poor condition in some areas, with thick grass cover in some areas and loose asphalt and gravel in other areas. The surface of the hardstand area was covered with demolition waste including brick, concrete, metal, tile fragments, glass, electrical cable and some fibro sheeting fragments (Photo 18). Former brick footings and concrete slabs were evident to the east of the former Chemical shed which are assumed to be associated with the former soil bays (including the former AST) evident in previous site photos (DWC, 2010). This area was largely overgrown with grass (Photo 19), however, no obvious staining was evident at the concrete or adjacent ground surface at the location of the former AST (Photo 20).

**Photo 15: Central portion of site comprising a concrete and asphalt sealed hardstand area associated with the former chemical shed, potting shed and machinery shed, looking south. Note: Crib-lock wall in the background**

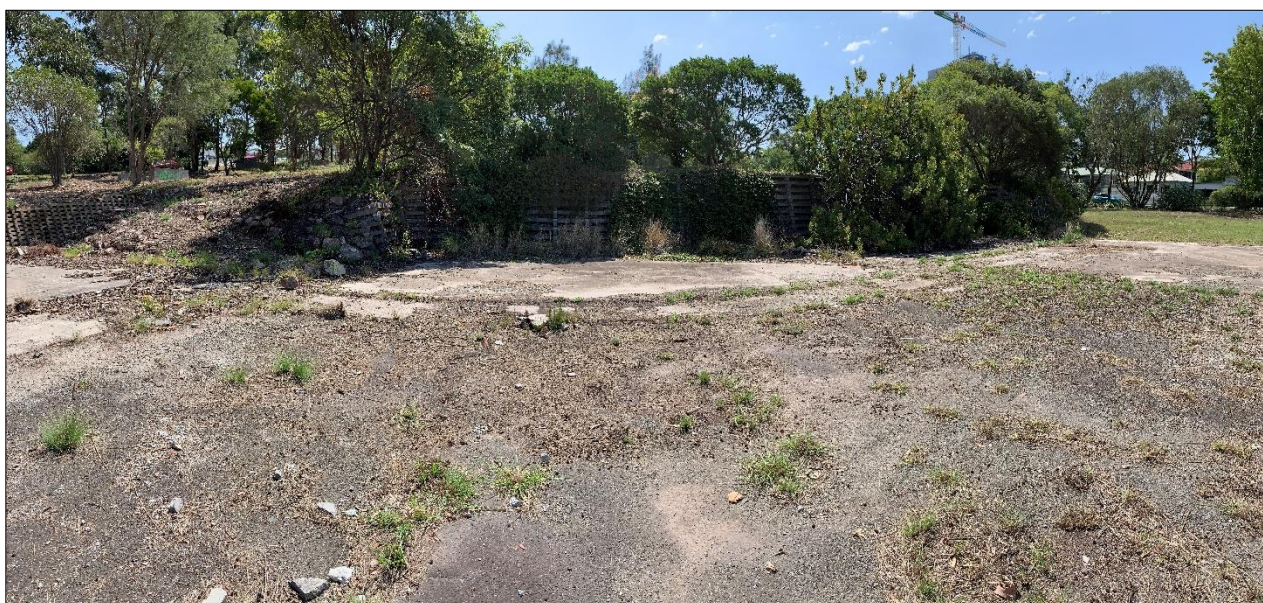
**Photo 16: Central portion of site comprising a concrete and asphalt sealed hardstand area associated with the former chemical shed, potting shed and machinery shed, looking west. Note: Crib-lock wall in the background**

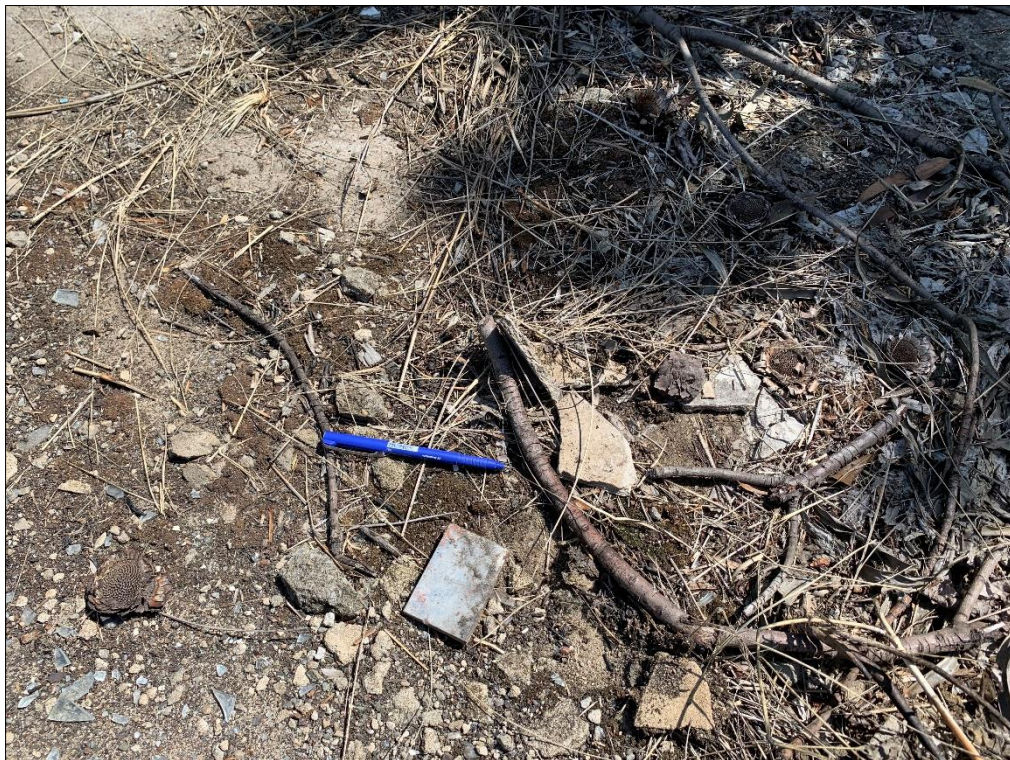
Photo 18: Fibro fragments on the surface of the hardstand in the south-western portion of the hardstand.

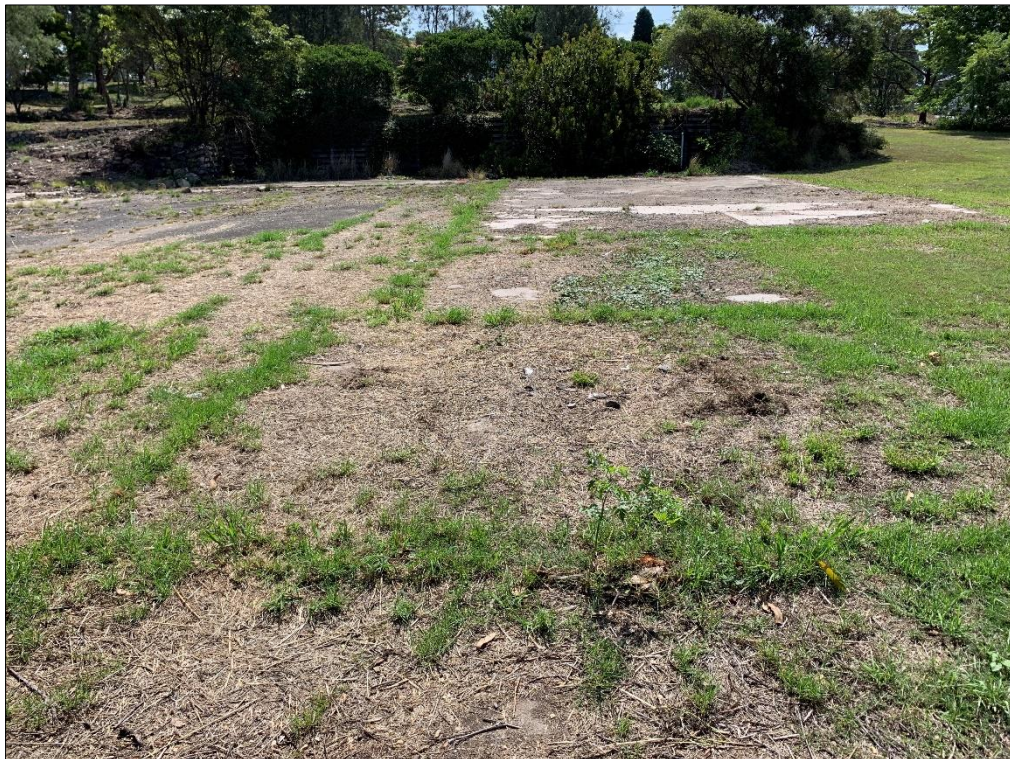
**Photo 20: Location of former AST in central portion of the site, looking west.**

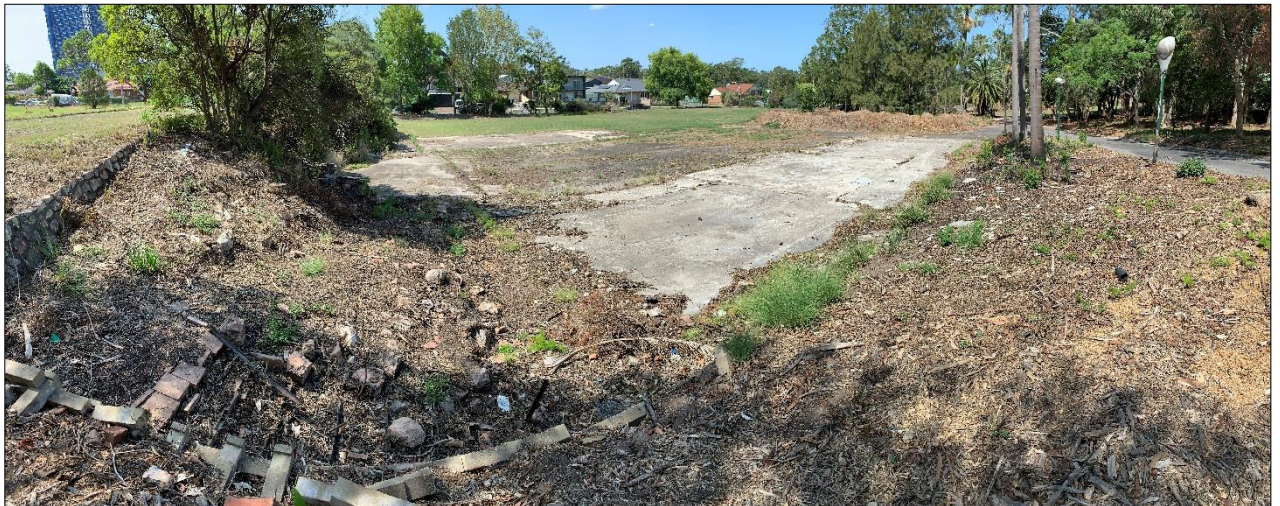
**Photo 23: Partially demolished rock retaining wall located in the south western corner of the hardstand area, looking north east.**

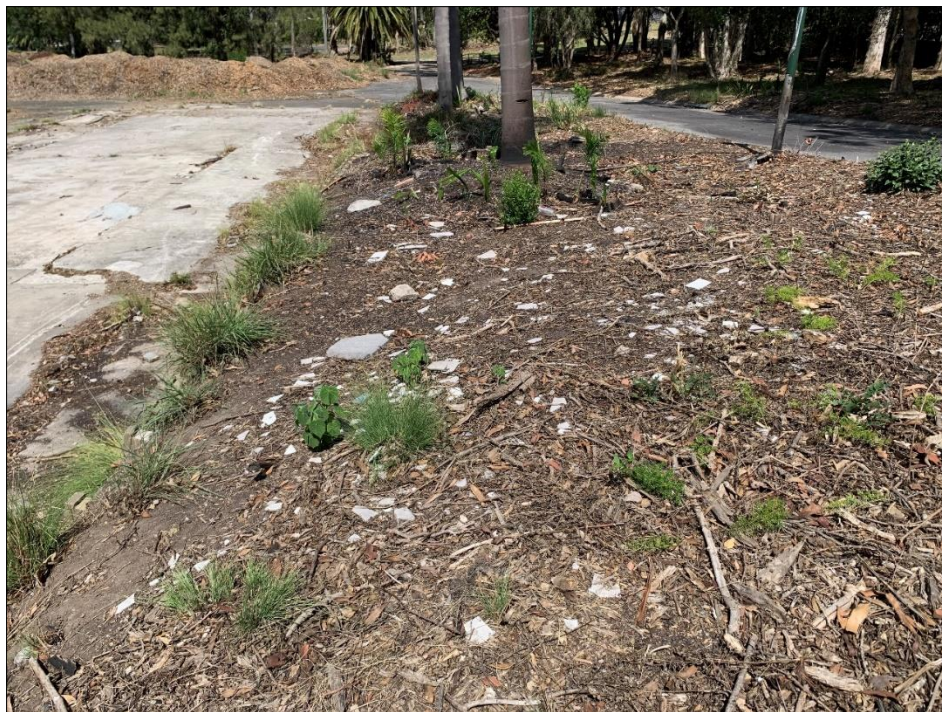
A garden bed situated to the south of the hardstand area between the crib-lock wall and the entrance driveway comprised a partially mulched surface with scattered demolition waste including multiple fibro sheeting fragments in generally in sound condition (Photo 24). Fibro fragments (generally in sound condition) were also evident at the base of a small ramp leading from the entrance driveway onto the Potting shed building slab.

**Photo 24: Garden bed south of the central hardstand area comprising abundant fibro sheeting fragments at the surface, looking east.**

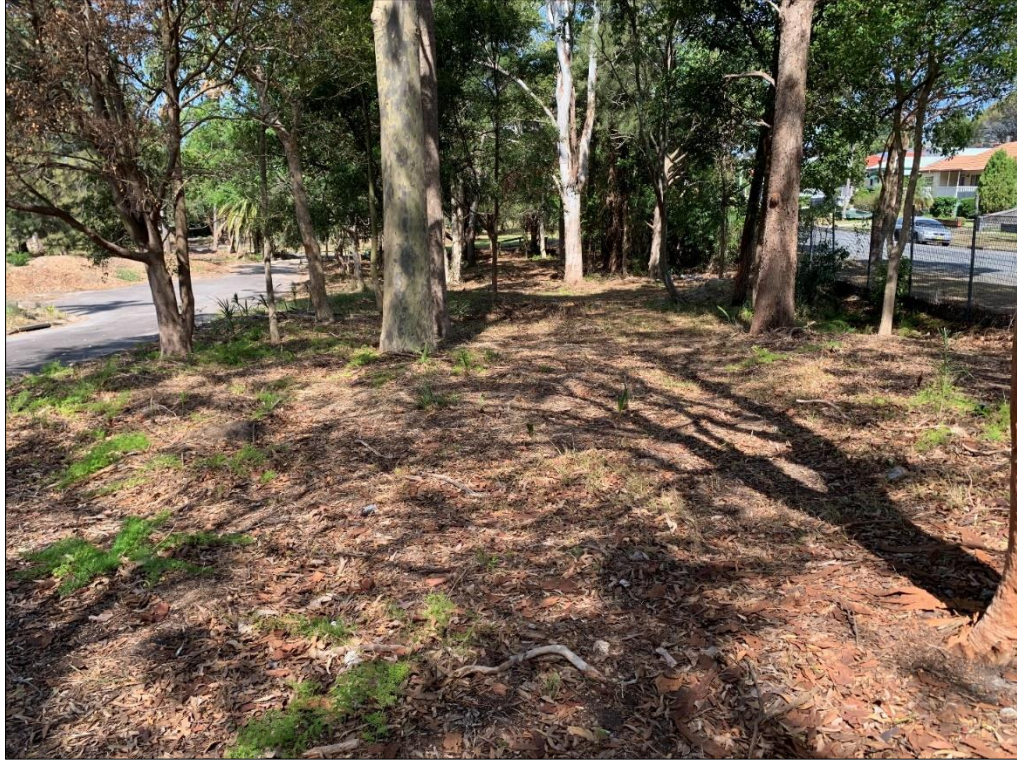
A garden area to the south of the central entrance driveway (Photo 25) comprises numerous mature trees and an undulating surface and was covered by mulch with intermixed building waste (including brick, concrete). A fibro fragment was observed at the surface in this area (Photo 26). Remnants of former sculptures (Photo 27) were also evident in this area. At the eastern end of this garden area an open stormwater drain, constructed with battered natural rock/cement walls and a concrete base, entered the site from Tiral Street (Photo 28). The open drain headed north, going under the entrance driveway to the former tennis court shed where the drain entered into a concrete stormwater pipe.

**Photo 25: Garden area, comprising undulated ground with mature trees, buried pavers, brick and concrete adjacent to the central entrance, looking east.**

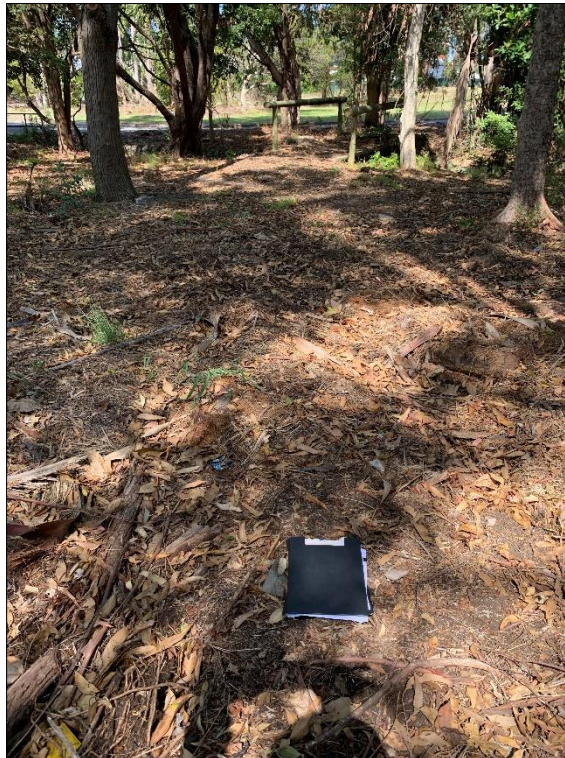
**Photo 26: Fibro fragment within the southern garden area west of the stormwater drain, looking east.**

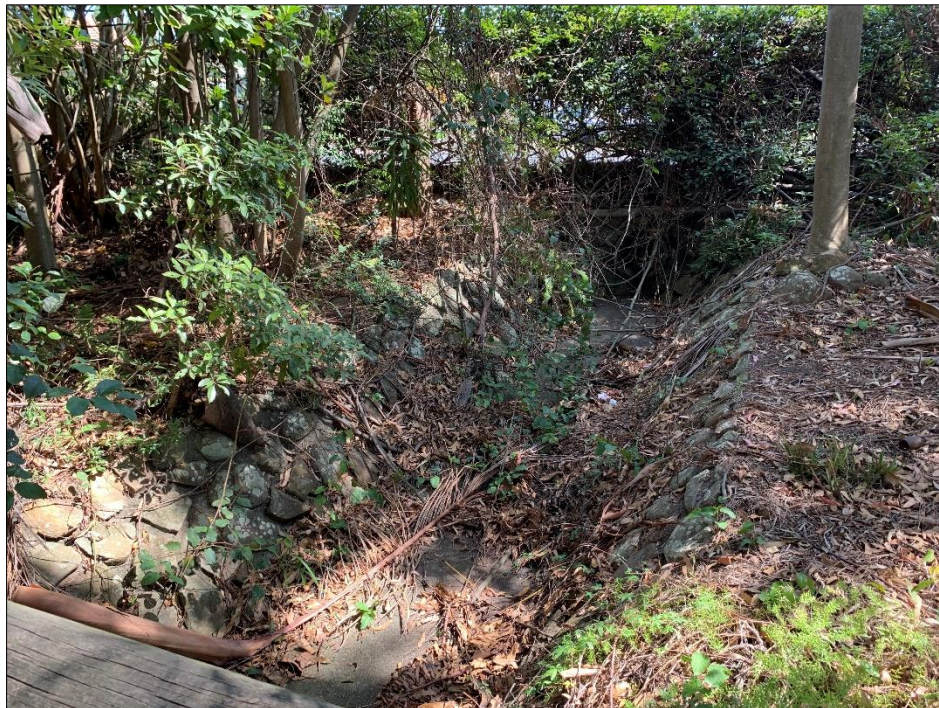
Photo 28: Open stormwater drain, constructed with battered natural rock/cement walls and a concrete base located at the eastern end of the garden area, looking south.

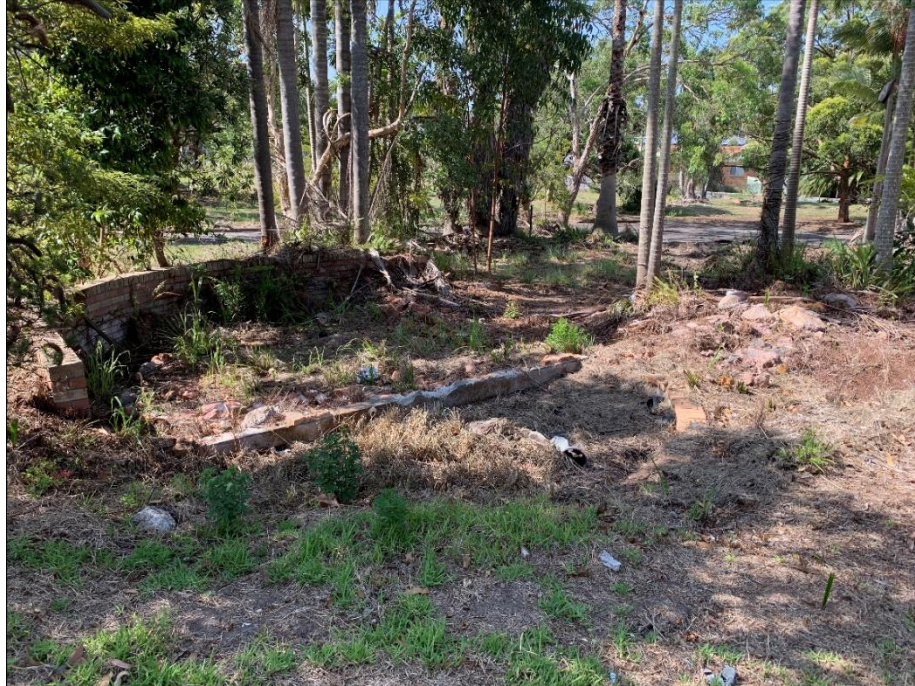
**Photo 29: Partially demolished pool and water feature, adjacent to the central driveway entrance, looking north east.**

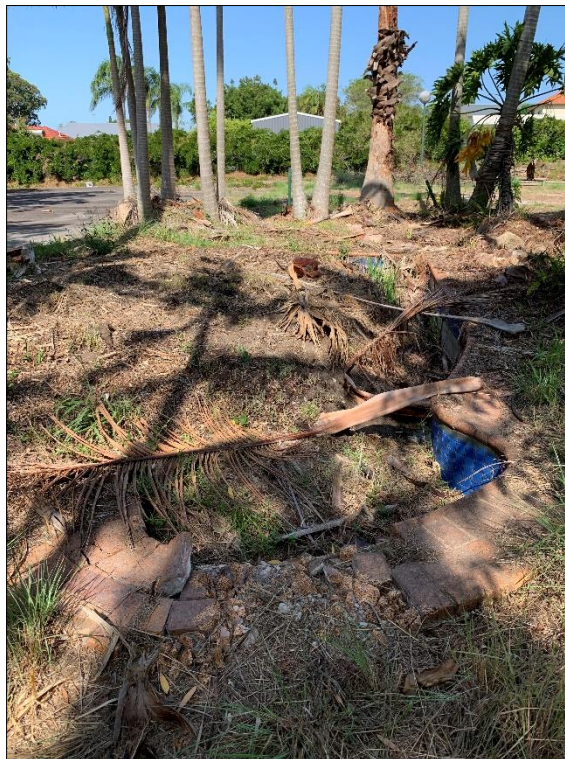
The in-ground pool has been backfilled with soils comprising building wastes including brick, concrete, asphalt, PVC, tile, plastic and trace fibro sheeting fragments (generally in sound condition) and organic matter.

**Photo 30: Backfilled inground pool, adjacent to the central driveway entrance. Note: Fibro sheeting fragments at surface**

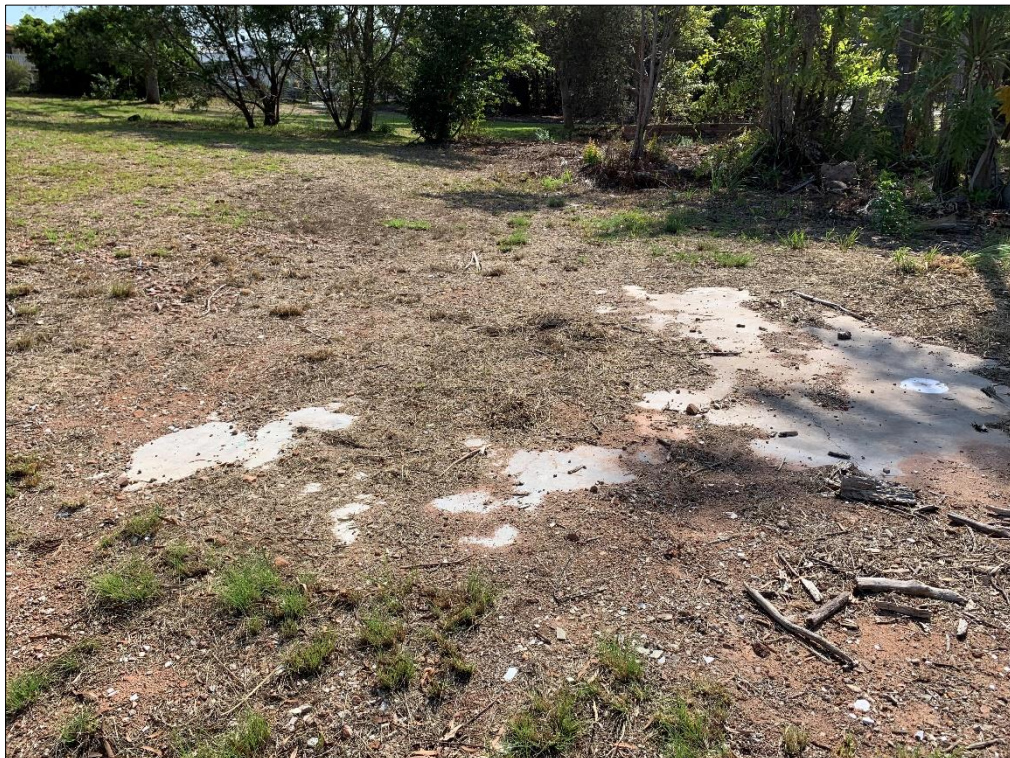
**Photo 32: Scattered demolition waste and fibro sheeting within the to former administration building footprint.**

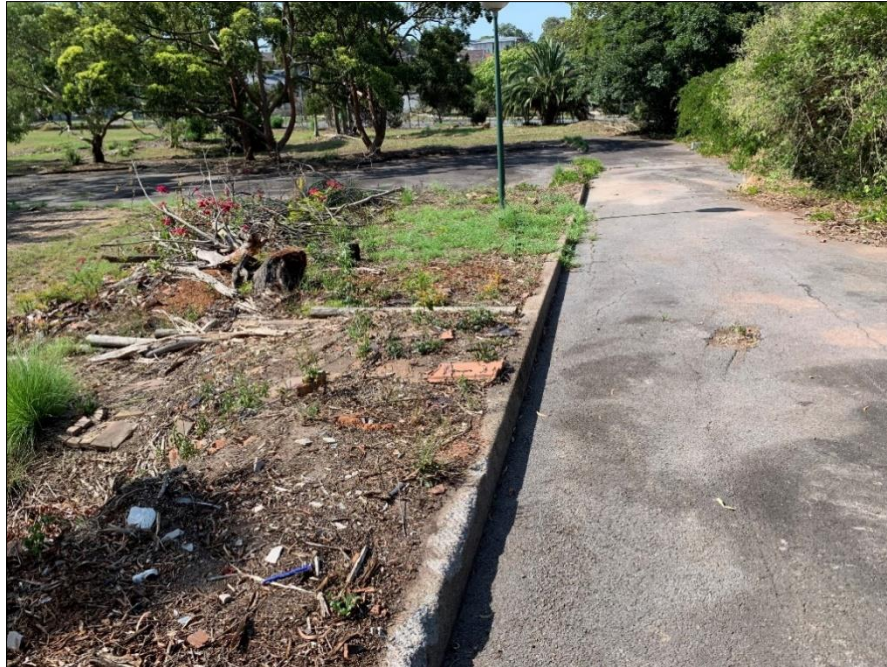
**Photo 33: Scattered demolition waste and fibro sheeting adjacent to former administration building footprint, looking north.**

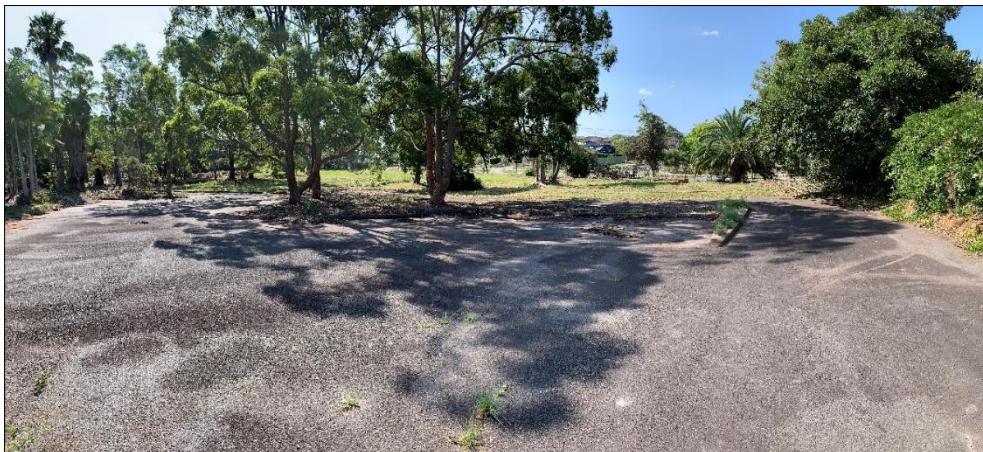
An asphalt sealed driveway and carparking area is situated to the north of the former Administration building (Photo 34) and slopes to the north east. The asphalt is in relatively good condition.

**Photo 34: Asphalt sealed driveway and carparking area situated to the north of the former Administration building, looking north.**

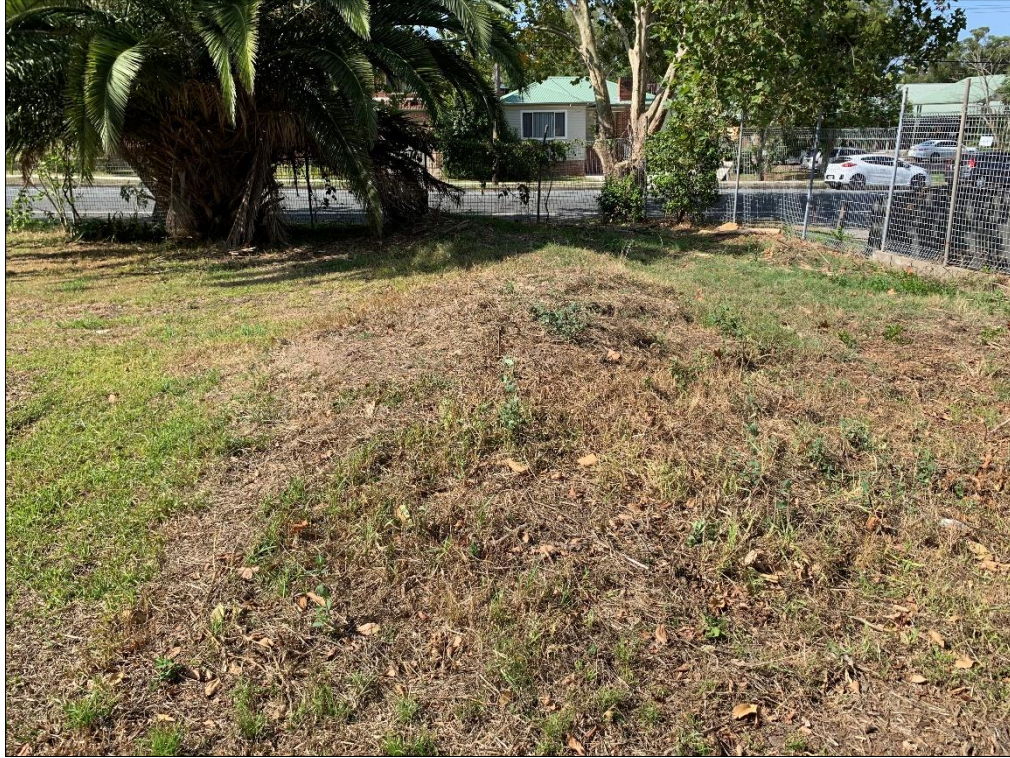
**Photo 35: Mounded fill area within north eastern portion of site, looking north.**

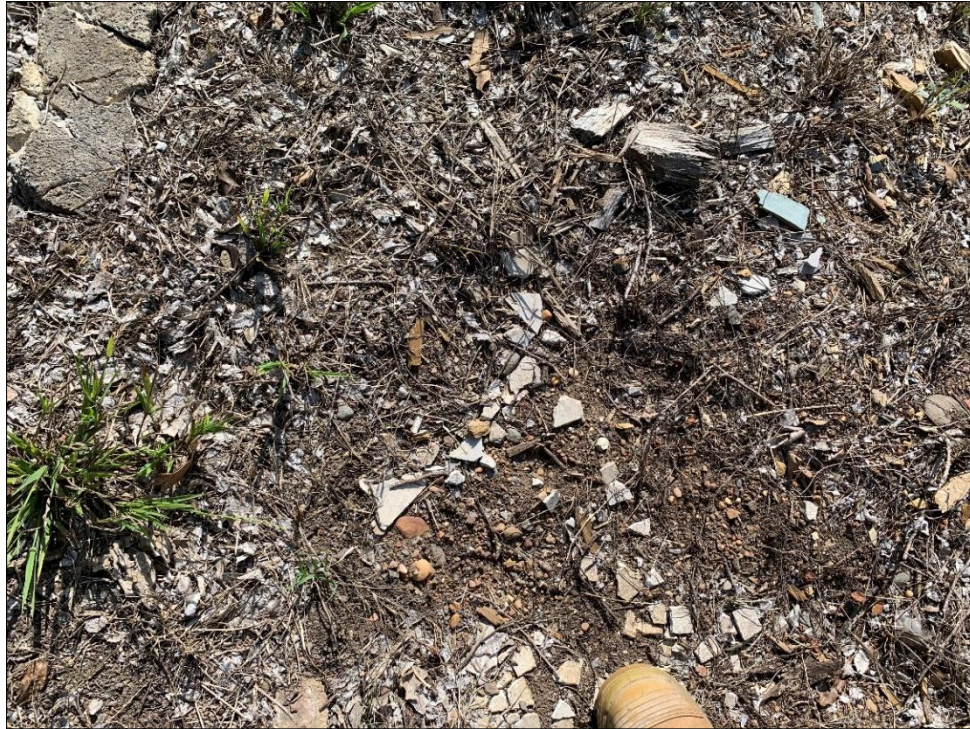
Photo 39: Demolition waste at the surface of former classrooms footprint including concrete, bricks, sandstone, pavers, PVC, agricultural pipe, PVC, metal and areas with multiple fibro fragments.

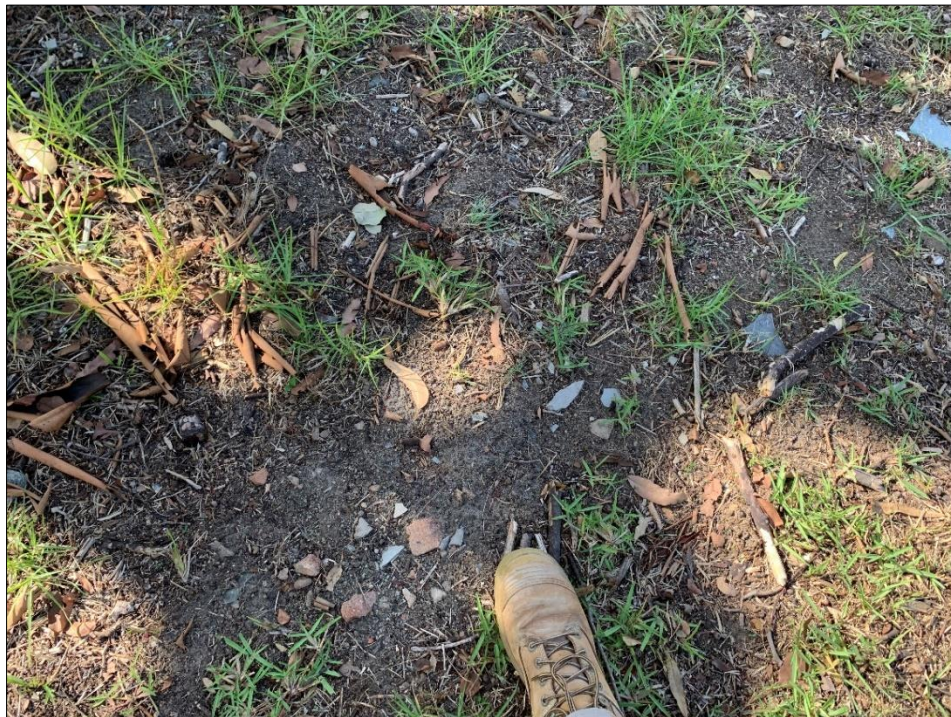
Photo 40: Demolition waste at the surface of former classrooms footprint including concrete, bricks, sandstone, pavers, PVC, agricultural pipe, PVC, metal and areas with multiple fibro fragments.

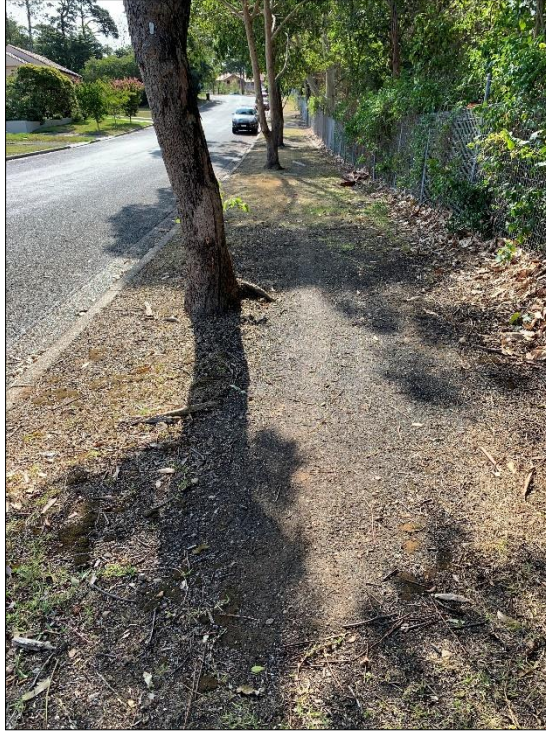
**Photo 43: Possible black slag fill observed at the surface in the road shoulder near the drainage reserve road crossing on Tiral Street.**

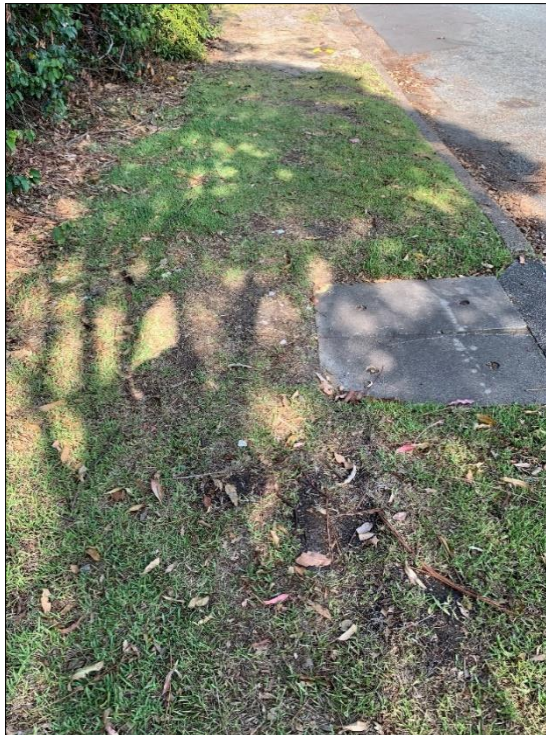
**Photo 44: Fibro fragments observed on surface of road shoulder along Tiral Street.**

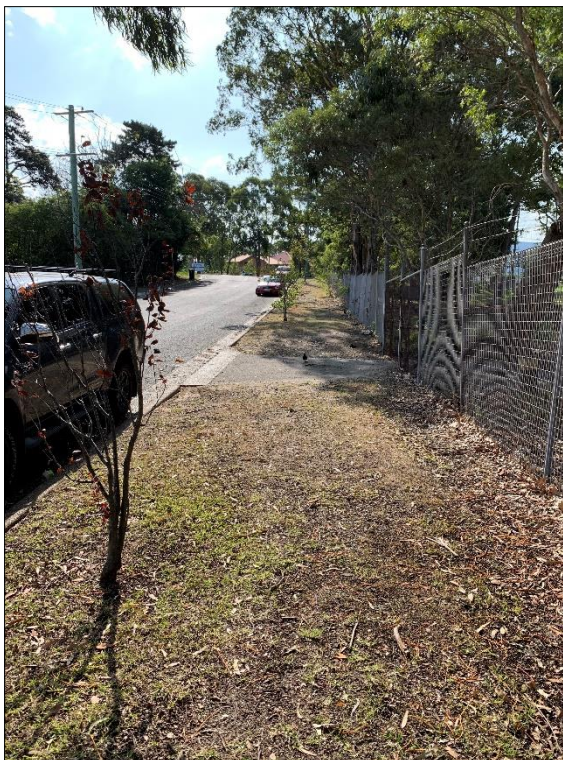
**Photo 45: Fibro fragments observed on surface of road shoulder along Tiral Street, looking west.**
