Our Ref: PSM4580-003L Rev1

**RE: 12 HASSELL STREET PARRAMATTA  
GEOTECHNICAL INVESTIGATION - DUE DILIGENCE**

This letter presents the results of PSM's due diligence stage geotechnical investigation of the proposed development at 12 Hassall Street, Parramatta. This investigation was undertaken in accordance with the our proposal PSM4580-001E dated 3 September 2021. To assist in the preparation of this letter, we have been provided with the following documents:

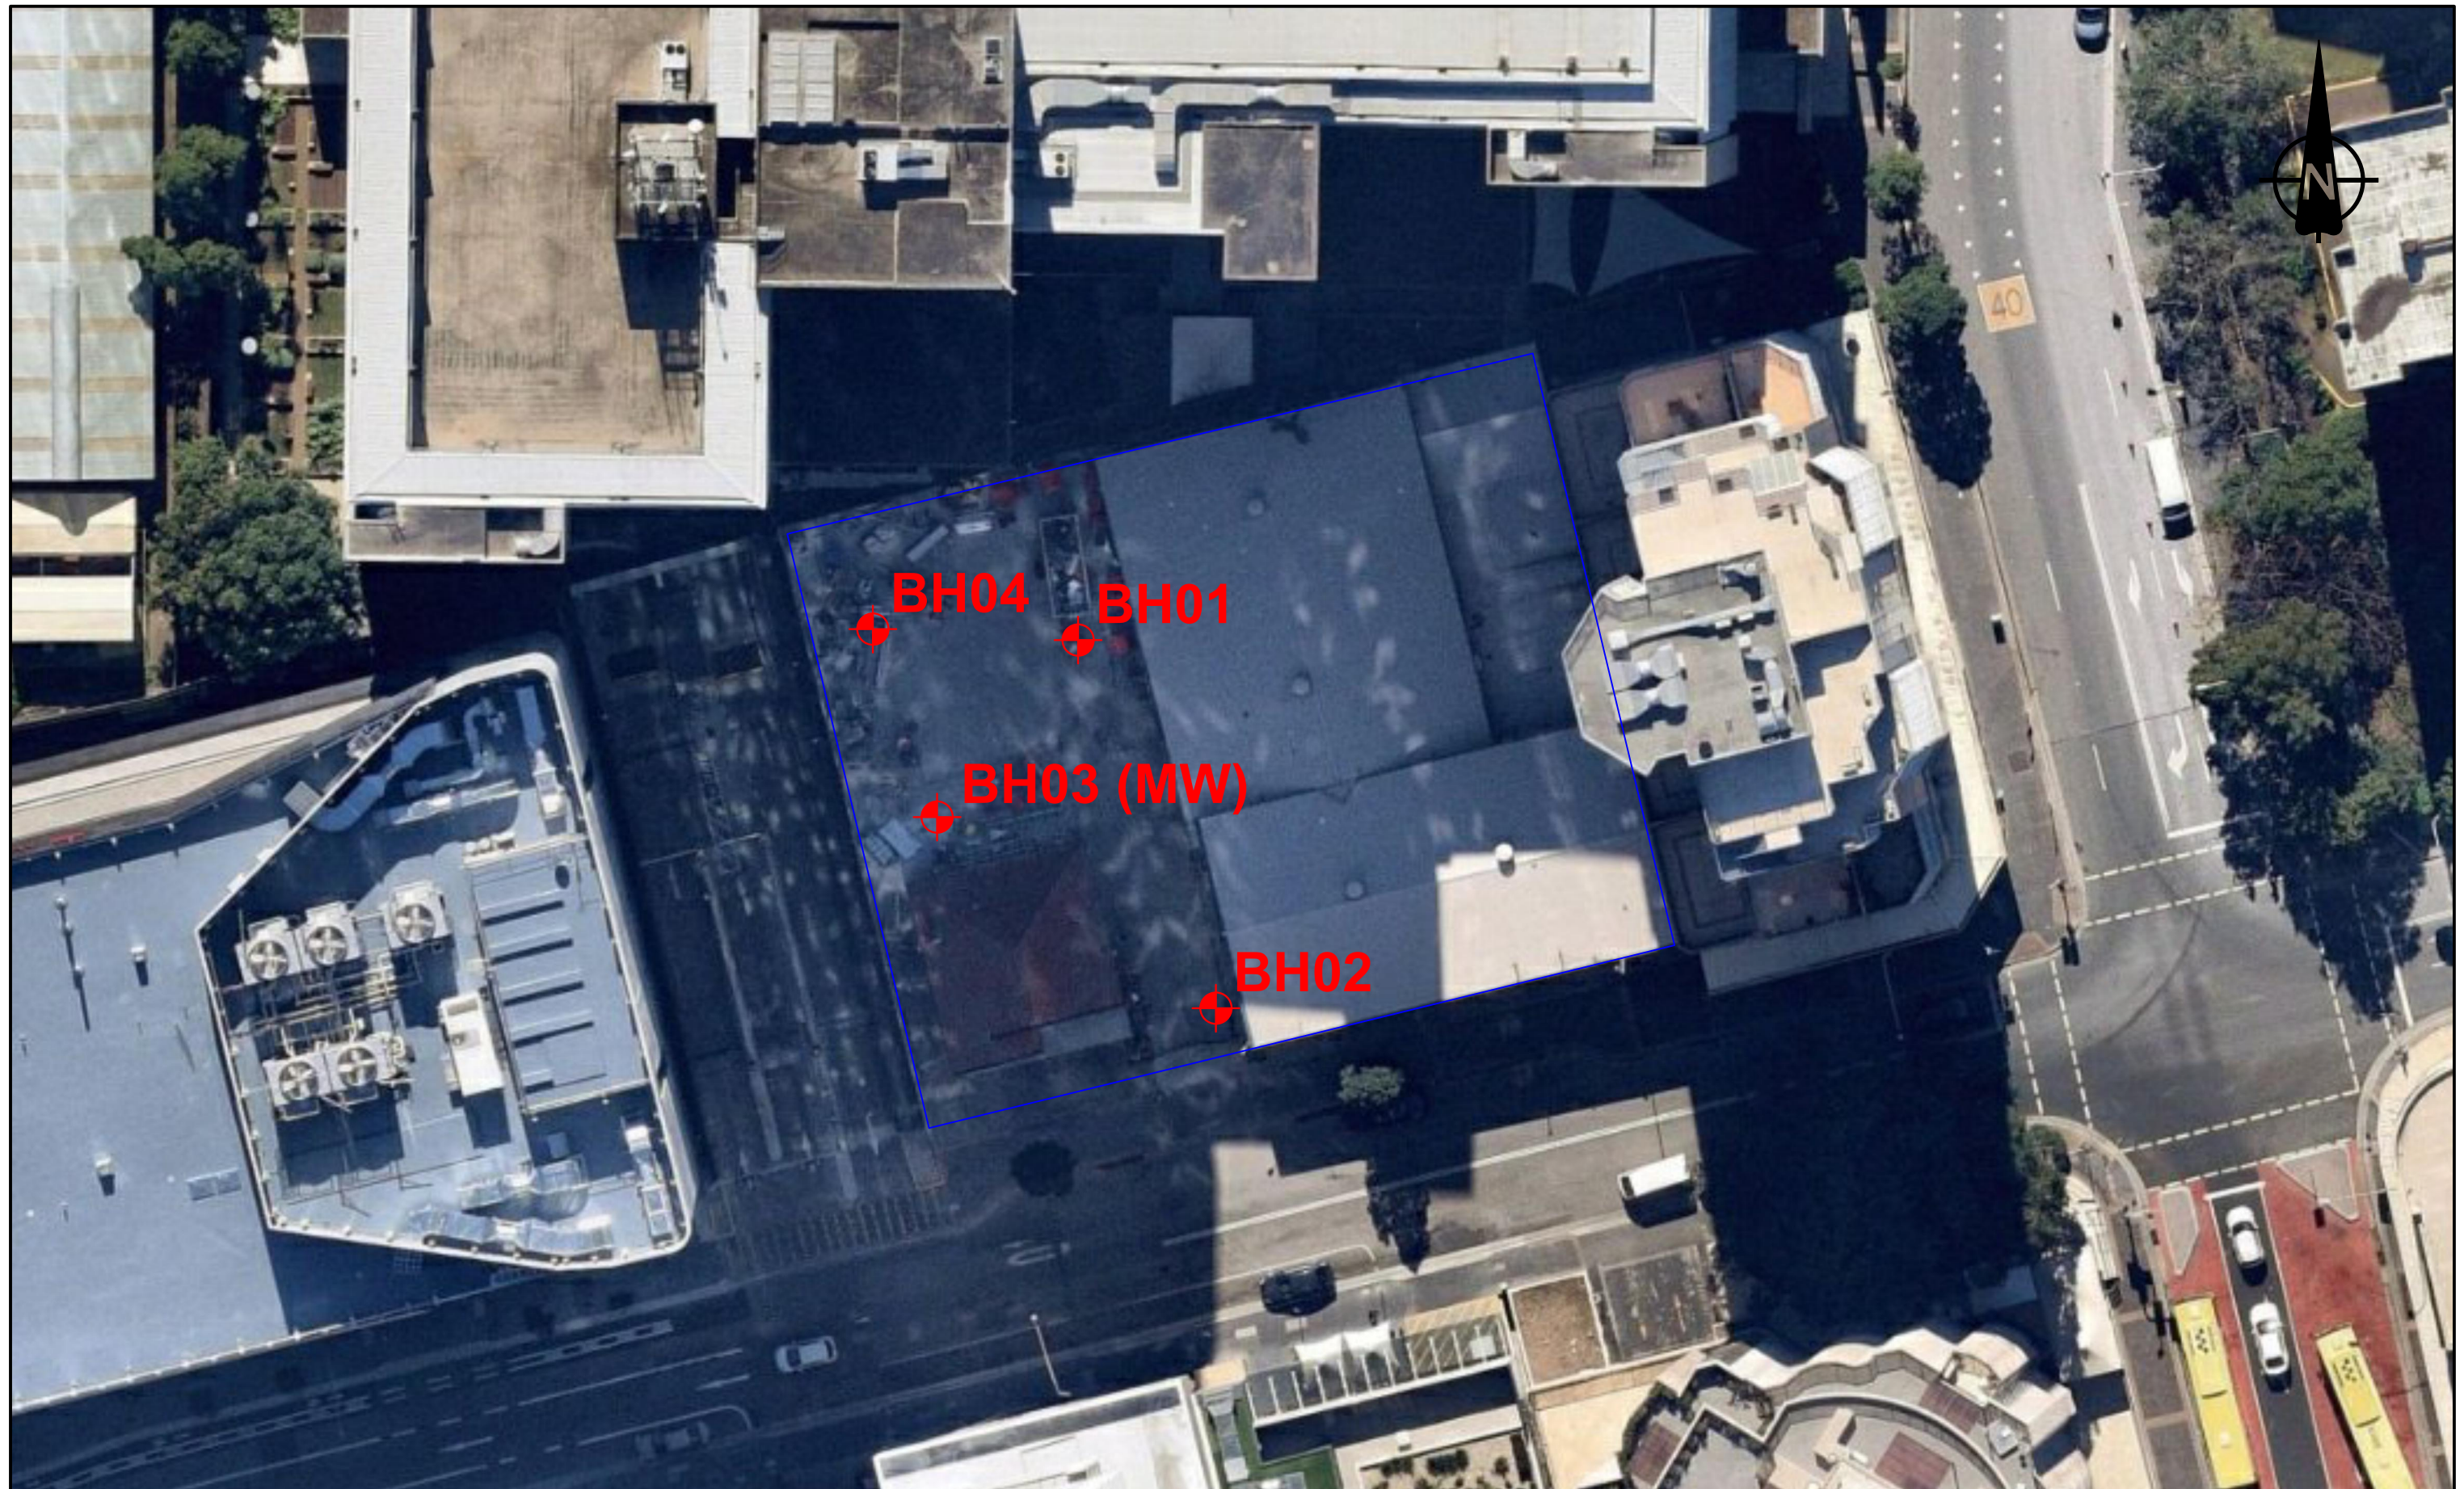
Figure 1

The locations of the boreholes are presented in Figure 1. Selected site photographs are presented in Figures 2 to 6.

At the time of the investigation the eastern half of the site was inaccessible due to the presence of an existing building. Therefore, no boreholes were undertaken towards the eastern edge of the site. We recommend that prior to the detailed design stage additional boreholes be undertaken to understand the ground conditions in this area. The depth of soil units (FILL, ALLUVIUM, and RESIDUAL) may vary across the site, impacting the design of the retention system.

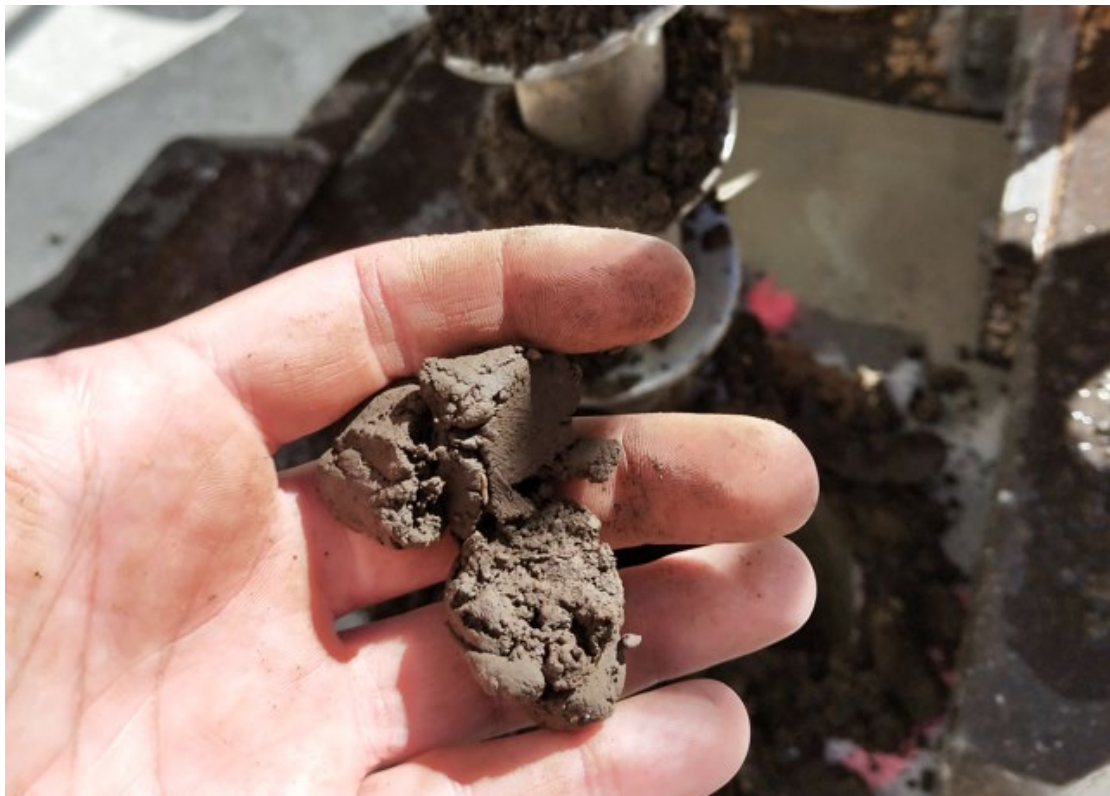
Photo 6 - Typical FILL (CLAY) unit

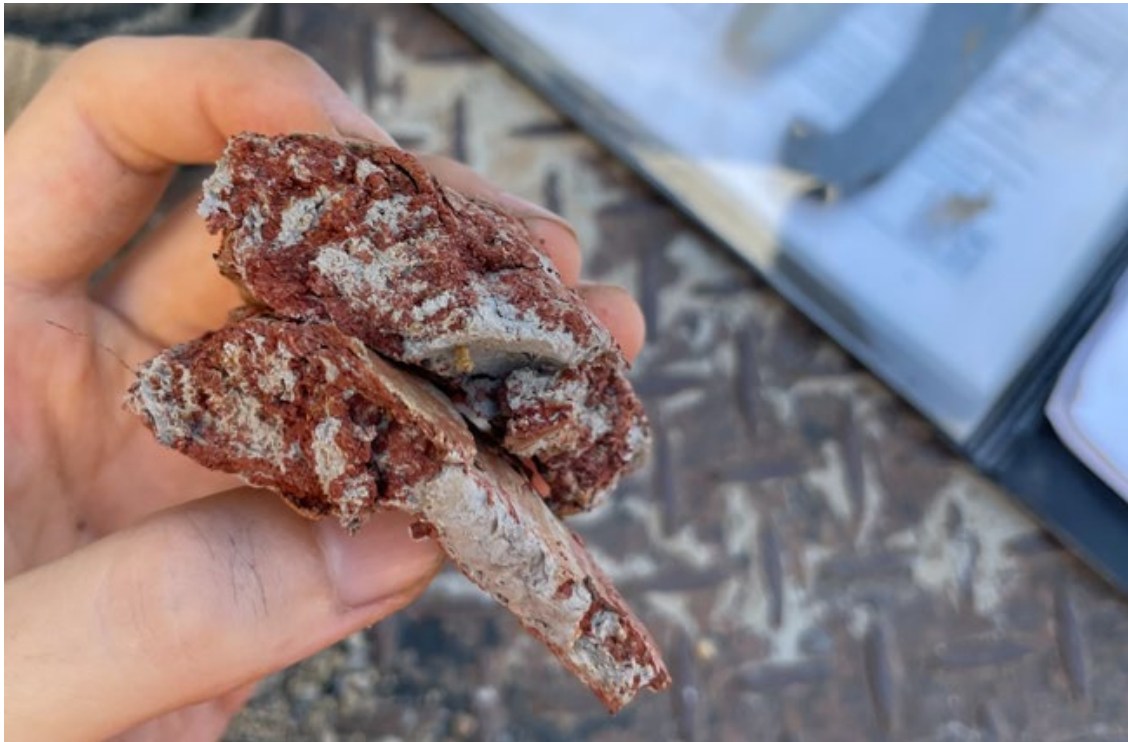
Photo 7 - Typical RESIDUAL (CLAY) unit

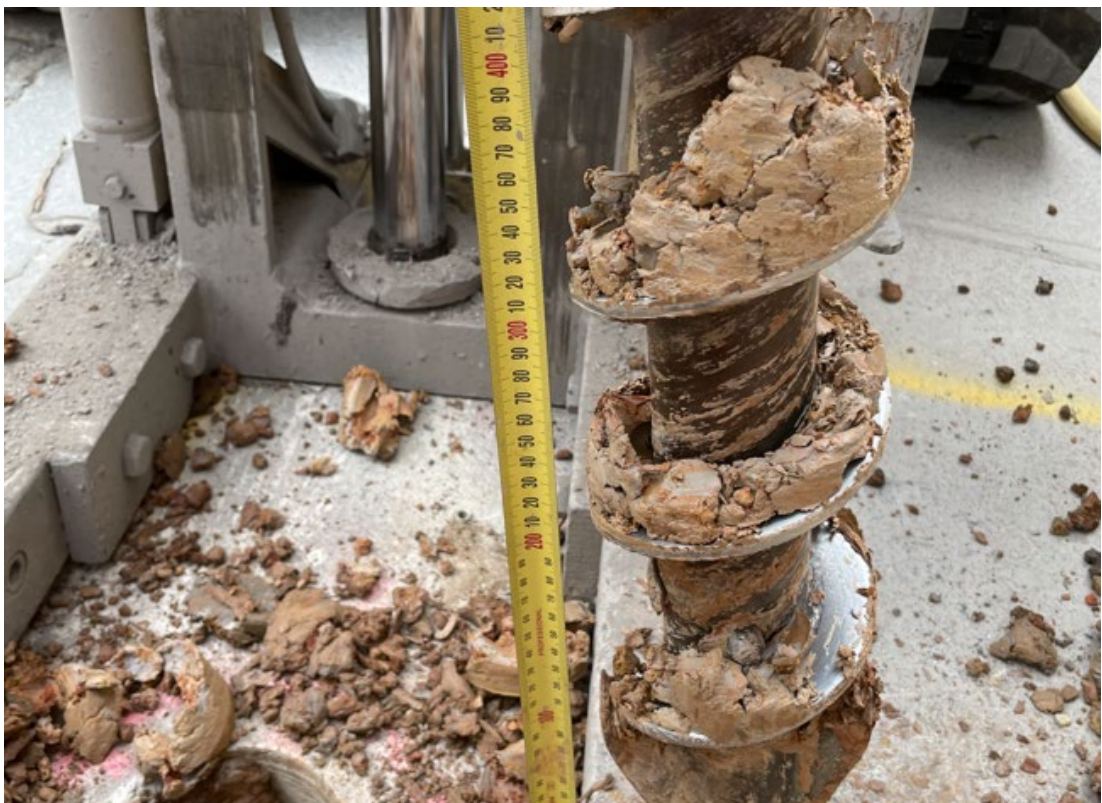
Photo 8 - Typical RESIDUAL (CLAY) unit at BH02

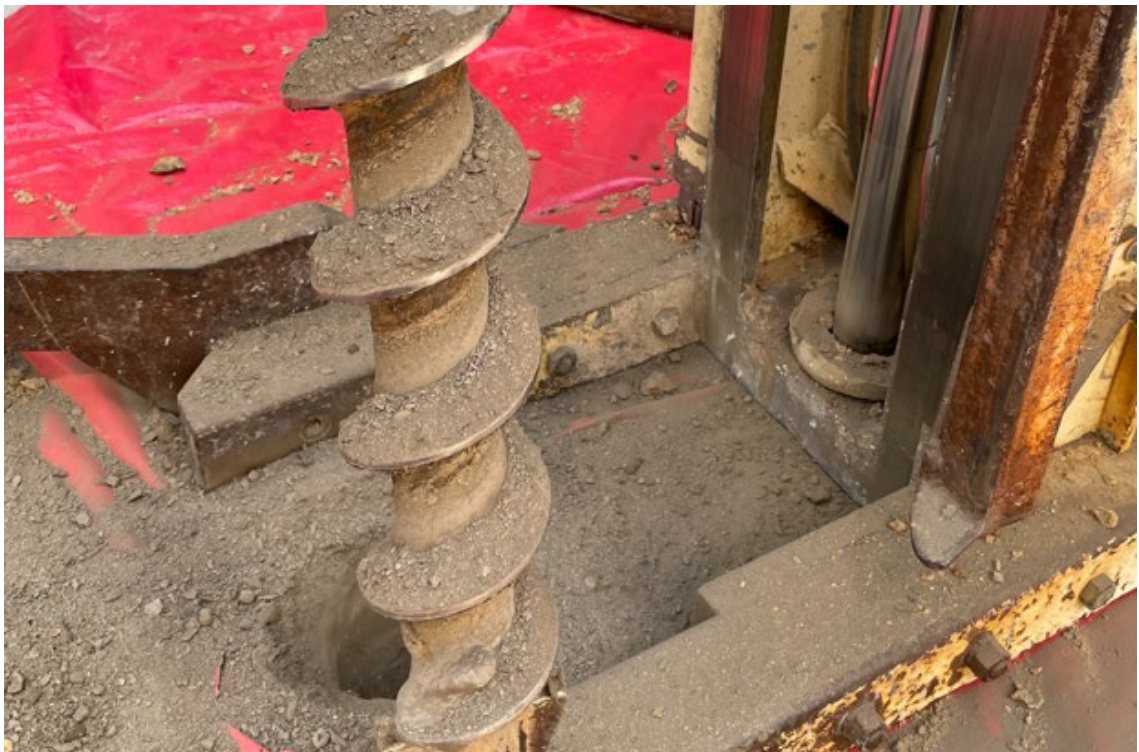
Photo 9 - SILTSTONE cuttings at BH03

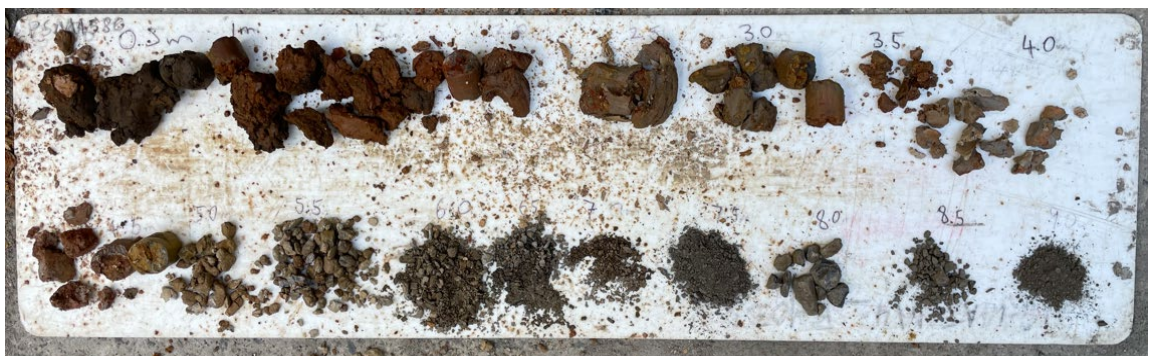
Photo 10 - Recovered cuttings from BH02

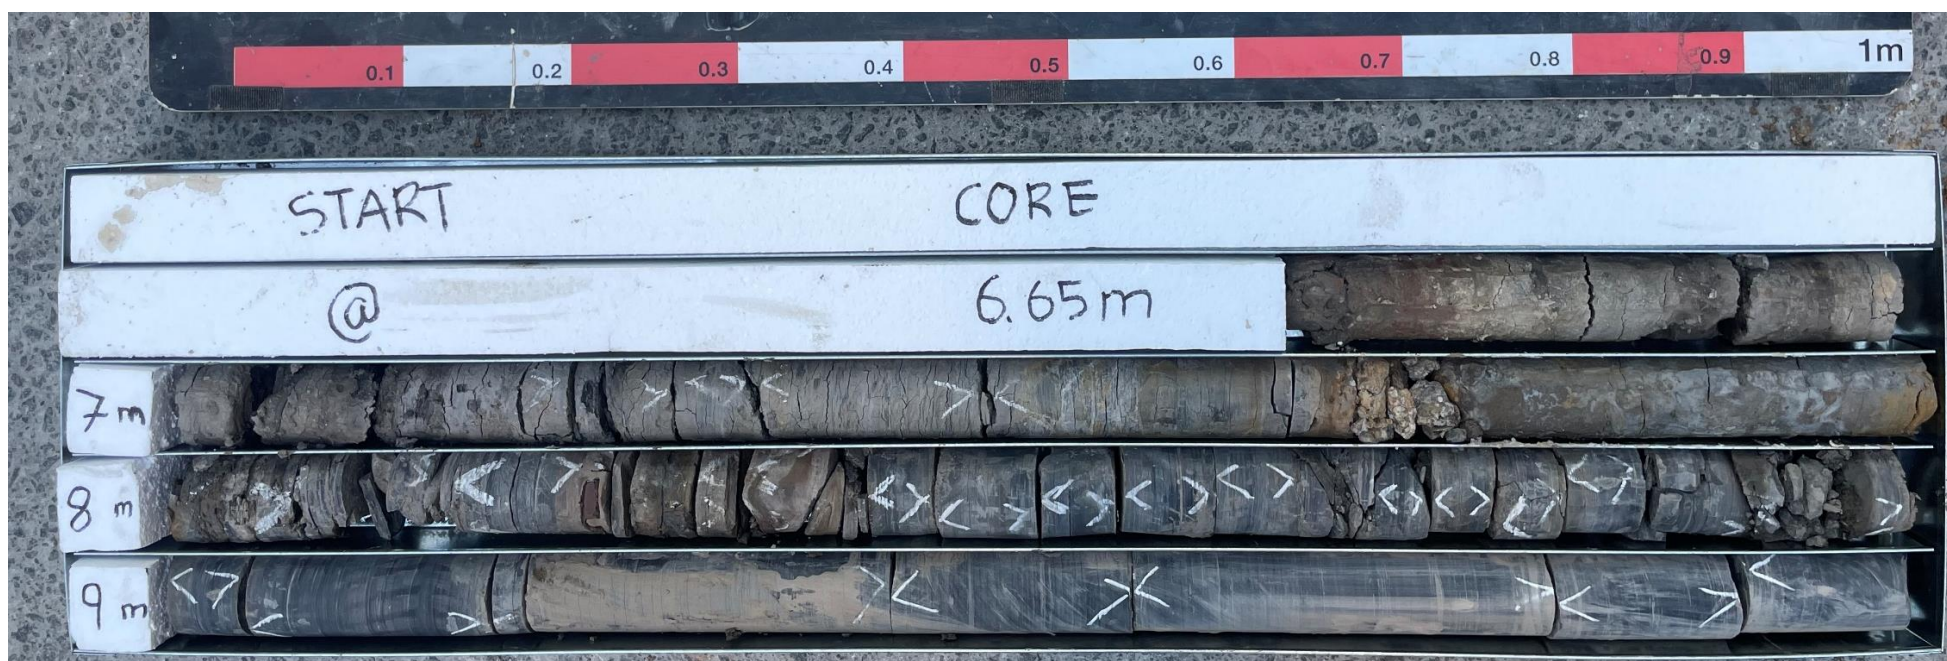
FROM: 6.65 m

TO: 10.0 m

Gurner  
12 Hassall Street  
Parramatta  
CORE PHOTOS BH01  
(Core Photo 1 OF 3)

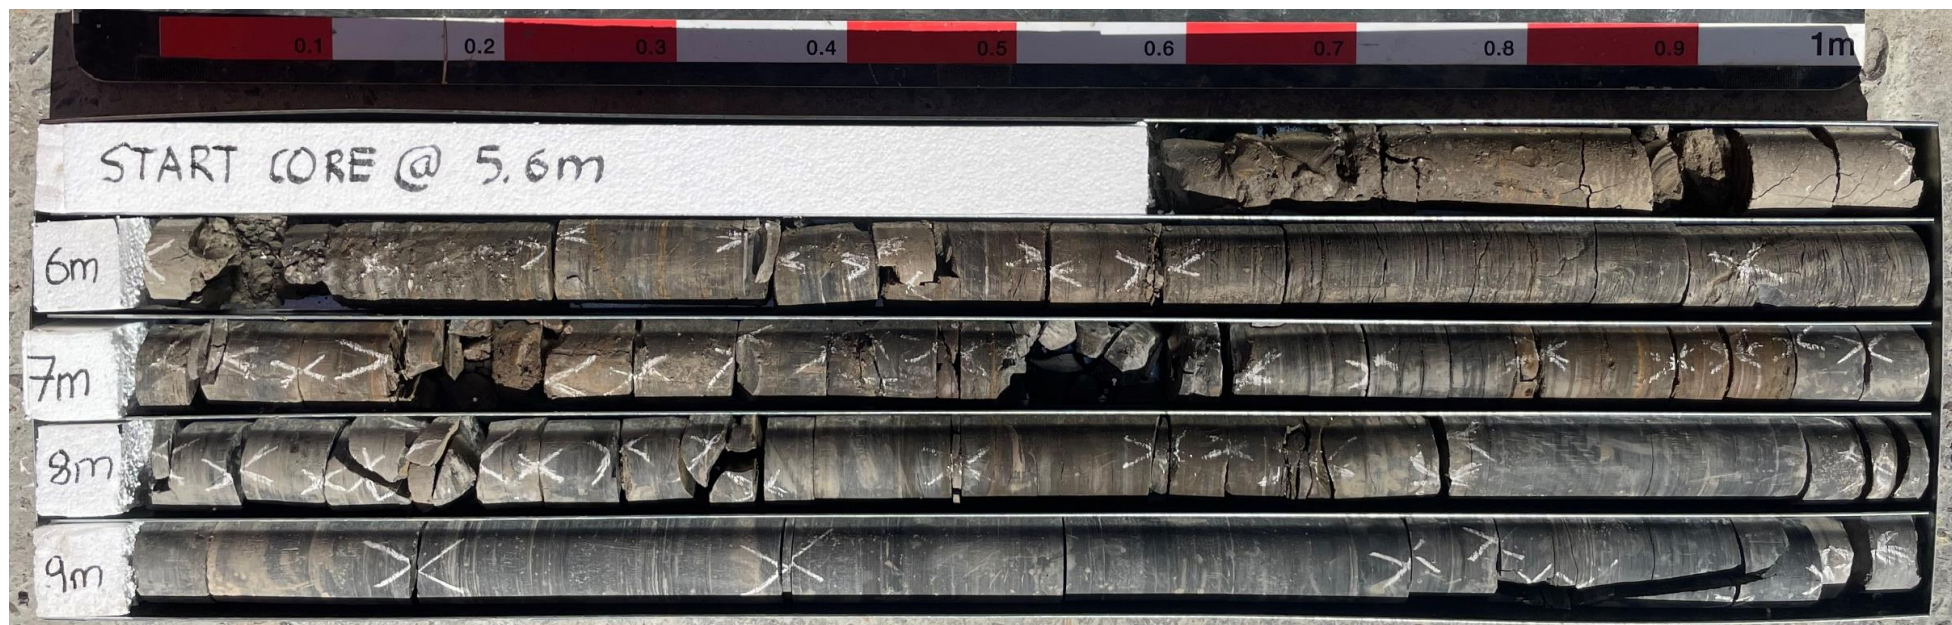
FROM: 5.6 m

TO: 10.0 m

Gurner  
12 Hassall Street  
Parramatta  
CORE PHOTOS BH03  
(Core Photo 1 OF 4)
