Remedial Action Plan

1-3 Burrows Road, St Peters

Client: Goodman Property Services (Aust) Pty Ltd

15-Apr-2020

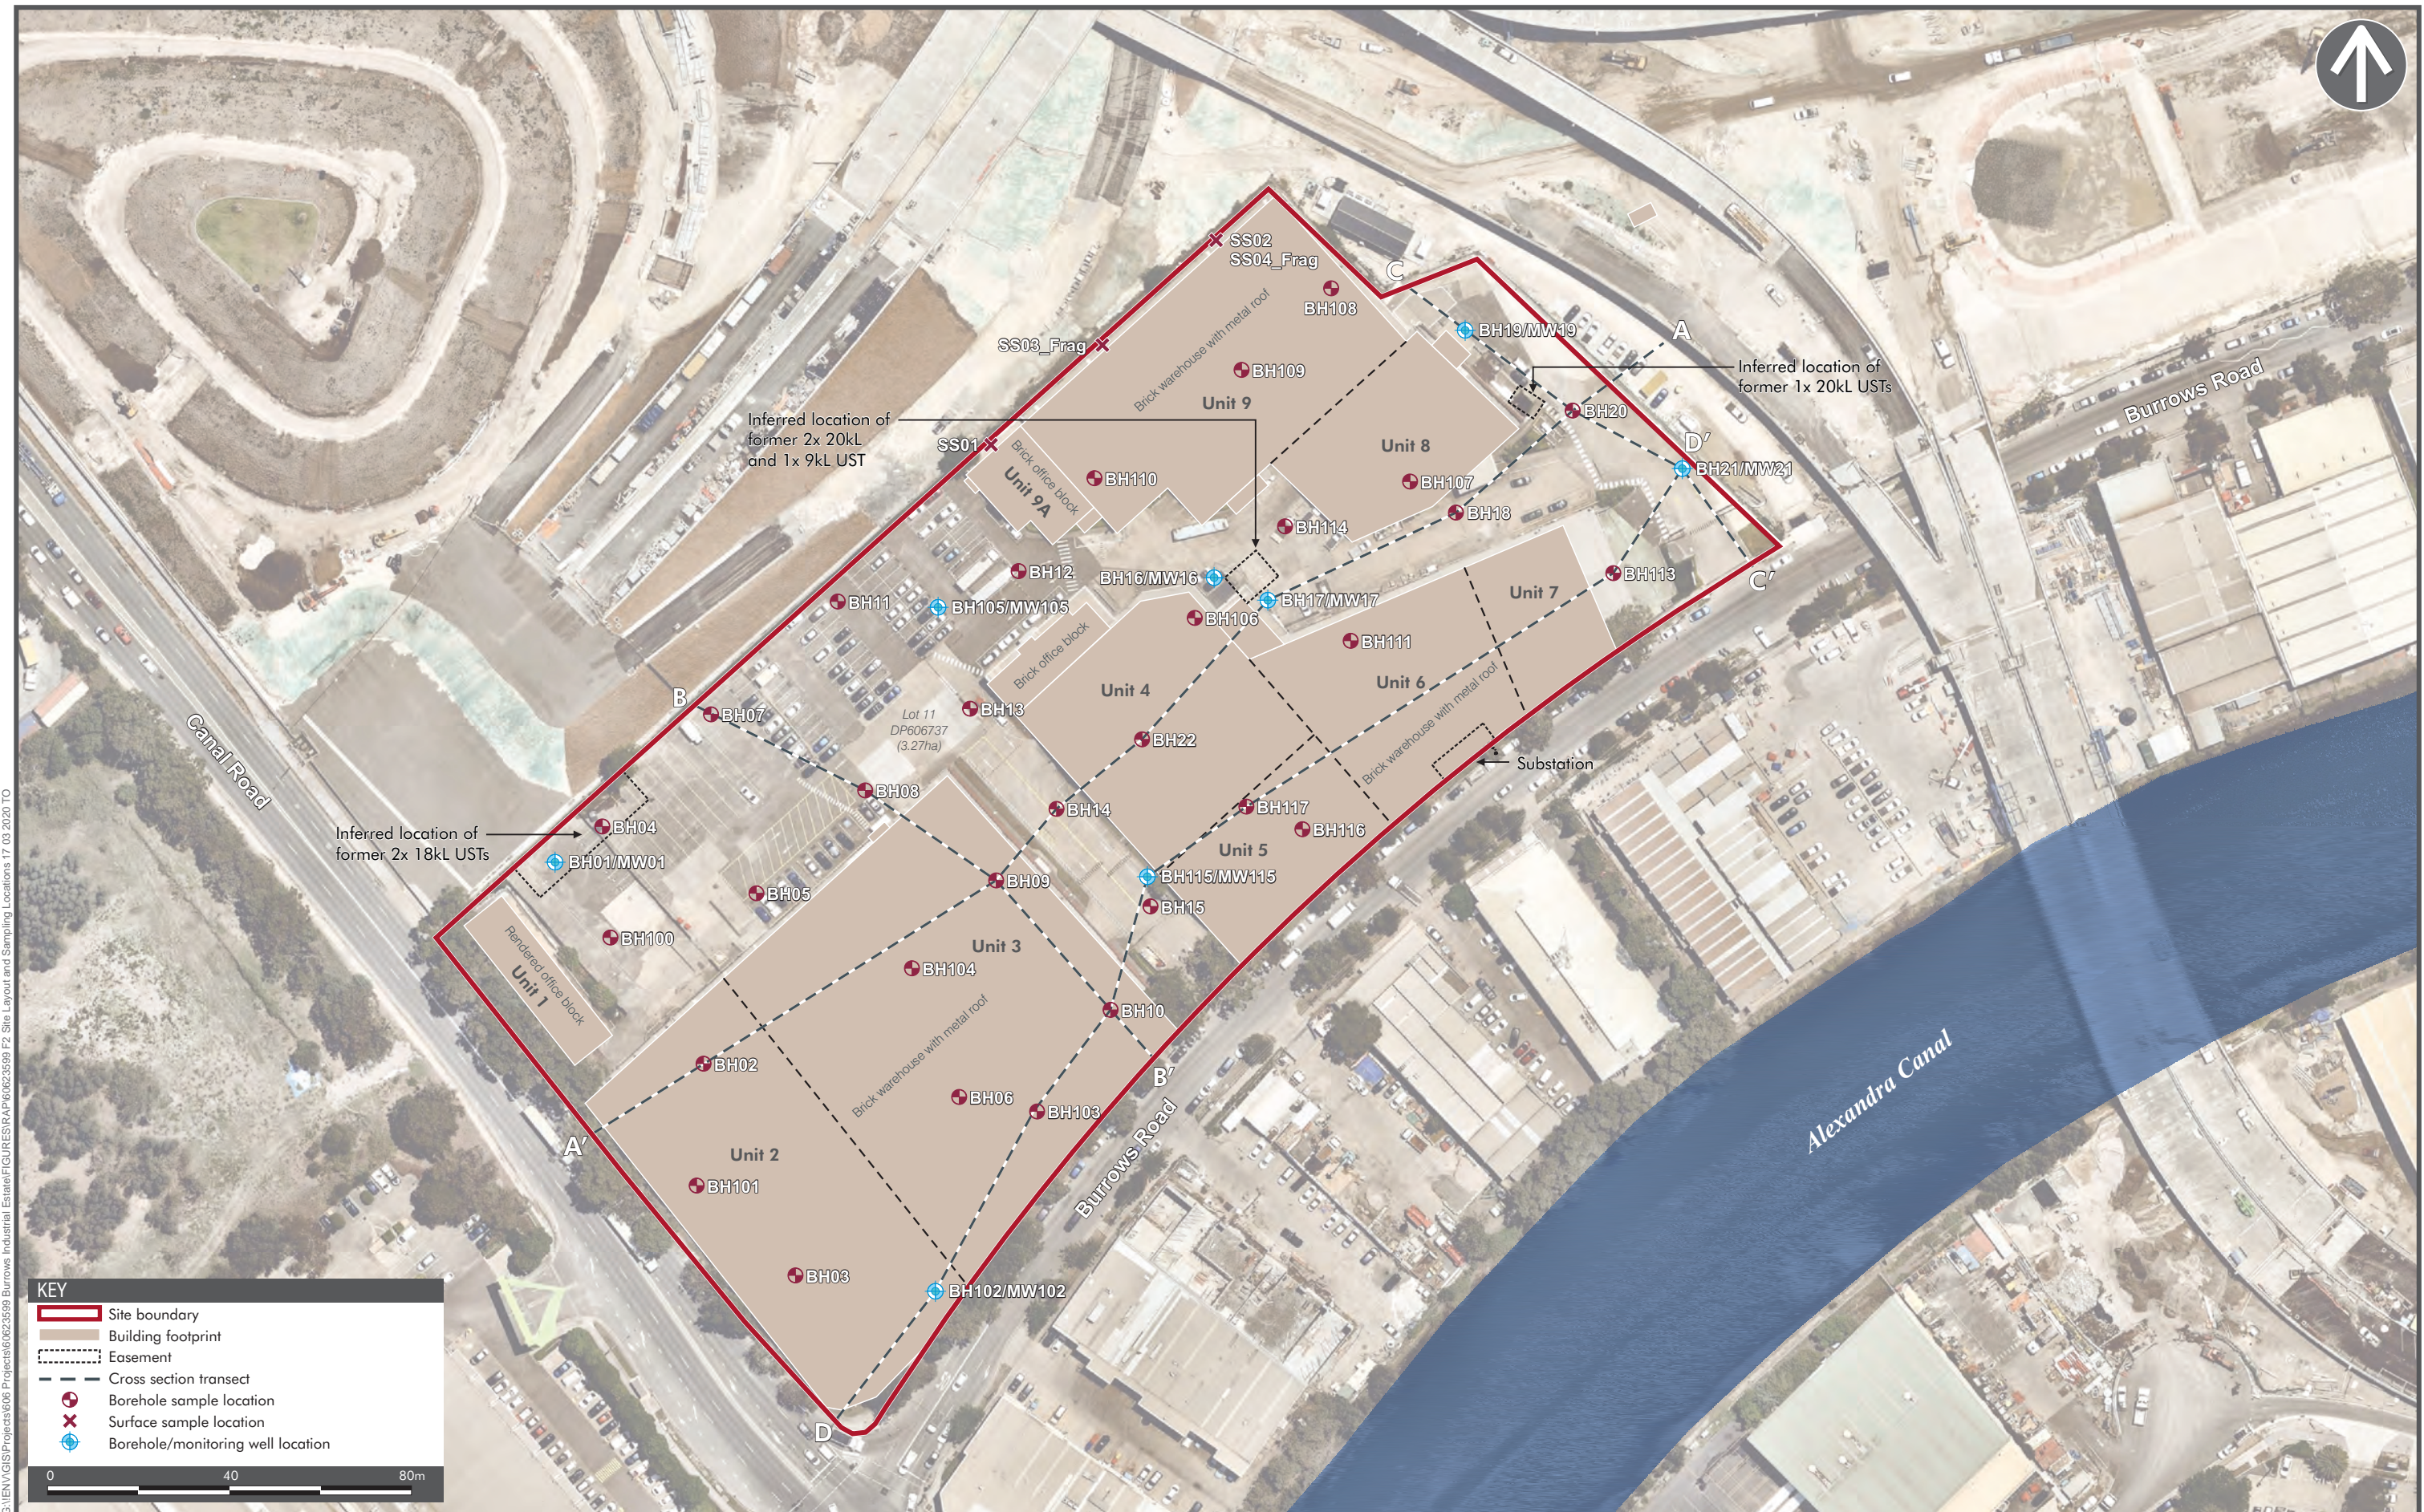
AECOM completed a Phase I and II Environmental Site Assessment (ESA) in March 2020¹. This RAP is based on the ESA data. The ESA sampling location plan is shown in **Figure 2** in **Appendix A** and tables of results are provided in **Appendix B**.
