**RE: BURROWS INDUSTRIAL ESTATE
1-3 BURROWS ROAD, ALEXANDRIA
GEOTECHNICAL INVESTIGATION (2015 & 2019)**

**BURROWS INDUSTRIAL ESTATE
GEOTECHNICAL INVESTIGATION**

PSM2808-005R REV1 MAY 2019

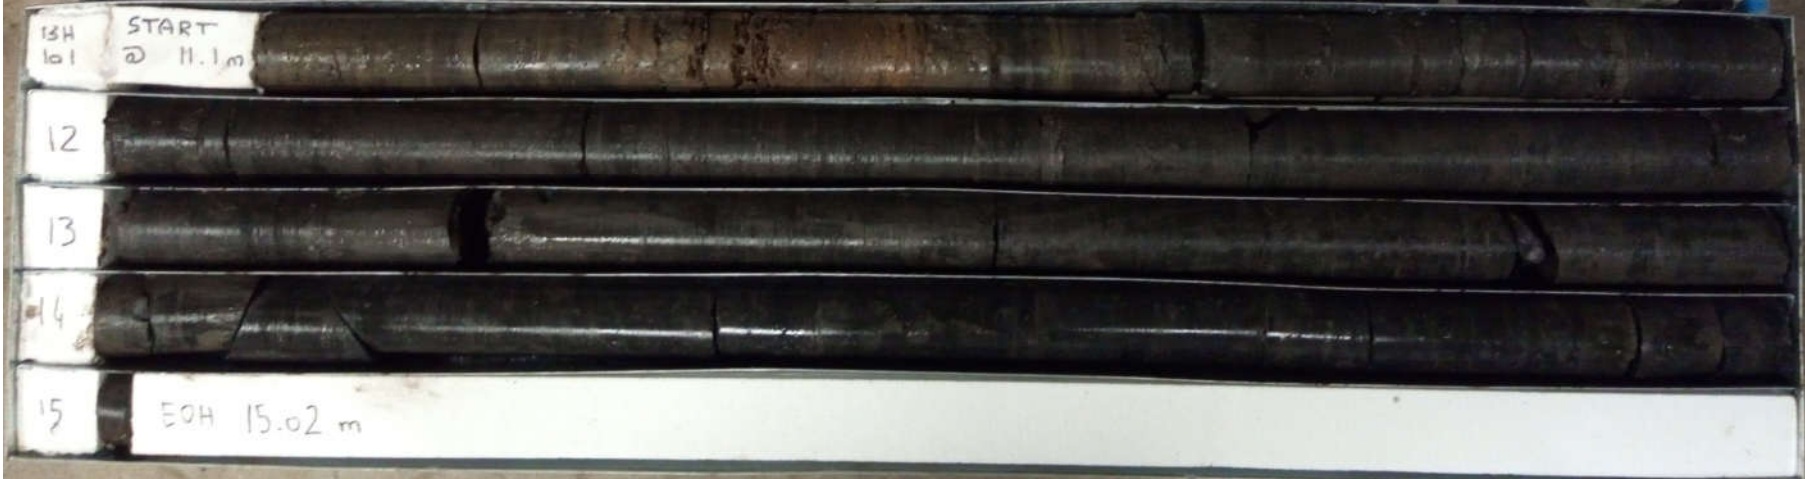
JOB No.: PSM 2808 BH ID: BH01
PROJECT: BURROWS RD
LOCATION: ST PETERS
FROM: 11.1 m TO: 15.2 m DATE: 23/04/19

Goodman Limited
1 - 3 Burrows Road, St Peters
Geotechnical Investigation
BOREHOLES CORE PHOTO
BH01 From 11.1 m to 15.02 m

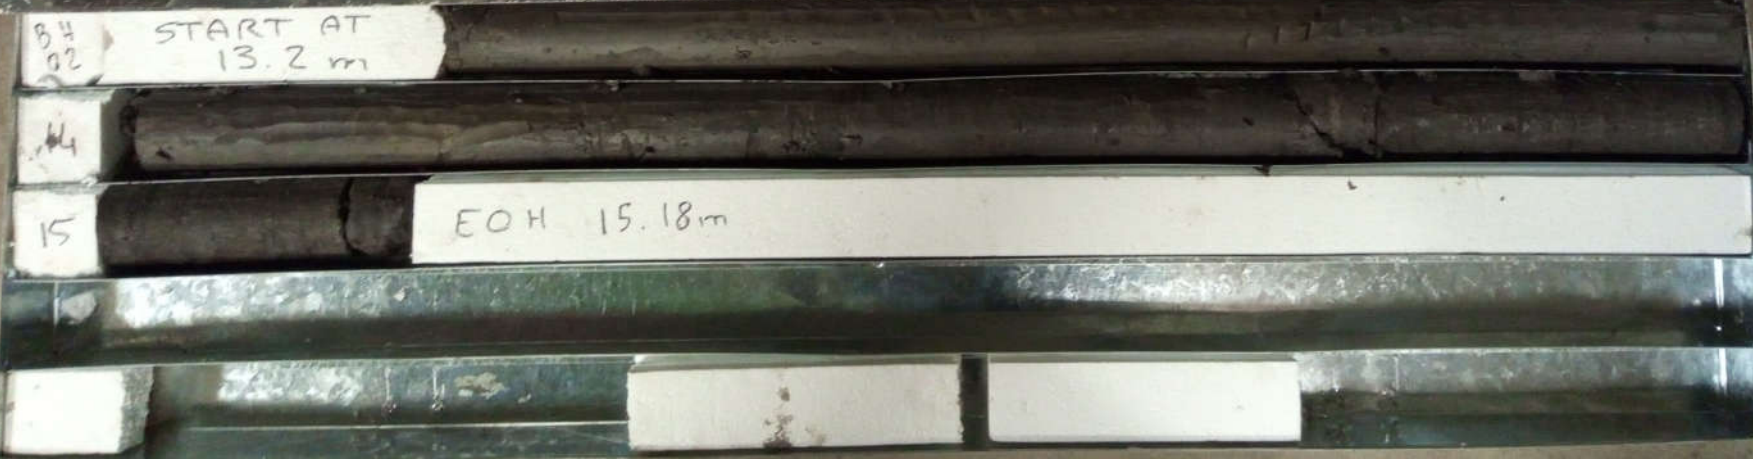
JOB No.: PSM 2808 BH ID: BH02
 PROJECT: BURROWS RD
 LOCATION: ST PETERS
 FROM: 13.2 m TO: 15.18 m DATE: 23/04/19

Goodman Limited
 1 - 3 Burrows Road, St Peters
 Geotechnical Investigation
 BOREHOLES CORE PHOTO
 BH02 From 13.2 m to 15.18 m

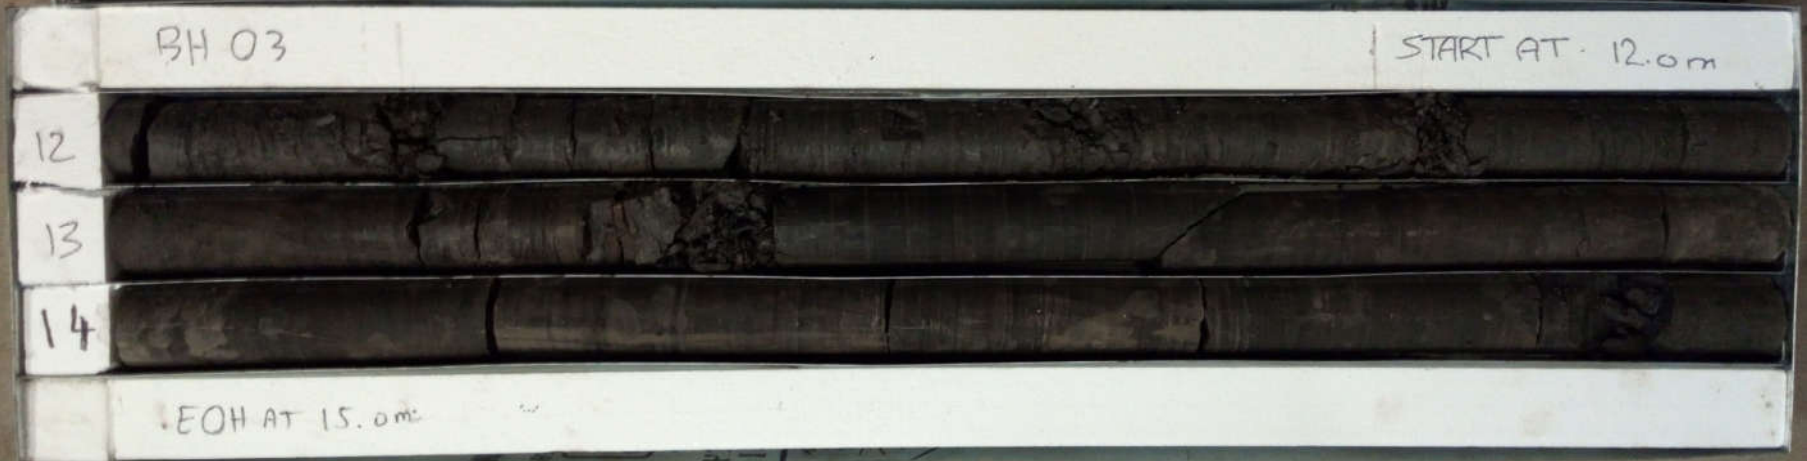
JOB No.: PSM 2808 BH ID: BH03
PROJECT: BURROWS RD
LOCATION: ST PETERS
FROM: 12.0m TO: 15.0m DATE: 24/04/19

Goodman Limited
1 - 3 Burrows Road, St Peters
Geotechnical Investigation
BOREHOLES CORE PHOTO
BH03 From 12.0 m to 15.0 m

We observed hydrocarbon within BH03 during drilling. Environmental assessment may be required to remove groundwater and material in this area.
