# Phase I & Limited Scope Phase II ESA

1-3 Burrows Road, St Peters

Client: Goodman Property Services (Aust) Pty Ltd

30-Sep-2015

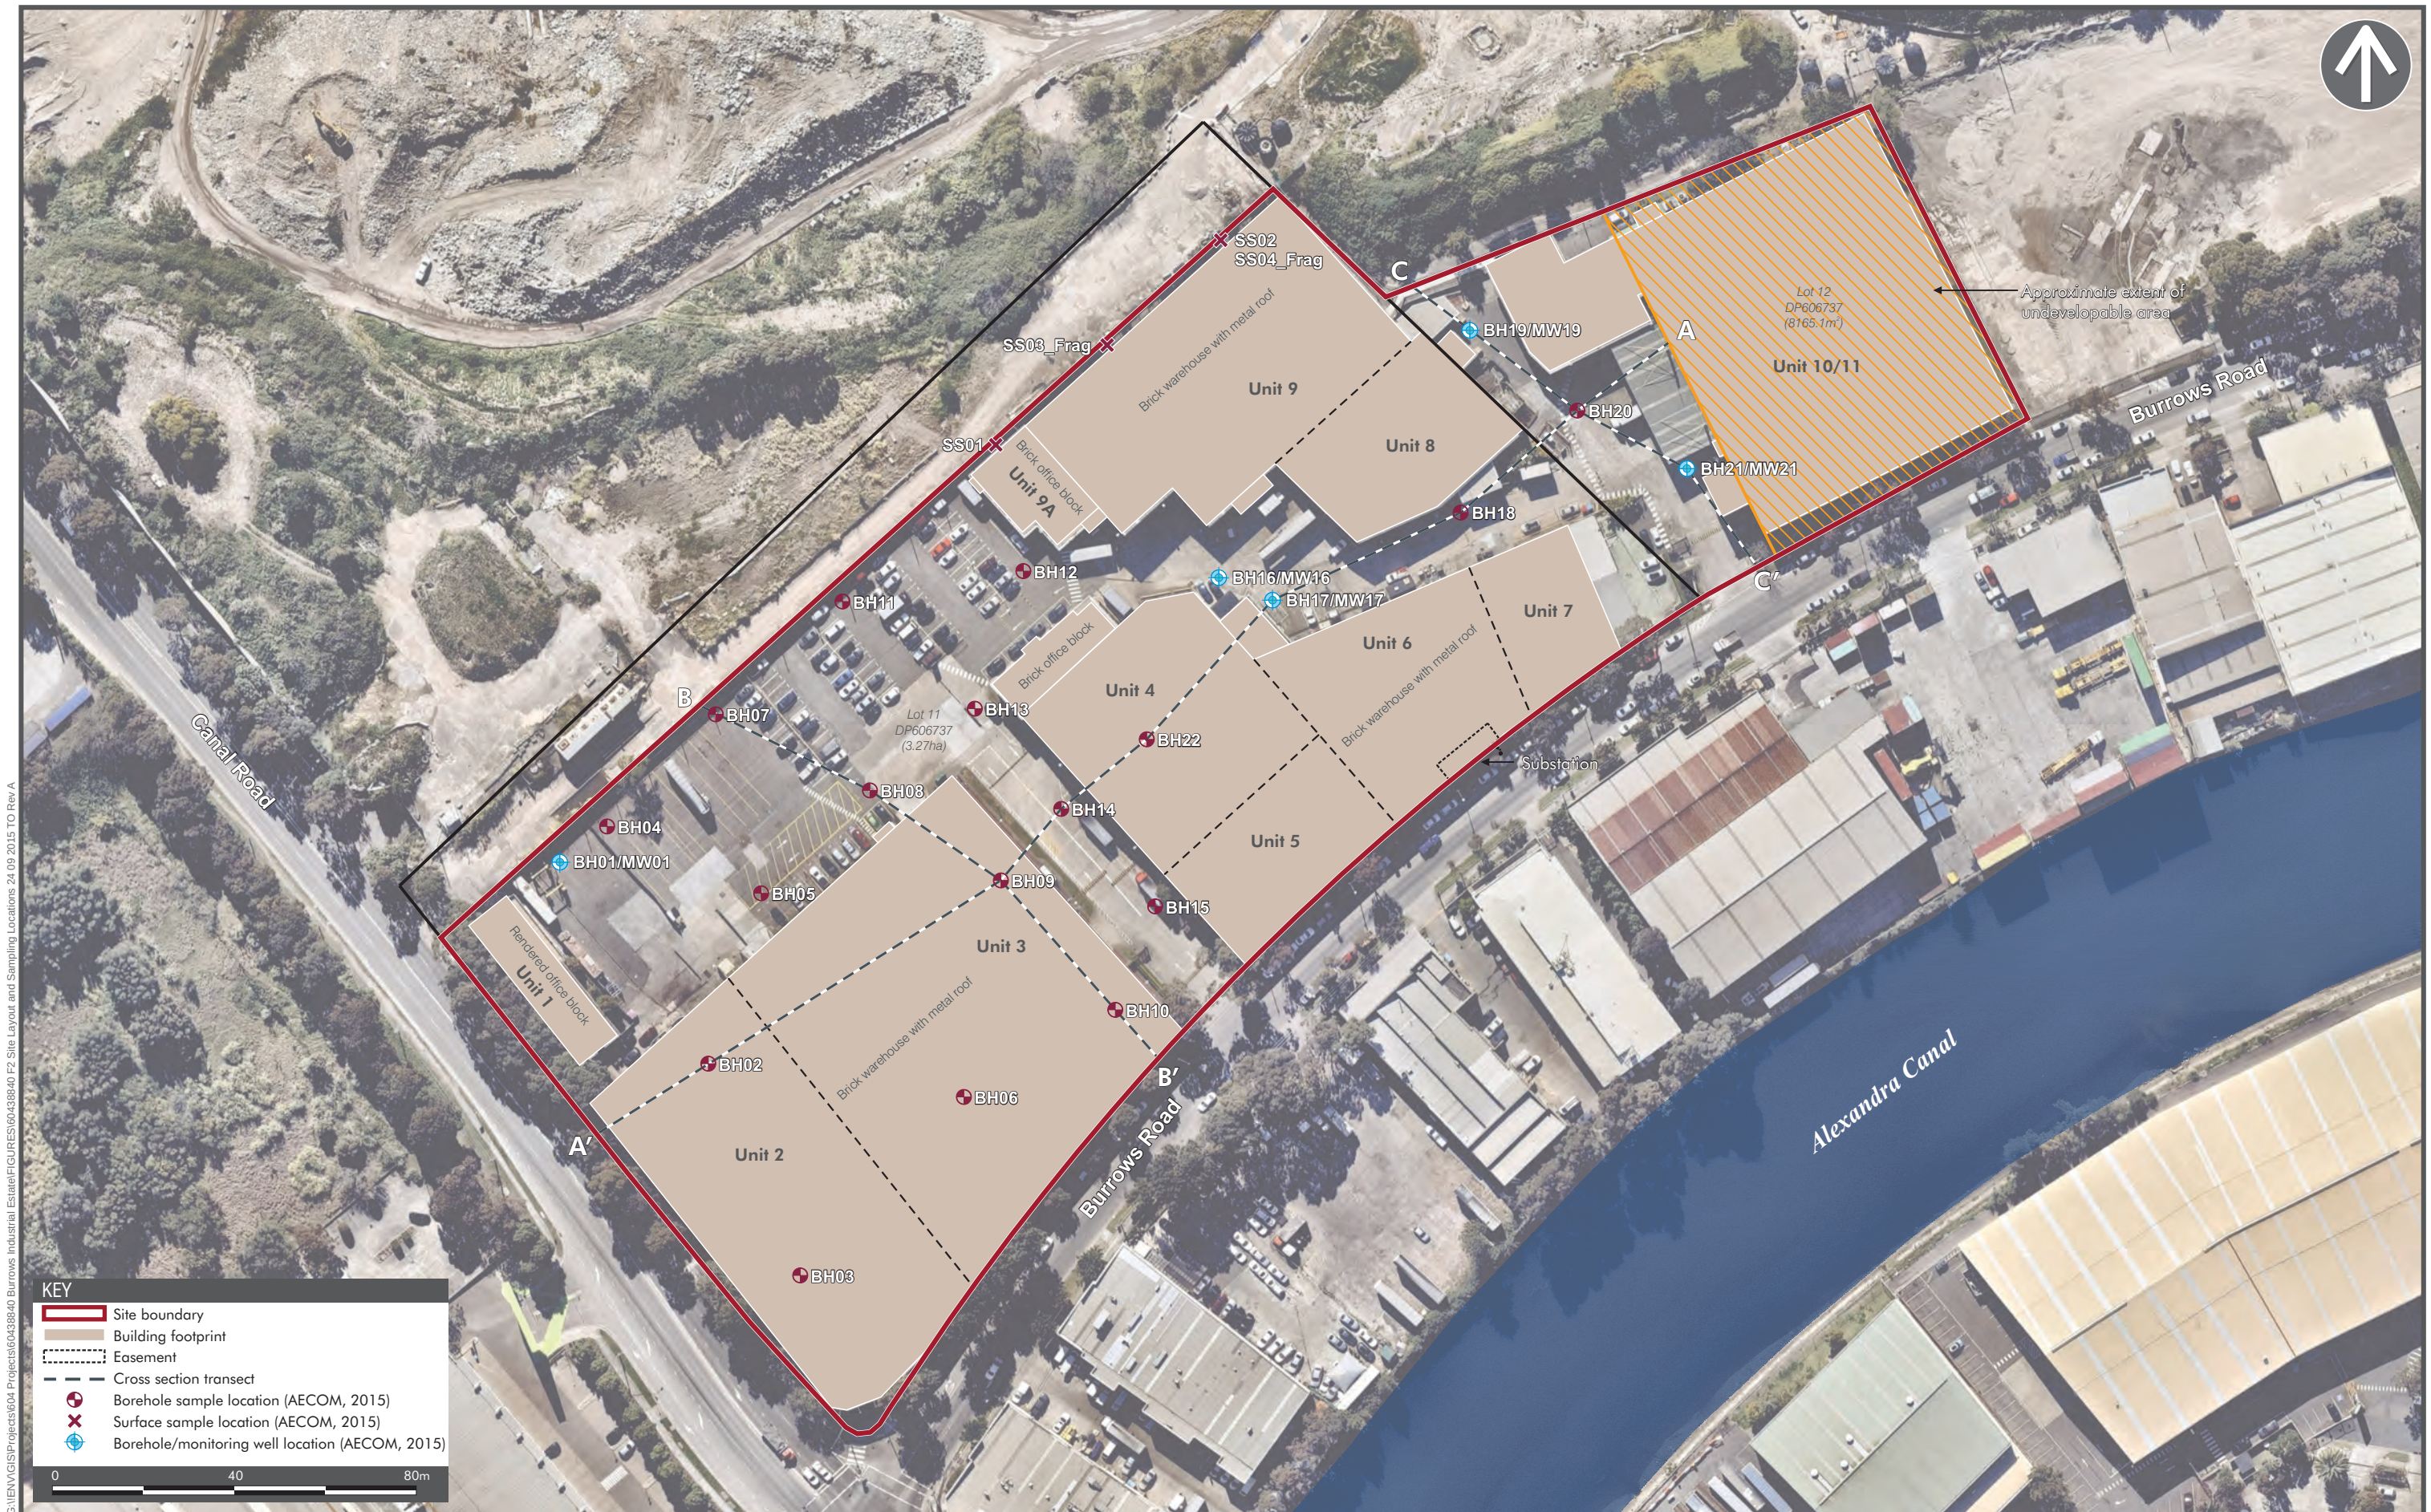
**FIGURE 2**

## SITE LAYOUT AND SAMPLING LOCATIONS

**Note:** Unit areas are approximate and inferred only

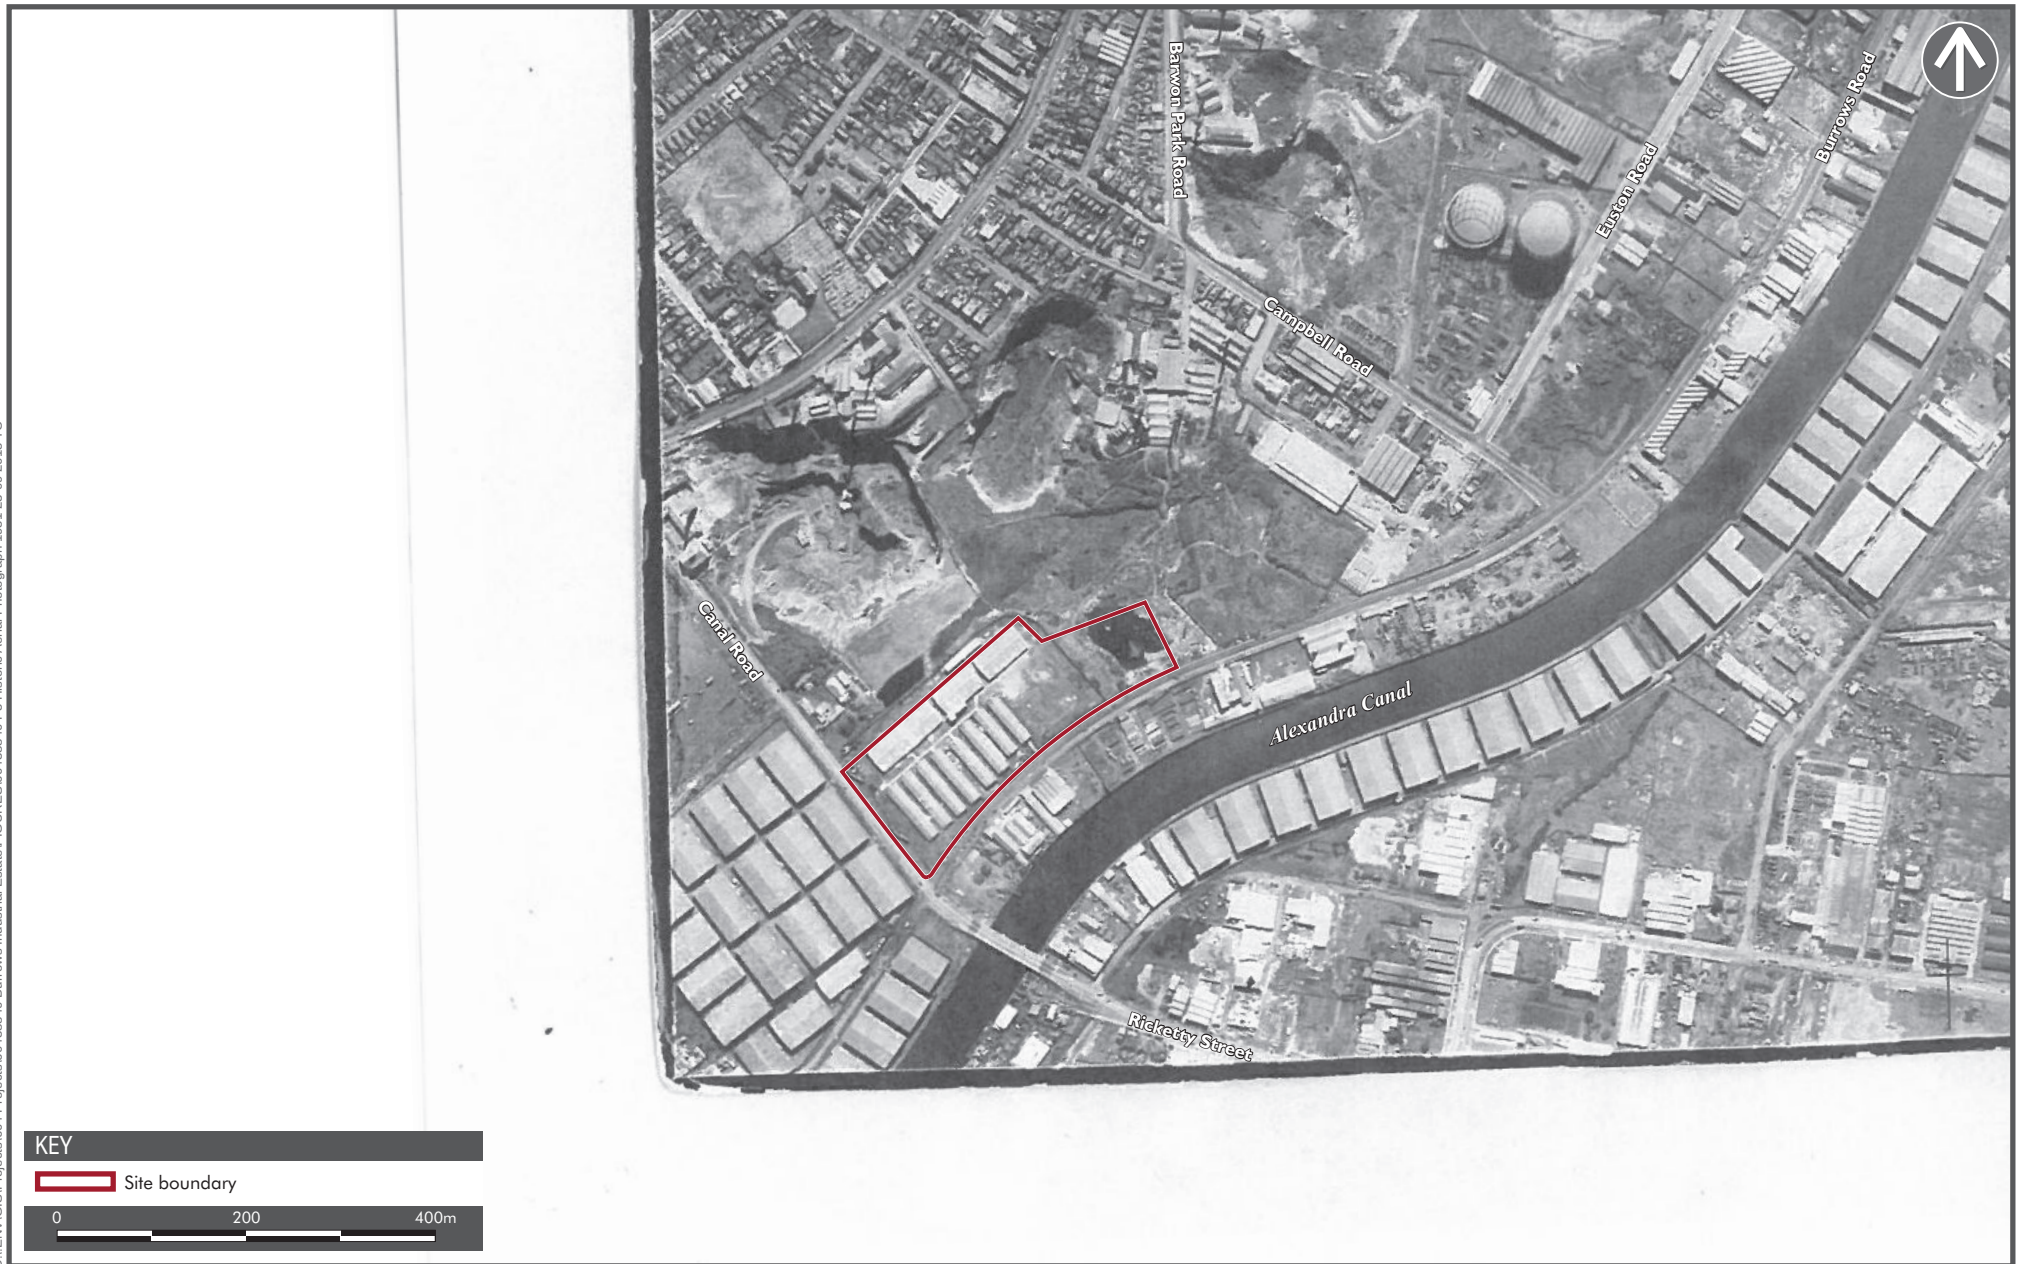
G:\ENVI\GIS\Projects\604 Projects\60438840 Burrows Industrial Estate\FIGURES\60438840 F6 Historic Aerial Photograph 1961 23 09 2015 TO

| Year | Comments |
|---|---|
| 1961<br>(Figure 6) | <p><b>Site:</b> eight buildings fronting Burrows Road are still present. There appears to have been additions to the buildings at the north western boundary area. Unit 1 appears to be present. The north eastern portion of Lot 11 appears to remain undeveloped. The dark area noted in Lot 12 in the 1943 photograph is not visible and appears to be 'filled' ground.</p> <p><b>Surrounds:</b> Expansion of brick-pit excavations, towards the Site. Cluster of buildings noted at 5/5A Canal Road, possibly representing the metal smelter.</p> |
