# 1-3 Burrows Road, St Peters - Soil Salinity Investigation

SSD-35962232: Burrows Road Multi-level  
Warehouse, St Peters

PSM2808-012R REV1      12 September 2022

Goodman Property Services (Aust) Pty Ltd

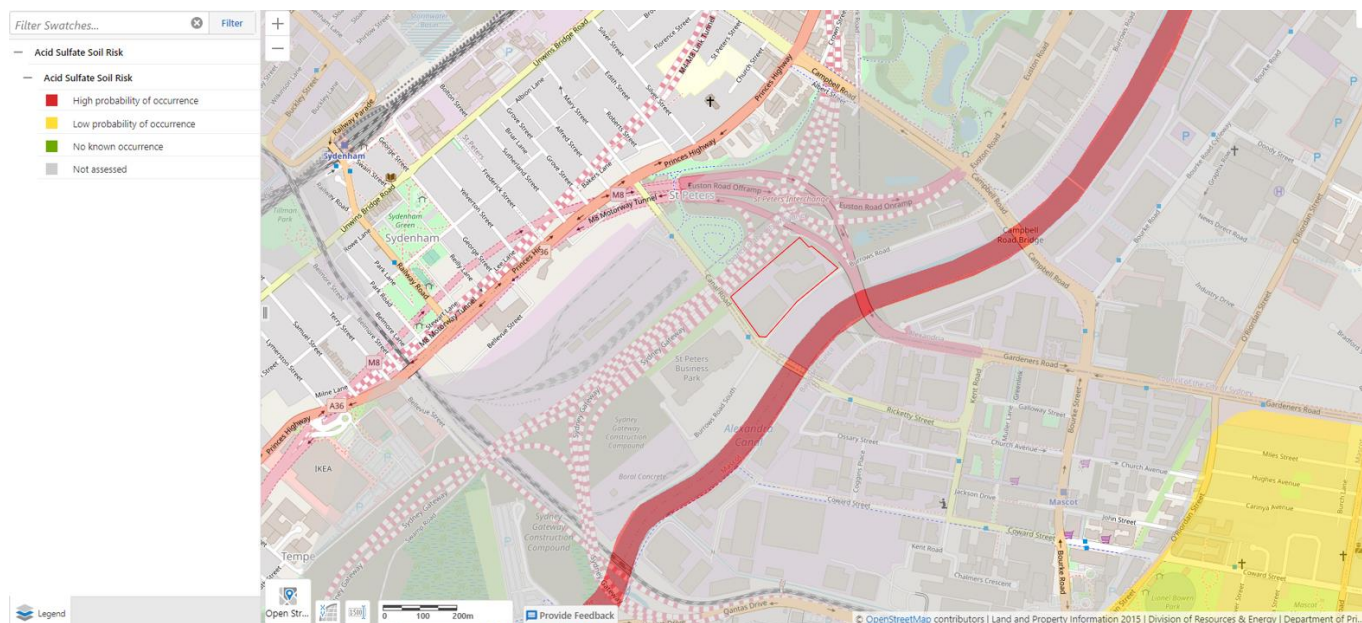
Based on the NSW Government SEED (Sharing and Enabling Environmental Data), the risk of acid sulfate soil is not assessed for the site.

**Inset 2: Acid Sulphate Soils Map – Red outline defines approximate site boundary**

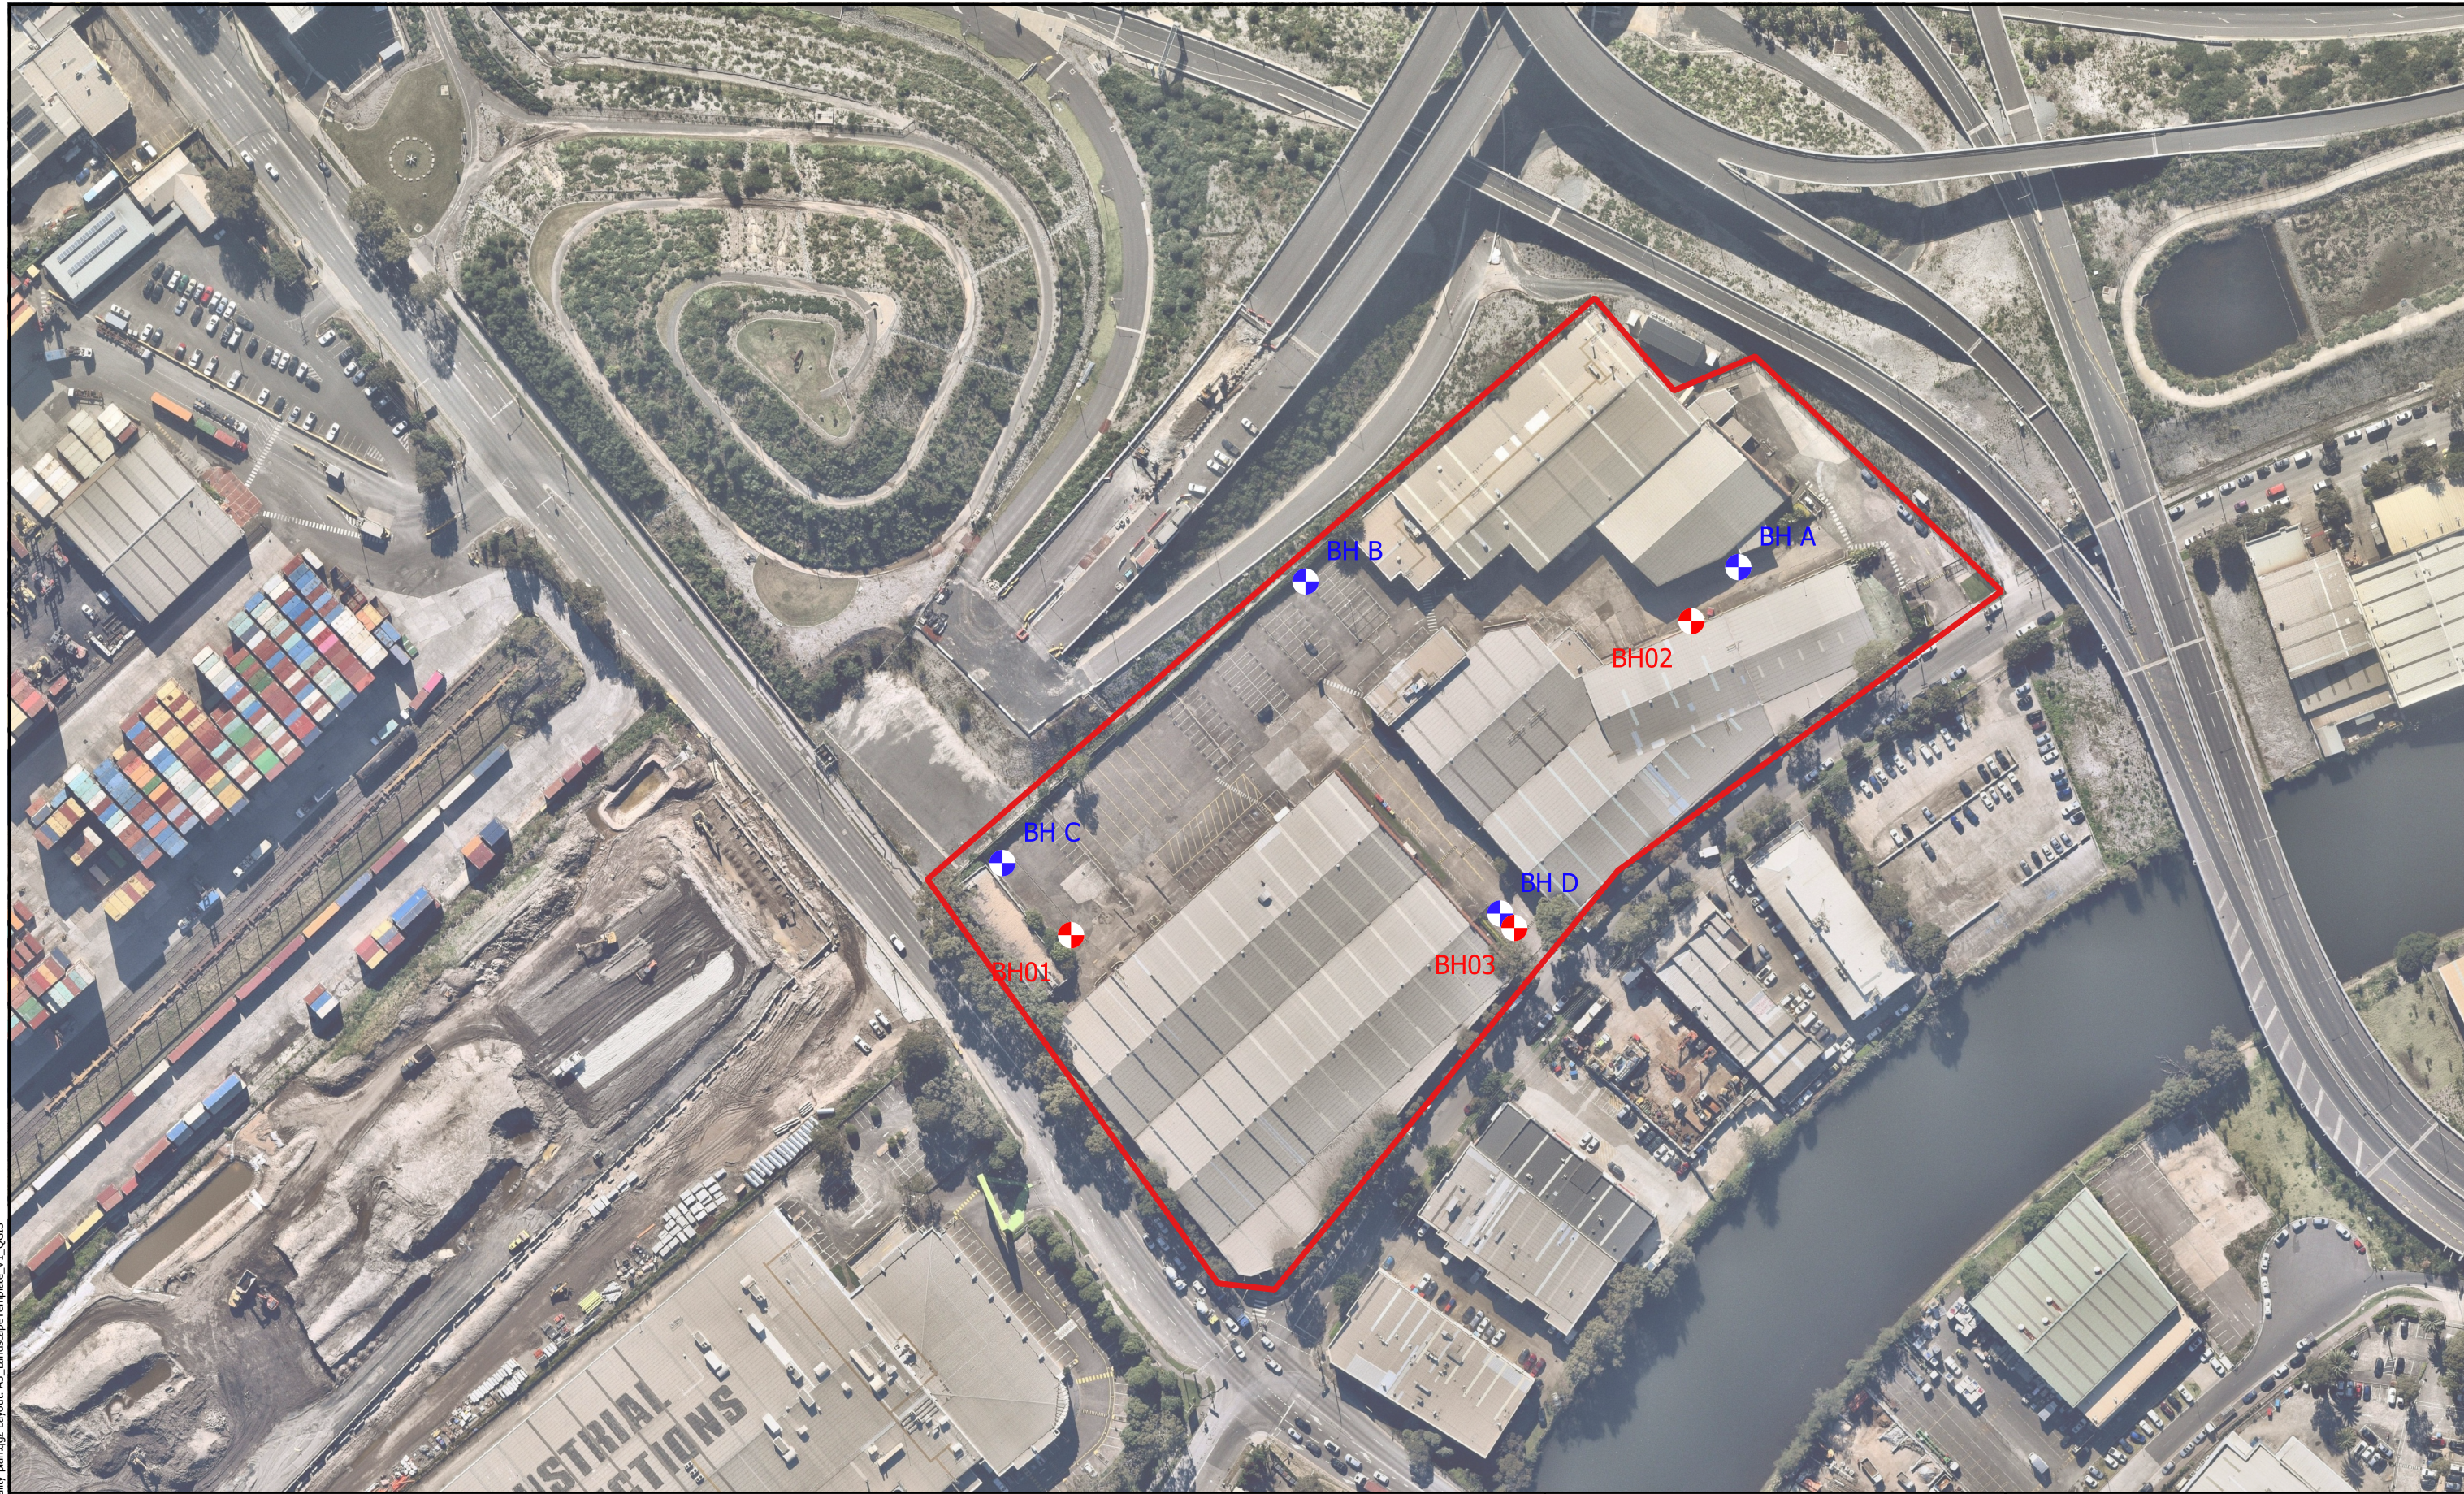
PSM2808-012R	Figure 1
--------------	----------

**Site Locality Plan  
Borehole Locations**

Figure 1 presents a site locality plan of the geotechnical investigation for the proposed development. Figure 2 and 3 present selected site photos.

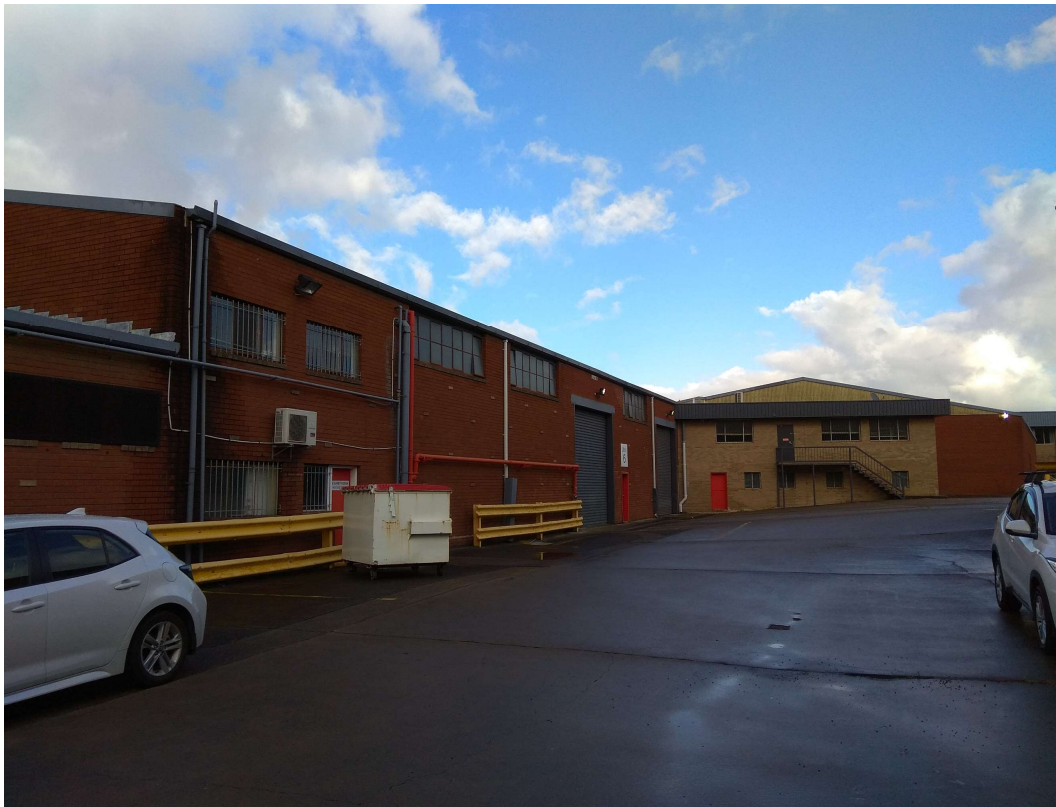
Photo 1: General site photo of the site near BH A looking towards the West (11/07/2022)

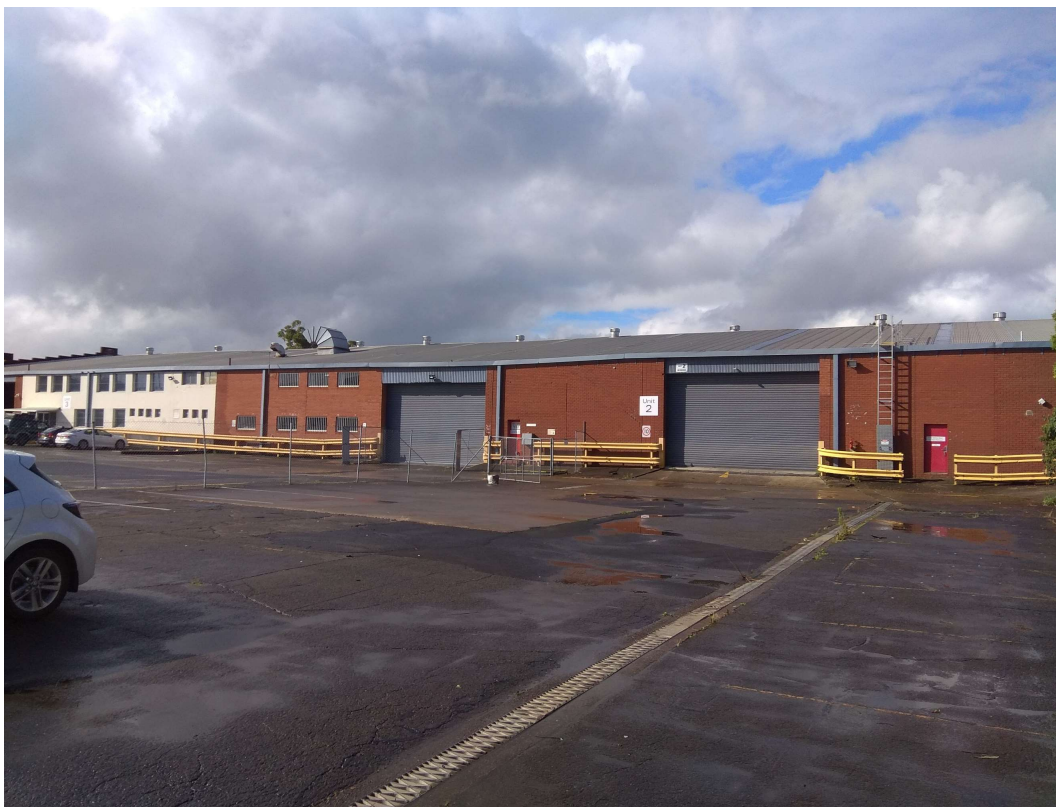
Photo 1: General site photo of the site near BH C looking towards the South East (11/07/2022)

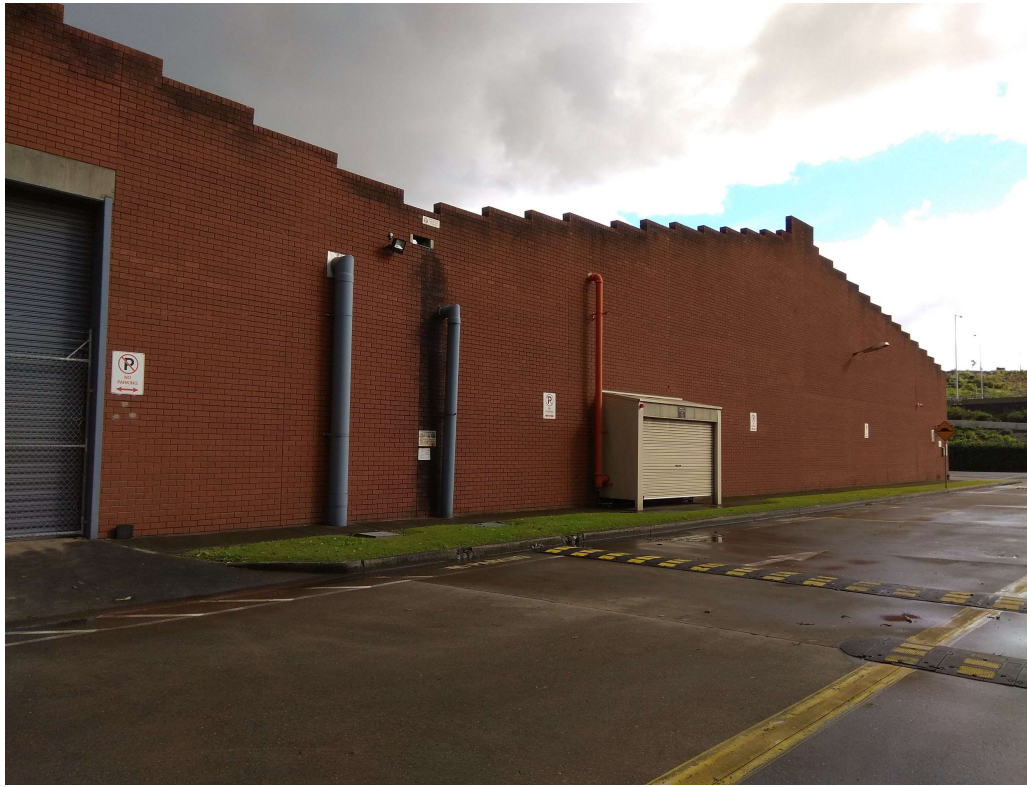
Photo 1: General site photo of the site near BH D looking towards the North west (11/07/2022)

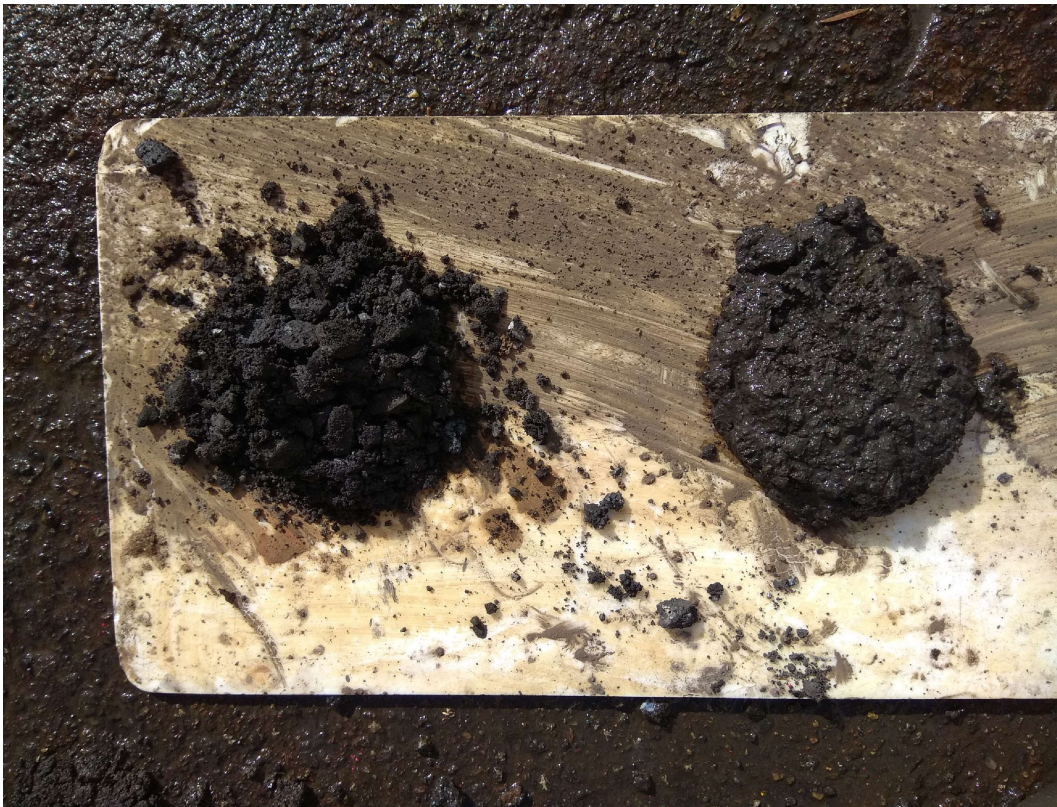
Photo 4: Typical FILL retrieved from the boreholes (11/07/2022)
