# Geotechnical Interpretive Report

## Shoalhaven Hospital Redevelopment

Prepared for  
NSW Health Infrastructure

29 June 2022

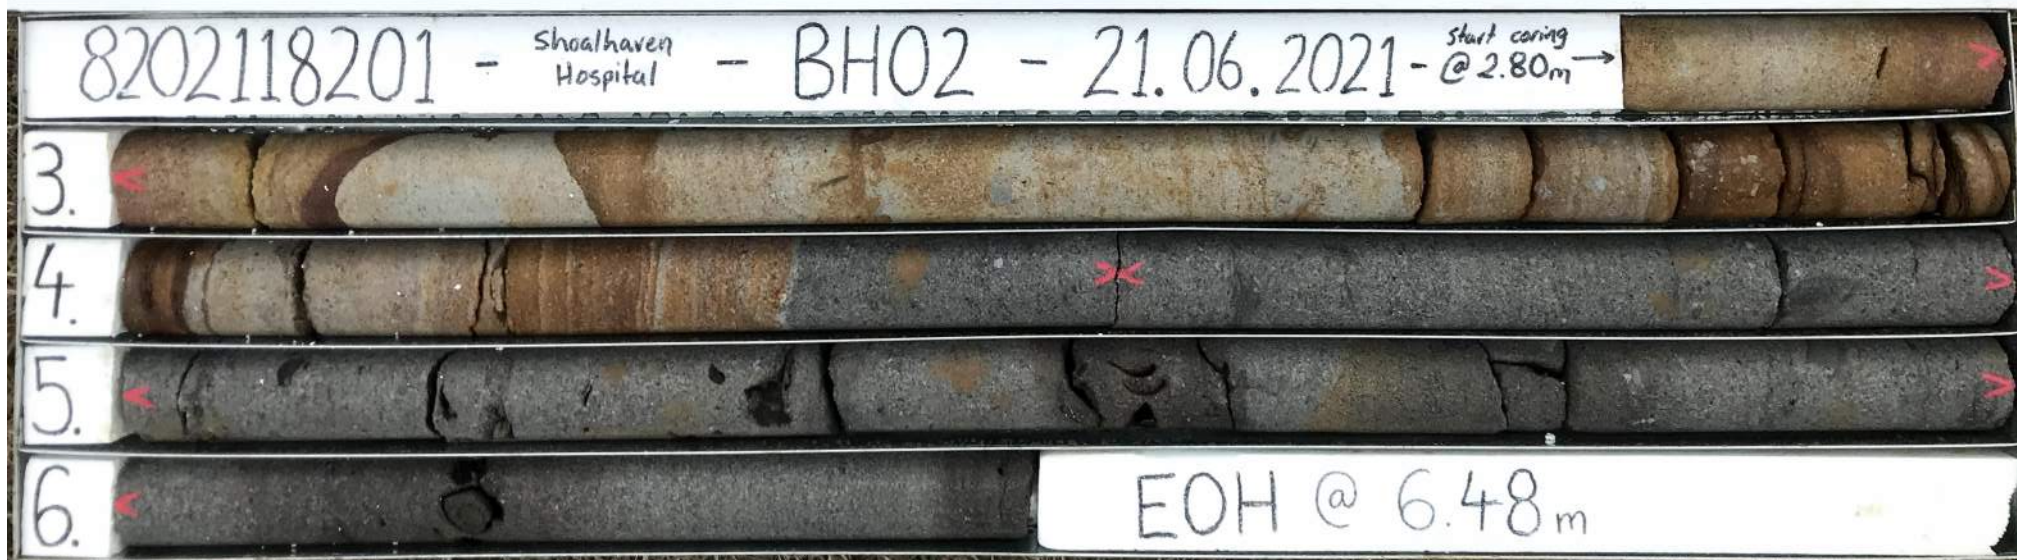
<b>Client:</b> NSW Health Infrastructure		<b>Hole No: BH03</b>	
<b>Project:</b> Shoalhaven Hospital		<b>Sheet: 1 of 3</b>	
<b>Location:</b> Scenic Drive, Nowra NSW 2541		<b>Job No:</b> 8202118201	
<b>Position:</b> E280285.178 N6138699.830 56 MGA2020		<b>Angle from Horizontal:</b> 90°	
<b>Rig Type:</b> Hanjin D&B 8D		<b>Surface Elevation:</b> 18.620 m AHD	
<b>Casing Diameter:</b> HW		<b>Driller:</b> CM	
<b>Date Started:</b> 21/6/21		<b>Contractor:</b> Total Drilling	
<b>Date Completed:</b> 21/6/21		<b>Checked By:</b> DR	
<b>Logged By:</b> BA

Drilling			Sampling & Testing		Material Description								
Method	Resistance	Casing			Water	Sample or Field Test	RL (m AHD)	Depth (m)	Graphic Log	Classification	SOIL TYPE, plasticity or particle characteristic, colour, secondary and minor components ROCK TYPE, grain size and type, colour, fabric & texture, strength, weathering, defects and structure	Moisture Condition	Consistency Relative Density
AD/T	E	HW	Not Encountered	ES 0.10 m	18.5	0.20m

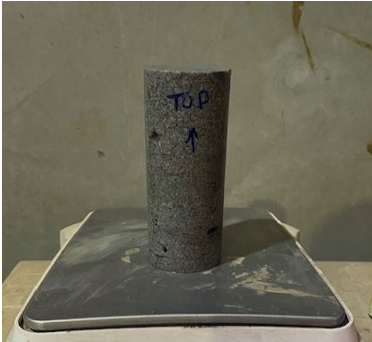
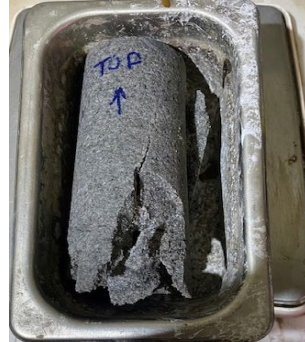
BH01

Specimen - After Failure

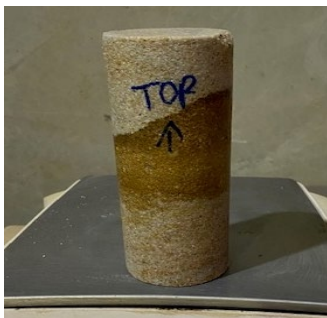
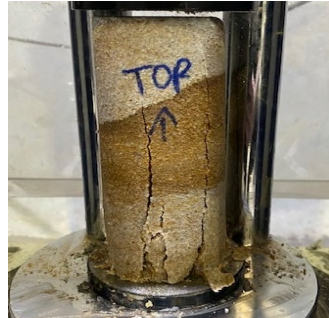
BH02

#### Uniaxial Compressive Strength (UCS Less Than 50 Mpa)

Specimen - After Failure
