Report on
Geotechnical Investigation

Proposed Industrial Development
42 Boorea Road, Lidcombe

Prepared for
Hale Property Services Pty Ltd

Project 210950.00
May 2022

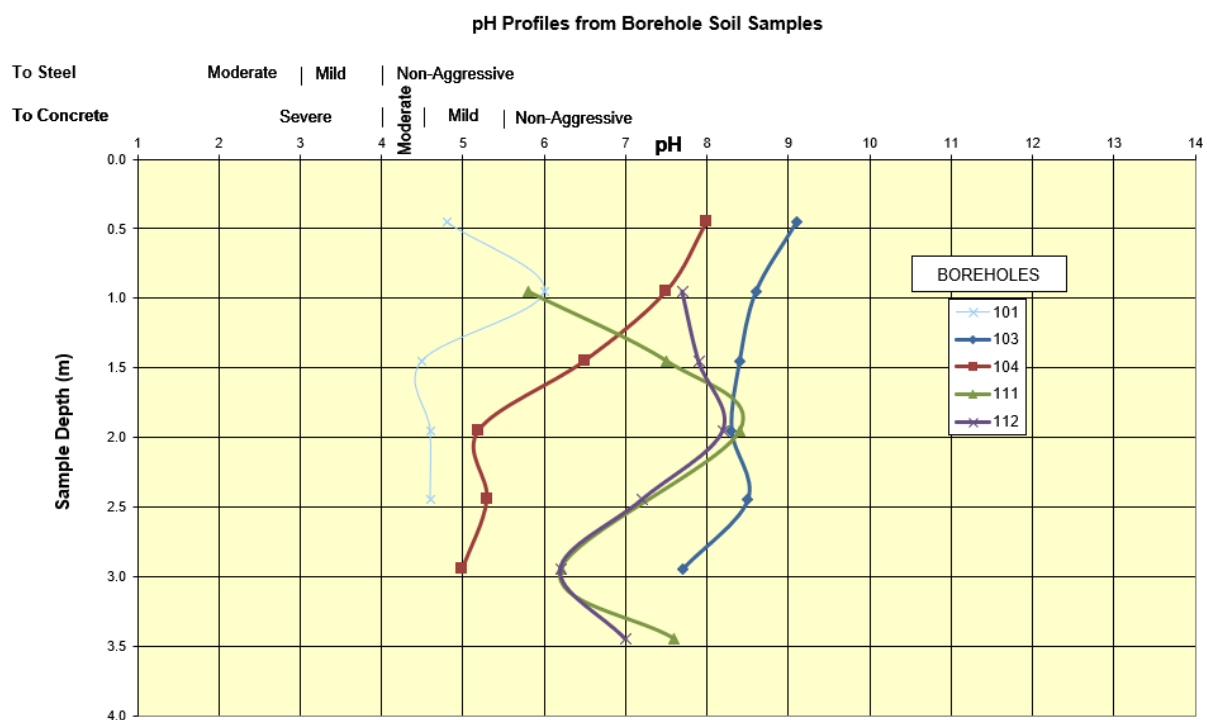
Figure 3. Vertical pH Profiles

Test results showing the aggressivity assessed by pH, resistivity, sulphate concentrations and chloride concentration criteria (of AS 2159) at the borehole locations, together with the aggressivity class ranges indicated in Australian Standard AS 2159 are given in Appendix D. The absence of free groundwater in the boreholes and the inferred very low permeability of the sampled clay-rich soils indicate that soils at all boreholes are in Condition “B” as defined by AS 2159.

The results show that the samples tested indicate the ground conditions are non-aggressive to moderately aggressive to concrete and non-aggressive to mildly steel with reference to AS2159. The pH profiles with depth are shown in Figure 3.

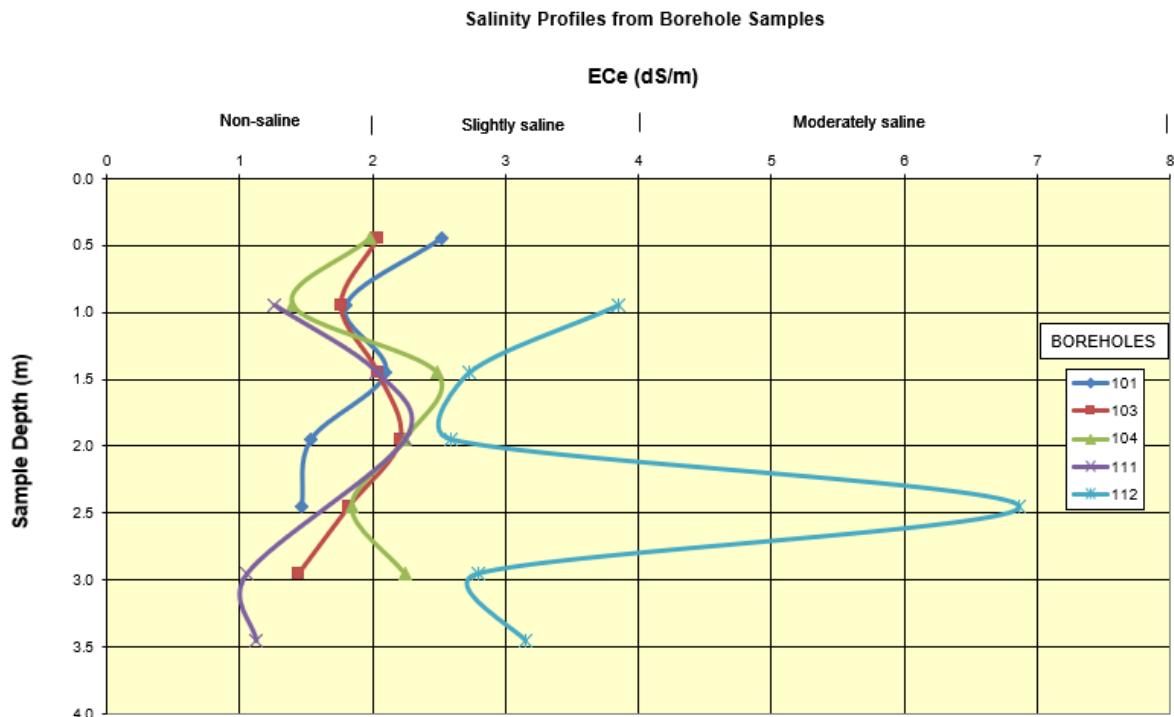
Figure 4. Vertical Salinity Profiles and Salinity Classes

Figure 4 shows the salinity classifications based on the electrical conductivity (ECe) at borehole locations, together with the salinity classifications of Richards (1954). Test results are provided in Appendix D.

The results indicate that the samples tested were varied ranging from non-saline to moderately saline.

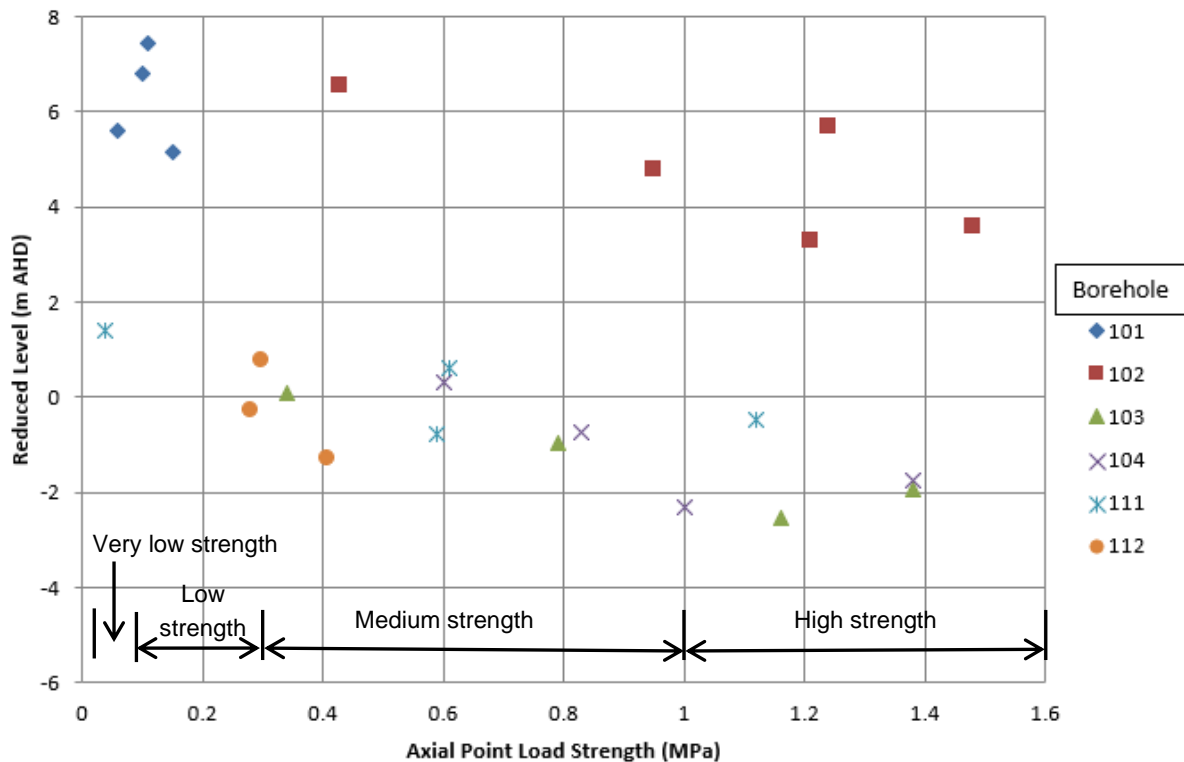
Figure 5. Results of Axial Point Load Tests

Point Load Strength Index (Is_{50}) testing was carried out on selected rock core specimens. The results of the tests are shown on the borehole logs at the appropriate depths. Figure 5 (following page) shows the range of Is_{50} results at the various depths (shown as Reduced Levels relative to AHD).

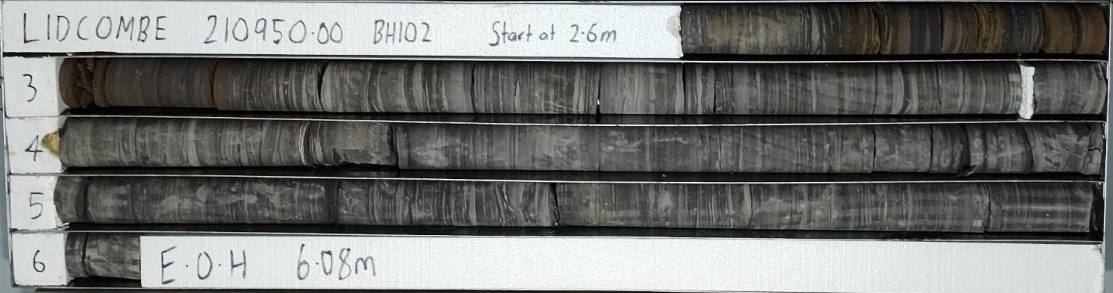
Project No: 210950.00
BH ID: BH102
Depth: 2.6-6.08m
Core Box No.: 1/1

2.6m – 6.08m

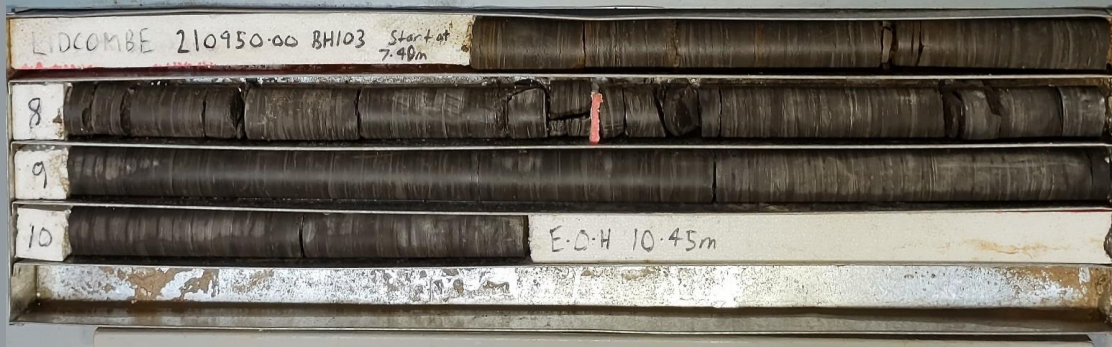
Project No: 210950-00
BH ID: BH103
Depth: 7.40-10.45m
Core Box No.: 1/1

7.4m – 10.45m

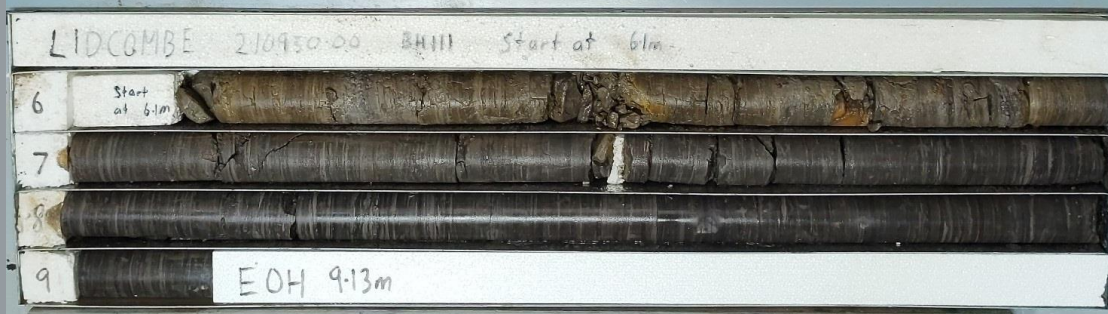
Project No: 210950.00
BH ID: BH111
Depth: 6.1-9.13m
Core Box No.: 1/1

6.1m – 9.13m

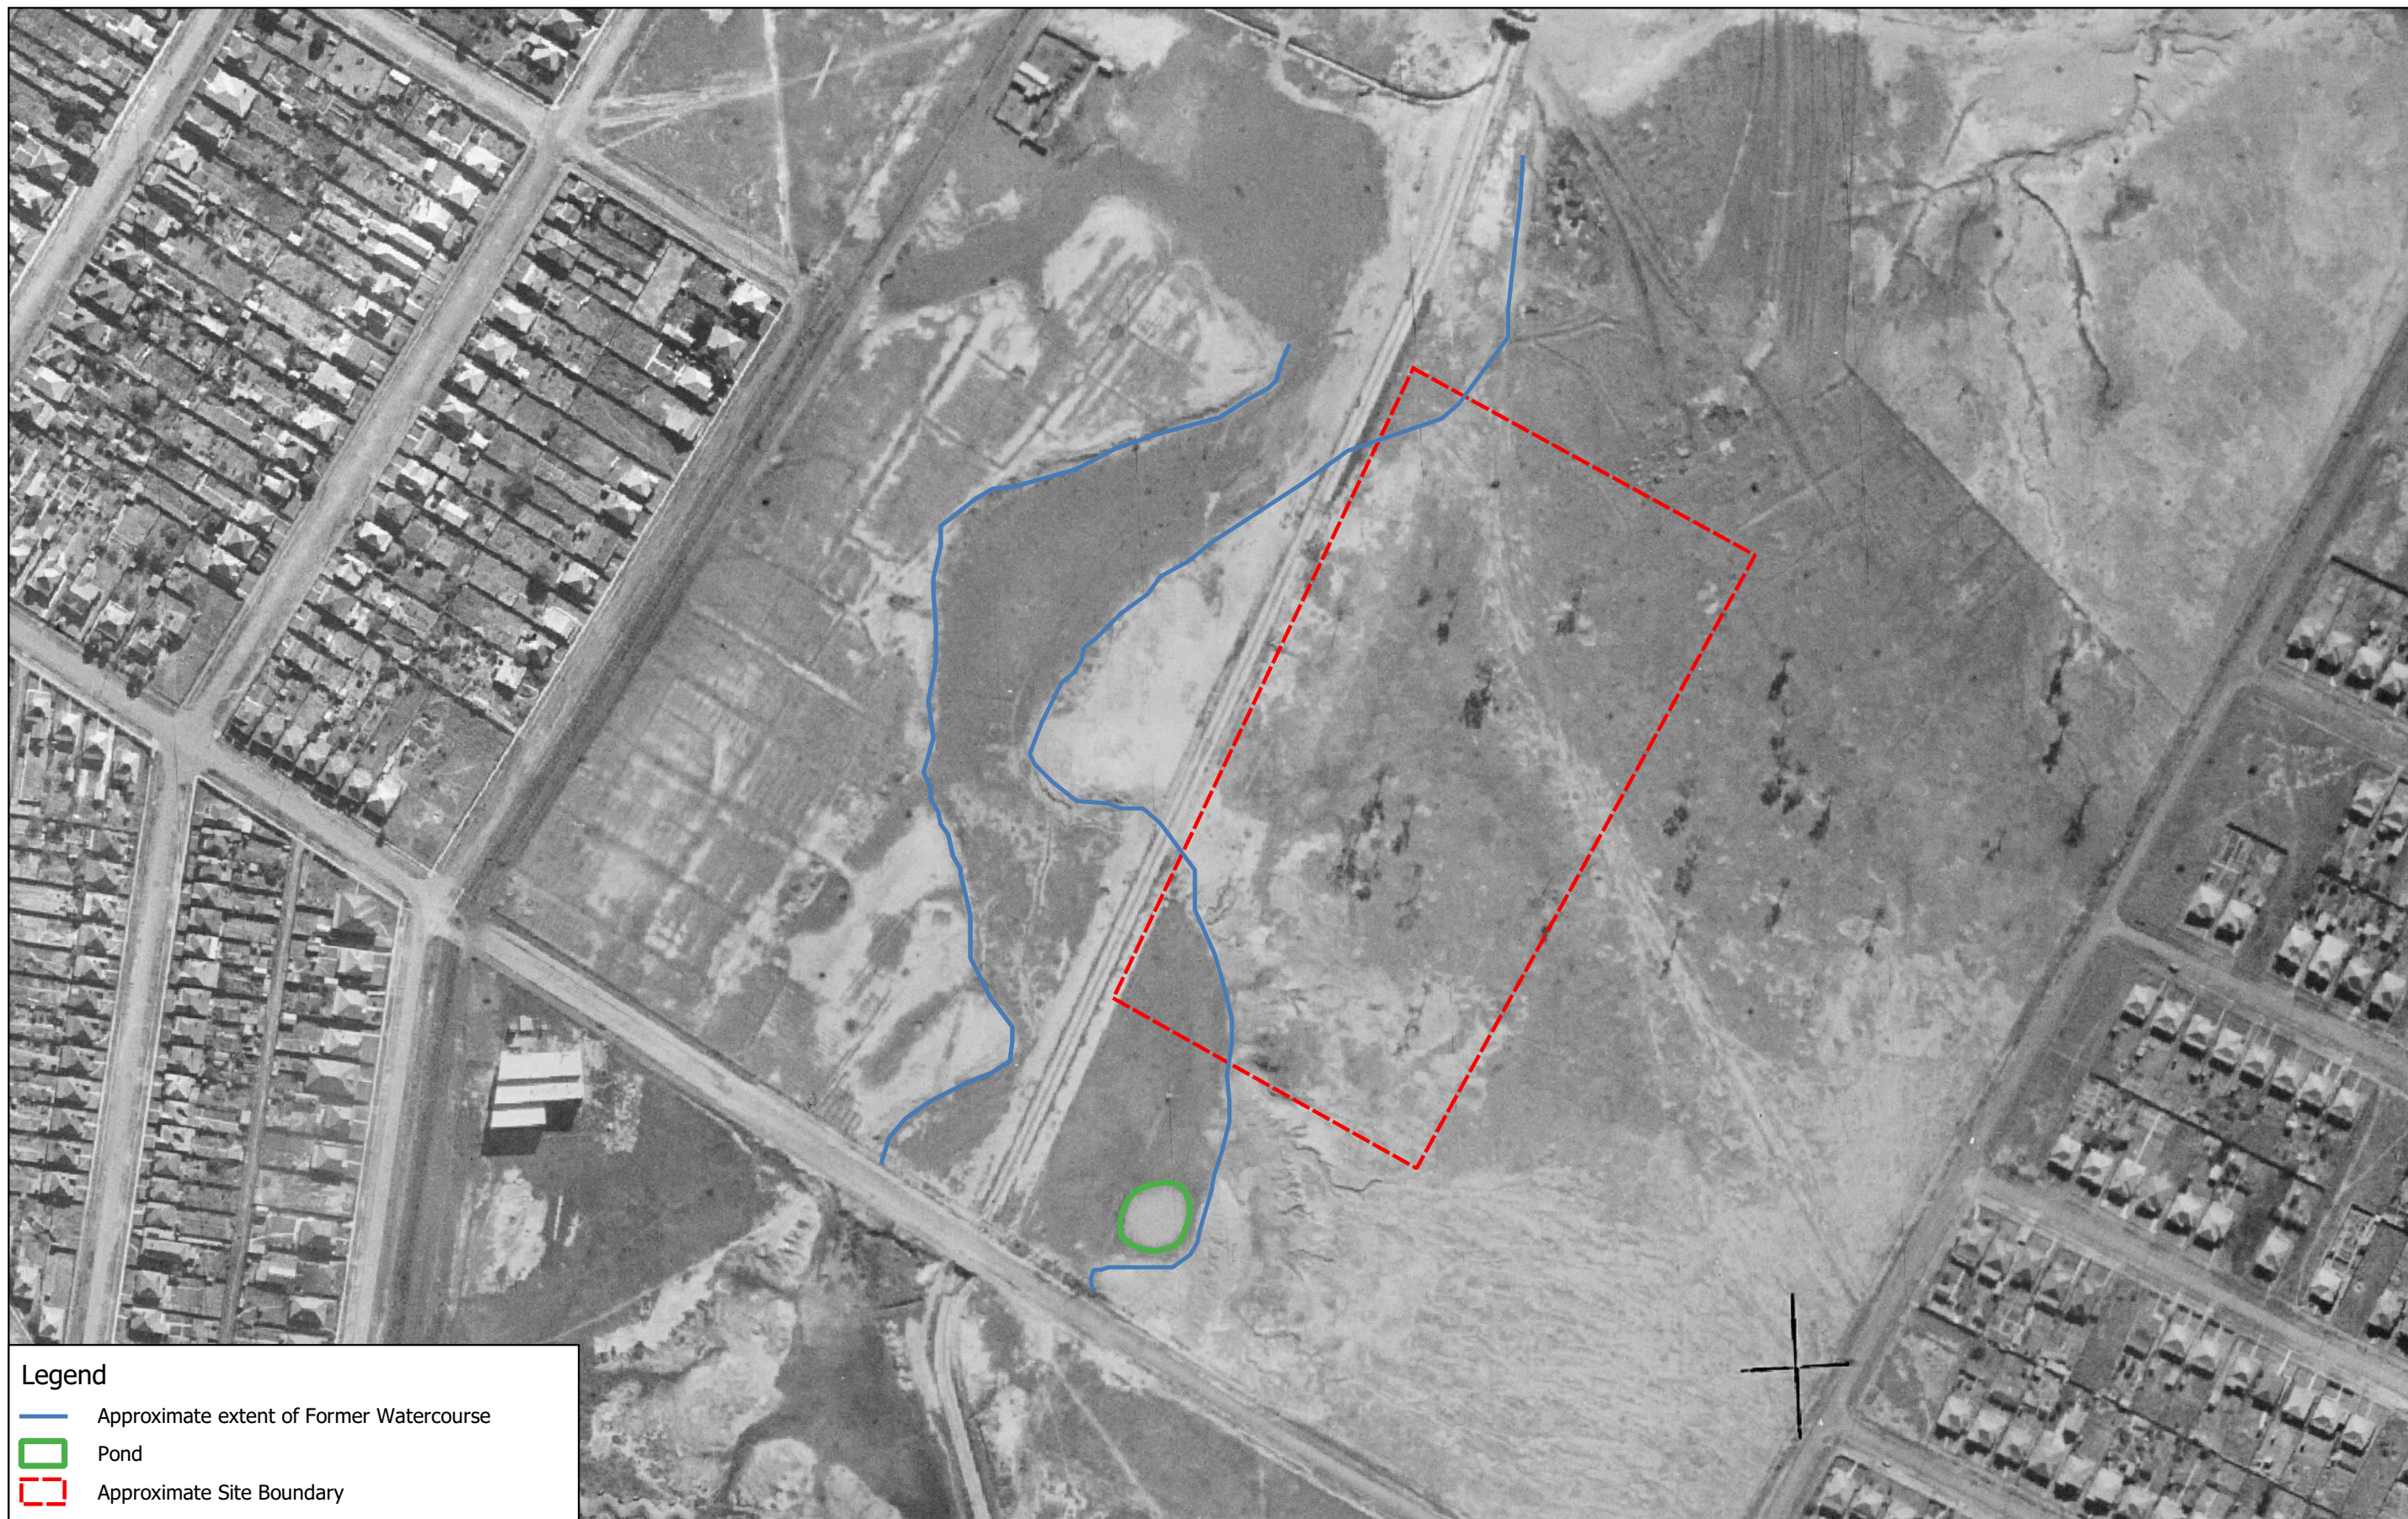
Historical Aerial Photographs

- Approximate extent of Former Watercourse
- Pond
- - - Approximate Site Boundary

A review of the 1943 Aerial Photograph indicates that the culvert was installed between 1919 and 1943. The alignment of the old watercourse is visible in the 1943 and is shown on Drawing 2 in Appendix B.
